**ANNEX G**  
**HAZARDOUS, TOXIC, AND RADIOACTIVE WASTE**

**SUBJECT:** Phase I Environmental Assessment  
Collier (Tract No. 105-024); Peeples (Tract No. 105-022);  
Comprehensive Review Study of the Central and Southern  
Florida Project (Restudy); Glades County

**GLADES COUNTY, FLORIDA**

**SOUTH FLORIDA WATER MANAGEMENT DISTRICT**  
**3932 RCA Boulevard, Suite 3210, Palm Beach Gardens, Florida**

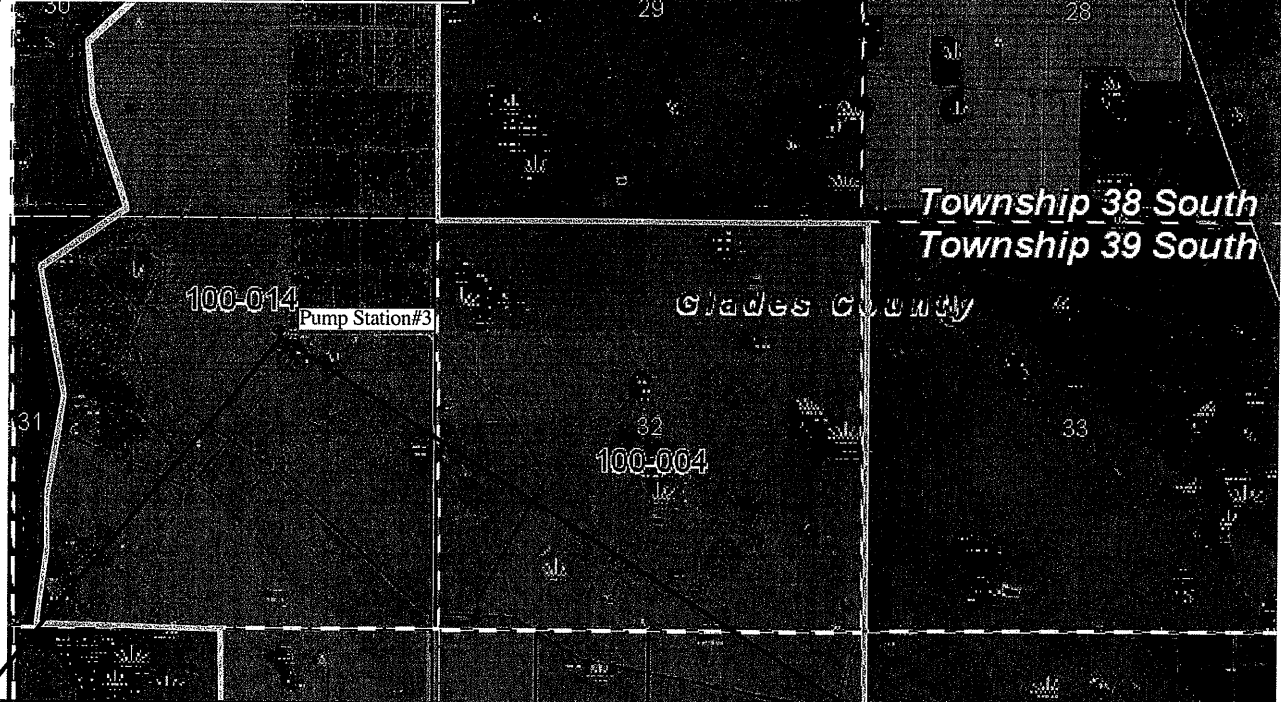
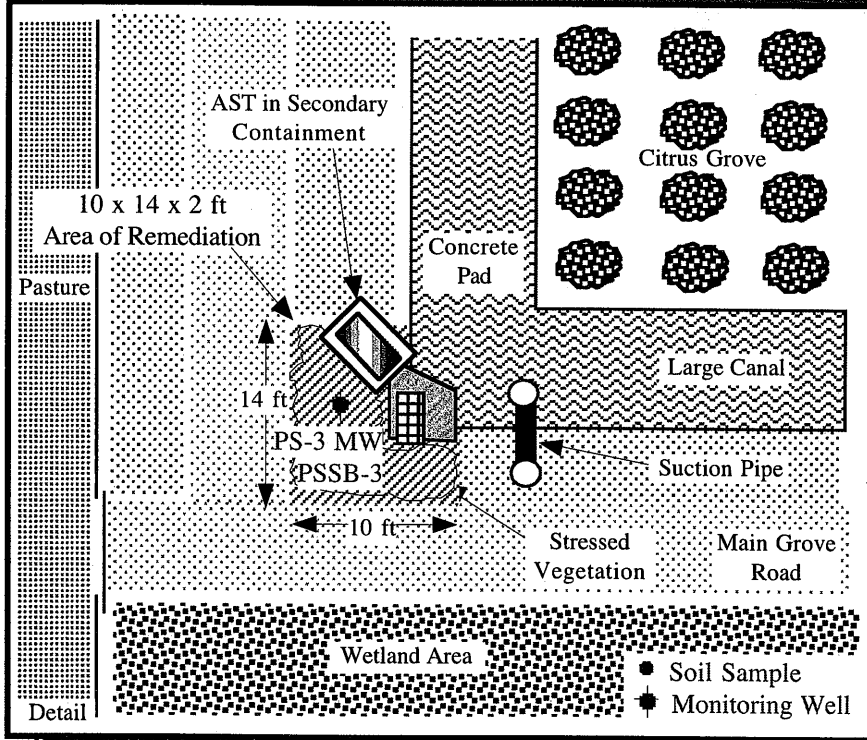
FIGURE 8-2.1  
 PUMP STATION #3 EXTENT OF REMEDIATION  
 PEARCE PROPERTIES, SR 78, BUCKHEAD RIDGE  
 GLADES COUNTY, FLORIDA  
 Source: ECT 2006

Analytes	PSSB-3
Pyrene (ug/kg)	310
TRPH (mg/kg)	9600

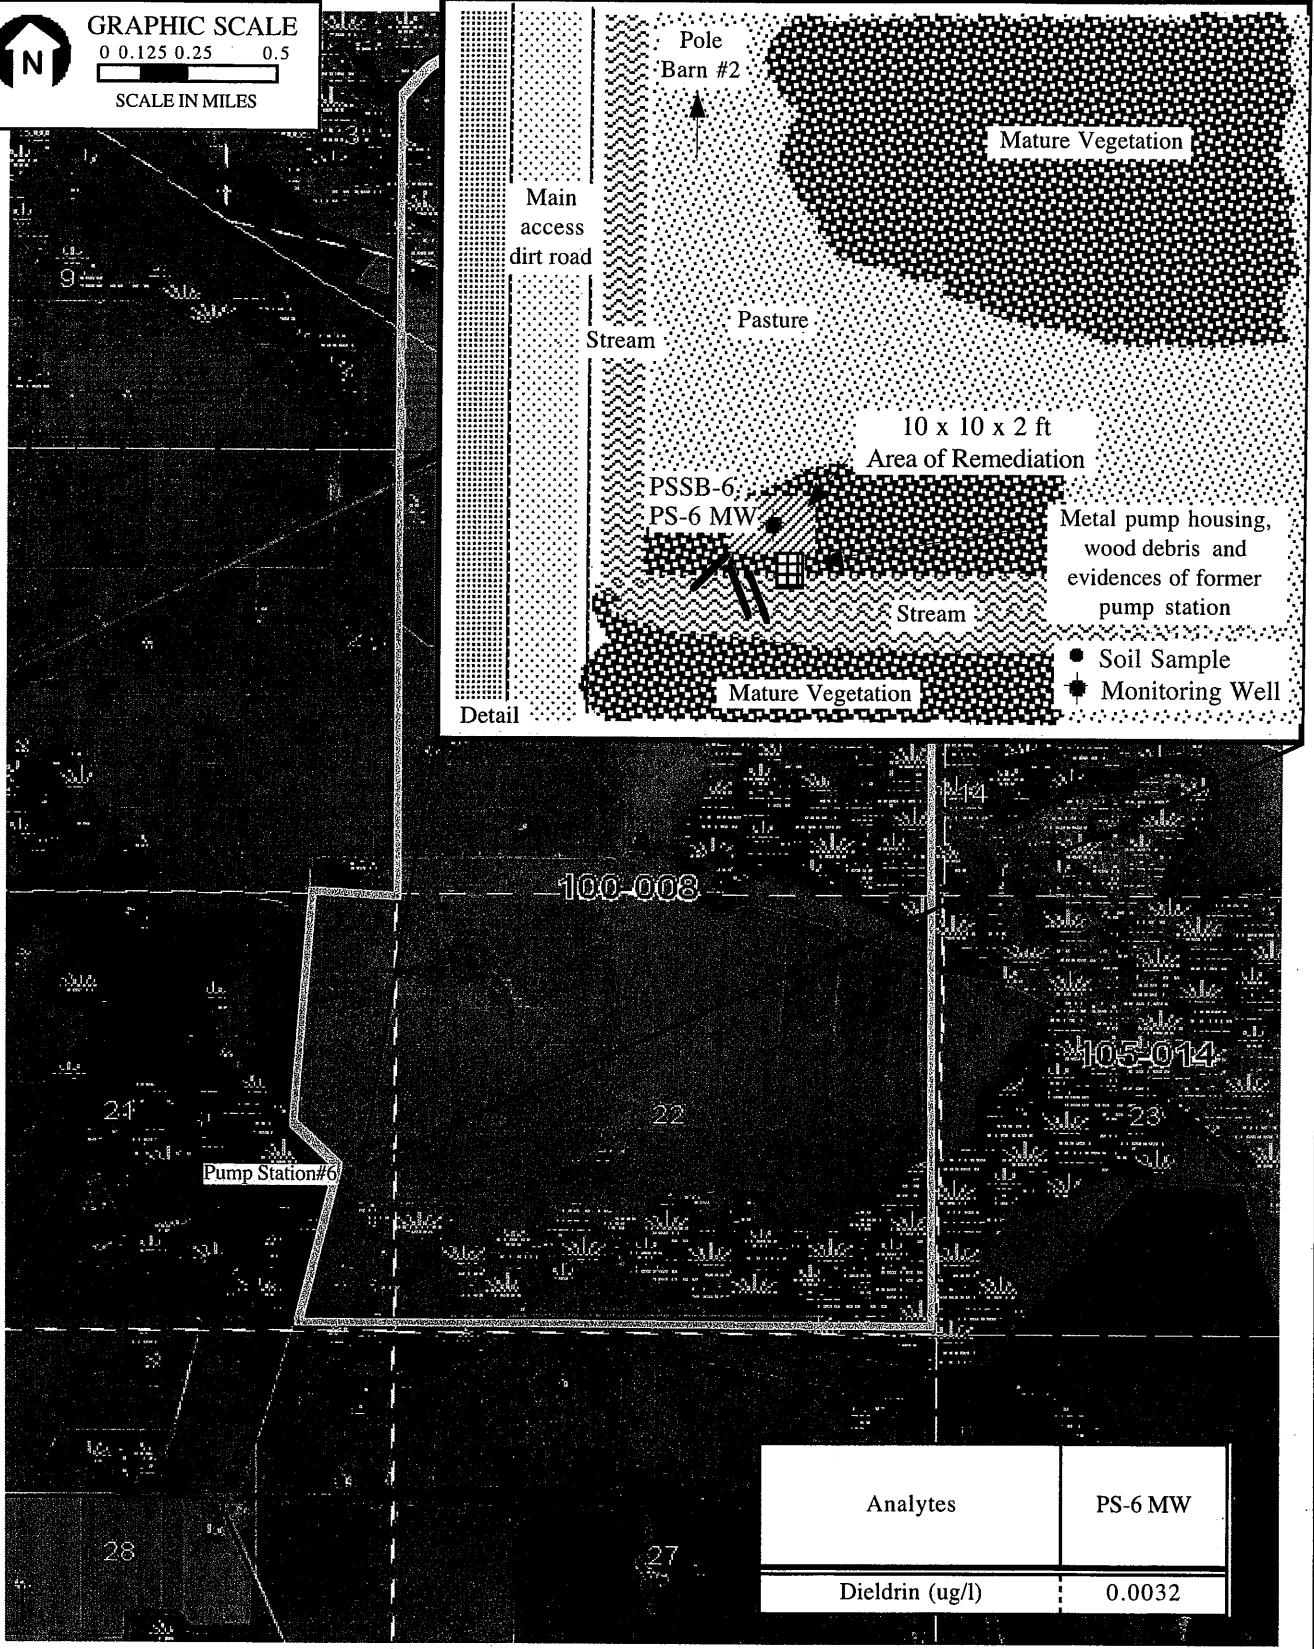
**FIGURE 8-2.2.**  
**PUMP STATION #6 EXTENT OF REMEDIATION**  
 PEARCE PROPERTIES, SR 78, BUCKHEAD RIDGE  
 GLADES COUNTY, FLORIDA  
 Source: ECT 2006

Pump stations #6 and #7 were located on the northern parcel. Neither of these pump stations are operable and consist of remnants and rusted components of former pump station facilities. The abandoned equipment referenced as pump station #6 is located south of dilapidated pole barn #2 and adjacent to a small stream. The rusted equipment included the pump assembly and wood trusses. The abandoned equipment referenced as pump station #7 is located immediately east of cattle pen #2 in the center of the northern parcel. The abandoned equipment includes a rusted AST resting on bare ground, wood, a 55-gallon drum, a crank casing and barbed wire. The area of potential concern is approximately 40 by 20 ft. Figure 2-5.2 illustrates the locations of the pump stations on the northern Pearce property.

Analytes	PS-6 MW
Dieldrin (ug/l)	0.0032

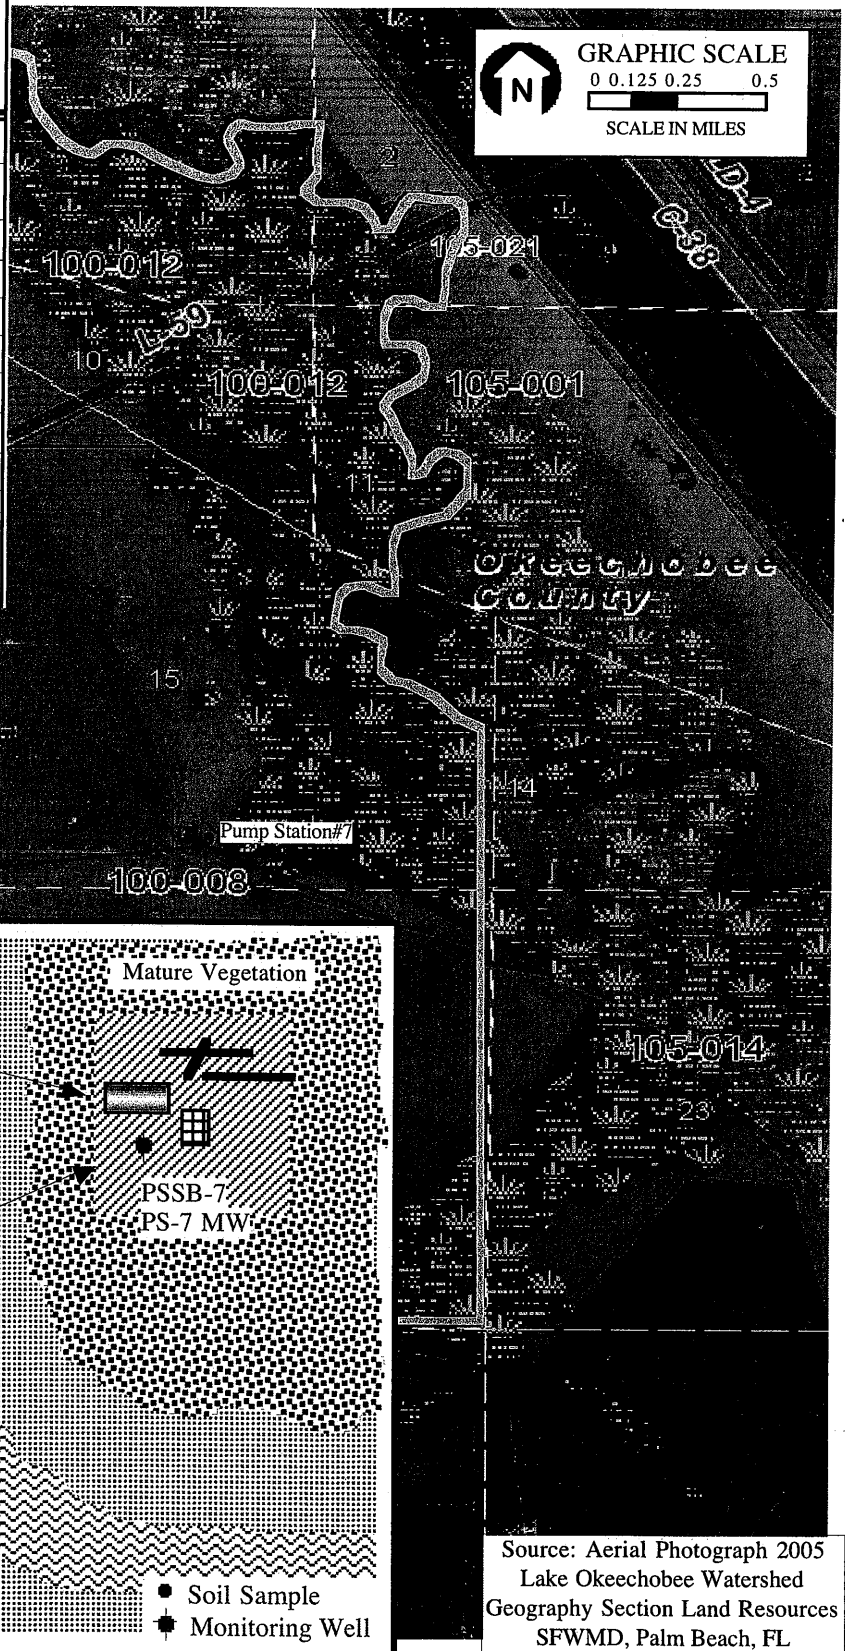
**FIGURE 8-2.3**  
**PUMP STATION #7 EXTENT OF REMEDIATION**  
 PEARCE PROPERTIES, SR 78, BUCKHEAD RIDGE  
 GLADES COUNTY, FLORIDA  
 Source: ECT 2006

Analytes (ug/kg)	PSSB-7
Acenaphthylene	4600
Benzo(a)anthracene	19000
Dibenz(a,h)anthracene	3300
Anthracene	4400
Chrysene	22000
Benzo(b)fluoranthene	37000
Fluoranthene	24000
Phenanthrene	900
Indeno(1,2,3-cd)pyrene	13000
Benzo(a)pyrene	16000
Pyrene	33000
TRPH (mg/kg)	570

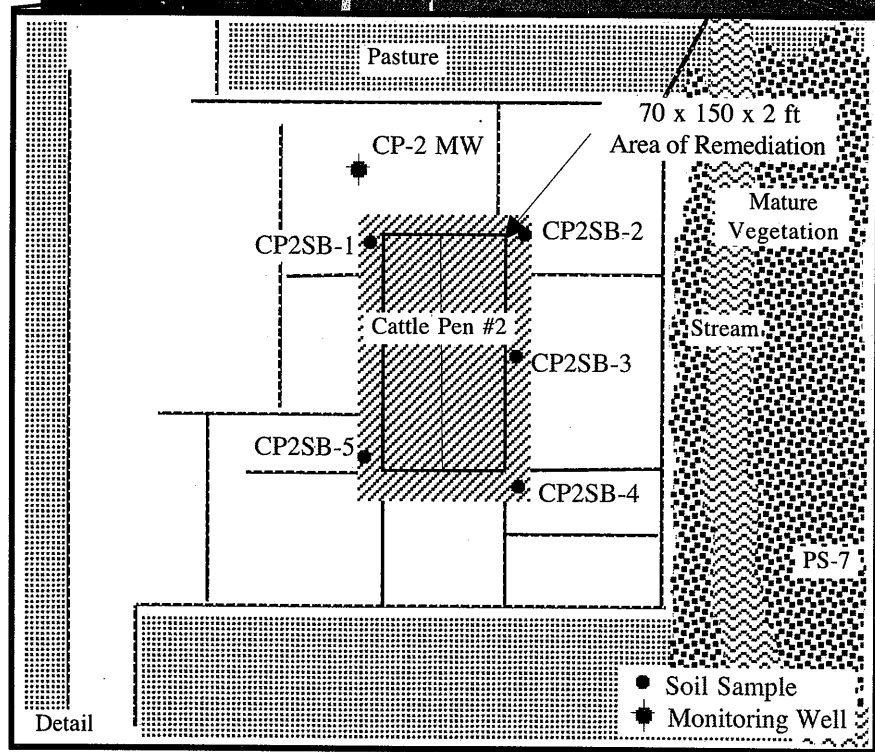
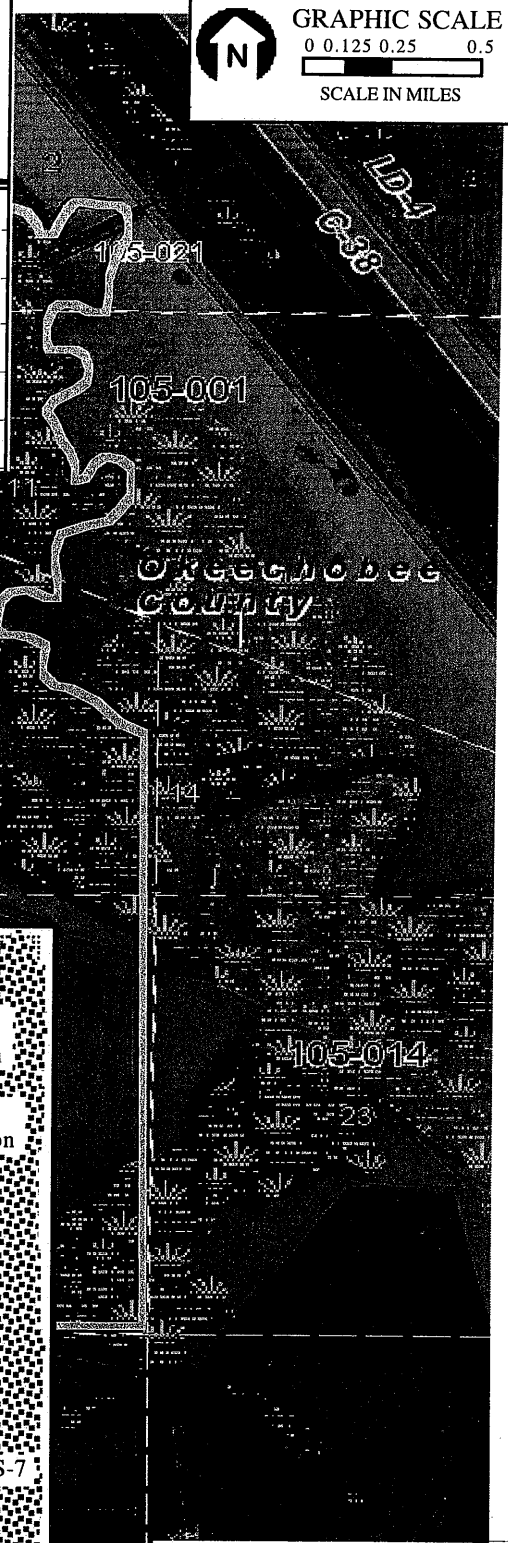
**FIGURE 8-3.2**  
**CATTLE PEN #2 EXTENT OF REMEDIATION**  
 PEARCE PROPERTIES, SR 78, BUCKHEAD RIDGE  
 GLADES COUNTY, FLORIDA  
 Source: ECT 2006

Two cattle pens, designated as cattle pen #1 and cattle pen #2, consisting of fenced compounds and wooden structures were located on the Pearce property. Cattle pen #1 was located near the southwestern boundary of the western parcel and appeared to be operable; cattle pen #2 was centrally located on the northern parcel. The fenced compounds associated with cattle pen #2 appeared to be in good condition; however, the metal roof was collapsed. The approximate dimensions of the area of potential concern for cattle pen #1 were 72 ft by 35 ft. The approximate dimensions of the area of concern for cattle pen #2 were 150 ft by 70 ft. Figure 2-6.1 illustrates the location of cattle pen #1 and 2-6.2 illustrates the location of cattle pen #2.

Analytes	CP-2 MW
Arsenic (ug/l)	12

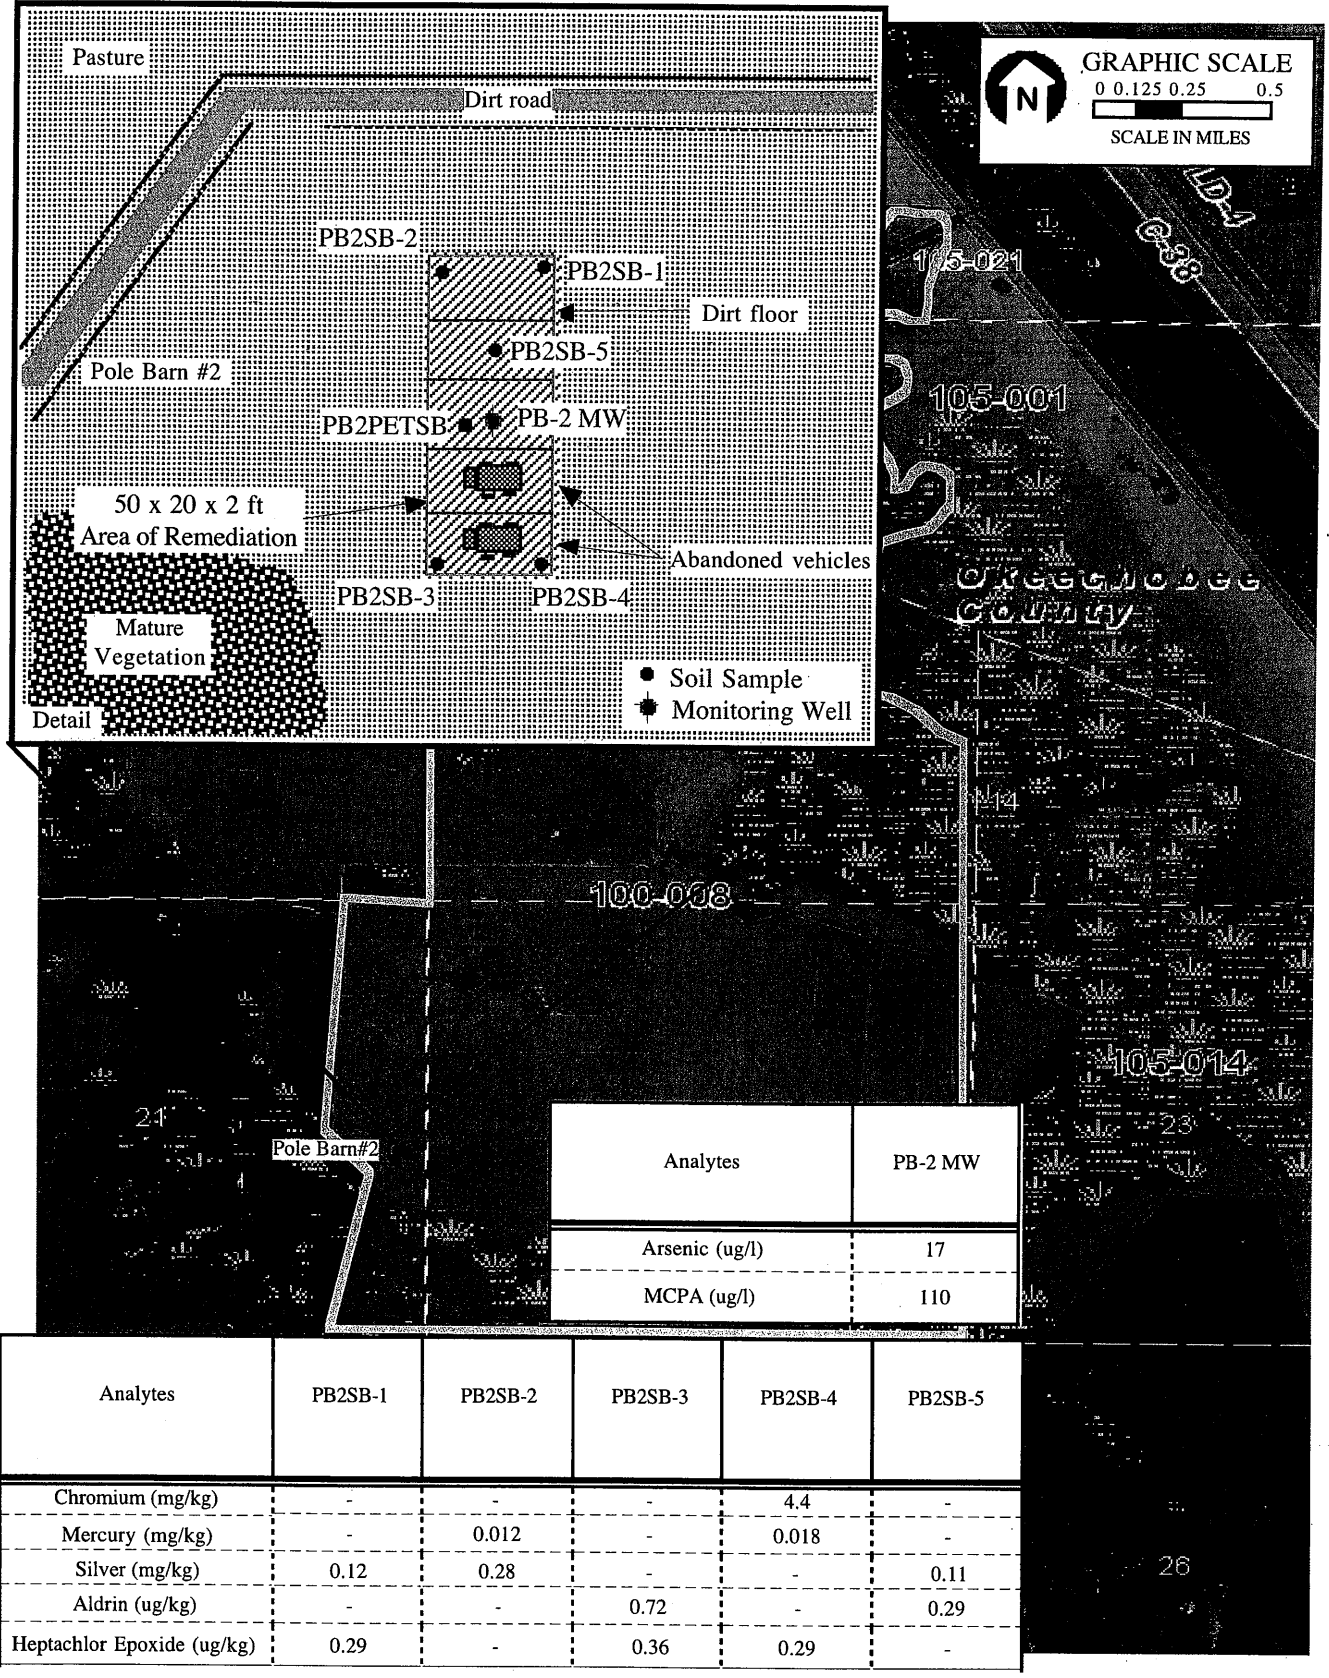
**FIGURE 8-4.2**  
POLE BARN #2 EXTENT OF REMEDIATION  
PROPERTIES, SR 78, BUCKHEAD RIDGE  
GLADES COUNTY, FLORIDA  
Source: ECT 2006

Pole barn #2 was located on the southwestern portion of the northern parcel. Pole barn #2 was dilapidated with no roof or siding present. Rusted and torn sheets of metal were observed on the ground in the vicinity of the pole barn. The wooden frame was still intact and had a dirt floor. The approximate dimensions of pole barn #2 were 20 ft by 50 ft. Figure 2-7.2 illustrates the location of pole barn #2 on the northern parcel.

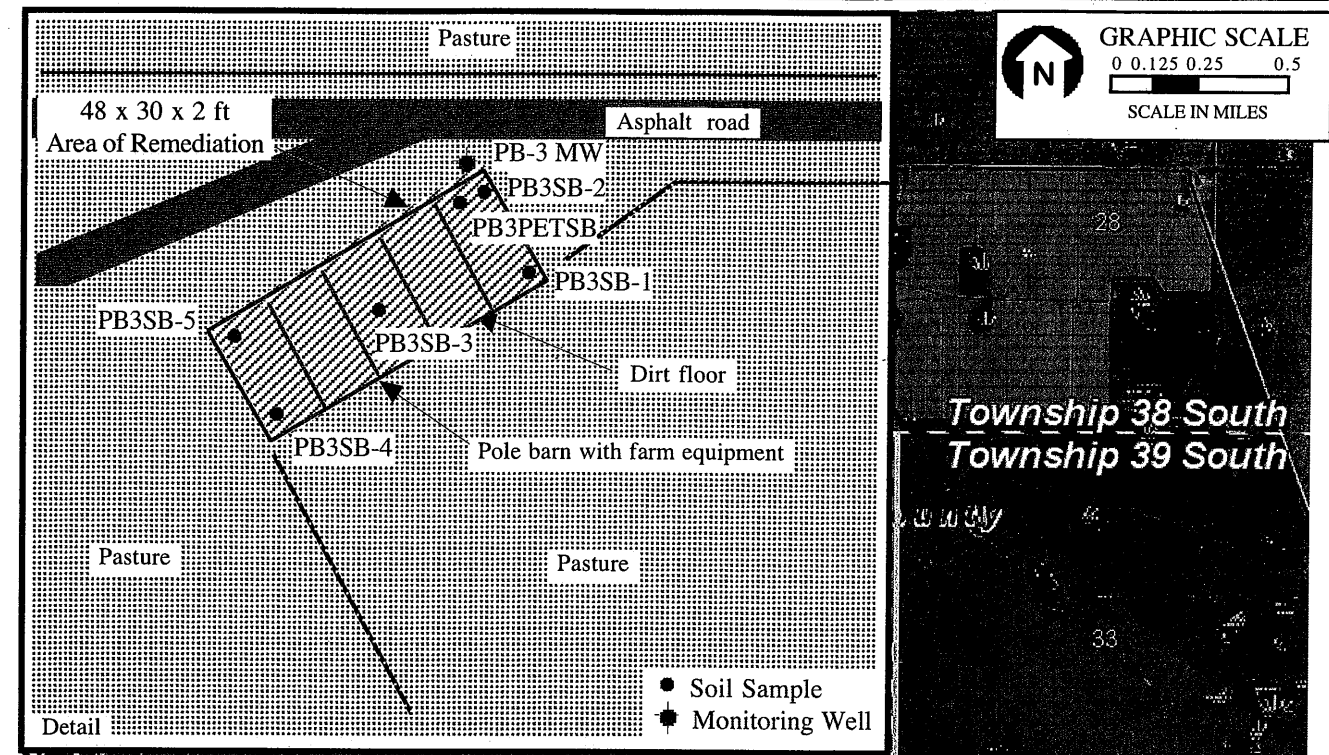
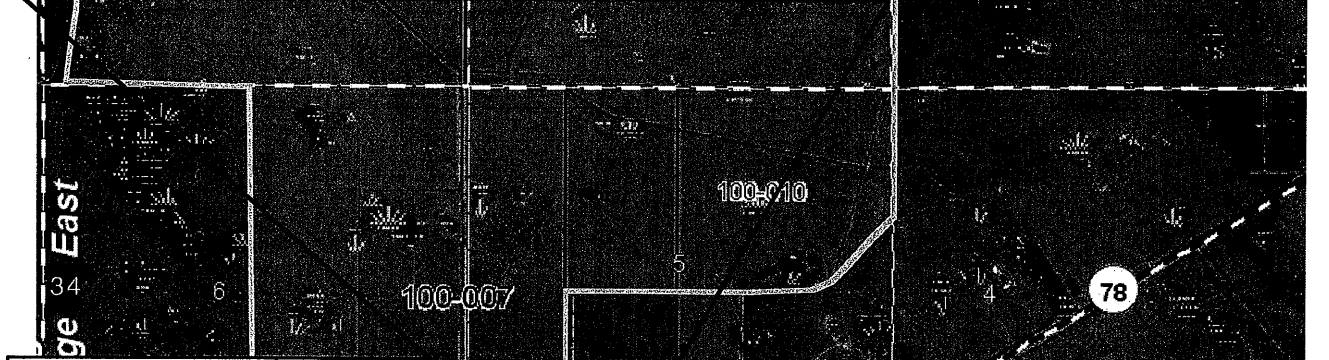
FIGURE 8-4.3  
POLE BARN #3 EXTENT OF REMEDIATION  
PEARCE PROPERTIES, SR 78, BUCKHEAD RIDGE  
GLADES COUNTY, FLORIDA  
Source: ECT 2006

Analytes	PB-3MW
Dieldrin (ug/l)	0.0024

Analytes	PB3SB-1	PB3SB-2	PB3SB-3	PB3SB-4	PB3SB-5
Arsenic (mg/kg)	2.5	3	-	-	2.9
Chromium (mg/kg)	4.3	-	-	-	-
Mercury (mg/kg)	-	-	-	-	0.012
Silver (mg/kg)	-	0.13	0.14	-	-
Aldrin (ug/kg)	-	-	0.25	0.23	-
Endosulfan Sulfate (ug/kg)	0.84	-	-	-	-
Fensulfothion (ug/kg)	9.4	-	-	-	-
Heptachlor Epoxide (ug/kg)	-	0.23	-	-	-

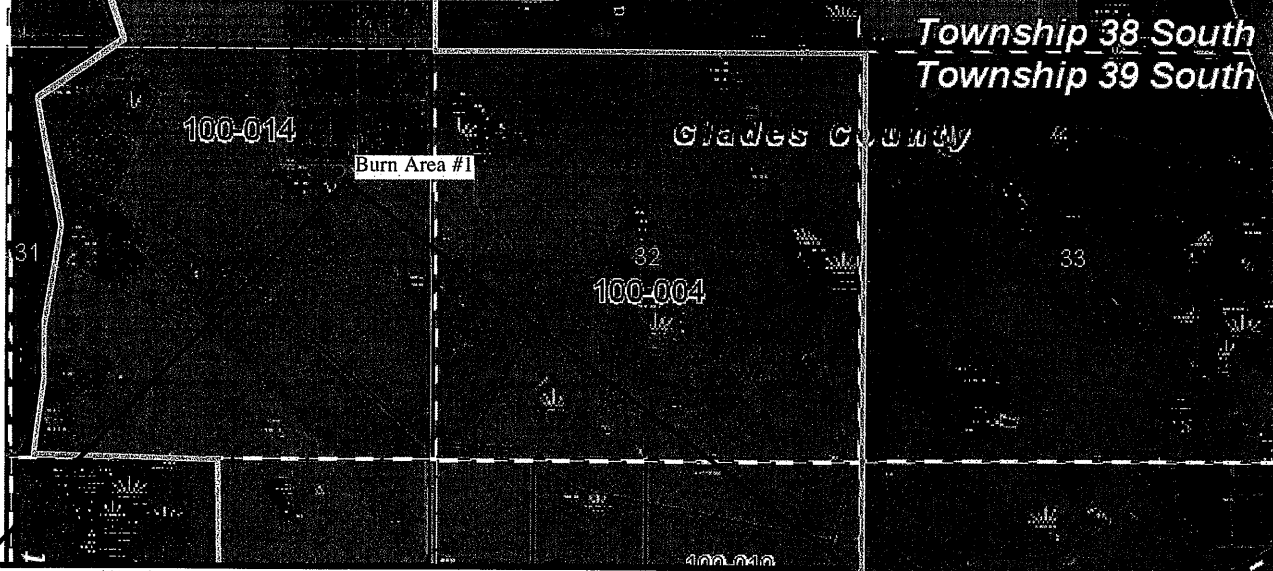
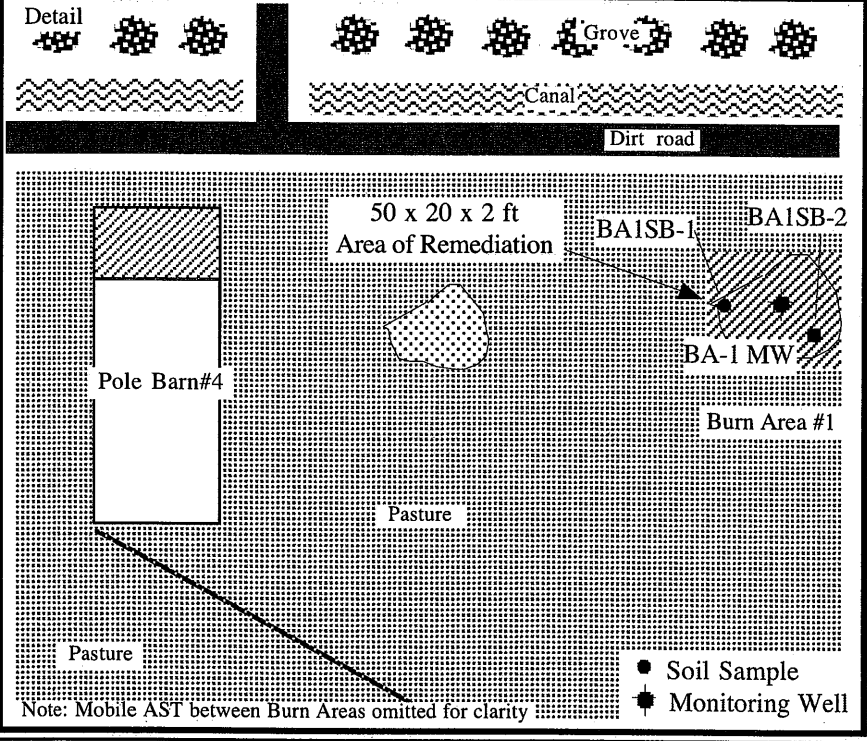
**FIGURE 8-6.1**  
 BURN AREA #1 EXTENT OF REMEDIATION  
 PEARCE PROPERTIES, SR 78, BUCKHEAD RIDGE  
 GLADES COUNTY, FLORIDA  
 Source: ECT 2006

Two (2) burn areas were centrally located on the western parcel, just east of pole barn #4, designated burn area #1 and burn area #2. The burn areas were characterized by burn residue and evidence of burnt/charred wood. The clearing in which burn area #1 occupied was approximately 20 ft by 50 ft; burn area #2 was approximately 14 ft by 24 ft. Figure 2-9 illustrates the burn area. The location of the burn areas was also notable as the former location of a large pole barn (2002 aerial photograph).

Analytes	BA1SB-1	BA1SB-2
Arsenic (mg/kg)	16	9.4
Chromium (mg/kg)	8.4	5.2
Mercury (mg/kg)	0.012	-
Silver (mg/kg)	0.1	-
Aldrin (ug/kg)	-	0.35
Dieldrin (ug/kg)	0.39	-
