## **Audit of Operations and Maintenance Capital Program**

**Project #17-06**

# SOUTH FLORIDA WATER MANAGEMENT DISTRICT

Re: Audit of Operations and  
Maintenance Capital Program  
*Project No. 17-06*

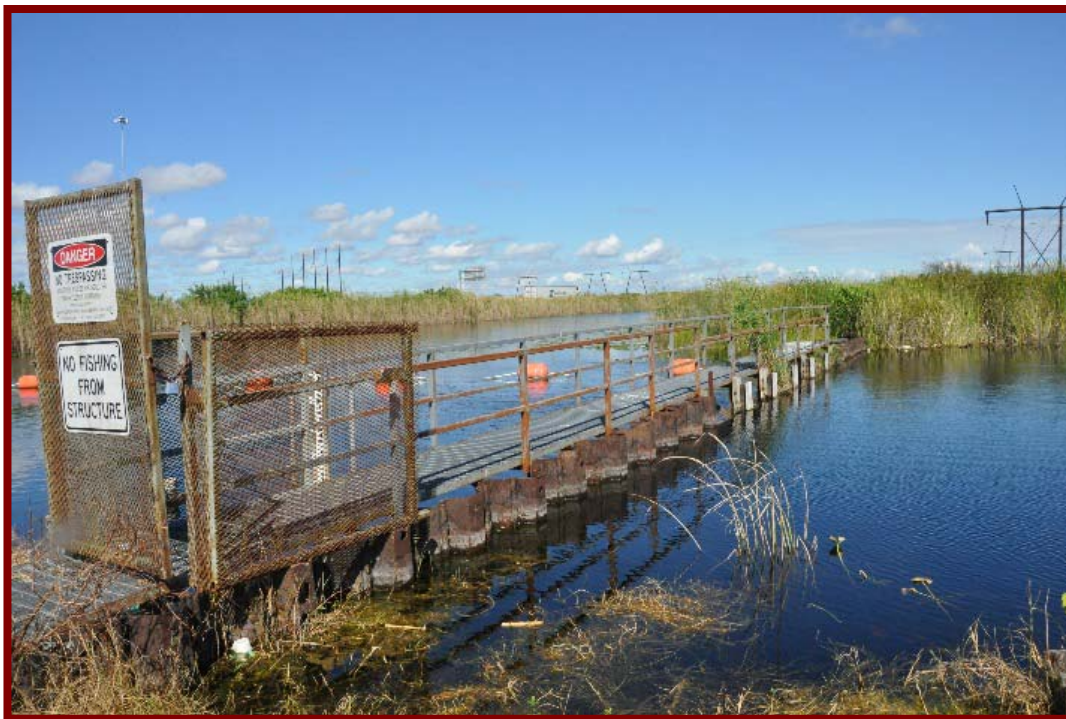
#### **S-141 Weir Unsafe Structure Condition**

Replacement of this structure was recommended by IMS in Fiscal Year 2007 and again in 2014. According to IMS staff, replacement was not initiated in 2007 because of other higher priority projects. However, as of June 2017, the replacement is in process. Due to extensive corrosion of the steel structure, the structure was not functional and impeded access to the levee around WCA 2B. In addition, the equipment platform was unsafe due to deterioration of the structural joints, about 30% of the platform was missing, and the flashboard risers were heavily rusted. In addition, the old structure was not designed for pedestrian traffic and was frequently trespassed. The replacement structure incorporates pedestrian traffic. An example of the structure's original condition is shown in the following photograph.

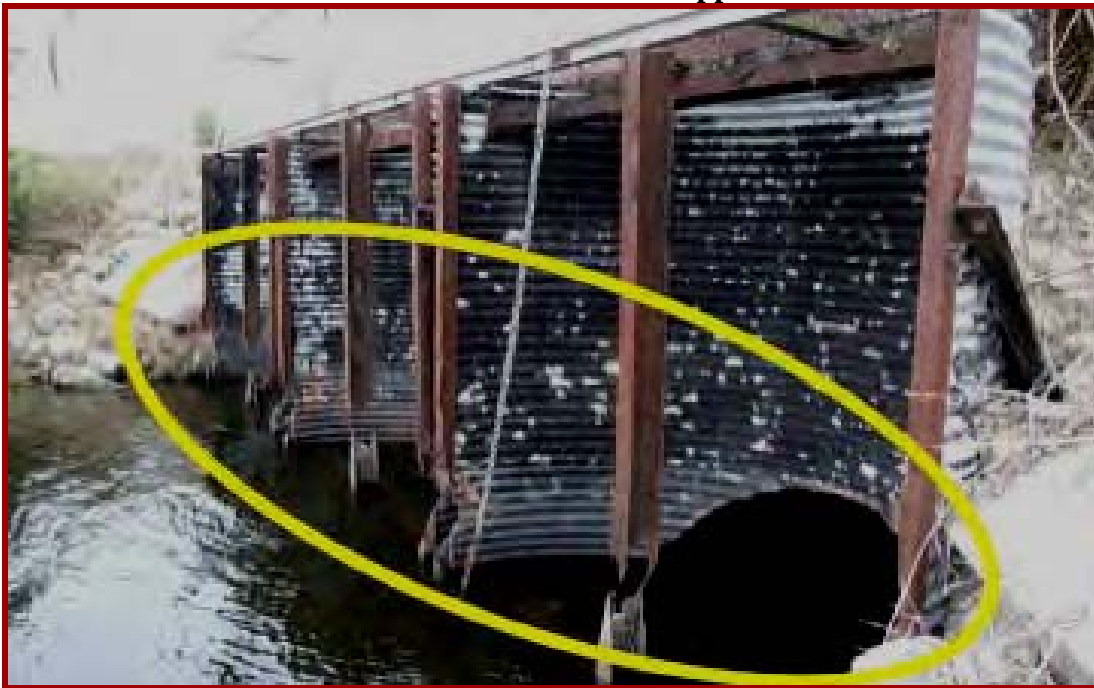
**S-39A Culvert  
Rusted Platform Support**

This structure together with S-38B, controls the seepage rate from Conservation Area 2A by regulating the water level in the north half of the Levee 36 borrow canal. This structure was rated C-5 in 2014 because it was dilapidated; for example, the culvert barrels were heavily rusted, the platform was unstable, and the flashboard risers were rusted through. This structure was also rated C-5 in 2007 and replacement of the entire structure was recommended to restore normal operations and for personnel safety. According to IMS staff, the 2007 issues were not addressed because the Army Corps of Engineers planned to include this structure in the Site 1 Reservoir project; however, the project has been delayed. As a result, the District proceeded with replacement. As of June 2017, this structure is being replaced and automated. An example of the structure's original condition is shown in the following photograph.

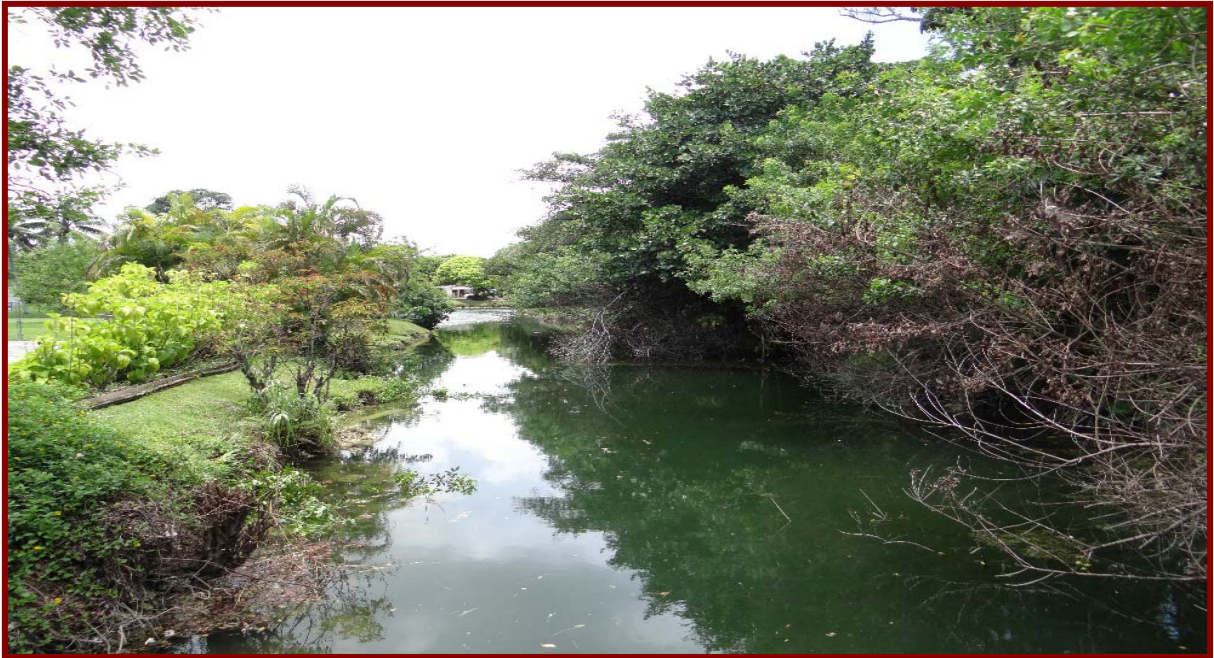
**C-100A Canal in Miami-Dade County  
September 2016 – Before Vegetation Removal**

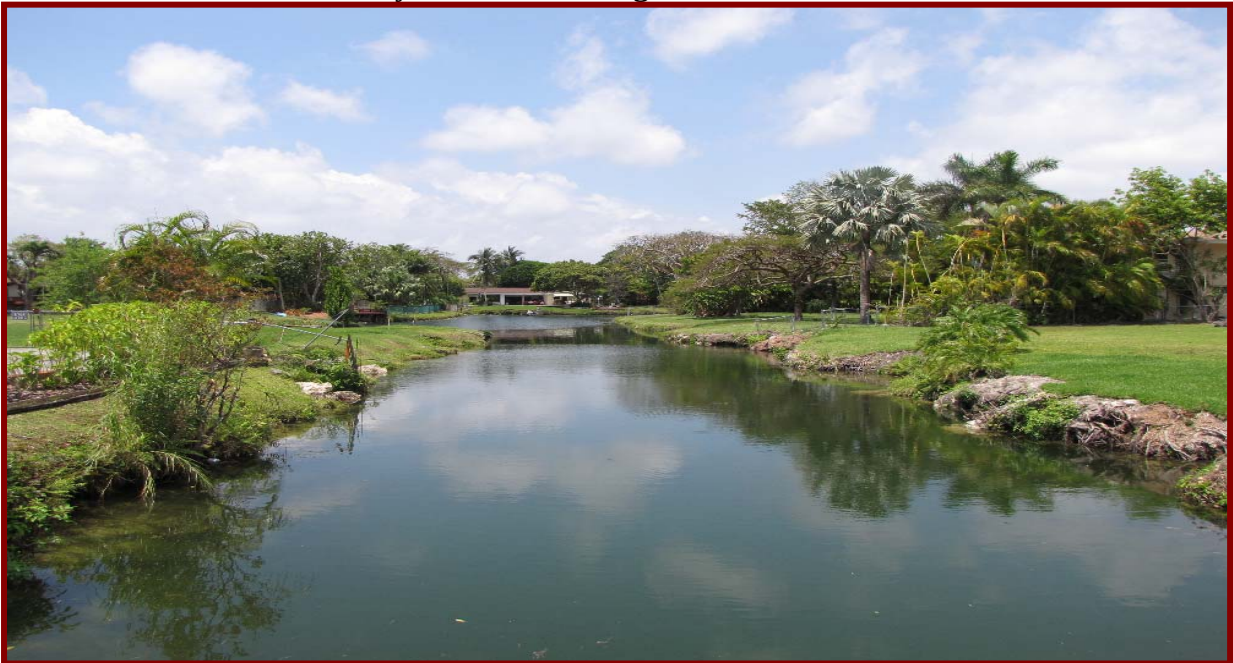
**C-100A Canal in Miami-Dade County  
February 2017 – After Vegetation Removal**

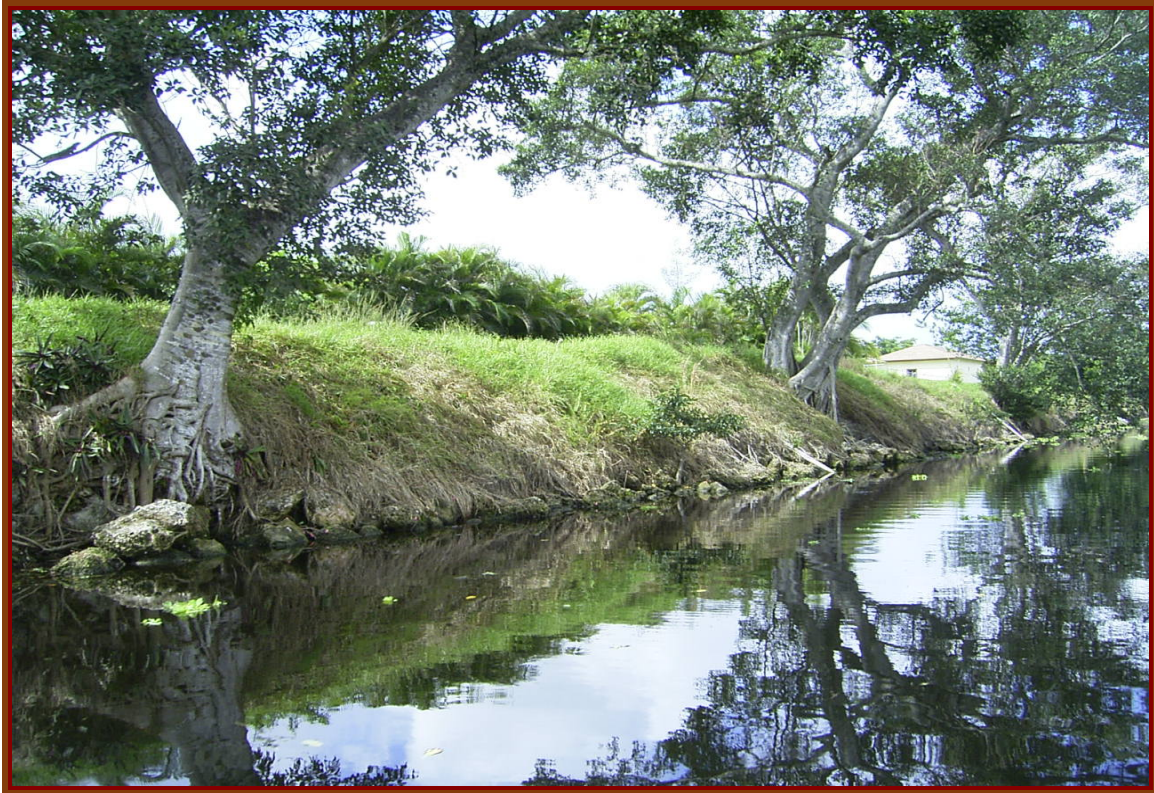
- **Hillsboro Canal:** This canal flows along the county line between Palm Beach and Broward counties. Through inspections, the District identified the need for major repairs due to bank erosion, sediment buildup, and heavy vegetation. As a result, a multi-year effort is underway to ensure a 10.5-mile section of the canal will effectively move water for a 50-year period. The District has spent \$14.3 million to complete two of the three phases of this project which included bank stabilization and dredging a one-mile section. The design for the remaining phase (three miles) has been completed and construction cost is estimated at about \$7 million; however, the Engineering and Construction Bureau is assessing whether to complete this phase because it does not pose a high risk to the public. Further, this segment may be incorporated as part of the Site 1 Impoundment project.

**Example of Canal Segment to be Rehabilitated (Tree Removal and Bank Stabilization) Needed Along the Hillsboro Canal**
