# Evaluation Report

## Repair, Maintenance and Transition Plan

# US Sugar Corporation

# South Florida Water Management District

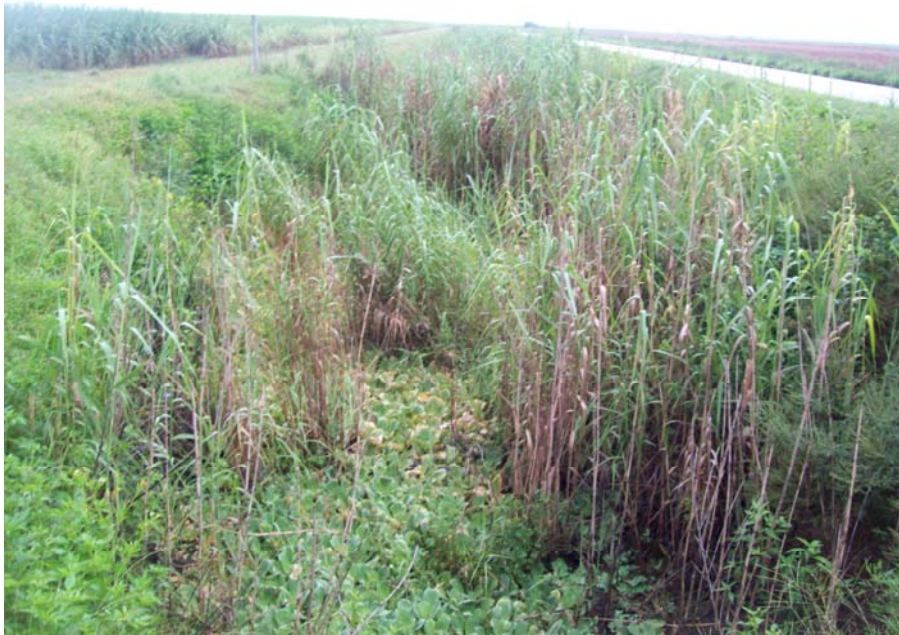
<p><b>Photographer</b> Nicolas Moran</p> <p><b>Date</b> August 6 - August 24, 2008</p> <p><b>Direction</b> North</p> <p><b>Comments</b> Embankment conditions were also considered in the canal grade. This embankment is in good (green) condition. Embankment walls are stable displaying little or no wear and no visible signs of erosion. However, the heavy vegetation would result in an amber canal grade.</p>

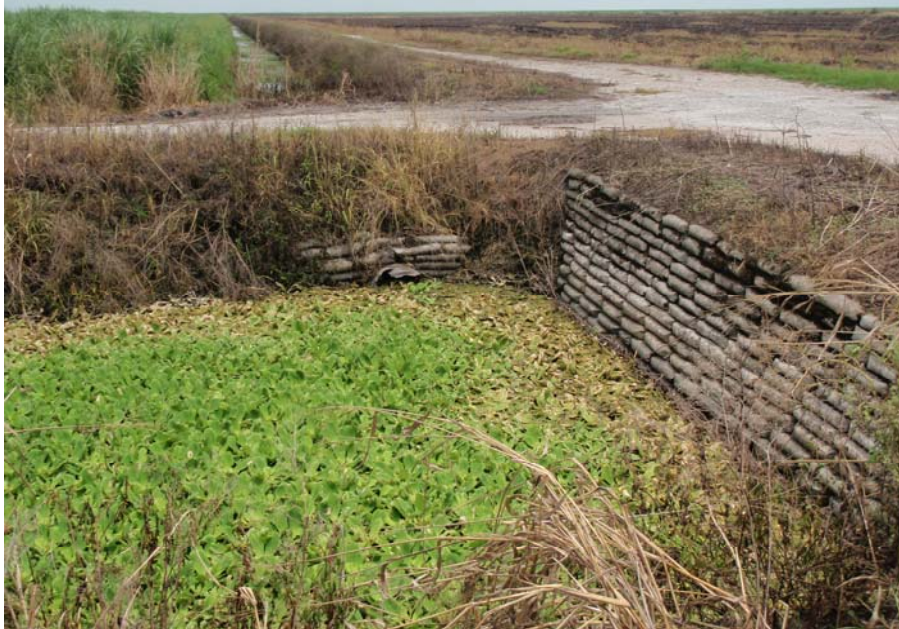
<p><b>Site Name: US Sugar Corporation</b></p>	<p><b>Site Location: Clewiston, Florida</b></p>
<p><b>Photographer</b> Nicolas Moran</p> <p><b>Date</b> August 6 - August 24, 2008</p> <p><b>Direction</b> West</p> <p><b>Comments</b> This embankment is in fair (amber) condition likely requiring repair in the near future. Embankment stability is compromised by erosion around and under embankment wall. Erosion is not currently a threat to road safety.</p>

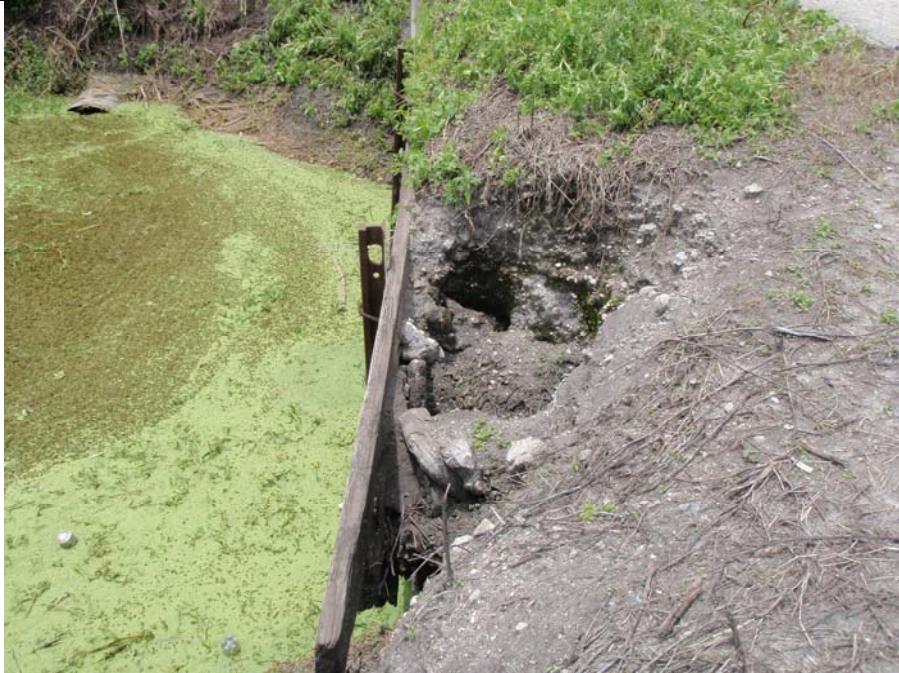
<p>A photograph showing a cross-section of an embankment. On the left, there is a body of water covered in a thick layer of bright green algae. A weathered wooden structure, possibly a culvert or part of a road barrier, runs vertically through the center. To the right of the structure, the embankment has eroded, showing exposed soil, roots, and some sparse vegetation. The top of the embankment is covered with green grass and weeds.</p>
<p><b>Photographer</b> Nicolas Moran</p> <p><b>Date</b> August 6 - August 24, 2008</p> <p><b>Direction</b> East</p> <p><b>Comments</b> This embankment is in poor (red) condition requiring immediate repair. Embankment wall has collapsed and blocked the culvert, limiting water movement.</p>

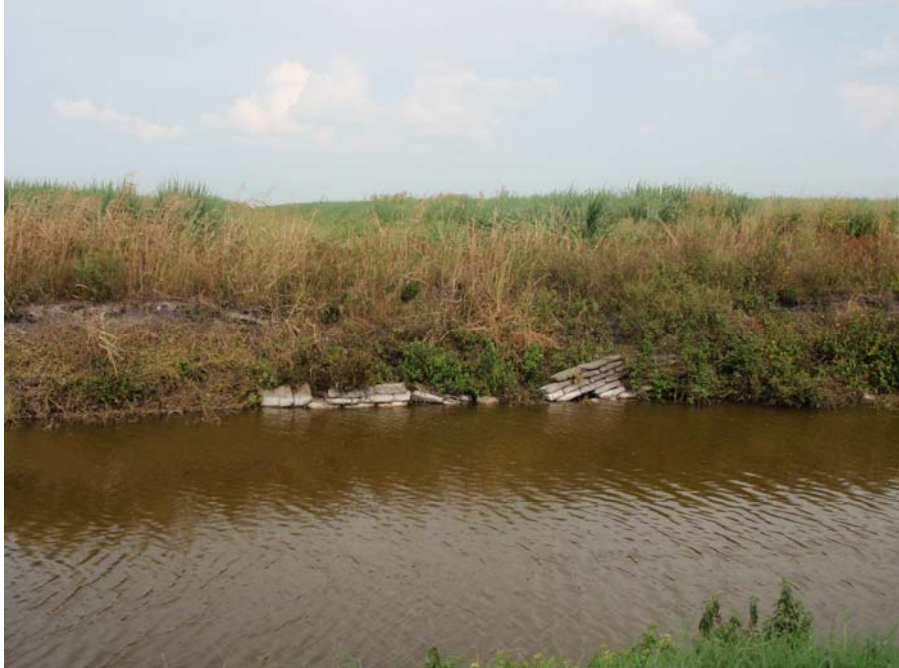
<p>A wide-angle photograph of a waterway. The water is dark brown and calm. In the background, a grassy embankment has collapsed, with a large pile of logs and debris blocking the path of a culvert. The sky is overcast with grey clouds.</p>

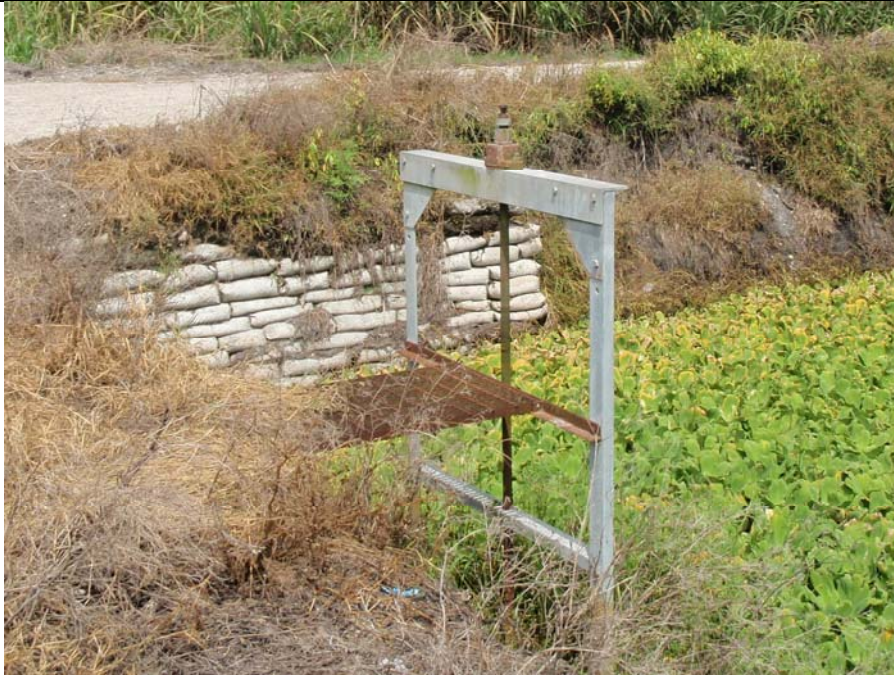
<p><b>Photographer</b> Nicolas Moran</p> <p><b>Date</b> August 6 - August 24, 2008</p> <p><b>Direction</b> North</p> <p><b>Comments</b> A culvert with a green grade. Culvert is solid with little or no corrosion on pipe. In addition, the culvert is free and clear of obstructions.</p>

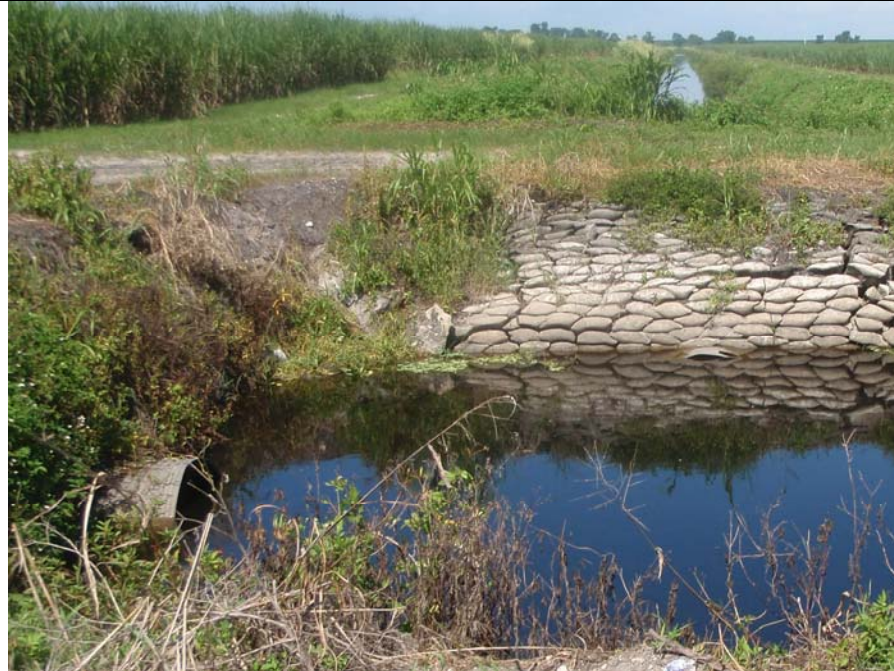
<p><b>Site Name: US Sugar Corporation</b></p>	<p><b>Site Location: Clewiston, Florida</b></p>
<p><b>Photographer</b> Nicolas Moran</p> <p><b>Date</b> August 6 - August 24, 2008</p> <p><b>Direction</b> East</p> <p><b>Comments</b> A culvert with an amber grade. Corrosion is beginning to form at the water line and vegetation is blocking the riser and culvert.</p>

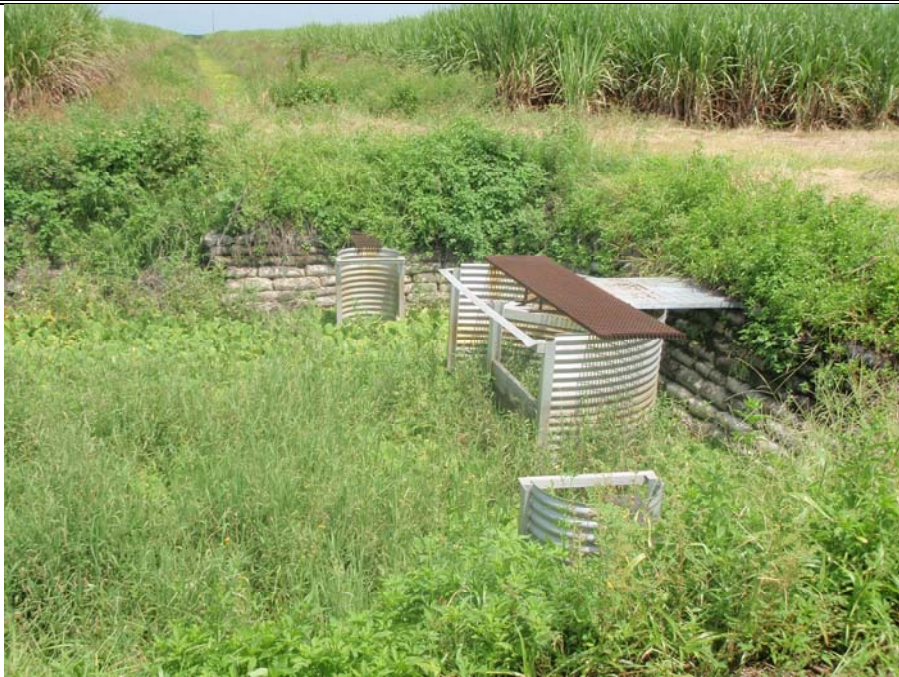
<p><b>Photographer</b> Nicolas Moran</p> <p><b>Date</b> August 6 - August 24, 2008</p> <p><b>Direction</b> West</p> <p><b>Comments</b> A culvert with a red grade. Riser has corroded completely through, leaving the riser non-functional to the intended design.</p>

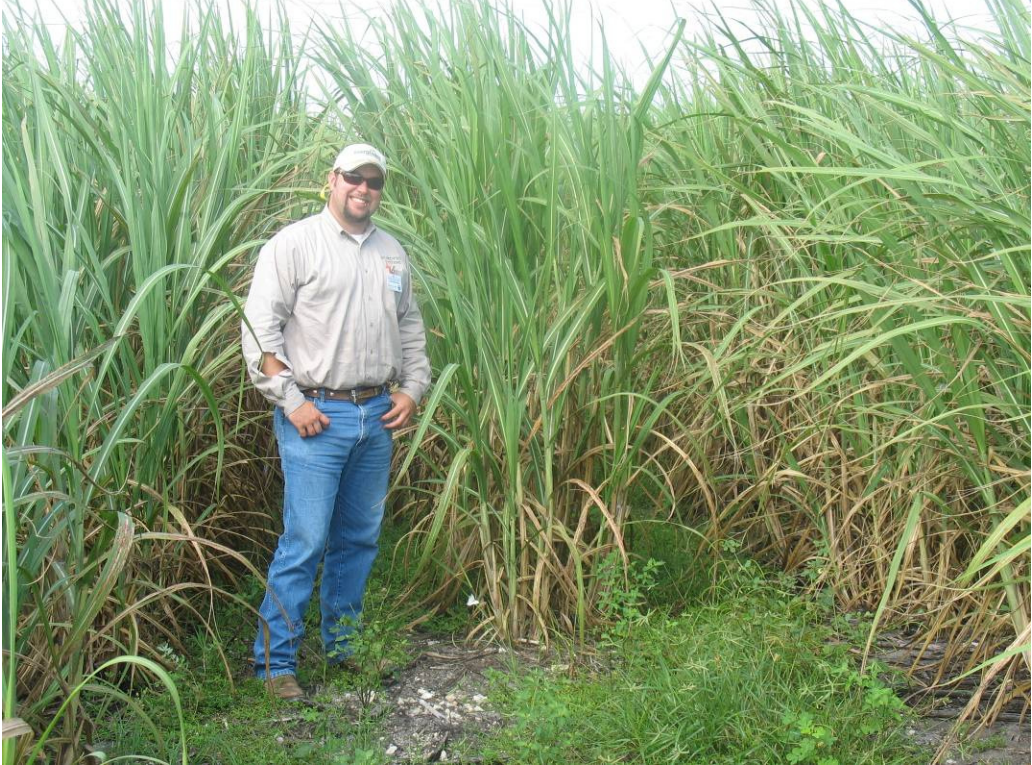
A man wearing a light-colored button-down shirt, blue jeans, a white cap, and sunglasses stands in a field of tall, green sugar cane stalks. The stalks are dense and reach above his head. The ground is sandy and has some low-lying green weeds.
<b>Photographer</b> B. Whiteley <b>Date</b> 9/25/2008 <b>Direction</b> West <b>Comments</b> Poor Cane on Sand. Overview.

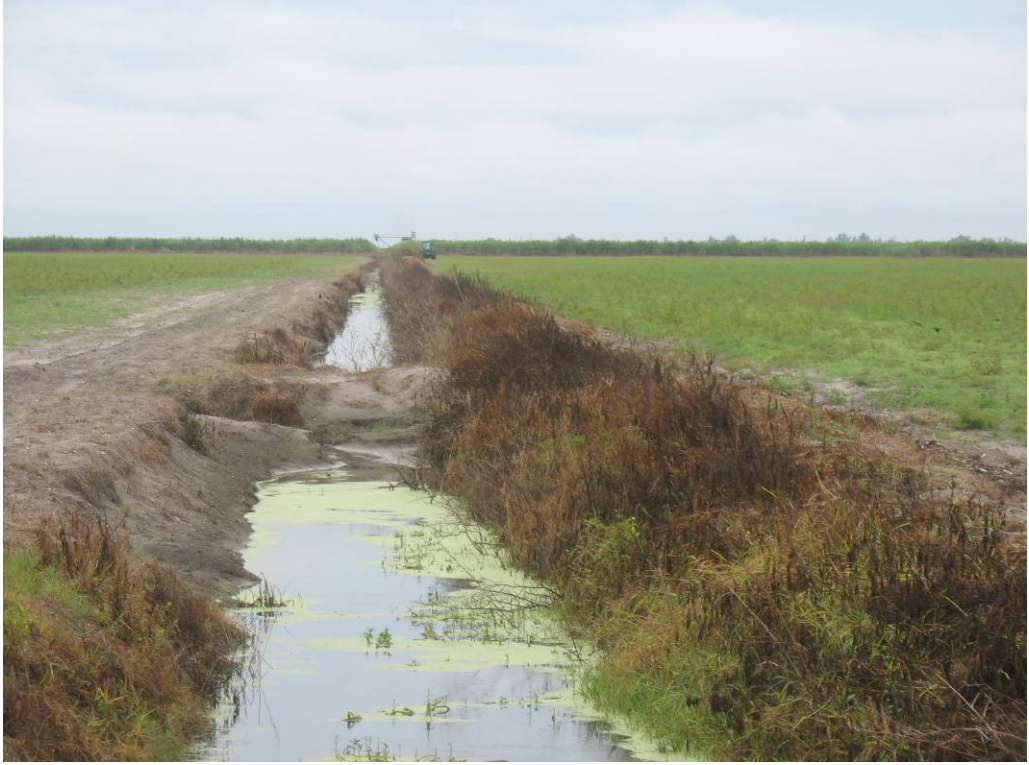
<b>Photographer</b> B. Whiteley <b>Date</b> 9/29/2008 <b>Direction</b> South <b>Comments</b> Excellent Cane. Ditch Blocked.

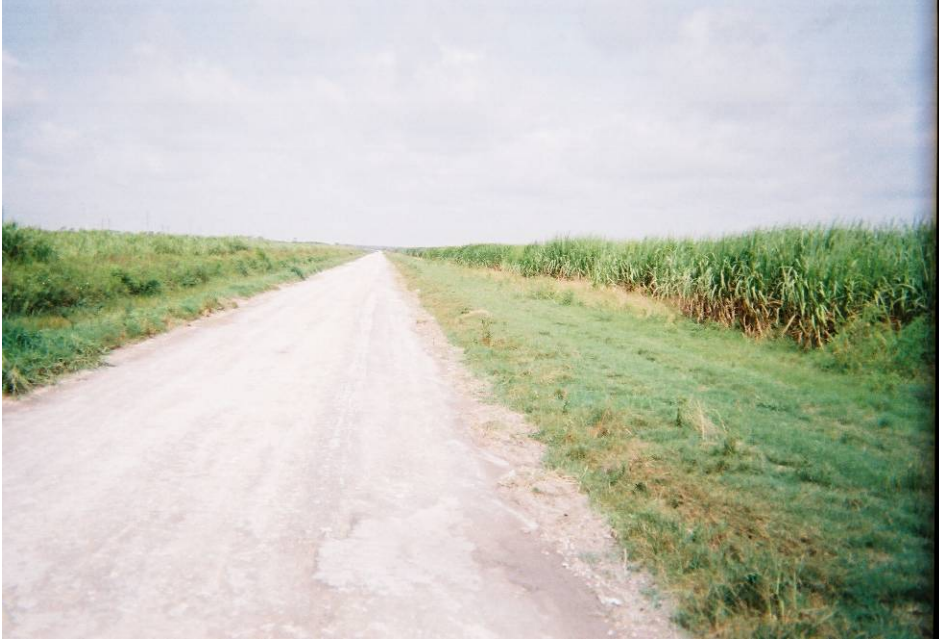
<p><b>Photographer</b> Jim Barrack</p> <p><b>Date</b> 8/13/2008</p> <p><b>Direction</b> View EB</p> <p><b>Comments</b> Paved road with loose gravel patches. Power lines at the SW quadrant of the runway. No centerline lane markings, no street lights.</p>

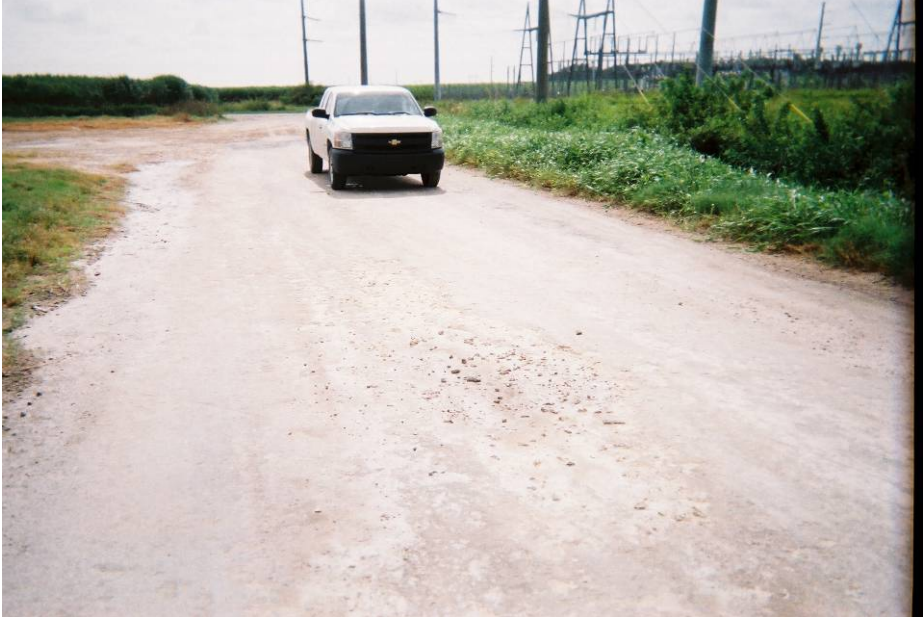
<p><b>Site Name: US Sugar Corporation</b></p>	<p><b>Site Location:</b> Landing Strip # 3 Area 1, Map 1 Section 3209</p>
<p><b>Photographer</b> Jim Barrack</p> <p><b>Date</b> 8/13/2008</p> <p><b>Direction</b> EB</p> <p><b>Comments</b> Soft gravel and sand base with ruts and ridges.</p>

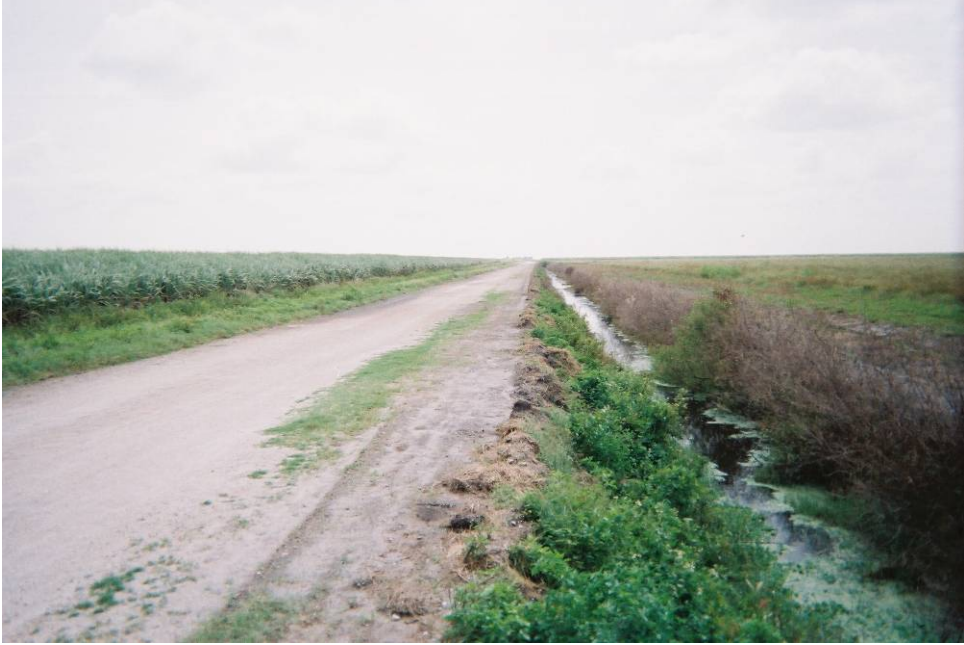
<p><b>Site Name:</b> US Sugar Corporation</p>	<p><b>Site Location:</b> Landing Strip # 5 Area 2 – Map Page 17, Ritta Main Canal</p>
<p><b>Photographer</b> Jim Barrack</p> <p><b>Date</b> 8/13/2008</p> <p><b>Direction</b> WB</p> <p><b>Comments</b> Ritta main canal is very close to road edge. Note earth berm.</p>	 
<p><b>Photographer</b> Jim Barrack</p> <p><b>Date</b> 8/13/2008</p> <p><b>Direction</b> EB</p> <p><b>Comments</b> Note potholes and muck in marl conditions. Roadbed poor crown, drains to right.</p>

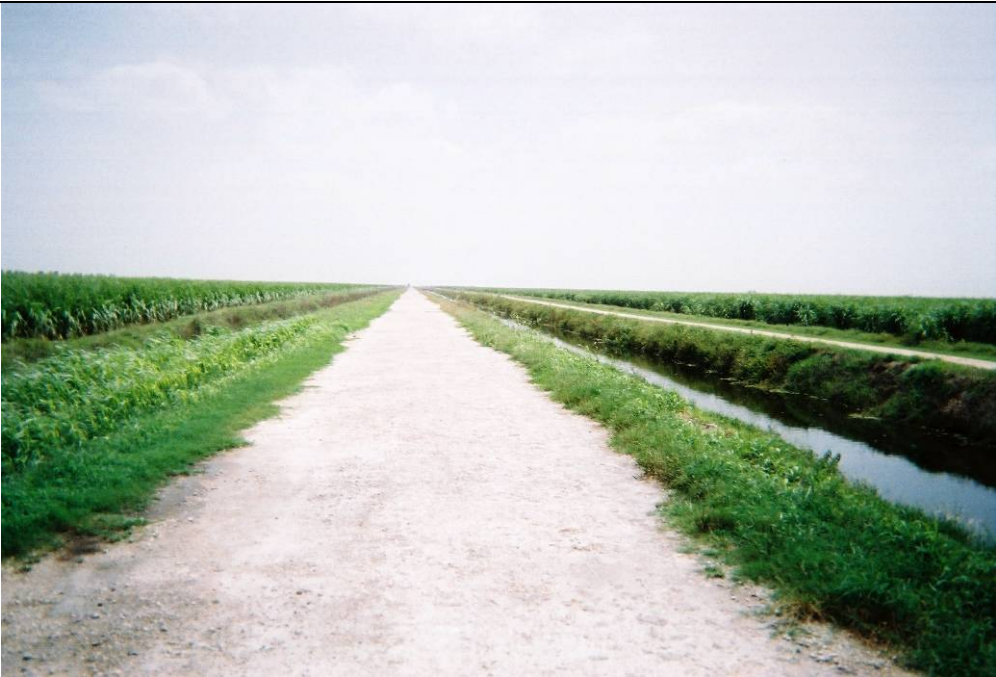
<p><b>Photographer</b> Jim Barrack</p> <p><b>Date</b> 8/13/2008</p> <p><b>Direction</b> NB</p> <p><b>Comments</b> Main canal along west edge, very close.</p>

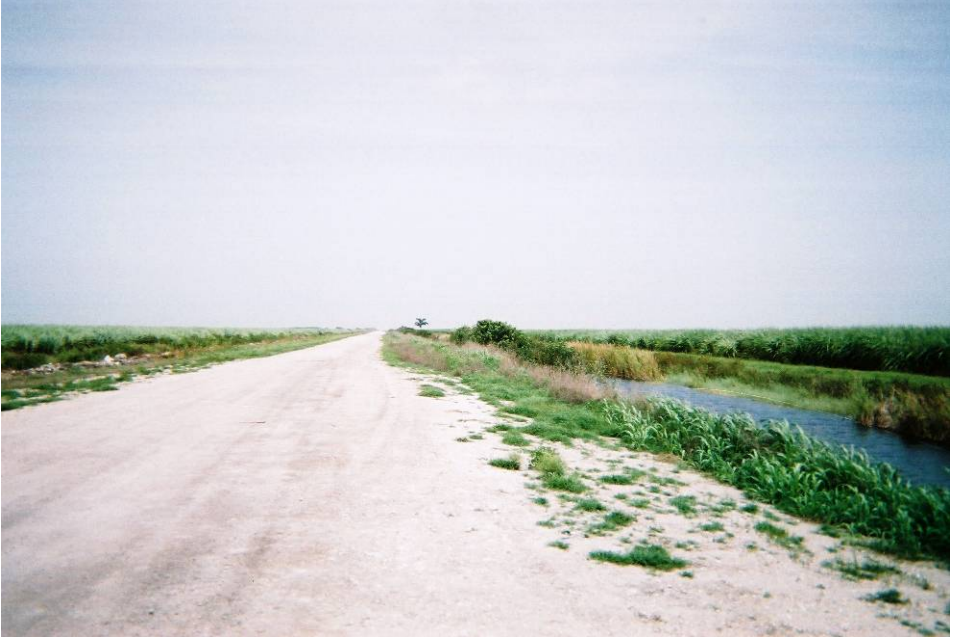
<p><b>Photographer</b> Jim Barrack</p> <p><b>Date</b> 8/13/2008</p> <p><b>Direction</b> WB</p> <p><b>Comments</b> End of runway (U-turnaround) has high tension lines. No fly zone.</p>

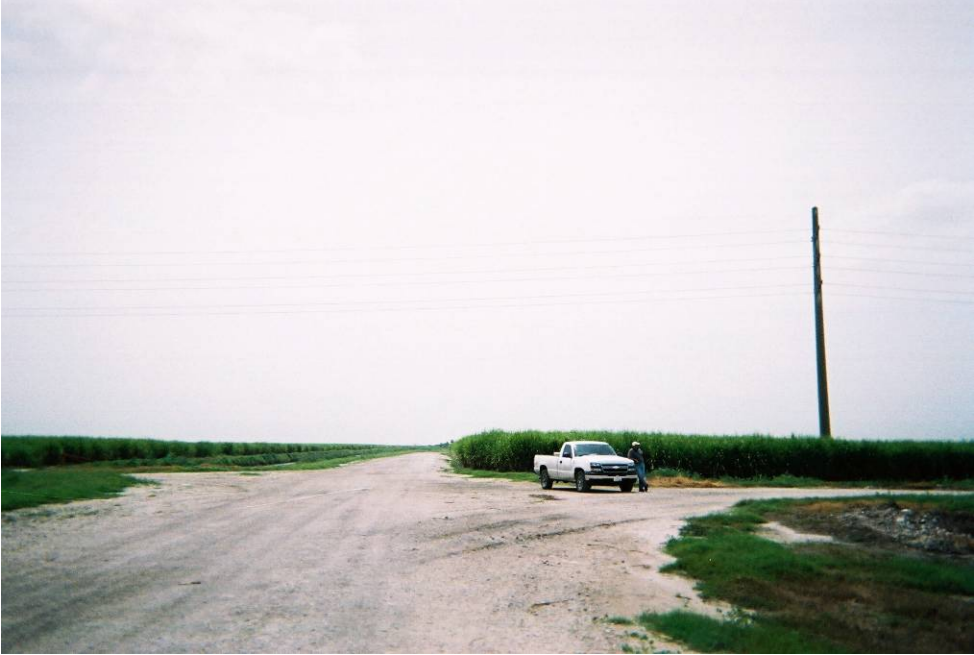
<p><b>Site Name:</b> US Sugar Corporation</p>	<p><b>Site Location:</b> Landing Strip # 8 Area 3 - Map Page 13, Section 33</p>
<p><b>Photographer</b> Jim Barrack</p> <p><b>Date</b> 8/14/2008</p> <p><b>Direction</b> NB</p> <p><b>Comments</b> This road is fairly narrow at 24 to 26 feet. Airstrip is 2600 LF. Roadbed has loose gravels with some ruts and weed intrusion. Canal very close.</p>	 
<p><b>Photographer</b> Jim Barrack</p> <p><b>Date</b> 8/14/2008</p> <p><b>Direction</b> SB</p> <p><b>Comments</b> Roadbed is in need of some grid rolling and widening to right side.</p>

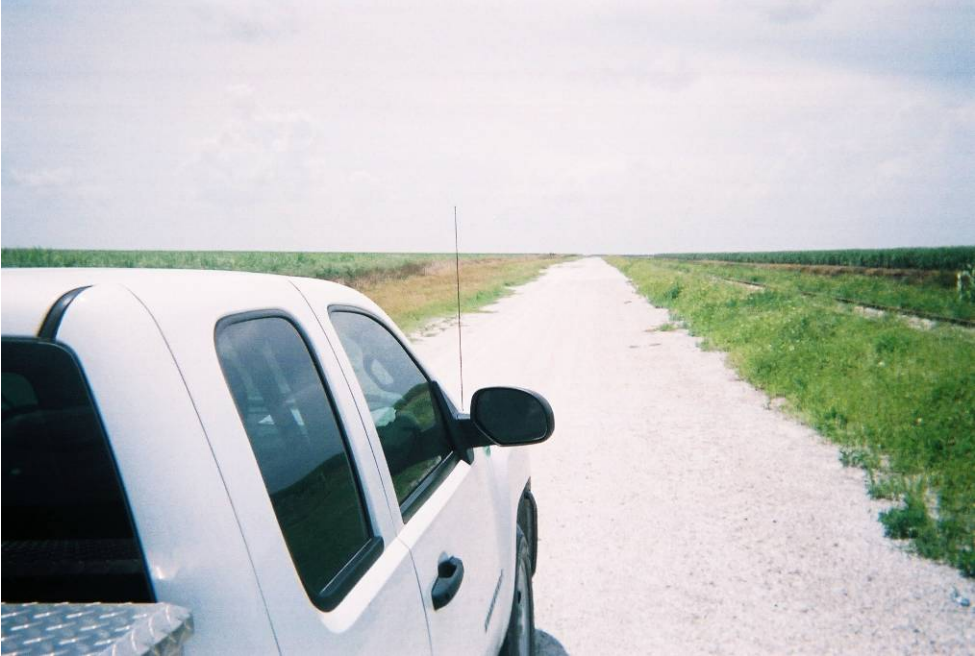
<p><b>Photographer</b> Jim Barrack</p> <p><b>Date</b> 8/14/2008</p> <p><b>Direction</b> WB</p> <p><b>Comments</b> Seems to be more room on left side. Possibly widen, shift runway to the left.</p>

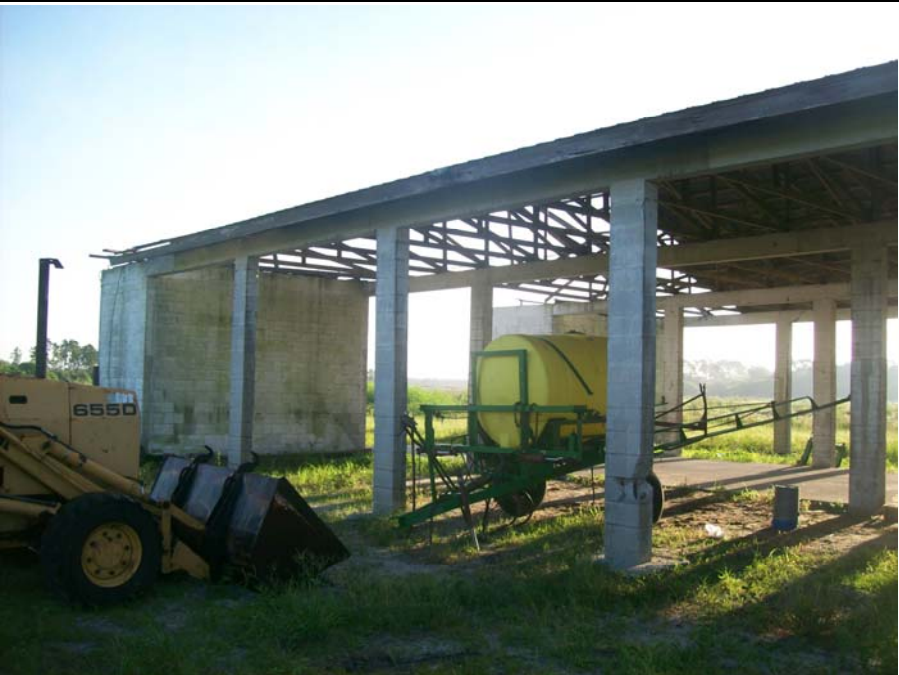
<p><b>Photographer</b> Woodard</p> <p><b>Date</b> 08/08/08</p> <p><b>Direction</b> North</p> <p><b>Comments</b> <b>(15) Clinic – Union Building.</b> Shed is dilapidated and an attractive nuisance. Recommend demolition.</p>

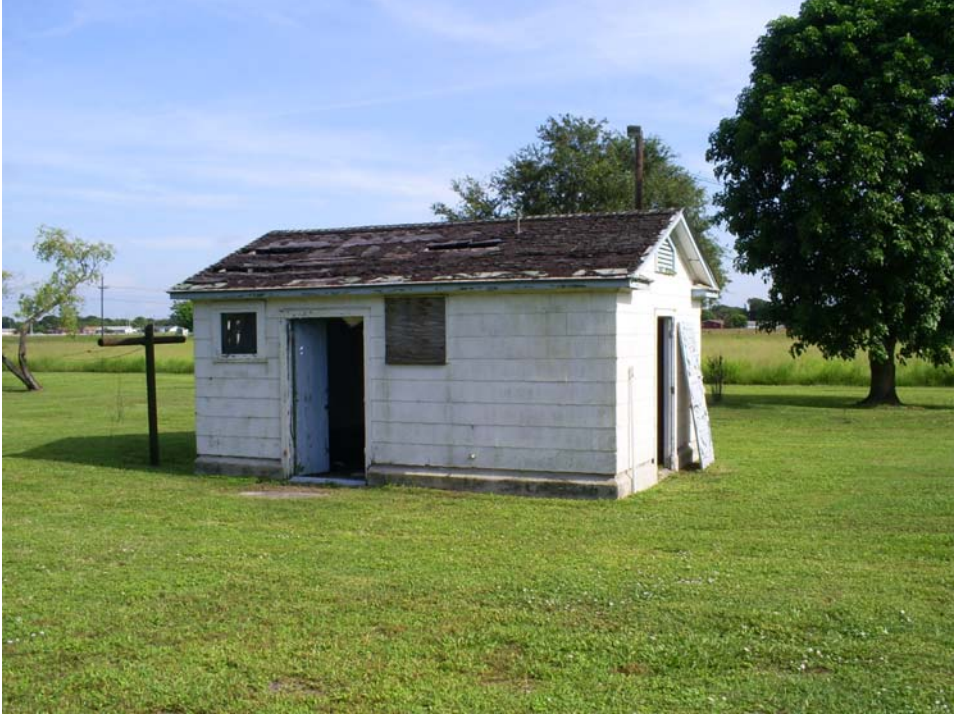
<p><b>Photographer</b> Erik J. Carlson</p> <p><b>Date</b> 08/07/2008</p> <p><b>Direction</b> Northeast</p> <p><b>Comments</b> <b>(16) Sugarland Park.</b> Shared garage that has been poorly maintained with numerous asbestos tiles missing. The exposed wood is degrading.</p>

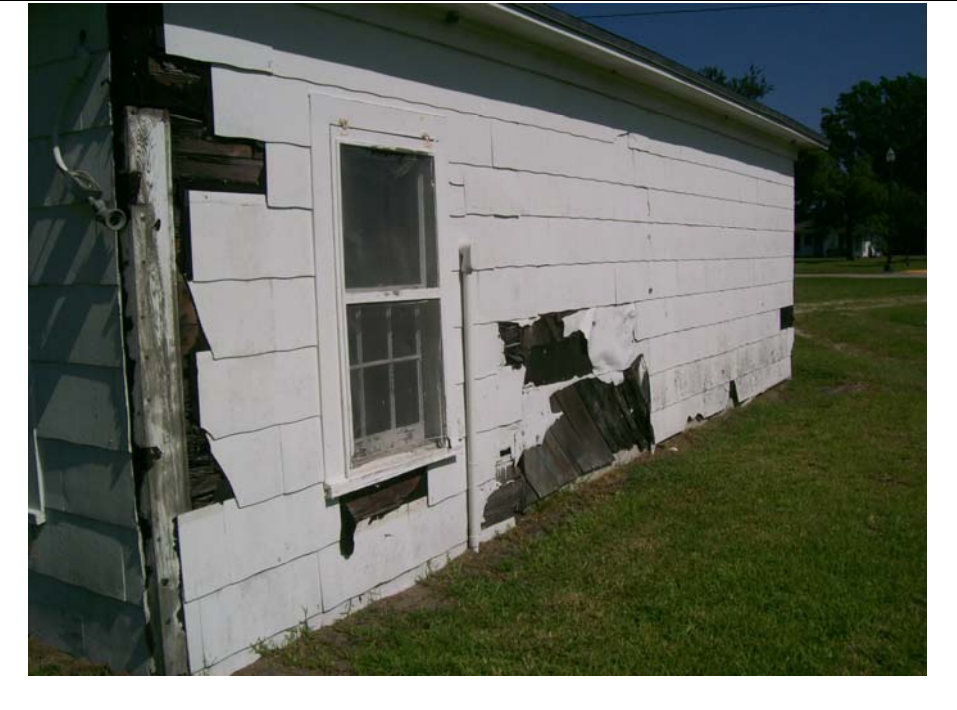
<p><b>Photographer</b> Erik J. Carlson</p> <p><b>Date</b> 08/07/2008</p> <p><b>Direction</b> North</p> <p><b>Comments</b> <b>(16) Sugarland Park.</b> House in Sugarland Park. Note the worn exterior, damaged hot water heater housing, asbestos siding, and broken window.</p>

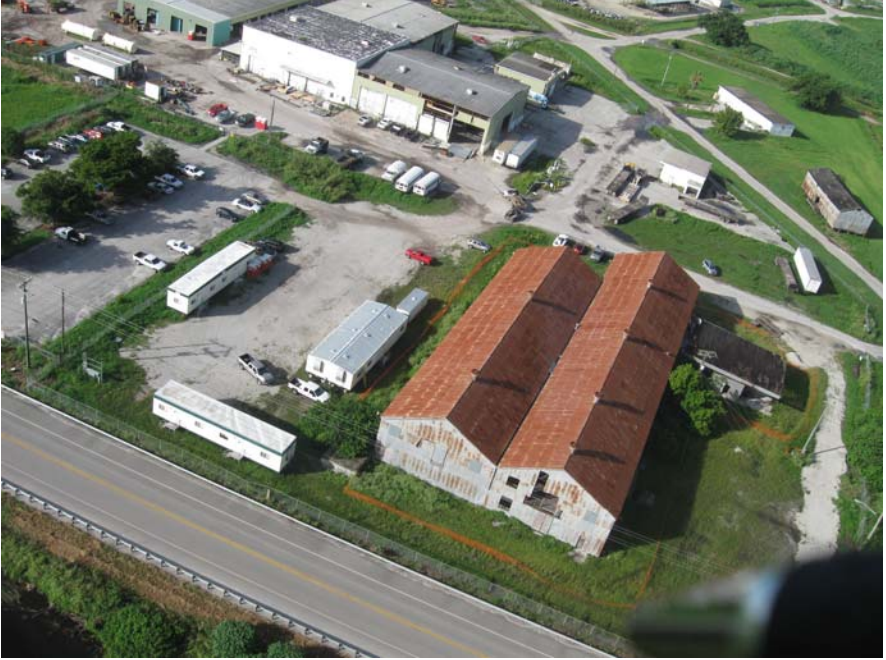
An aerial photograph showing an industrial site. A large, long building with a rusted brown metal roof is the central focus. To its left is a parking lot with several vehicles and smaller white buildings. A road with a guardrail runs along the bottom edge of the frame. The surrounding area includes green grass and other smaller structures.
<p><b>Photographer</b> Farrington</p> <p><b>Date</b> Aug. 3, 2008</p> <p><b>Direction</b> North</p> <p><b>Comments</b> <b>(31) East. AES</b> <b>Complex and</b> <b>Parts Storage</b> – 1976 building in foreground and gas station to left recommended for demolition. 1930s warehouse with brown roof at rear is aban- doned and recommended for demolition.</p>

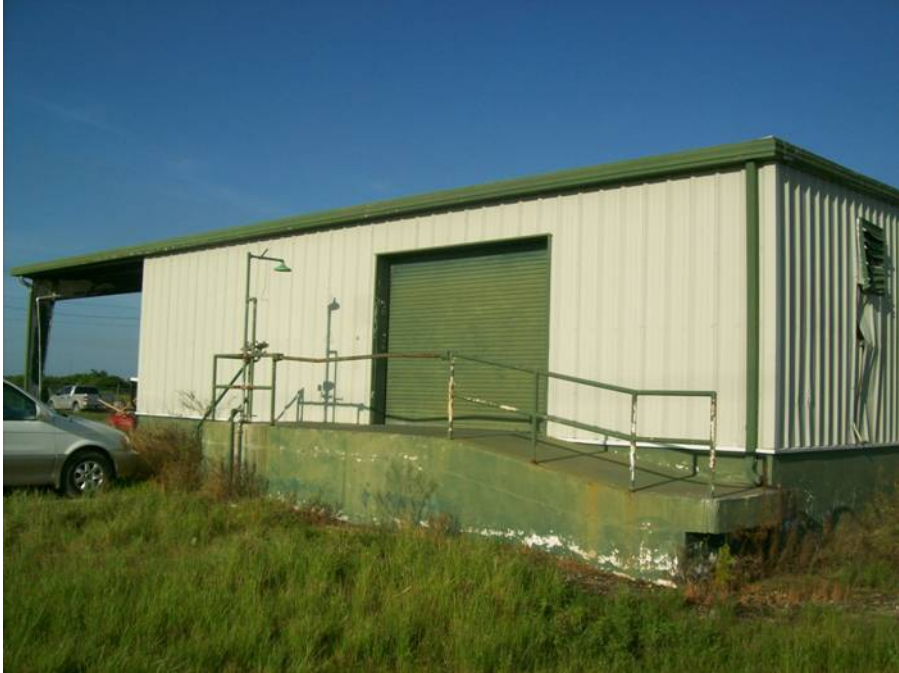
<p><b>Photographer</b> Erik J. Carlson</p> <p><b>Date</b> 08/01/2008</p> <p><b>Direction</b> North</p> <p><b>Comments</b> <b>(44) Tractor Shed East of Citrus.</b> Tractor shed east of citrus plant supported by a steel frame on a reinforced concrete slab on grade and steel roof.</p>
