PROJECT DEFINITION REPORT

LAINHART & MASTEN DAMS

PS ID 100816

JANUARY 3, 2013

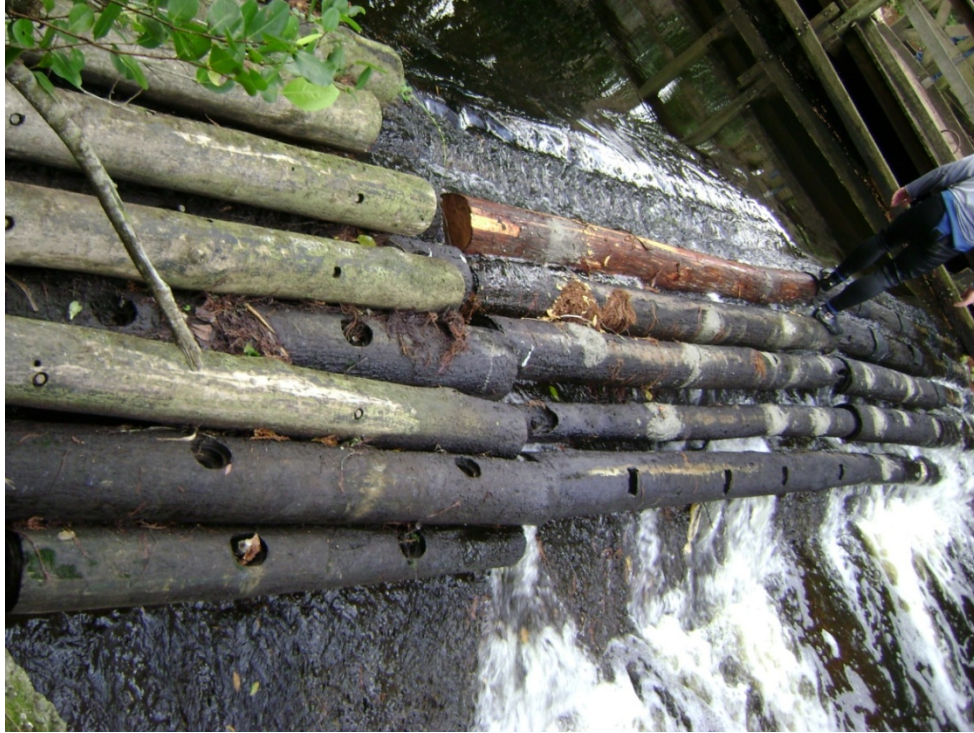
Log installation on the top of Lainhart Dam

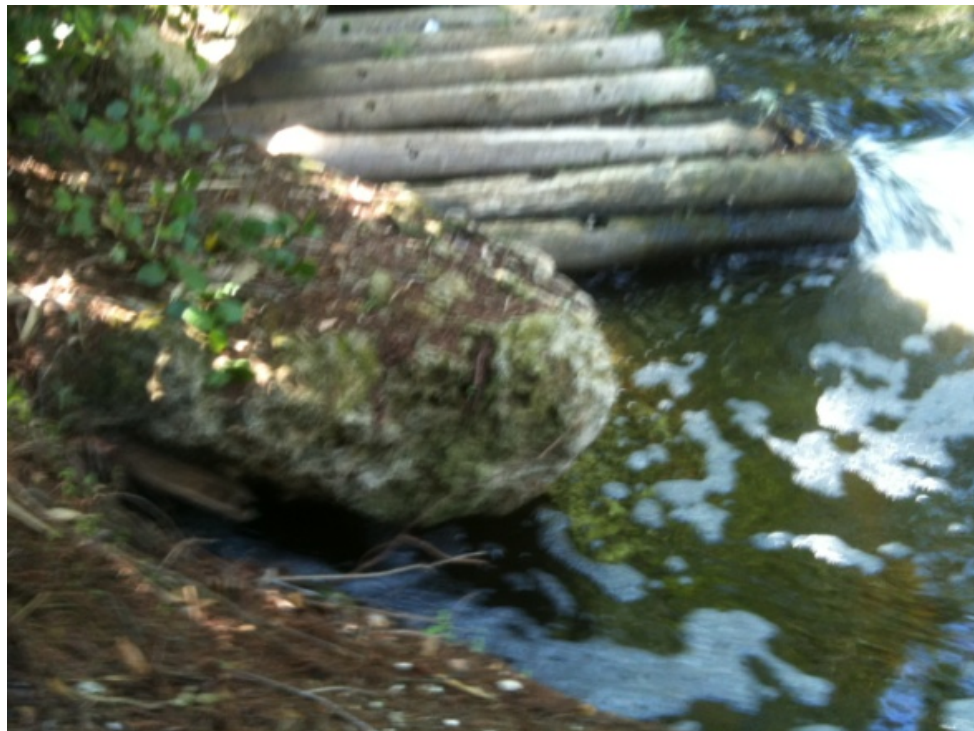
Lainhart Dam - East bank looking southwest, flow under the rock appears to bypass main structure

A detailed inspection should be performed during low flow conditions (normally April) to further define the existing conditions at each structure. A dive inspection should be commissioned to investigate

potential piping under each structure and a remedial plan developed based on the results of the inspection and initial evaluation.
