Technical Memorandum

DATE: August 1, 2005

- FROM: Deborah Daigle, P.G, Sr. Hydrogeologist Barry Meyer, P.E., Project Design Director
- SUBJECT: Documentation of Existing Information, Site Conditions and Site History C-44 Reservoir/Stormwater Treatment Area (STA) Porject CN040918, Work Order 6, Task 1, P507.5.1.2.6.1

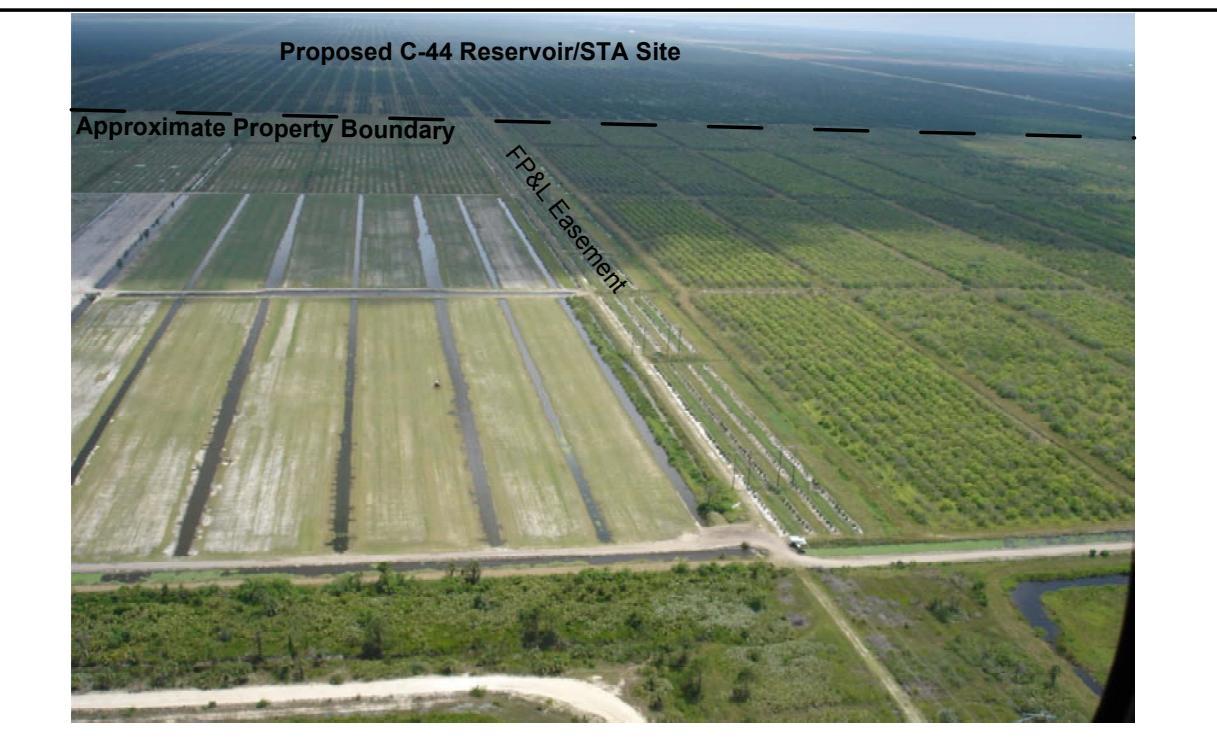
View of the FP&L Easement that traverses the central portion of the site in a north-south direction (from north of the Proposed C-44 Reservoir/STA Site facing south).

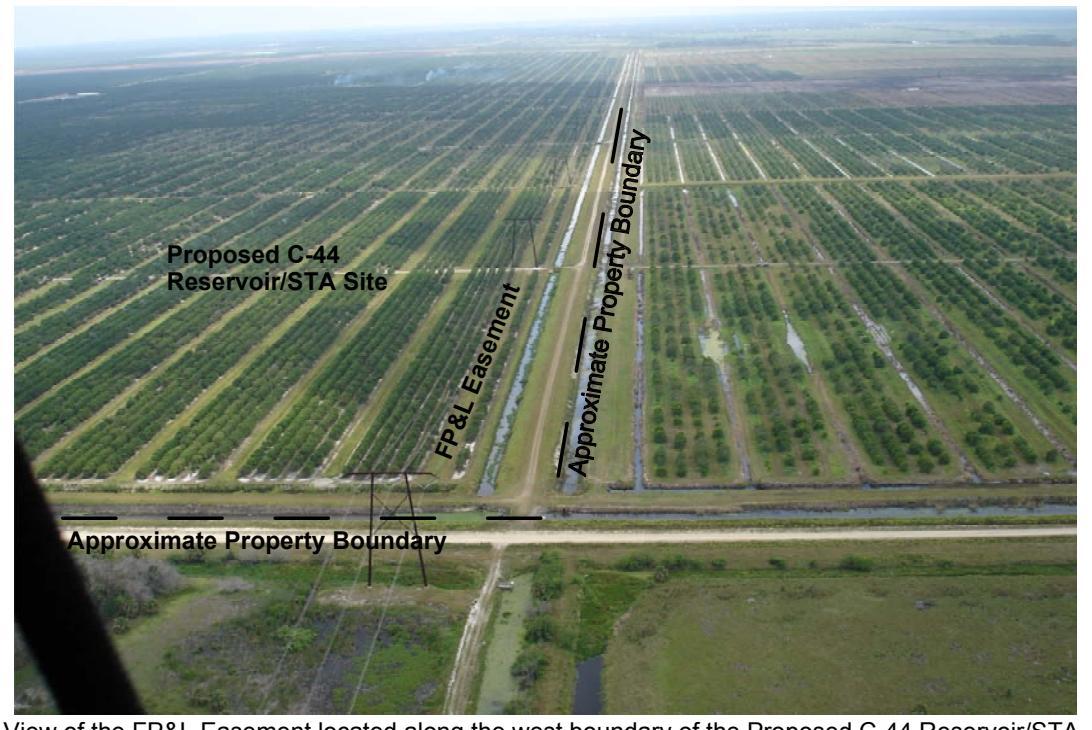
View of the FP&L Easement located along the west boundary of the Proposed C-44 Reservoir/STA Site (from the northwest corner of the site facing south).

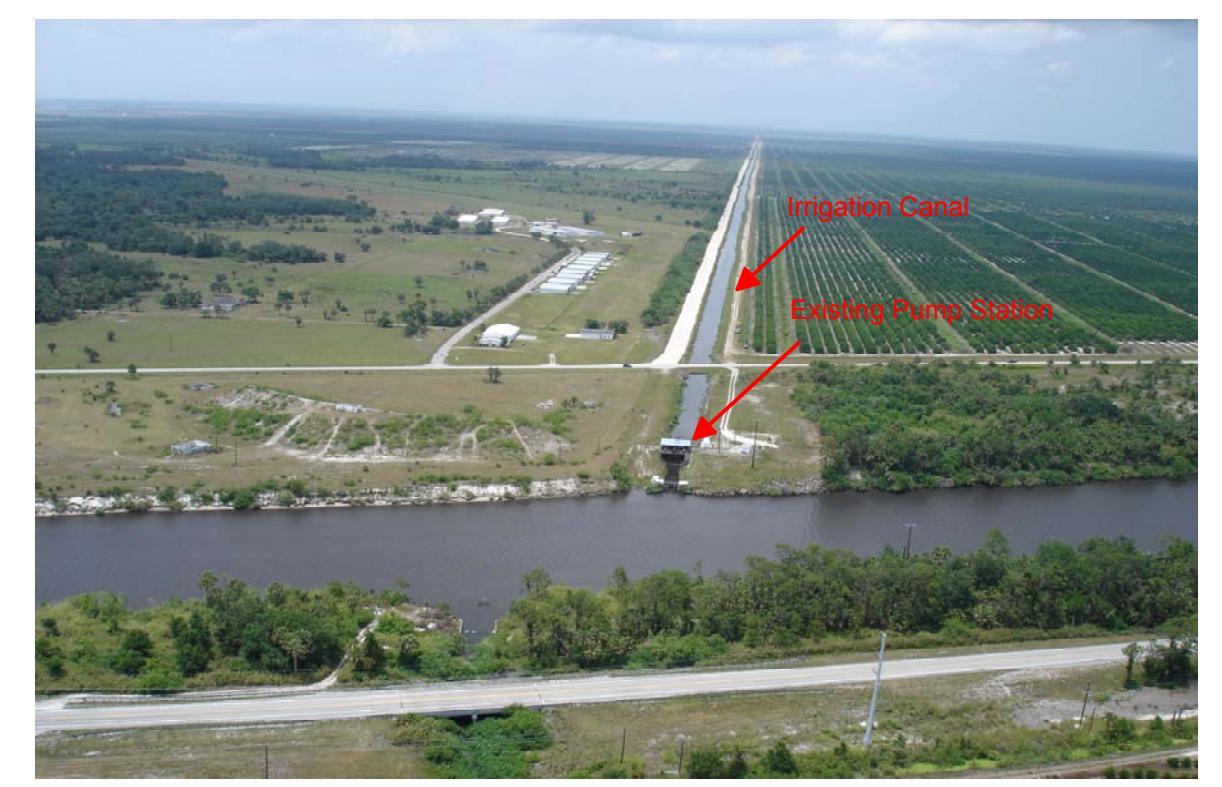
View of the southern portion of the existing citrus grove (Proposed C-44 Reservoir/STA Site) from just south of the Canal at the main irrigation canal. Existing pump station is visible.

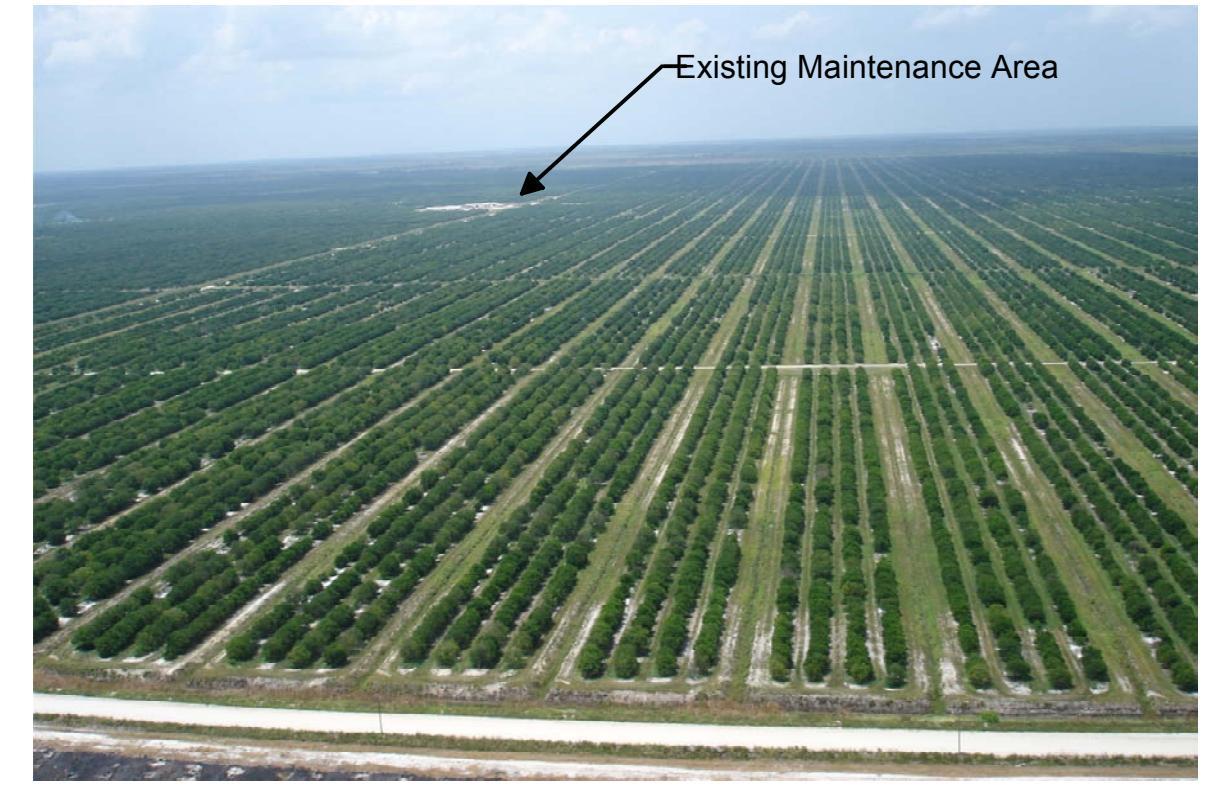
View of the north end of the existing citrus grove (Proposed C-44 Reservoir/STA Site) (facing south). The existing maintenance area for the citrus grove is visible to the left and rear of the photograph.

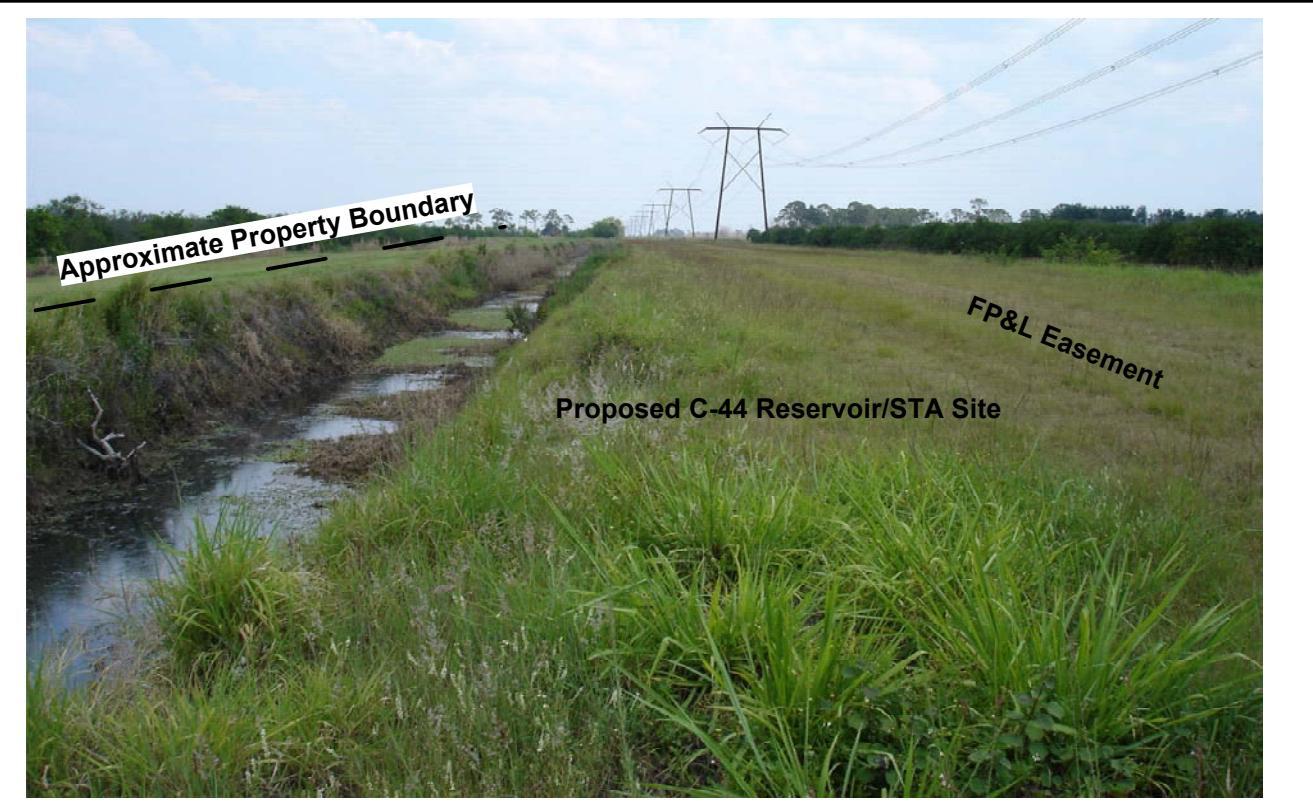
View of the FP&L transmission line easement which traverses the Proposed C-44 Reservoir/STA Site in a north-south direction along the west property boundary (facing north). An adjacent drainage canal is also visible in the photograph.

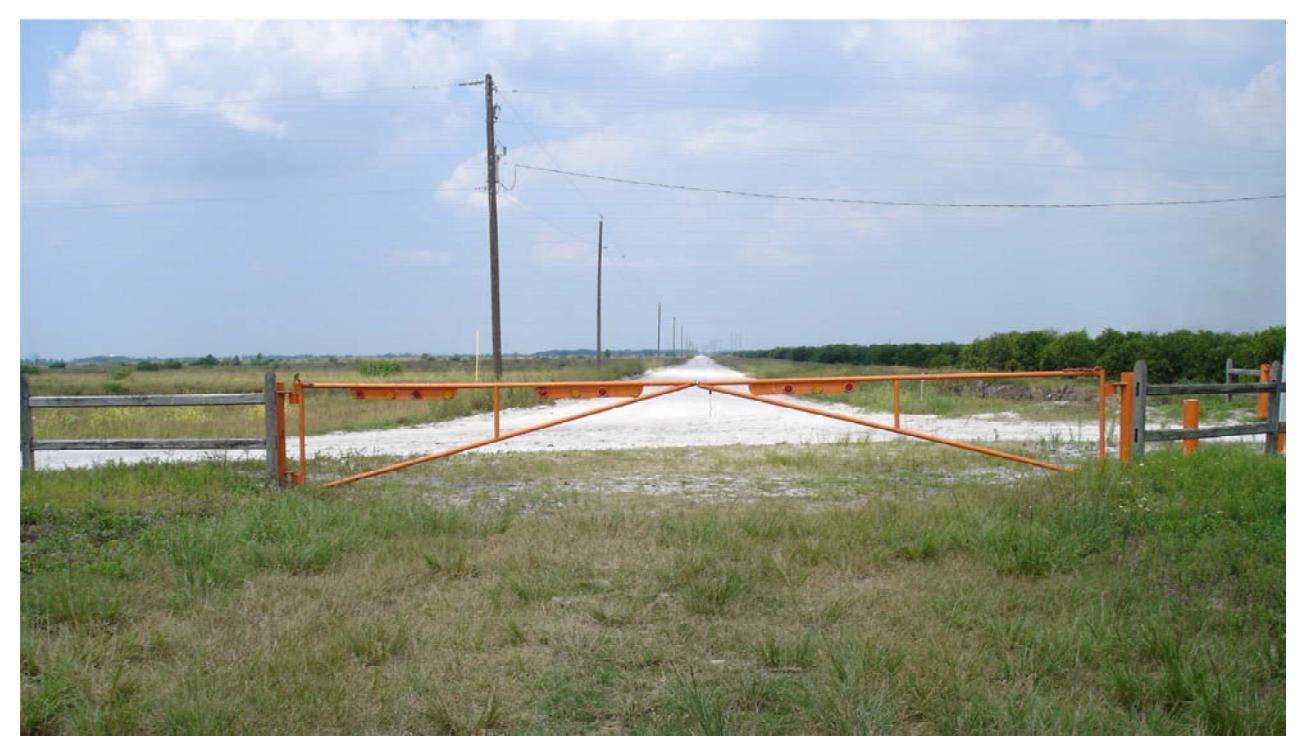
View of Minute Maid Road from the approximate location of the Proposed C-44 Reservoir/STA Site pump station (facing west).

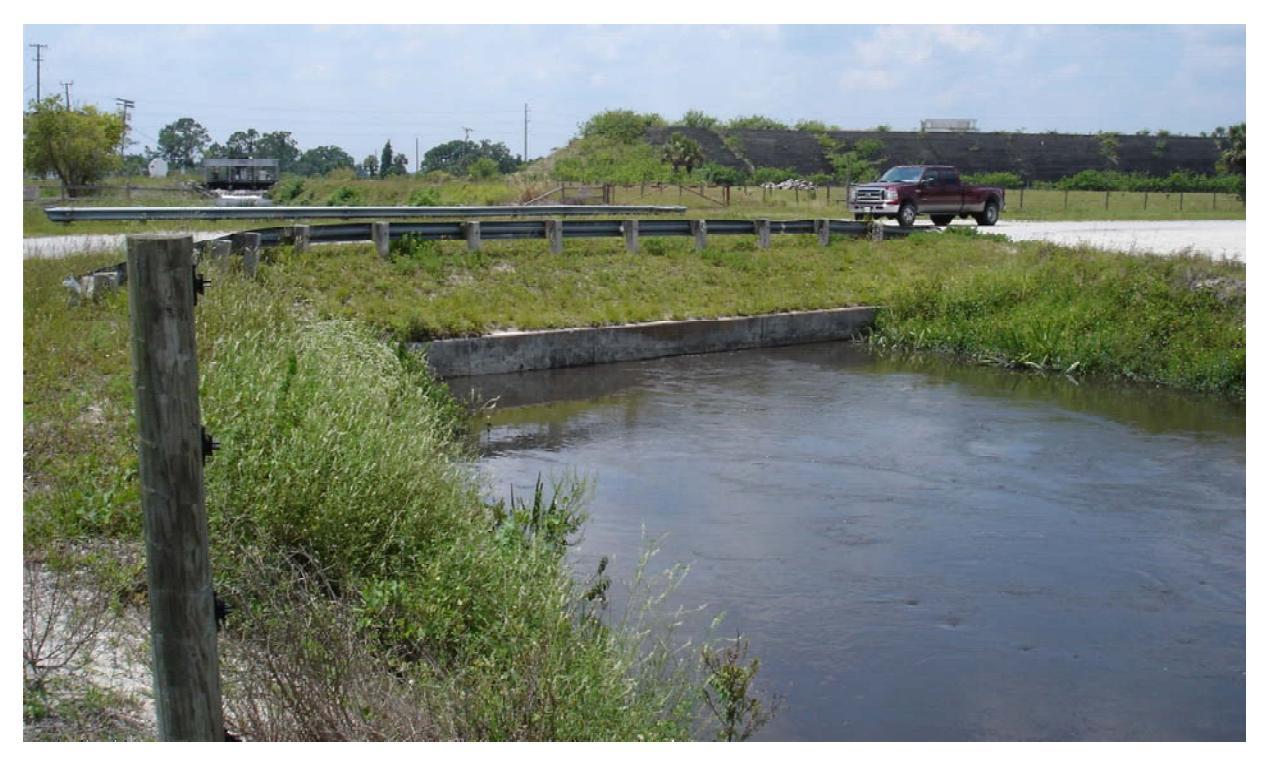
View of the irrigation canal at Citrus Boulevard located south of the southwest corner of the Proposed C-44 Reservoir/STA Site (facing south) (Easement No.5).

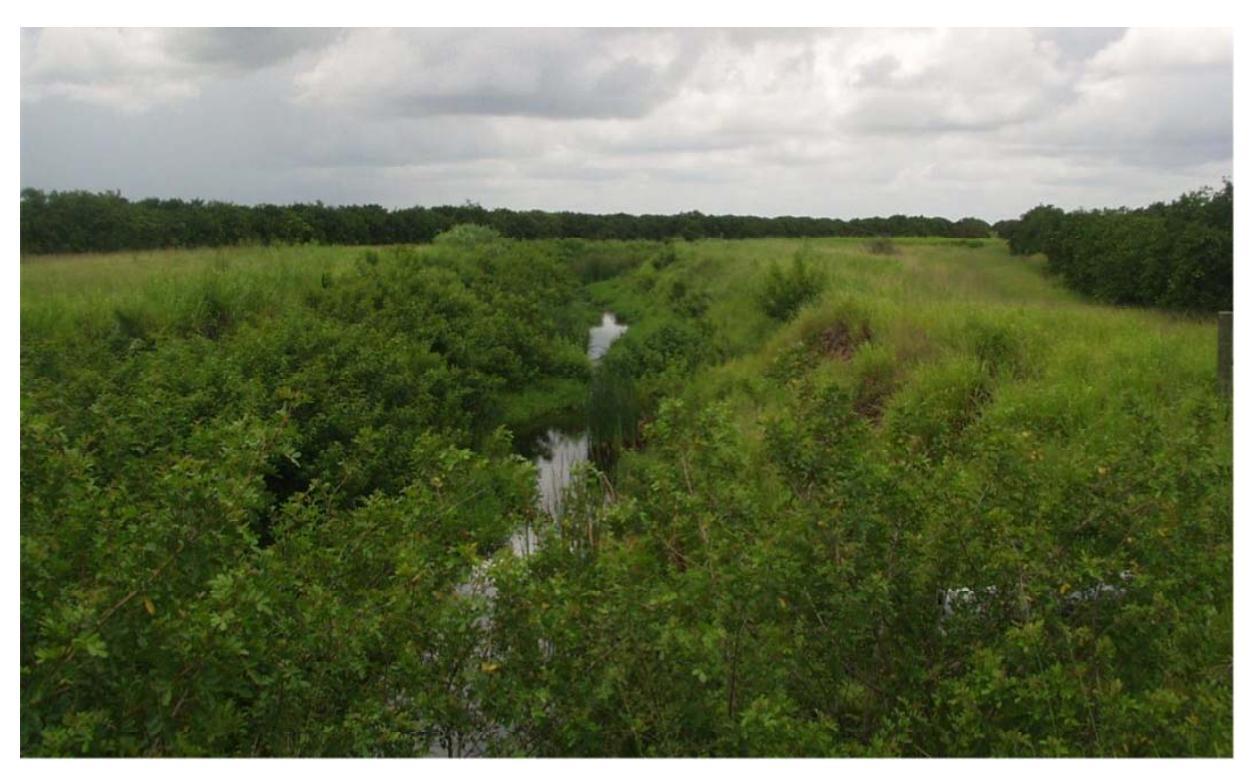
View of the drainage canal located on the citrus grove (Proposed C-44 Reservoir/STA Site) at Easement No. 4 (facing north from Citrus Boulevard).

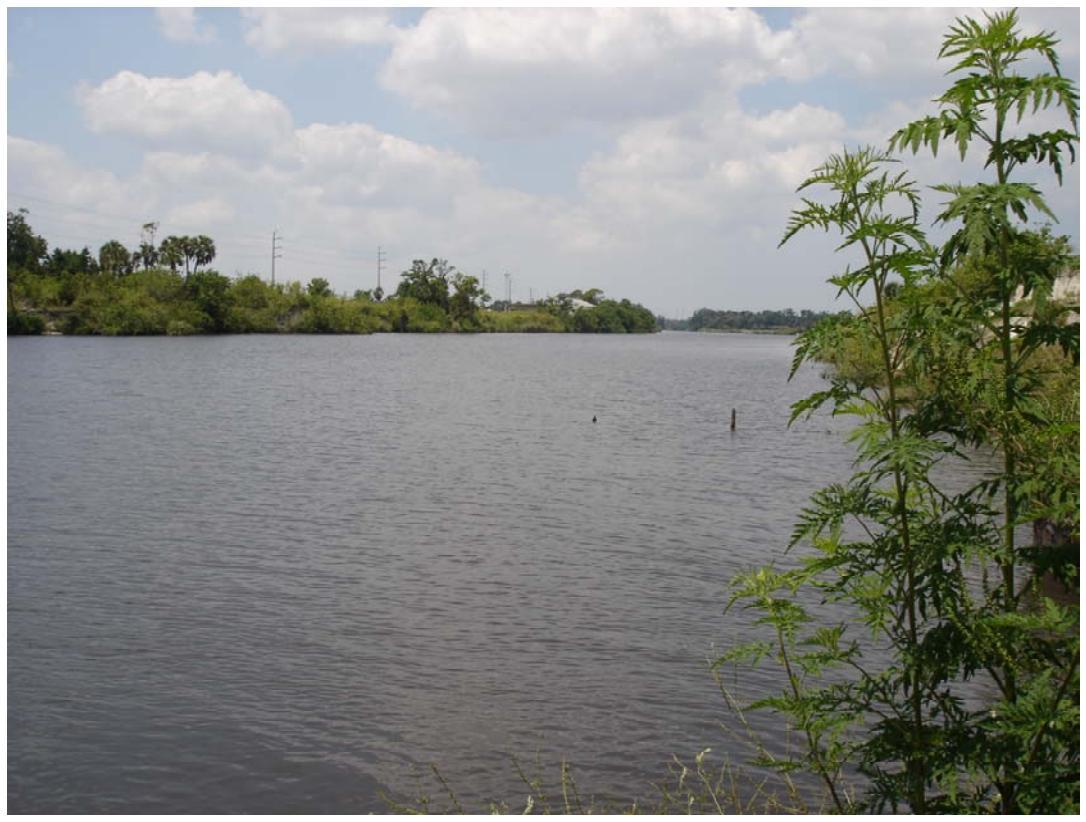
View of the C-44 Canal located south of the Proposed C-44 Reservoir/STA Site (facing southwest).

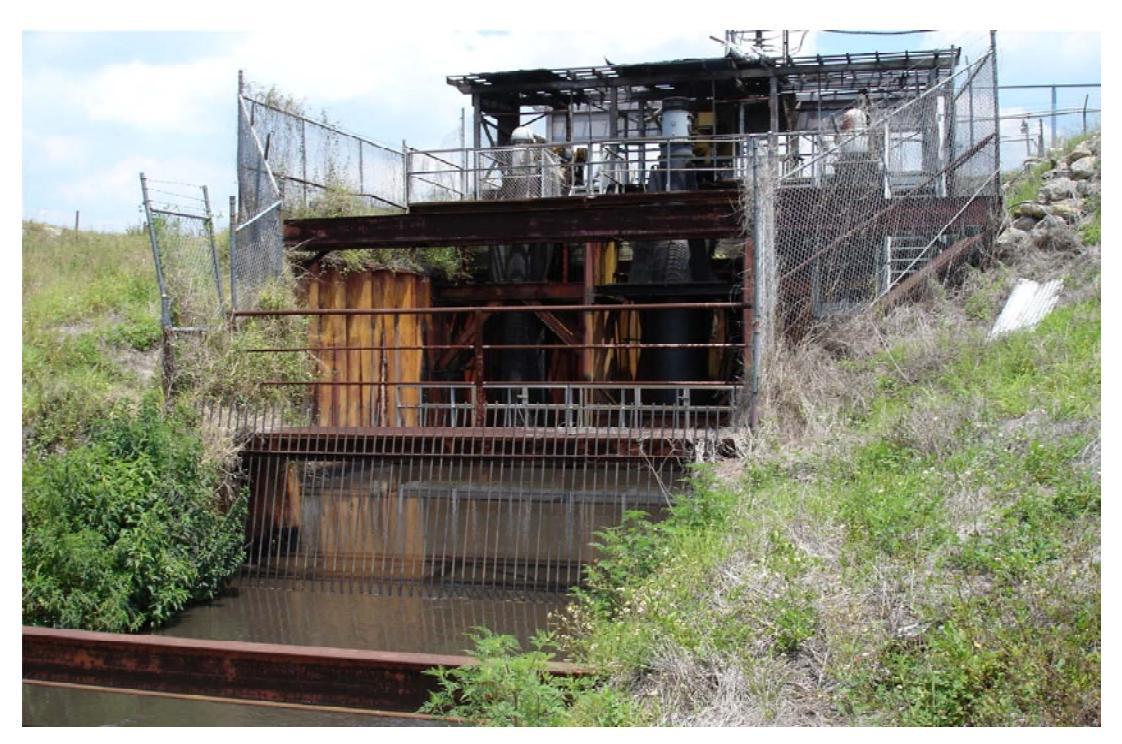
View of the pump station which transfers water from the C-44 Canal to an existing citrus grove irrigation canal located on the Proposed C-44 Reservoir/STA Site. The pump station is located along the north bank of the C-44 Canal at the location of the proposed intake canal (facing northwest) (Easement No. 5).

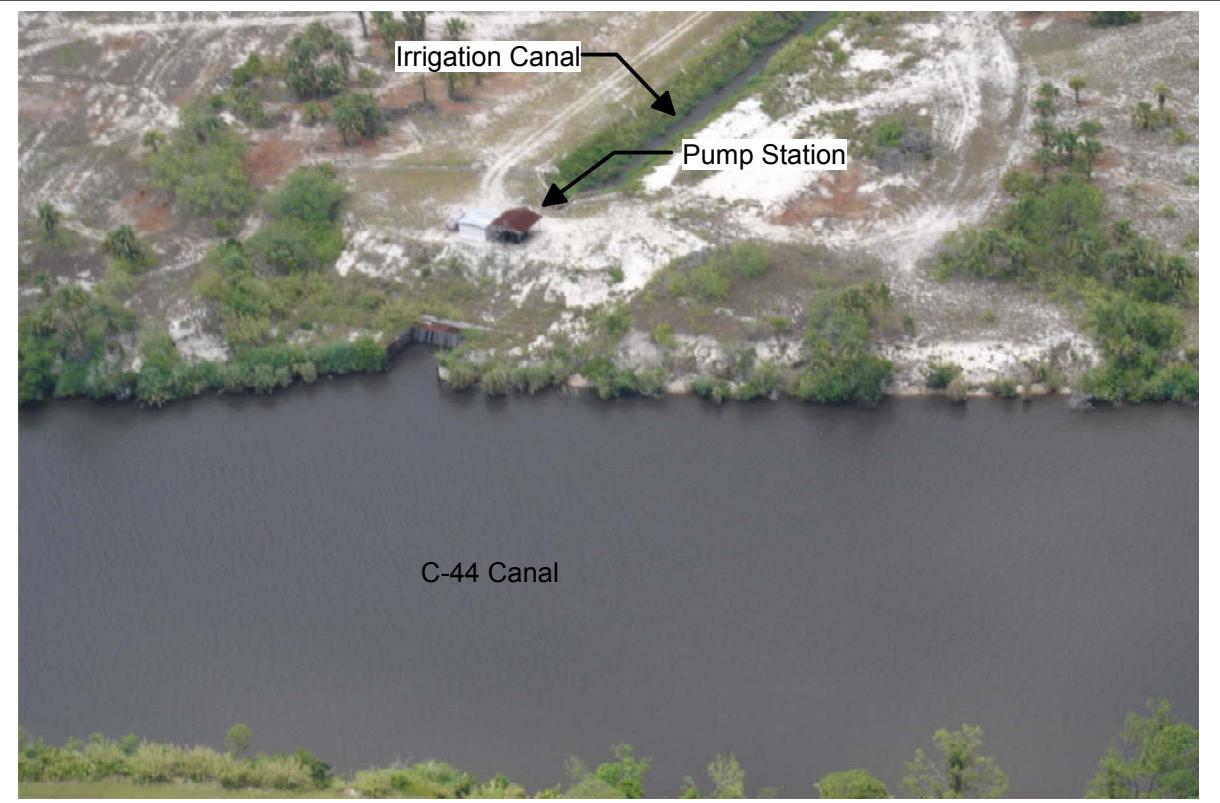
View of the C-44 Canal and an existing citrus grove irrigation canal and pump station located at the southeast corner of the Proposed C-44 Reservoir/STA Site (facing northwest) (Easement No. 1).

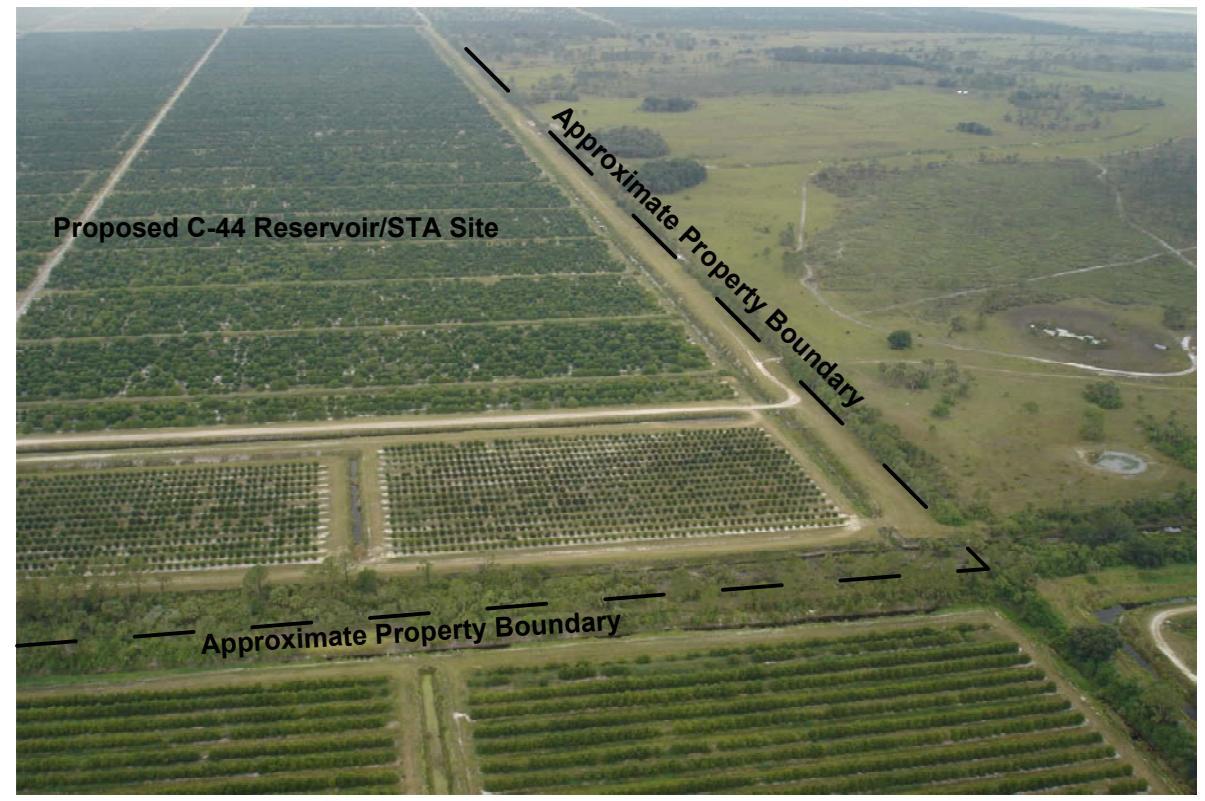
View of the north end of the existing citrus grove (Proposed C-44 Reservoir/STA Site) from near the northeast corner (facing west).
