Aquatic Vegetation, Trash and Debris Entering District Waterways

**South Florida Water Management District
Public Workshop January 10, 2022**

Rich Virgil, P.E., PMP Director - Field Operations

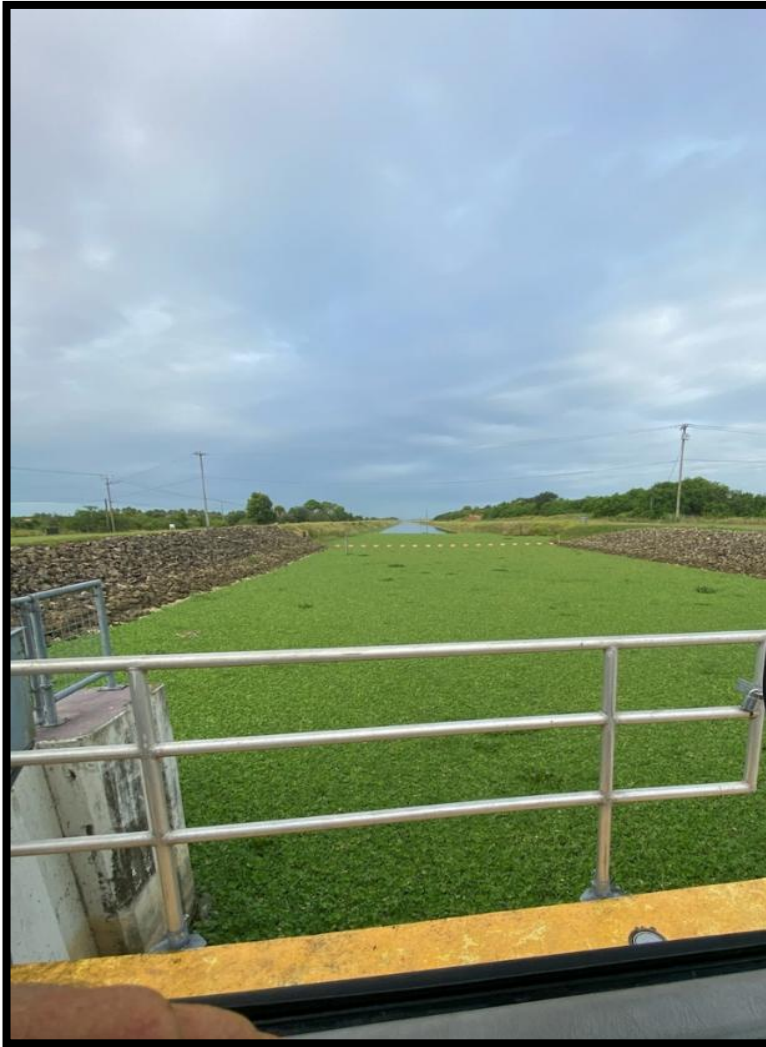
- **Structure S-99 in the C-25 Canal looking west.**

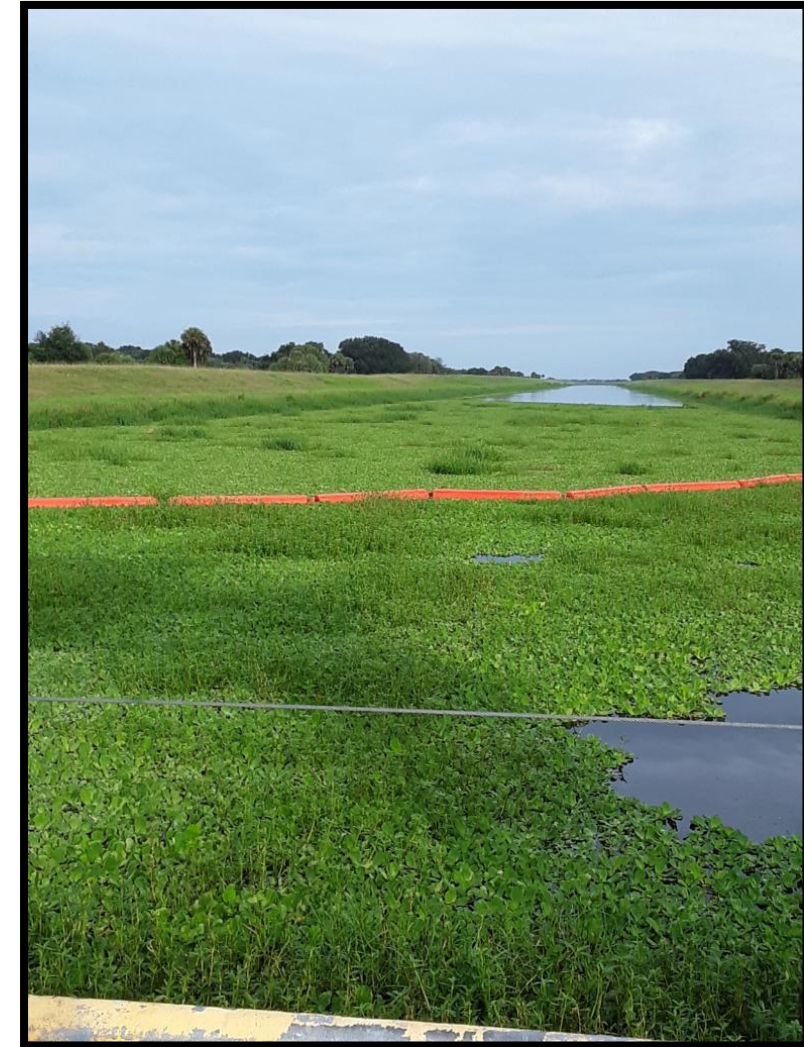
- **Structure S-97 in the C-23 Canal looking west.**

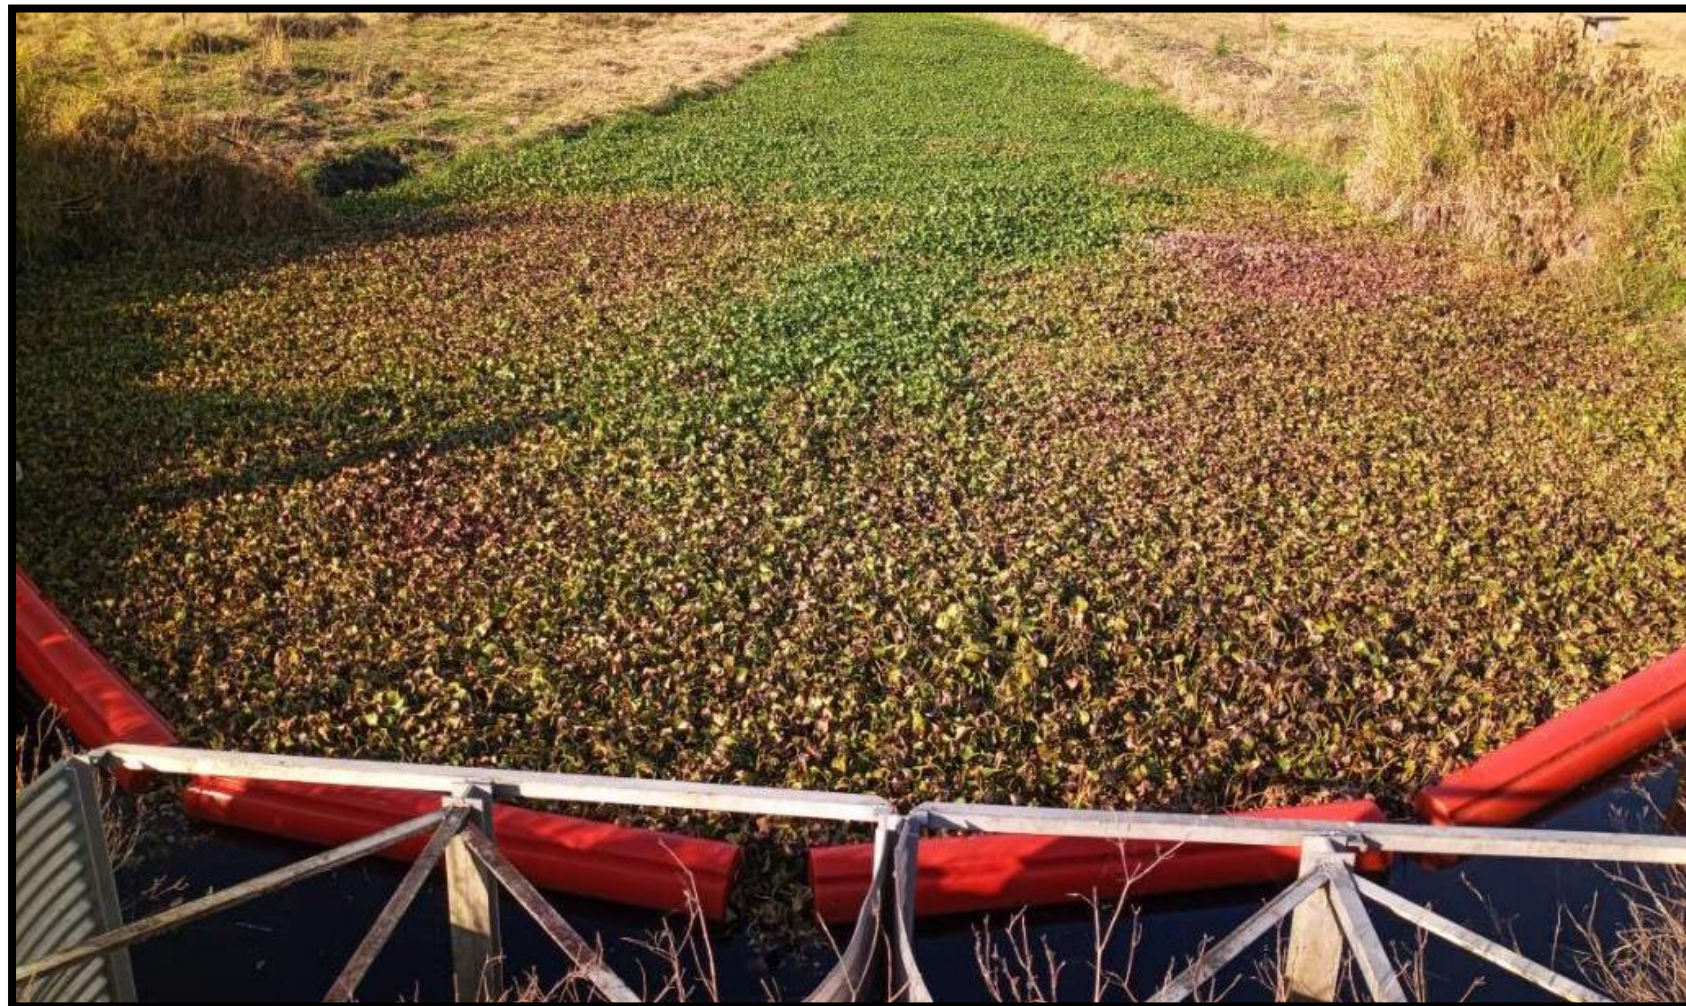
- **Vegetation being discharged to the District Canals from private lands via project culverts (PCs).**

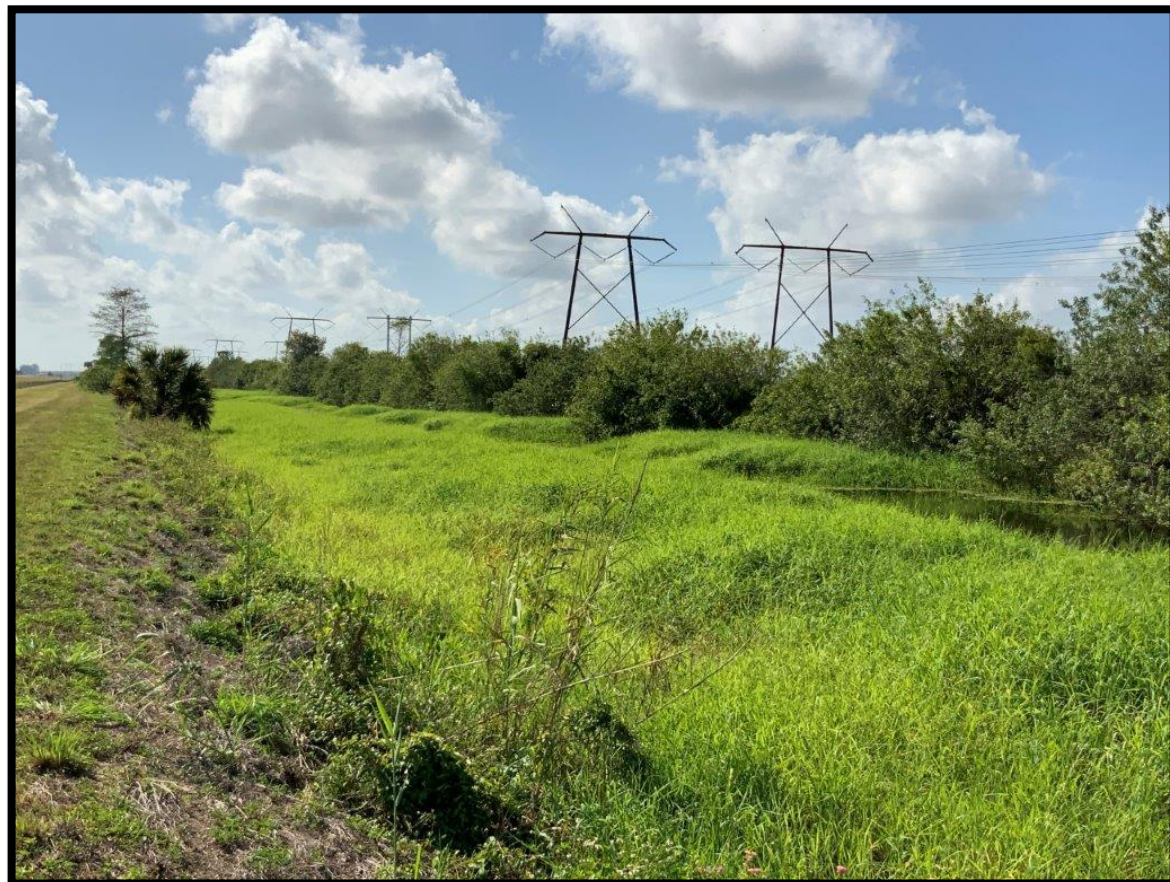
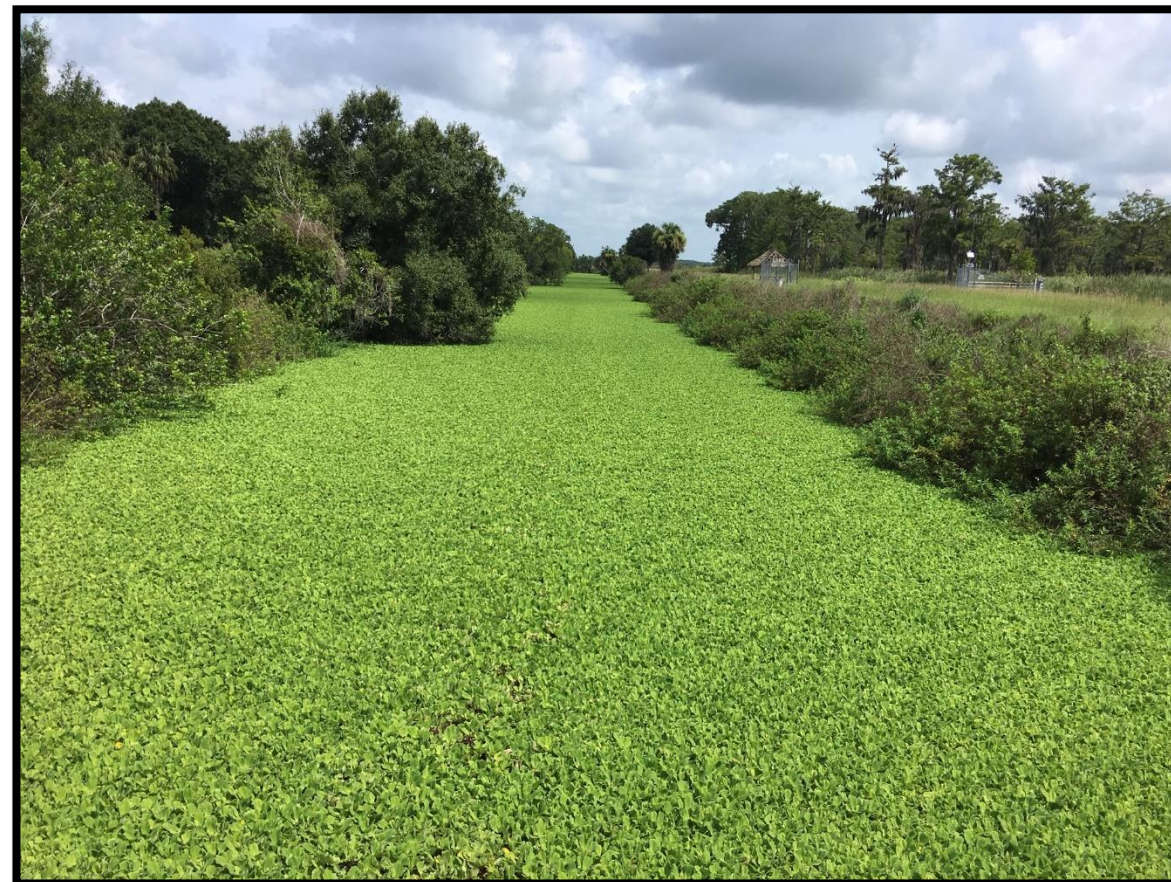
- **Vegetation being discharges to the District Canals from private canals such as the C-25 Extension**

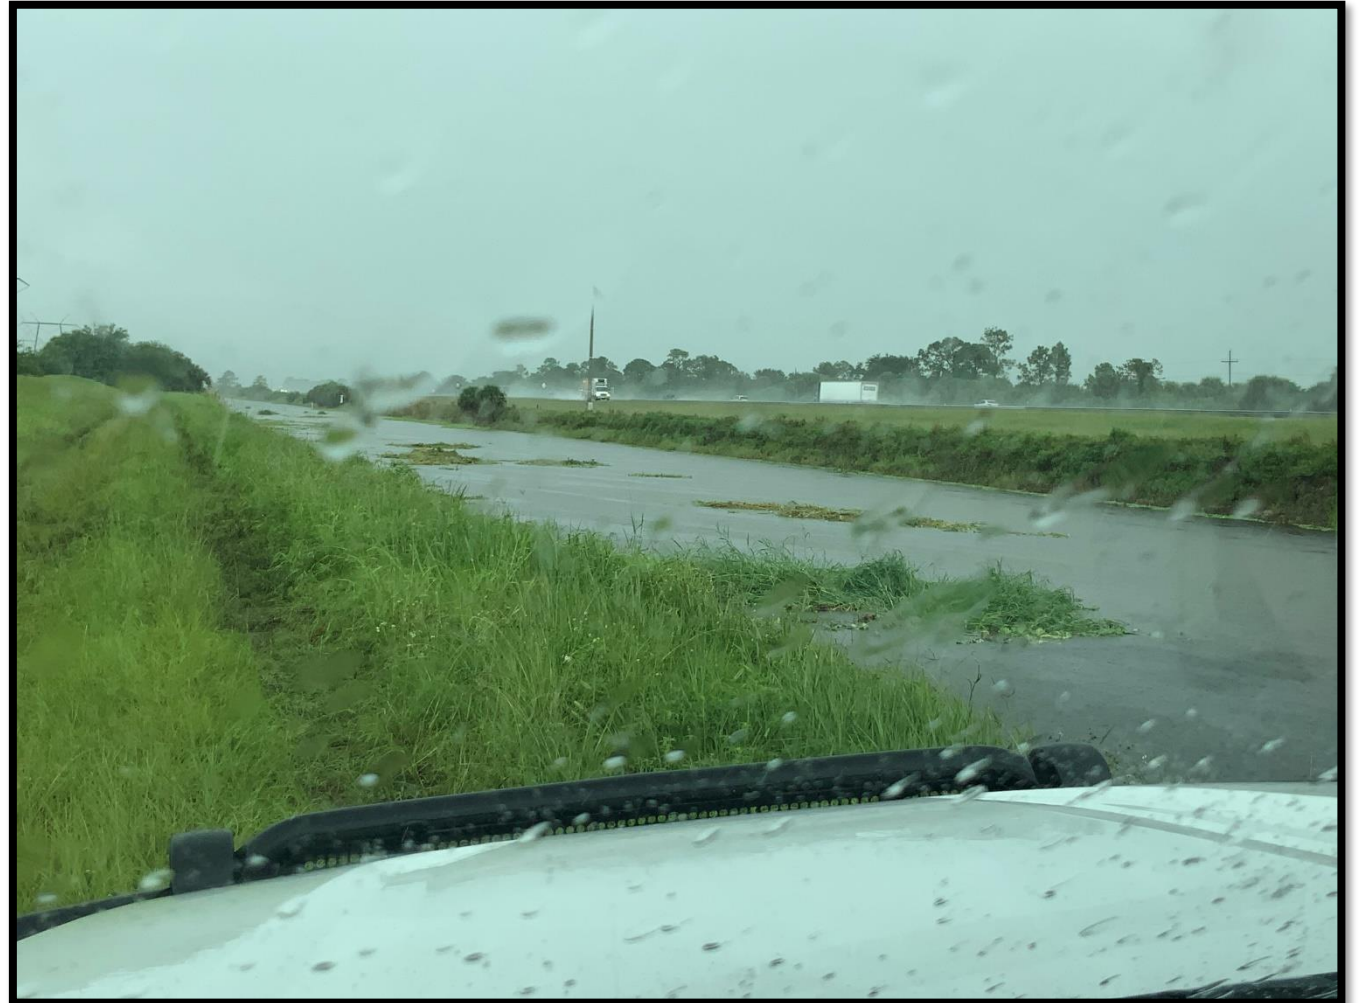
- Once the rains start vegetation is broken loose causing it to discharge into the District Canals from private canals such as the C-25 Extension.

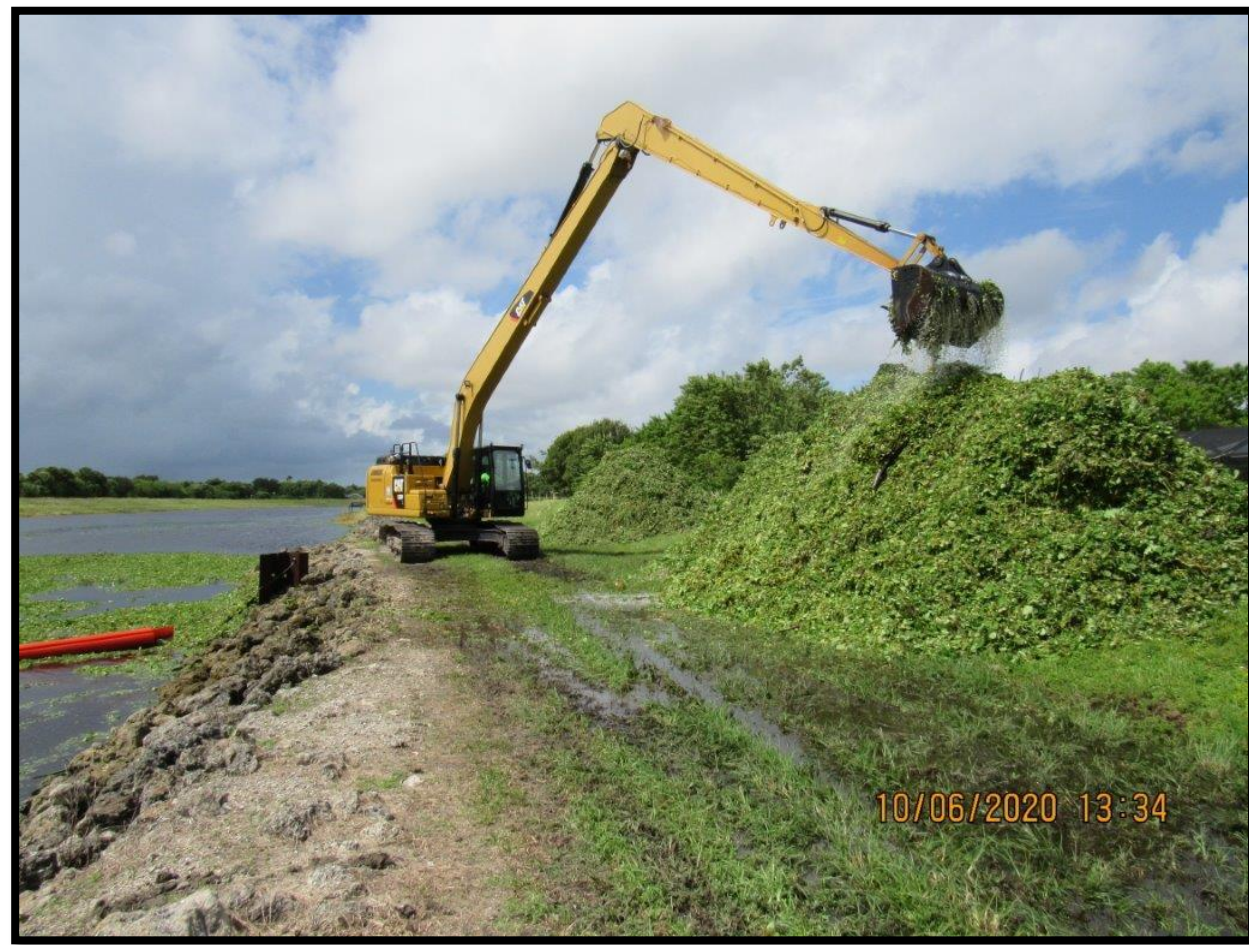
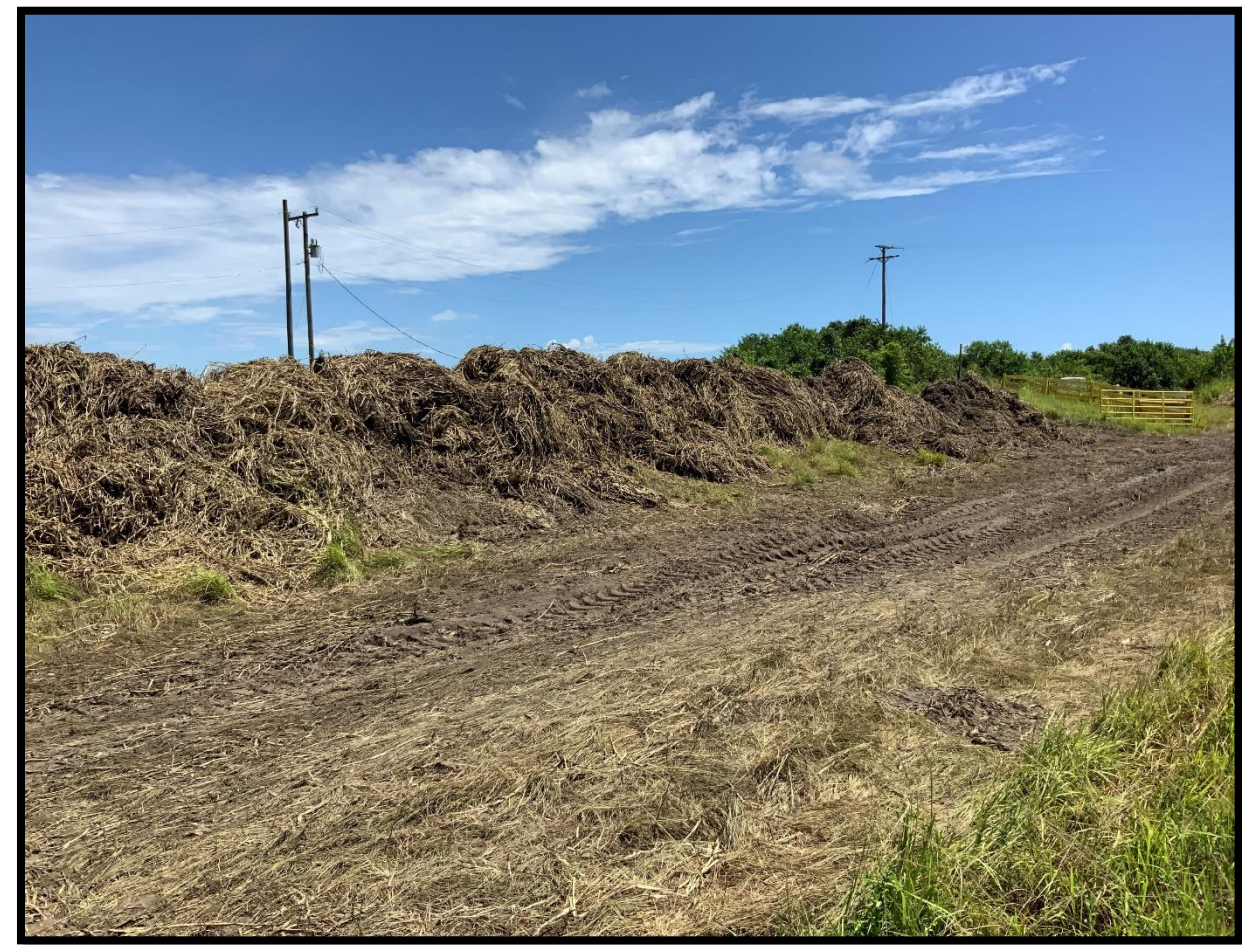
- Mechanical Harvesting

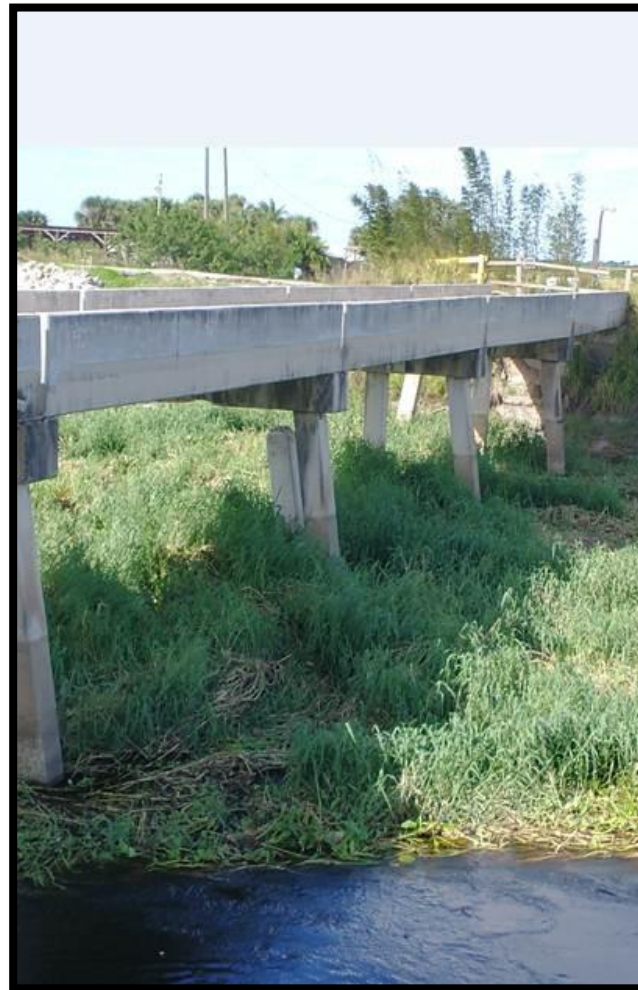
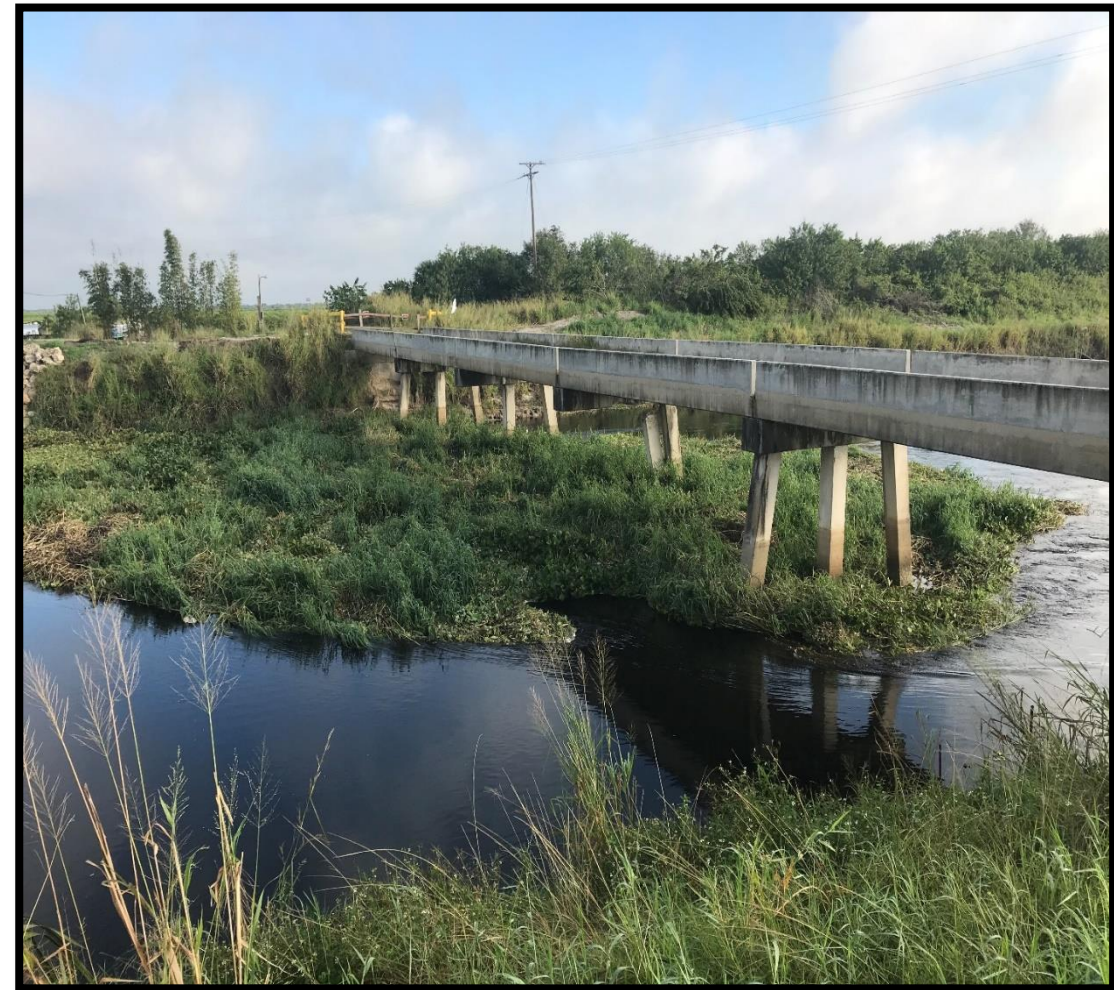
- Severe damage to bridge caused by the extreme pressure applied by floating vegetation, which required removal and replacement of the bridge.

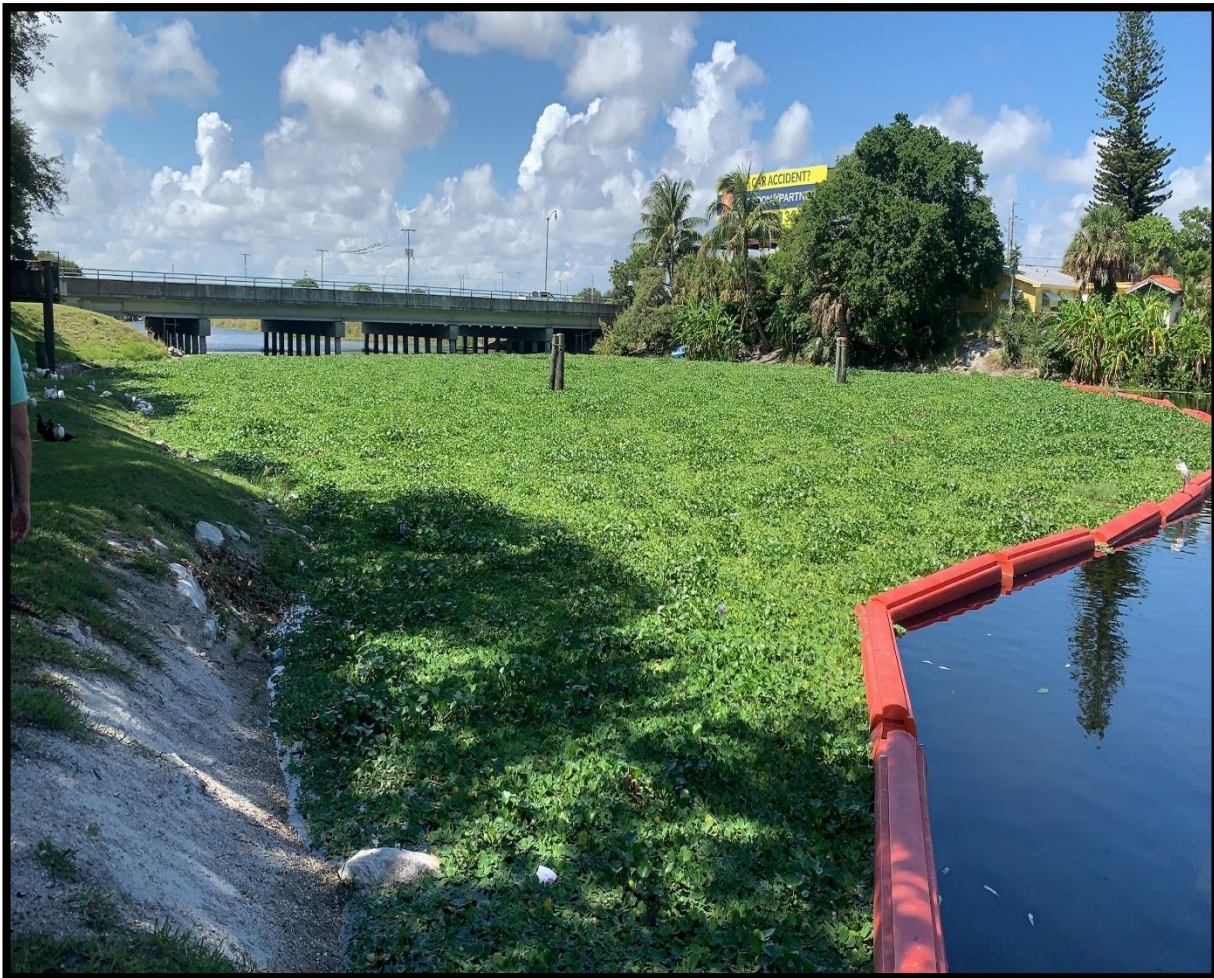
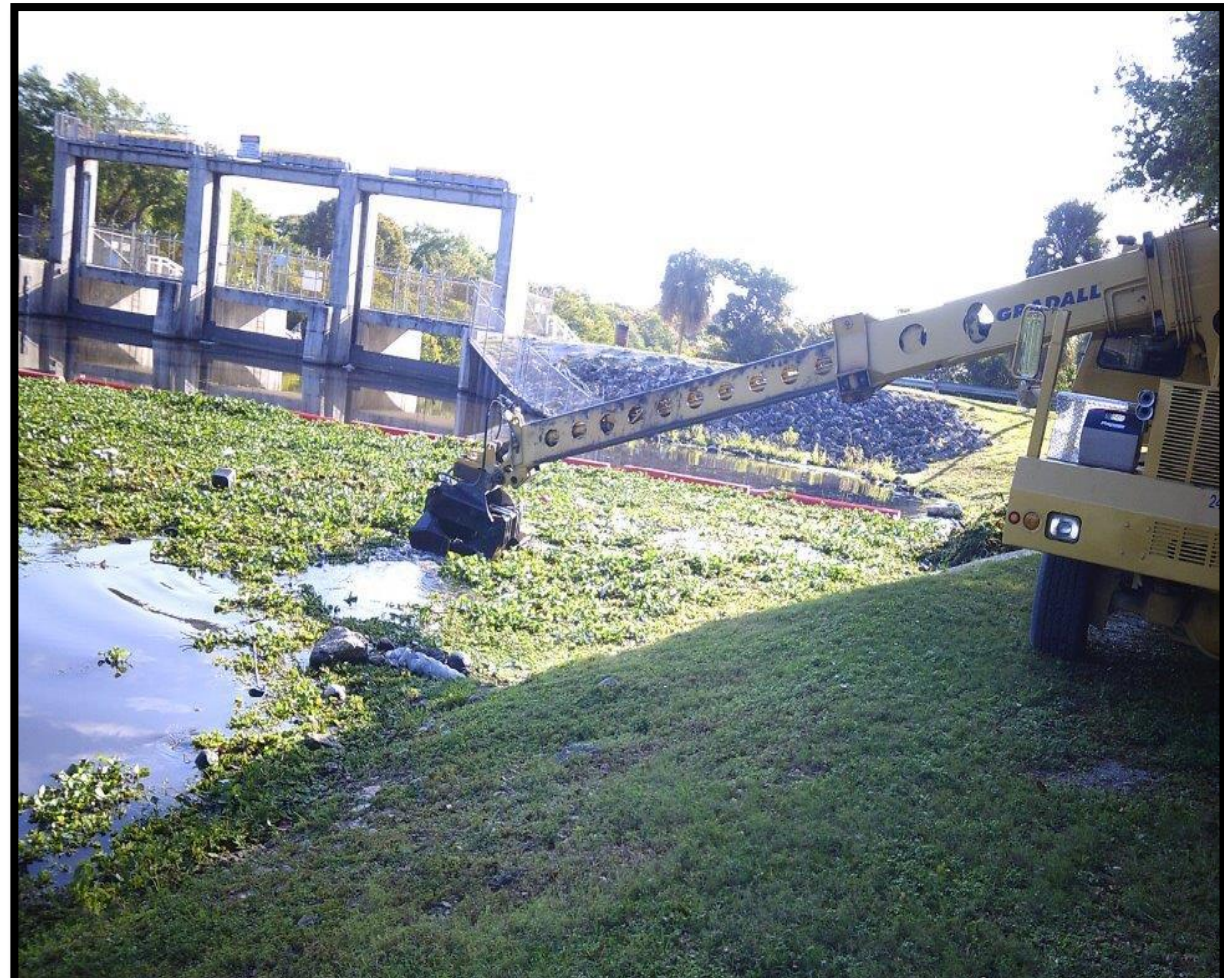
Aquatic Vegetation Accumulation at S-155 in the C-51 Canal

- **S-155: 60 Tons Average**
- **G-56: 2 Tons Average**
- **G-16: 2 Tons Average**
- **C-14: 1 Ton Average**
- **C-12: 2 Tons Average**
- **G-15: 2 Tons Average**

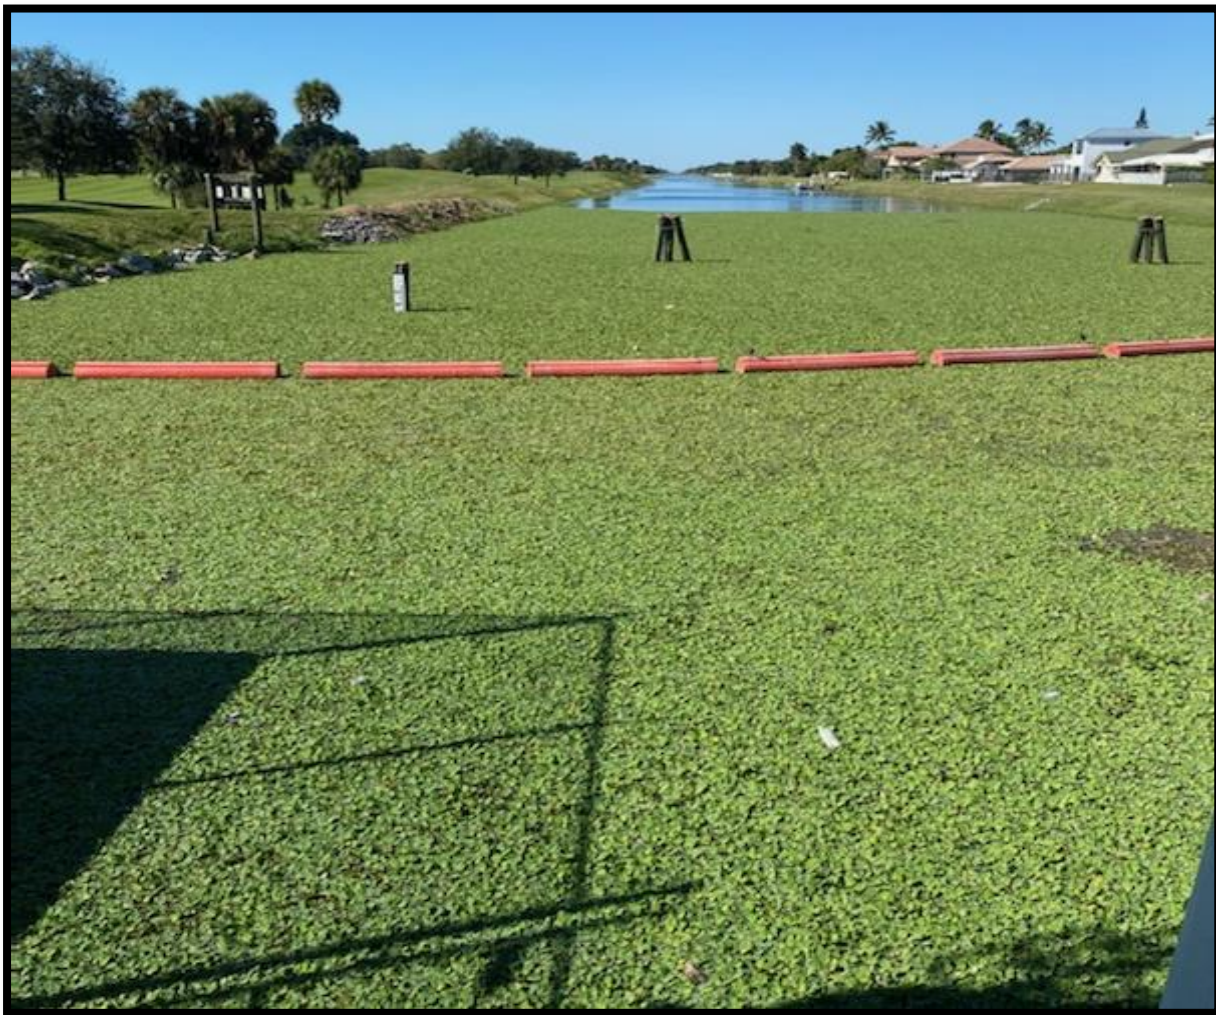
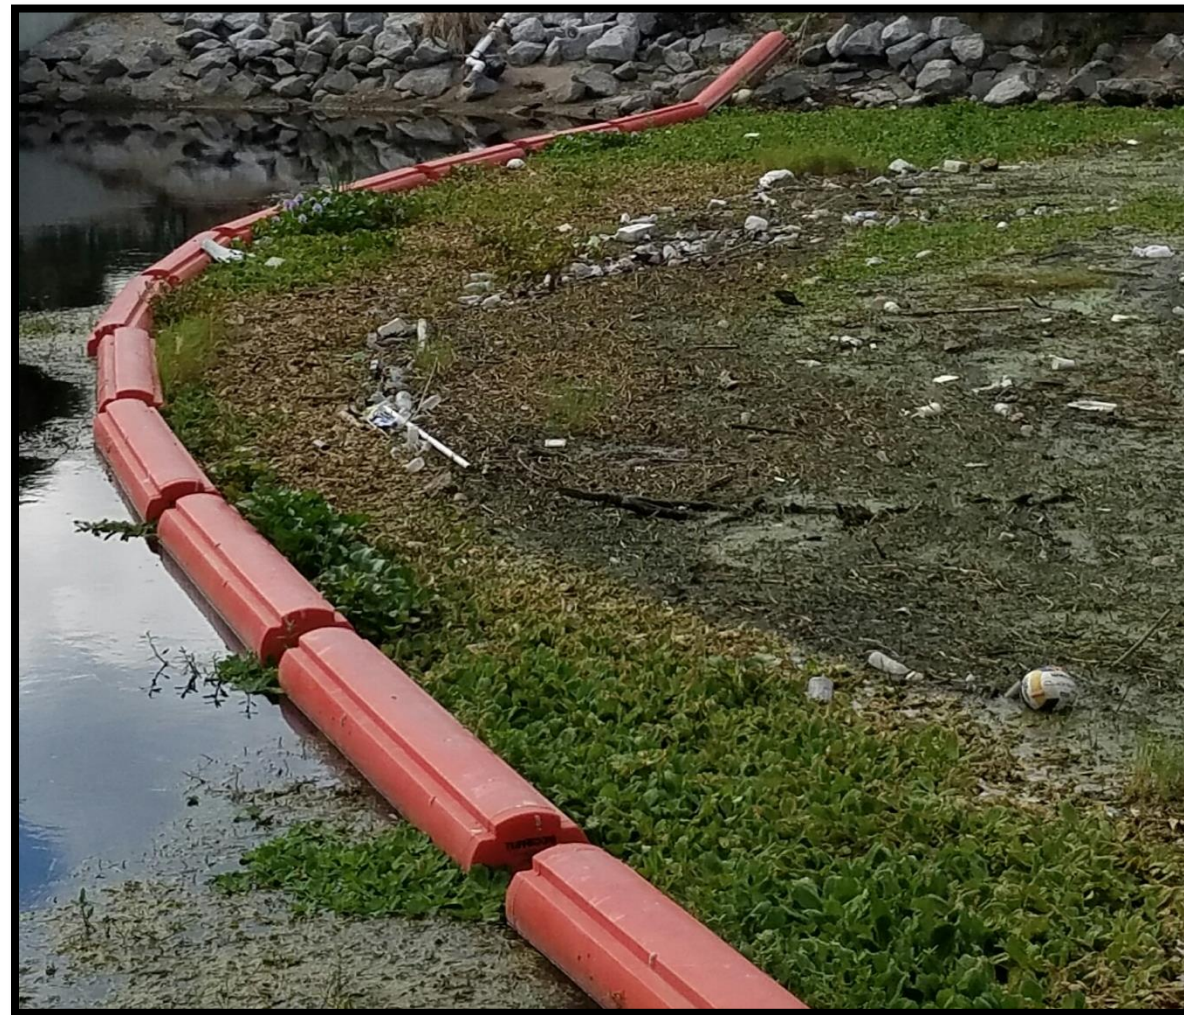
Aquatic Vegetation Accumulation at G-56 in the Hillsboro Canal

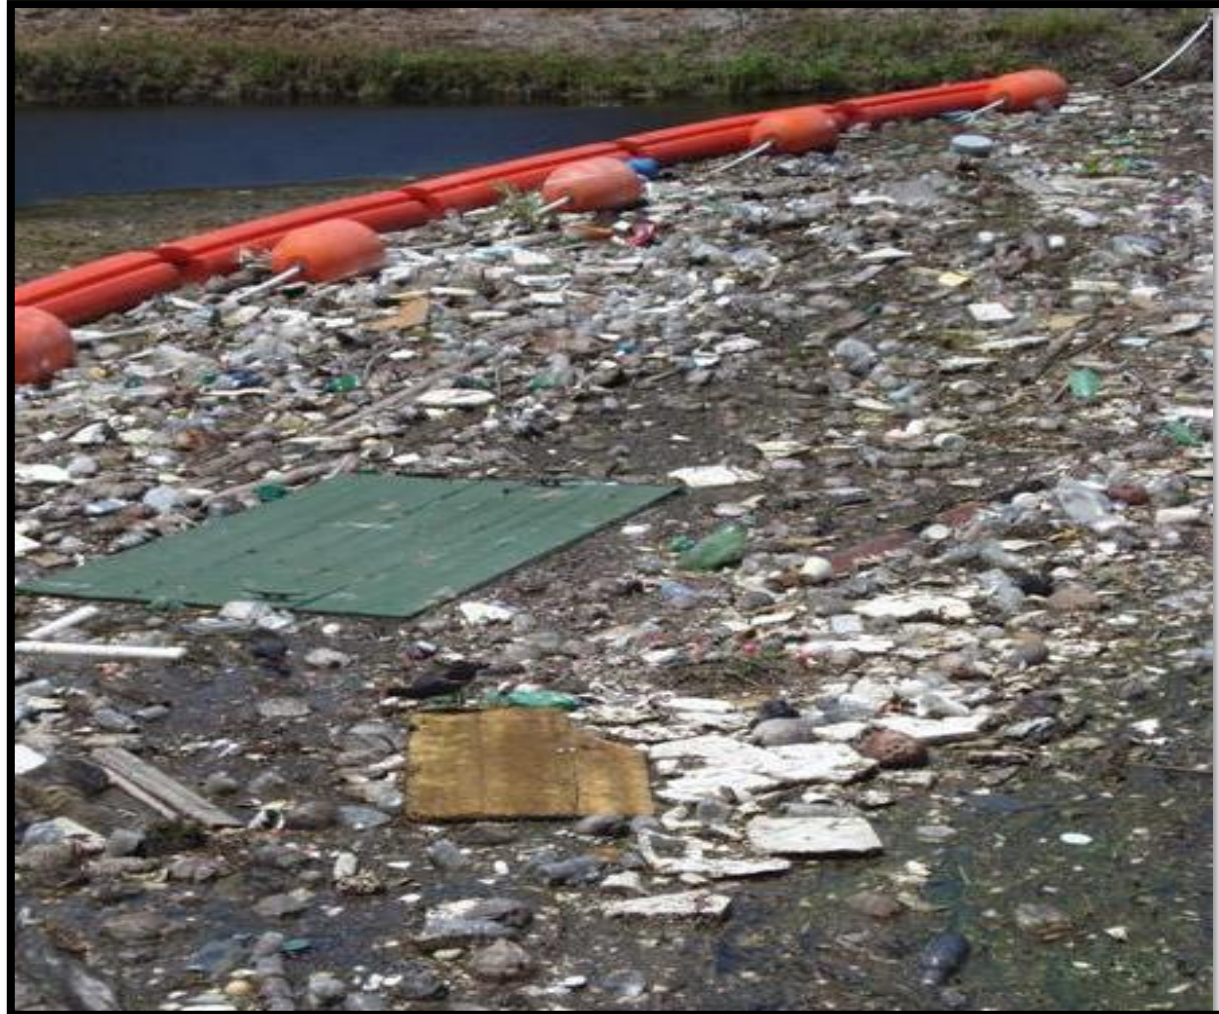
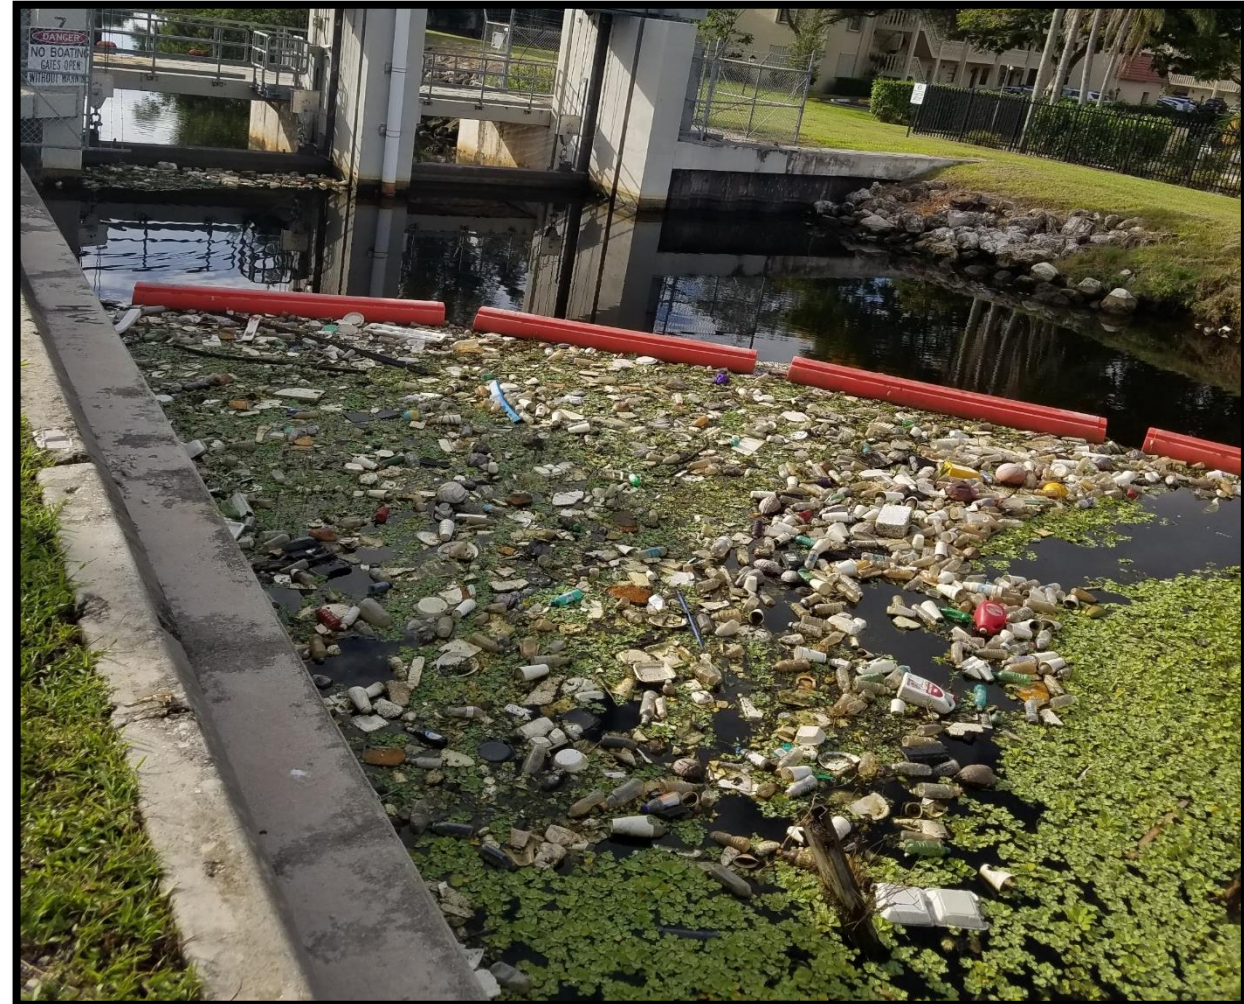
Debris Accumulation in the G-16 Canal

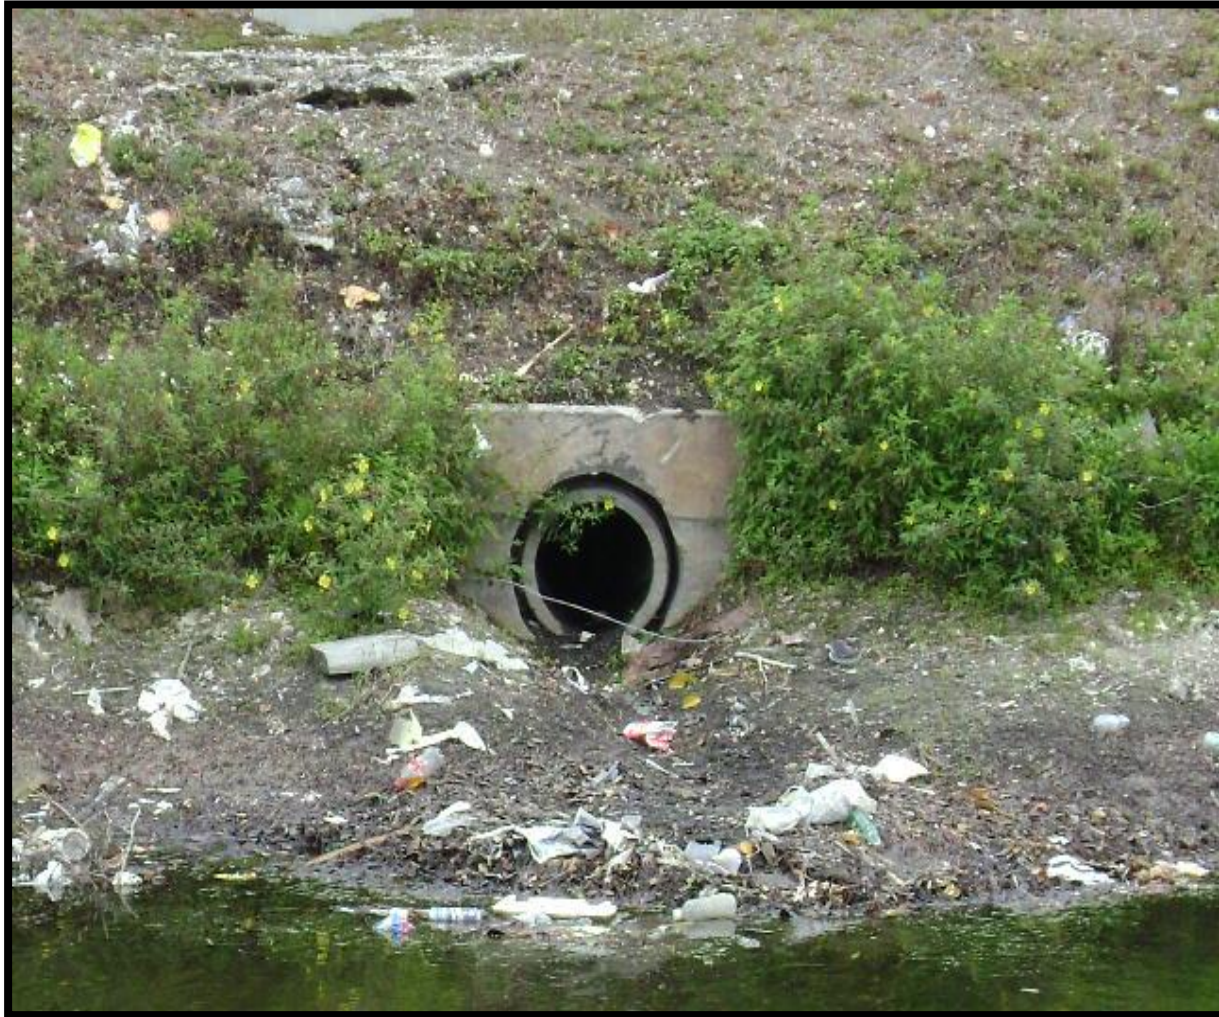
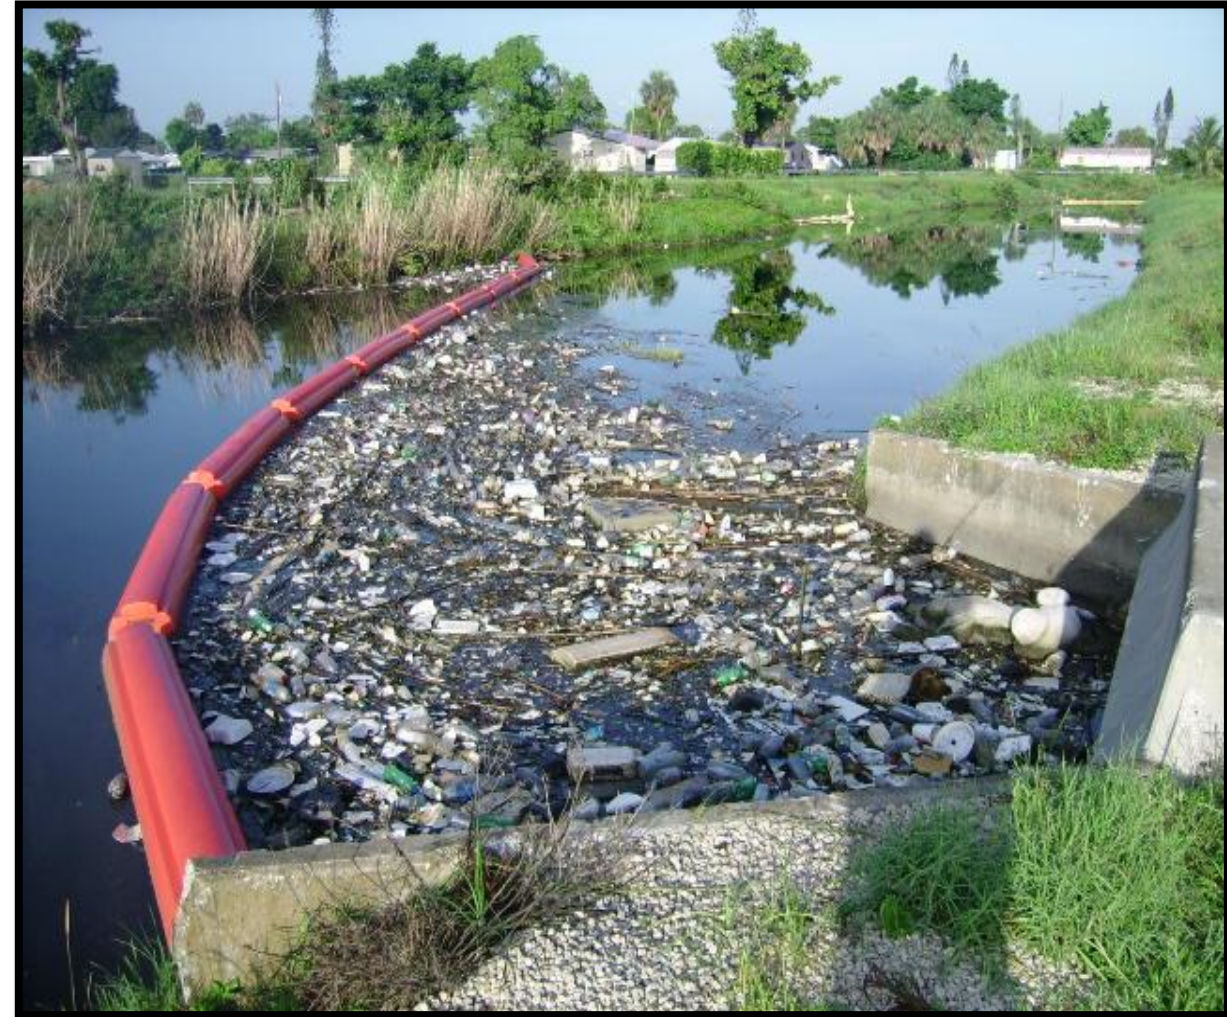
Debris Accumulation in the C-12 Canal

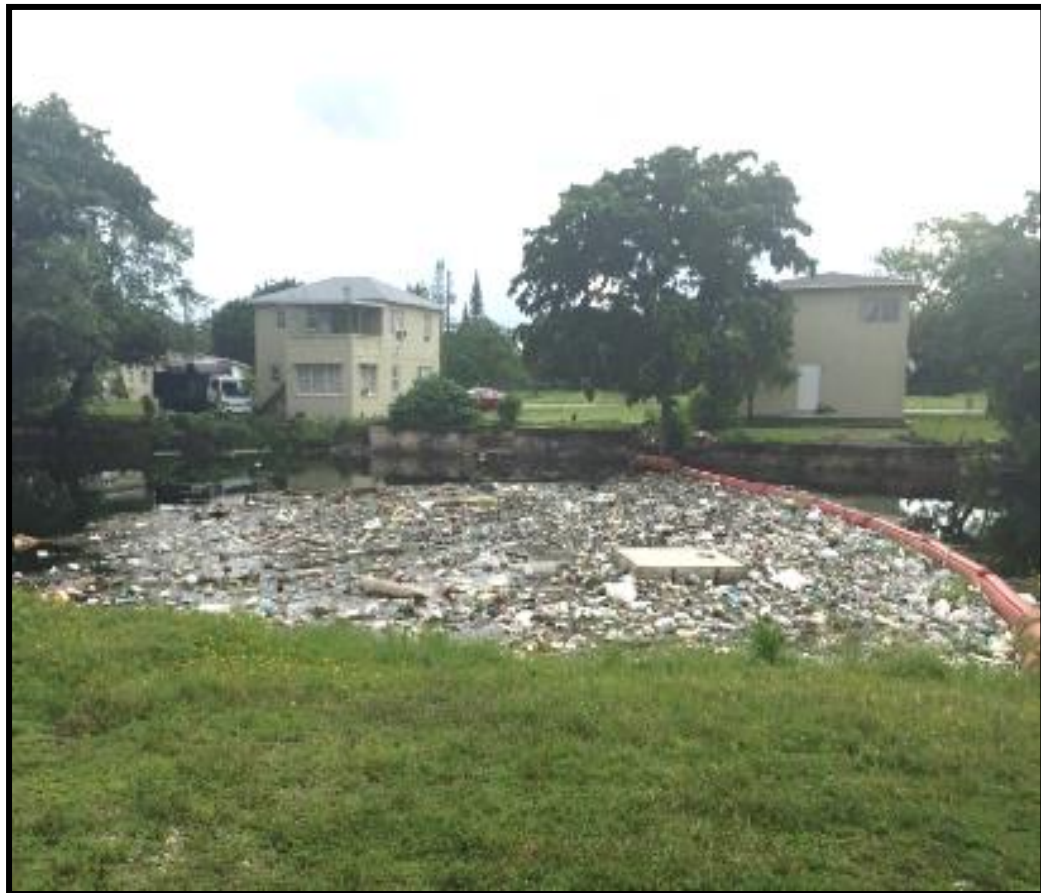
- Plastic water bottles, Styrofoam cups, coconuts and vegetation

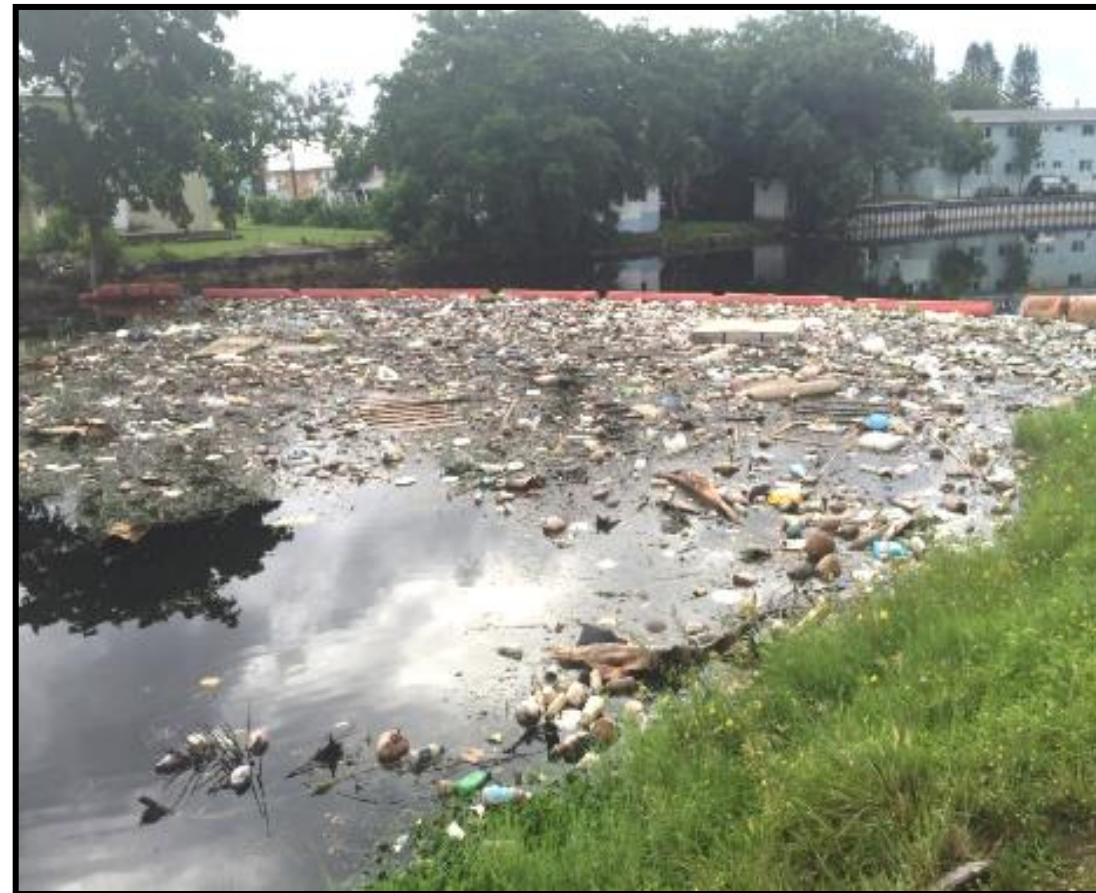
- Doors, bed mattresses, couches, coolers, tires and pallets
