Aquatic Vegetation, Trash and Debris Entering District Waterways

**South Florida Water Management District
Public Workshop January 10, 2022**

Rich Virgil, P.E., PMP Director - Field Operations

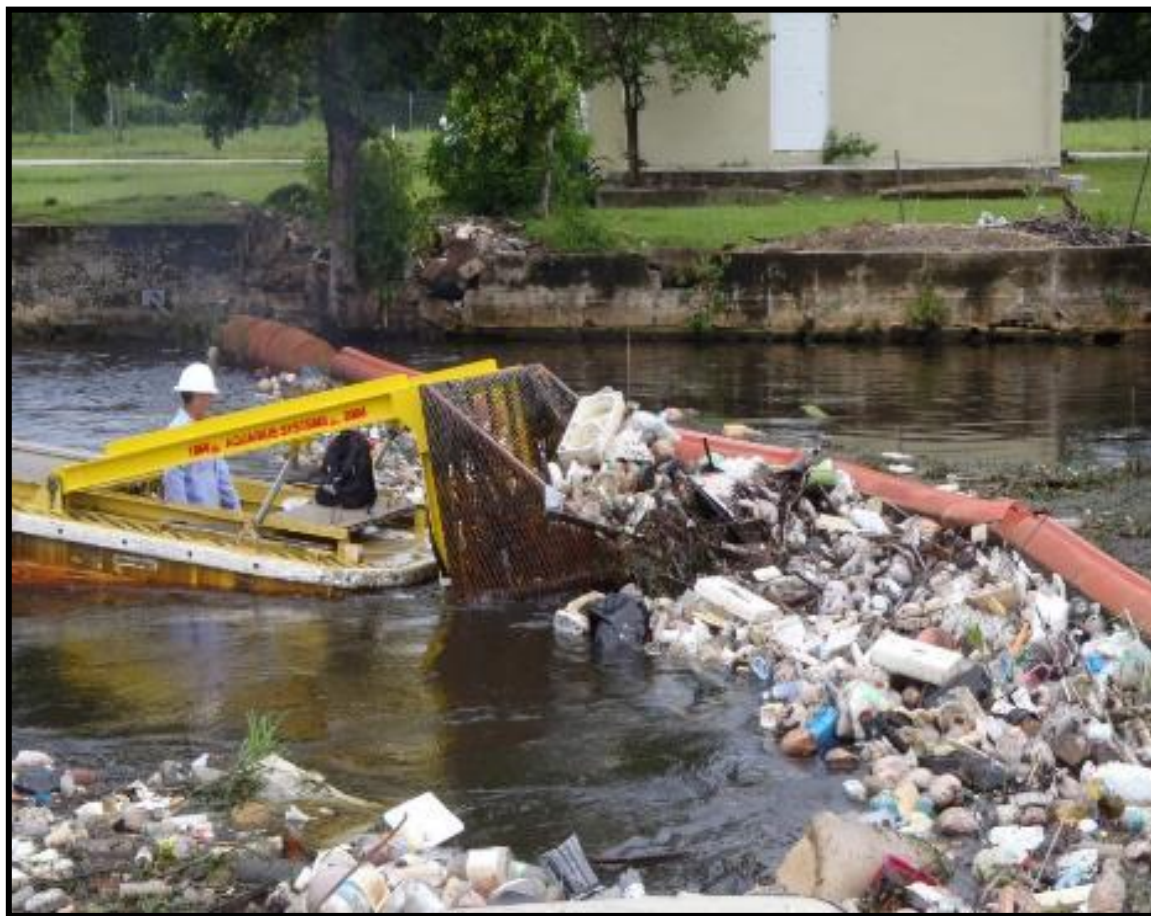
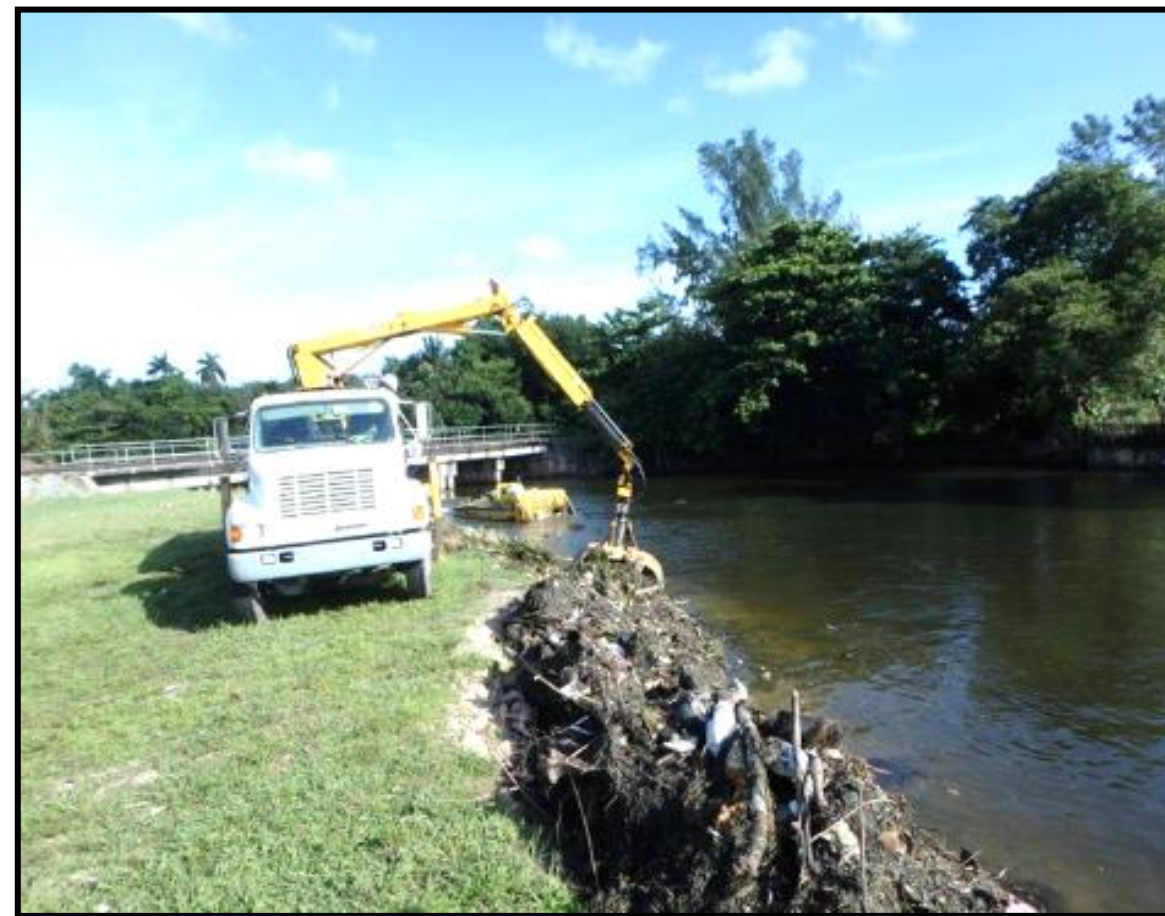
- **Towboat and trash truck in action removing debris from the canal**

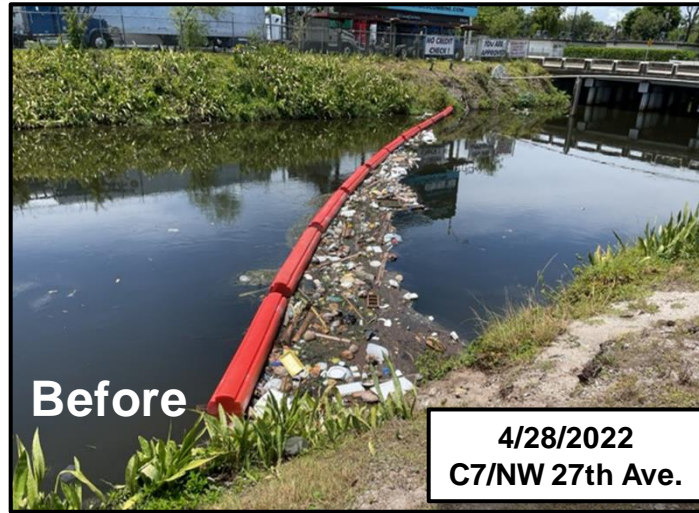
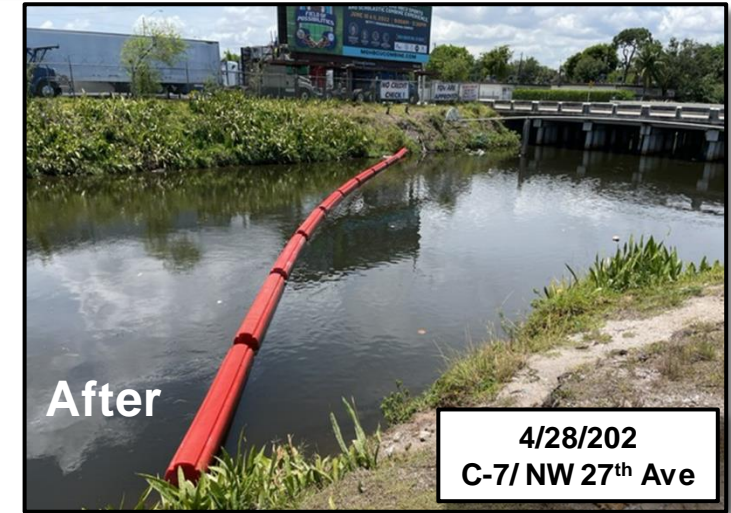
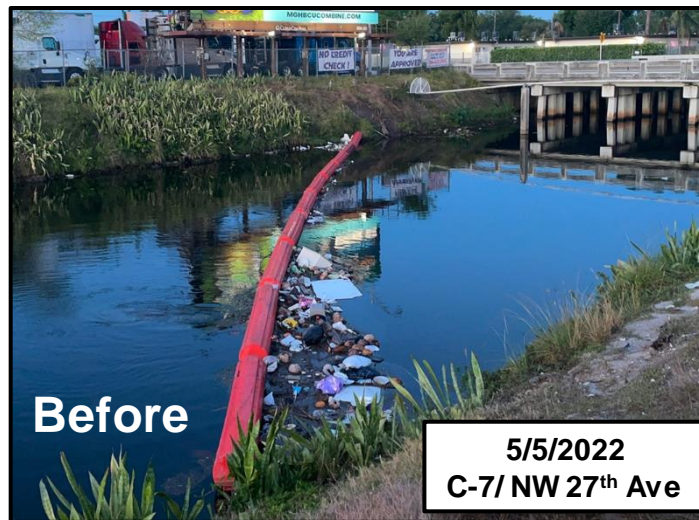
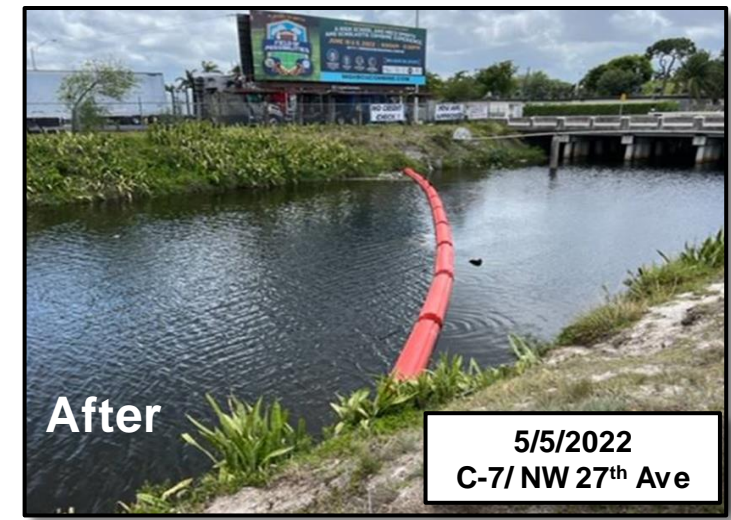
- In an ongoing effort to reduce debris in the Miami Little River C-7 Canal the District has installed a second tuff boom at NW 27th Avenue.
- The S-27 Structure and NW 27th Avenue booms are cleaned twice a week.

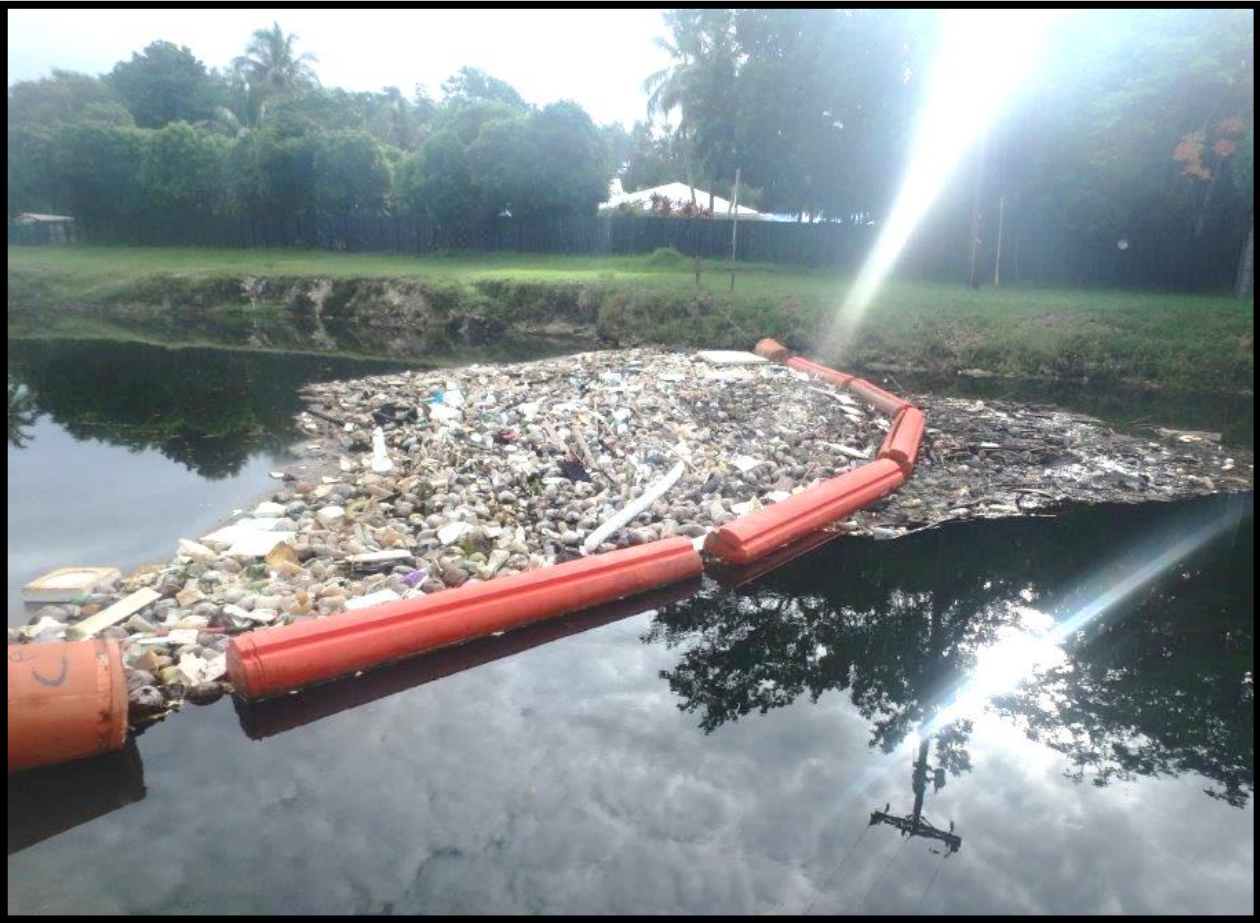
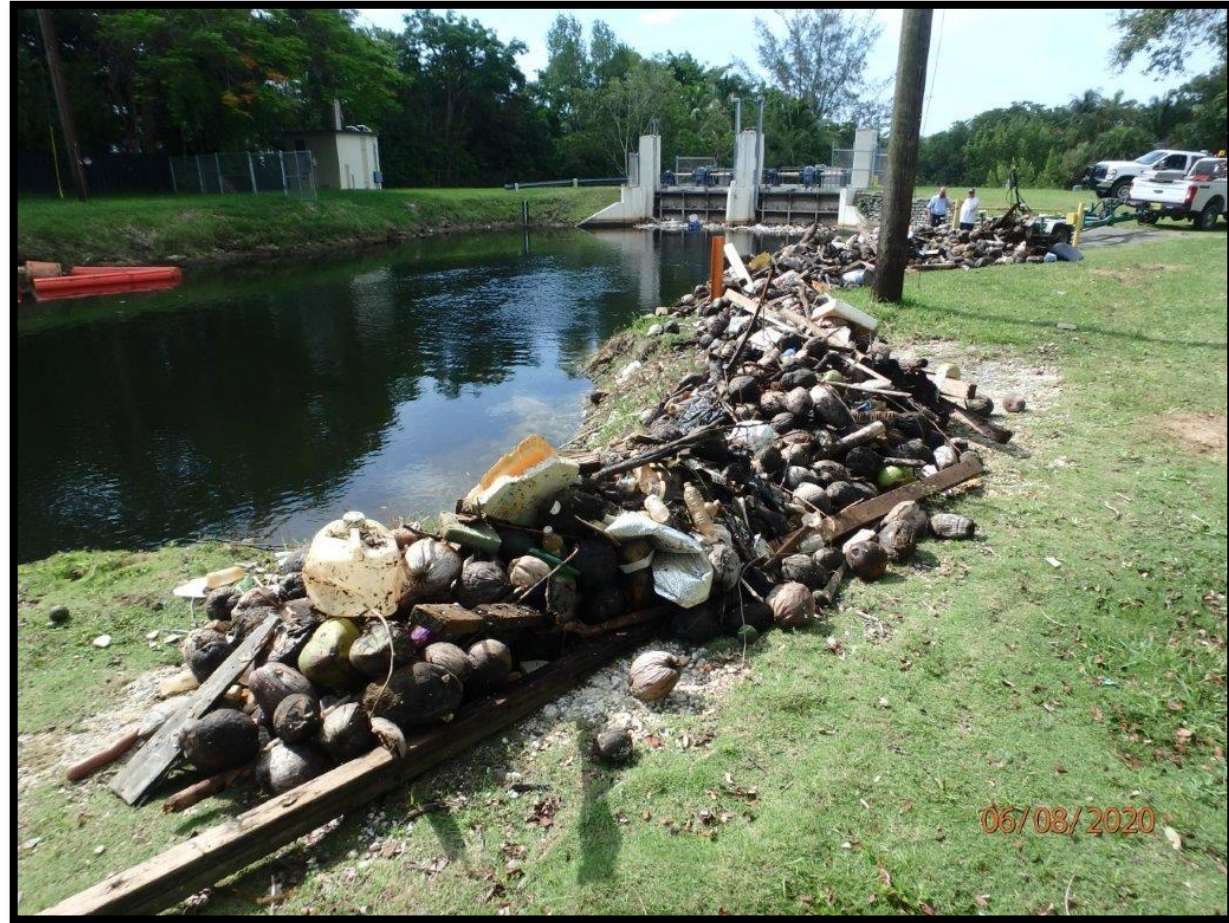
Debris Accumulation at S-22 in the C-2 Canal

- **S-22: 25 Tons Average - 19 Cleanings**
- **S-26: 2 Tons Average - 2 Cleanings**
- **S-27: 217 Tons Average - 97 Cleanings**
- **S-28: 84 Tons Average - 57 Cleanings**
- **G-58: 2 Tons Average - 4 Cleanings**

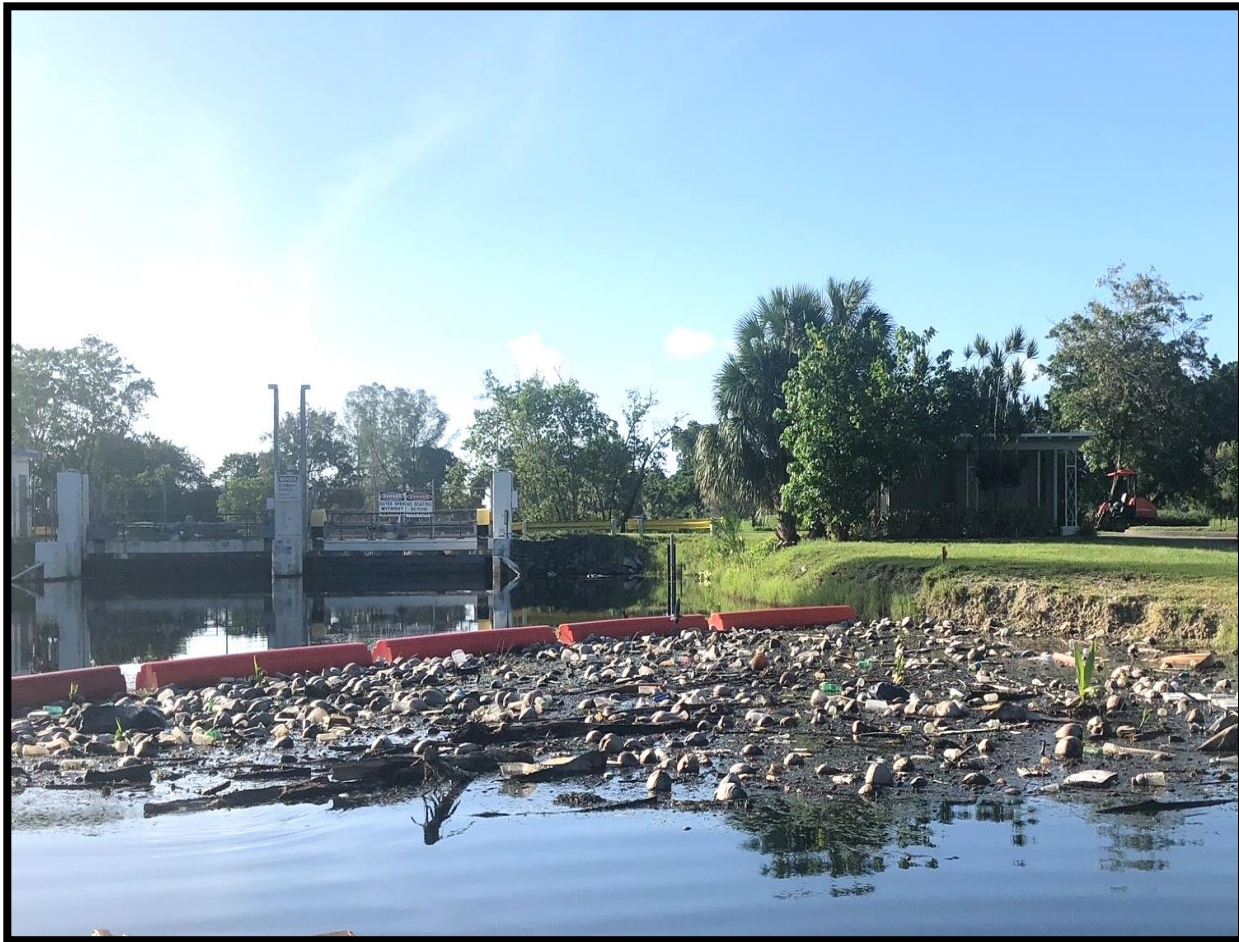
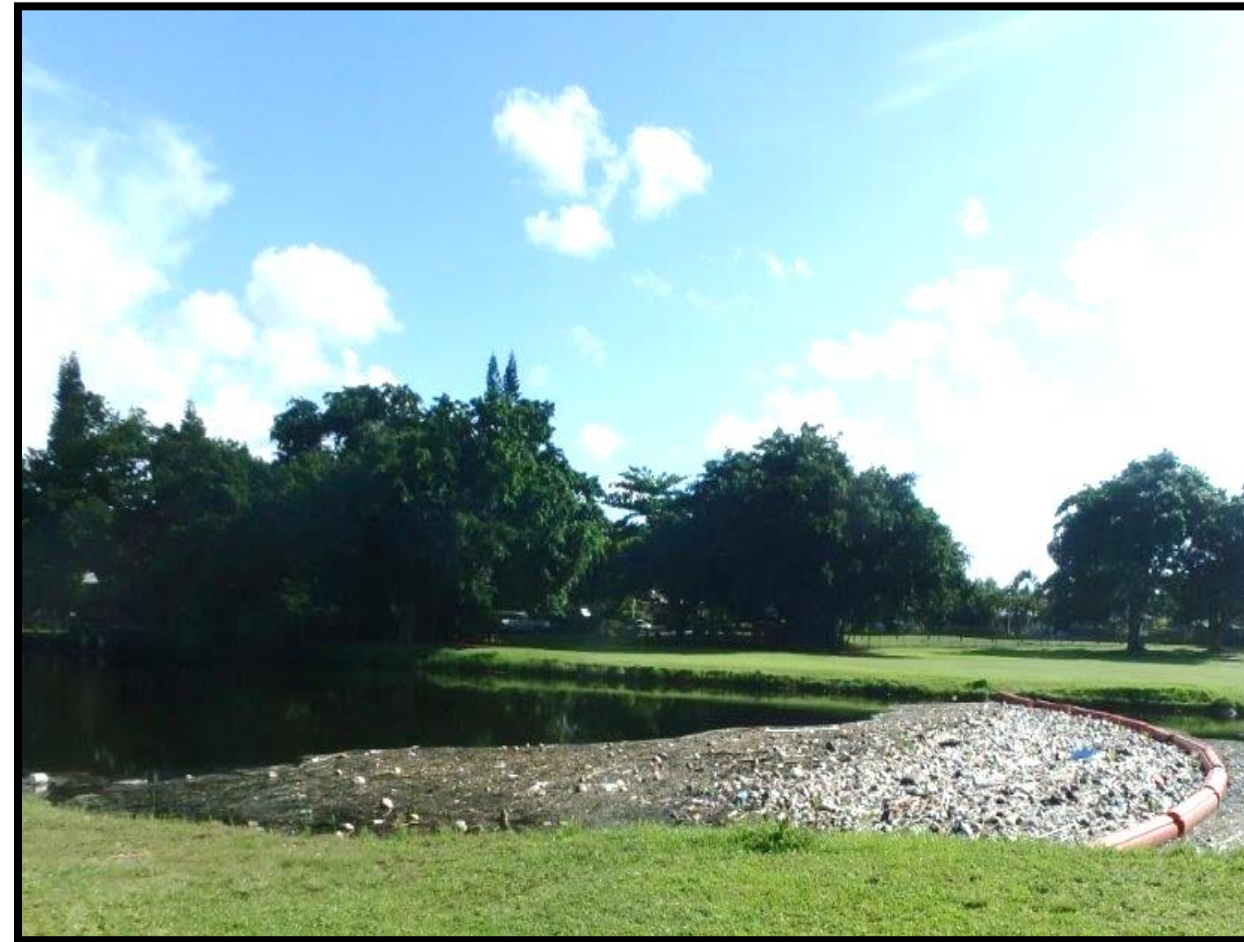
Debris Accumulation at S-28 in the C-8 Canal

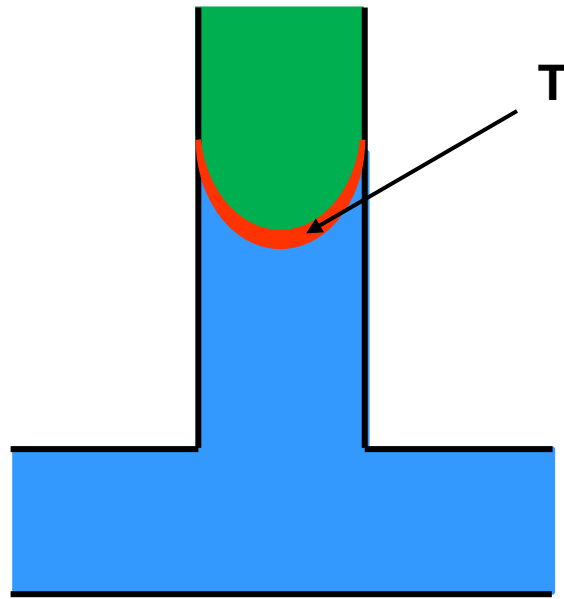
Canal to Canal

Typical Barrier Placement

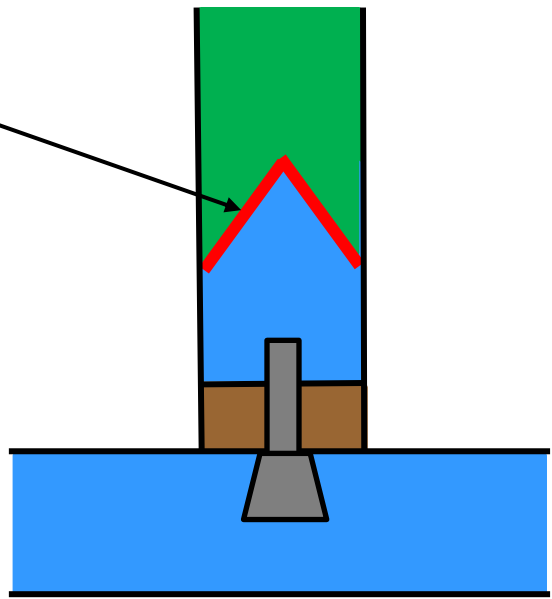
Culvert to Canal

Typical Barrier Placement

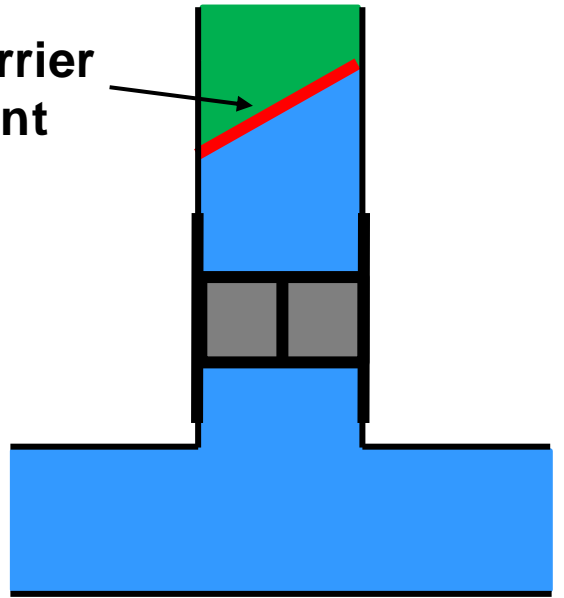
Water Control Structure to Canal

Typical Barrier Placement for Various Types of Connections

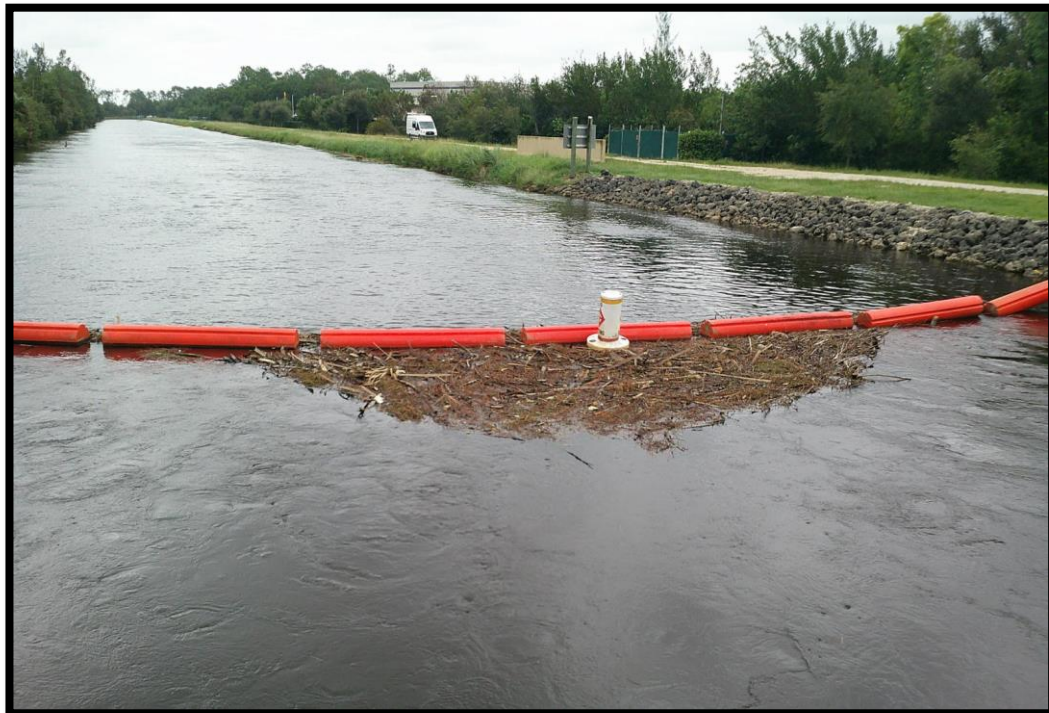
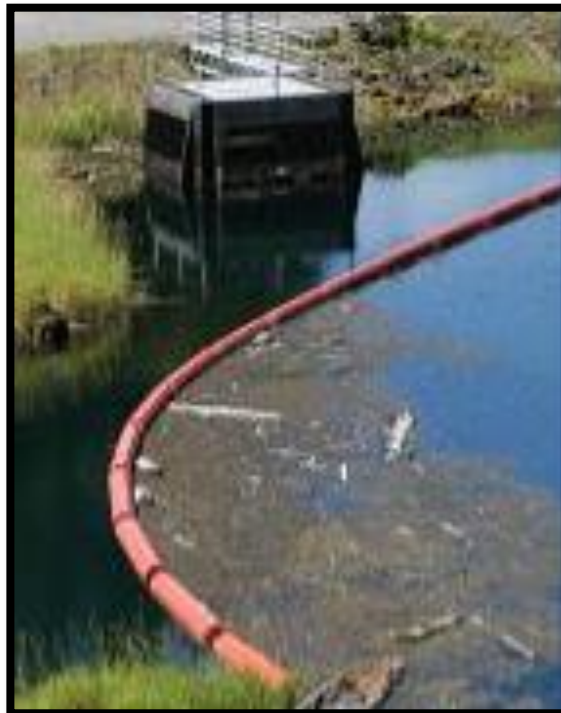
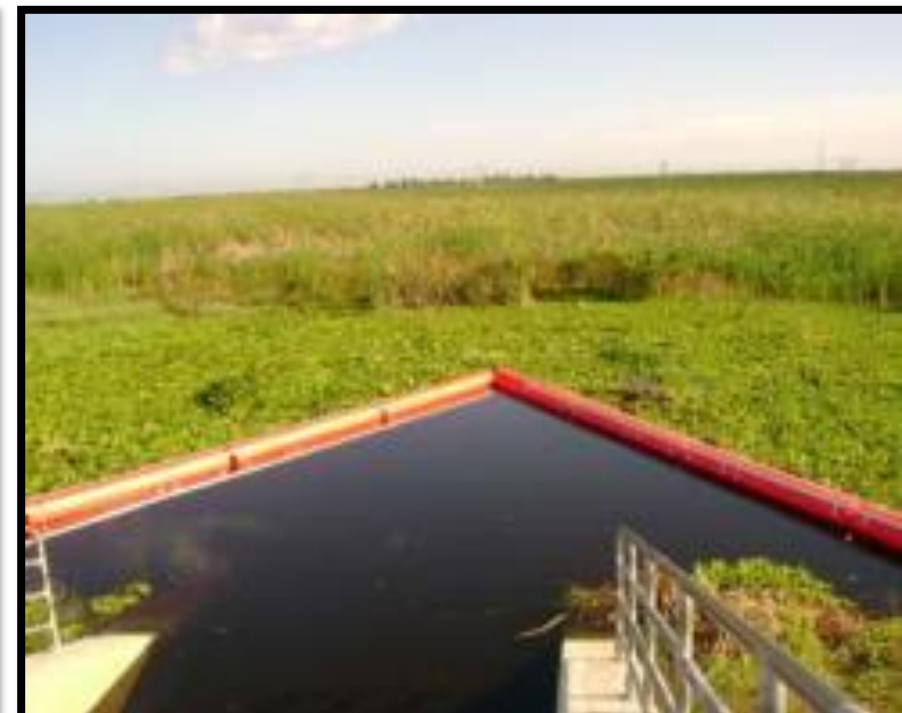
Canal

Culvert

Water Control Structure

Typical Barrier Placement for Various Types of Connections

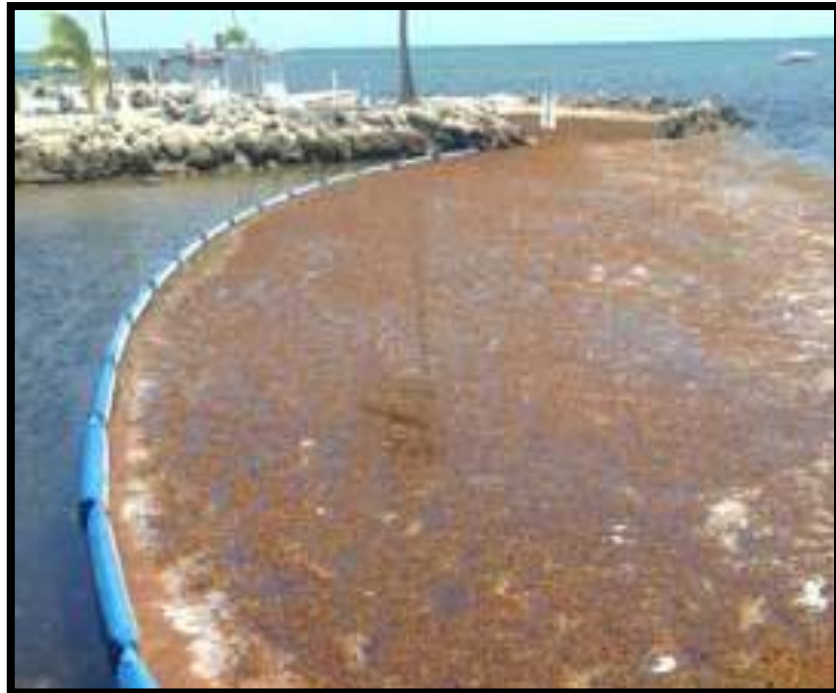
Blue Floating Barrier

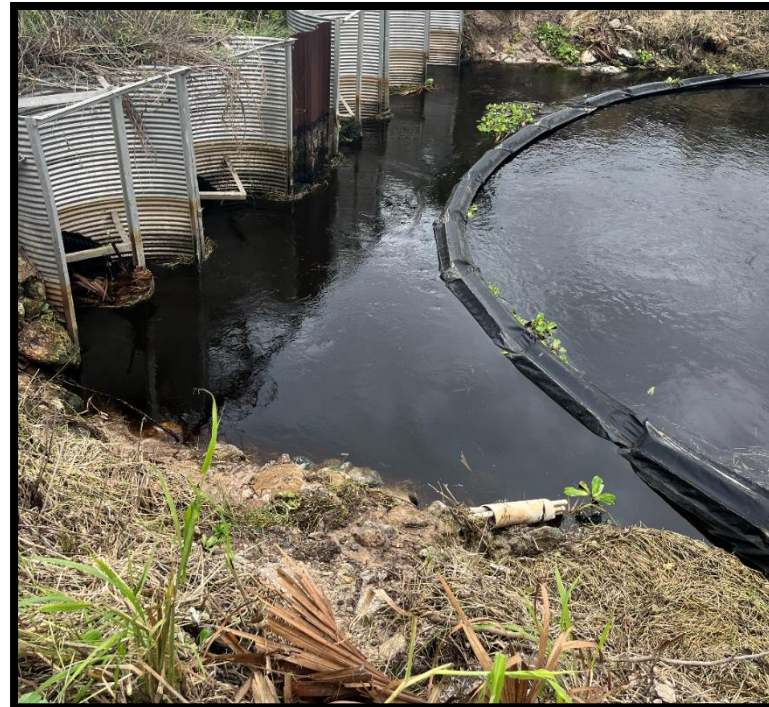
Black Floating Barrier

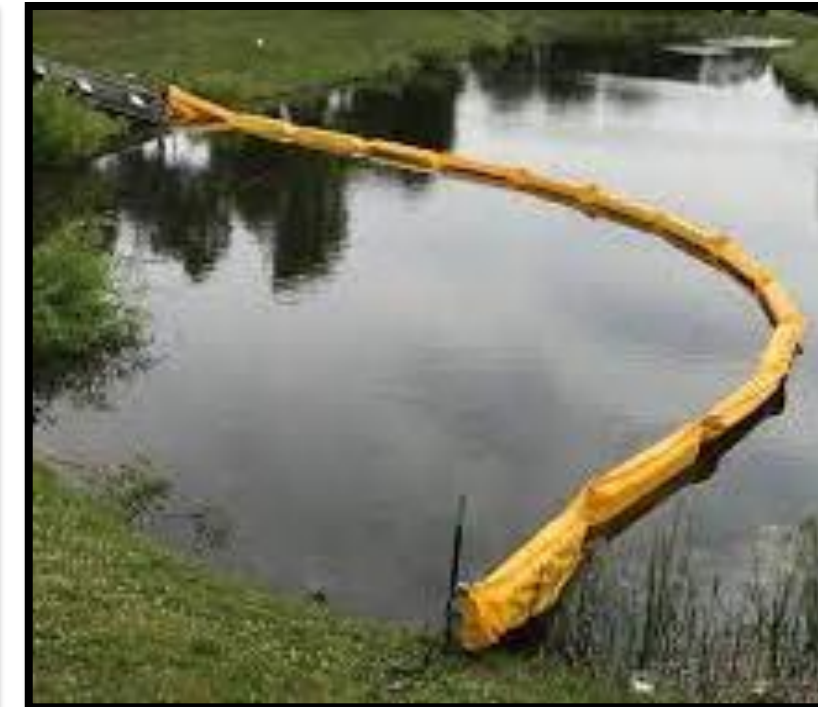
Turbidity Barrier

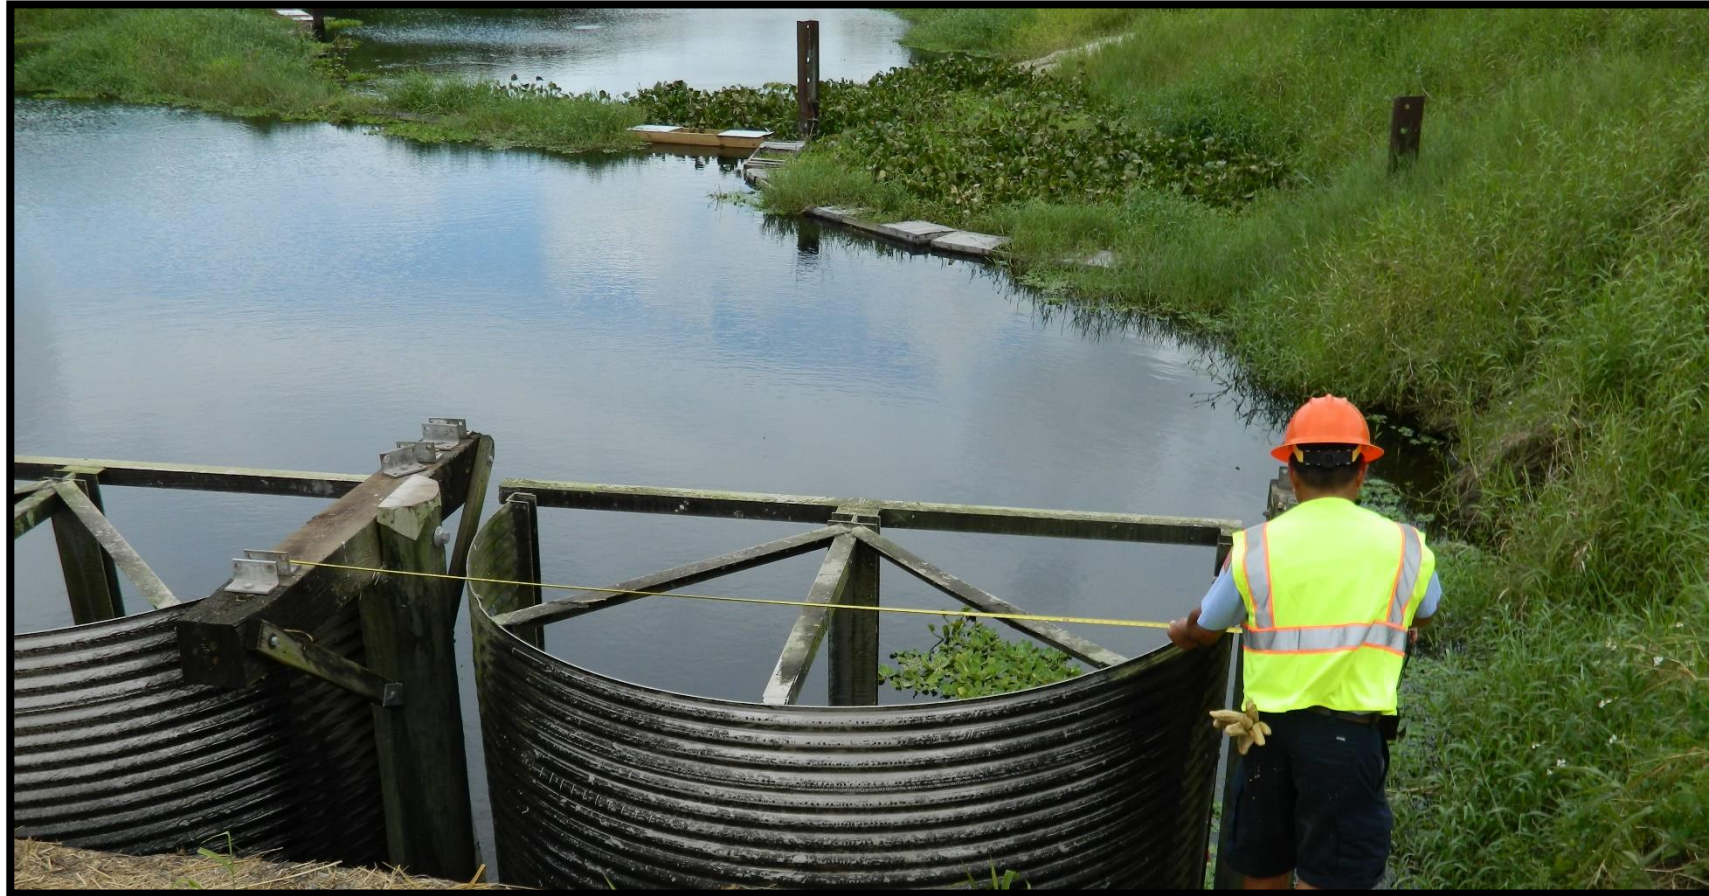
Wood & Styrofoam Floating Barrier

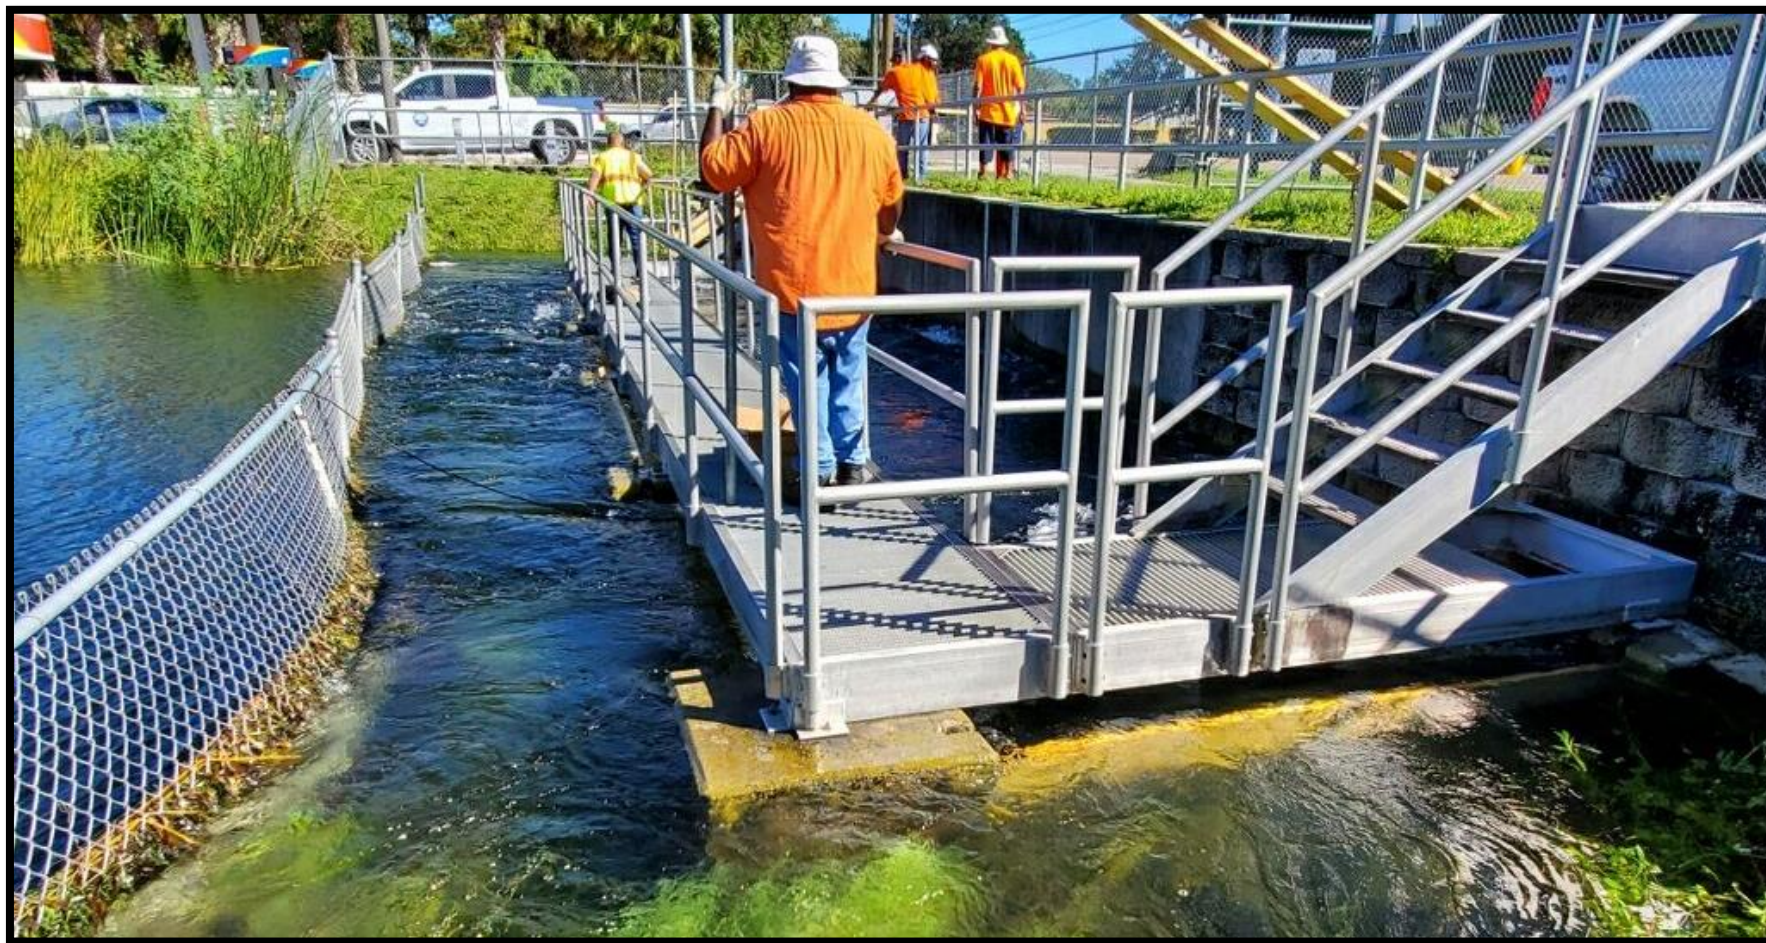
Chain-link Fence used as a Barriers

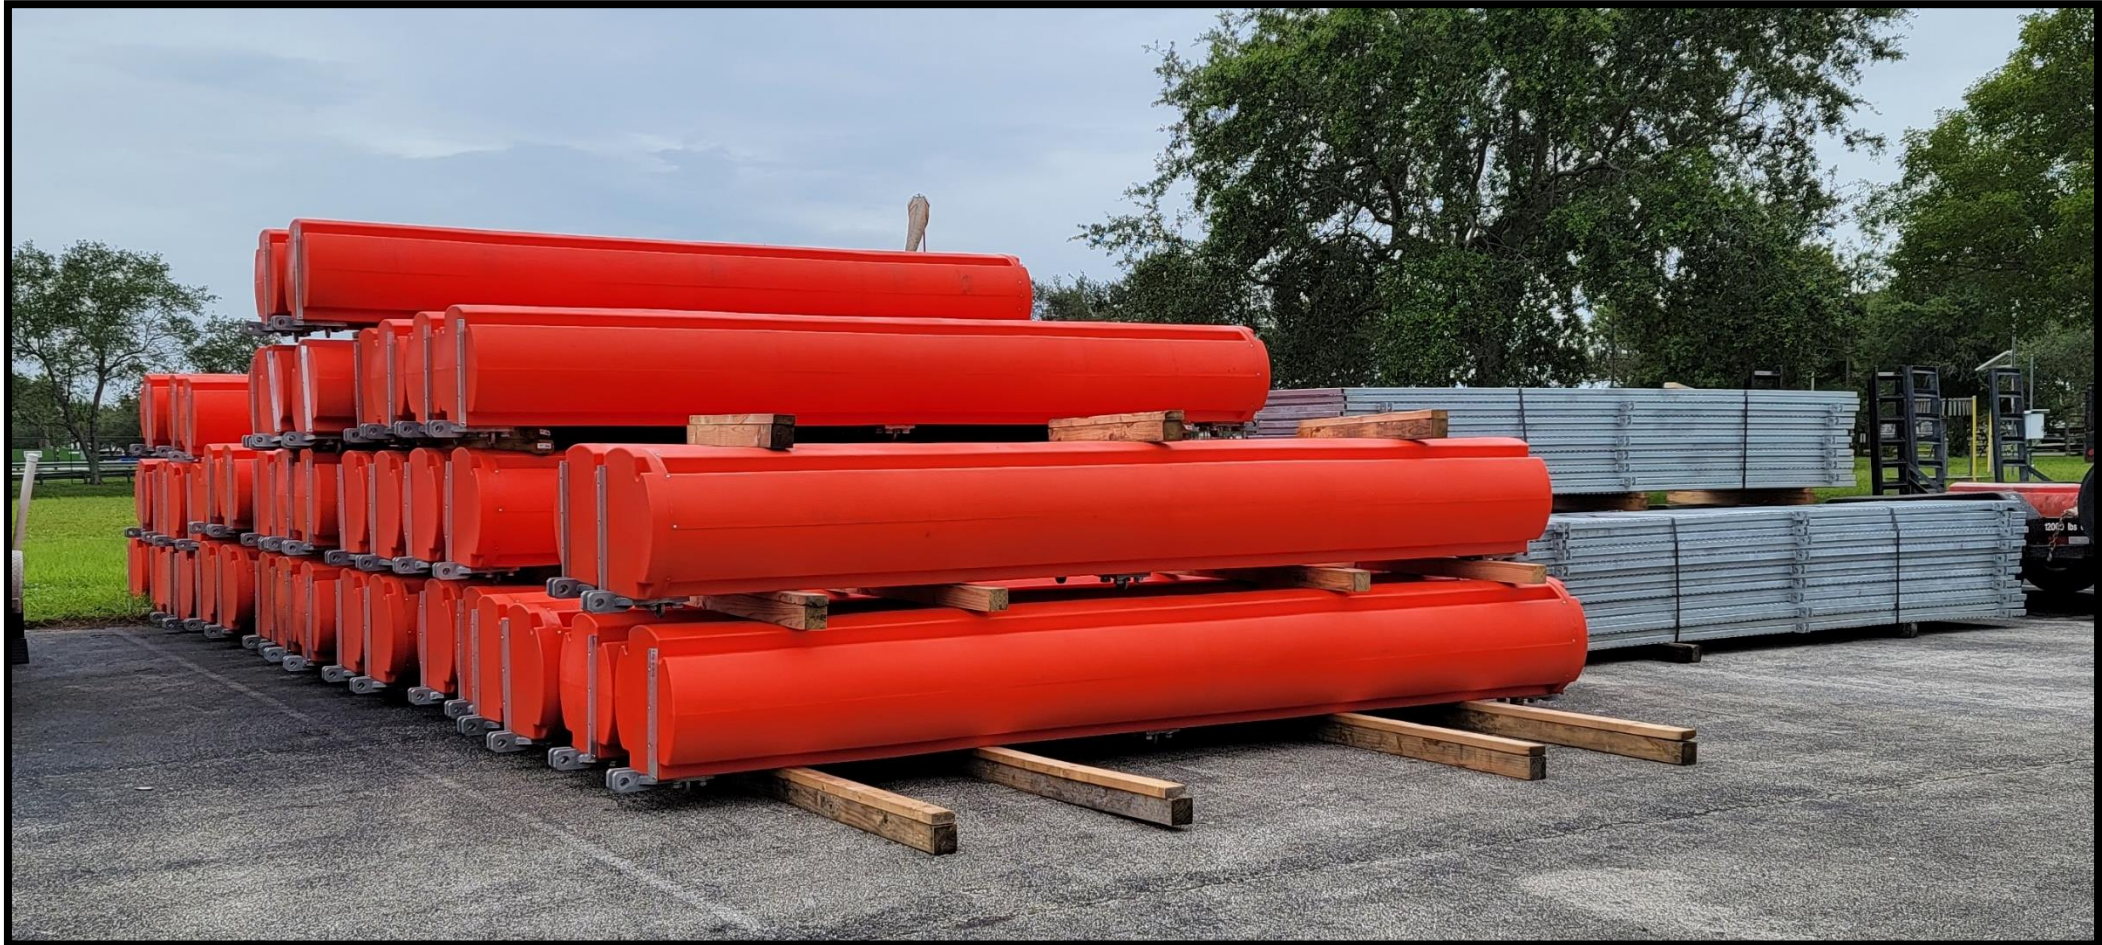
District Standard Barrier – Tuff Boom
