August – October 2014 Quarterly Kissimmee Basin Environmental and Restoration Features

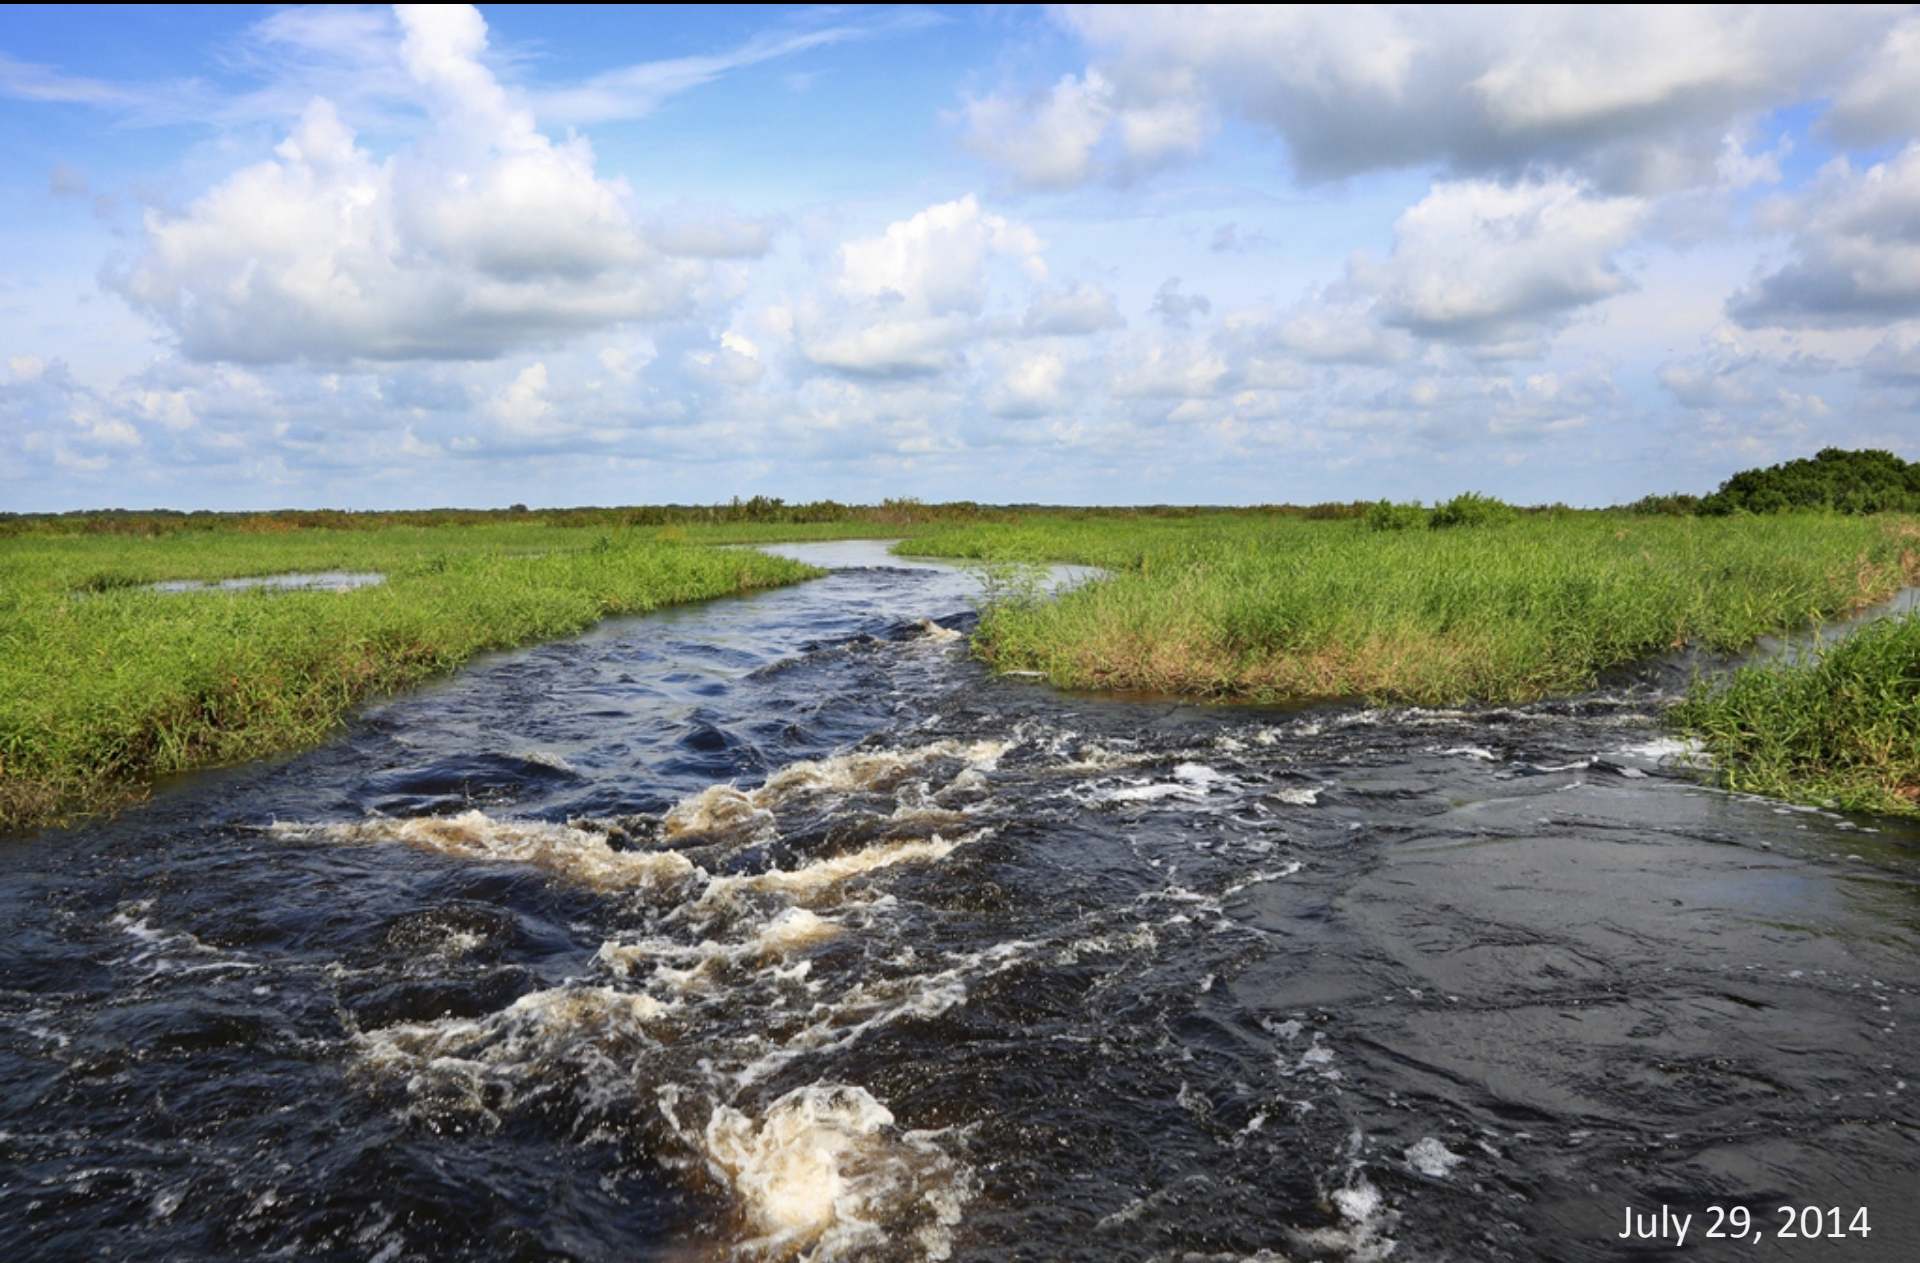
July 29, 2014

Water flowing off the Phase I restoration area floodplain into the MacArthur ditch during high flows.

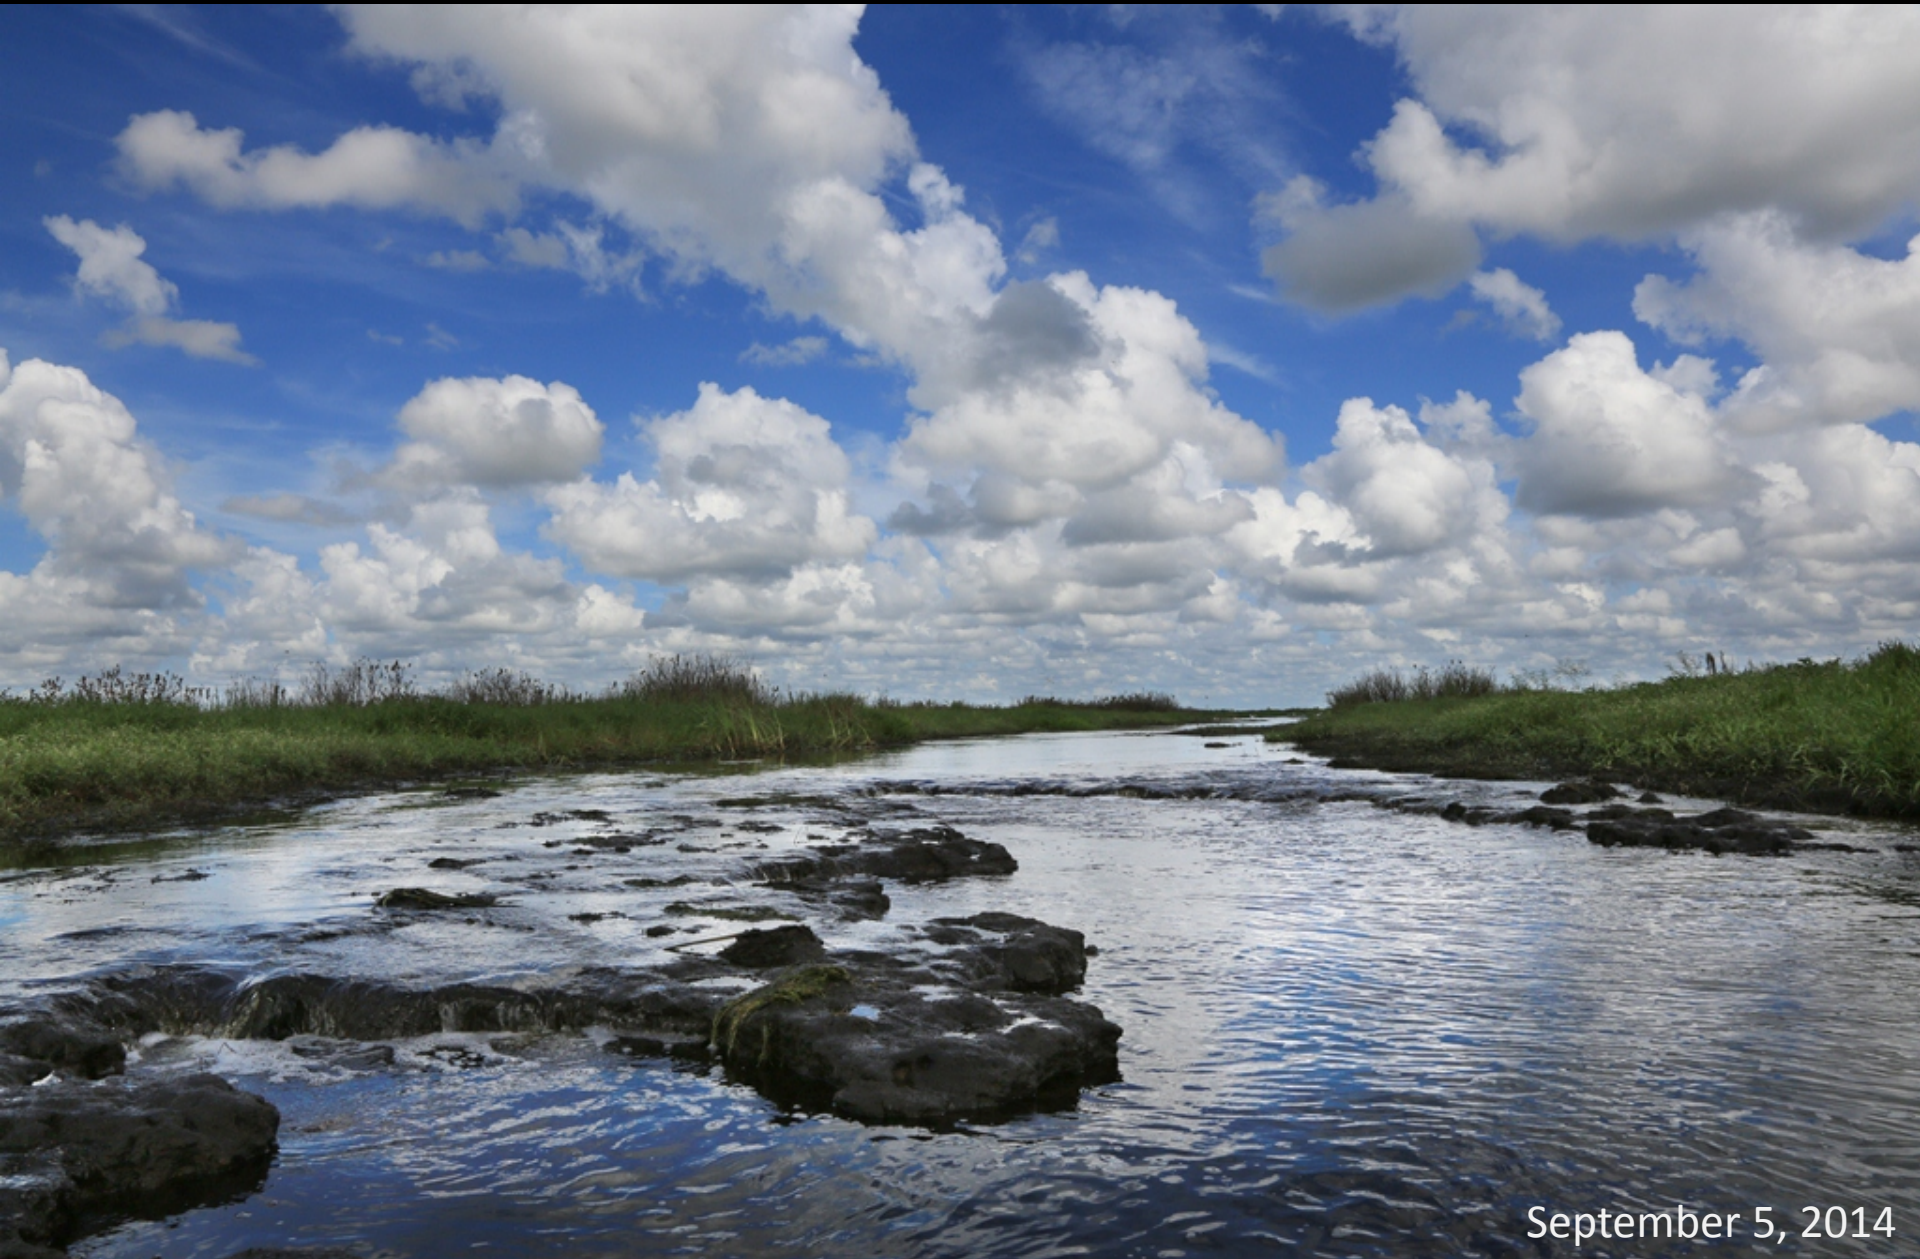
September 5, 2014

Phase I restoration area floodplain where the MacArthur floodplain flows into the MacArthur ditch. This particular area is showing erosion from recent high flows event.

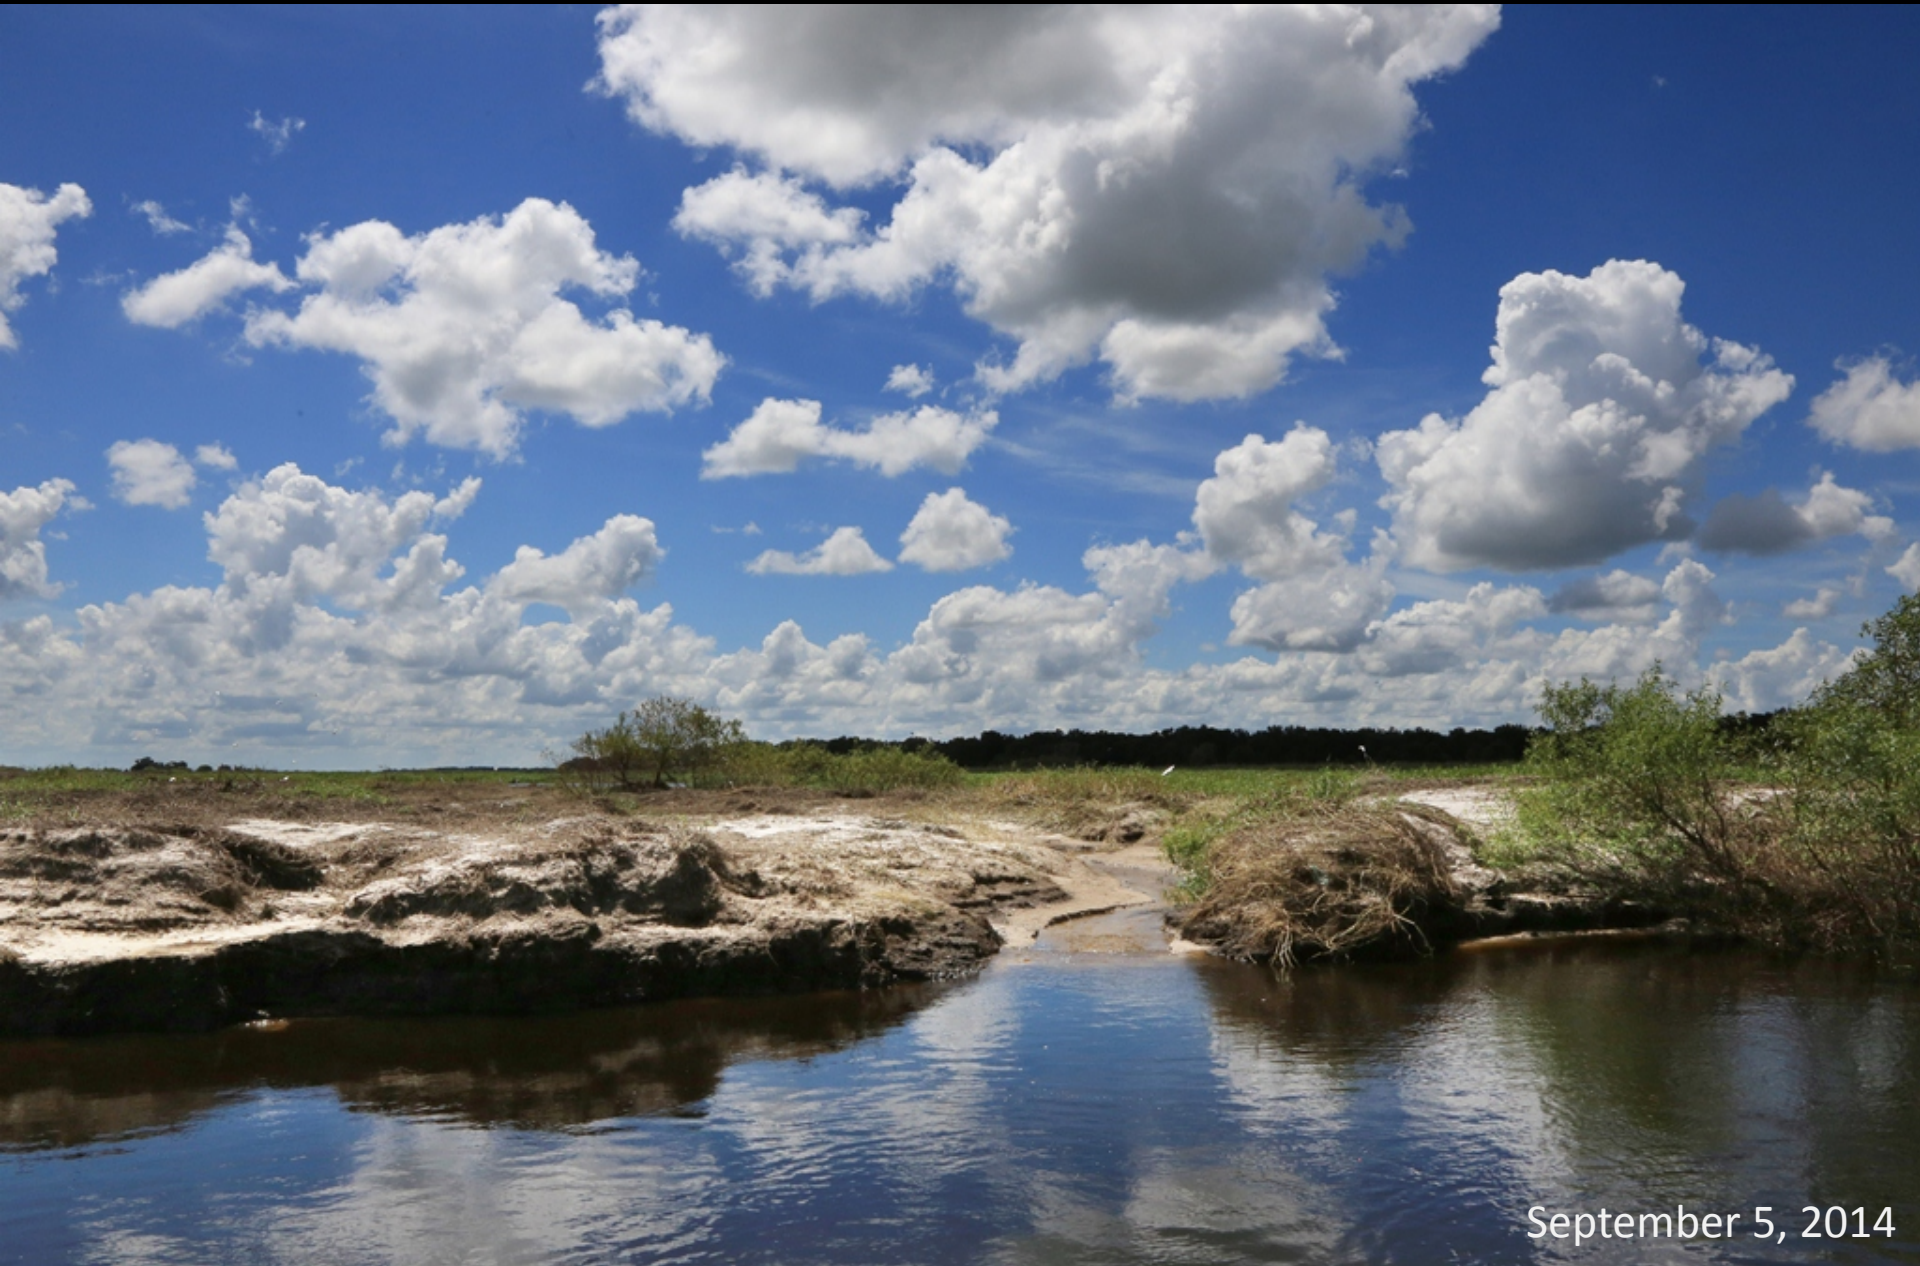
September 5, 2014

Phase I restoration area MacArthur river channel showing sandy banks as a result of recent high flows

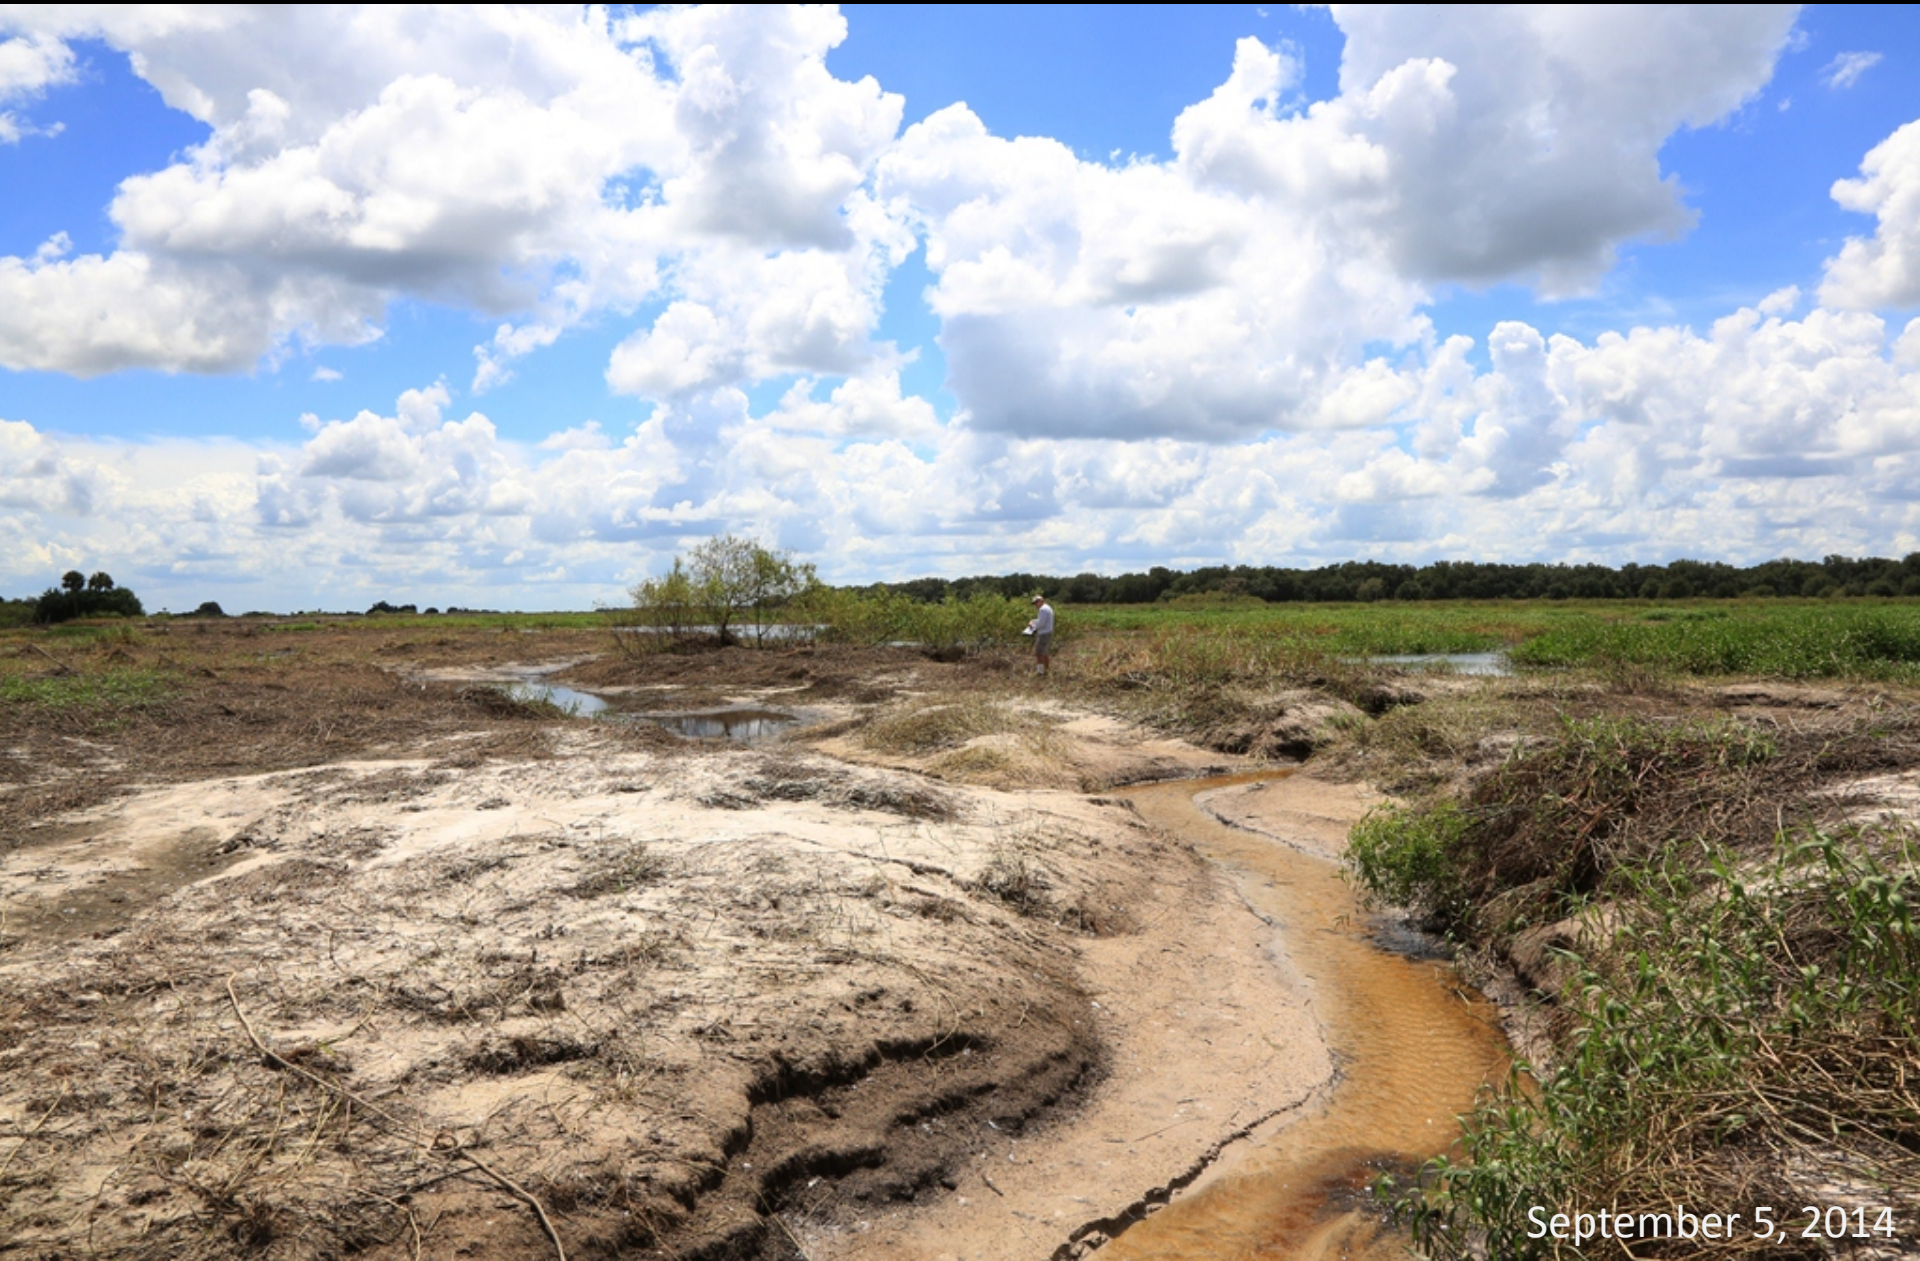
September 5, 2014

An environmental scientist documents changes in the landscape of the Phase I restoration area river channel as the result of seasonal high velocities of water cutting through the floodplain.

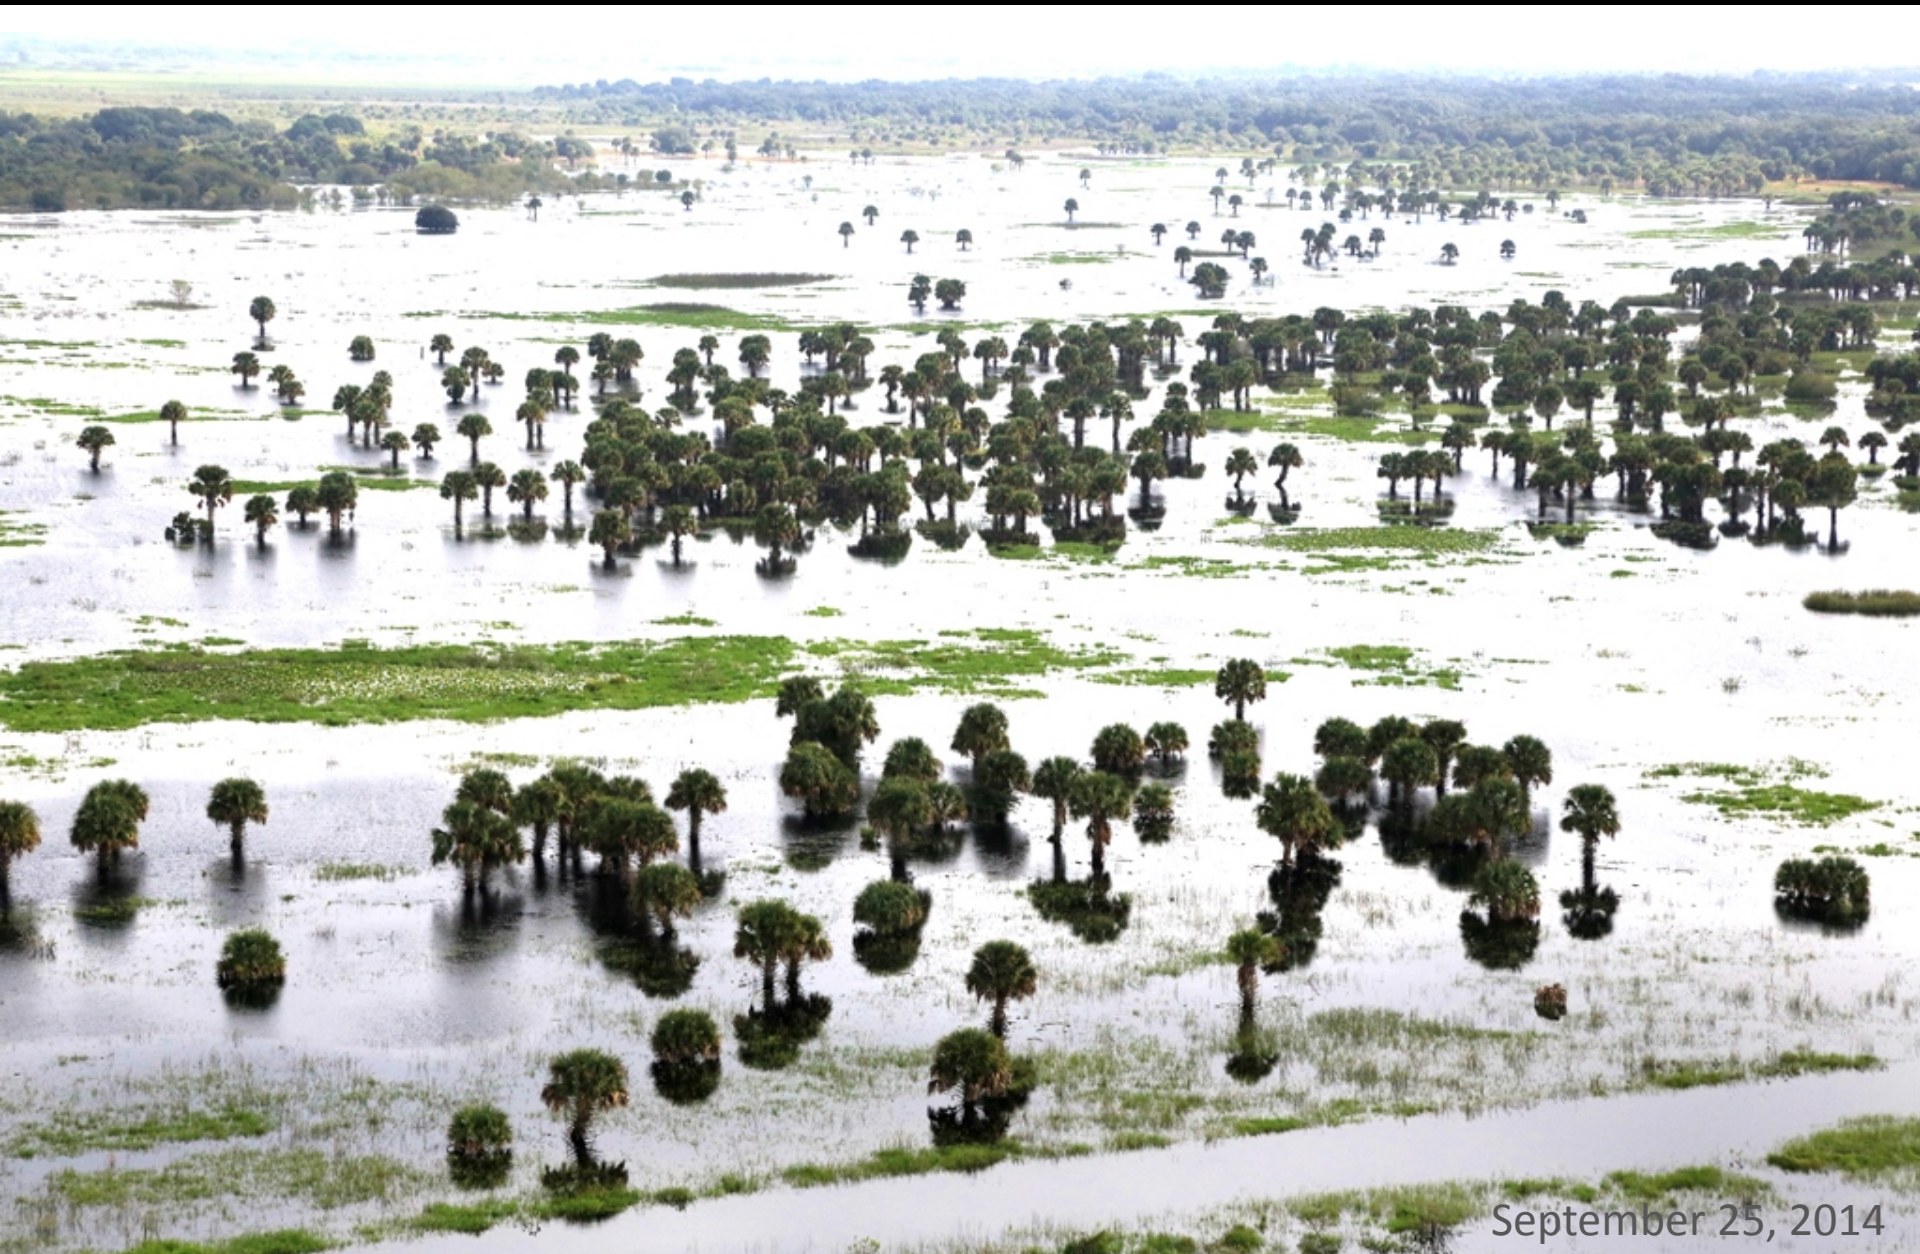
September 25, 2014

Kissimmee Prairie State Park floodplain just north of the Phase IVB restoration backfill area. During high-flow events, a backwater effect inundates the floodplain in this non-backfilled area.

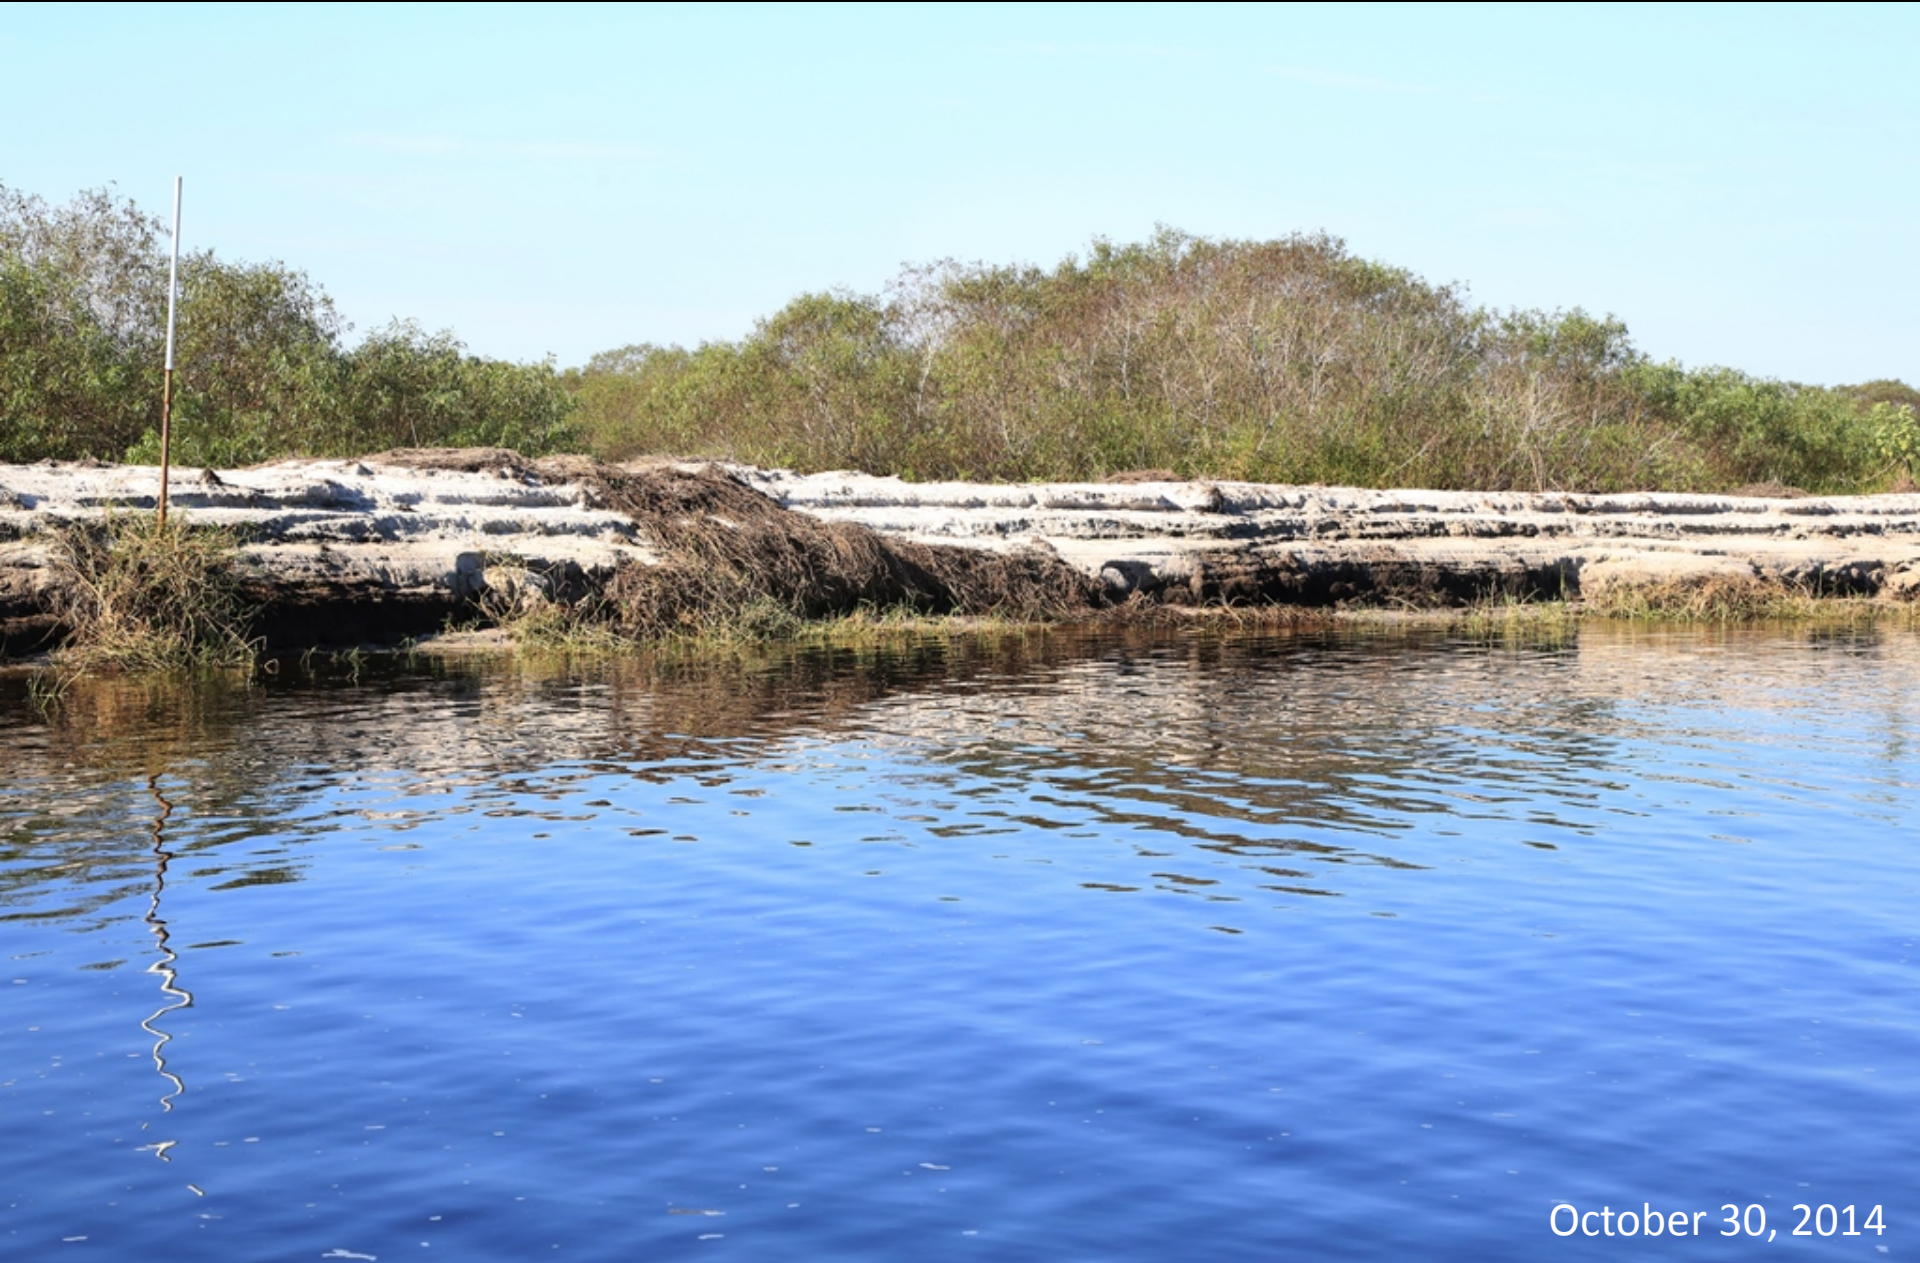
October 30, 2014

Signs of erosion are evident along the banks of the Phase I restoration area where discharges near 7,000 cfs stripped the vegetation from the banks and cut away at the sandy shoreline on this outer bend river channel.

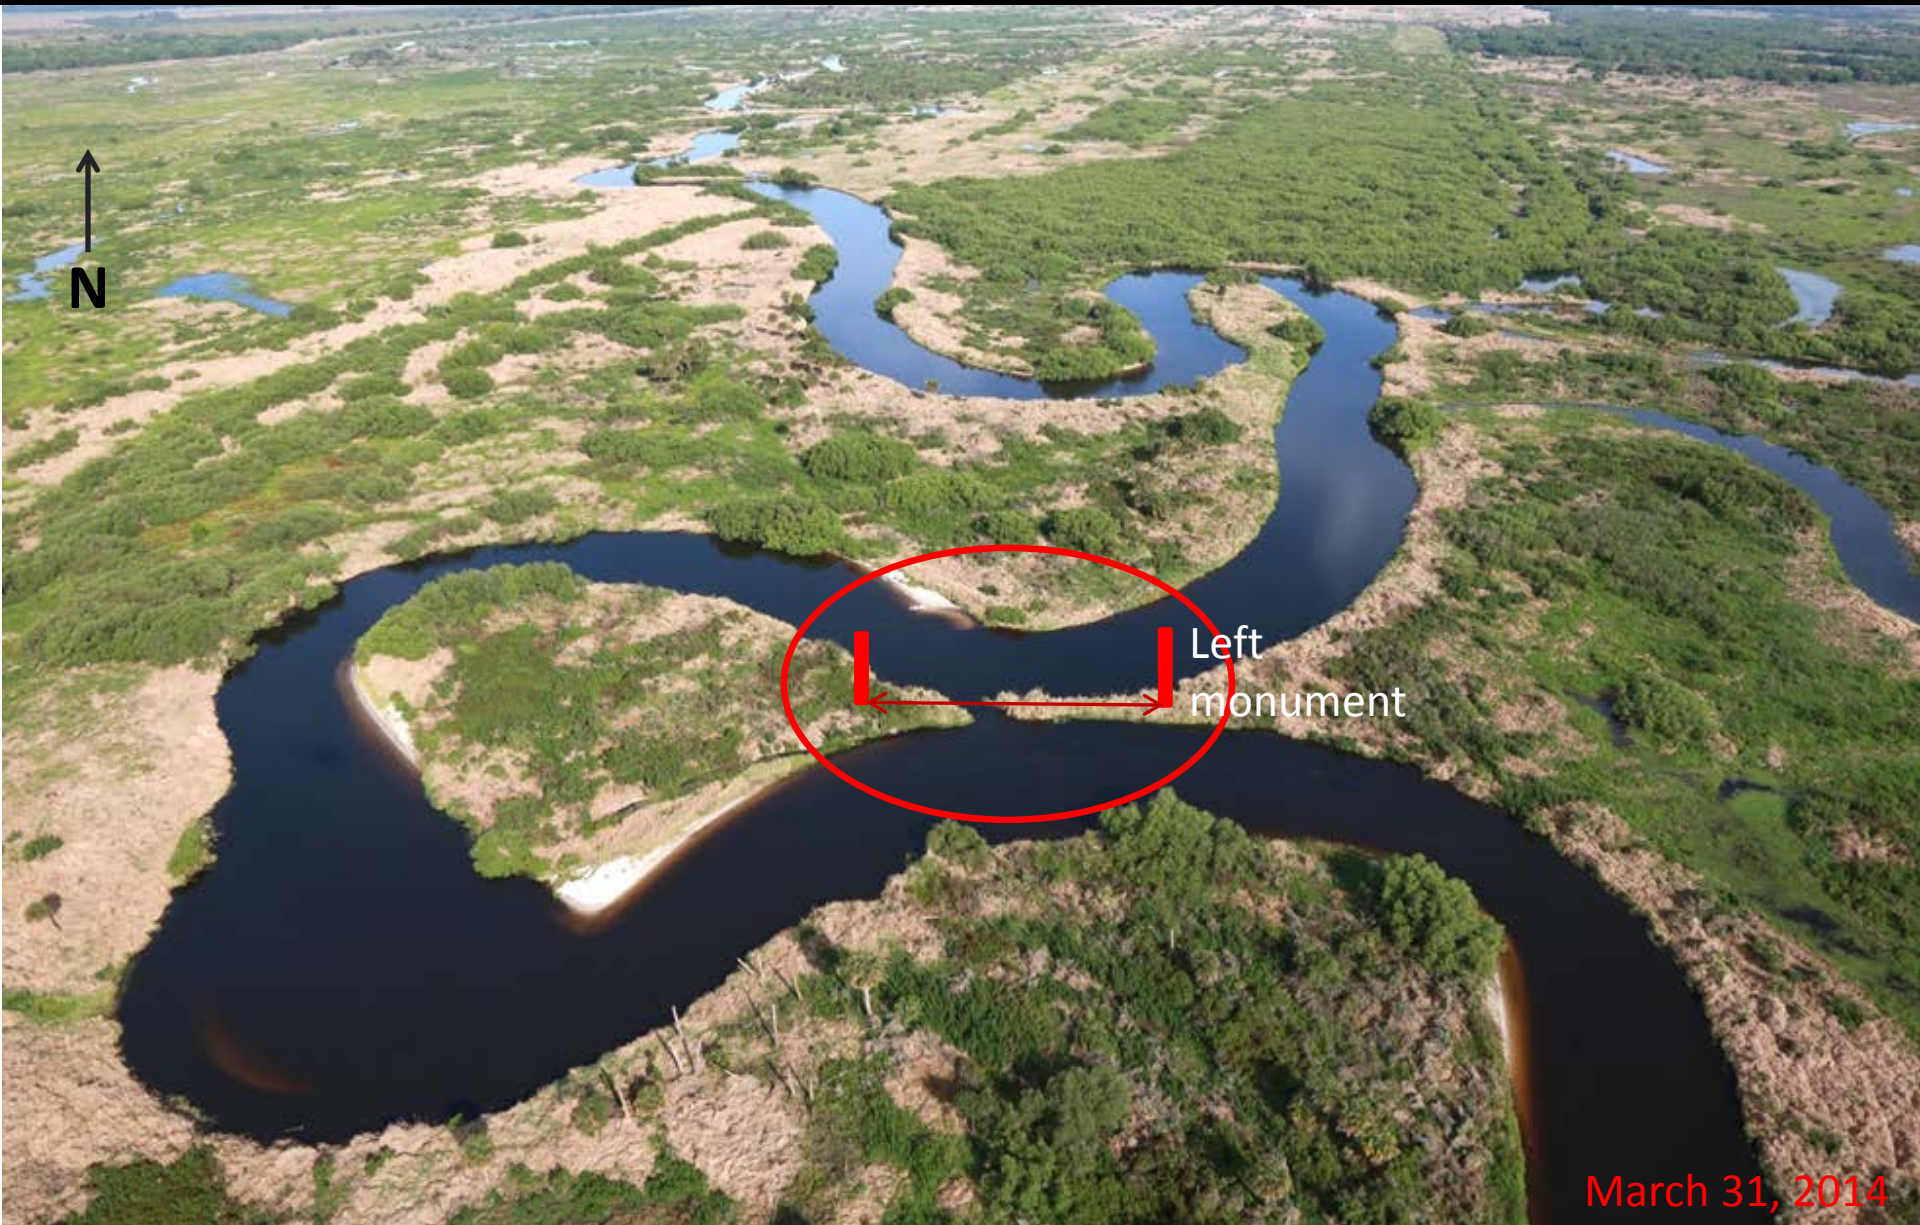
The beginning formation of a meander cutoff in Micco Run in the Kissimmee River. The cutoff formed sometime in the two weeks prior to the photo date and may ultimately form an oxbow lake. A cross-section survey transect was set up to capture monthly changes in the cutoff channel.

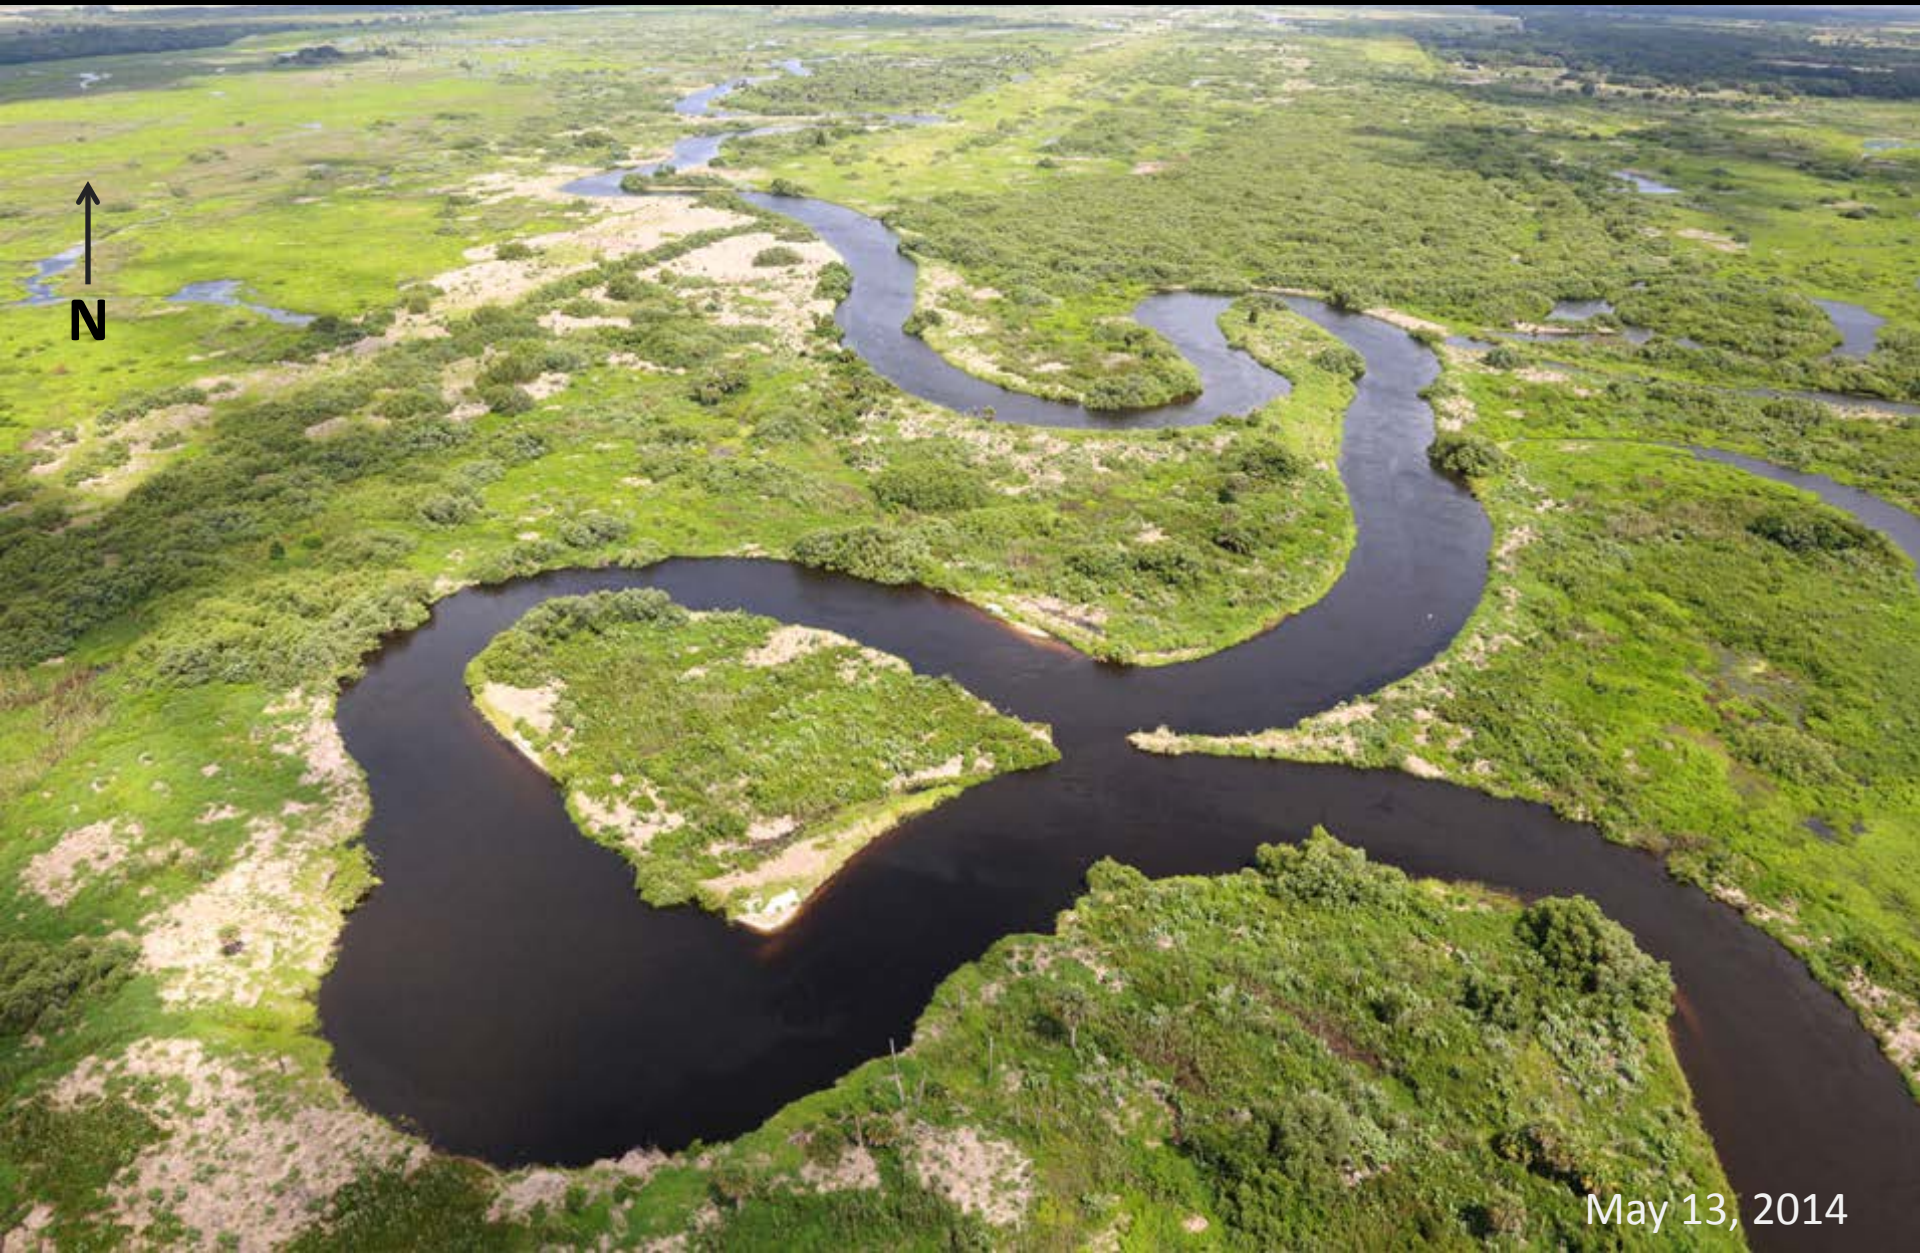
May 13, 2014

The meander cutoff has almost doubled in width in a month and a half since the previous slide as flows begin to increase into the wet season.

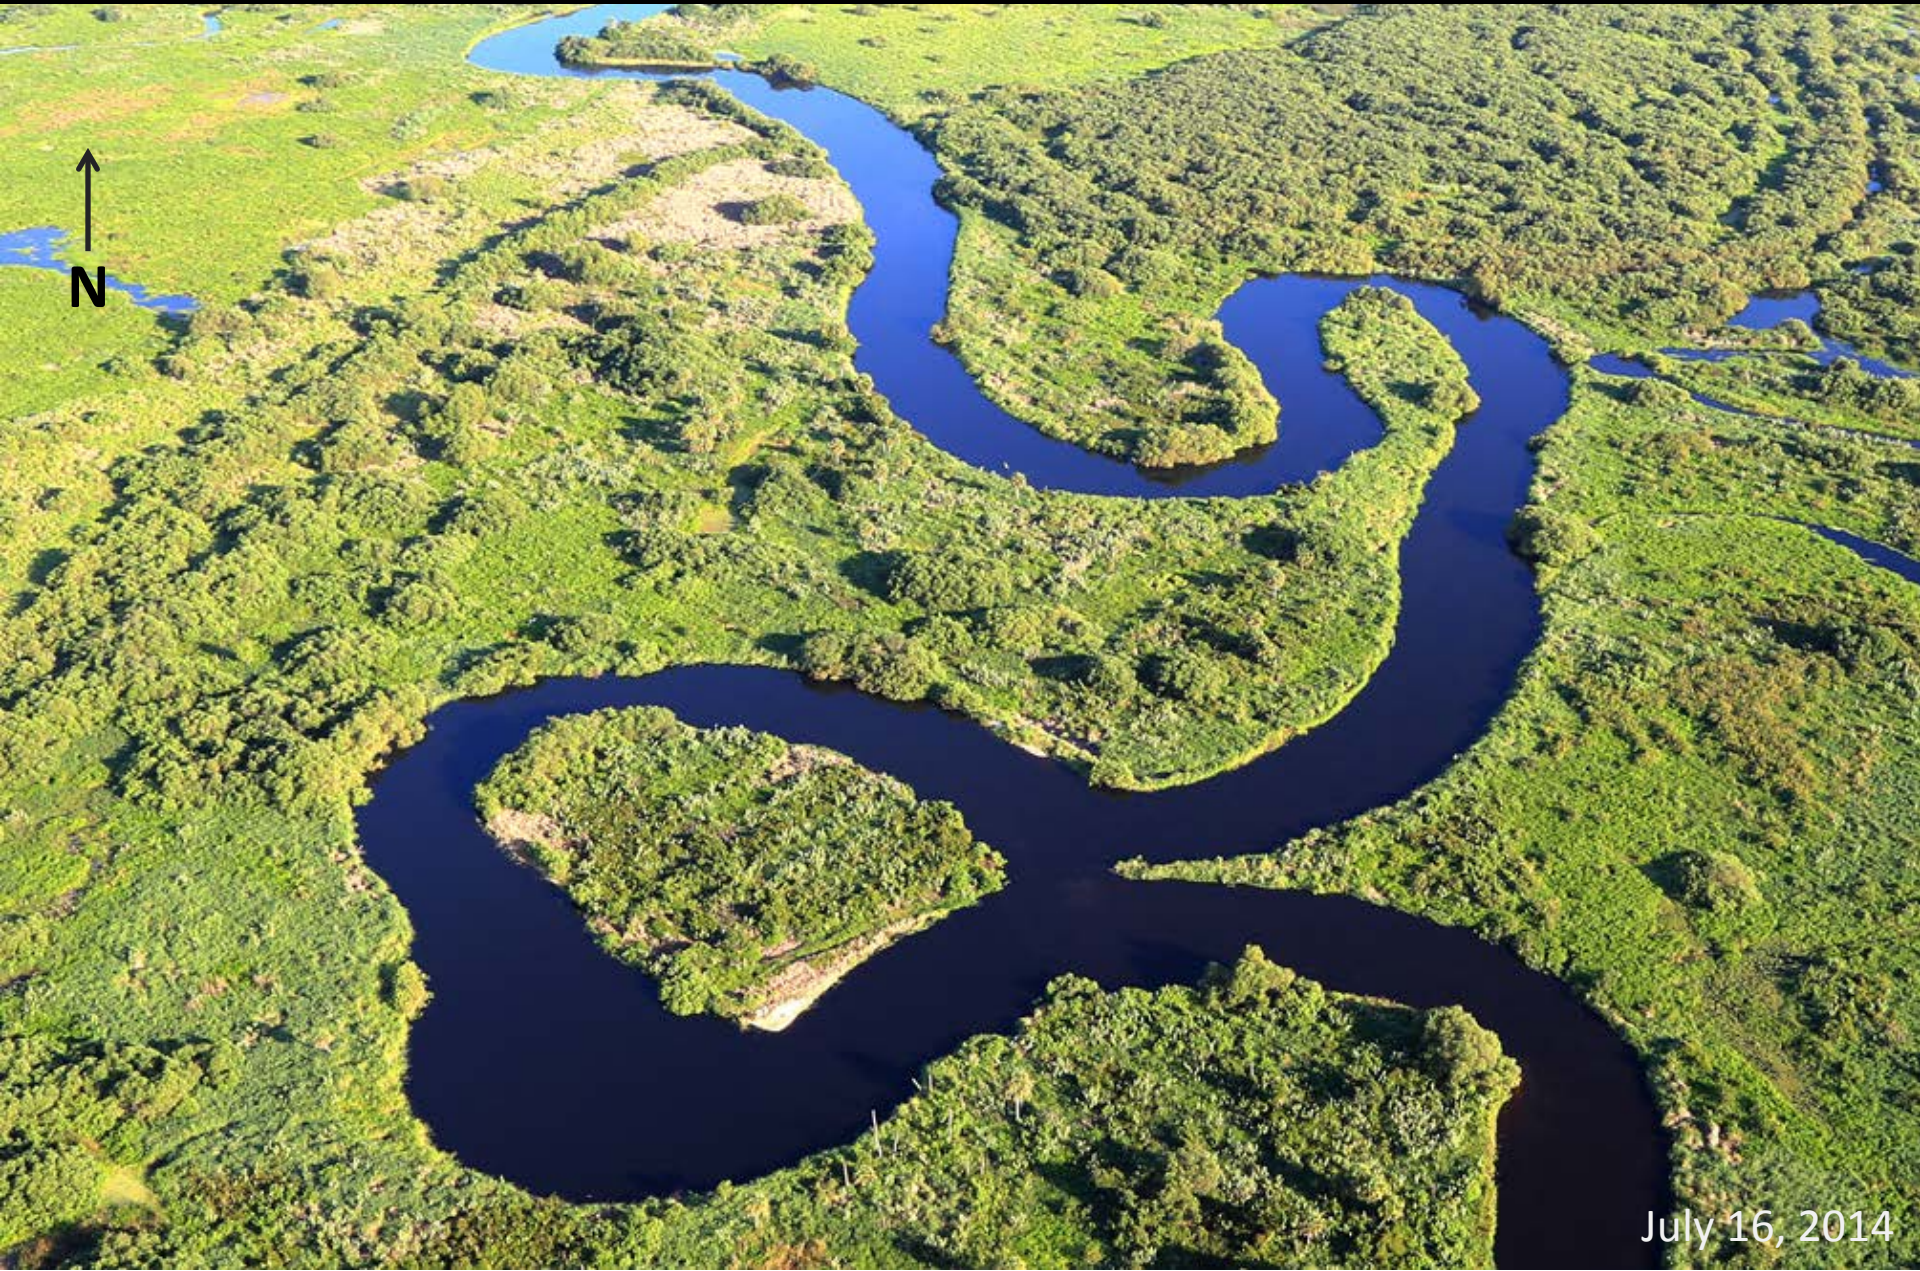
July 16, 2014

The same shot one month later in July shows that the meander cutoff continues to become more defined.
