August – October 2014 Quarterly Kissimmee Basin Environmental and Restoration Features

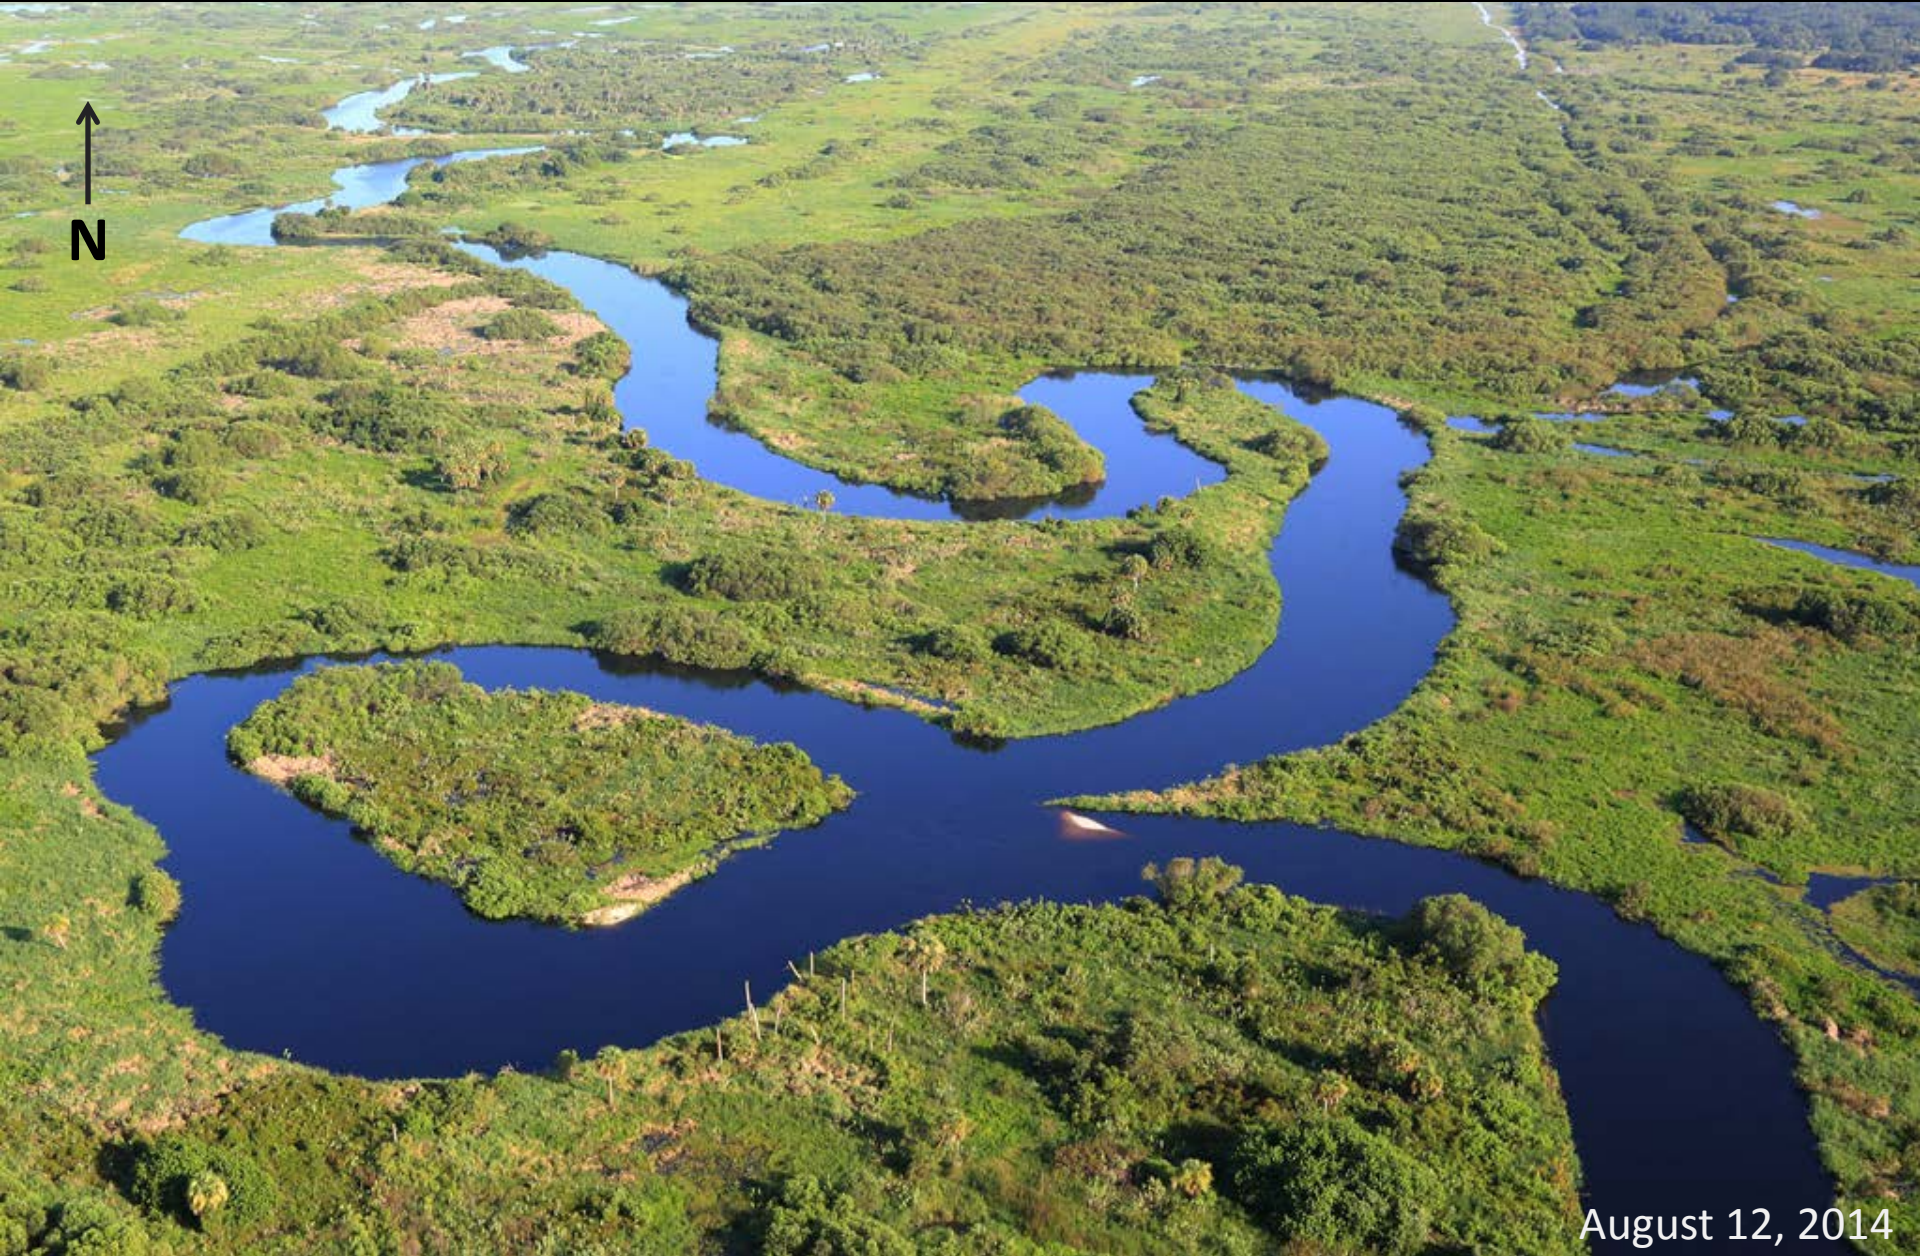
August 12, 2014

Significant scouring has continued in the Micco Bluff Run breakthrough with higher flows through July and August. Also, a sandbar has formed on the downstream point of the breakthrough.

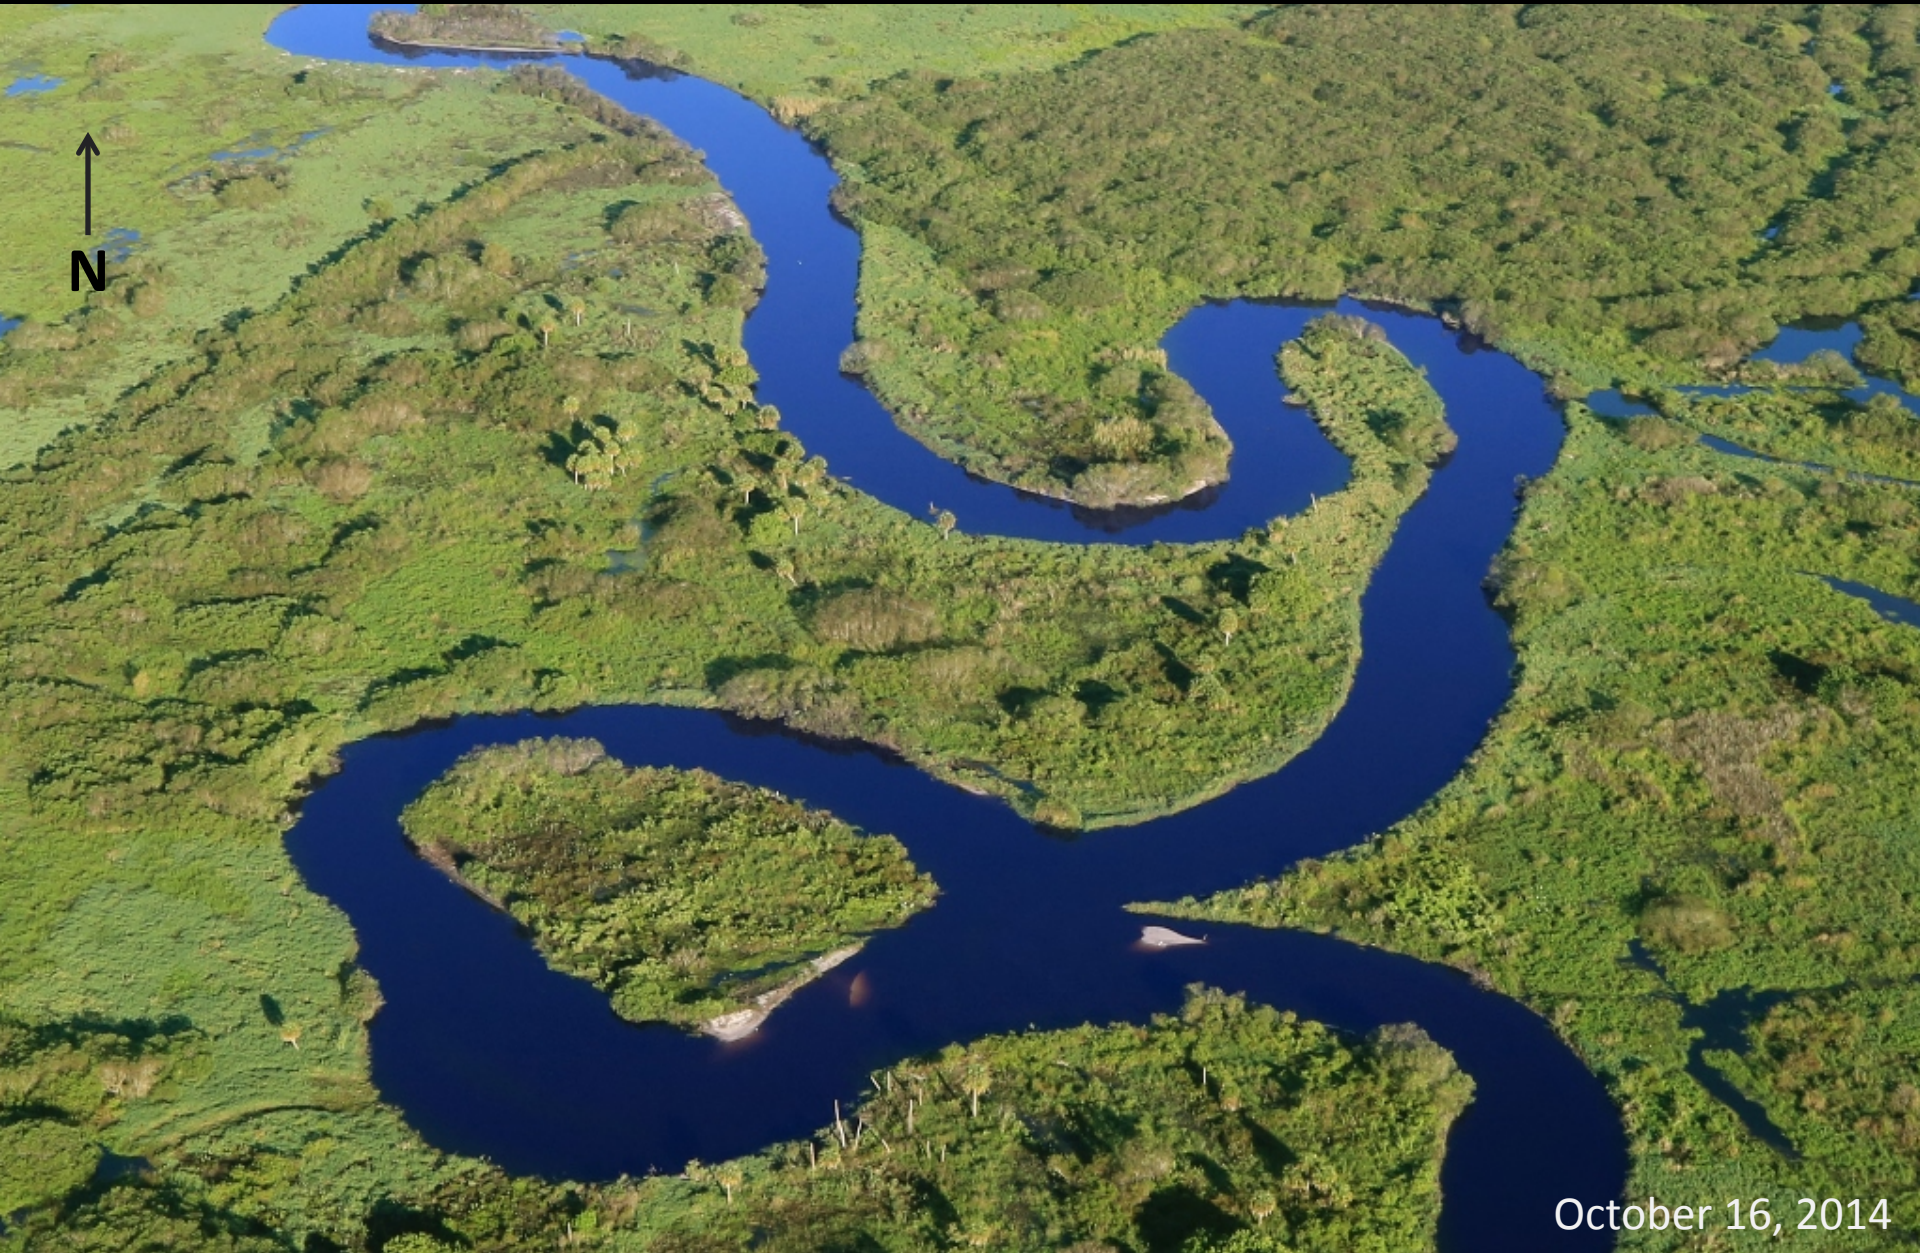
October 16, 2014

A second sandbar is beginning to form downstream of the breakthrough next to the island. This feature is new since the 7,000 cfs event.

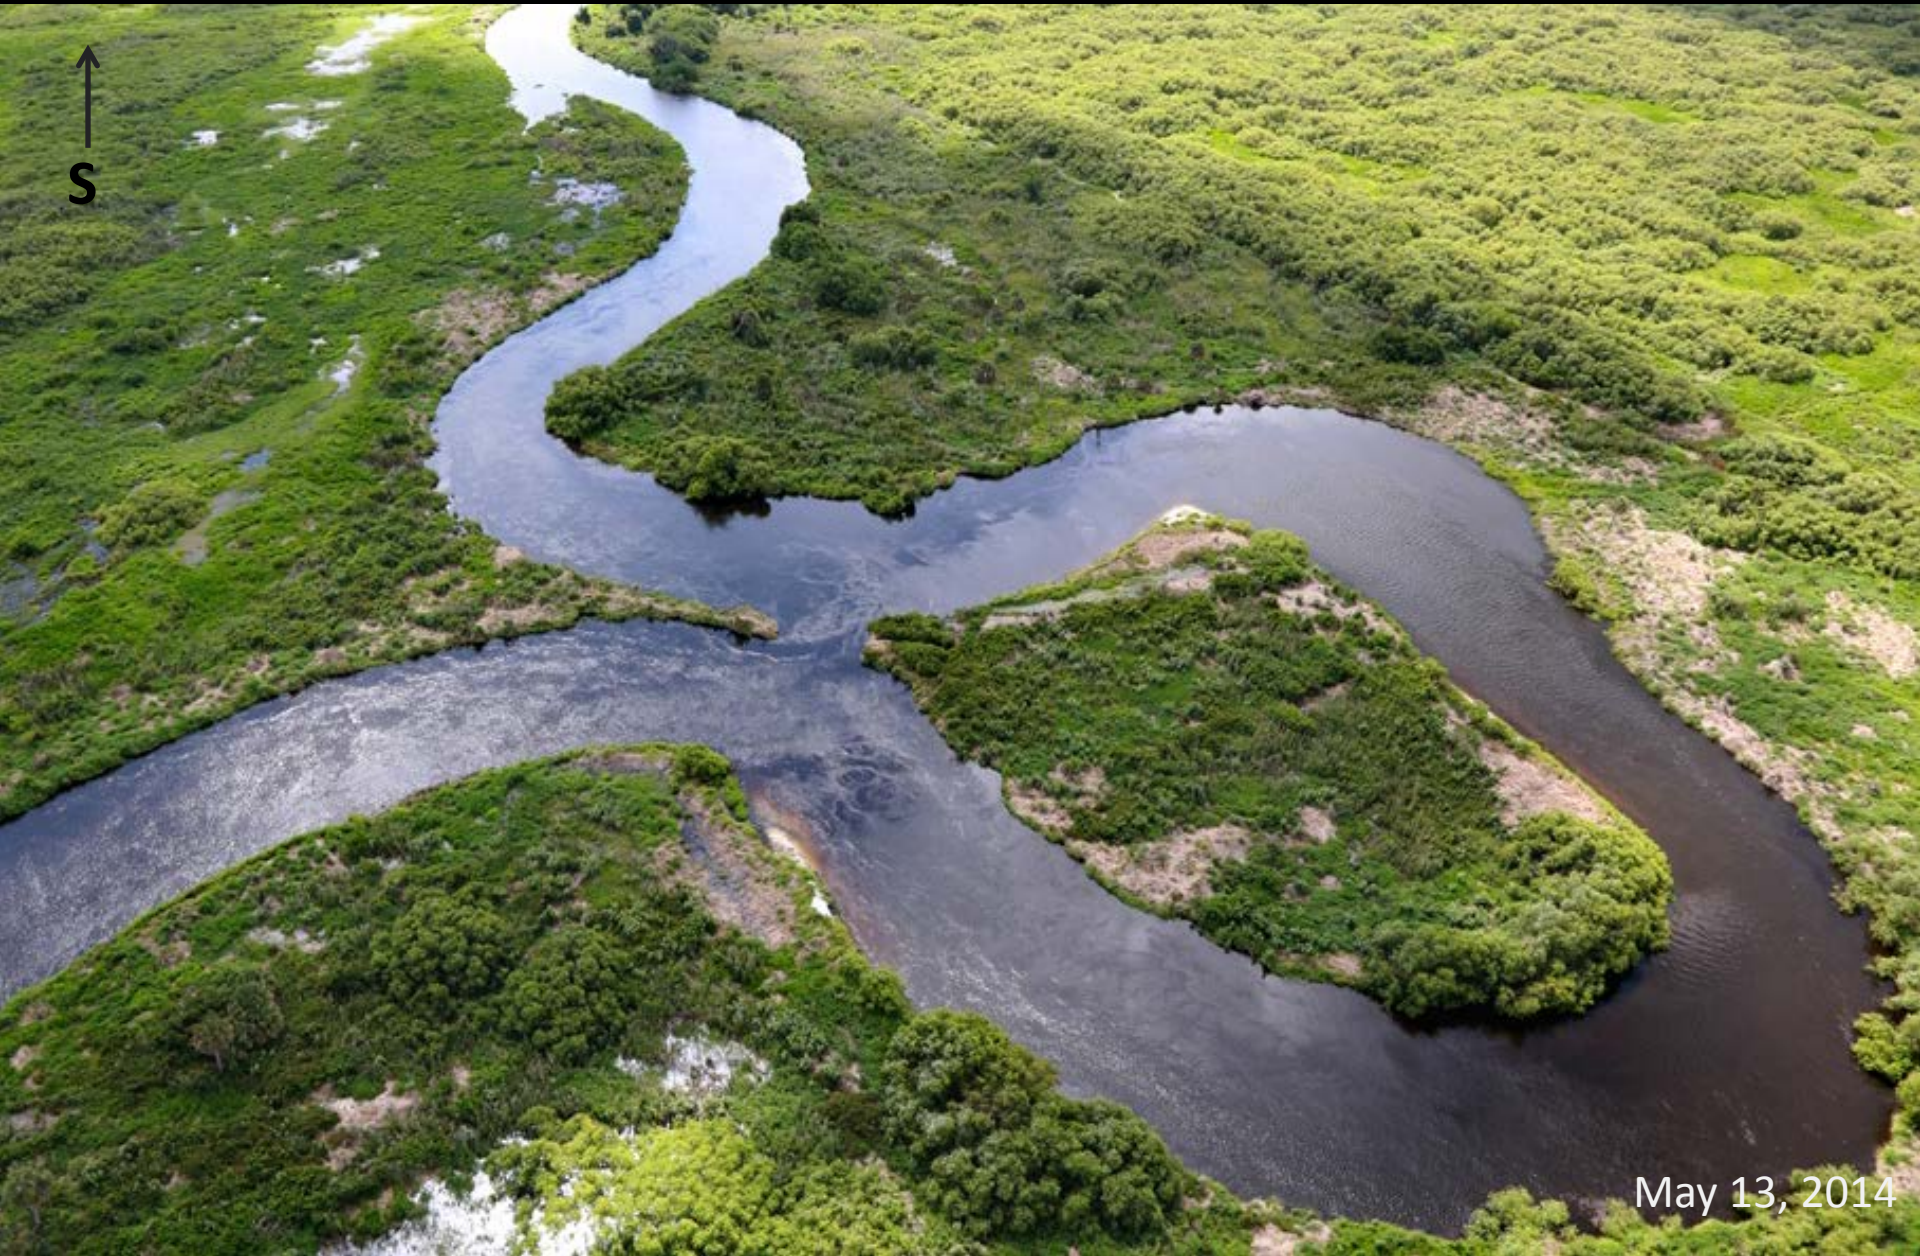
Later in May with higher flows you can see the current in the cutoff as it continuously widens.

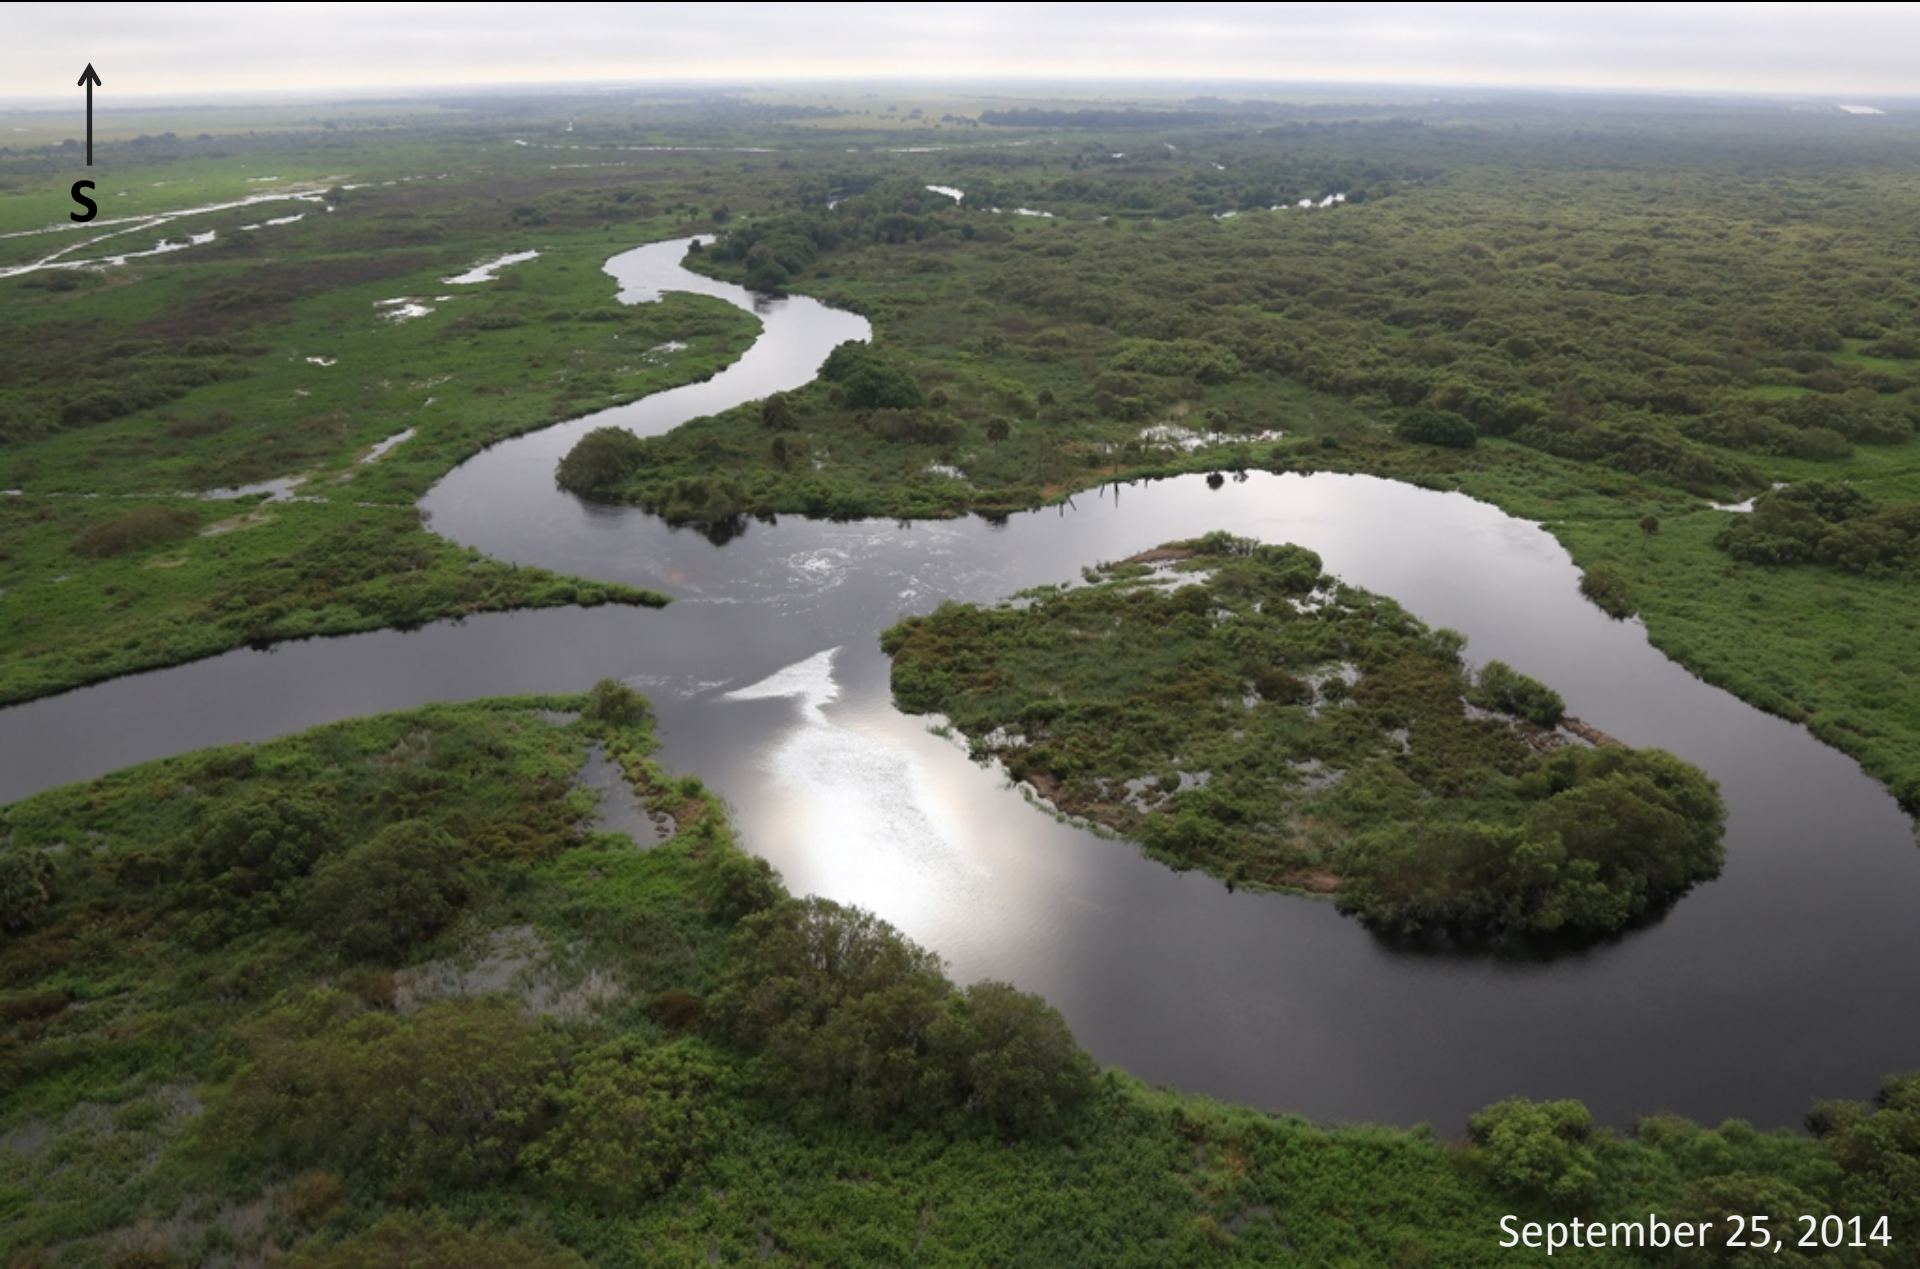
September 25, 2014

Drastic widening has occurred in the Micco cutoff channel since May (previous slide).

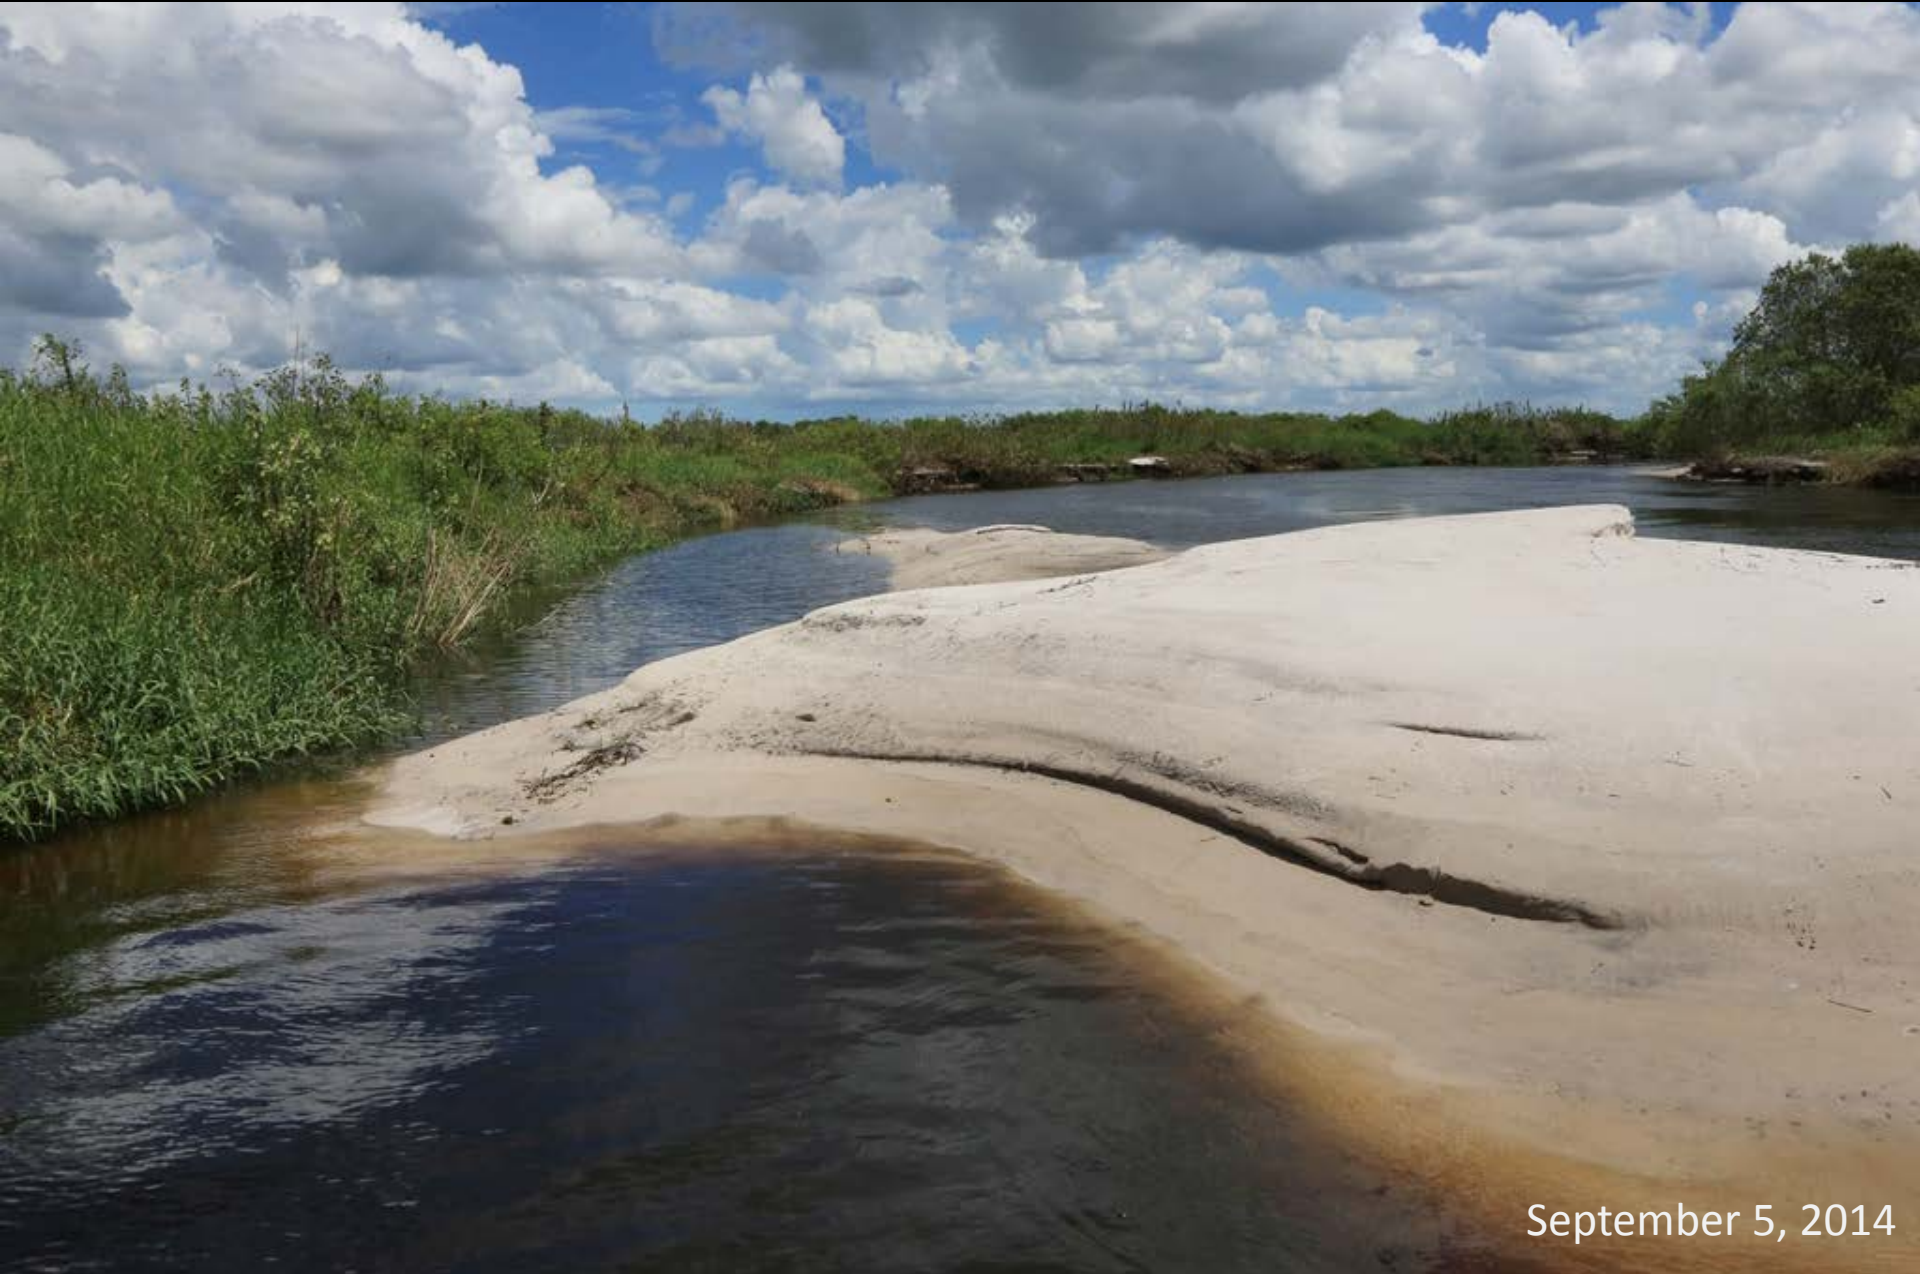
September 5, 2014

Looking downstream from inside the Micco breakthrough, a large sandbar formed just below the Micco Run oxbow cutoff.
