**GEOMORPHIC MONITORING OF THE KISSIMMEE RIVER RESTORATION:**

**2006-2009**

Final Report

September 2009

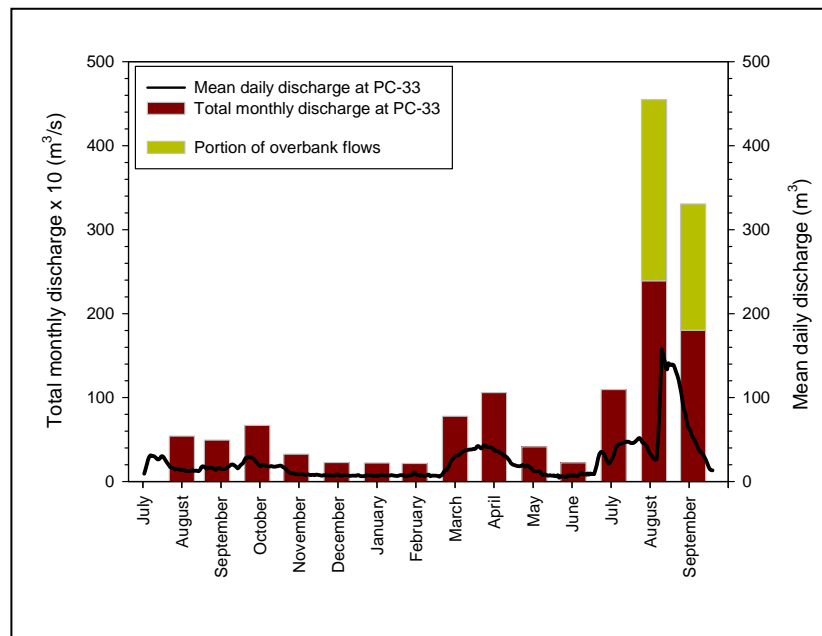
Figure 2-2. a) Mean daily and total monthly discharge for the restored section of the Kissimmee River at PC-33 near Basinger, Florida. Also included are the portion of flows that went overbank from August 19 to September 22, 2008.

Daily discharges were computed using the time series discharges computed from the recorded stage and velocity data, and the stage-area and index-velocity ratings previously described. Daily and monthly streamflow for the period July 21, 2007 to September 30, 2008 are shown in Figure 2-2. The mean daily discharge for this period was 24.5 m<sup>3</sup>/s. Low-flow conditions from July 21, 2007 through July 2, 2008, interrupted by some wetter periods in March and April 2008, prevailed and the mean-daily streamflow for this period was 15.7 m<sup>3</sup>/s. Beginning on July 3, 2008, tropical storm activity caused wetter conditions and the mean daily discharge for the period July 3 through September 30, 2008 was 58.0 m<sup>3</sup>/s, which is 3.5 times higher than the earlier period. The highest mean daily discharge during the period of study, 157 m<sup>3</sup>/s, occurred on August 22, 2008 as a result of heavy rains associated with Tropical Storm Fay. For the period August 19 to September 22, 2008, 3.11x10<sup>8</sup> m<sup>3</sup> of flow went overbank (fig. 2-2), which is 52% of the total flow for this period (restored channel + overbank flows) and 25% of the total flow for the period of study.

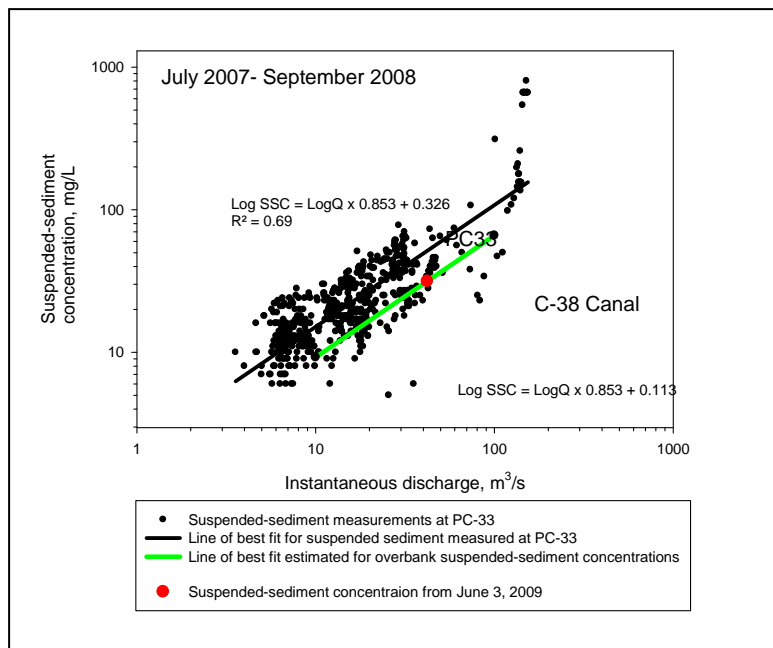
Figure 2-3. Suspended-sediment transport curve for the restored section of the Kissimmee River at PC-33 near Basinger, Florida, July 21, 2007 through September 30, 2008. Also included is the line of best fit used to estimate suspended-sediment concentrations in the overbank portion of flow. [SSC = suspended-sediment concentration, mg/L; Q = Discharge, m<sup>3</sup>/s]

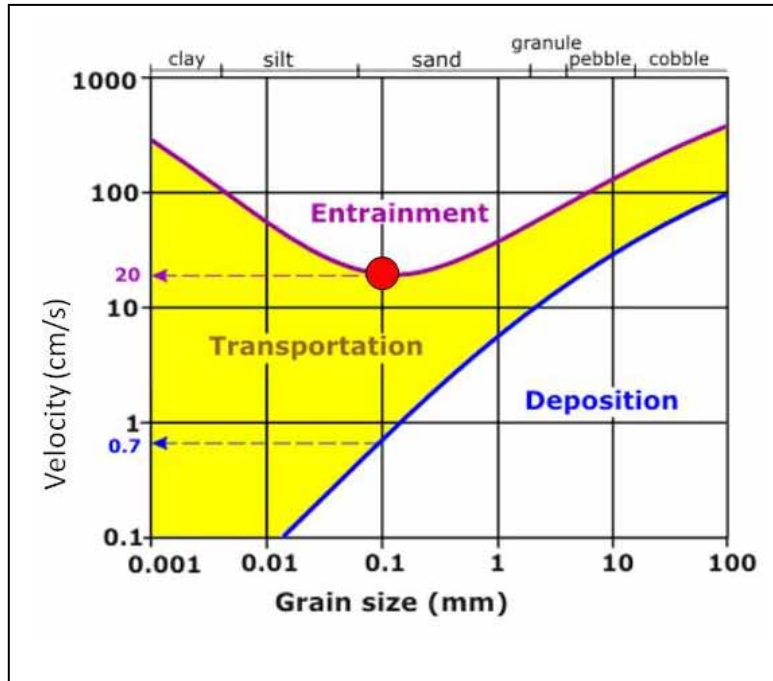
Figure 2-13. Hjulstrum curve for the initiation of sediment motion. The red circle indicates the range of median bed material found on the Kissimmee River, which would be entrained at velocities near 20 cm/s.

Maximum measurements of instantaneous velocity near the channel bed on March 20, 2008 were close to 30.0 cm/s (centimeters per second). The median grain size of the bed material from two measurements (Figure 2-8) varied from 0.18 to 0.33 mm, a fine sand and medium sand, respectively. Examination of the Hjulstrum curve for the initiation of sediment transport indicates that for the range of median bed-material found on the Kissimmee River, sediment movement is initiated when the velocity at the channel bed approaches 20 cm/s (Figure 2-13). The discharge measurement made on March 20, 2008 of 33.1 m<sup>3</sup>/s had velocities near the bed that are just above the threshold to initiate bedload transport. Based on these relations, a discharge of 28.3 m<sup>3</sup>/s was assigned the discharge at which bedload transport begins.

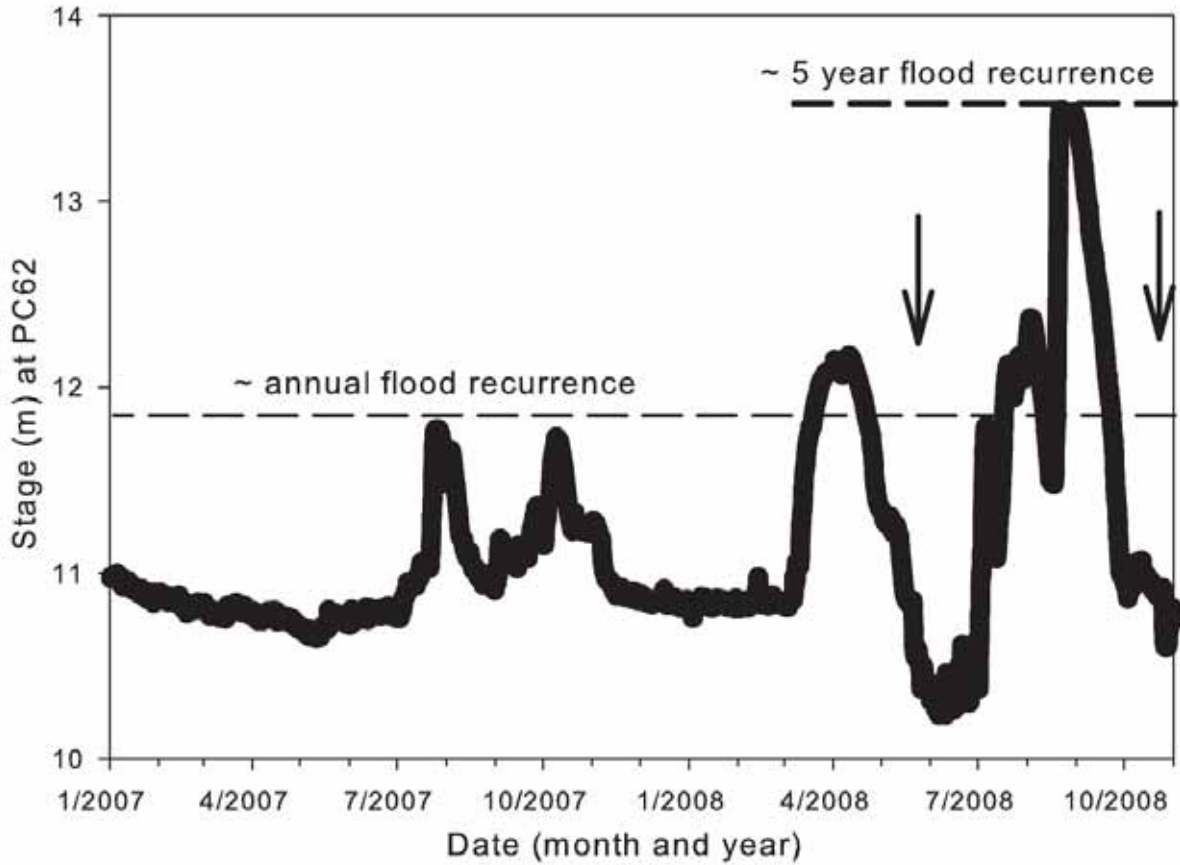
Figure 3-2. Mean daily flow measured at the PC 62 streamgage near the old Pool B/C control structure. Arrows denoted our sediment measurement dates. The approximate annual and 5 year flood recurrence is also noted (from Leroy Pearman, USGS Orlando, personal communication).

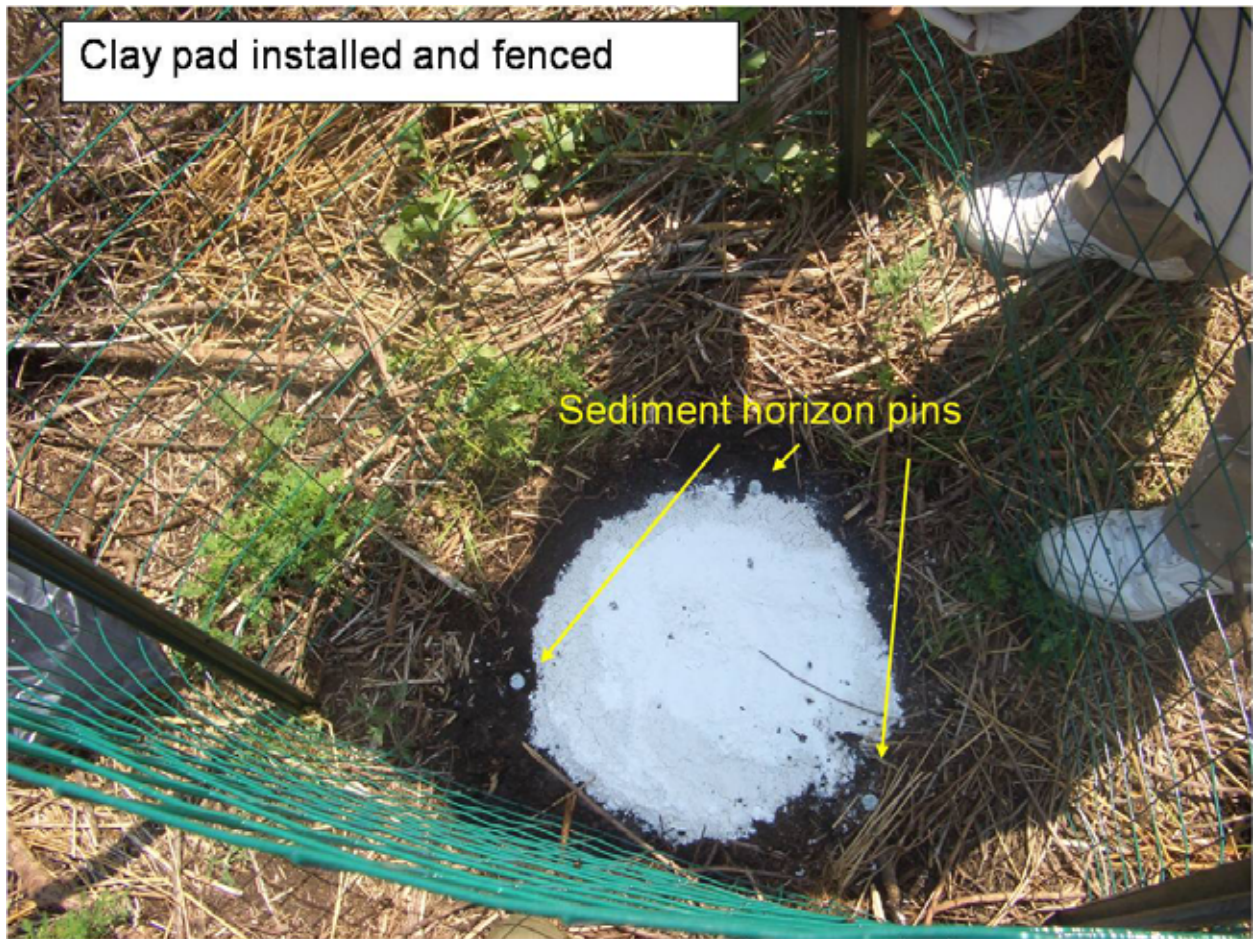
Figure 3-3. Typical feldspar clay pad with associated sediment horizon pins and fenced enclosure. Enclosures were used only in Pool D to prevent disturbance from cows or other grazers. Photo credit: Edward Schenk, USGS.

Artificial marker layers (clay pads) were placed at each sampling point, typically spaced along transect at intervals of approximately 50 meters. These markers are made by placing powdered white feldspar clay approximately 20 mm in thickness over an area of about 0.5 m<sup>2</sup> on the sediment surface that has been cleared of coarse organic detritus. This clay becomes a fixed plastic marker after absorption of moisture that permits accurate measurement of short-term net vertical accretion (Baumann et al. 1984, Hupp and Bazemore 1993, Kleiss 1996, Ross et al. 2004). The clay pads were examined periodically and measured for depth of burial during the course of study. Landscape spikes were placed on the edges of claypads to measure possible erosion and to aid in re-locating the claypad (Fig. 3-3).

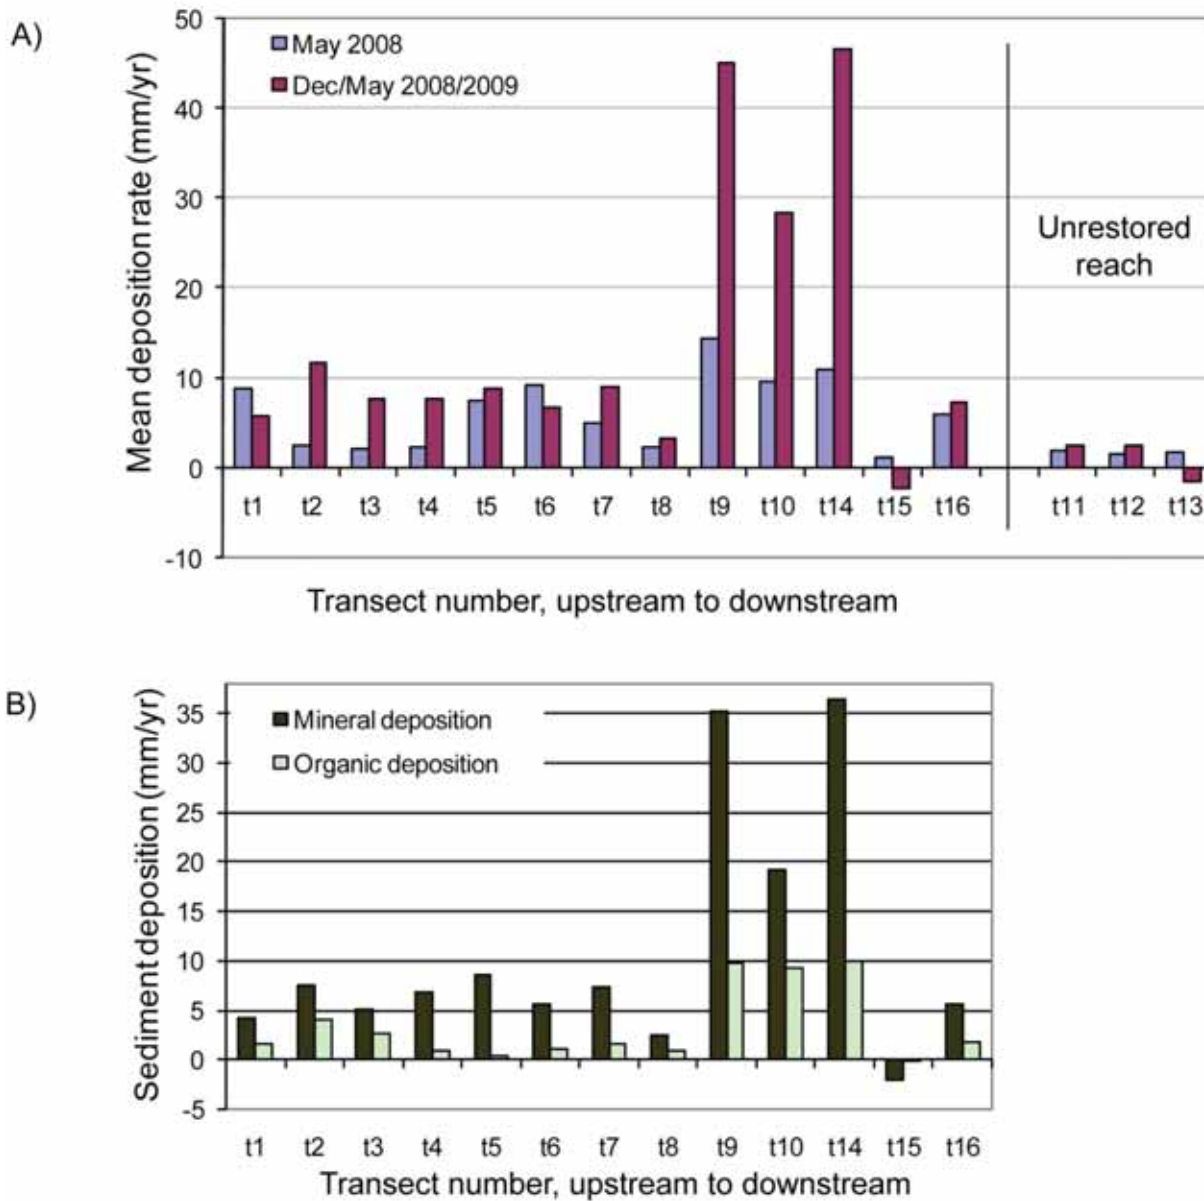
Figure 3-5. A) Mean sedimentation by transect from upstream to downstream determined for the spring flood and for the entire study period. The difference in deposition rates includes the impact of Tropical Storm Fay. B) Mean mineral and organic sedimentation by transect from upstream to downstream.

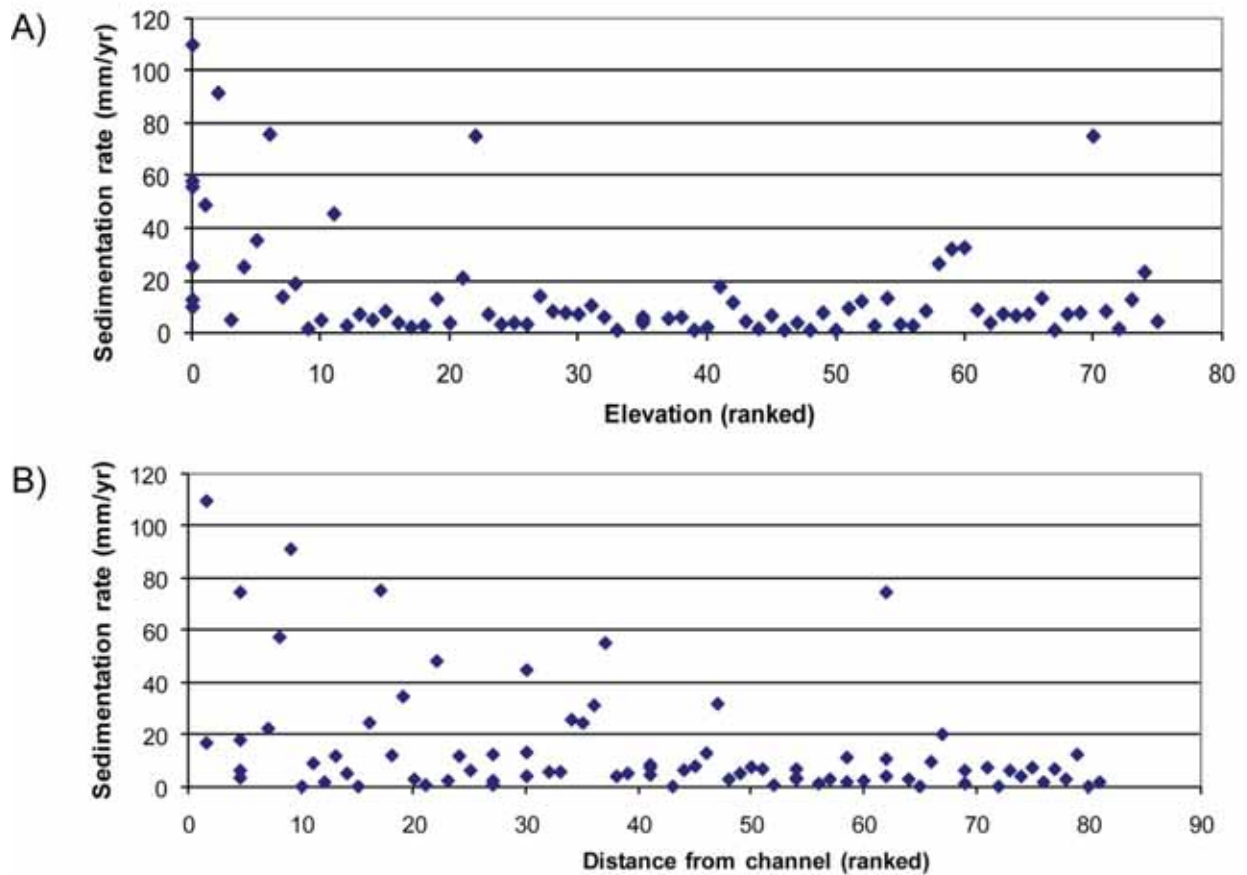
Figure 3-8. Sediment deposition (mineral + organic) by A) elevation above an arbitrary river stage transformed by rank (lower rank equals lower claypad on the landscape) and B) by distance from main channel also transformed by rank. In general the sites with the highest deposition were lowest on the landscape and/or closest to the main channel.

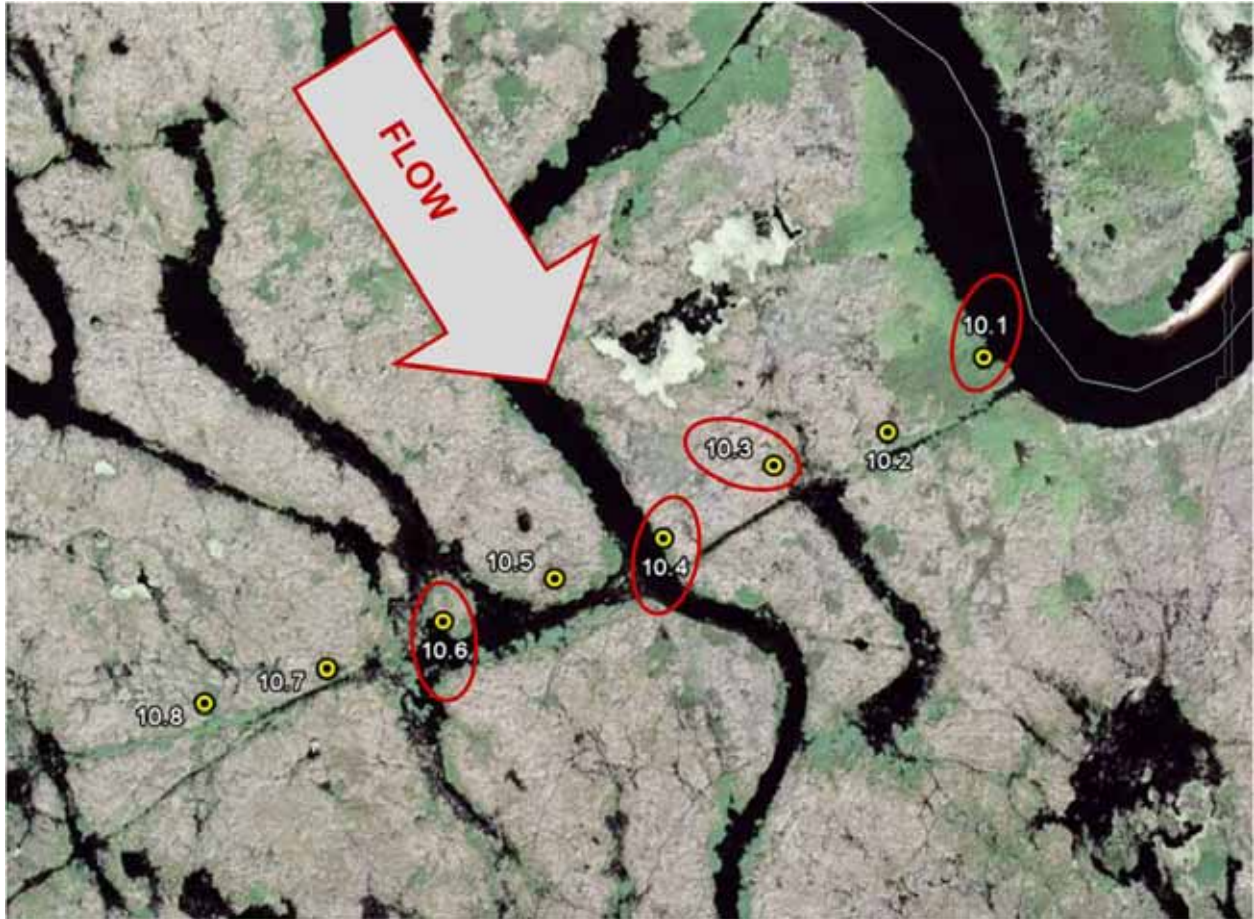
Figure 3-9. Side channels and sloughs at transect 10, main channel is adjacent to transect 10 pad 1 (10.1 on figure). Observed high deposition areas are outlined in red. All four high deposition sites are adjacent to a high flow route during flooding. The deposition results are in the following figure.

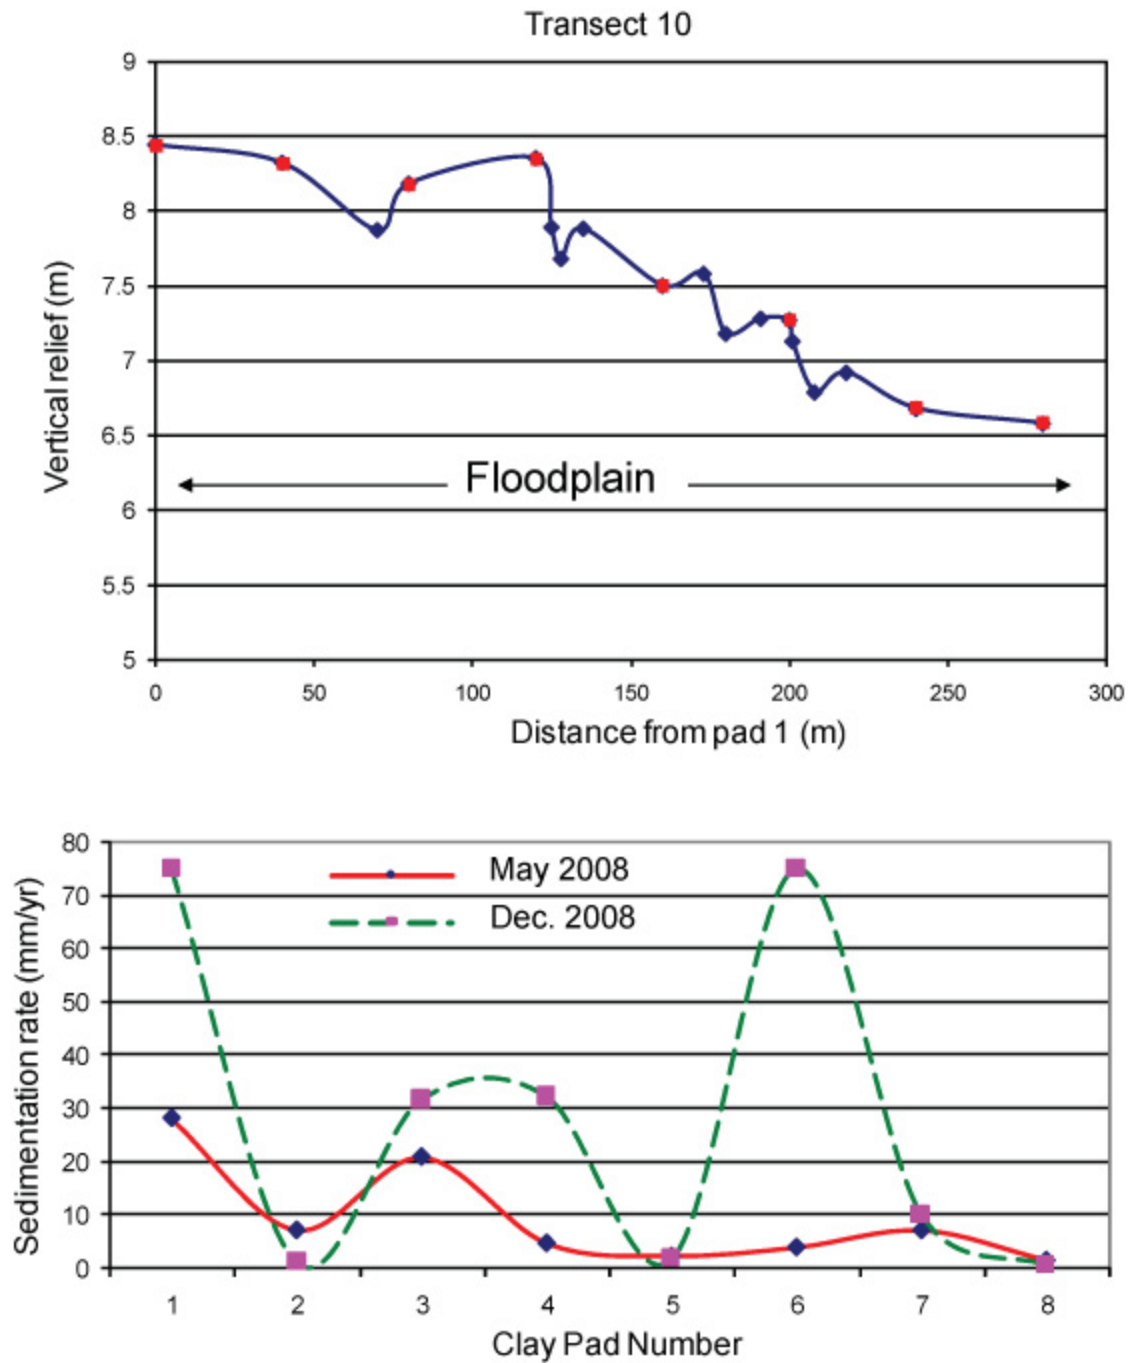
Figure 3-10. A) Microtopography of transect 10 starting at pad 1 adjacent to the main channel and moving out across the floodplain. Red circles indicate clay pads on figure A) and figure B) only includes claypad sites. B) Sediment deposition rates at transect 10 after the two floods.

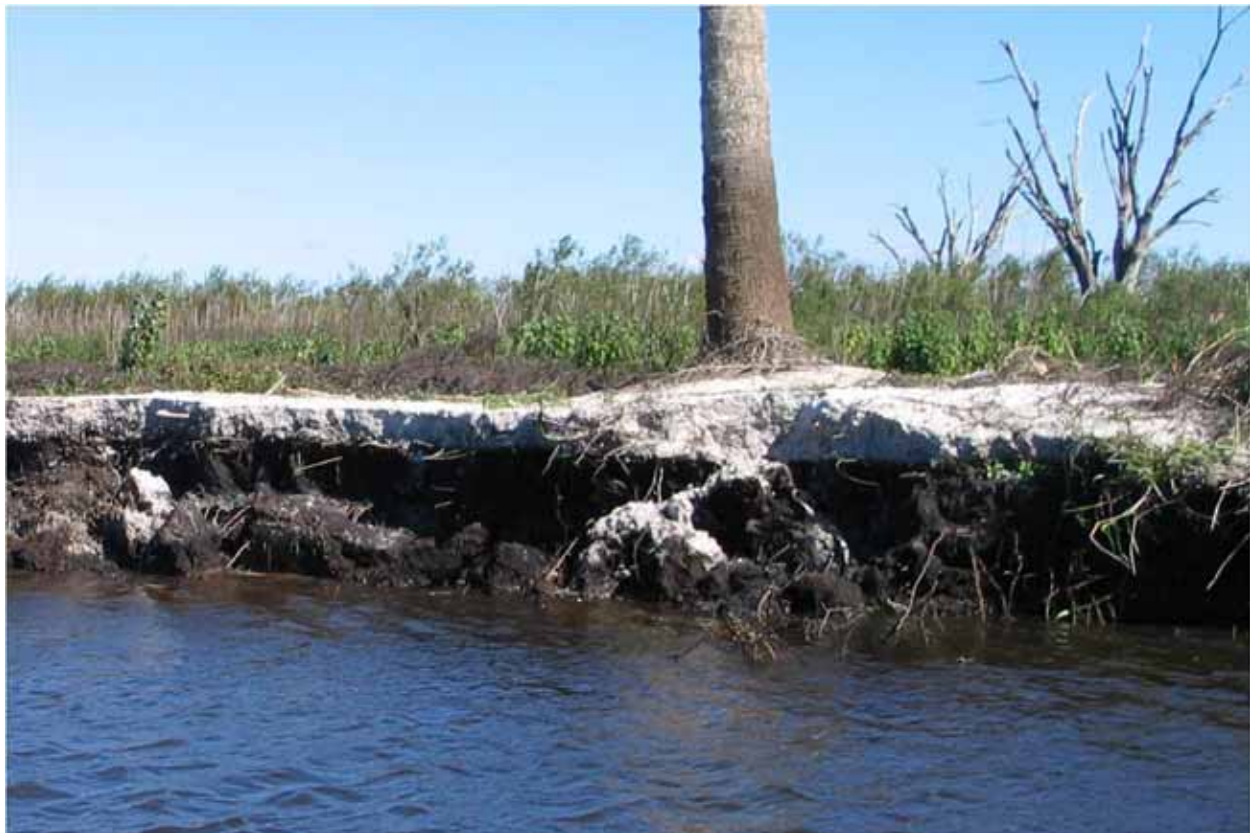
Figure 3-12. A sand splay 26 cm deep (levee building event), measured in December, 2008 between transect 3 and transects 4, 5, and 6. Photo credit: Edward Schenk, USGS.

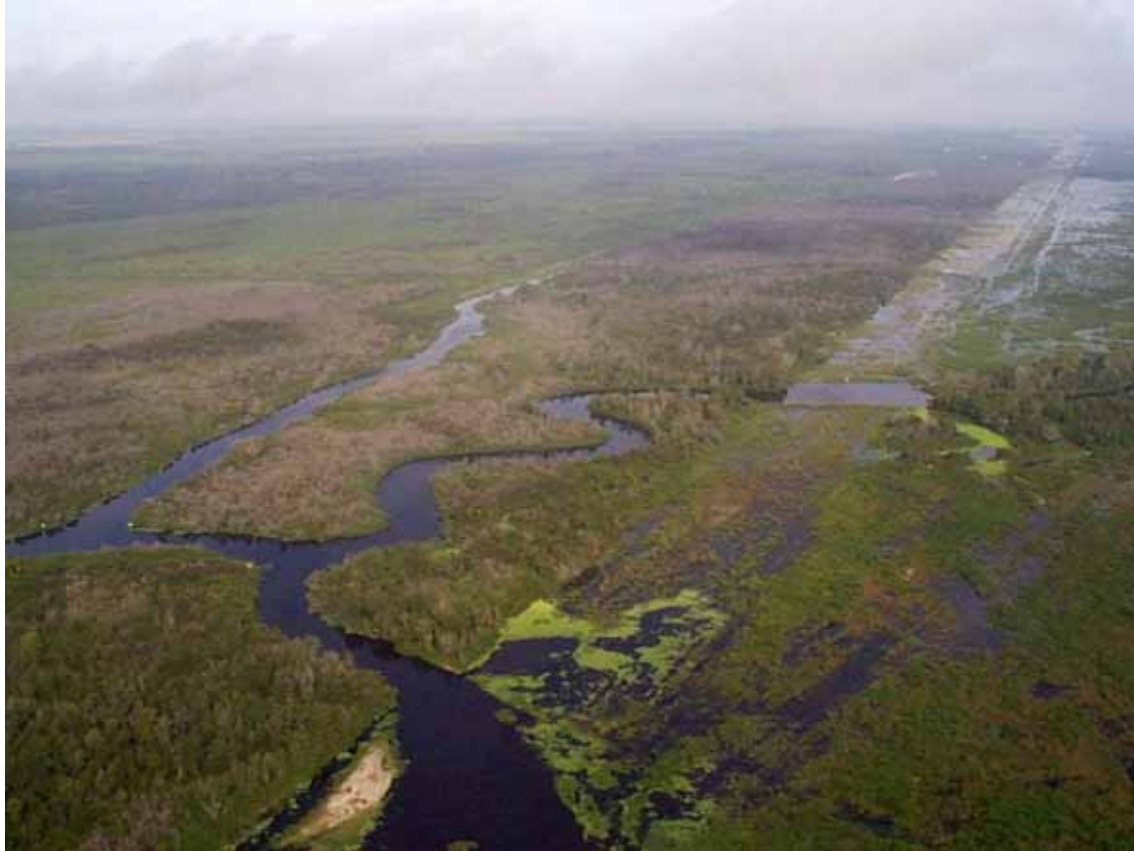
Figure 4-3. Restored portion of the Kissimmee River, Pool B/C. Remnants were left as is, recarved portions were dredged through former spoil deposits, and connectors go across backfilled C-38. Backfilled areas appear to have more ponding than the adjacent floodplain (Source: [http://www.saj.usace.army.mil/dp/Kissimmee/Aerial\\_1.jpg](http://www.saj.usace.army.mil/dp/Kissimmee/Aerial_1.jpg)), although in time the difference may be reduced.

The three major types of river reaches that occur in the restored portion of the river are as follows: 1) remnant channels, which are former channels that were essentially left intact during channelization; 2) recarved channels, which were artificially excavated to approximate the geometry of former channels buried by spoil during channelization; and 3) connector channels, which are short segments of channel that go across backfilled portions of C-38 and are in approximately the same position as former channels (Figure 4-2). The connector channels appear wider than either the remnant or recarved channels, and were designed that way to reduce velocities and minimize potential erosion to the backfilled areas (Figure 4-3).

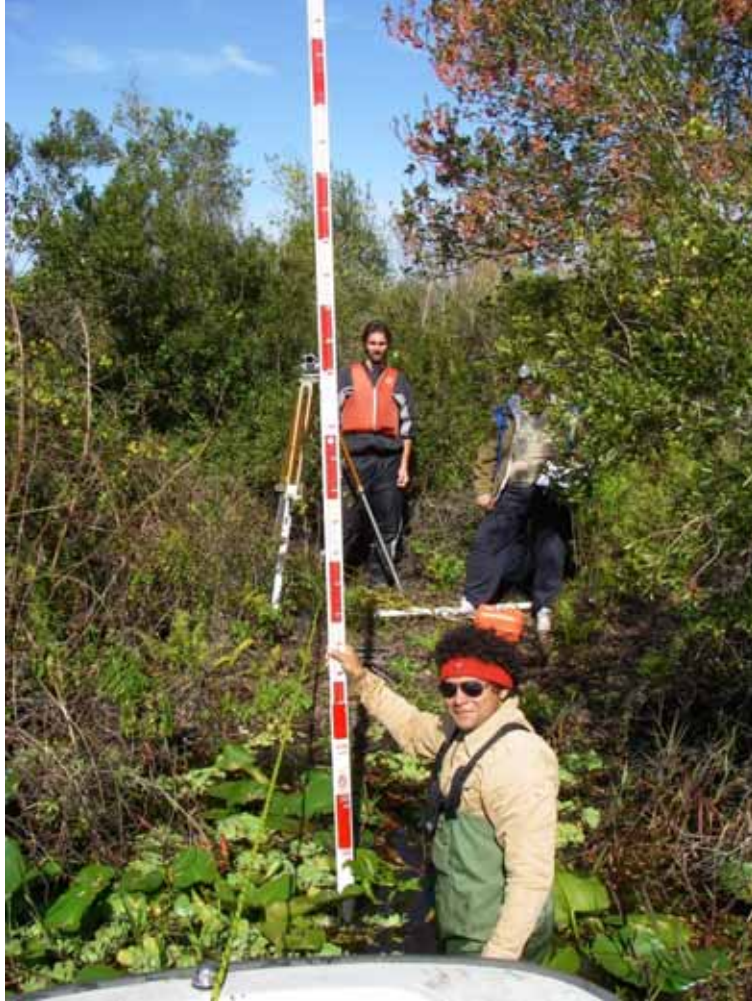
Figure 4-5. Survey methods using survey rod, level and rope along designated river transects. This photograph was taken in January 2009 in Persimmon Mound Run in Pool A.

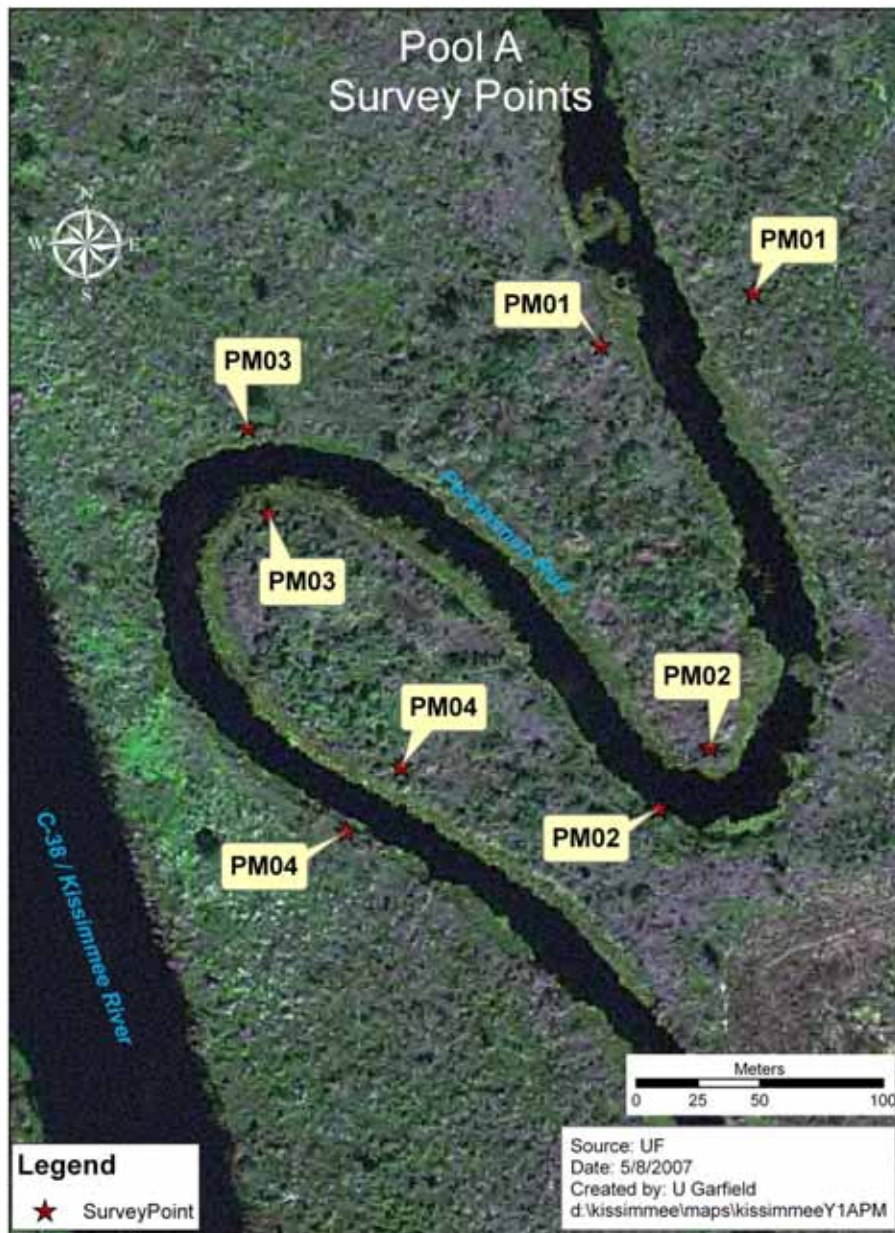
Figure 4-6. Transect locations in Persimmon Mound Run, Pool A. Transects 1 and 4 are considered straight reaches and Transects 2 and 3 are bendways.

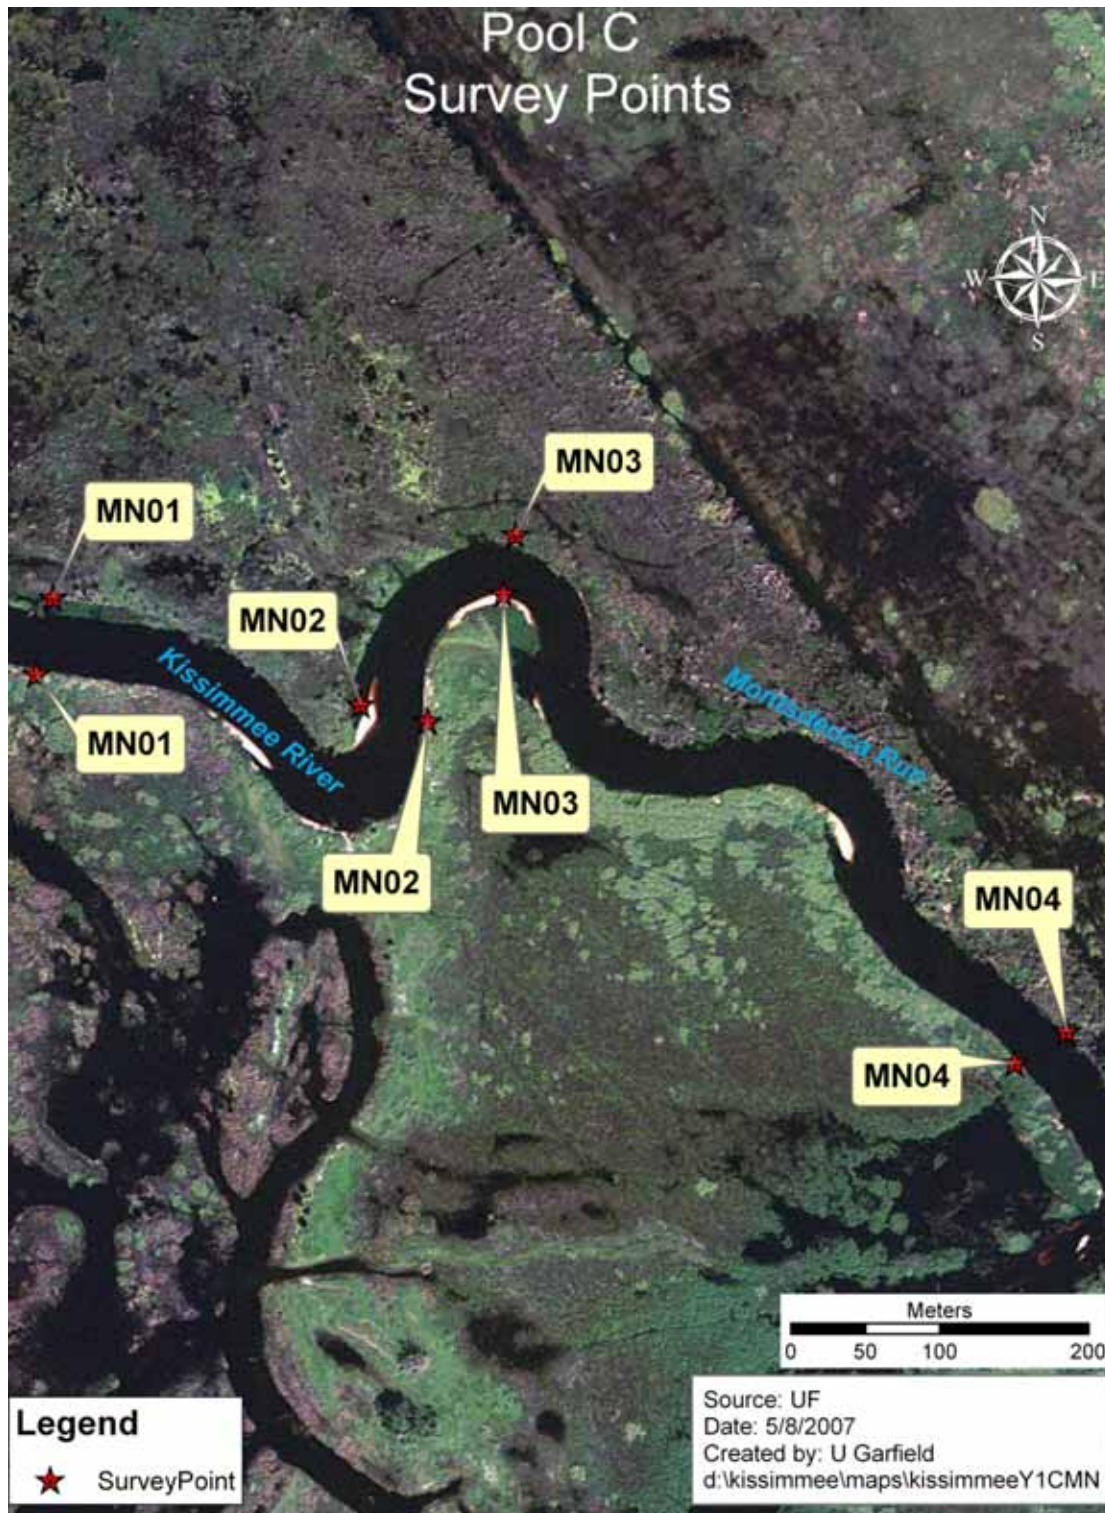
Figure 4-9. Transect locations in Montsdeoca Run, Pool C. Transects 1 and 4 are considered straight reaches and Transects 2 and 3 are bendways located across the bar apex.

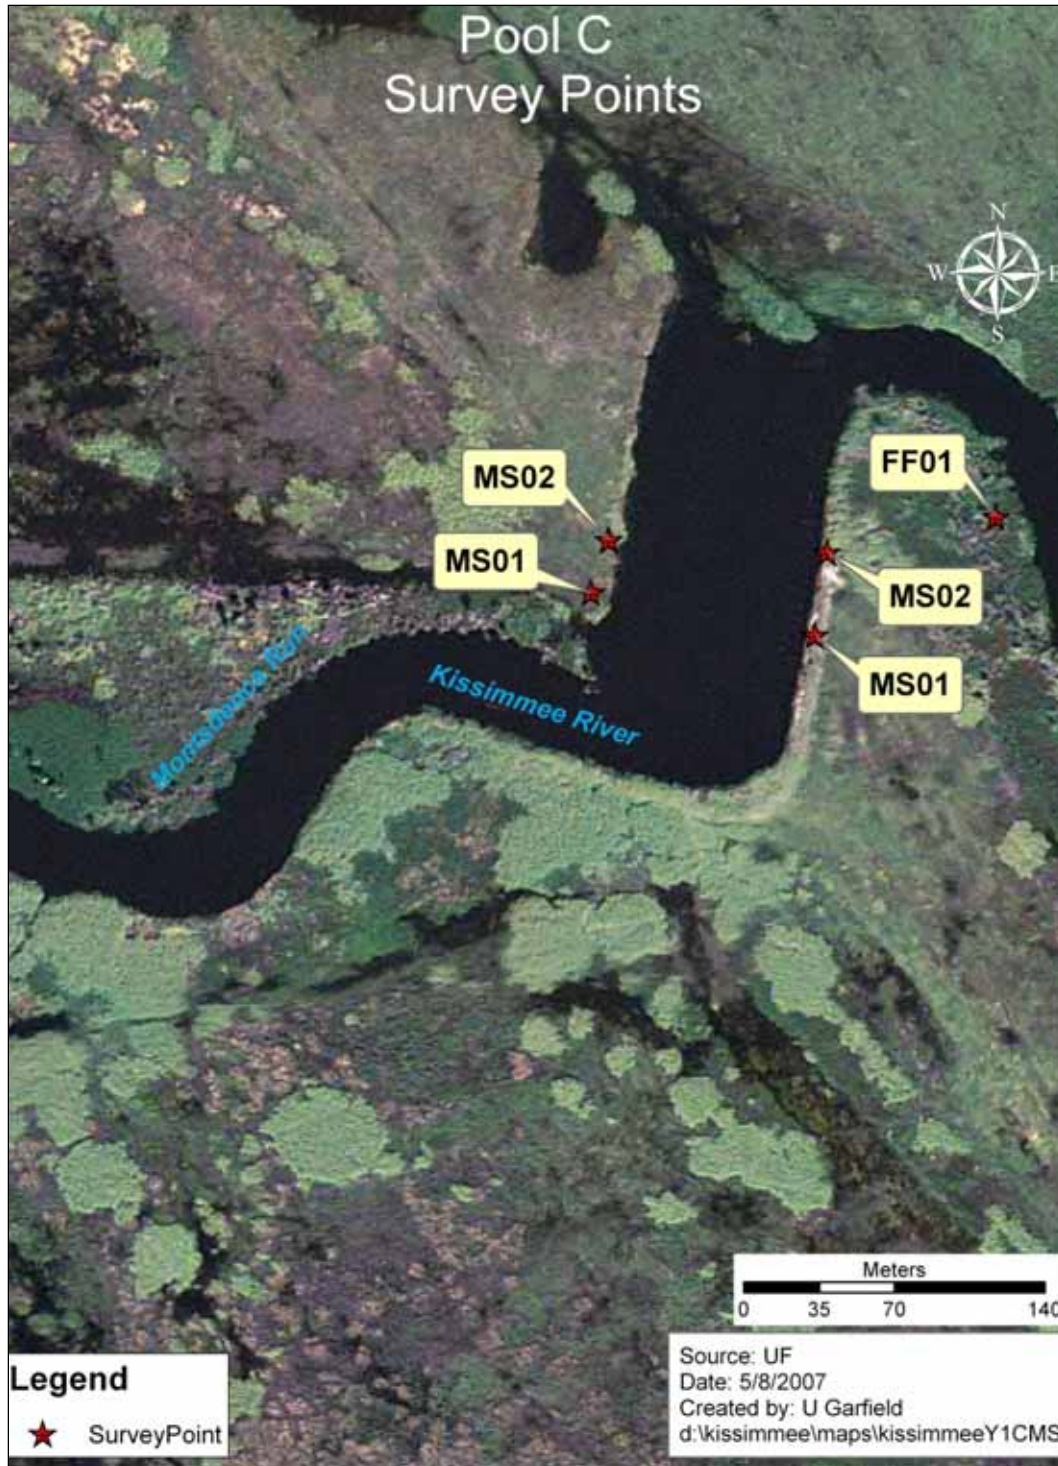
Figure 4-12. Transect locations in Montsdeoca South, a connector with two transects.

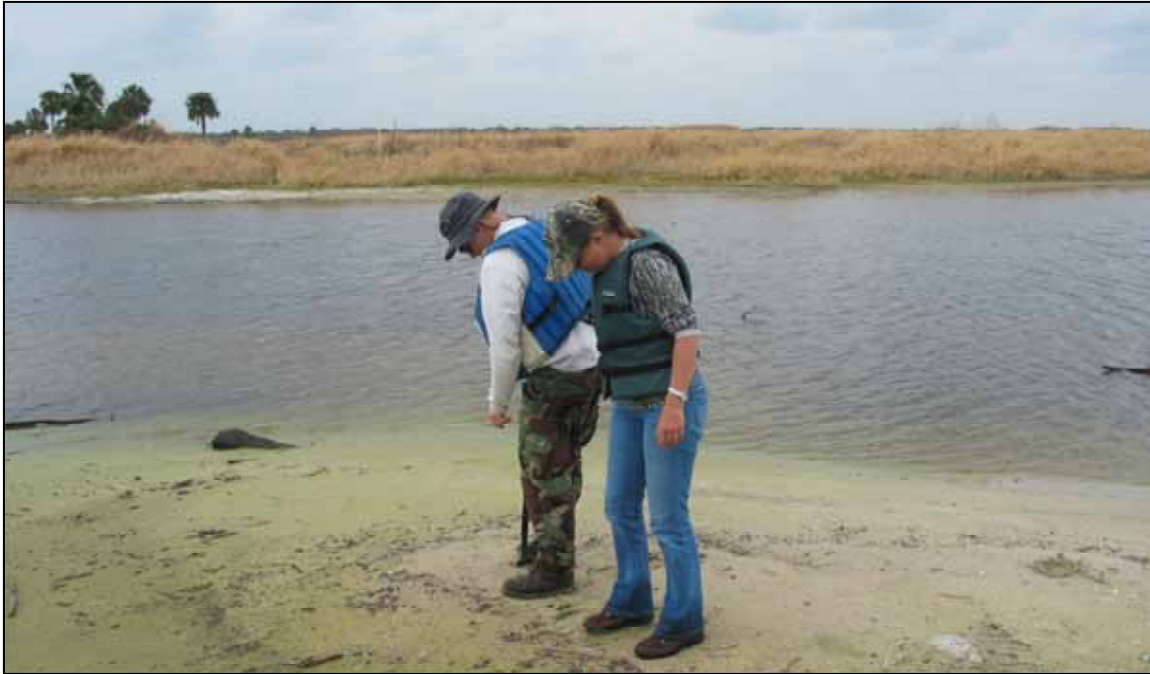
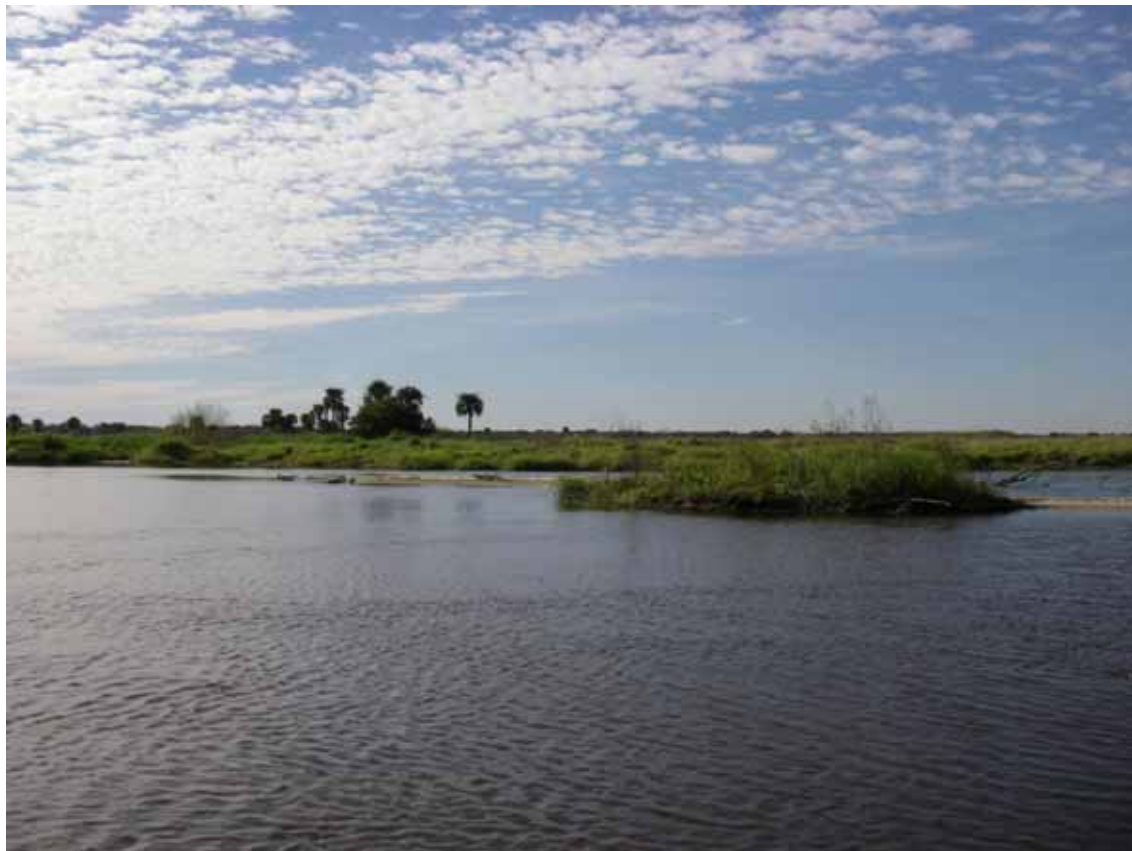
Figure 4-14. South of Montsdeoca Run, a bar has formed in the Montsdeoca Connector. This bar was emergent during February 2007 field sampling and fully vegetated in January 2009.

Montsdeoca South connector in Pool B/C also shows marked changes, particularly during 2009, the most recent year of monitoring (Figure 4-13). In cross section 1, the bar is becoming wider by about 5-10 m on each side, limiting navigation to a small section. In cross section 2, the bar experienced about 50 cm of sedimentation across nearly 50 m of width. It is unknown what the source of the sediment is, but certainly some of it could have come from upstream erosion of areas such as cross section 3 in Montsdeoca Run (Figure 4-11). Also in Pool B/C, Fulford Run transects in straight reaches show some migration, but no pronounced change in channel capacity (Figure 4-16). Fulford Run transects in bendways again have different responses; cross section 2 seemed to increase markedly (>10%) in channel capacity in 2009, whereas cross section 3 was fairly stable (Figure 4-17). Downstream of Fulford Run is the Fulford South connector. The bar here is only growing slightly (Figure 4-19), less so than the Montsdeoca connector, but now emergent during low water like the Montsdeoca connector. Cross section 1 seems to have enlarged in 2009. The timing of the widening could be partly due to the effects of Tropical Storm Fay in August 2008. In Pool D, there is no restoration and thus no flow at this point in time. As expected, Caracara Run transects were rather stable (Figure 4-21). The Ft. Basinger transect was established in 2009 (Figure 4-23), although it is likely stable as well. Chandler Run is heavily vegetated and the most difficult of the sites to survey. Both transects also are fairly stable over the study period (Figure 4-25).

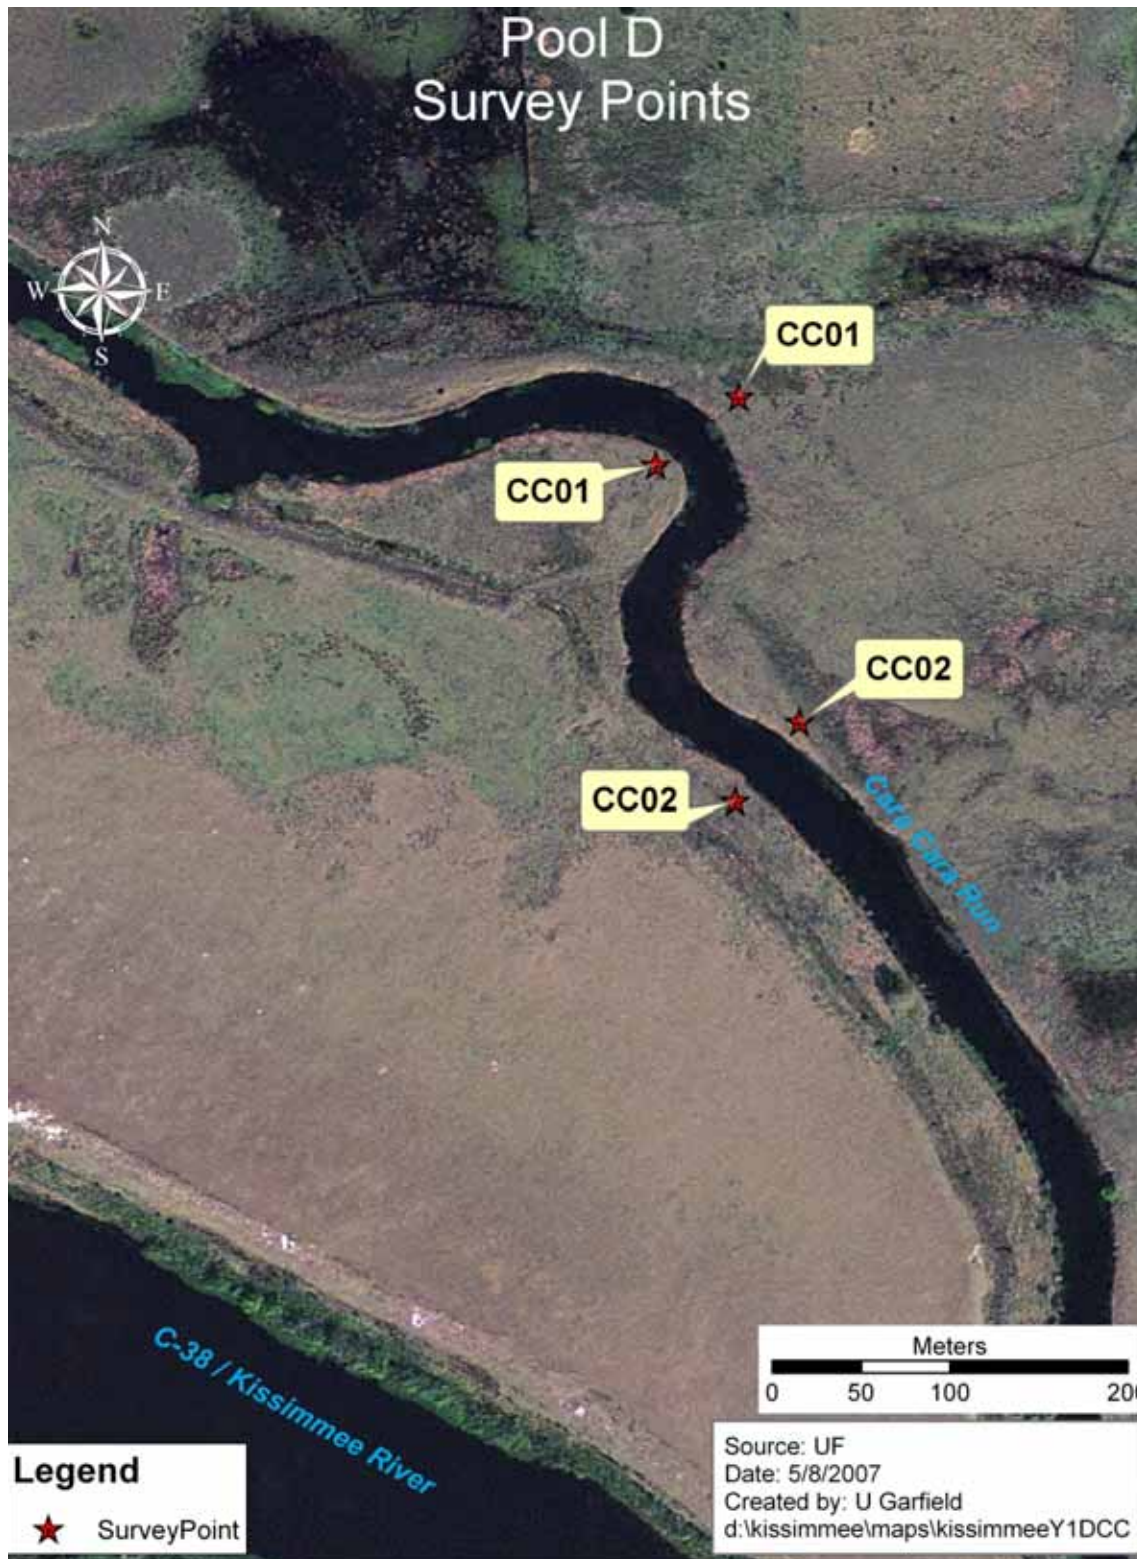
Figure 4-20. Transect locations in Caracara Run, Pool D. Transect 1 is in a bendway and Transect 2 is in a straight reach.

Caracara Run erosion pins (Table 4-7) showed no significant change for either 2008 or 2009. This area is heavily impacted by cattle and a few pins were found loose, most likely dislodged by cattle moving along the paths where the erosions pins were placed. Erosion pins placed in Chandler Run (Table 4-7) showed minimal change with the largest being in 2008 along CH02 left bank. This deposition was most likely caused by organics due to the higher water levels.
