**GEOMORPHIC MONITORING OF THE KISSIMMEE RIVER RESTORATION:**

**2006-2009**

Final Report

September 2009

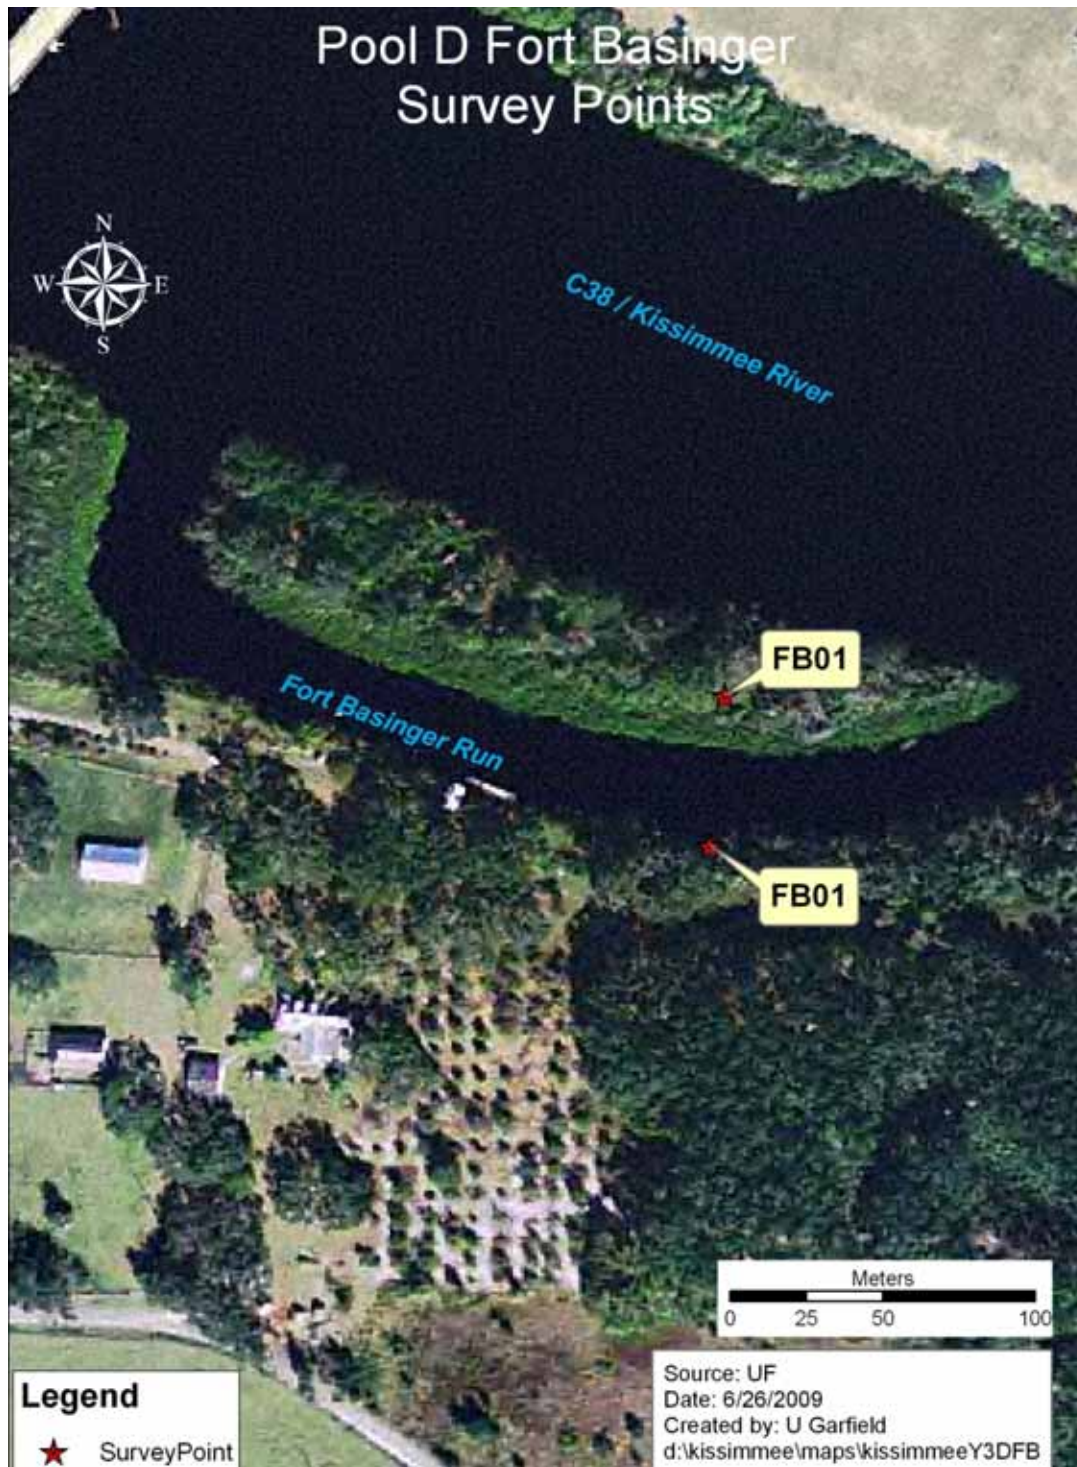
Figure 4-22. Transect location in Ft. Basinger Run, Pool D. This is a very short run where a new transect was placed in 2009.

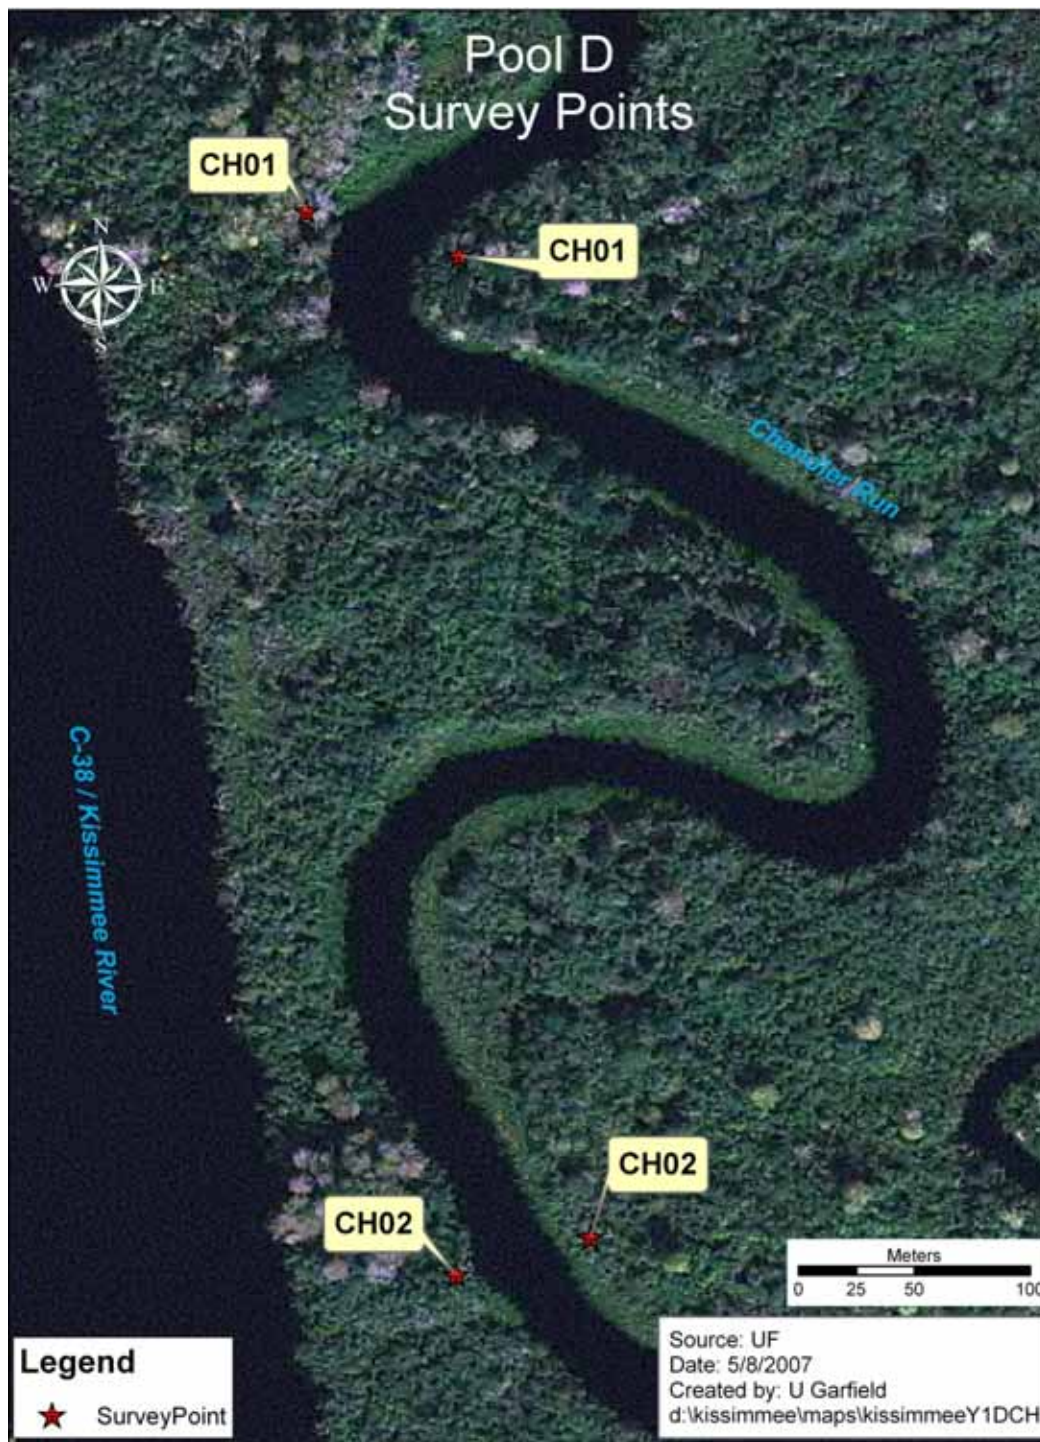
Figure 4-24 Transect locations in Chandler Run, Pool D. Transect 1 is in a bendway and Transect 2 is in a straight reach.

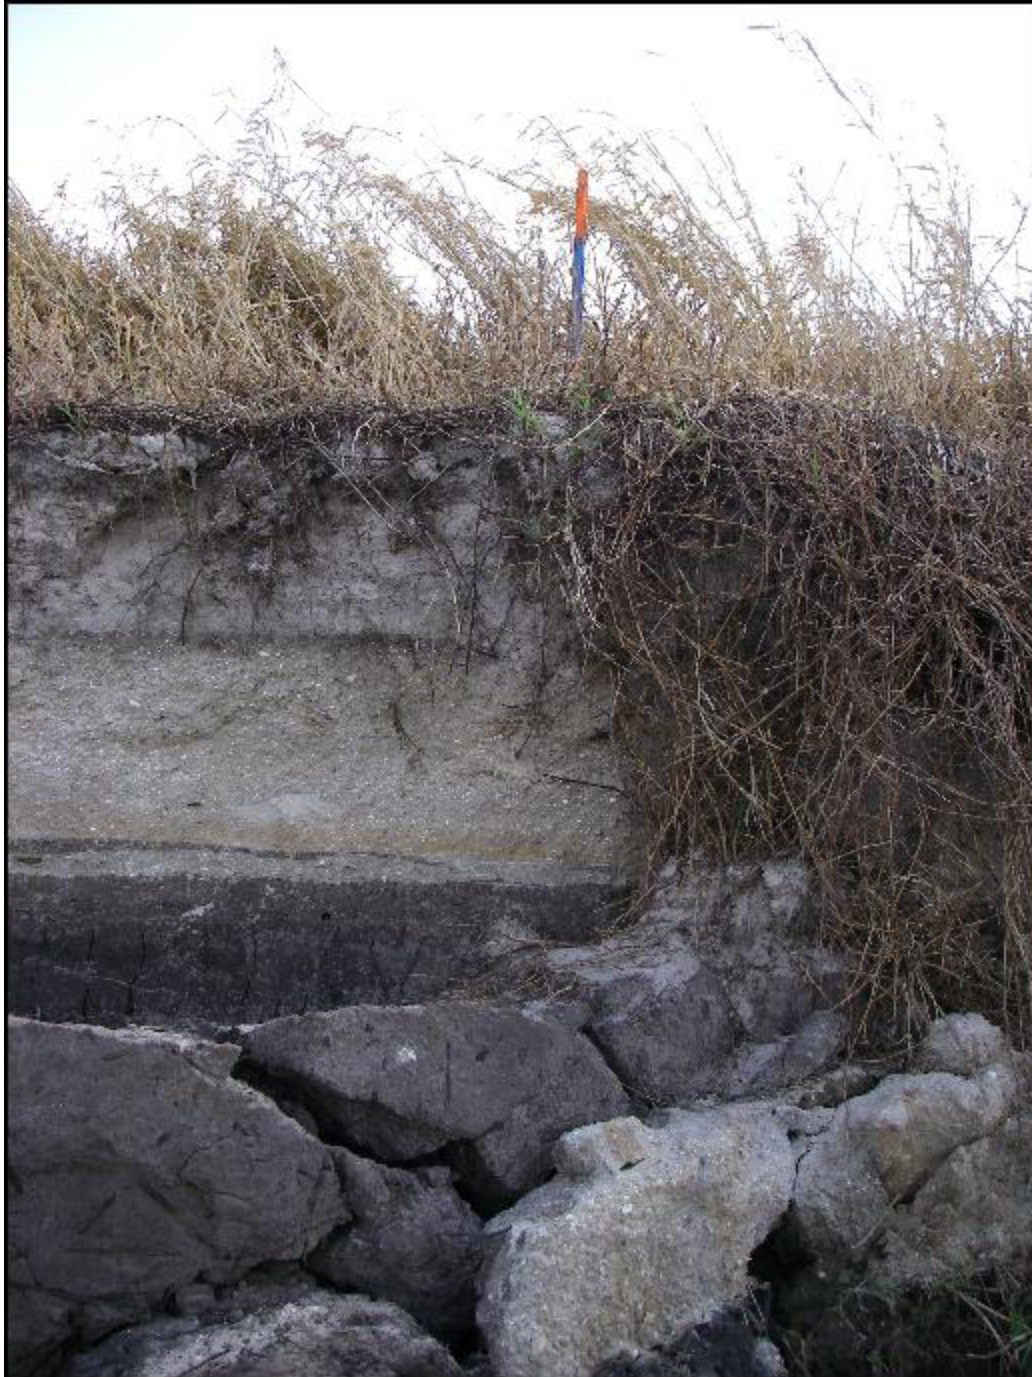
Figure 5-2. Variable bank sediments upstream in Pool C (Montsdeoca Run)

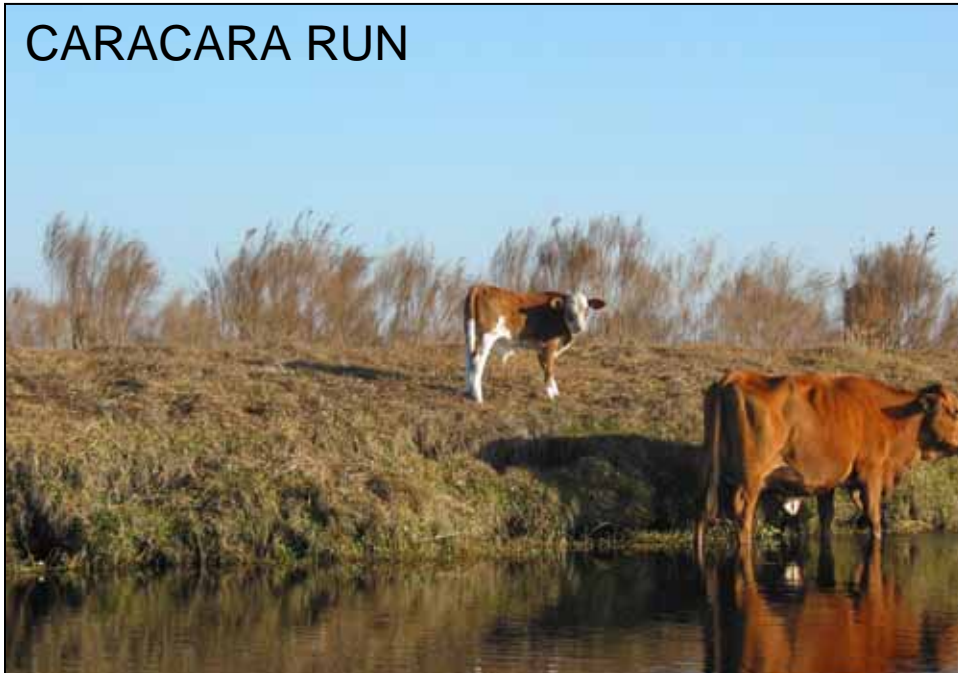
Figure 5-4. Typical land use and land cover in Caracara Run. Riverwoods Run is similar.

The area of interest was in Pool D, from the beginning of Riverwoods Run to the end of Chandler Run. These runs have been quiescent since construction of C-38 in the 1960s, and have accumulated fine and organic sediments plus sands and other materials from bank failures. The bed is not currently active or mobile as in most alluvial rivers, but will likely become that way following restoration. Bottom sediments and organic layers were cored in portions of the river that were not yet restored when water levels were relatively low early each calendar year (Figure 5-3). Still, water depths locally exceeded 3m, which made coring a challenge. Riverwoods and Caracara runs are dominated by cattle pasture (Figure 5-4). Chandler Run is forested (Figure 5-5).

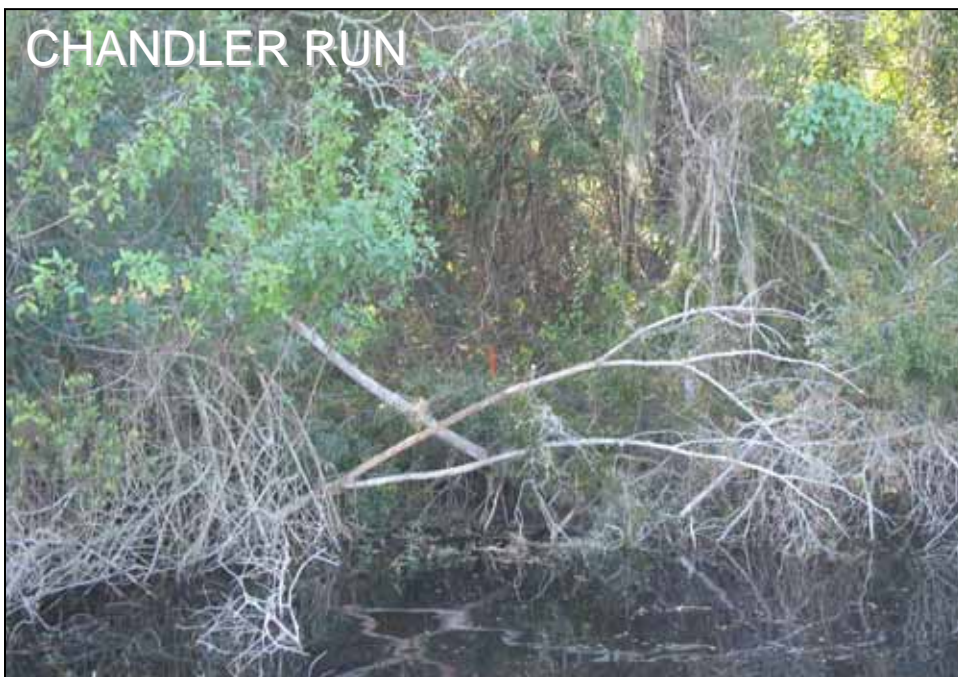
Figure 5-5. Typical land use and land cover in Chandler Run.

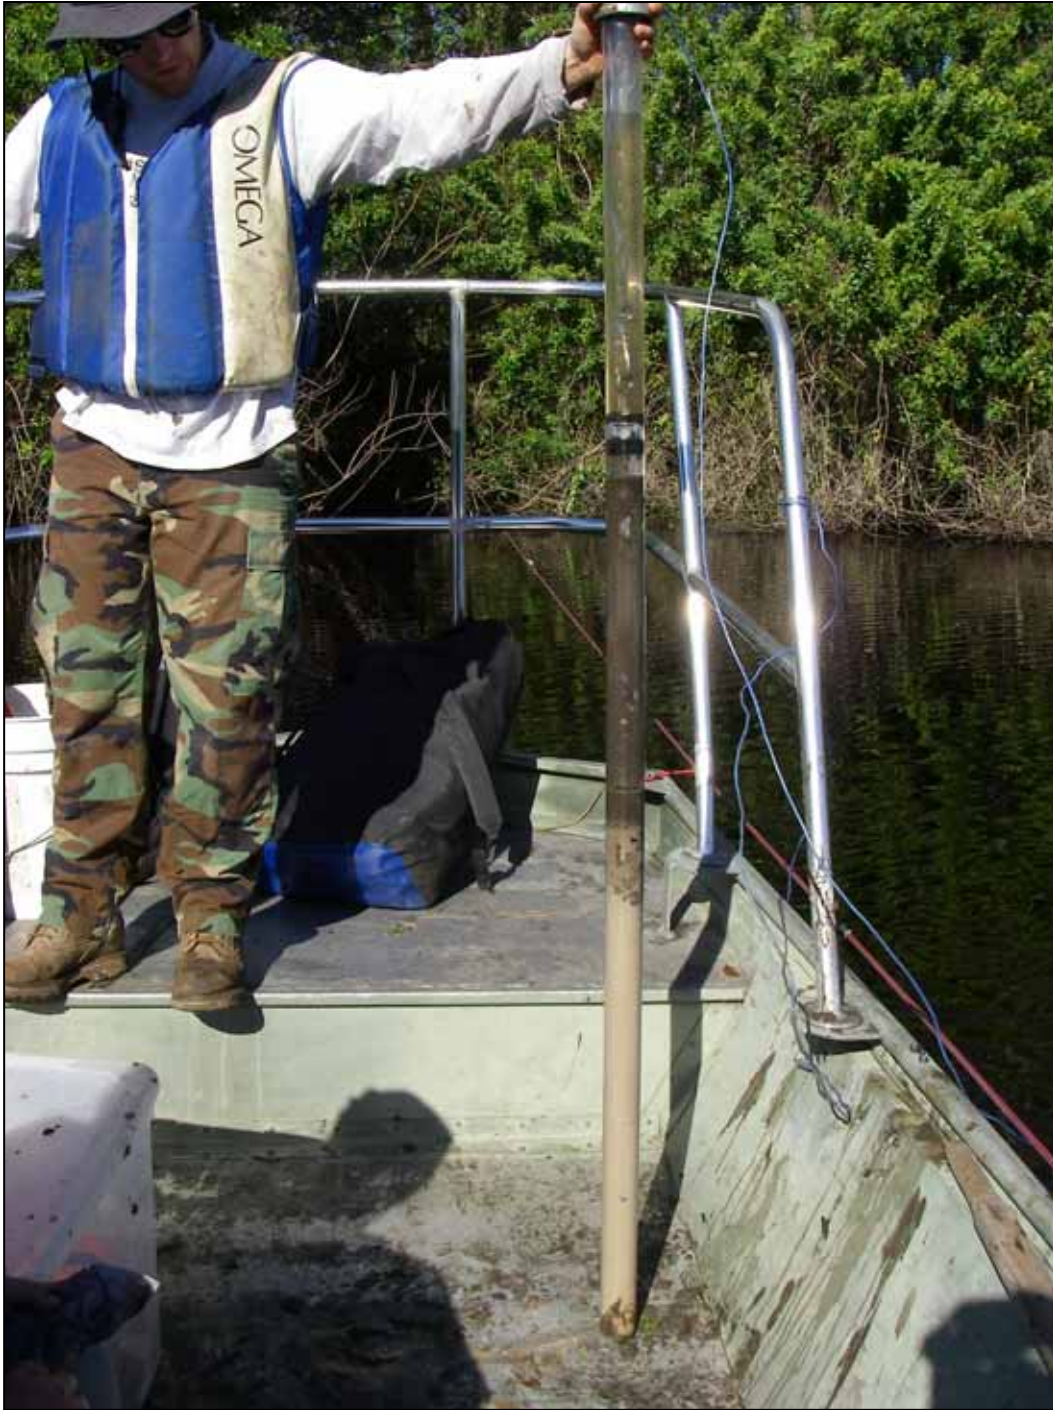
Figure 5-6. This photograph shows the length of polycarbonate tubing and how the bottom sediments of the Kissimmee River can be described. In this core, organic and fine sediments overlie a sand bottom, presumably the bed of the channel prior to channelization.

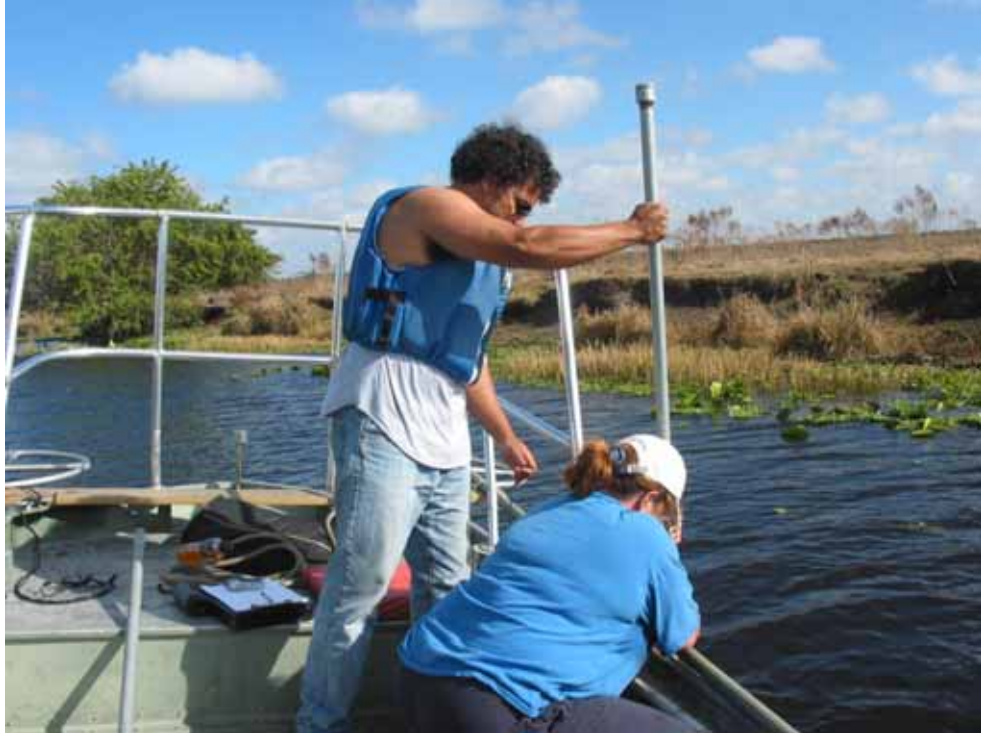
Figure 5-8. Coring the streambed with vacuum piston corer. Photograph shows galvanized pipe extension.

A random number generator was run for the entire data set of 17821 points. Out of these points, 100 were chosen as possible coring point locations as determined by the random number generator from the website: <http://www.random.org/integers/>. No duplicate numbers were generated from the 100 attempts. Of the first 50 points (numbers) selected randomly, 13 were on dry land or in C-38. To bring the total core points to 50 the next 13 numbers generated were chosen and locations verified using the 2004 DOQQs. Of the 50 random core point locations, 34 were in Riverwoods Run, 10 were in Caracara Run, 2 were in Ft. Basinger Run and 6 were in Chandler Run. The coordinates of these randomly chosen locations were saved as waypoints in a GPS, and were navigated to by boat. Coring was done within 3 m of the selected location, aiming to be near the center of the channel. The boat position was maintained by using an anchor and long poles for temporary support (Figures 5-8, 5-9 and 5-10).

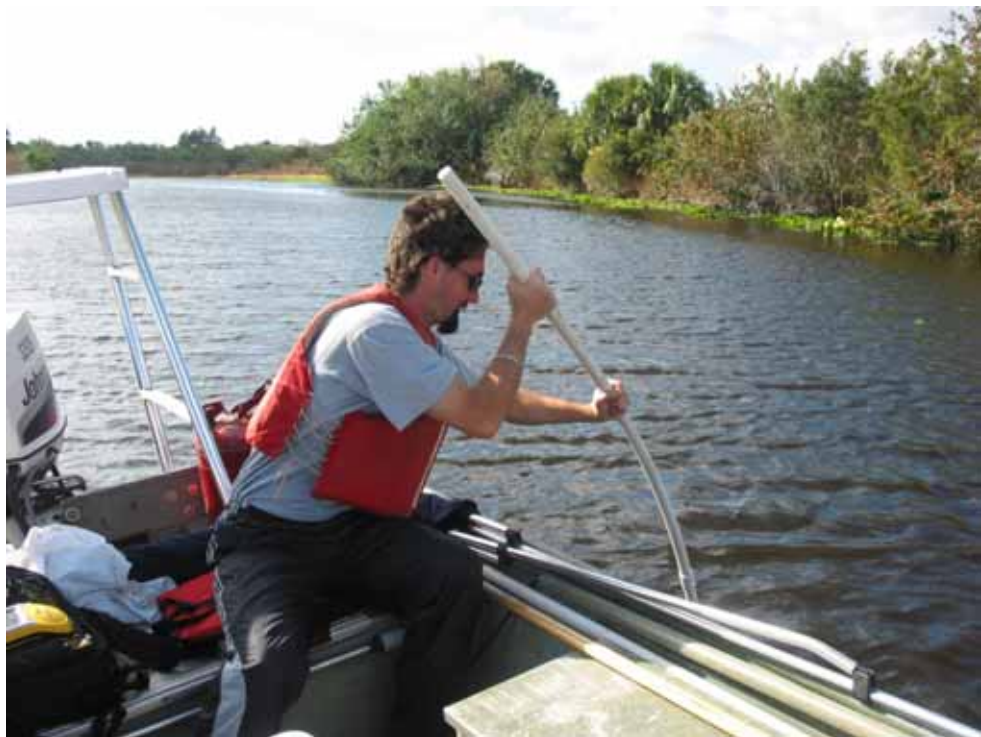
Figure 5-9. Stabilizing the boat with PVC pipes to streambed to facilitate coring.

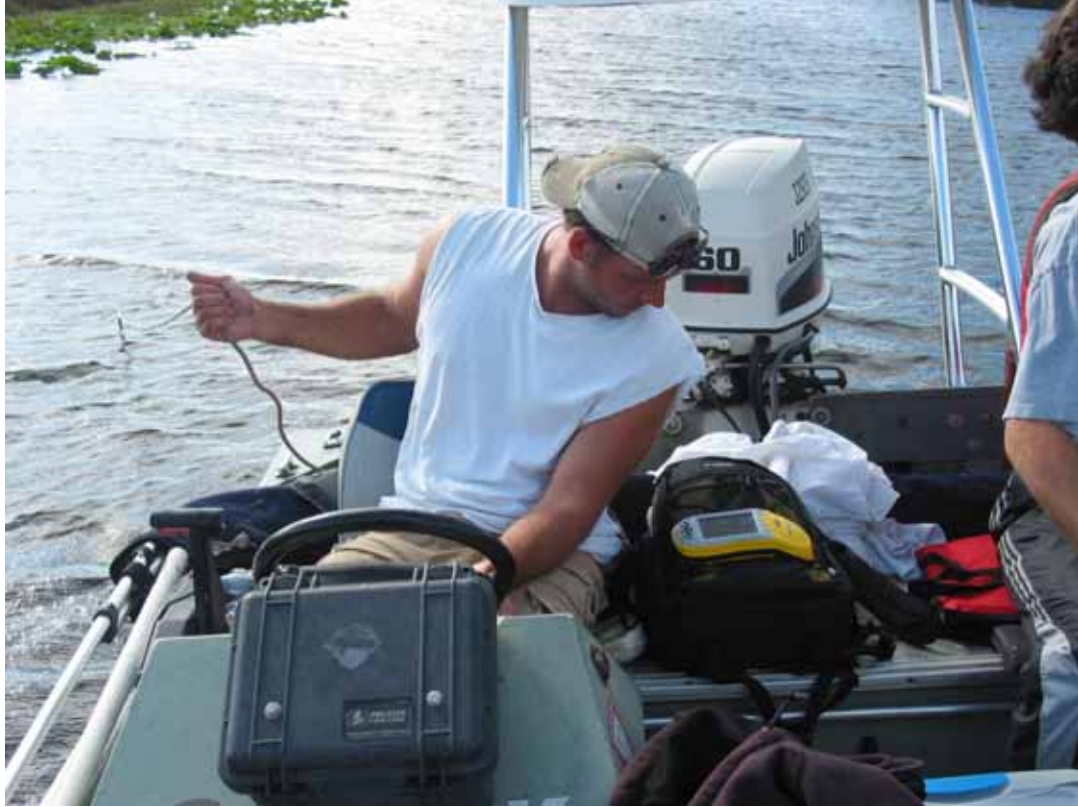
Figure 5-10. Stabilizing the boat with anchor and checking the GPS for randomly selected predetermined coring location.

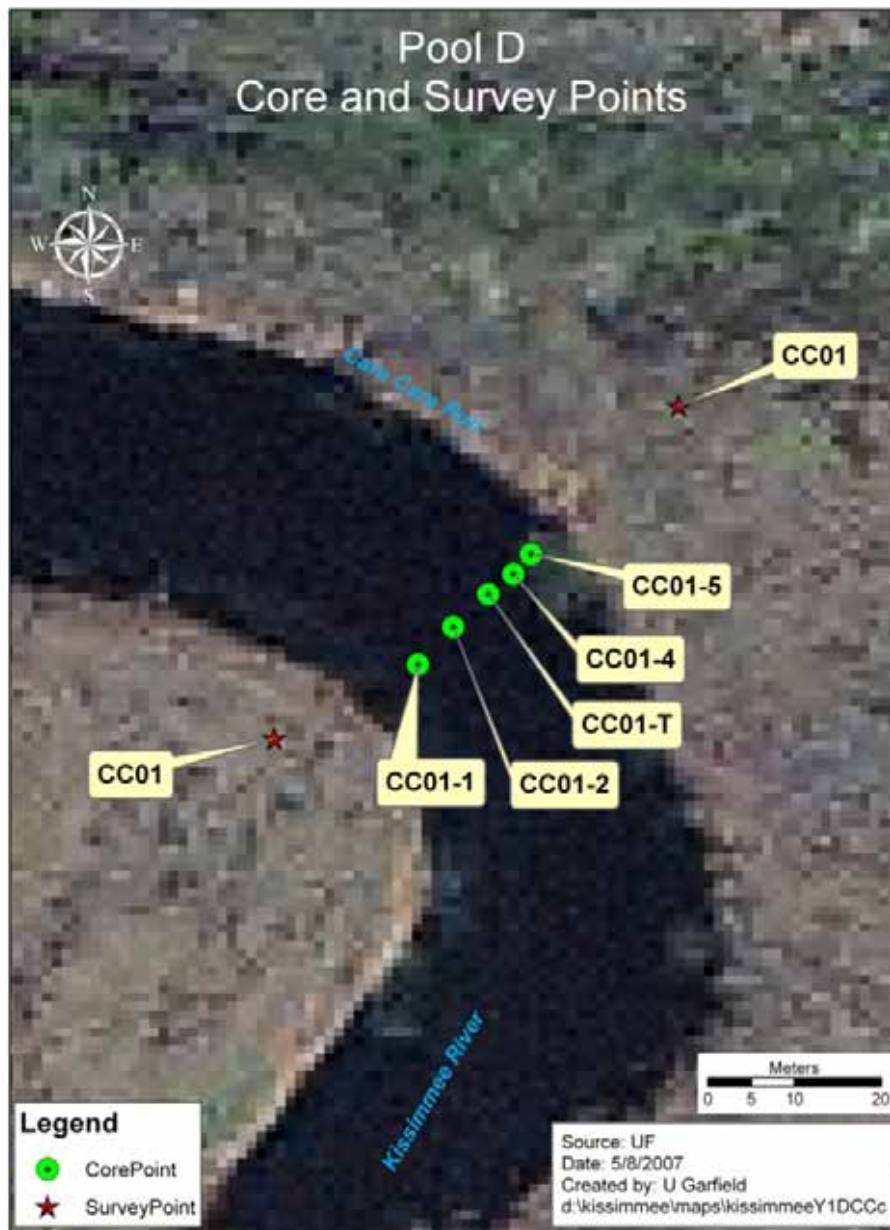
Figure 5-13. Caracara Run Transect 1. Coring in 2007 was conducted at the same locations as survey transects. Location where the 5 cores were obtained are shown with the thalweg core labeled T. An additional core was collected approximately 2 m downstream for comparison.

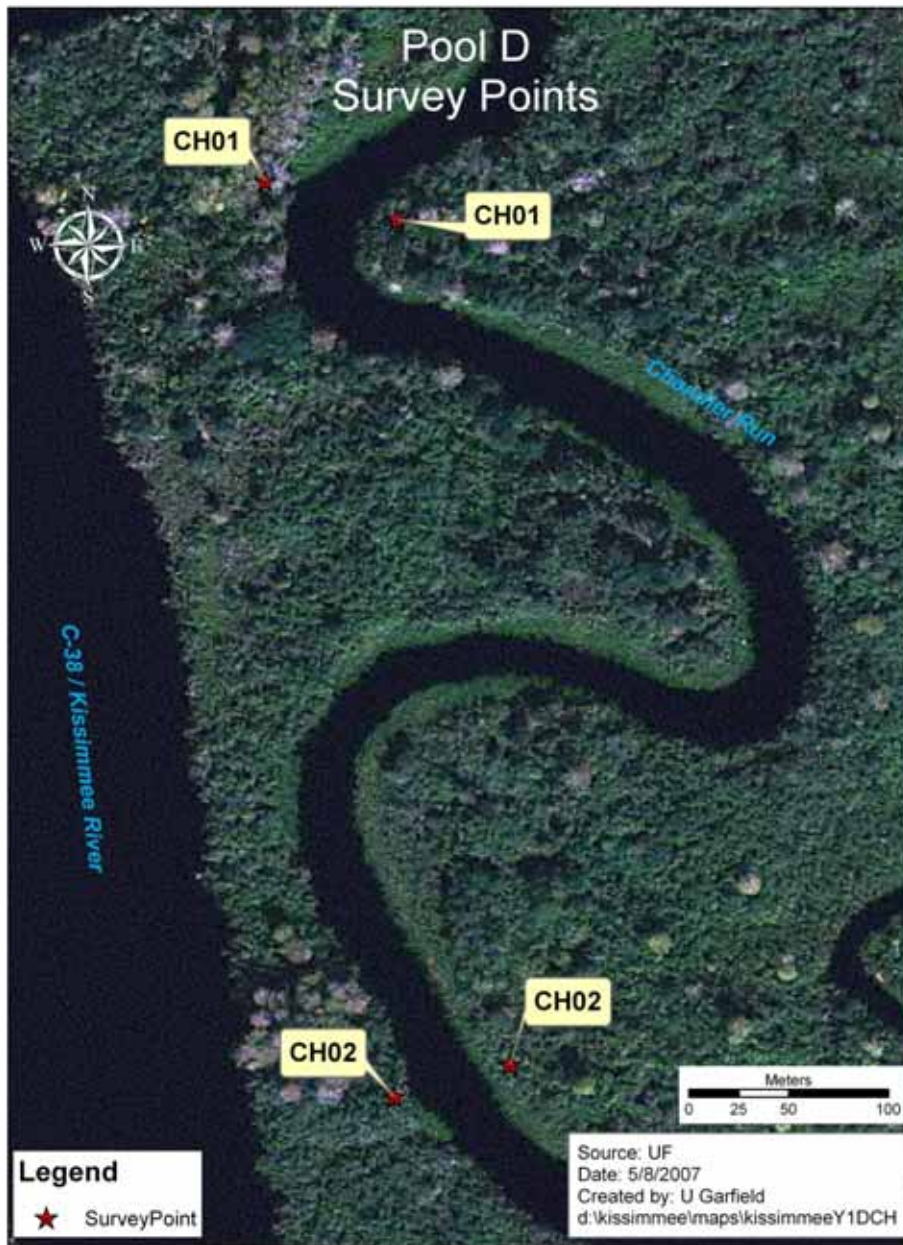
Figure 5-15. Coring in 2007 was conducted at the same locations as survey transects. This image shows locations of Chandler Run Transects 1 and 2.

In Chandler Run (Figures 5-15 to 5-17), the thickest organic layer was always at the top (Figures 5-22 to 5-25). Where the channel geometry was asymmetric (bendway), it was located on the shallower side (Figure 5-22). Where the channel geometry was symmetric (straight), thick organic layers were found on both sides of the channel (Figure 5-24). At both transects in this run, the thalweg core and nearby downstream core were much more similar (Figures 5-23 and 5-25).

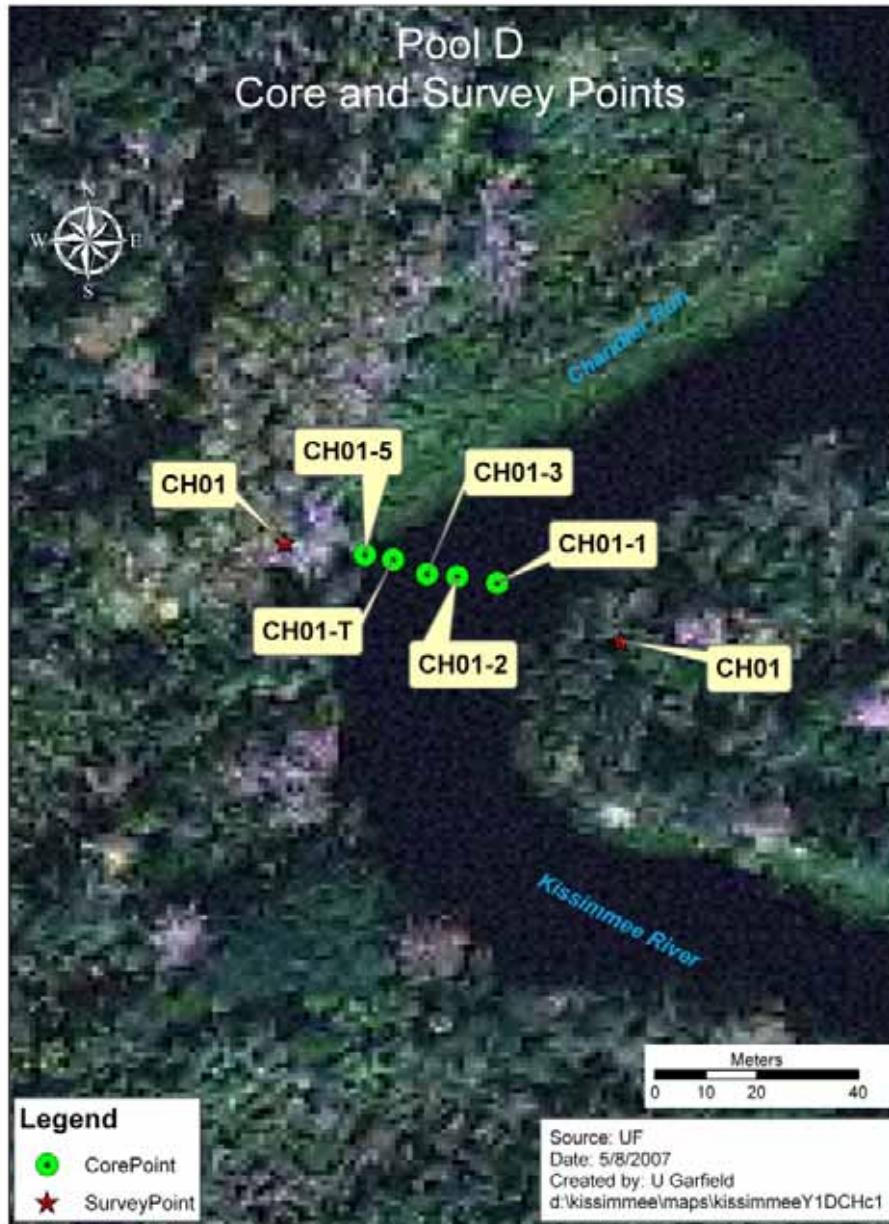
Figure 5-16. Chandler Run Transect 1. Coring in 2007 was conducted at the same locations as survey transects. Location where the five cores were obtained are shown with the thalweg core labeled T. An additional core was collected approximately 2 m downstream for comparison.

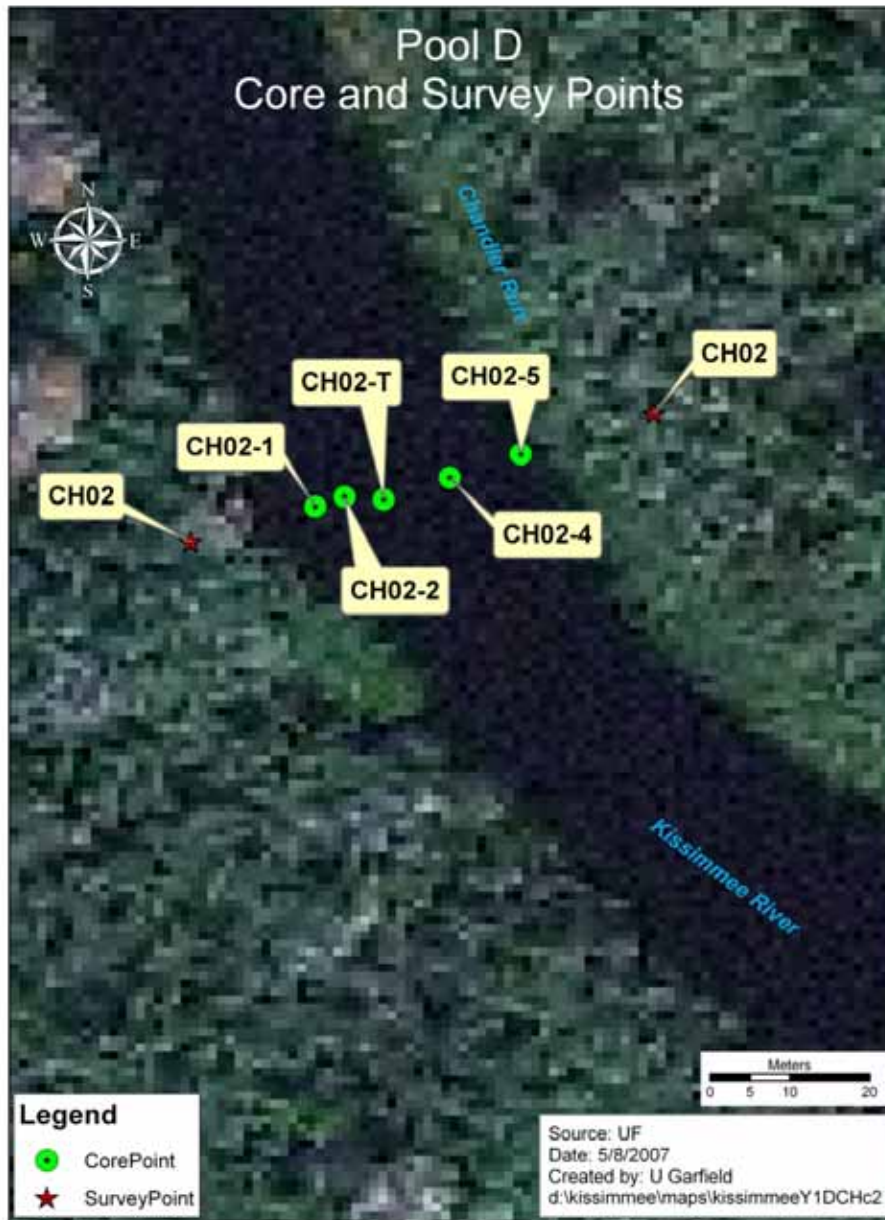
Figure 5-17. Chandler Run Transect 2. Coring in 2007 was conducted at the same locations as survey transects. Location where the 5 cores were obtained are shown with the thalweg core labeled T. An additional core was collected approximately 1 m downstream for comparison.

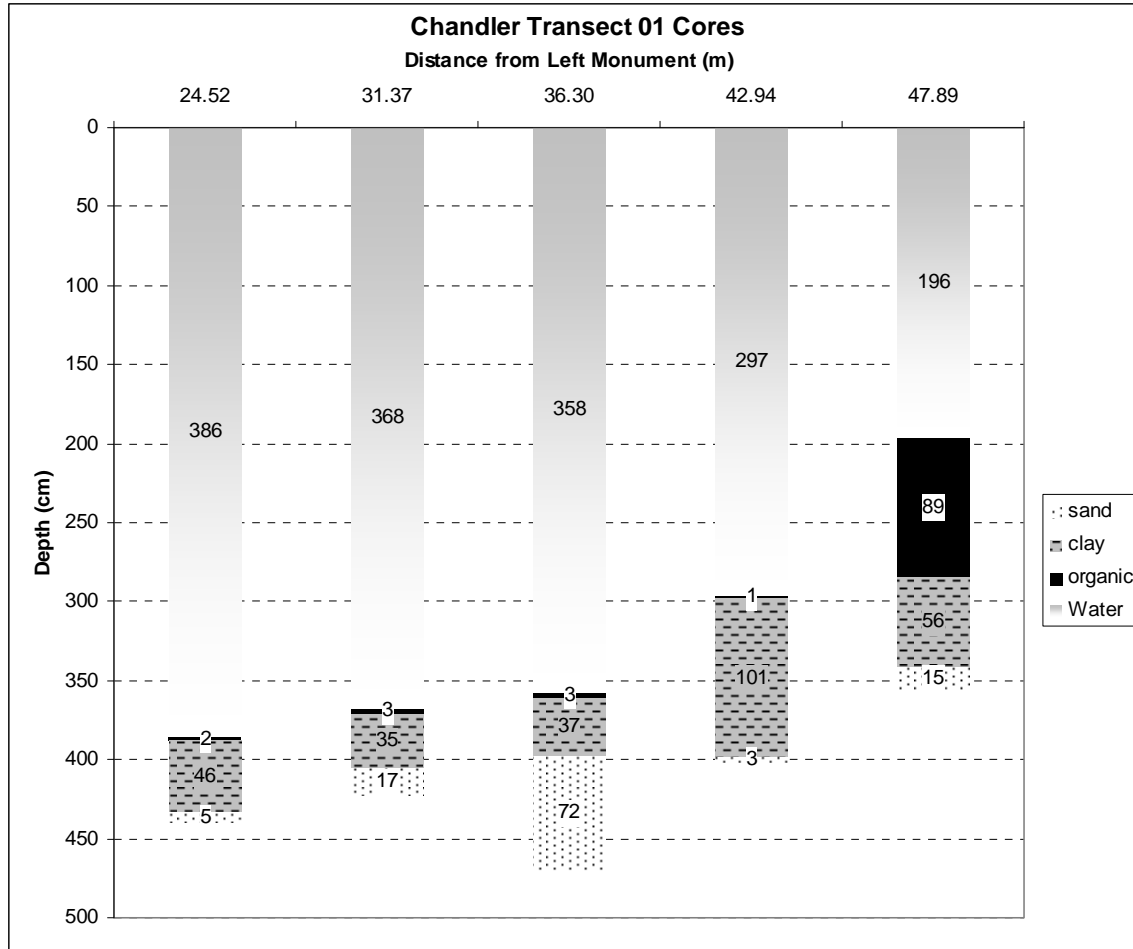
Figure 5-22. Major stratigraphic layers in Chandler Run, Transect 1 located at a bendway from 2007 core sampling.

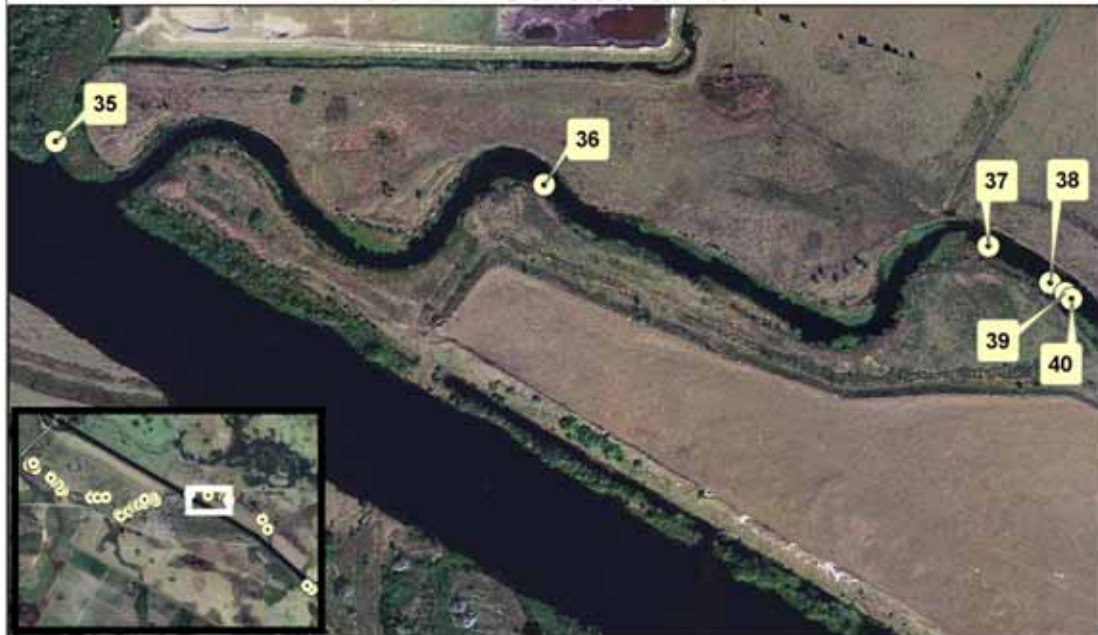
## Kissimmee River 2009 Random Core Locations Pool D - Caracara Run

Figure 5-50. Location of cores collected in 2009 in the upper portion of Caracara Run. Cores were collected with a vacuum-piston auger and characterized into 3 basic categories: sand, fines (silt & clay) and organics. Water depths sampled, and basic core descriptions and thicknesses are graphed.

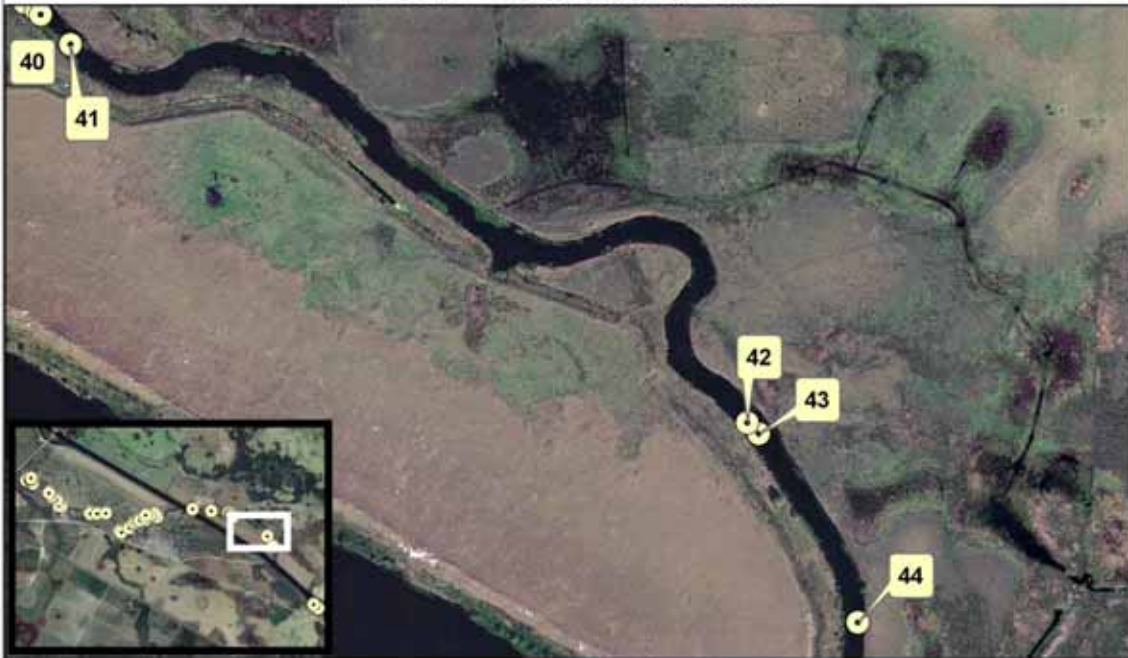
## Kissimmee River 2009 Random Core Locations Pool D - Caracara Run

Figure 5-51. Location of cores collected in 2009 in the lower portion of Caracara Run. Cores were collected with a vacuum-piston auger and characterized into 3 basic categories: sand, fines (silt & clay) and organics. Water depths sampled, and basic core descriptions and thicknesses are graphed.

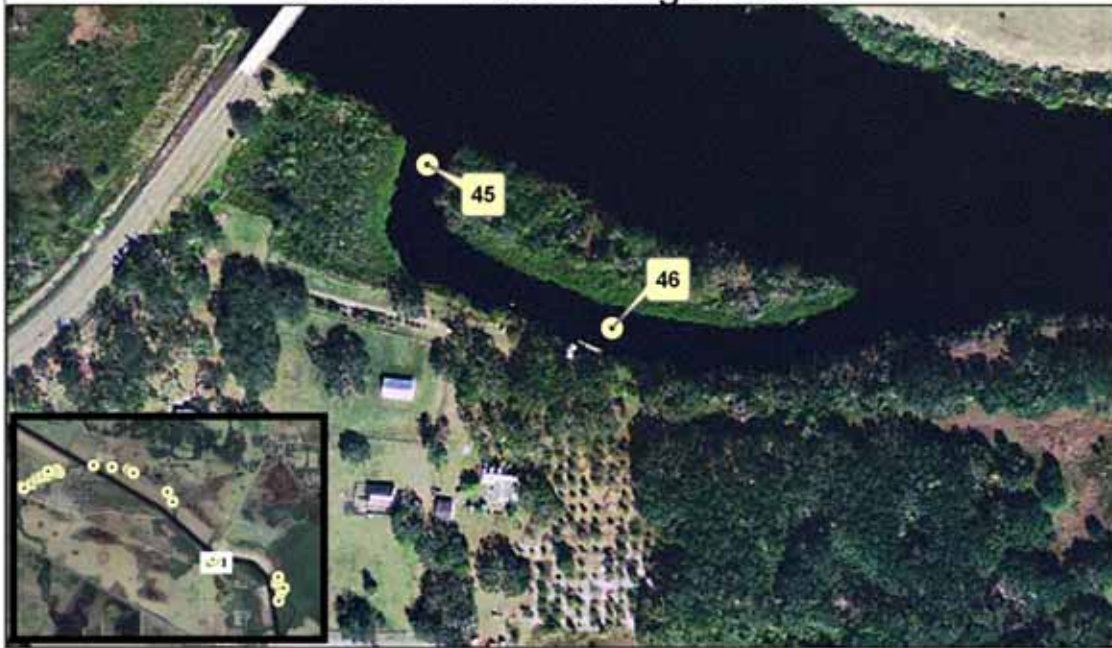
## Kissimmee River 2009 Random Core Locations Pool D - Fort Basinger Run

Figure 5-52. Location of cores collected in 2009 in Fort Basinger Run. Cores were collected with a vacuum-piston auger and characterized into 3 basic categories: sand, fines (silt & clay) and organics. Water depths sampled, and basic core descriptions and thicknesses are graphed.
