# Stormwater Treatment Areas

## Water Year 2013 (WY2013)

### Performance

David Unsell, Section Administrator  
Water Quality Treatment Technologies  
Long-Term Plan Meeting, August 23, 2013

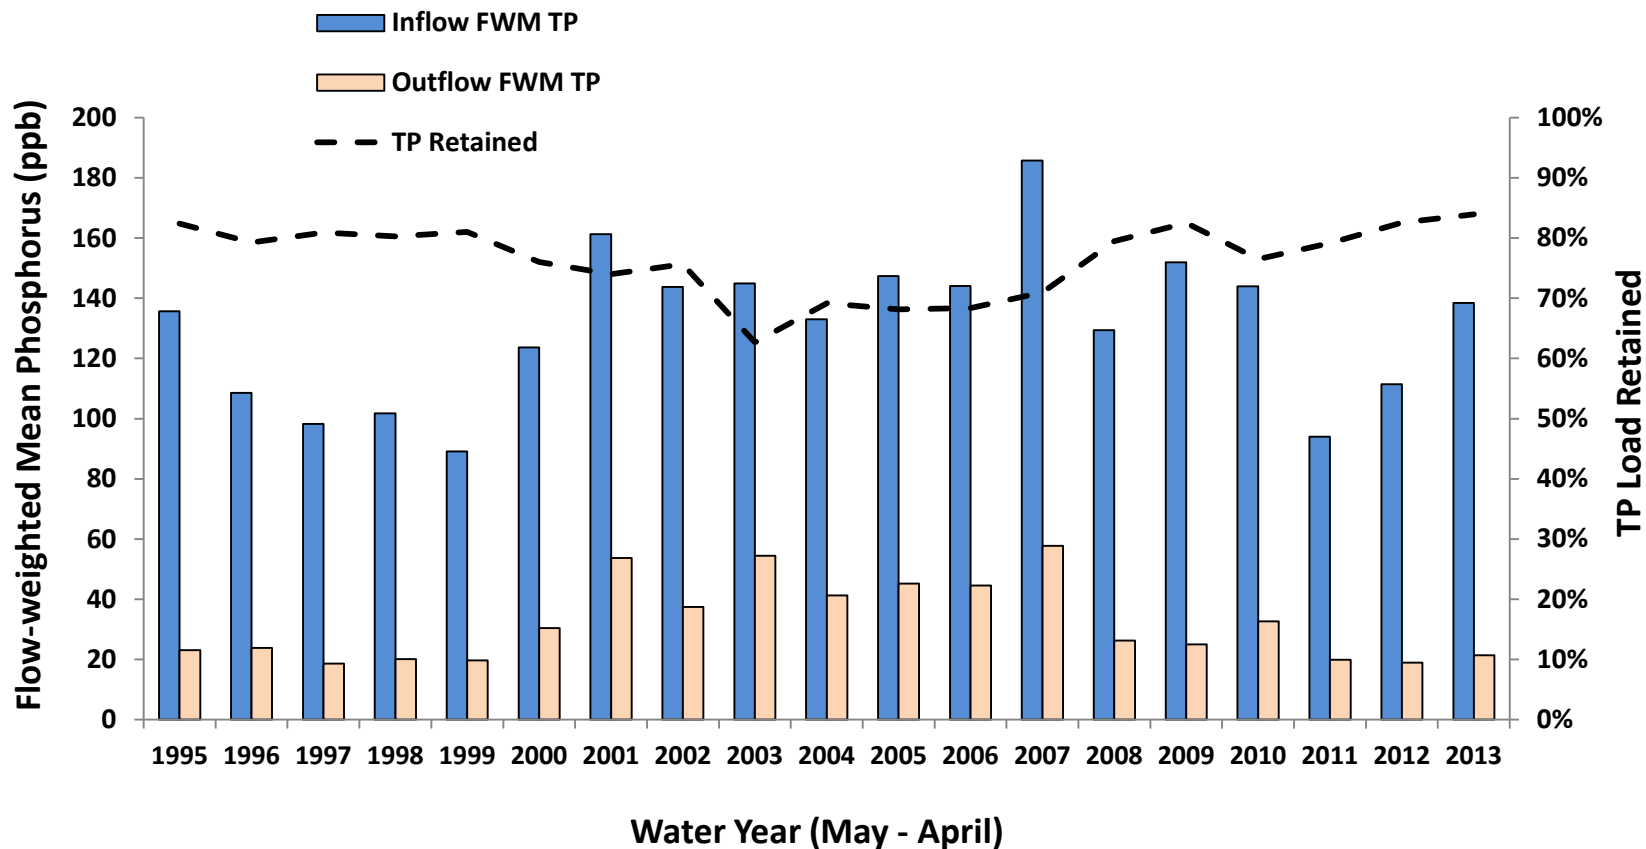
# Period of Record Performance

*WY2013 TP Load Reduction of 84% is highest on record*

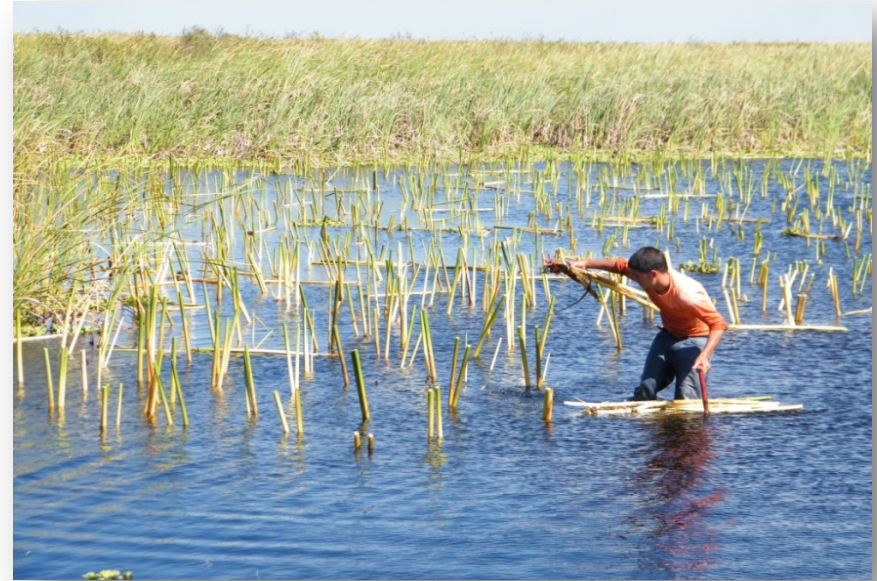
*Bulrush plantings in open water areas & vegetation strips in STA-1E, STA-1W, STA-3/4, and STA-5/6.*

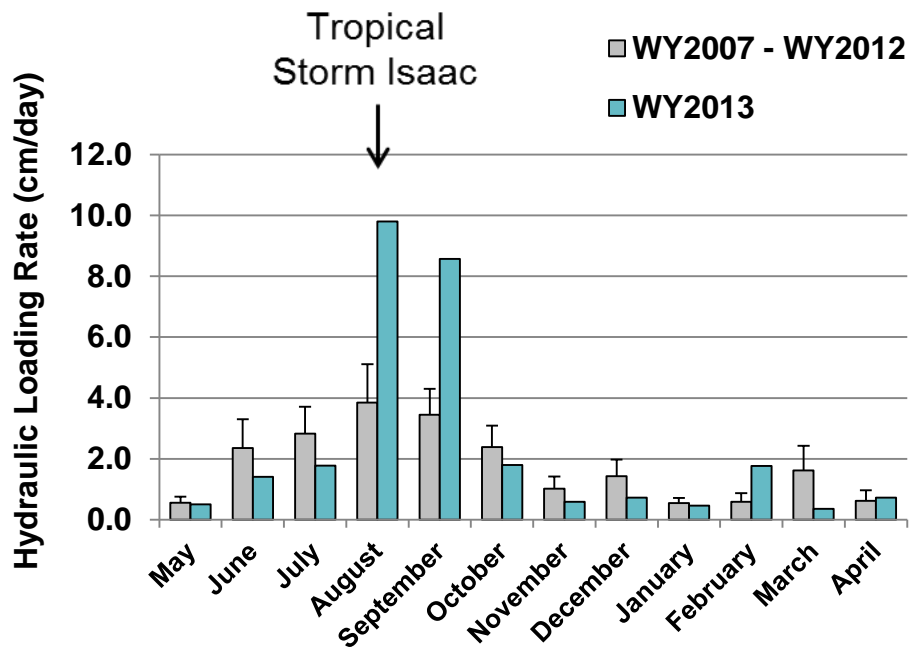
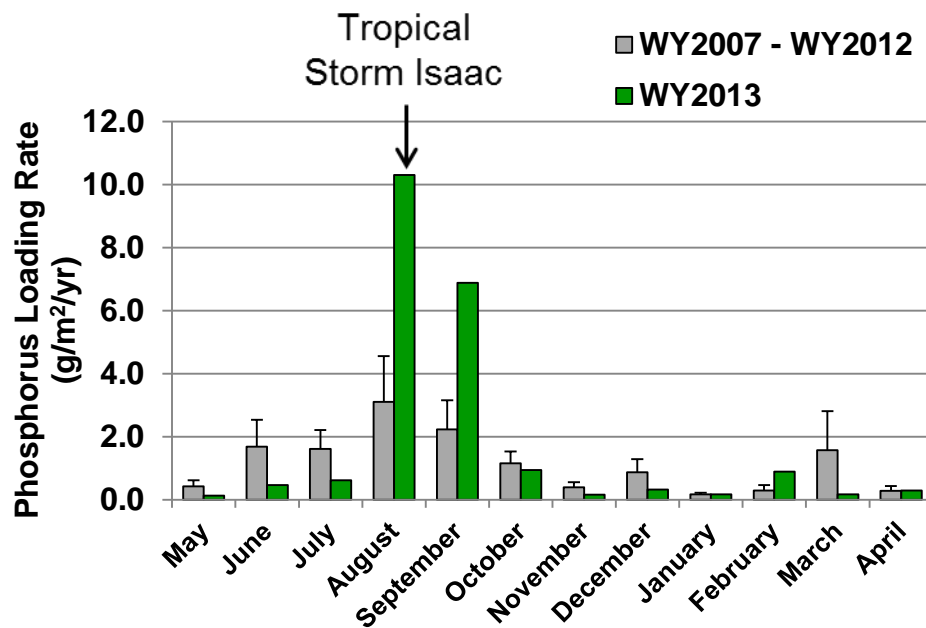
# STA-1E Hydraulic & Phosphorus Loadings

Standard Error bars shown.

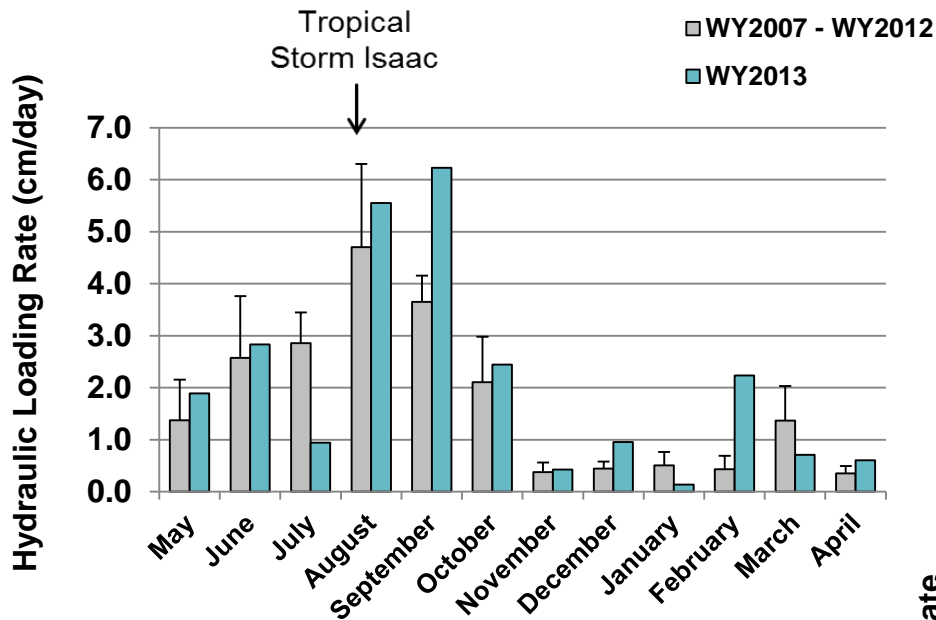
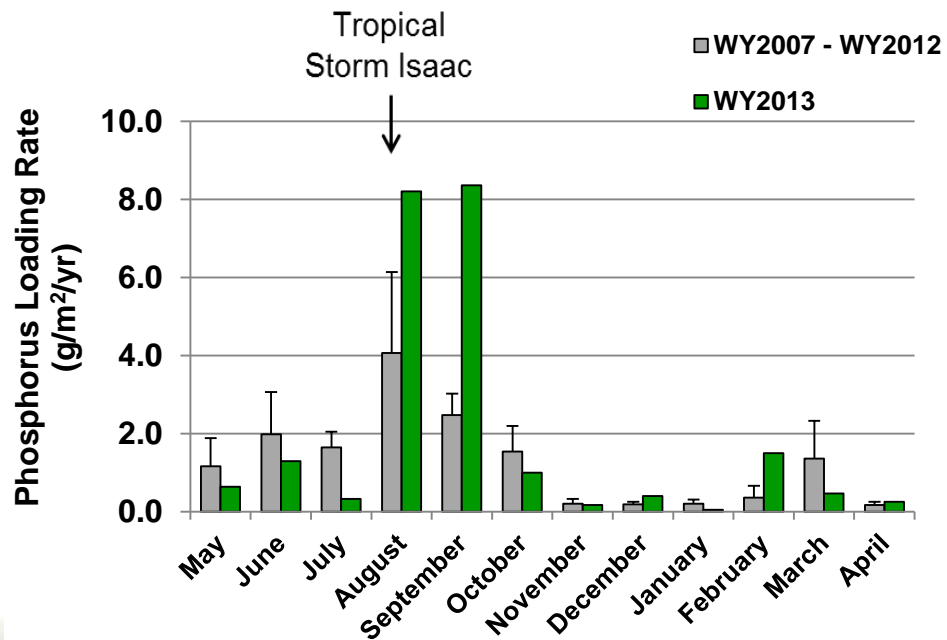
# STA-1W Hydraulic & Phosphorus Loadings

Standard Error bars shown.

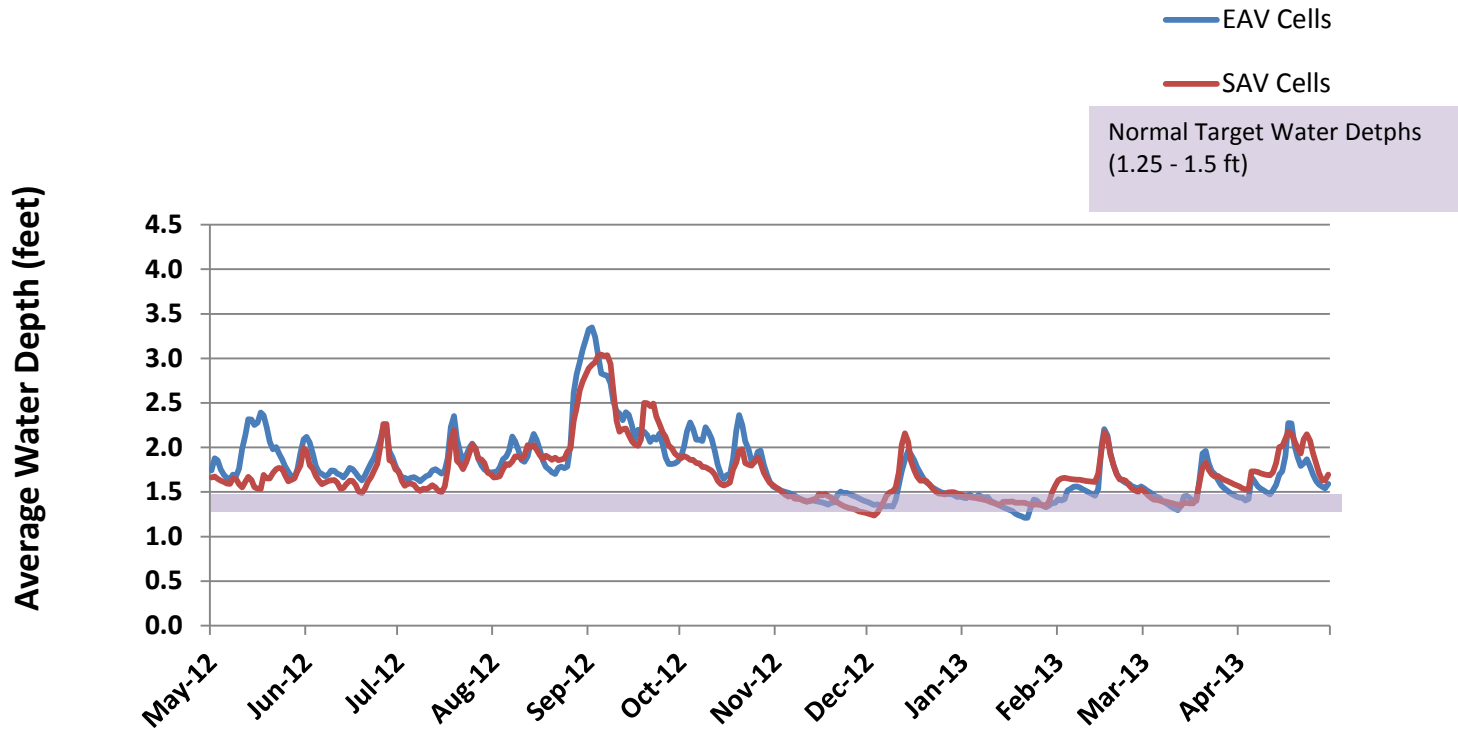
# STA-2 Water Levels

Graph excludes Flow-way 5 which was off-line in WY2013

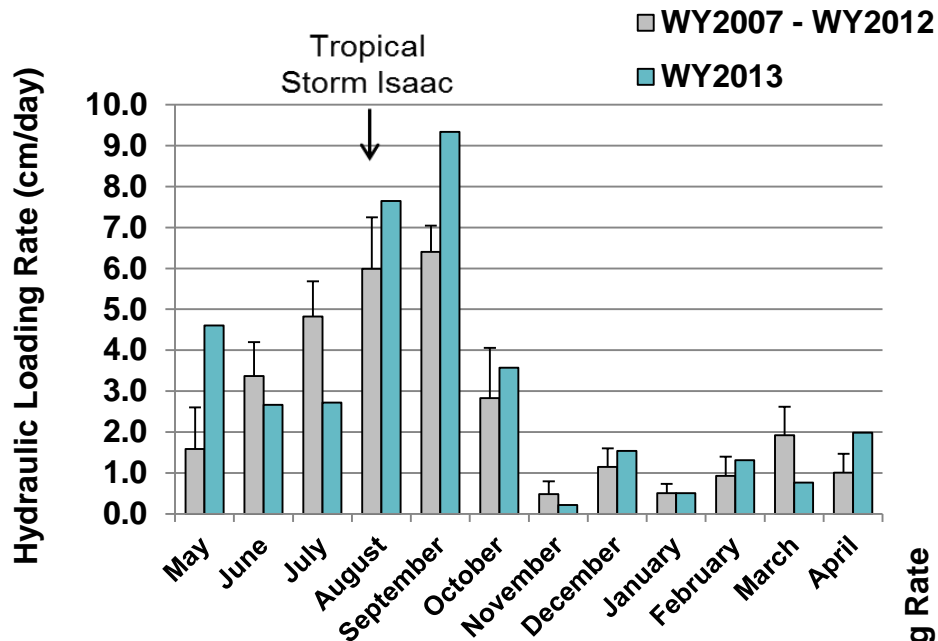
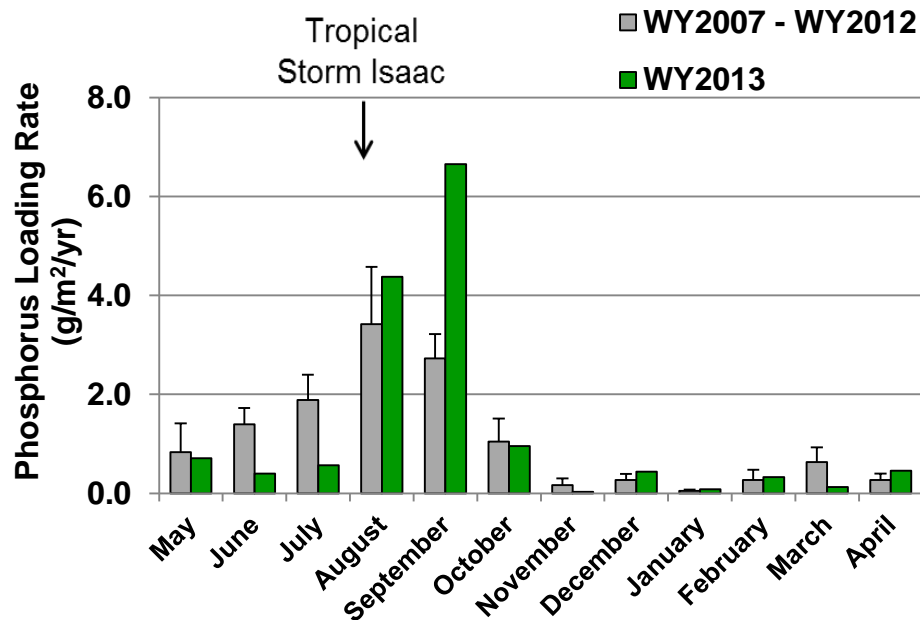
# STA-2 Hydraulic & Phosphorus Loadings

Standard Error bars shown.

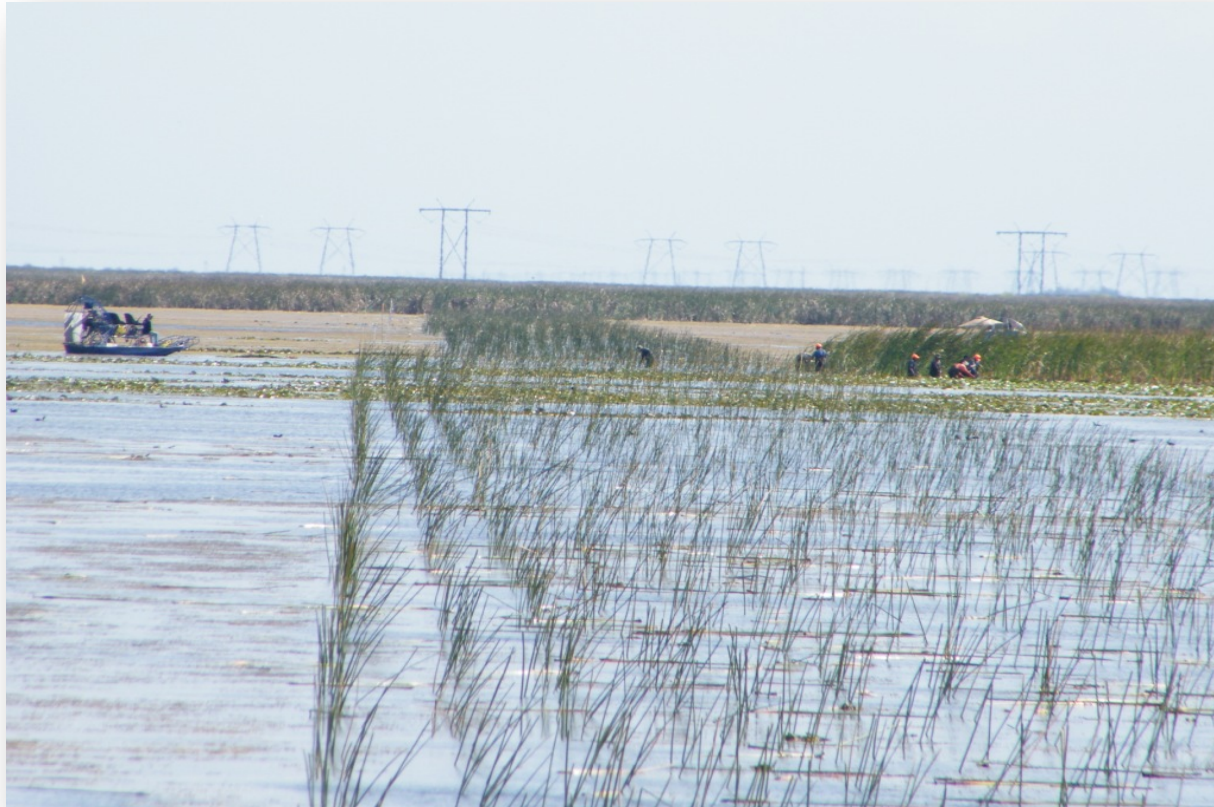
# STA-3/4 Bulrush Plantings

*Bulrush planted in open water areas or areas devoid of vegetation improve phosphorus removal efficiency.*

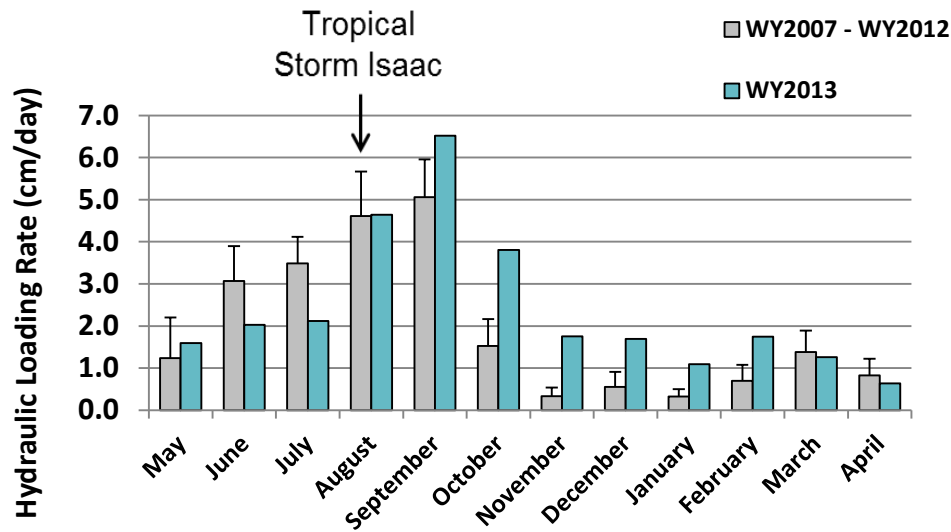
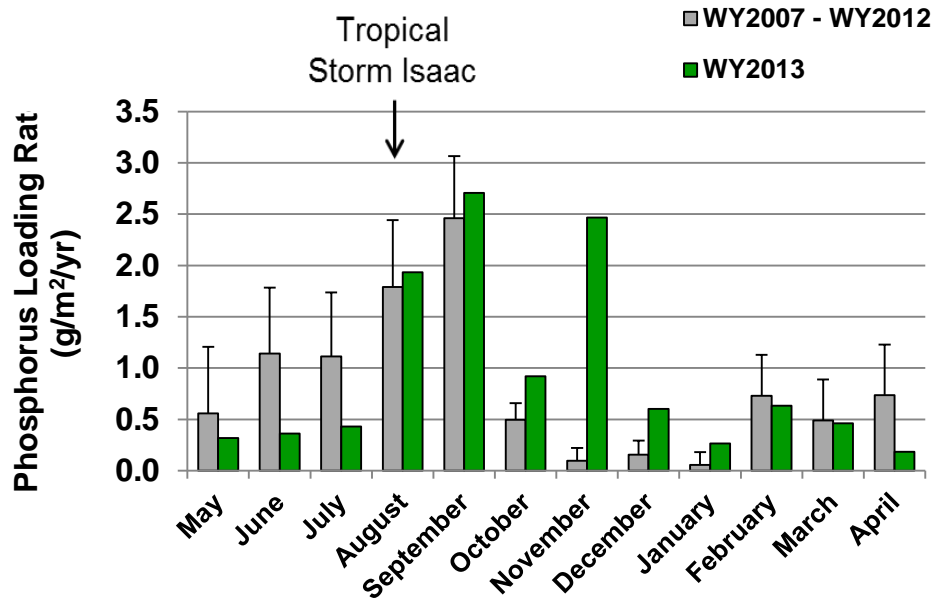
# STA-3/4 Hydraulic & Phosphorus Loadings

Standard Error bars shown.

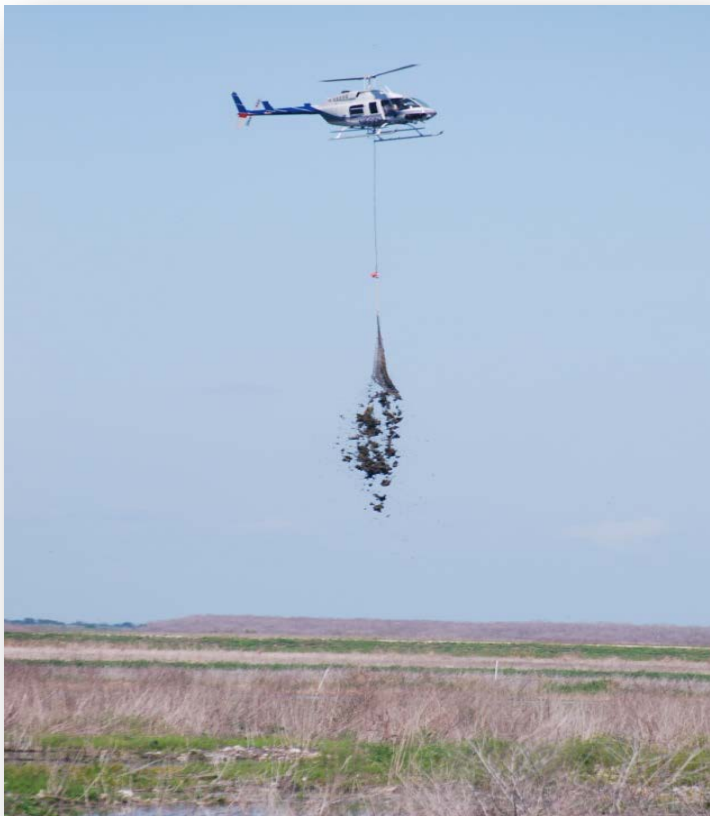
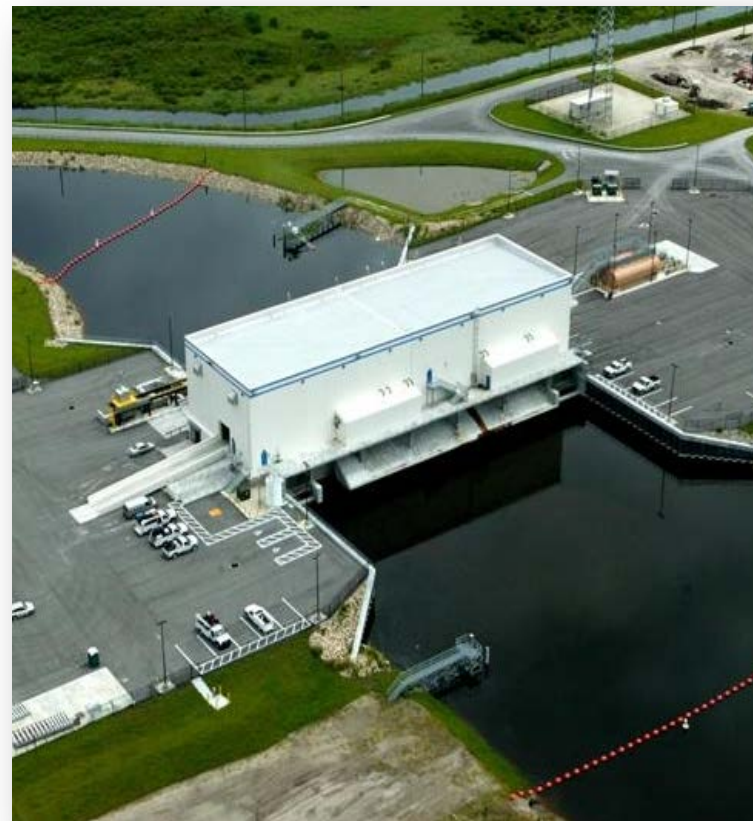
# STA-5/6 Compartment C

*Aerial inoculation of submerged aquatic vegetation in Cells 5-3B and 5-4B (left); and the new Compartment C inflow pump station G-508 (right).*

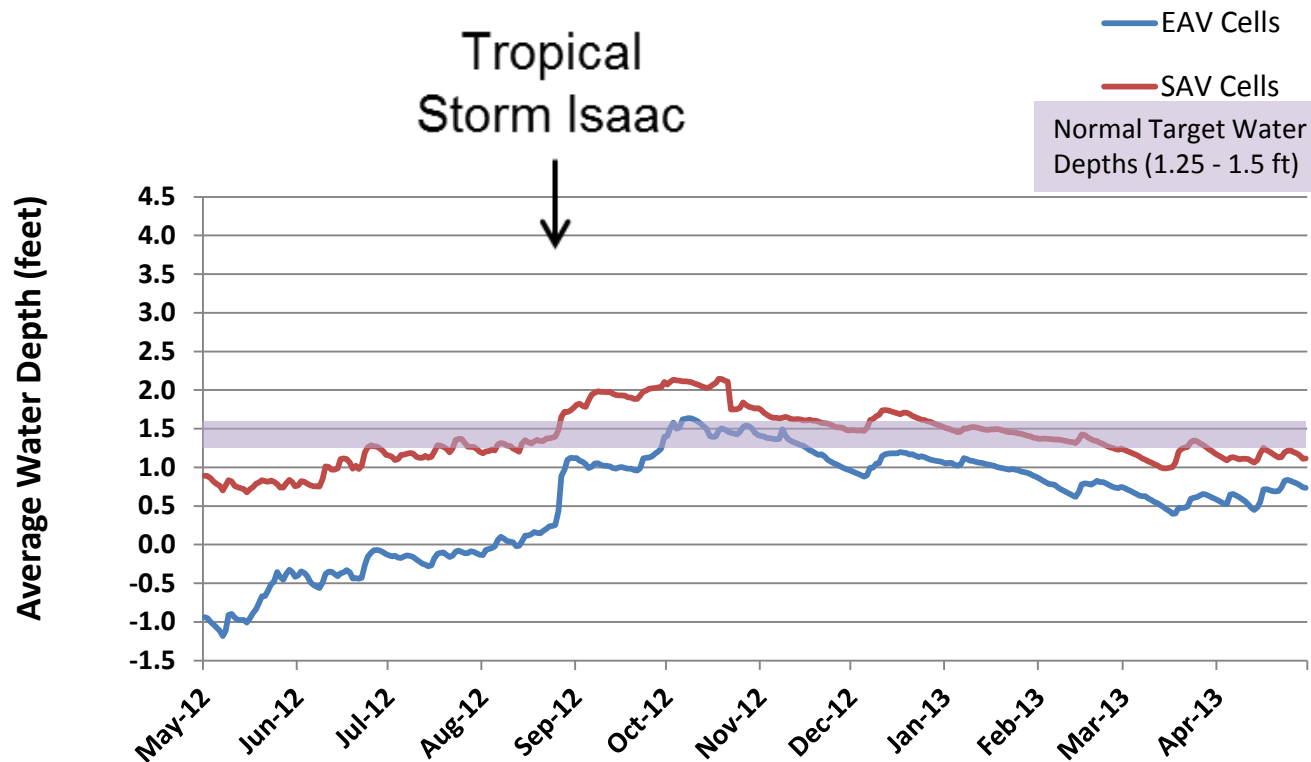
# STA-5/6 Water Depths

Graph excludes Flow-way 5 which was off-line in WY2013

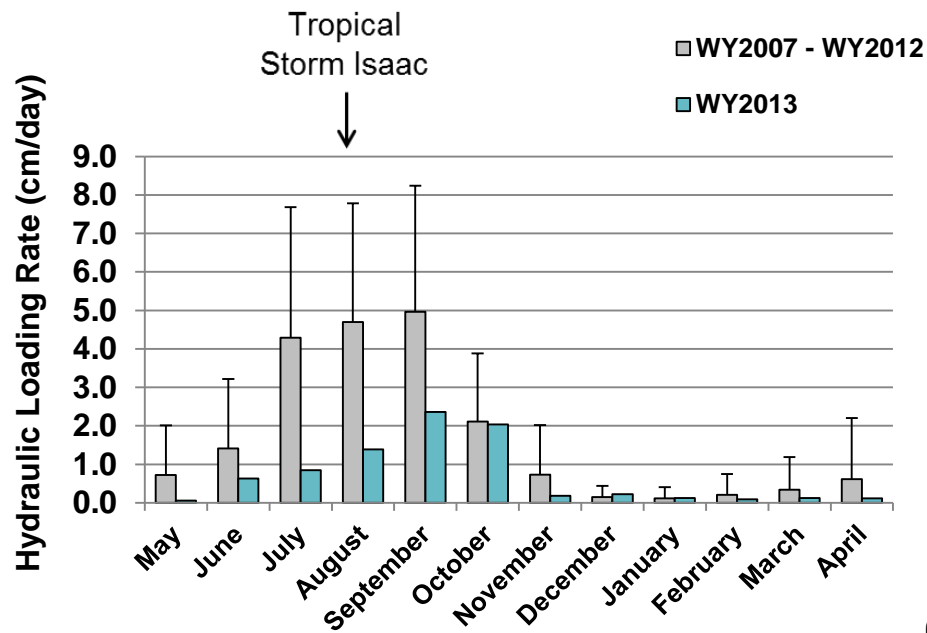
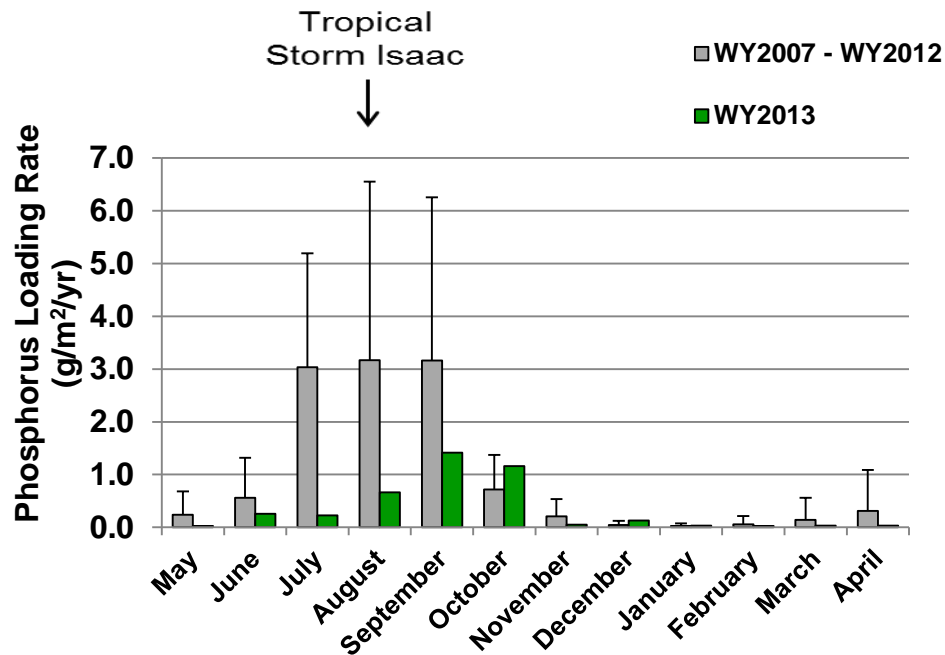
# STA-5/6 Hydraulic & Phosphorus Loadings

Standard Error bars shown.
