# STA-1E (PSTA/SAV)

Advanced Treatment Technology Implementation

January 2004

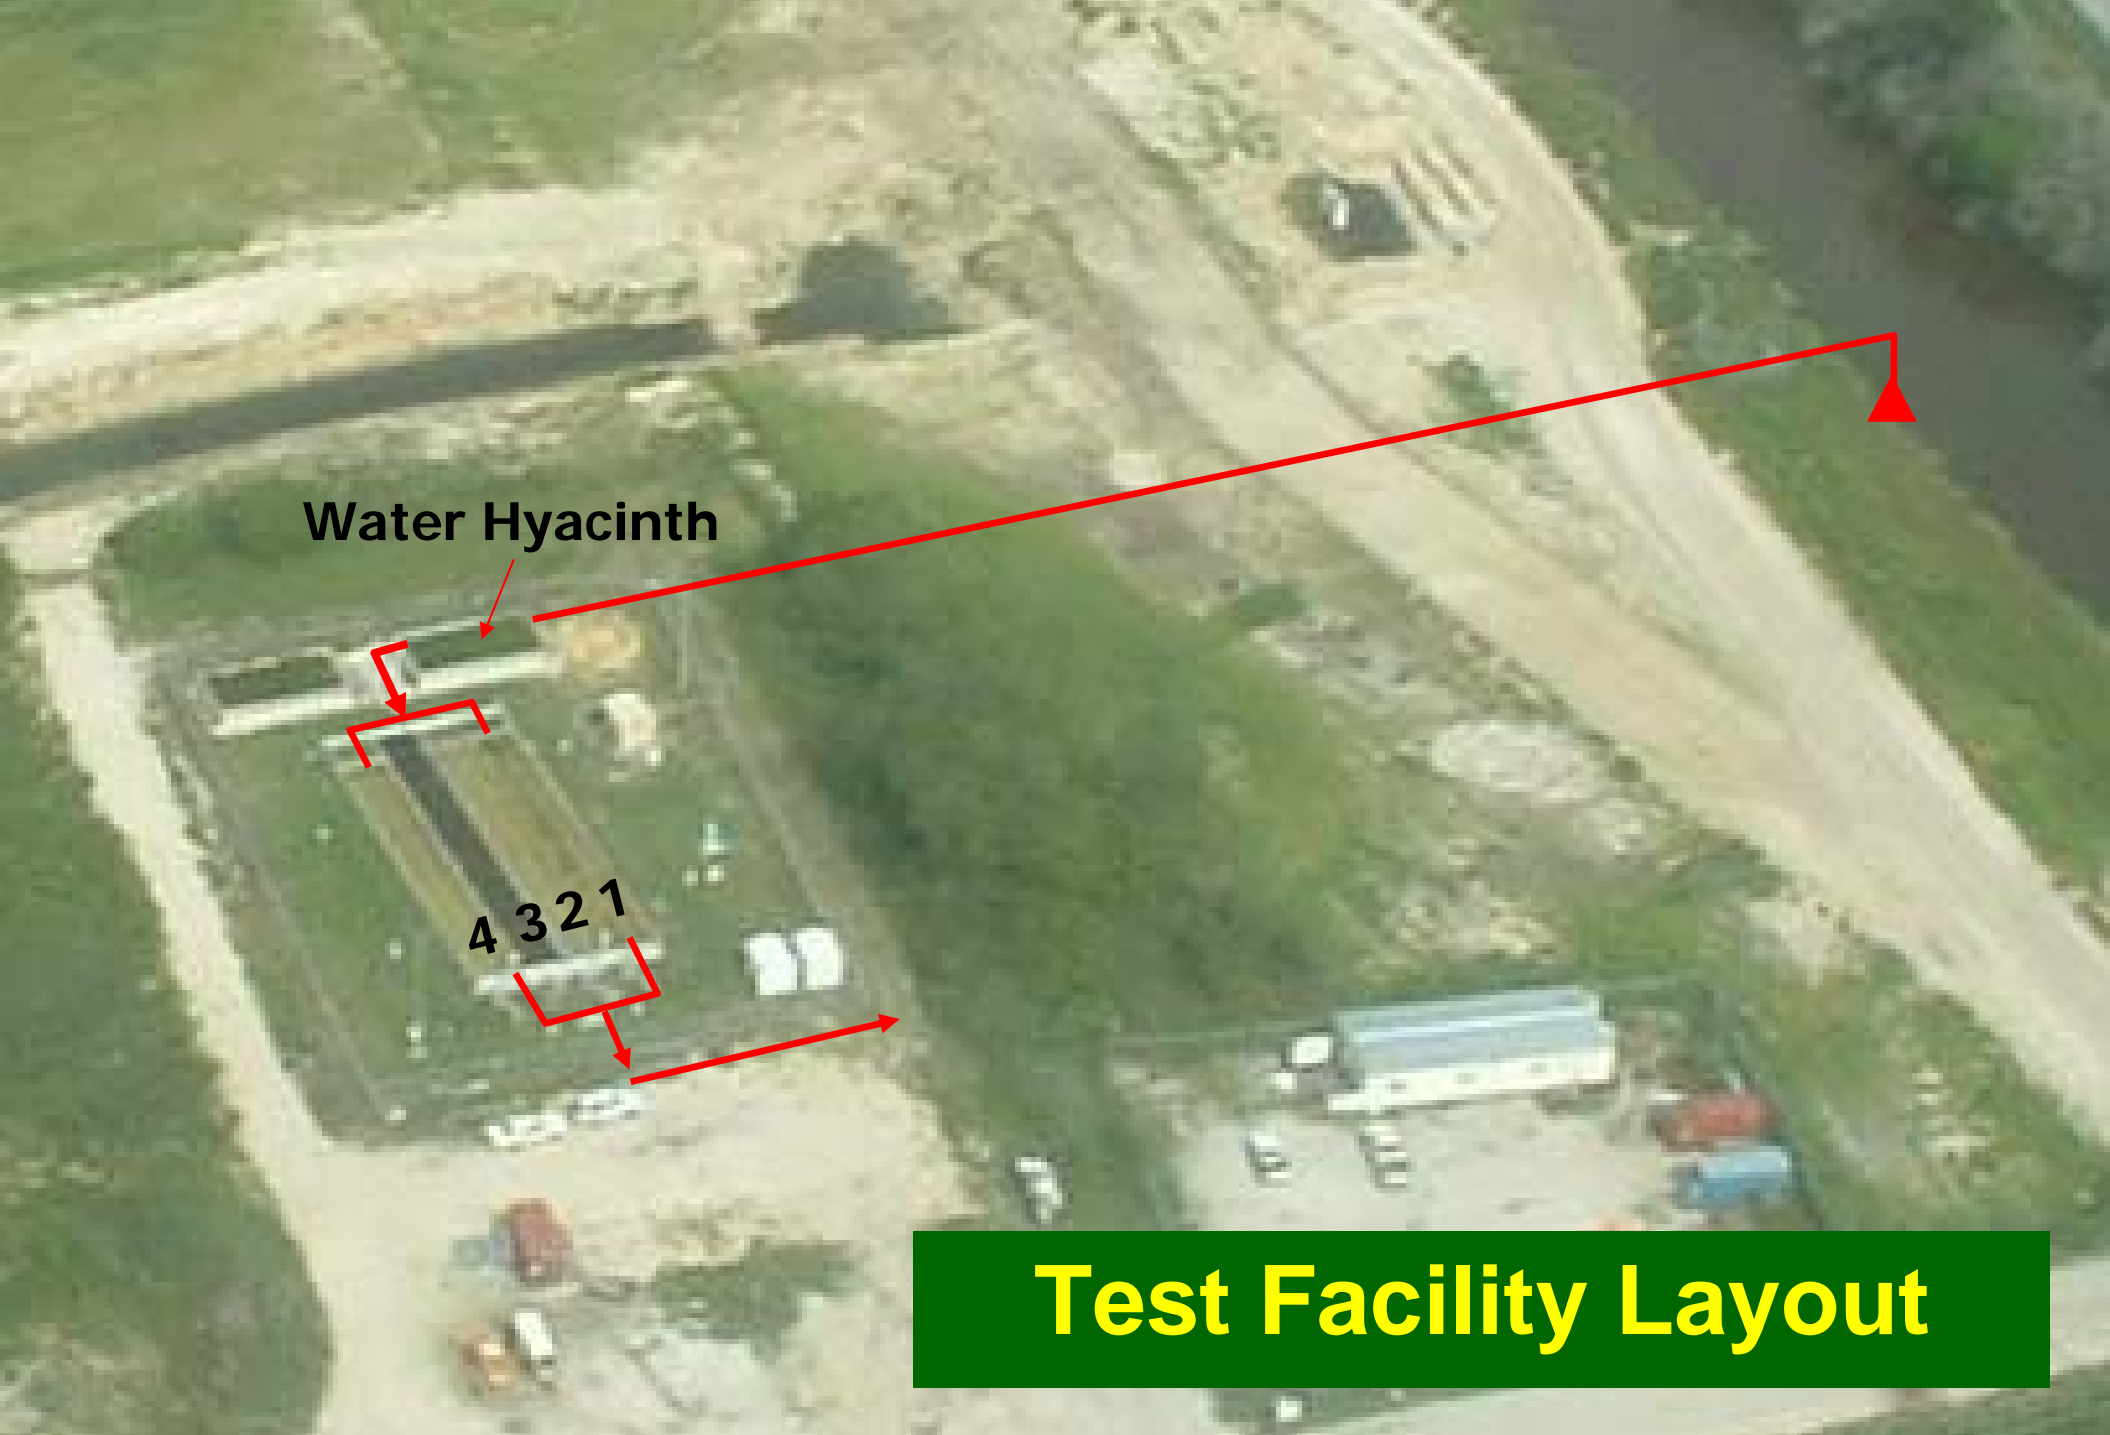
**Test Facility Layout**

- STA-1E Test Cells ~ 90 m<sup>2</sup> (Corps)
- C-111 Frog Pond & Spoil Mounds Removal Area (Corps)  
- > 50 acre naturally established calcareous periphyton –  
seasonal dry-outs
- 1' x 145' shallow raceways SFWMD (DB Environmental)
- ~ 500 m<sup>2</sup> test cells Wellington (CH2MHill)
- 6 m<sup>2</sup>, 18 m<sup>2</sup>, ½ acre, 5 acre, ~100 acre PSTA test cells  
(SFWMD – CH2MHill)

Water Hyacinth

4 3 2 1

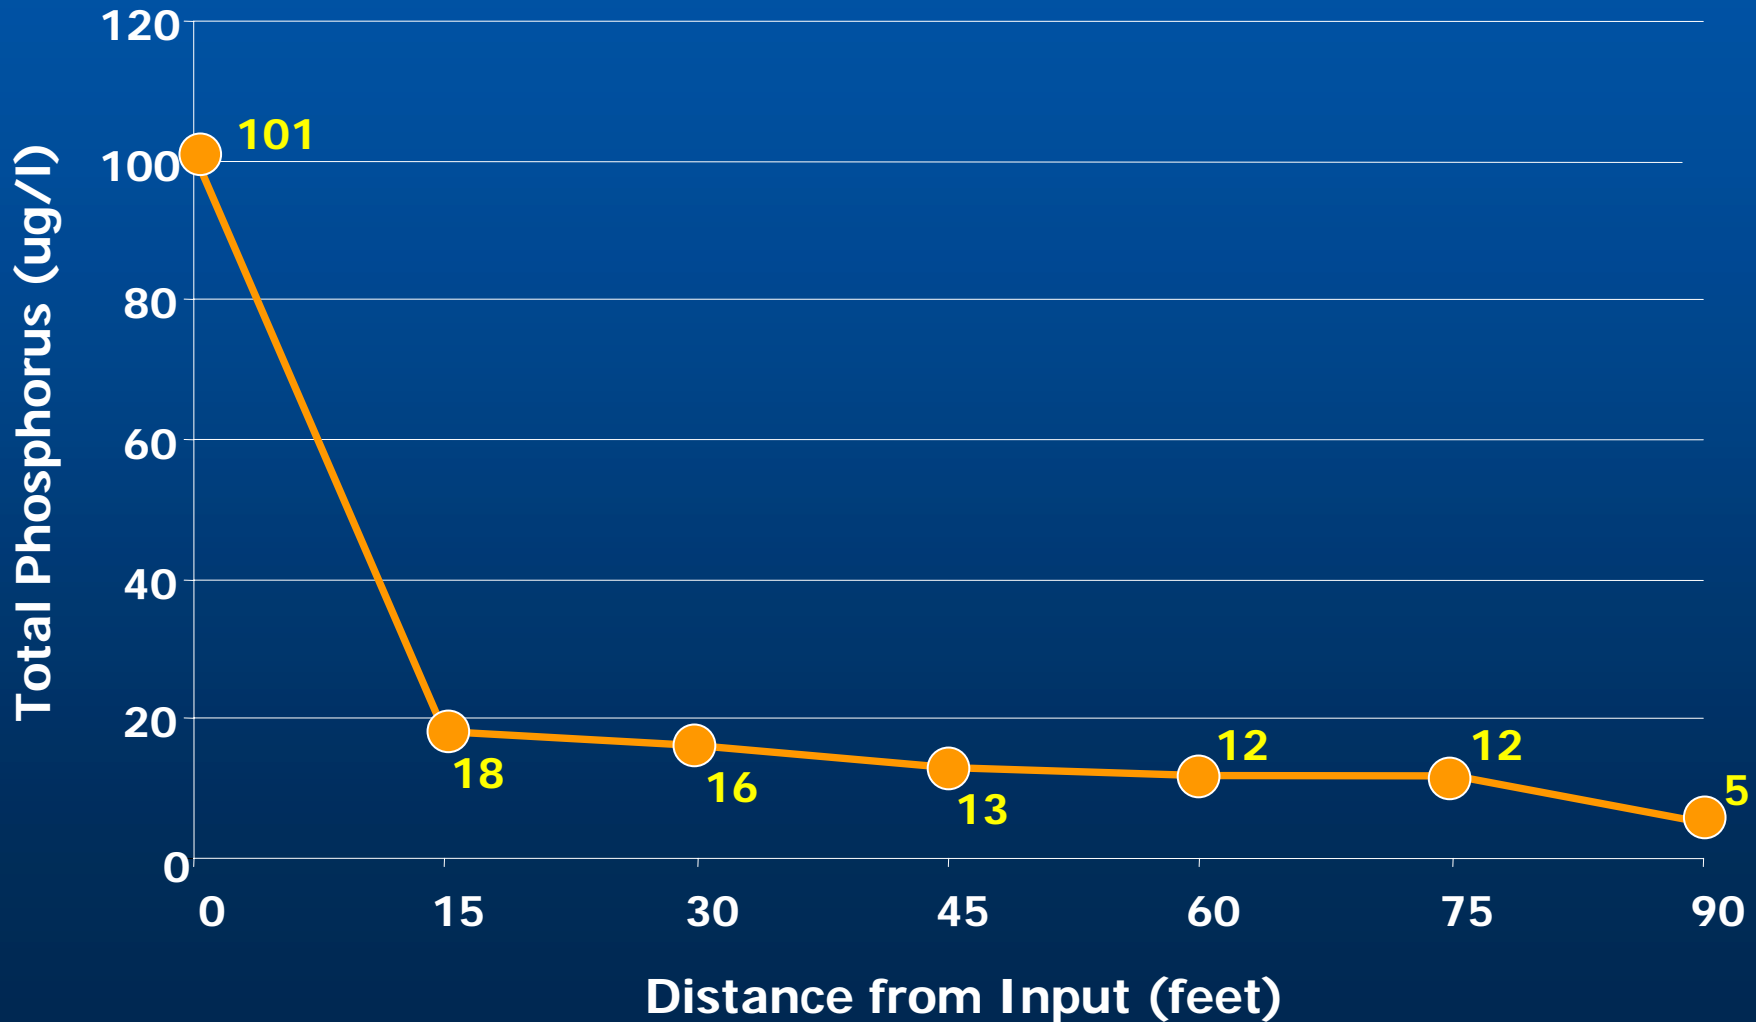
# Cell 4 Phosphorus Transect

1' depth, 7 day HRT – 6/06/03

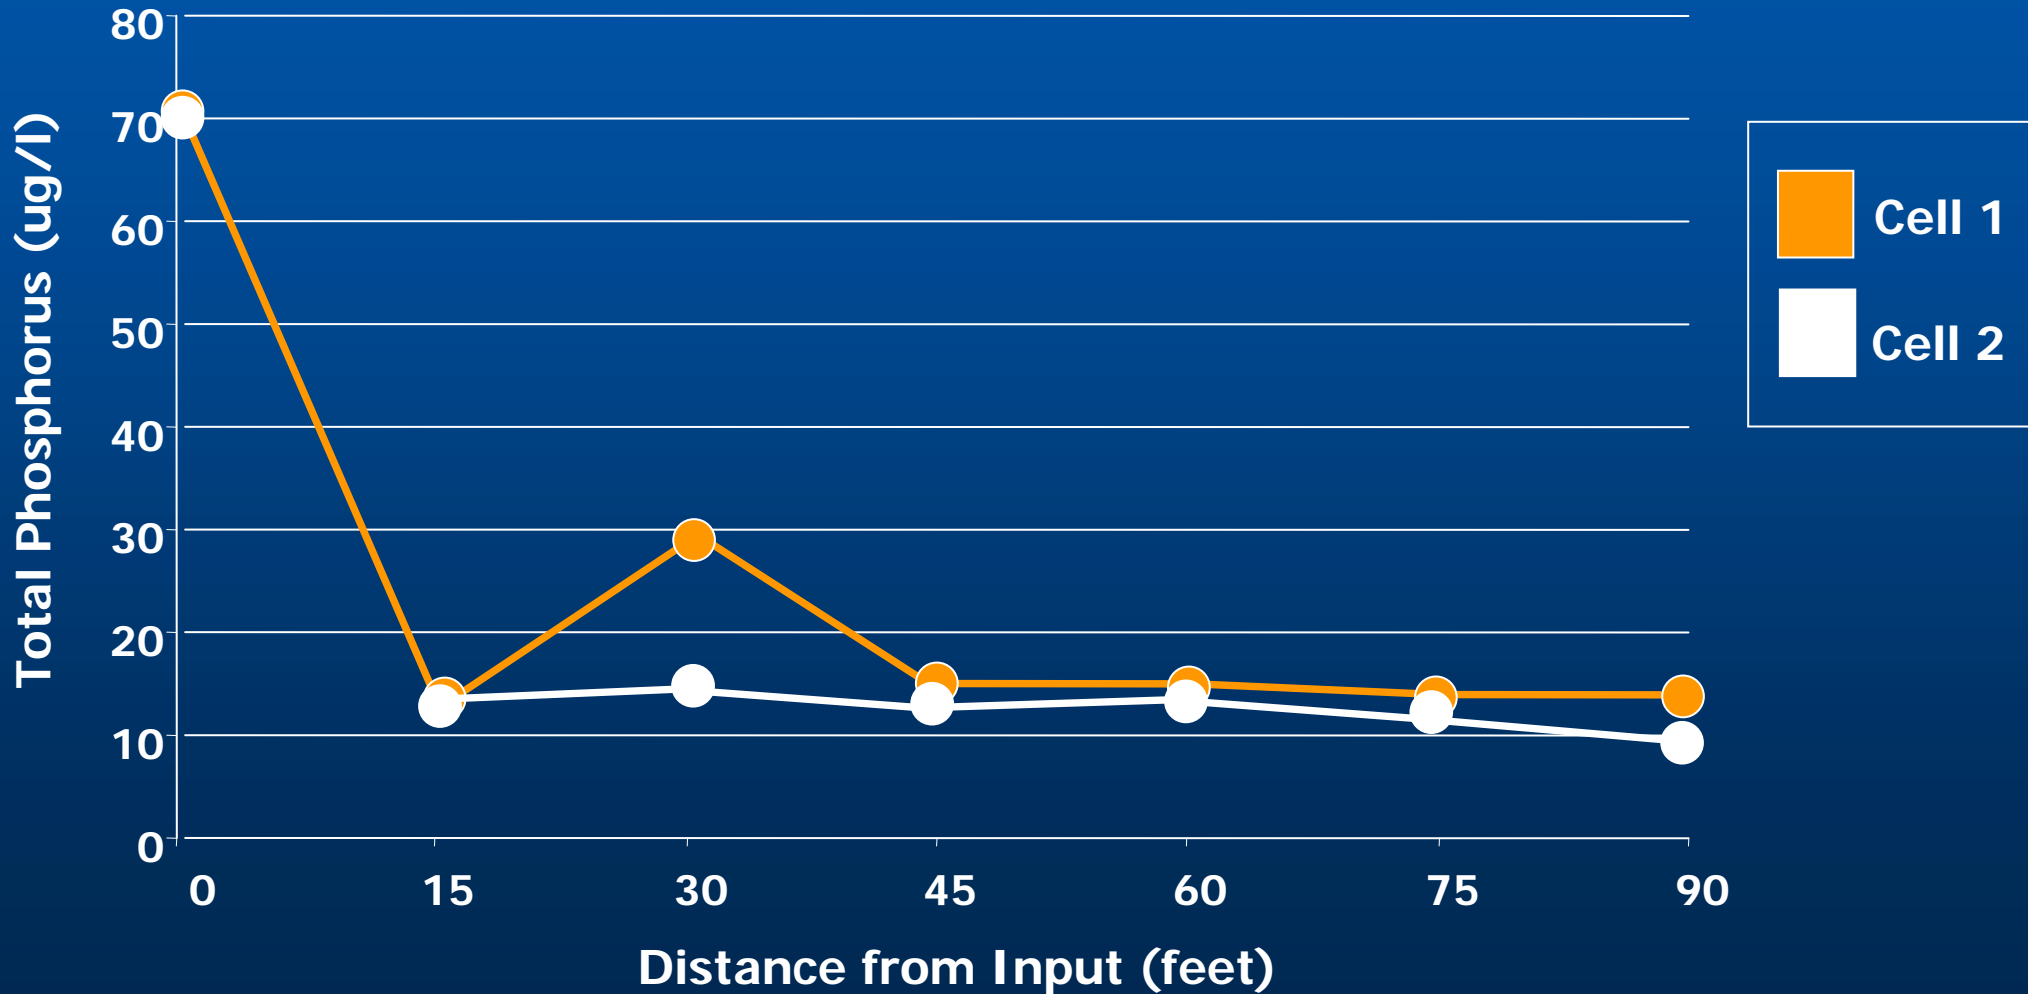
# Cells 1 & 2 - Phosphorus Transect

1' depth, 14 day HRT – 6/06/03

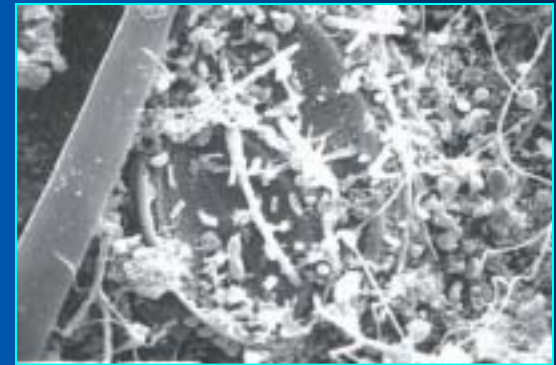
## Periphyton covered SAV

SAV provides a platform for periphyton mat formation in deeper water

Typical calcium carbonate precipitate within periphyton mat

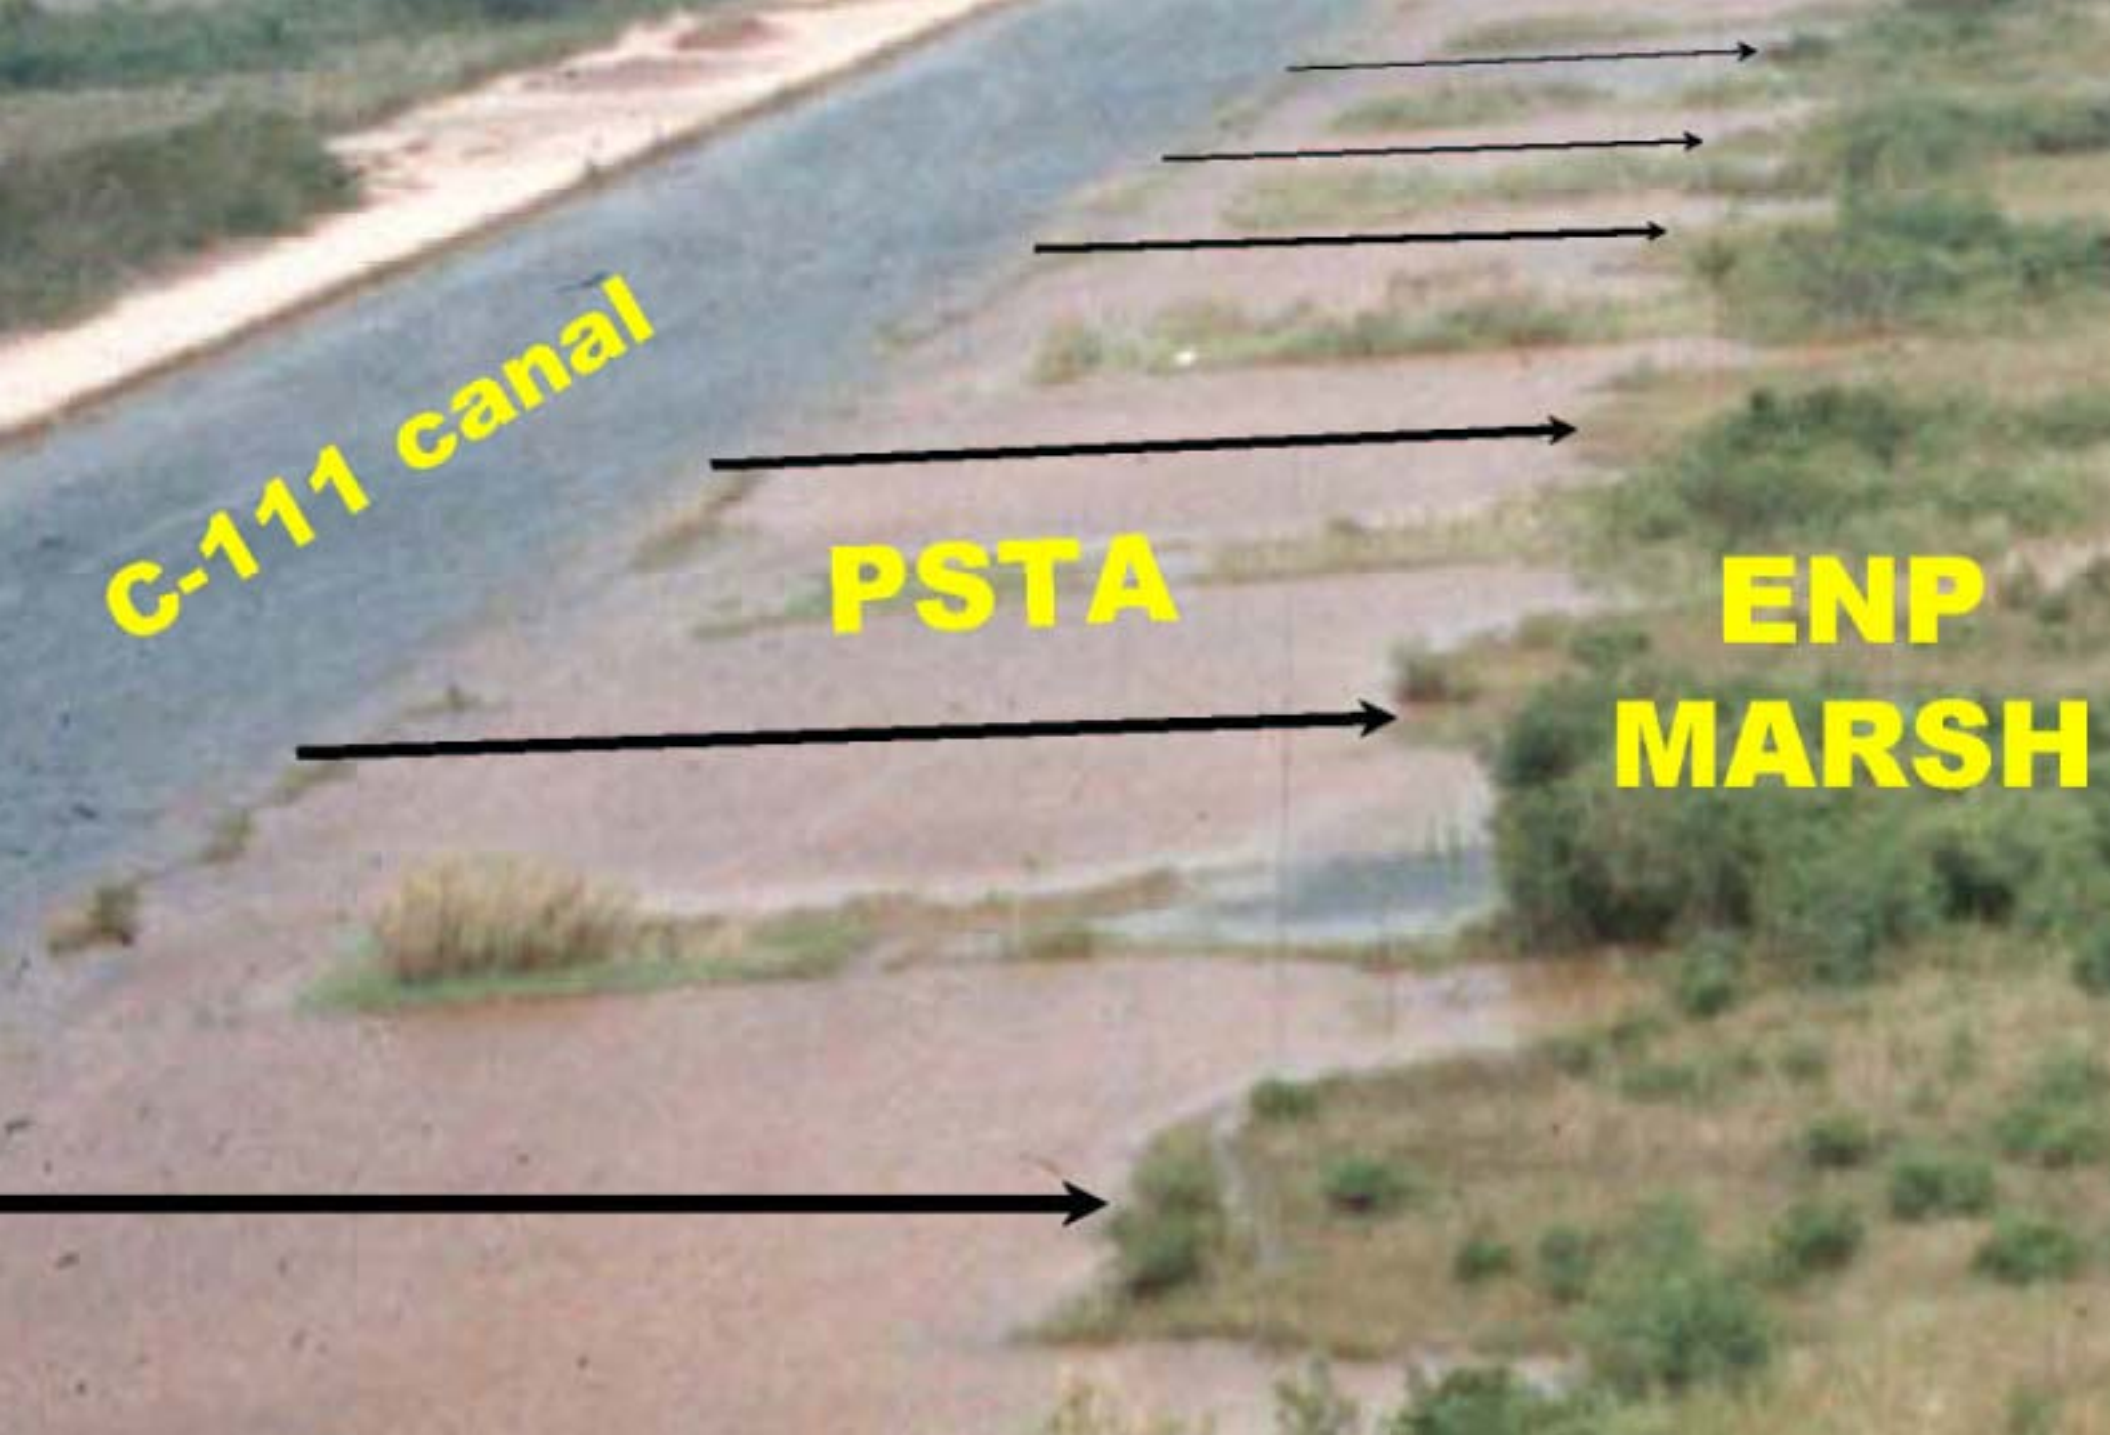
**C-111 canal**

**PSTA**

**ENP  
MARSH**
