Historical Overview of Current Kissimmee Basin Projects: How the Pieces Fit and Overlap

Lawrence Glenn
Kissimmee Division - SFWMD

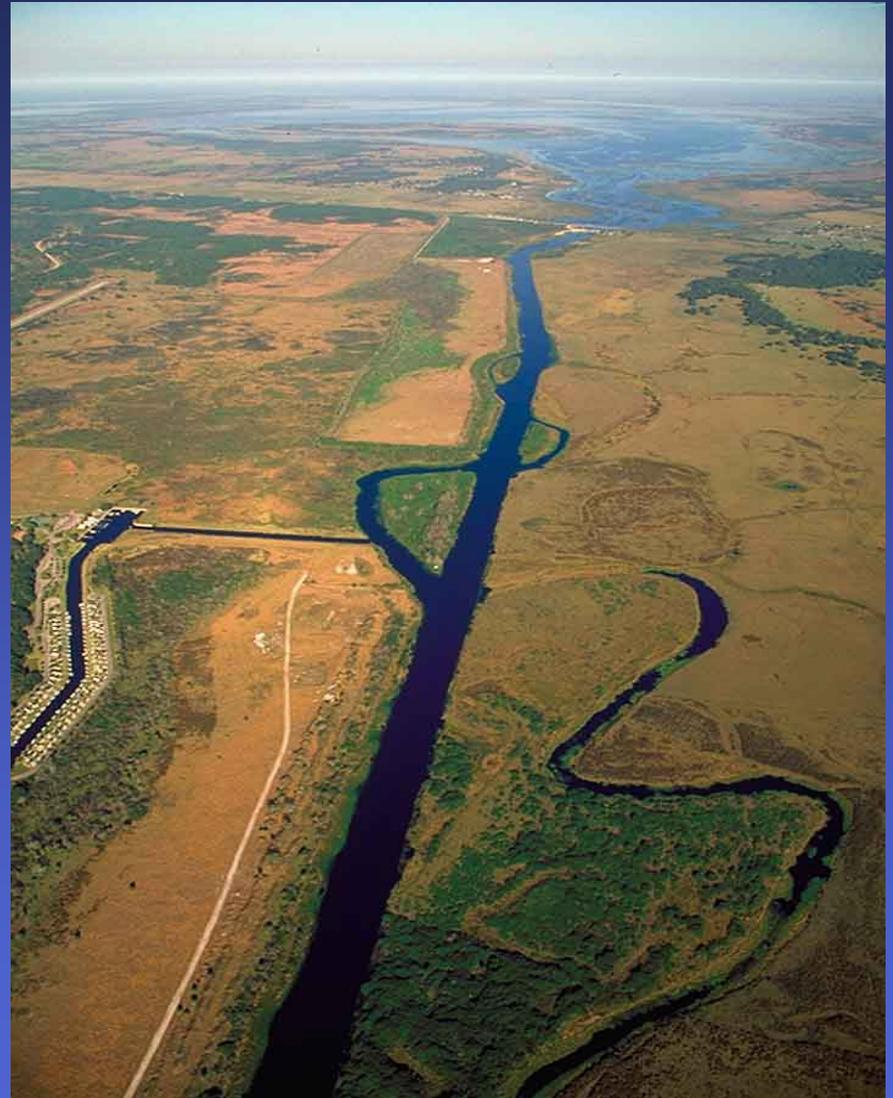
Pre-channelization

Post-channelization

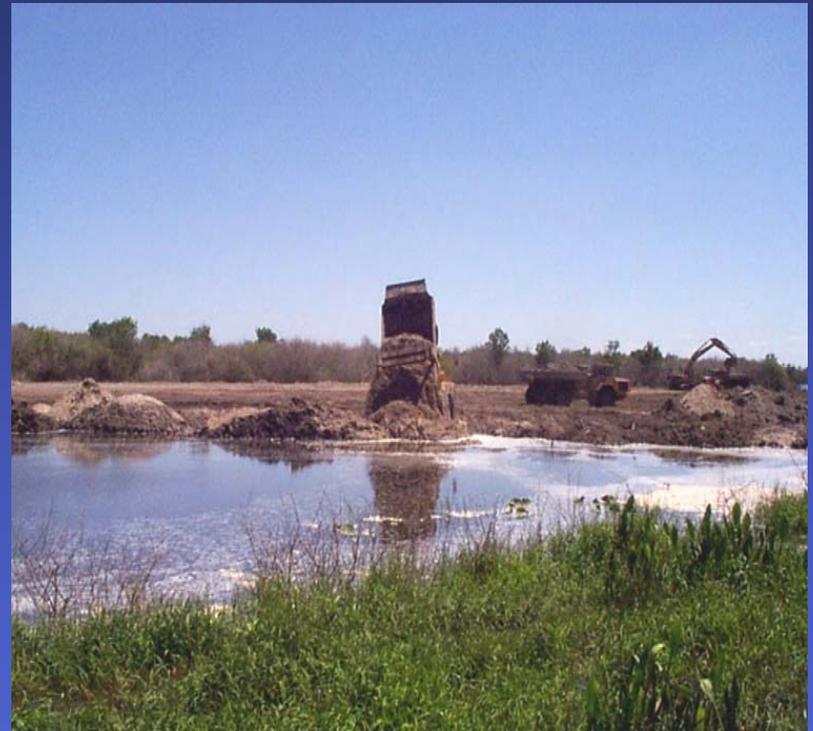
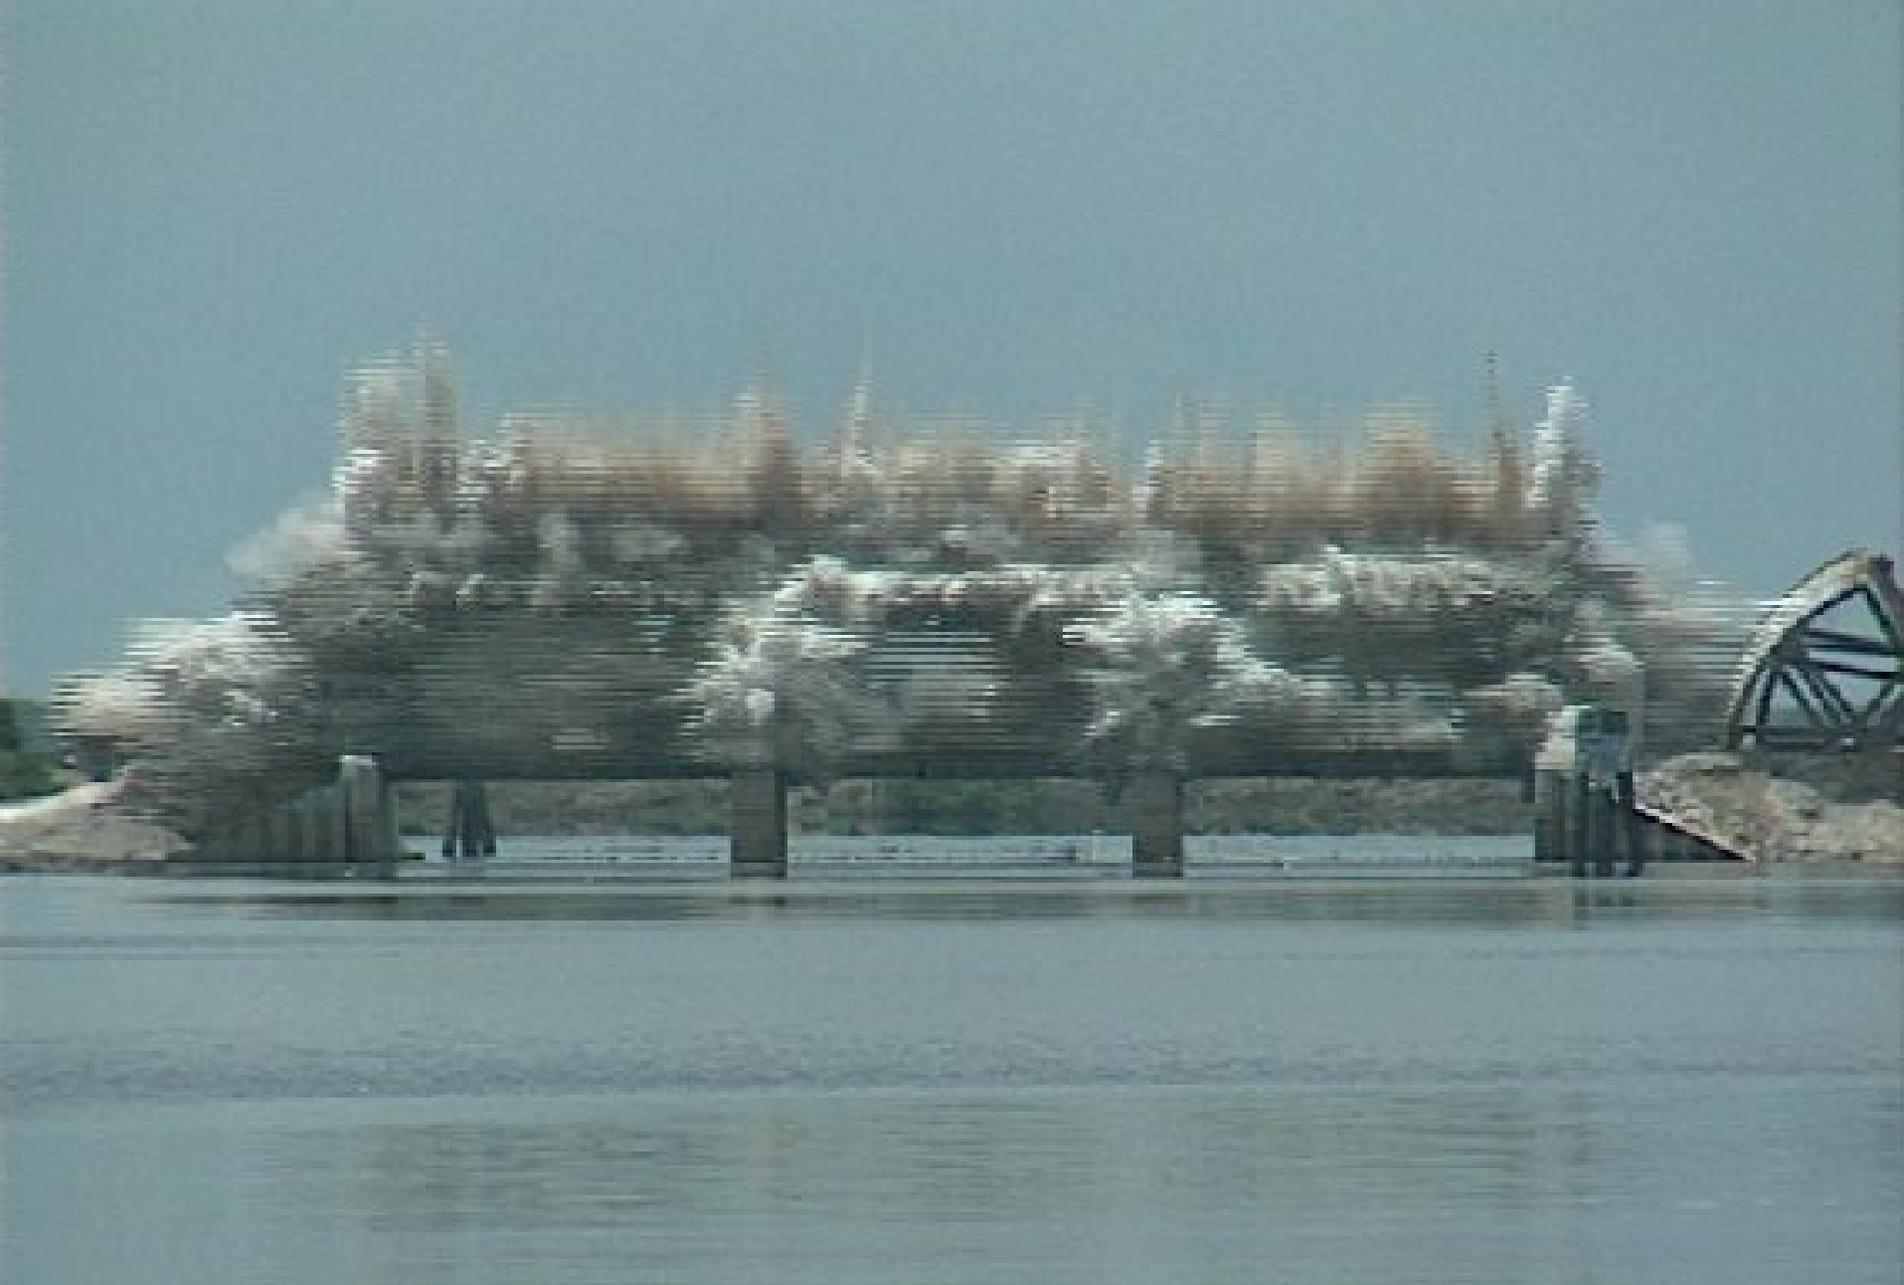
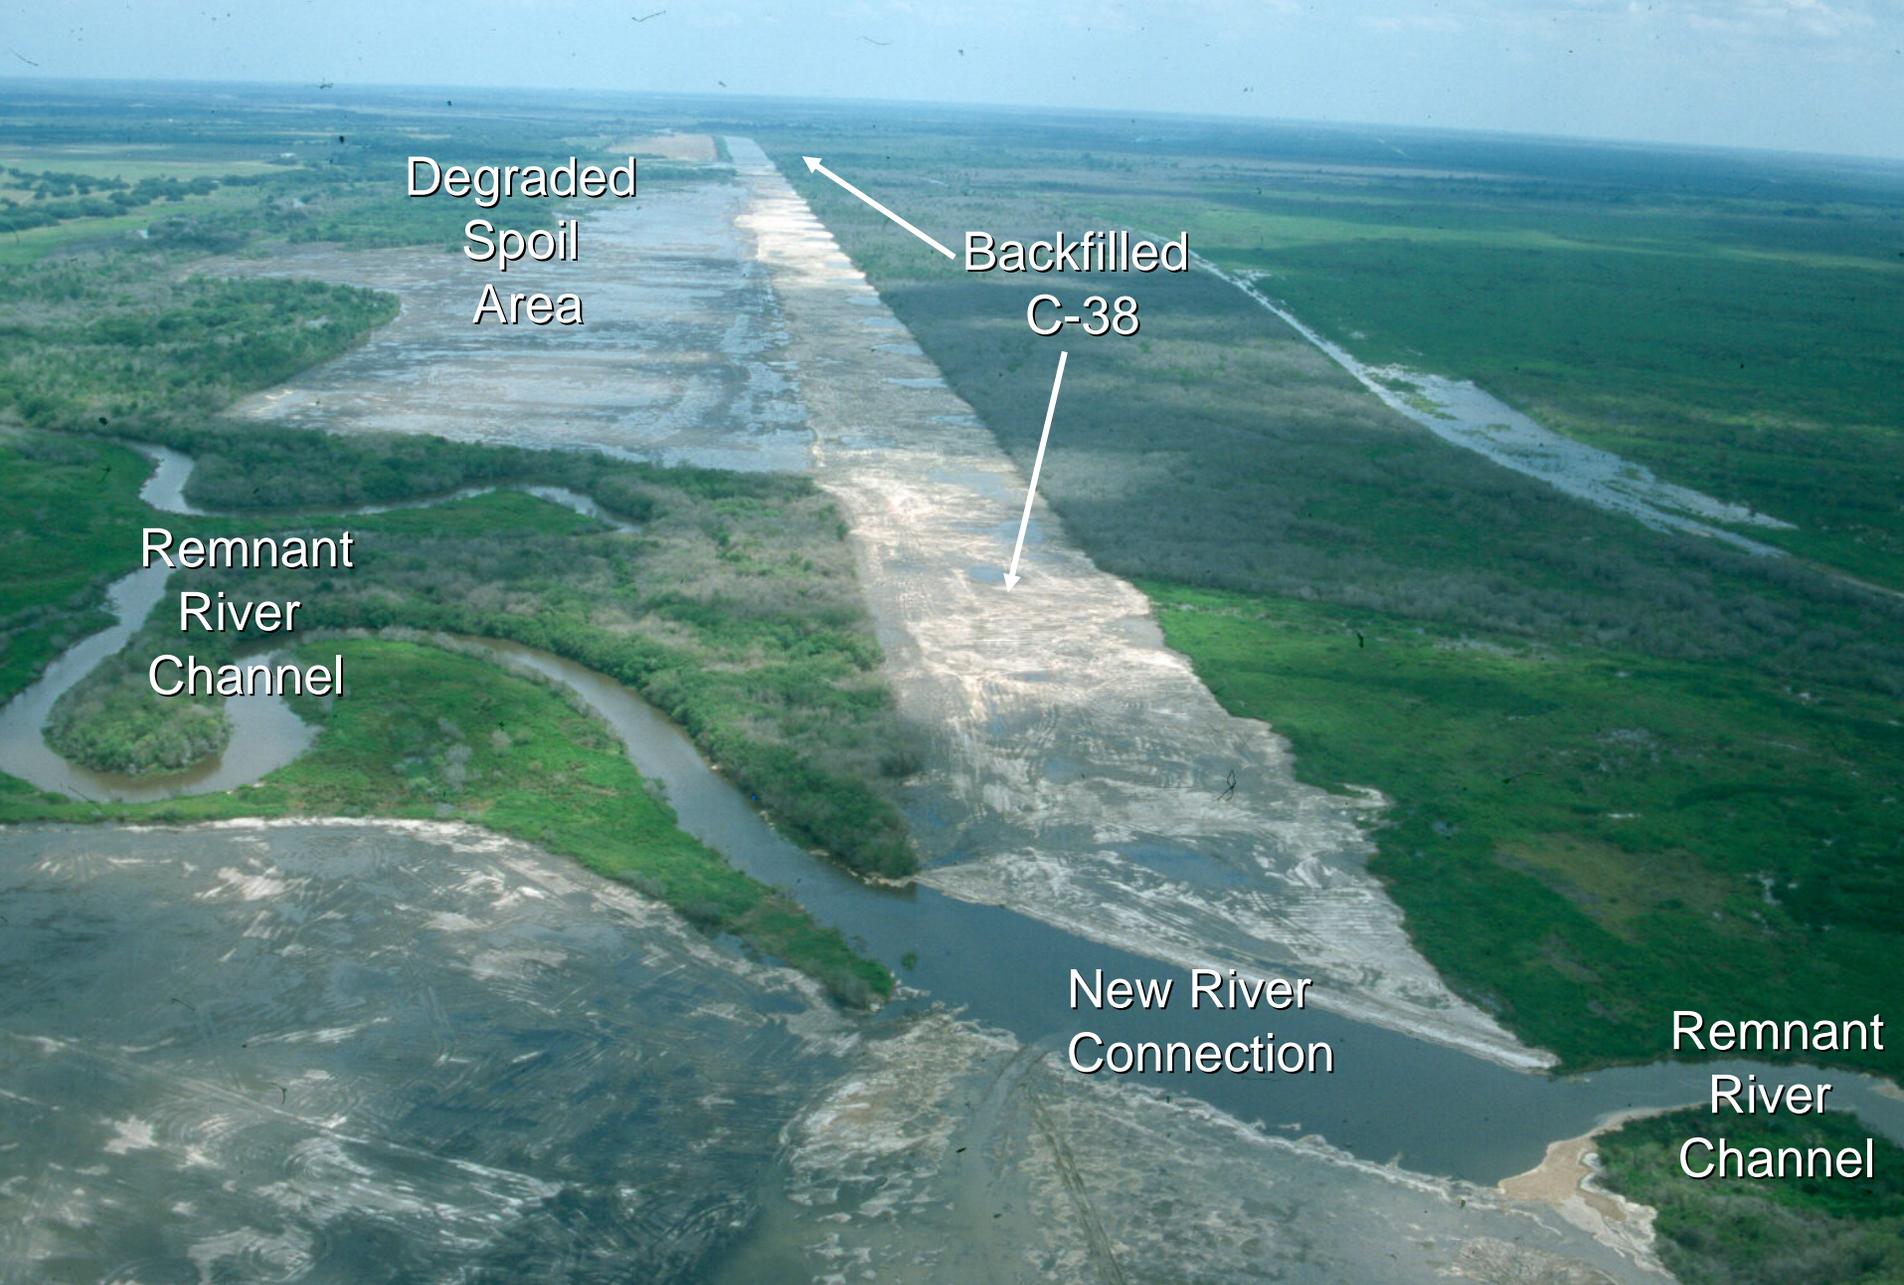
Phase 1 Construction

Degraded
Spoil
Area

Backfilled
C-38

Remnant
River
Channel

New River
Connection

Phase I Backfilling

- Fill 7 miles C-38 canal
- Re-carve 1.2 miles river channel
- Remove S-65B
- Restore 15 miles contiguous river channel
- Completed in Feb 2001

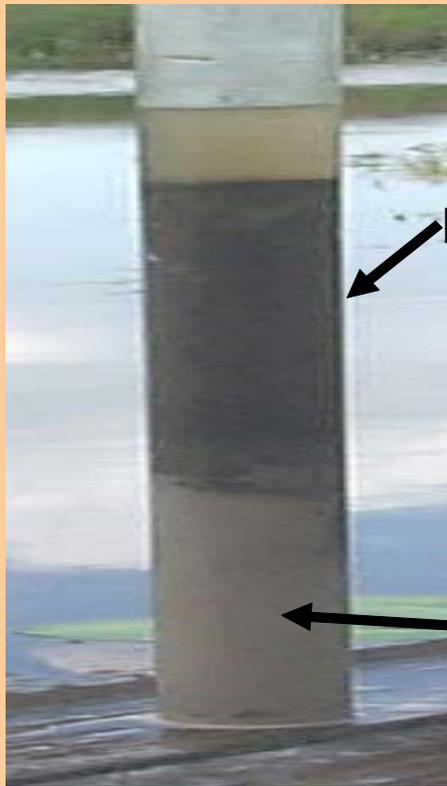
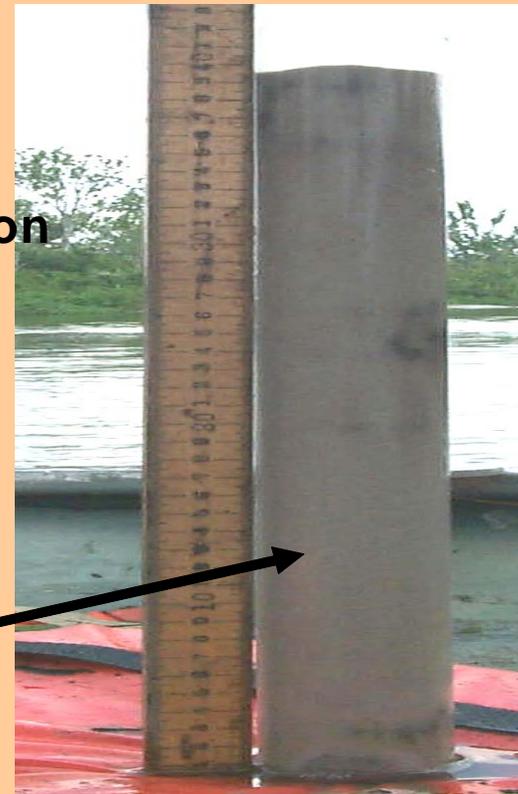
Remnant Channel

Restored Channel

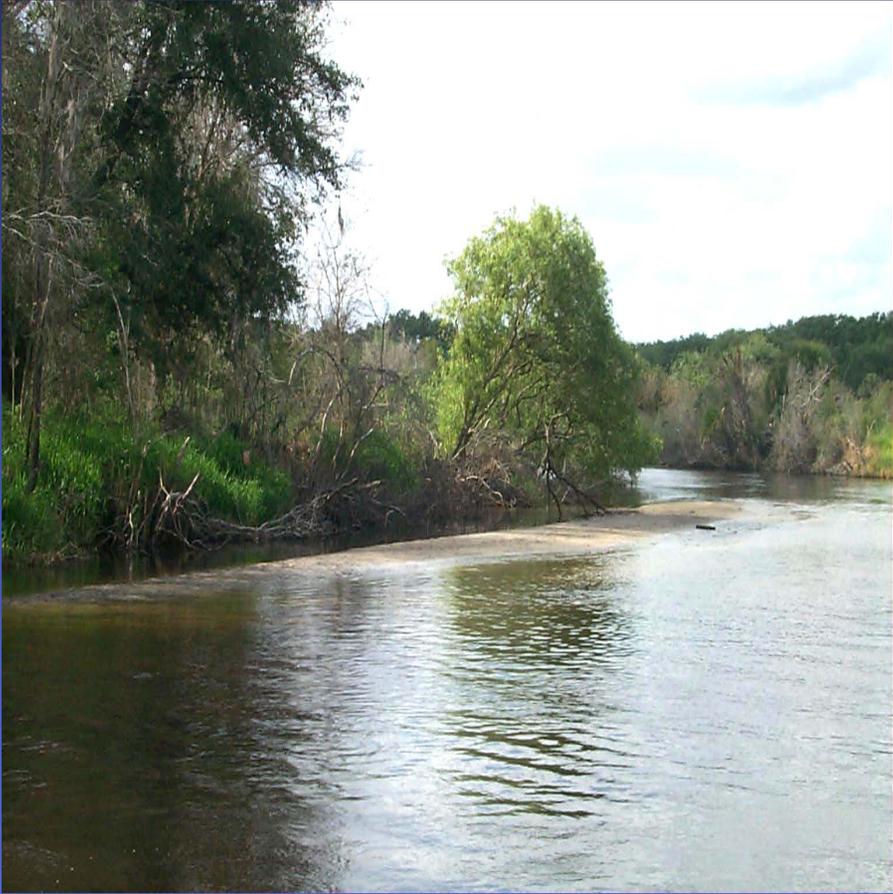
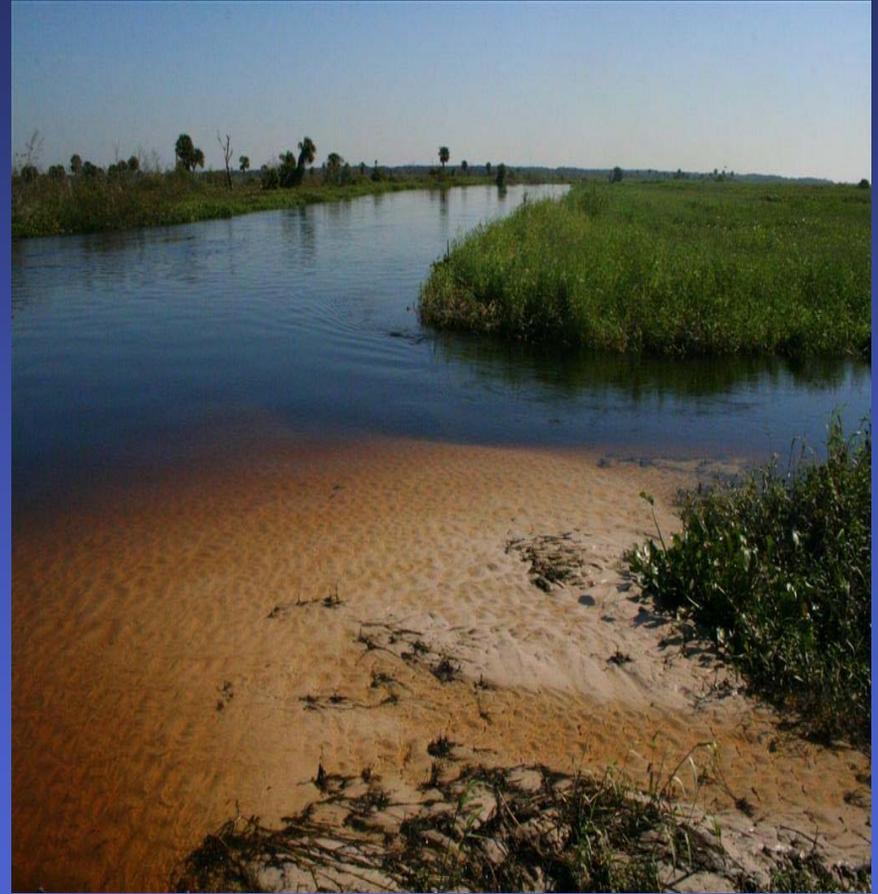
Deposition

Sand

Sandbar Formation

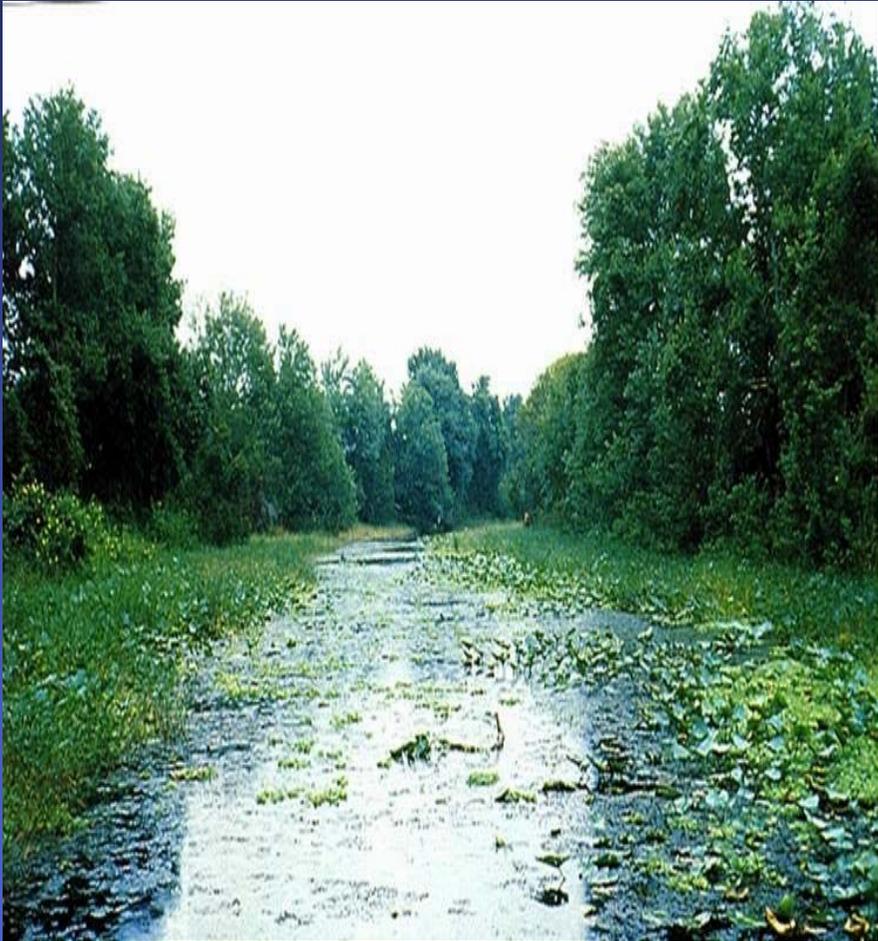
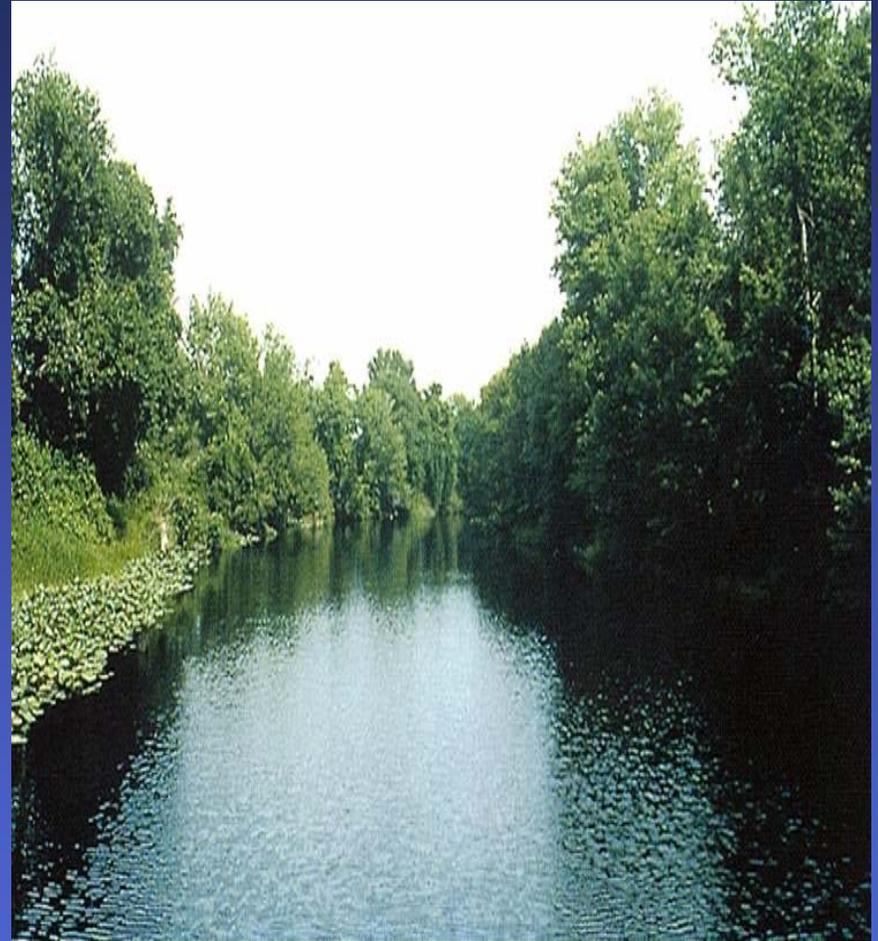
Phase I Response – River channel vegetation

Pre-restoration

Post-restoration

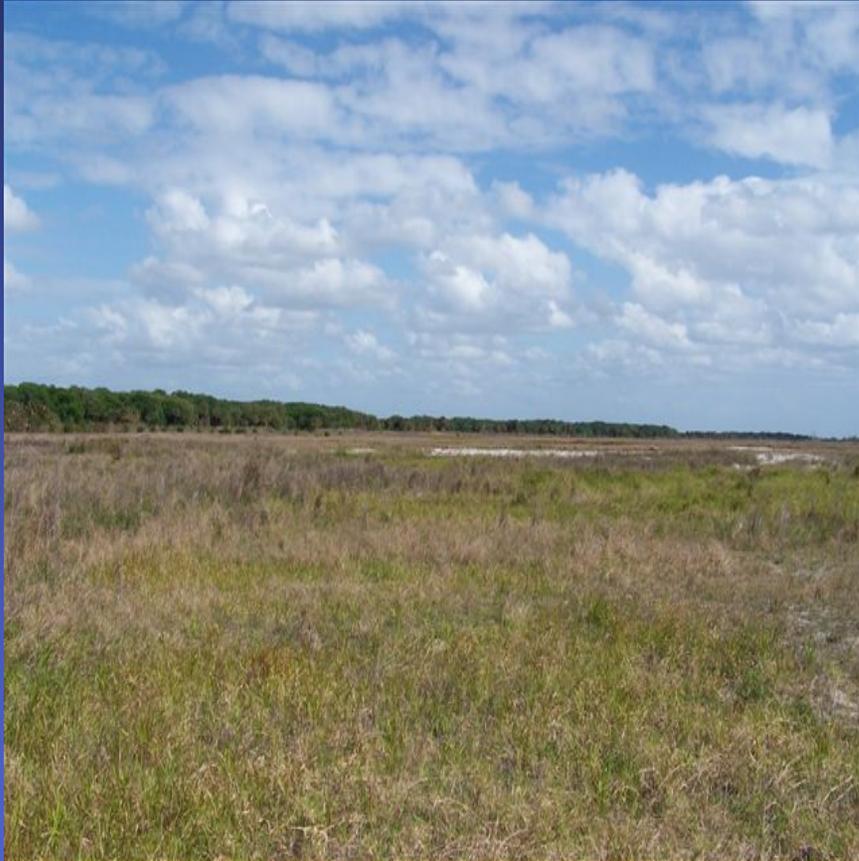
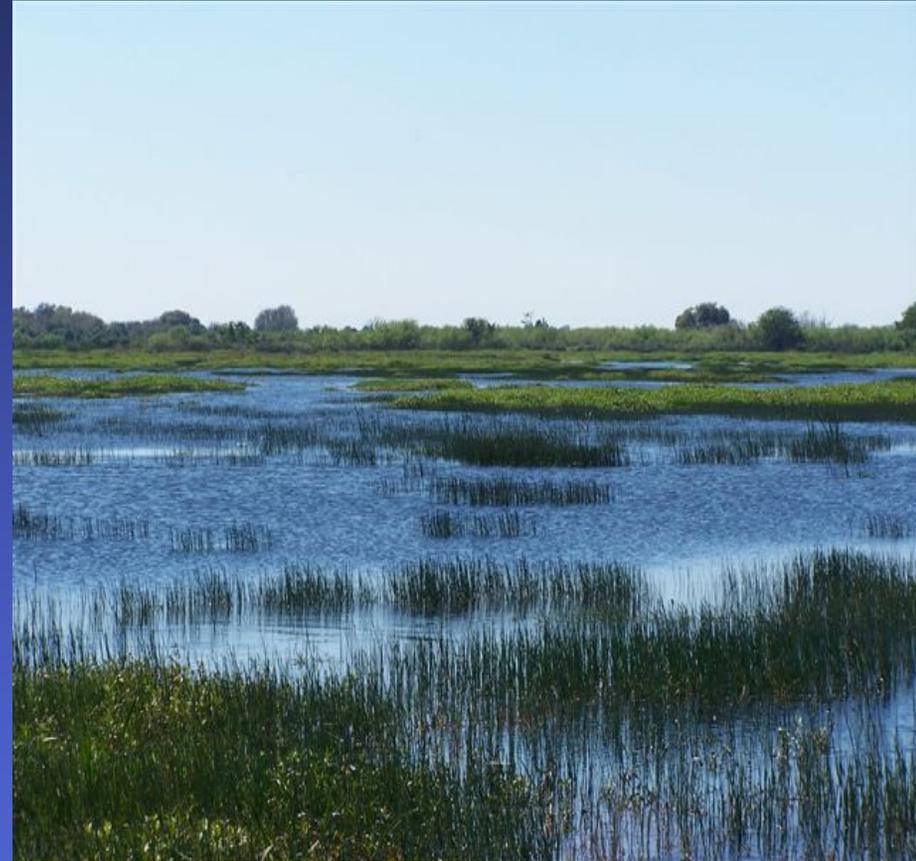
Phase I Response –Floodplain vegetation

Pre-restoration

Post-restoration

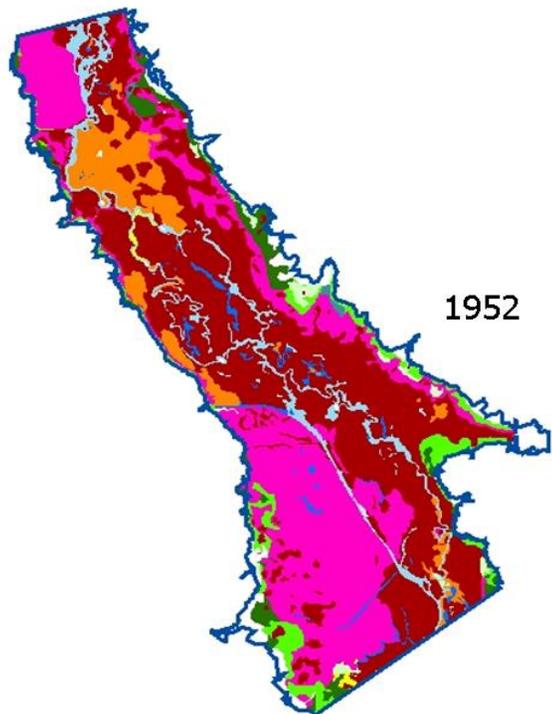
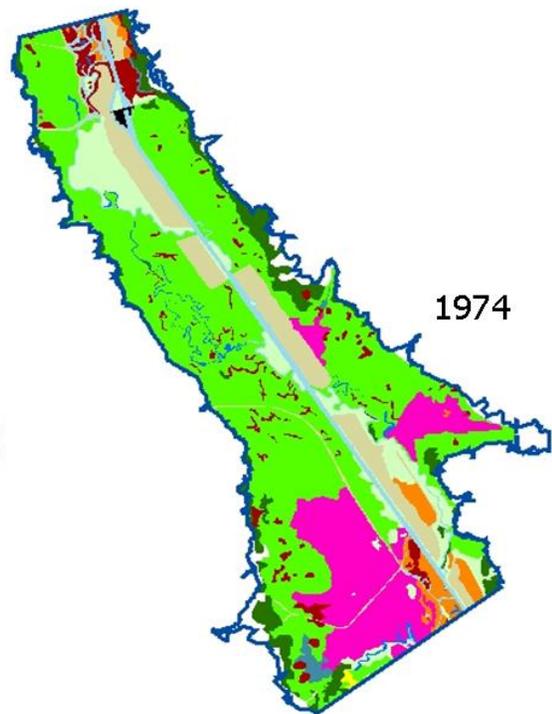
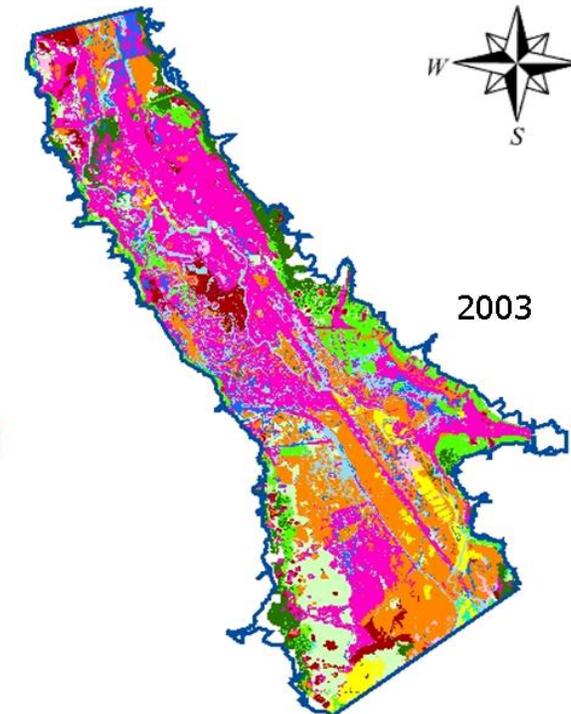
Vegetation Types	
Aquatic Vegetation	Upland Forest
Broadleaf Marsh	Upland Herbaceous
Human-made Structures	Upland Shrub
Miscellaneous Wetlands	Vines
Non-vegetated Bare Ground	Wet Prairie
Open Water	Wetland Forest
Unclassified and Unknown	Wetland Shrub
