**FISHEATING CREEK SUB-WATERSHED
FEASIBILITY STUDY
PHASE 1**

(Contract No. 4600000912-WO01)

**DOCUMENT/DATA SUMMARY REPORT
(draft Final)**

JANUARY 2009

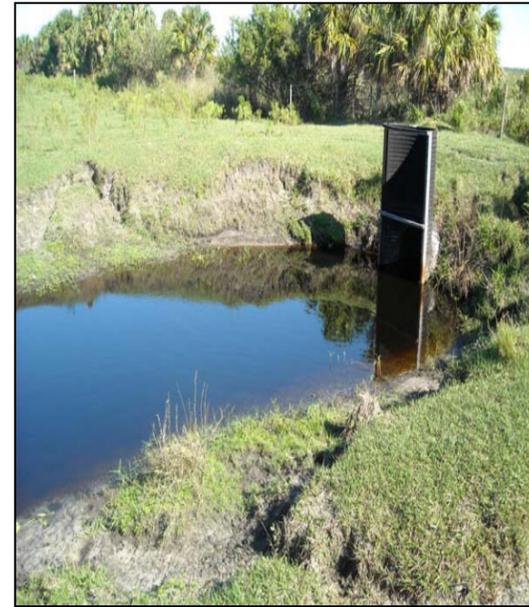
Figure 8. Culvert Located at the Downstream of Check Dam No1 (27.27513 N, 81.47126 W)

Therefore, site visits were mostly conducted on the publicly structures (Check Dam No.1 and Drop Spillway No.1) were landowners by FDACS and SFWMD representatives. **Figure 5** the FEC. These two (2) structures located on the northern part prevention and agricultural water management purposes observed to be occupied mostly with pasture lands and cattle structures (**Figure 8** and **Figure 9**). Although pasture lands

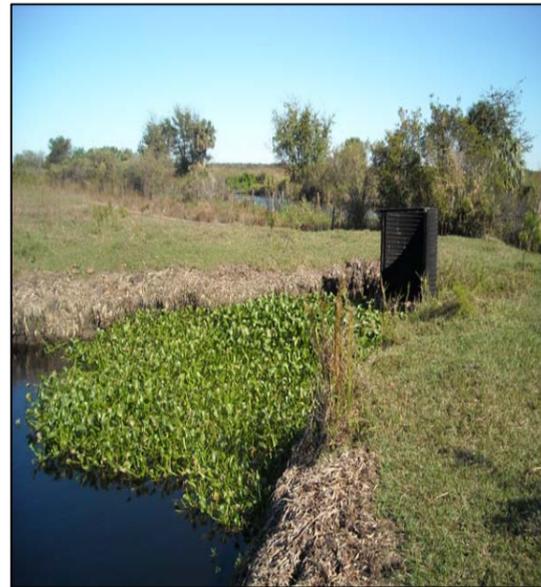
Figure 9. A Culvert Discharging to FEC at the Downstream of Drop Spillway No.1 Structure (27.27513 N, 81.47126 W)

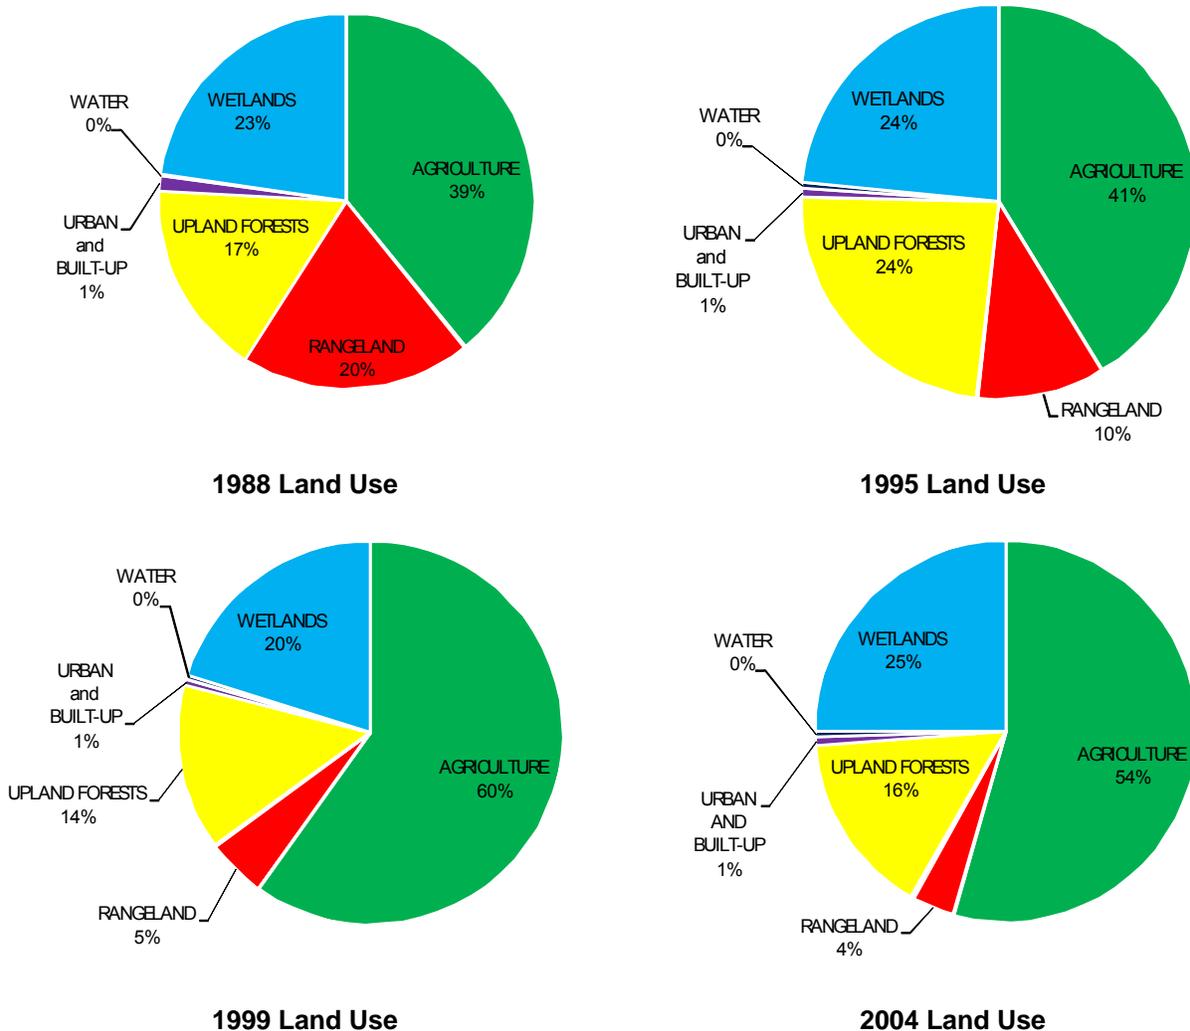
Figure 42. Land Use Categories, Distributions and Variations (1988-2004)

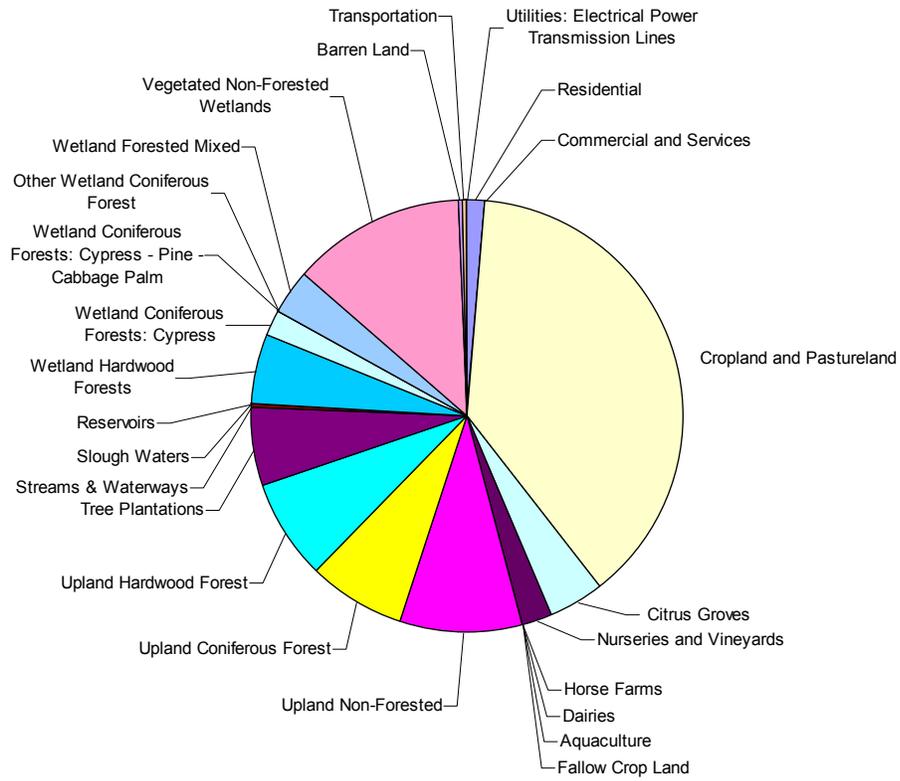
Figure 43: Land Use Categories, Distributions and Variations (2006)

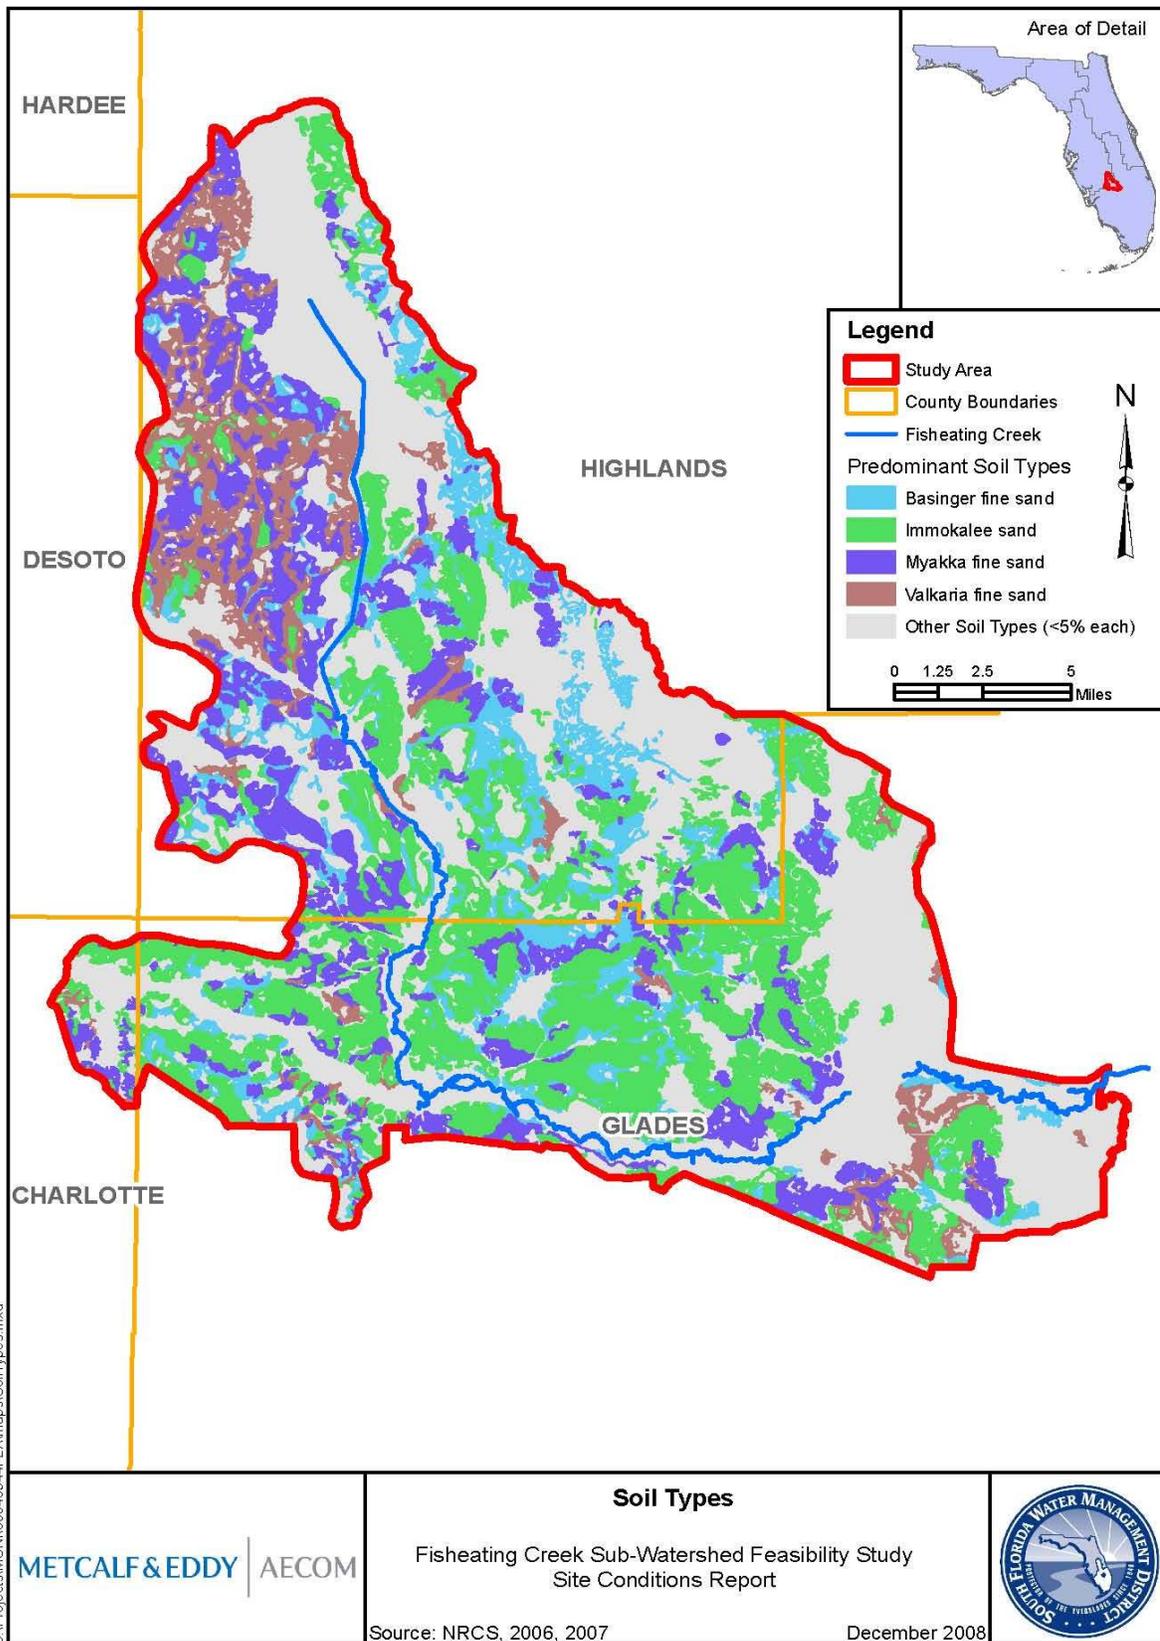
Figure 44. Soil Types in the Fisheating Creek Sub-Watershed Study Area

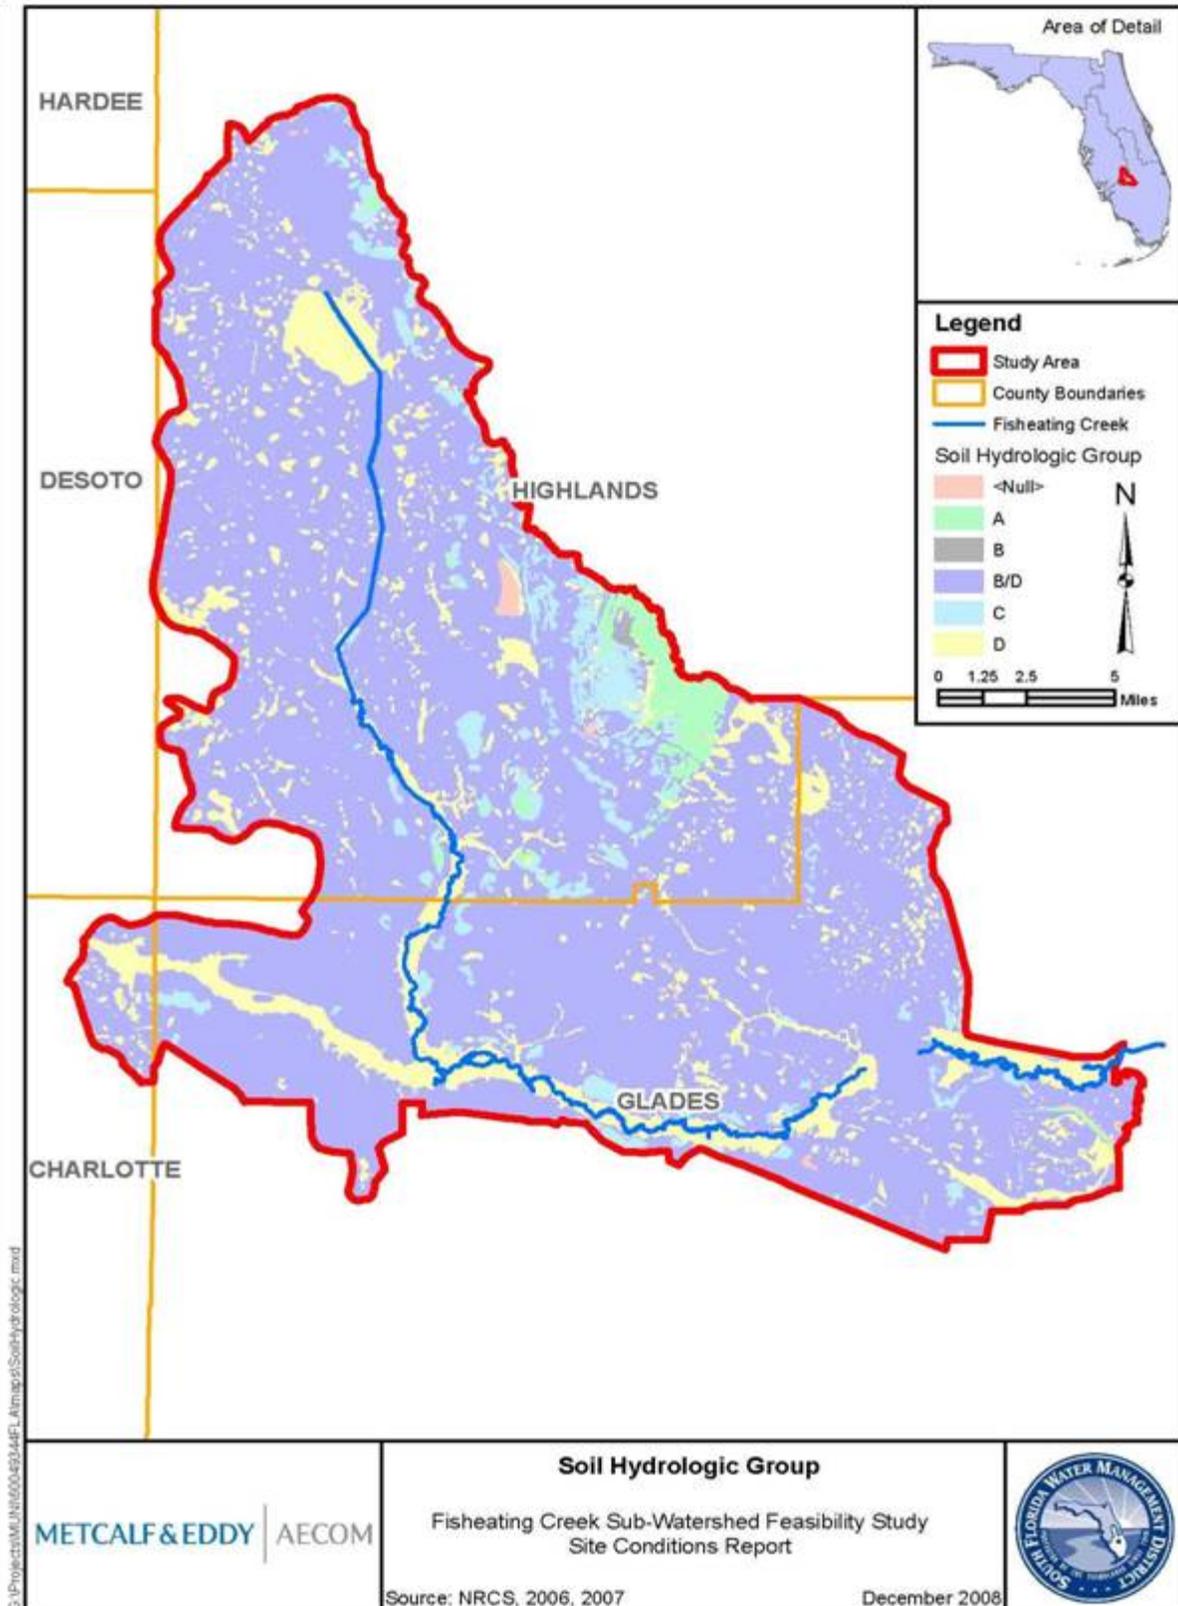
Figure 45. Hydrologic Soil Groups in the FEC Sub-Watershed Study Area

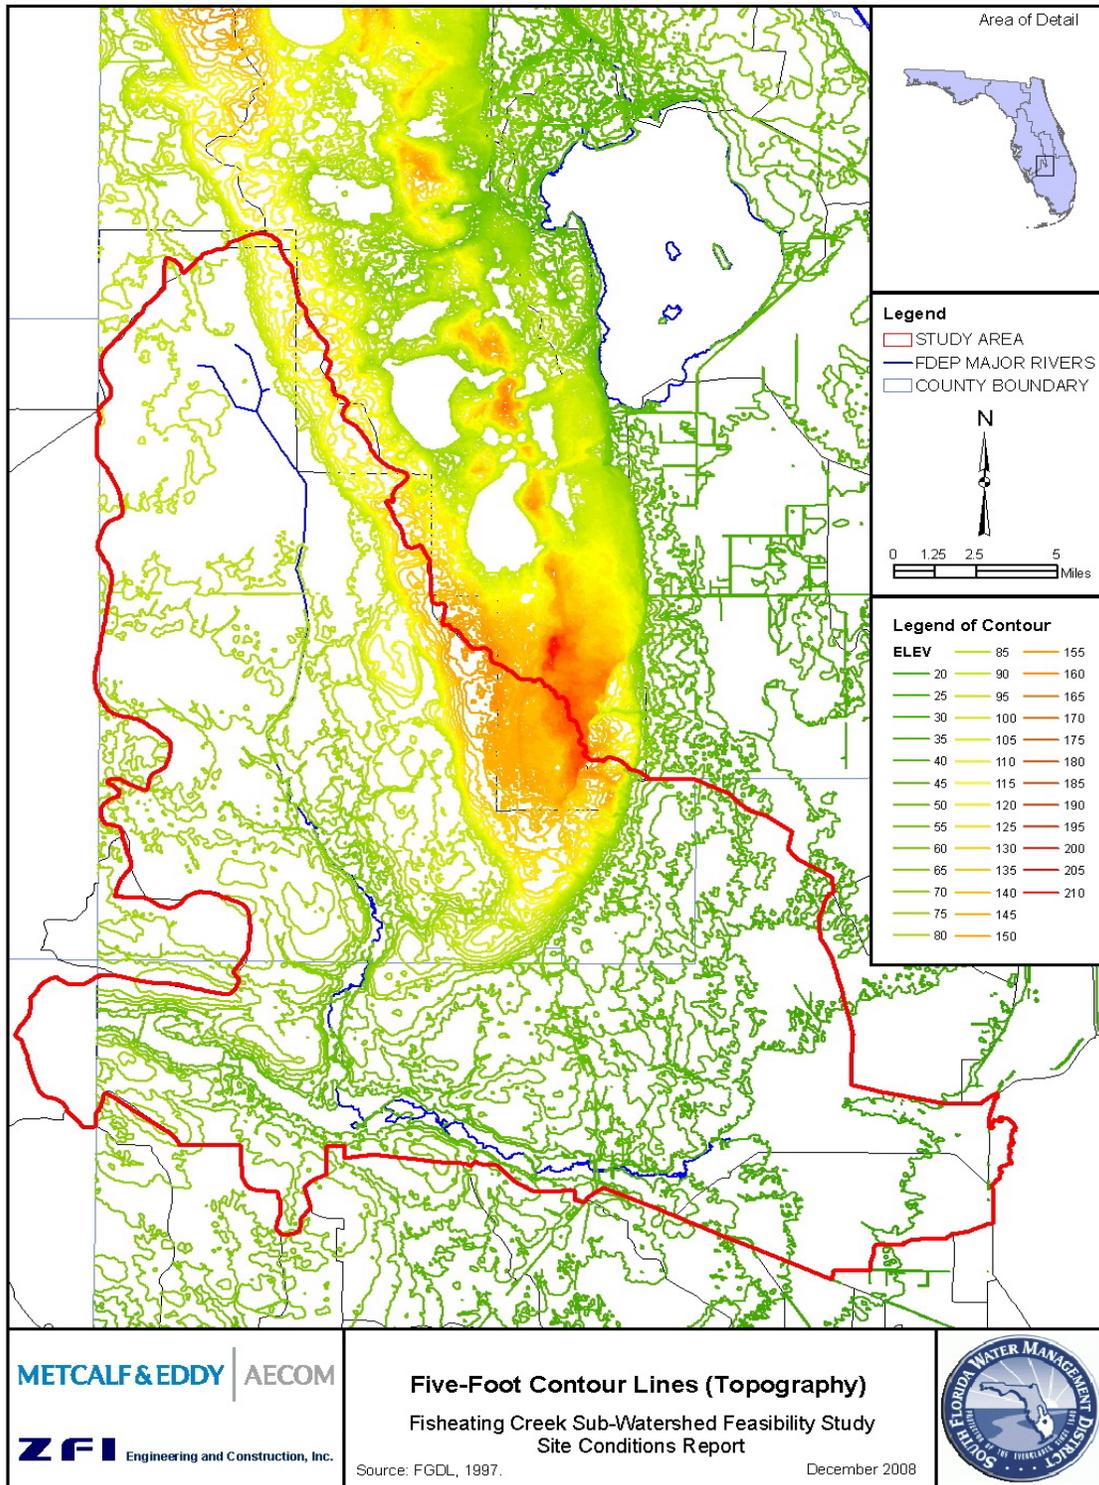
Figure 47. Five-Foot Contour Lines (Topography)

1285 Bootleg Creek and the Platt Branch both enter Fisheating Creek from the east in the vicinity of
1286 SR 731 (**Figure 47** and **Appendix B**). Bootleg Creek drains an extensive forested wetland

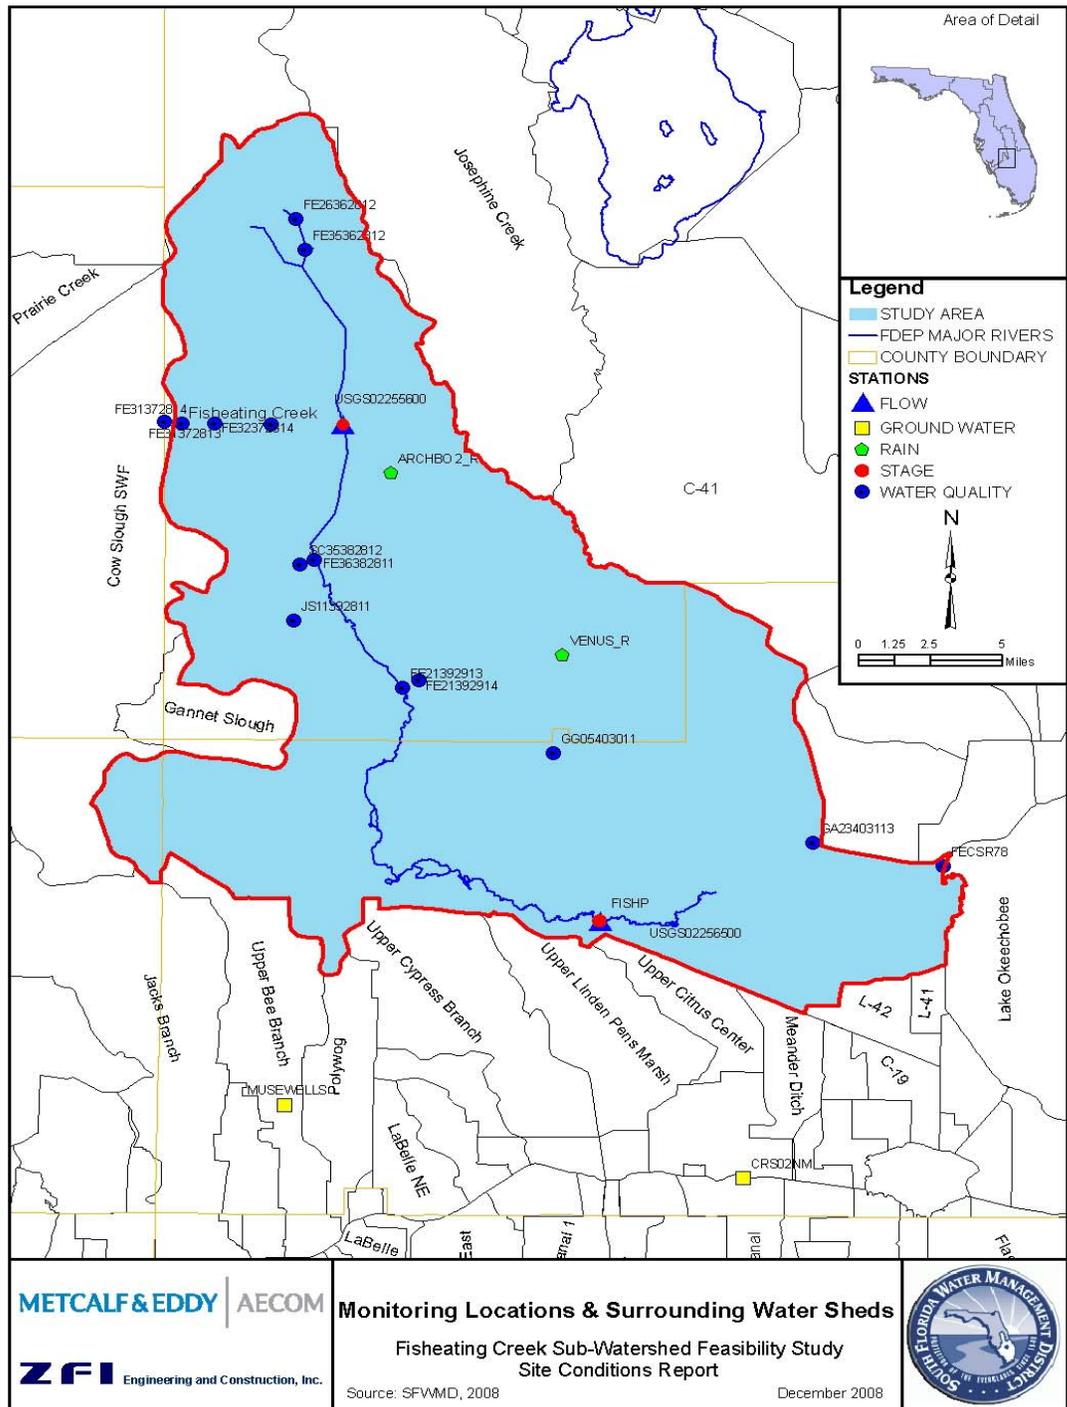
Figure 48. Monitoring Locations & Surrounding Watersheds

883 The distance between FISHP and FECSR78 is about 12 miles. The distance between
 884 USGS02255600 and FE36382811 is about 5 miles. These stations are shown in **Figure 48**.

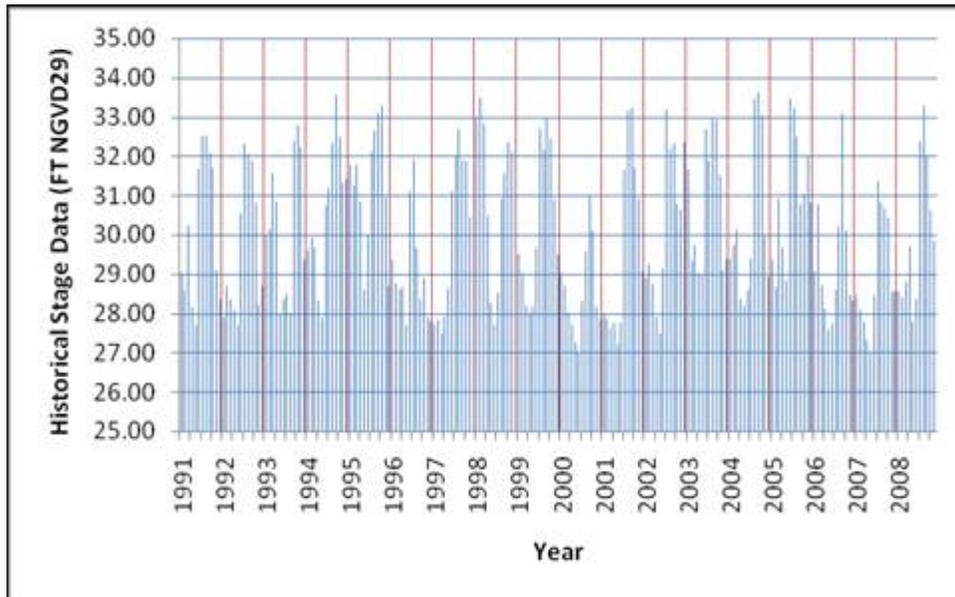
918 **Figure 50. Monthly Averaged Stage Data Measured at FISHP Station**
919 **(SFWMD DBHYDRO (DBKey 00088) 1991-2008)**

920 The patterns of water levels in the creek were observed to be inconsistent from year to year.
921 Water levels in winter/spring months for some years (e.g., years 1993, 1995, 1998 and 2003)
922 were significantly higher than the winter/spring water levels in other years (e.g. years 1997,
923 2001 and 2007). Swamps and wetlands near the southern boundary of the sub-watershed play
924 an important role of controlling water level and its temporal variation along the creek water
925 course. Analysis of the relationship between FEC rainfall and stage indicates a well-correlated
926 response during its ascending process, but poor correlation in the stage recession process.
927 Hydrologic characteristics of wetlands, such as duration/frequency of hydro-periods and level of
928 inundation affect the water level fluctuation of the FEC.

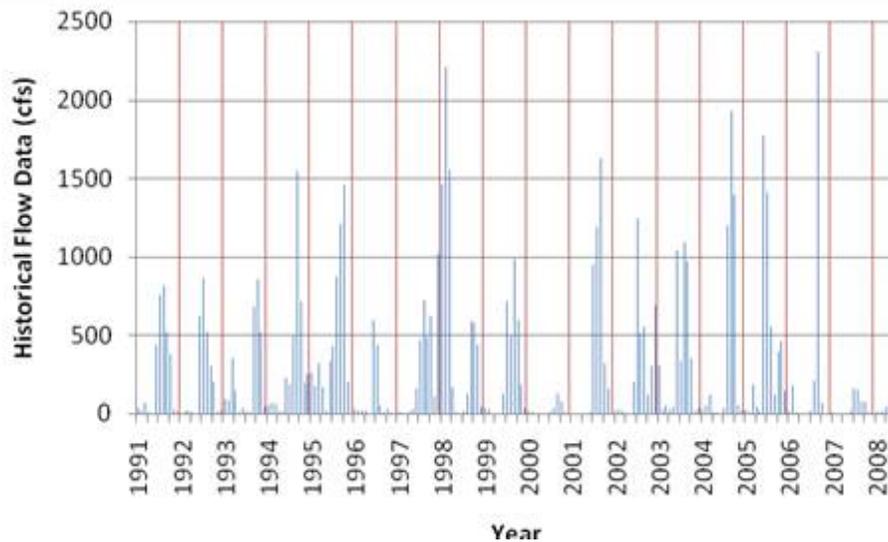
Figure 53. Monthly Averaged Flow Data Measured at FISHP Station (SFWMD DBHYDRO (DBKey 15627) 1991-2008)

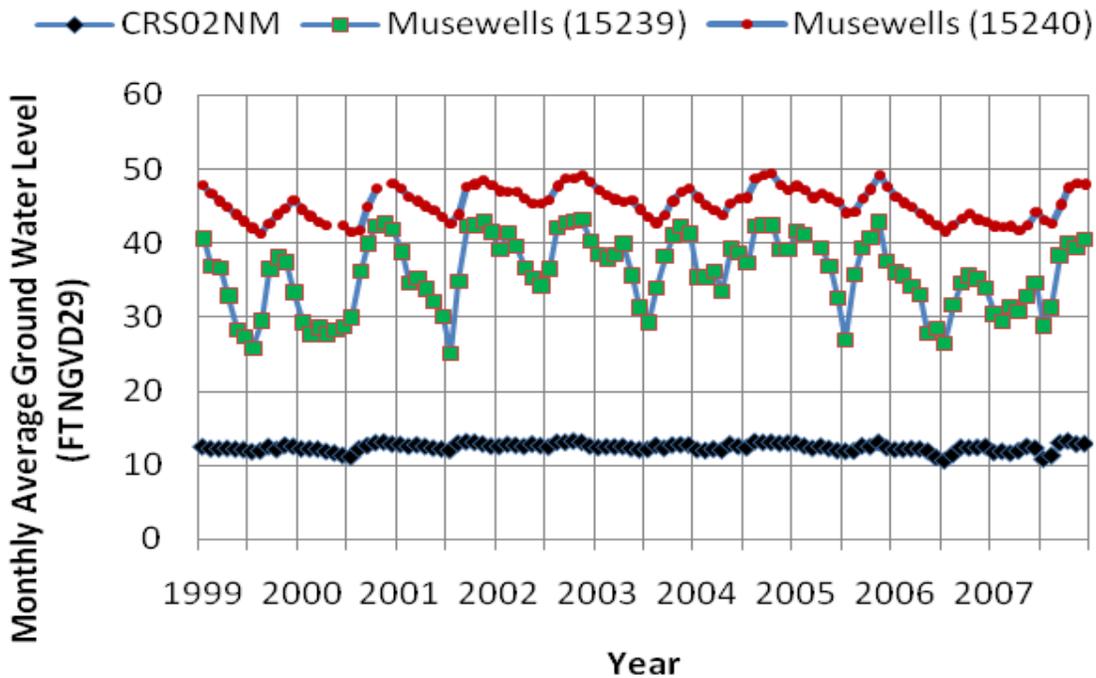
1014 **Figure 55. Monthly Average Groundwater Levels Recorded at Monitoring Wells South to**
1015 **the Sub-Watershed**
1016

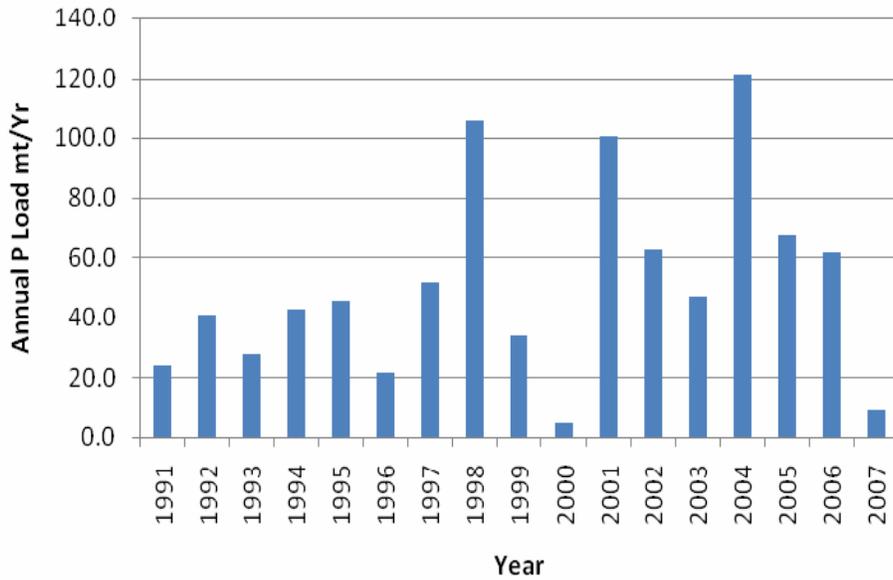
Figure 56. Annual Total Phosphorous Loads from the FEC Sub-Watershed to Lake Okeechobee (SFWMD DBHYDRO (Station FECSR78 and FISHP) 1991-2007)

1069 The phosphorous loads from the FEC sub-watershed are correlated with the discharge flow
 1070 rates. Low levels of phosphorous loads occurred in drought years 2000 and 2007, while high
 1071 levels of phosphorous loads happened in wet years of 1998 and 2004. Phosphorous loads in
 1072 the sub-watershed are primarily generated at non-point sources due to agricultural land uses.
 1073 Surface water runoff and agricultural discharge are major means of phosphorous load
 1074 generation.

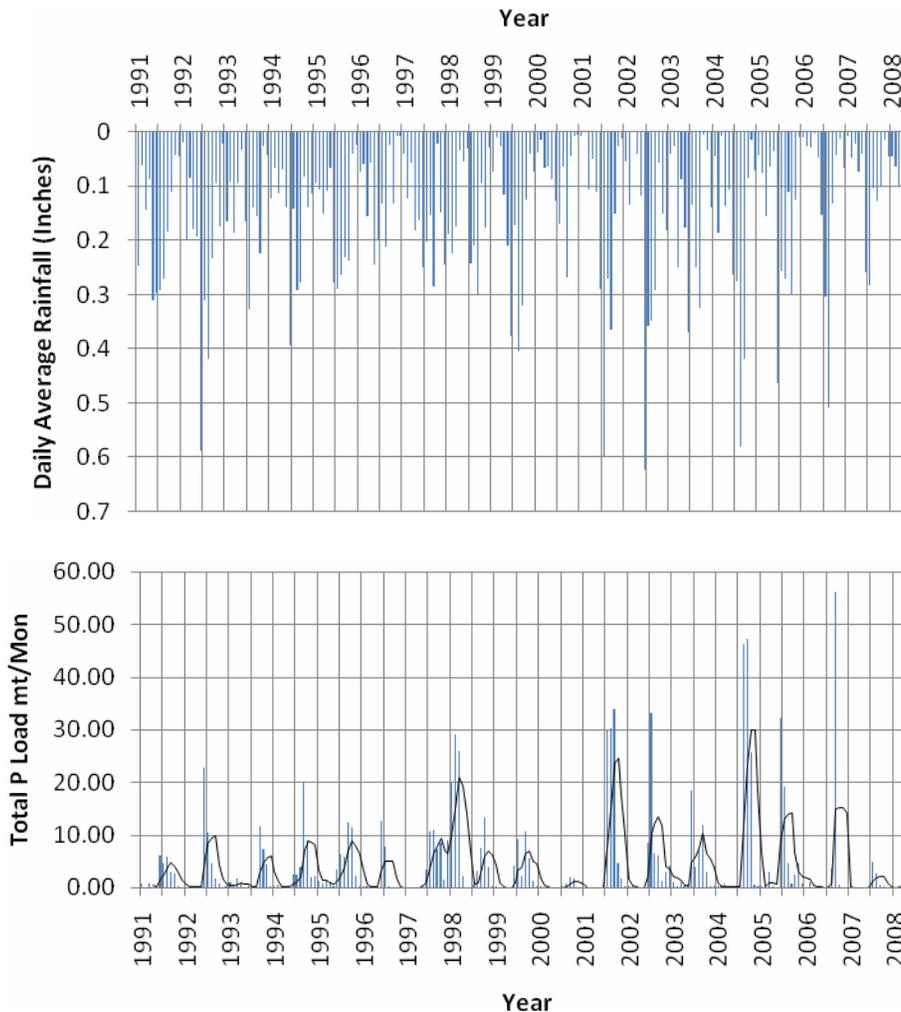
Figure 57. Monthly Averaged Rainfall and Phosphorous Loads Around FISHP Station (SFWMD DBHYDRO (Station ARCHBO 2_R, FECSR78 and FISHP) 1991-2008)

1075 The correlation between phosphorous loadings and hydrological conditions also exists in the
 1076 relation of rainfall and phosphorous loads. **Figure 57** presents monthly averaged rainfall and
 1077 phosphorous loads around FISHP station for the period from 1991 to 2008. As shown in the
 1078 12-month moving average on the P load series, in years with higher rainfall higher phosphorus
 1079 loads are observed. This is due to more phosphorus being flushed from the sub-watershed
 1080 during these higher rainfall events. Peak values of phosphorous loads occurring slightly later
 1081 than the rainfall peaks is also observed on **Figure 57**.

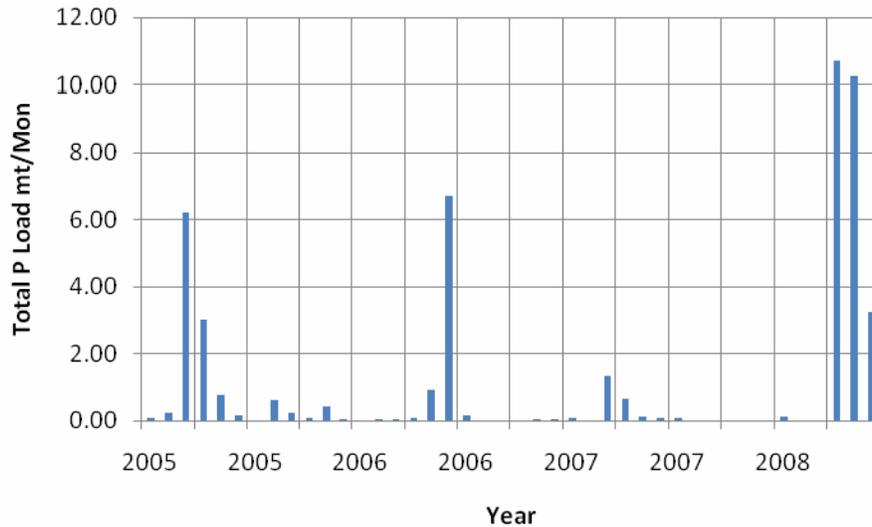
Figure 58. Total Phosphorous Loads in the Upstream Stream Section (SFWMD DBHYDRO (Station FE36382811) and USGS (Station 02255600) 1991-2008)

1082 The phosphorous loads generated from the agricultural non-point sources in the upstream
 1083 section of the FEC sub-watershed are estimated by using the flow measurement data at
 1084 USGS02255600 station and water quality data sampled at FE36382811 Station. The results
 1085 are plotted in **Figure 58**.

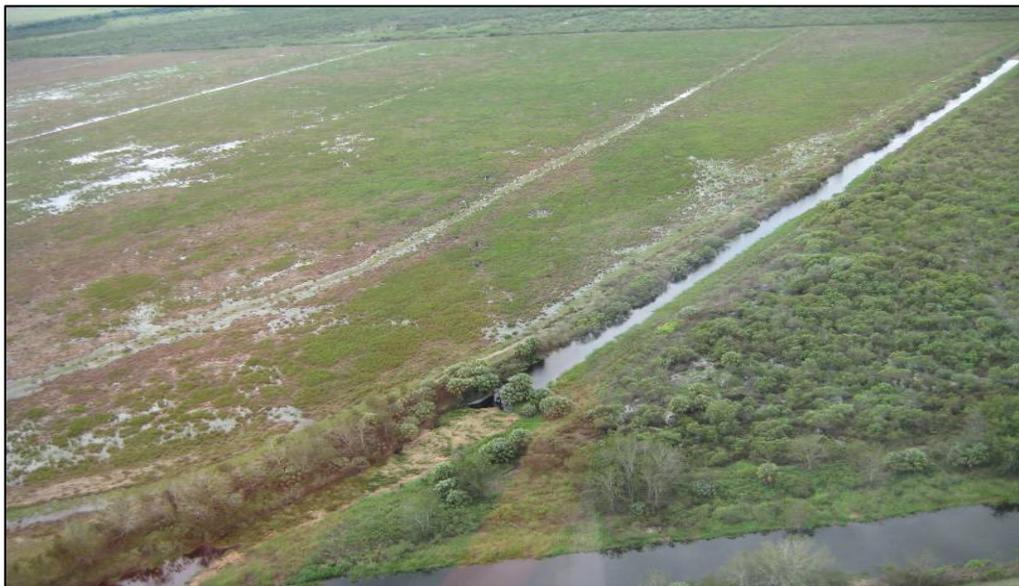
Figure 62. Channelized Portion of FEC Just South of Headwaters, View to the North

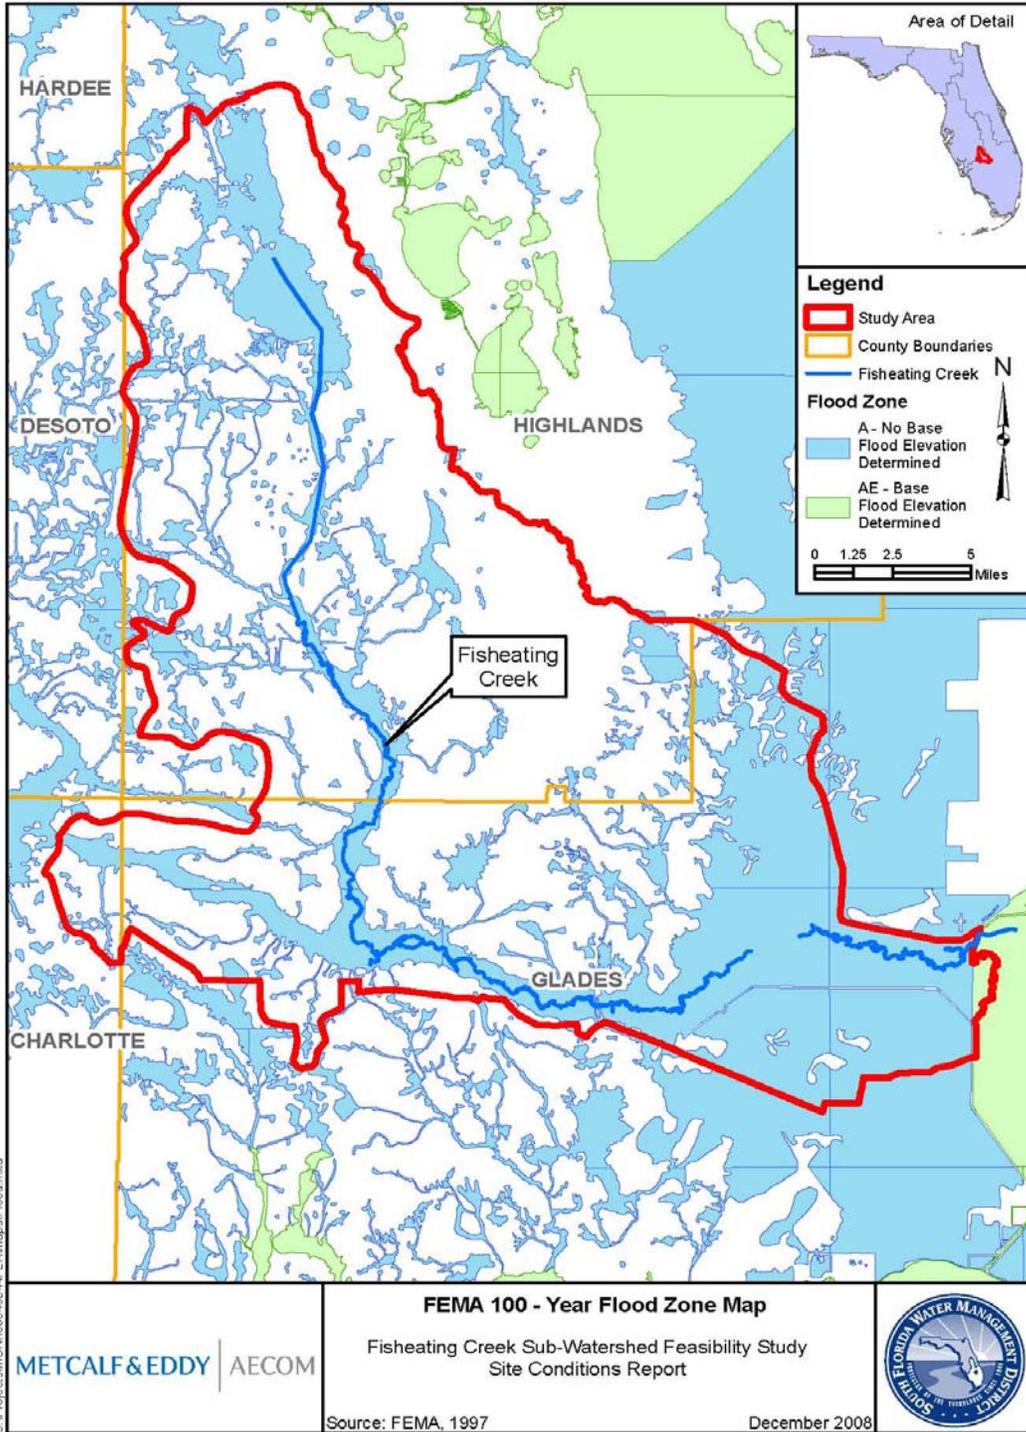
Figure 70. FEC Sub-Watershed Study Area 100-year Flood Zone Map

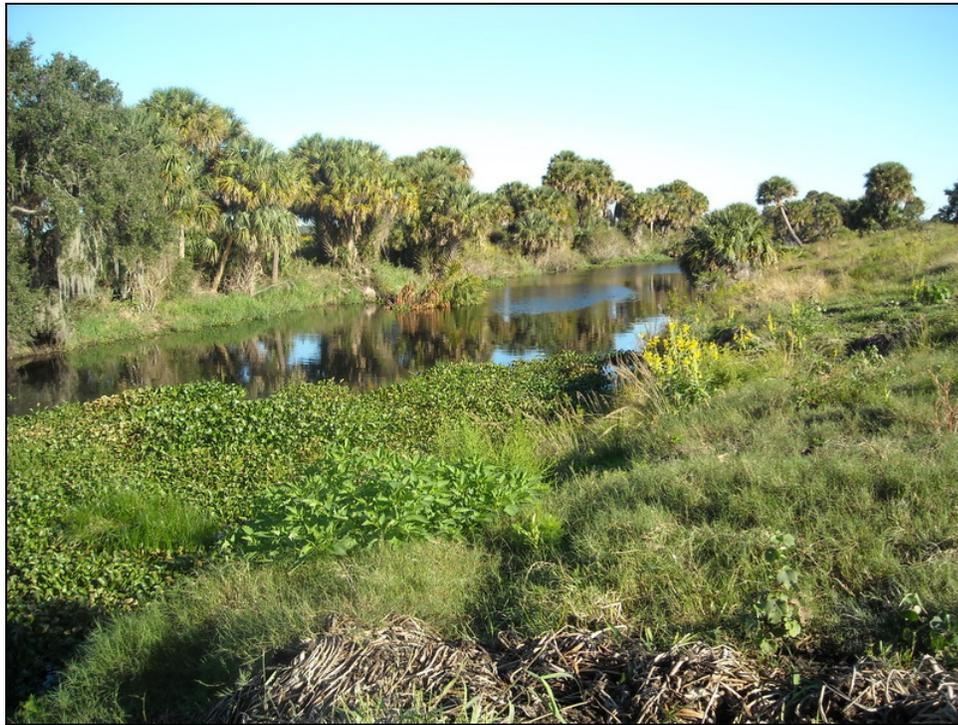
Figure 80. View of Fisheating Creek before it passes under Check Dam No.1 PL-566 Structure
