Caloosahatchee Estuary - Oysters

Caloosahatchee Estuary – CRE 2 Submerged Aquatic Vegetation

Caloosahatchee Estuary – CRE 8 Seagrass

Impacts of Hurricane Irma New Pass in Estero Bay

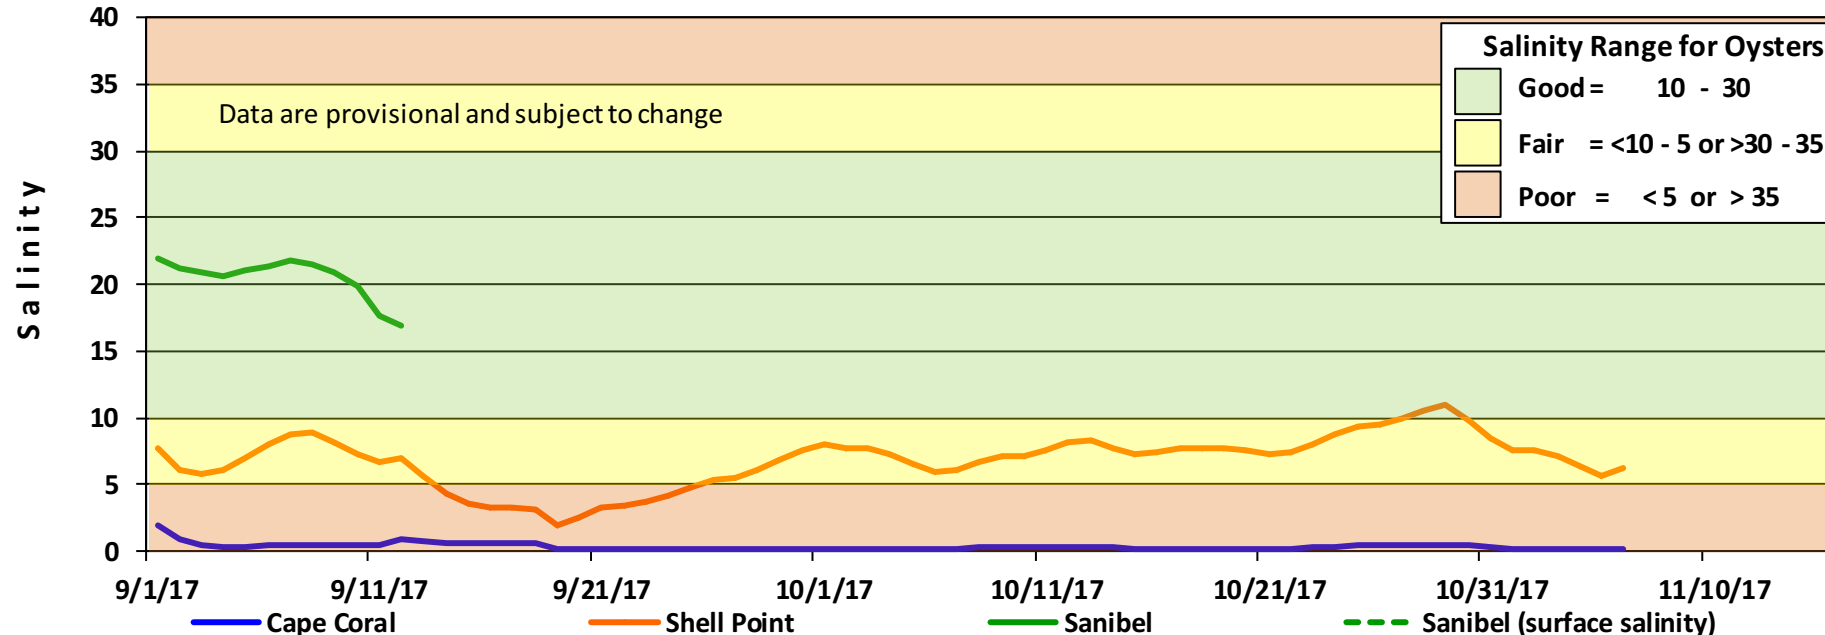
Seven day mean salinity of the water column at 3 monitoring stations in the Caloosahatchee Estuary

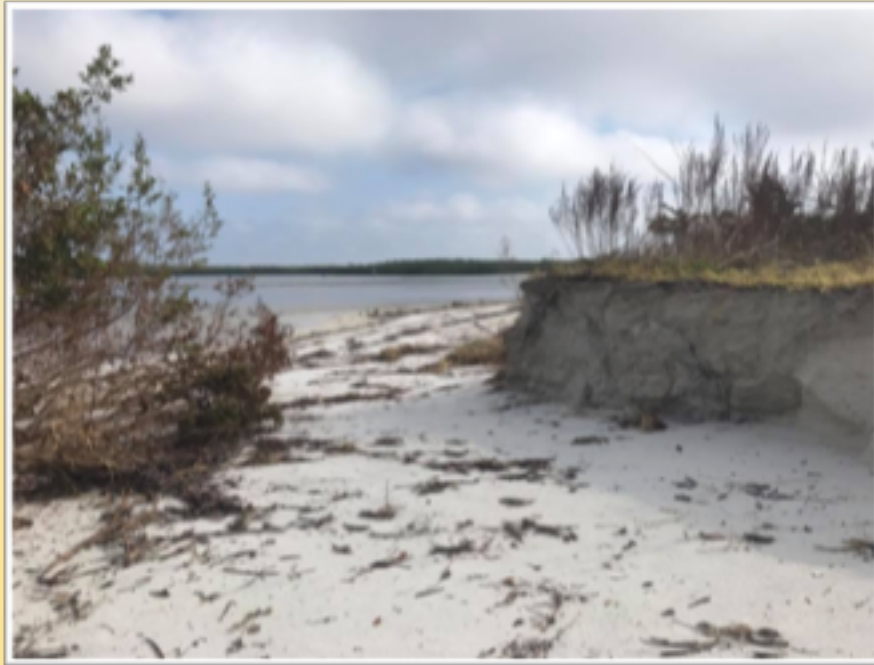
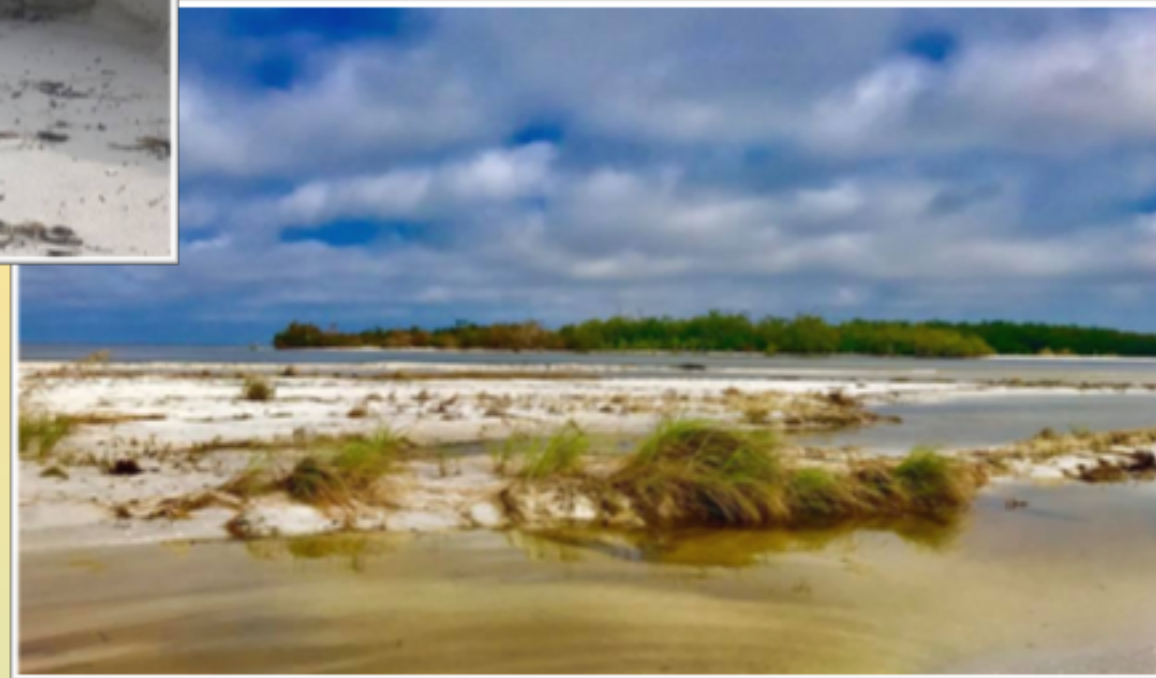
Coastal
re-sculpting
at New Pass
on Estero Bay

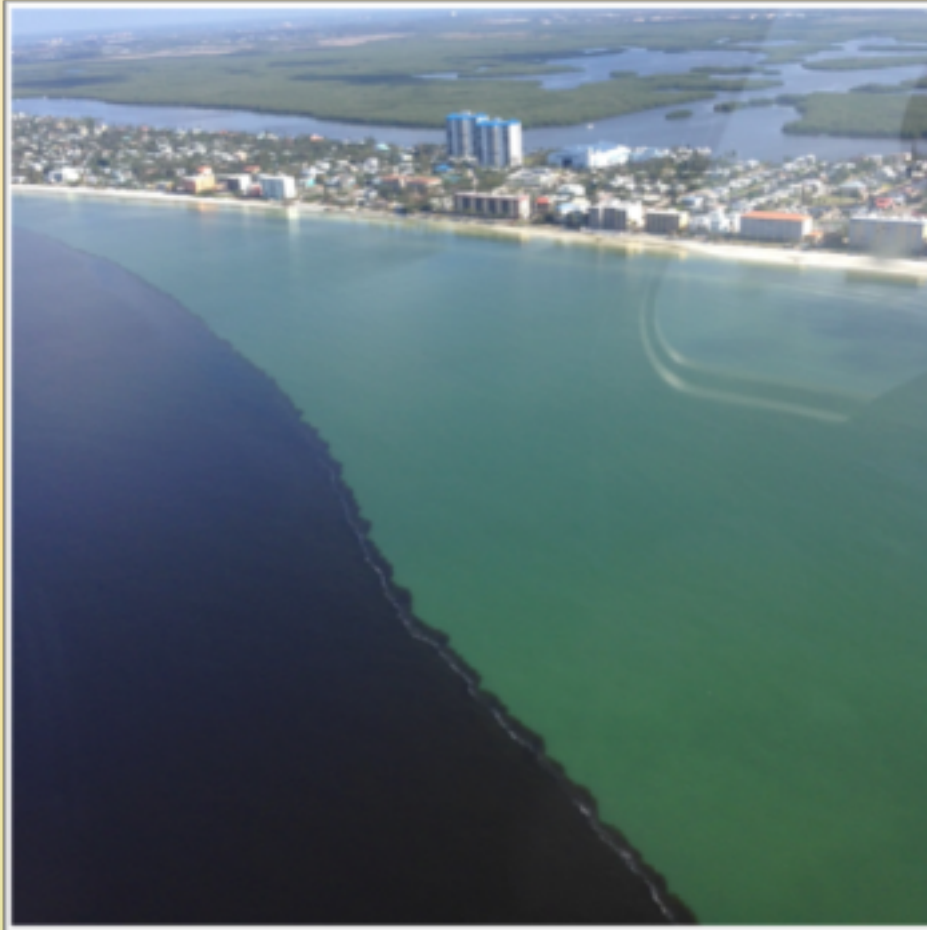
Ft. Myers Beach

Local Basin Watershed Discharges

(No Lake Okeechobee Releases)
