**Environmental Assessment for the Transfer of Federal Grant
Encumbrance to Facilitate the Construction of the Miramar Parkway /
Pembroke Road Extension**

Broward County, Florida
May 16, 2022

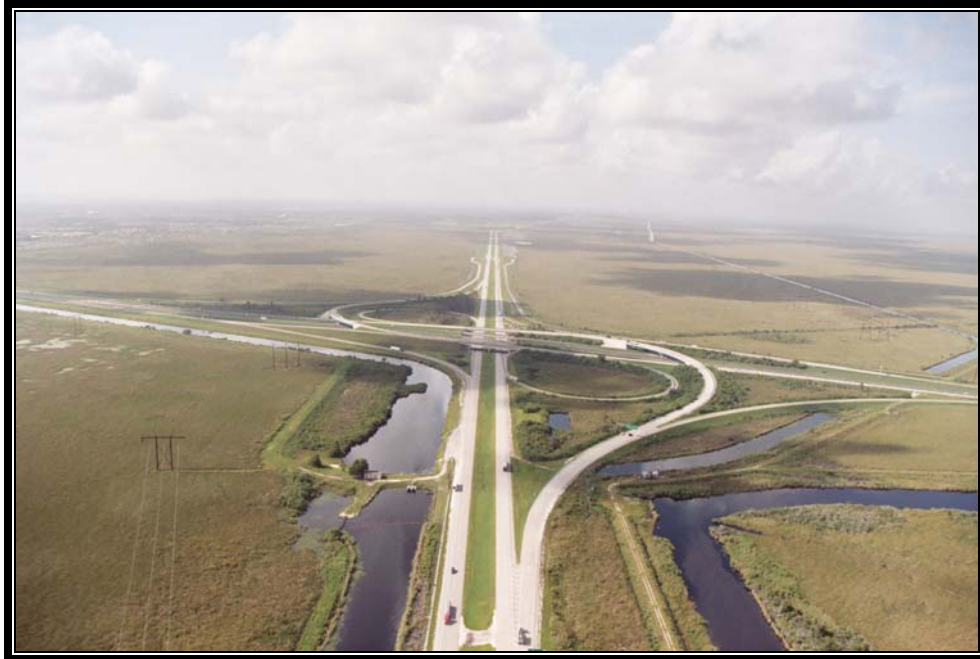
Photograph 1 – Aerial view of the northern section of the project area. View toward the south.

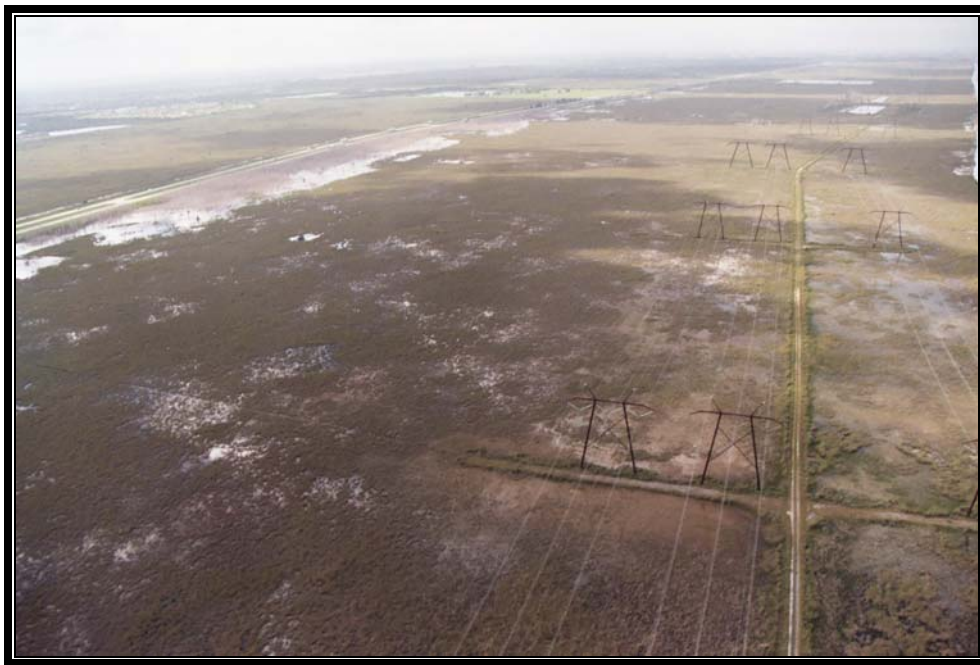
Photograph 2 – Typical aerial view of the land tracts located west of U.S. Highway 27.
View toward the south.

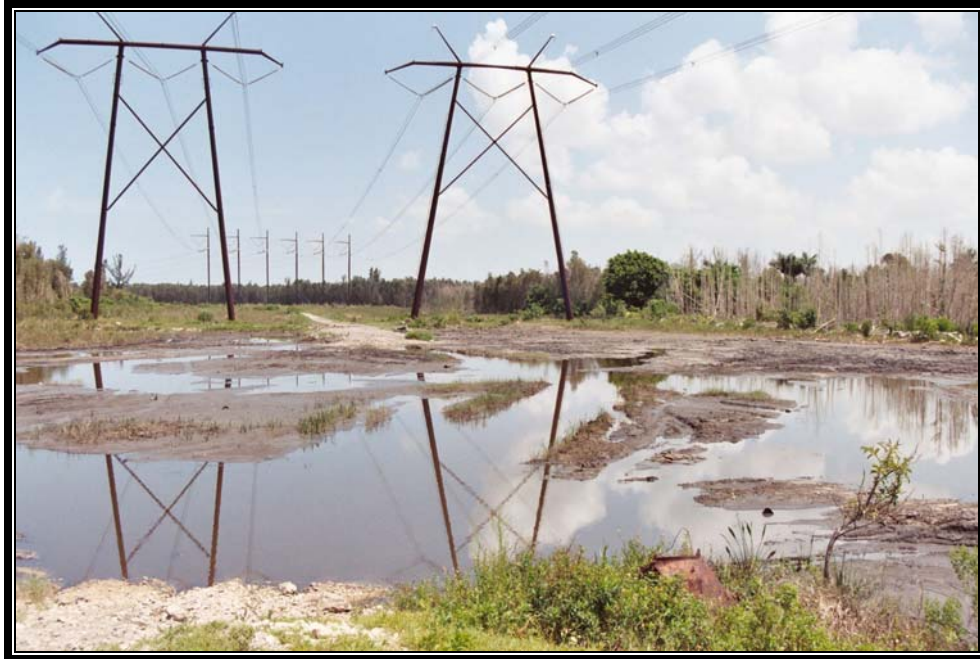
Photograph 3 – Typical debris observed along the electrical transmission line right-of-way.
View toward the northwest.

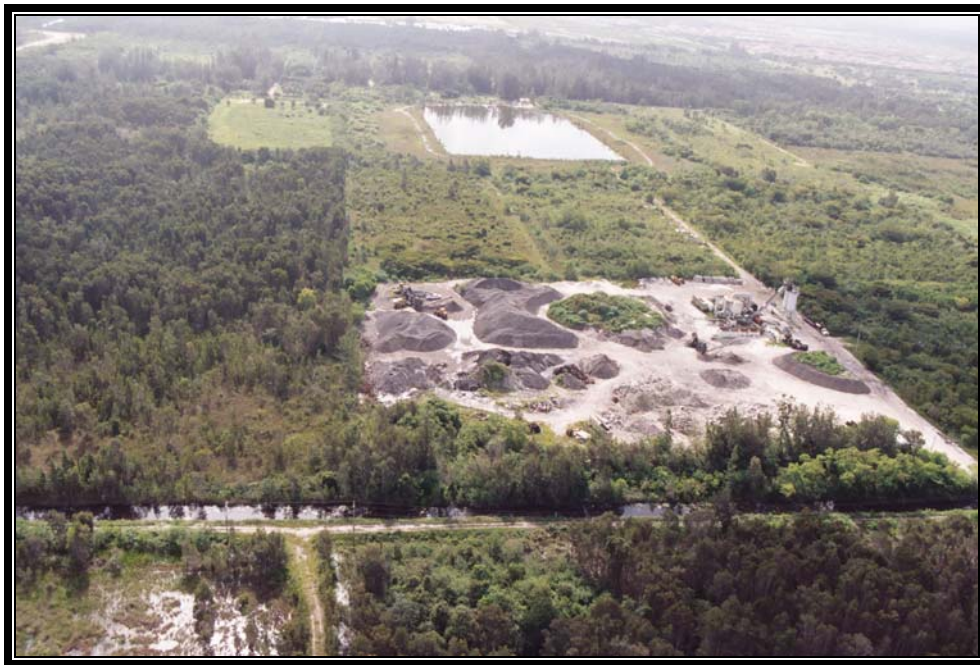
Photograph 4 – Aerial view of Tracts 9201-075, 9201-076 and 9201-80 (Weekley Asphalt Property).
View toward the east.

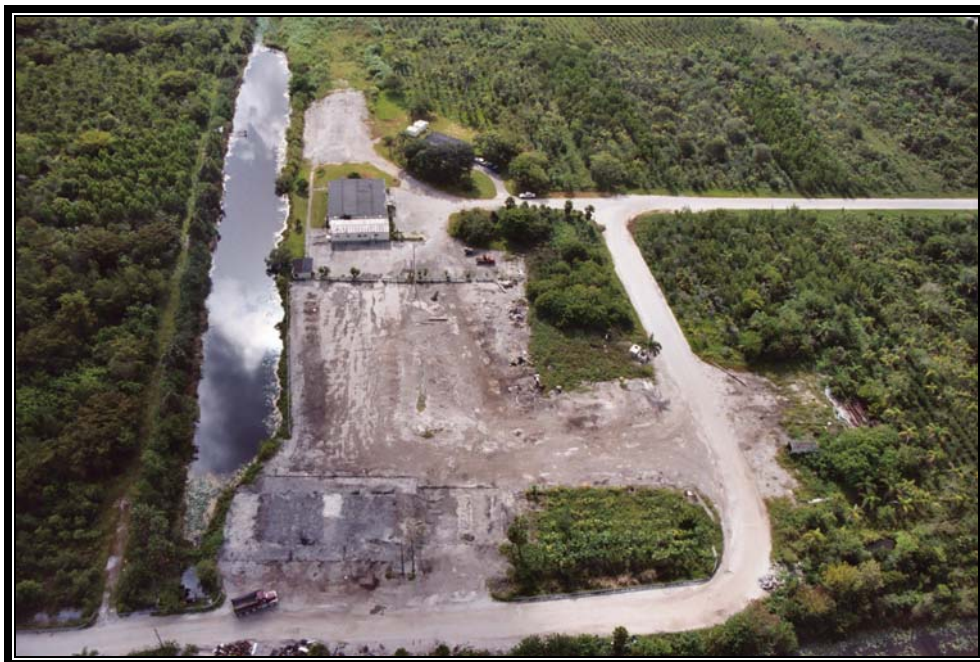
Photograph 5 – Aerial view of Tract 9201-072 (former Weekley Maintenance Area and office location). View toward the east.

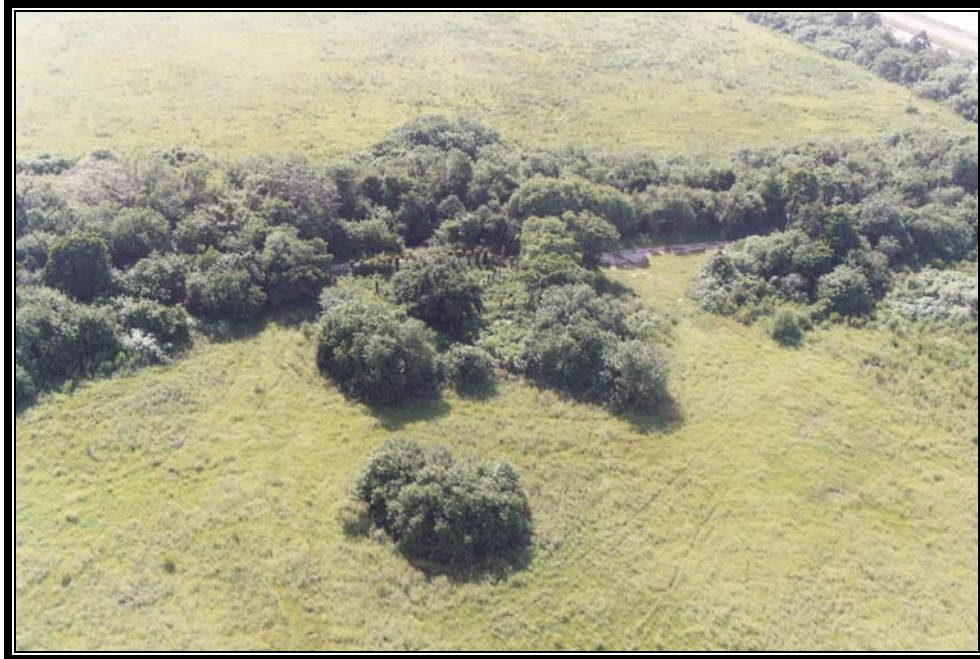
Photograph 9 – View of a former livestock pen located on Tract 9200-902. View toward the east.

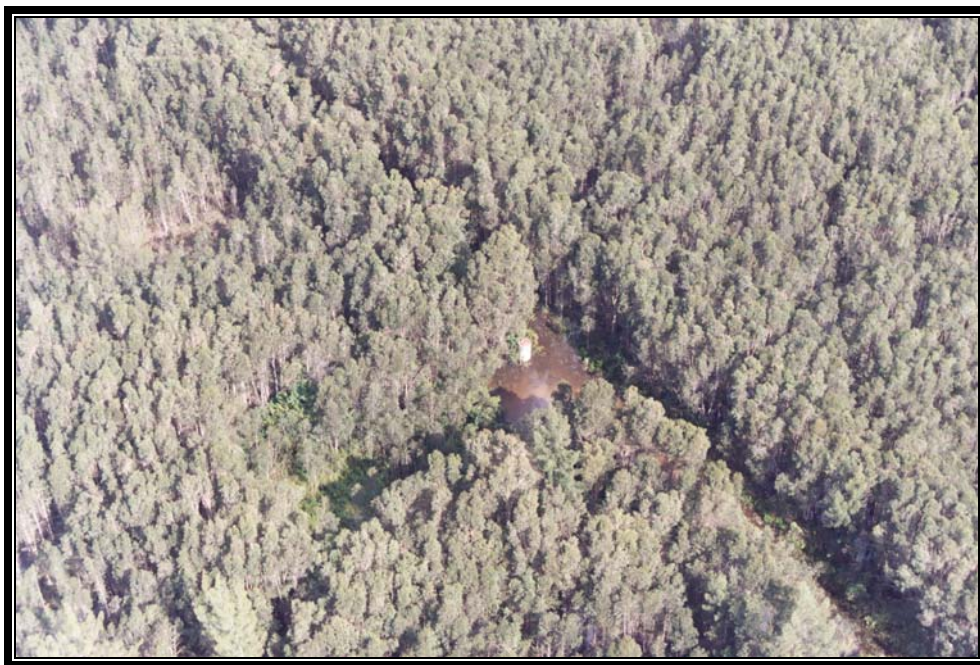
Photograph 10 – Aerial view of an aboveground storage tank located on Tract 9200-930 (Kolt Property). The access road was flooded therefore the storage tank could not be inspected. The use and contents of the storage tank are unknown.

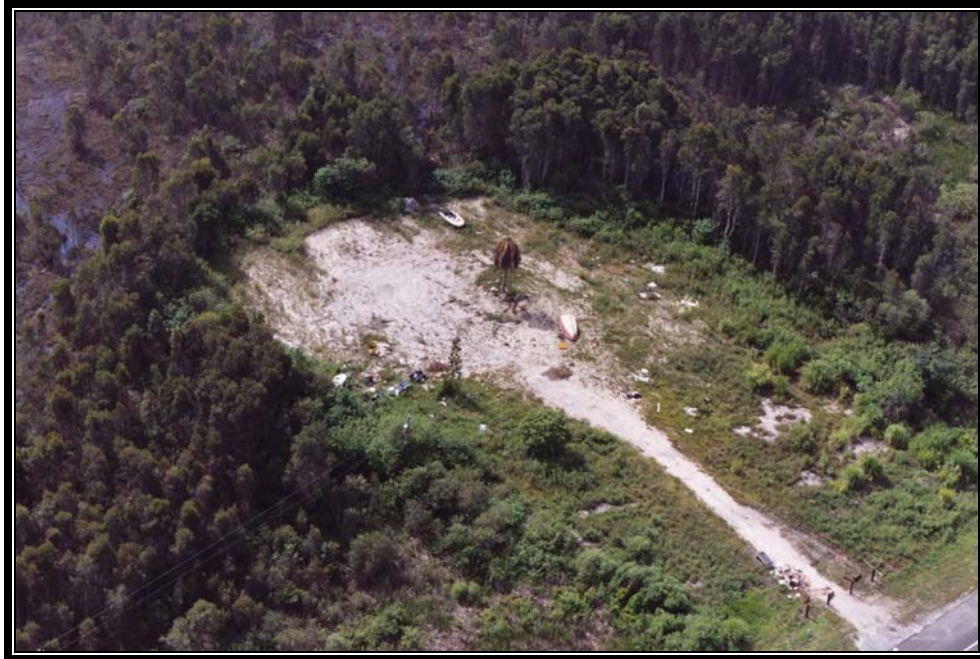
Photograph 11 – Aerial view of debris located on Tract 9200-921 (former Vietnamese Buddhist Cultural Center Property). View toward the southeast.

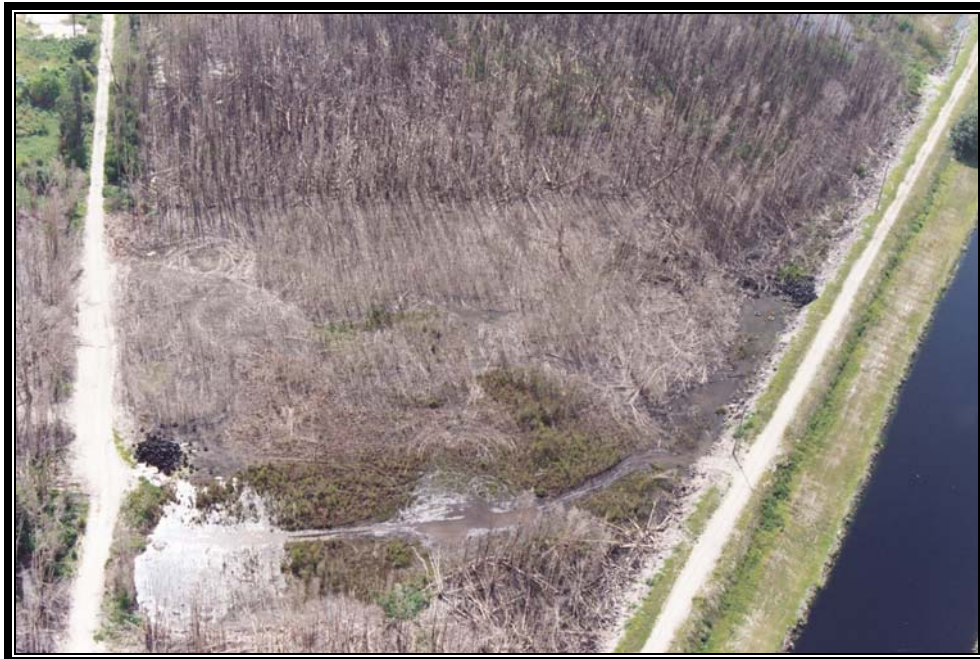
Photograph 13 – Aerial view of two piles of dumped tires located on Tract 9312-018 (Correa Property).
View toward the southeast.

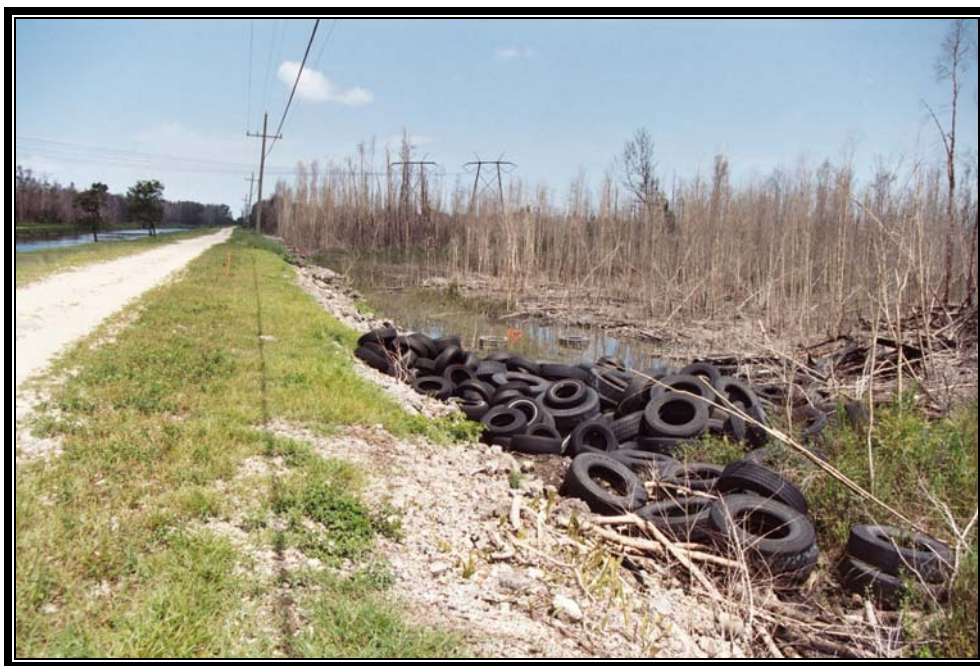
Photograph 14 – View of tire pile located on the southwest portion of Tract 9312-018 (Correa Property).
View toward the northwest.

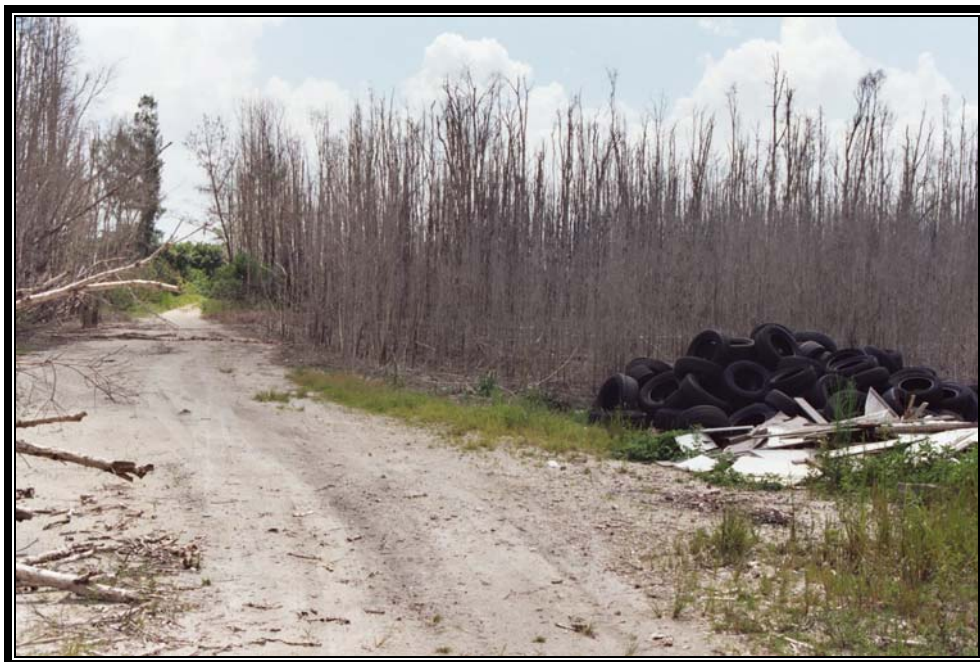
Photograph 16 – View of tire pile located on the northern portion of Tract 9312-018 (Correa Property).
View toward the east.

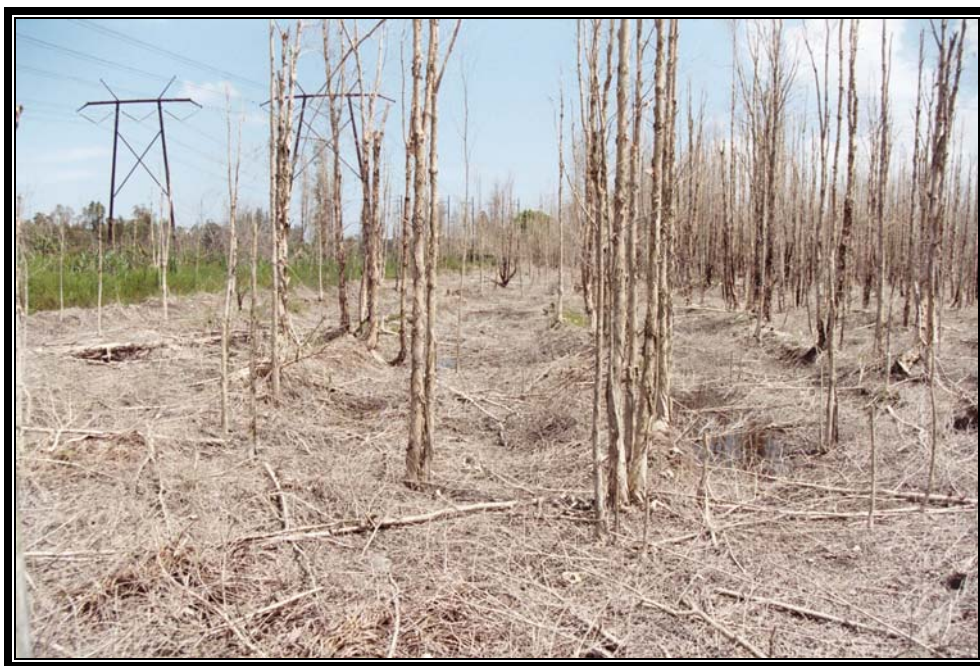
Photograph 17 – Furrowed surface soils observed on Tract 9312-026 (Socarras Property). View toward the north.

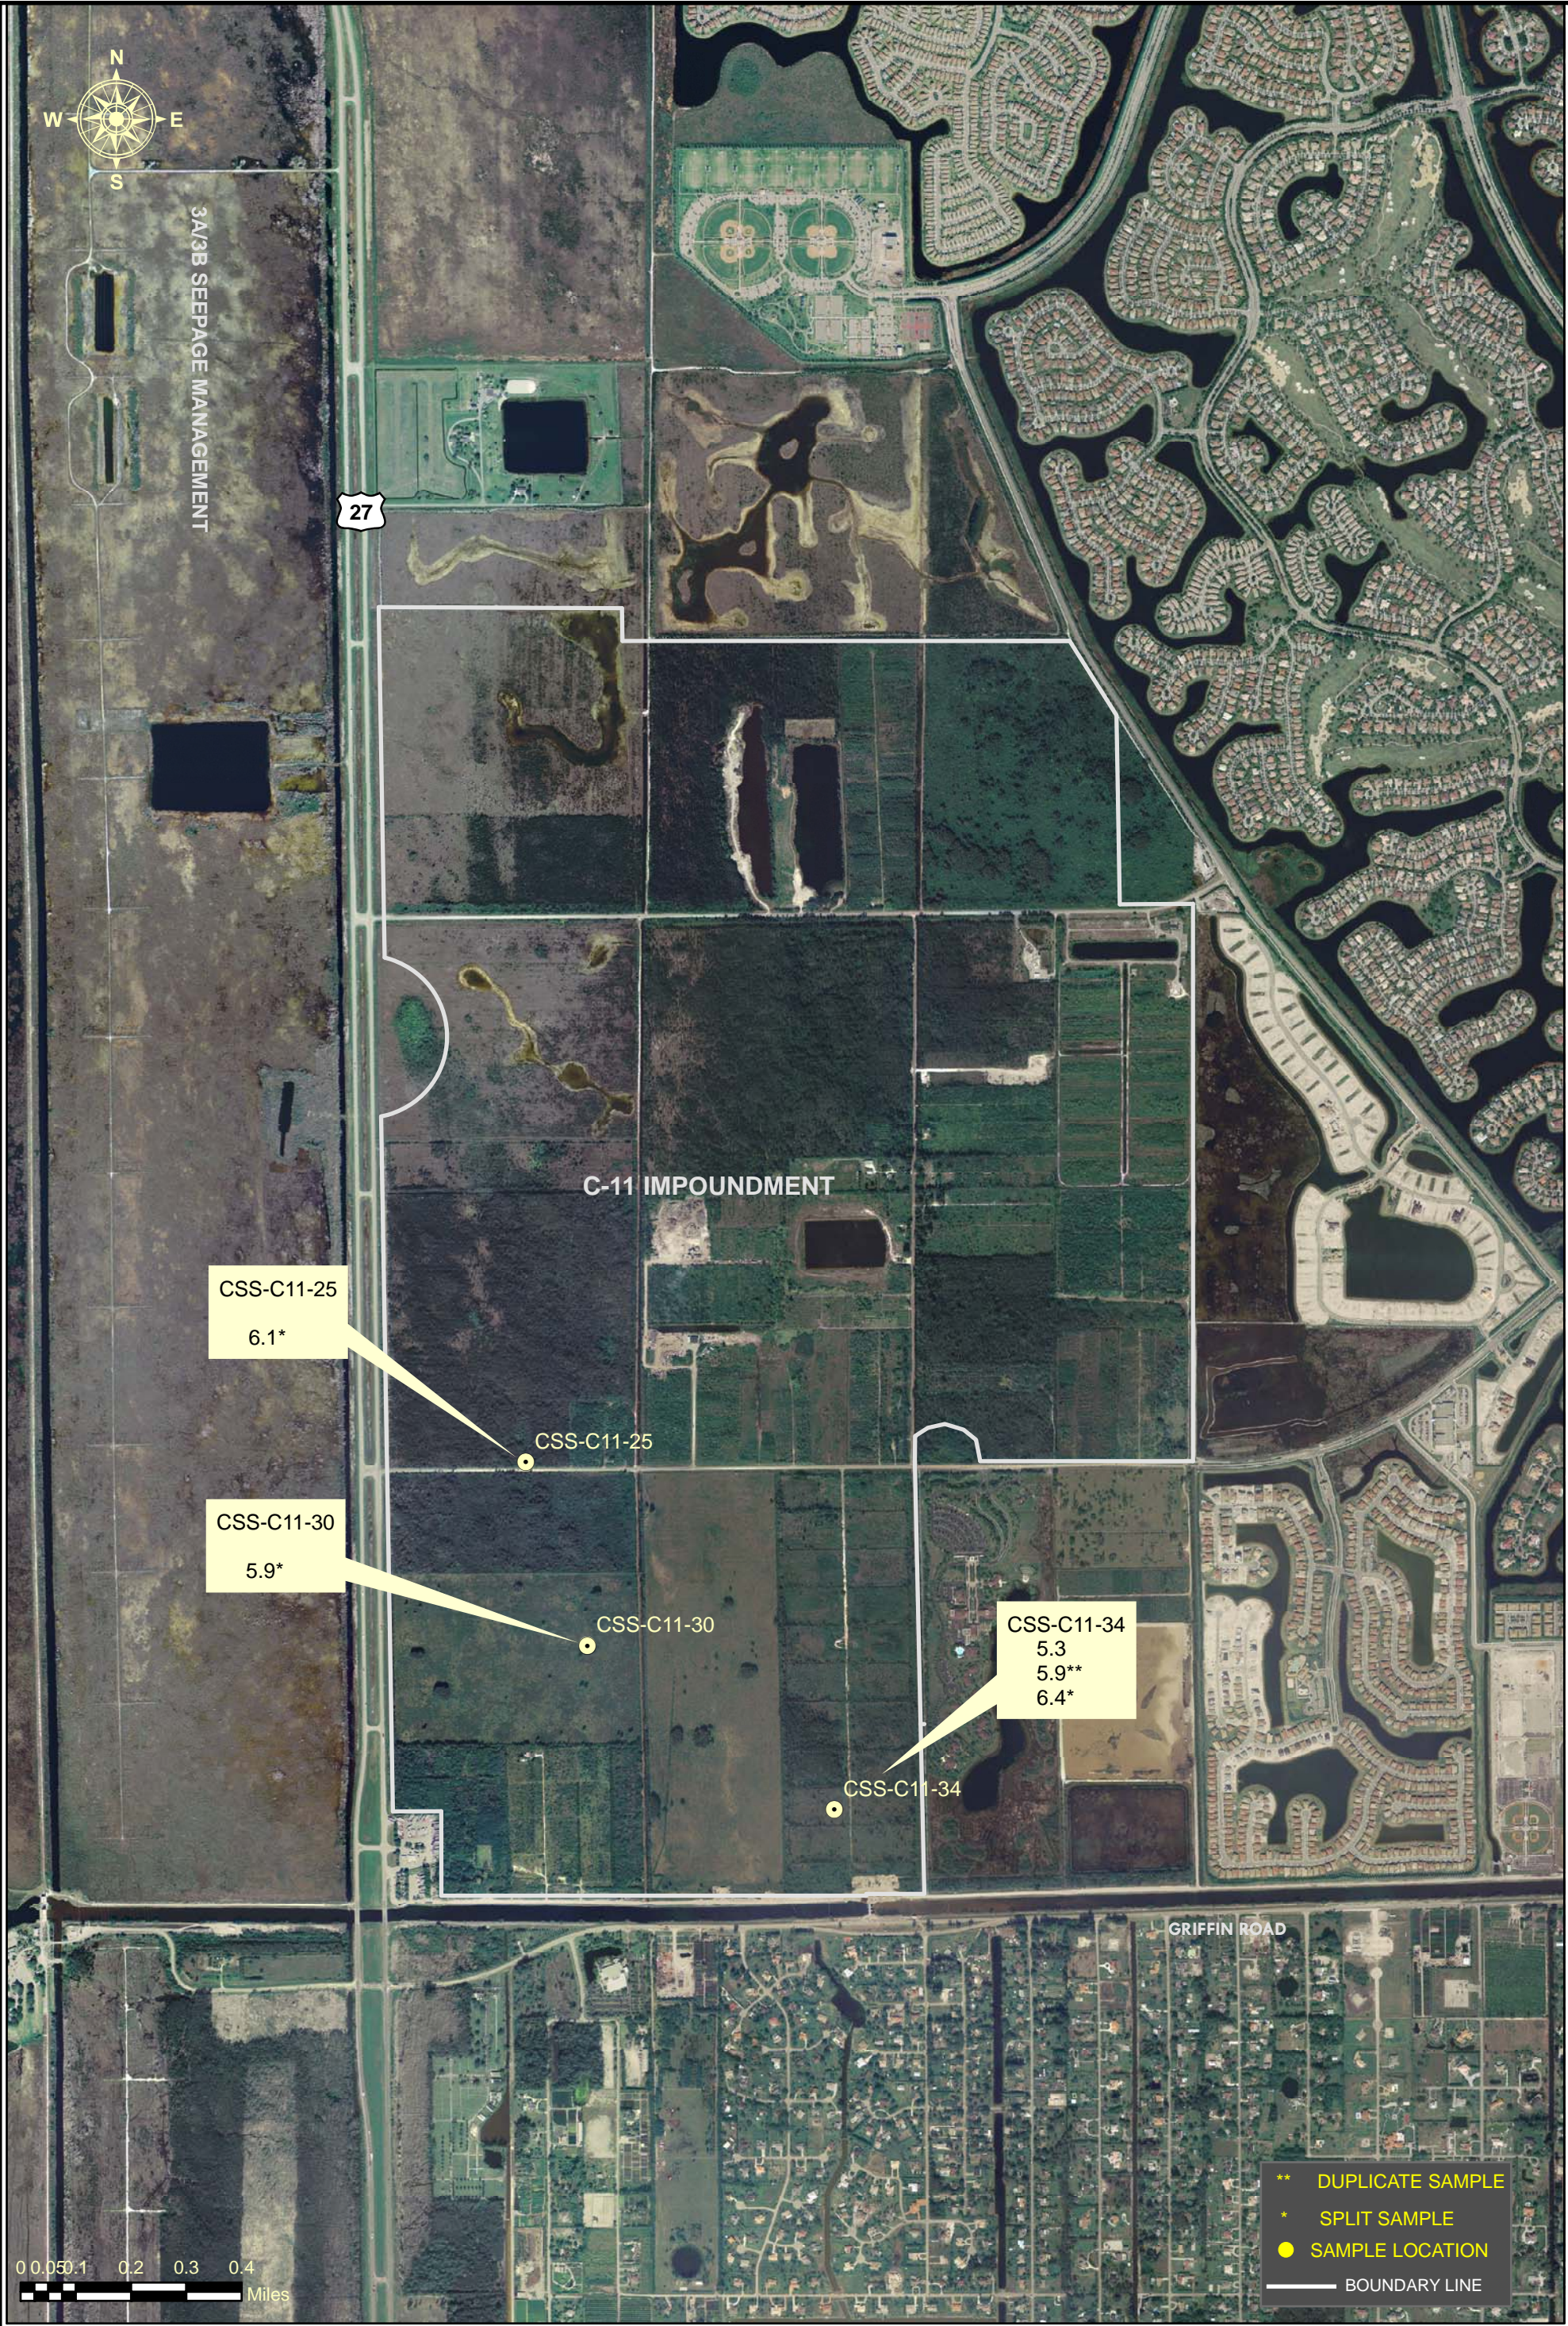
Figure:
5

C-11 IMPOUNDMENT
SELENIUM EXCEEDANCE

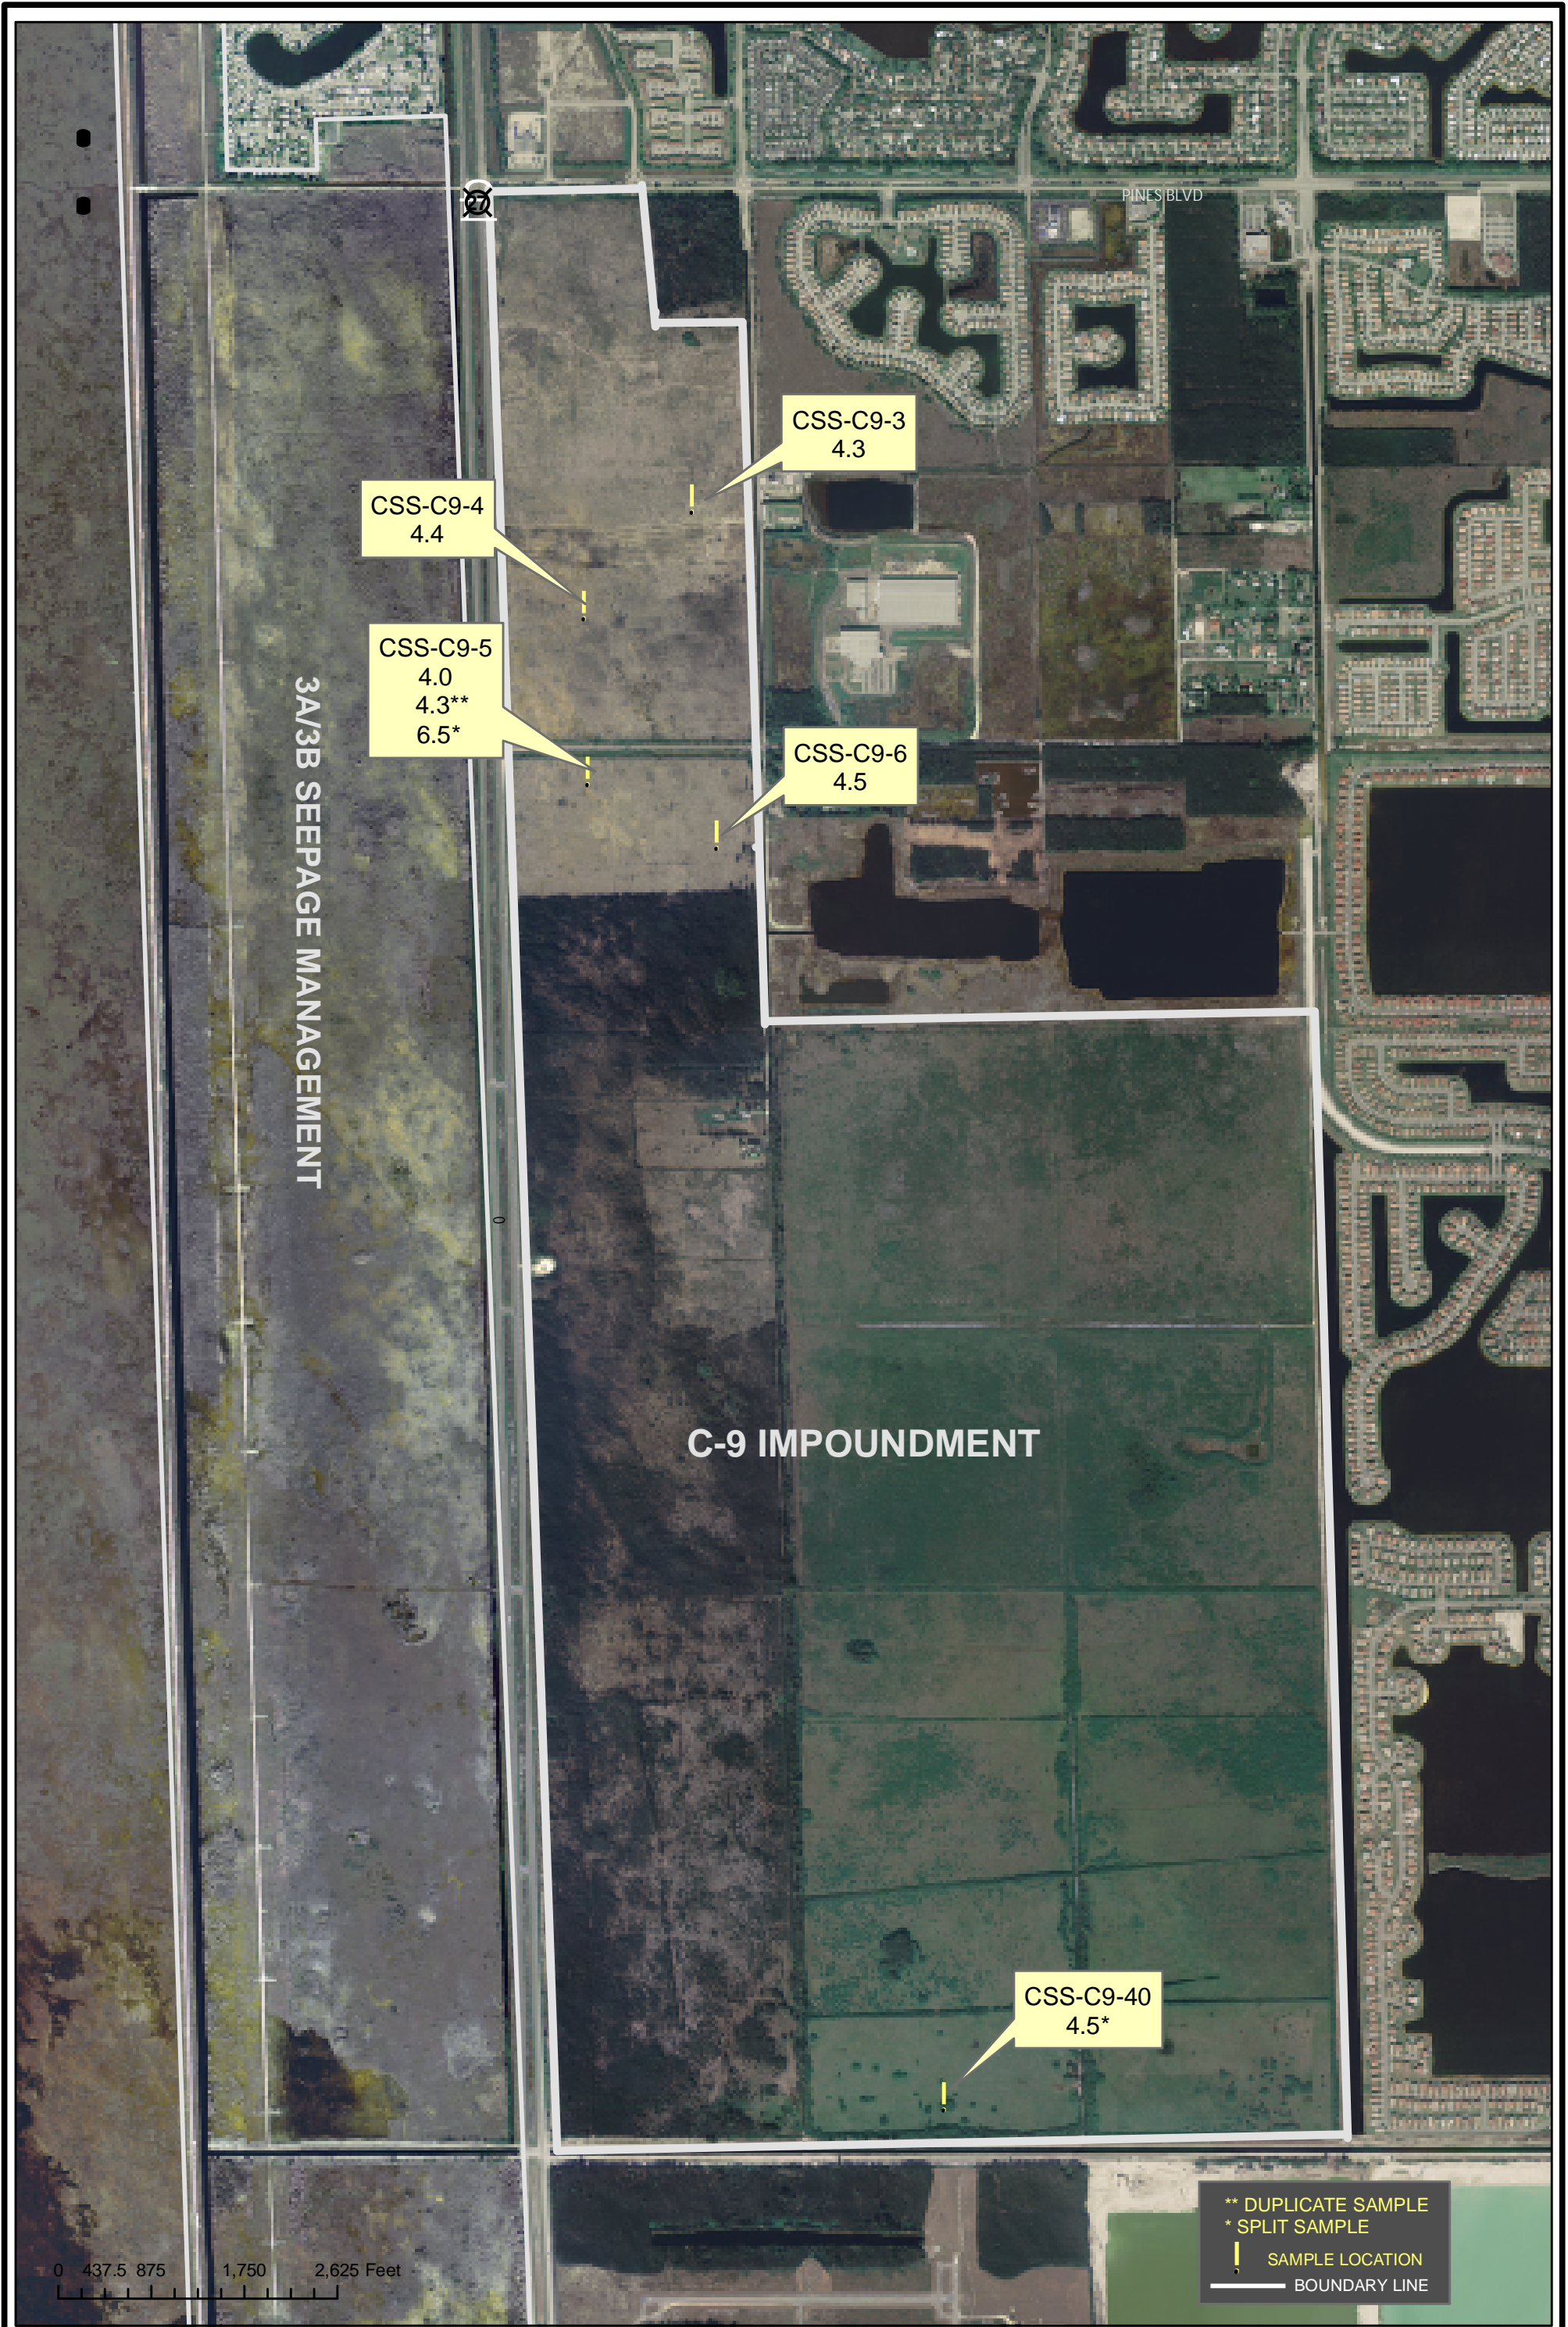
Figure:
6

C-9 IMPOUNDMENT
SELENIUM EXCEEDANCE

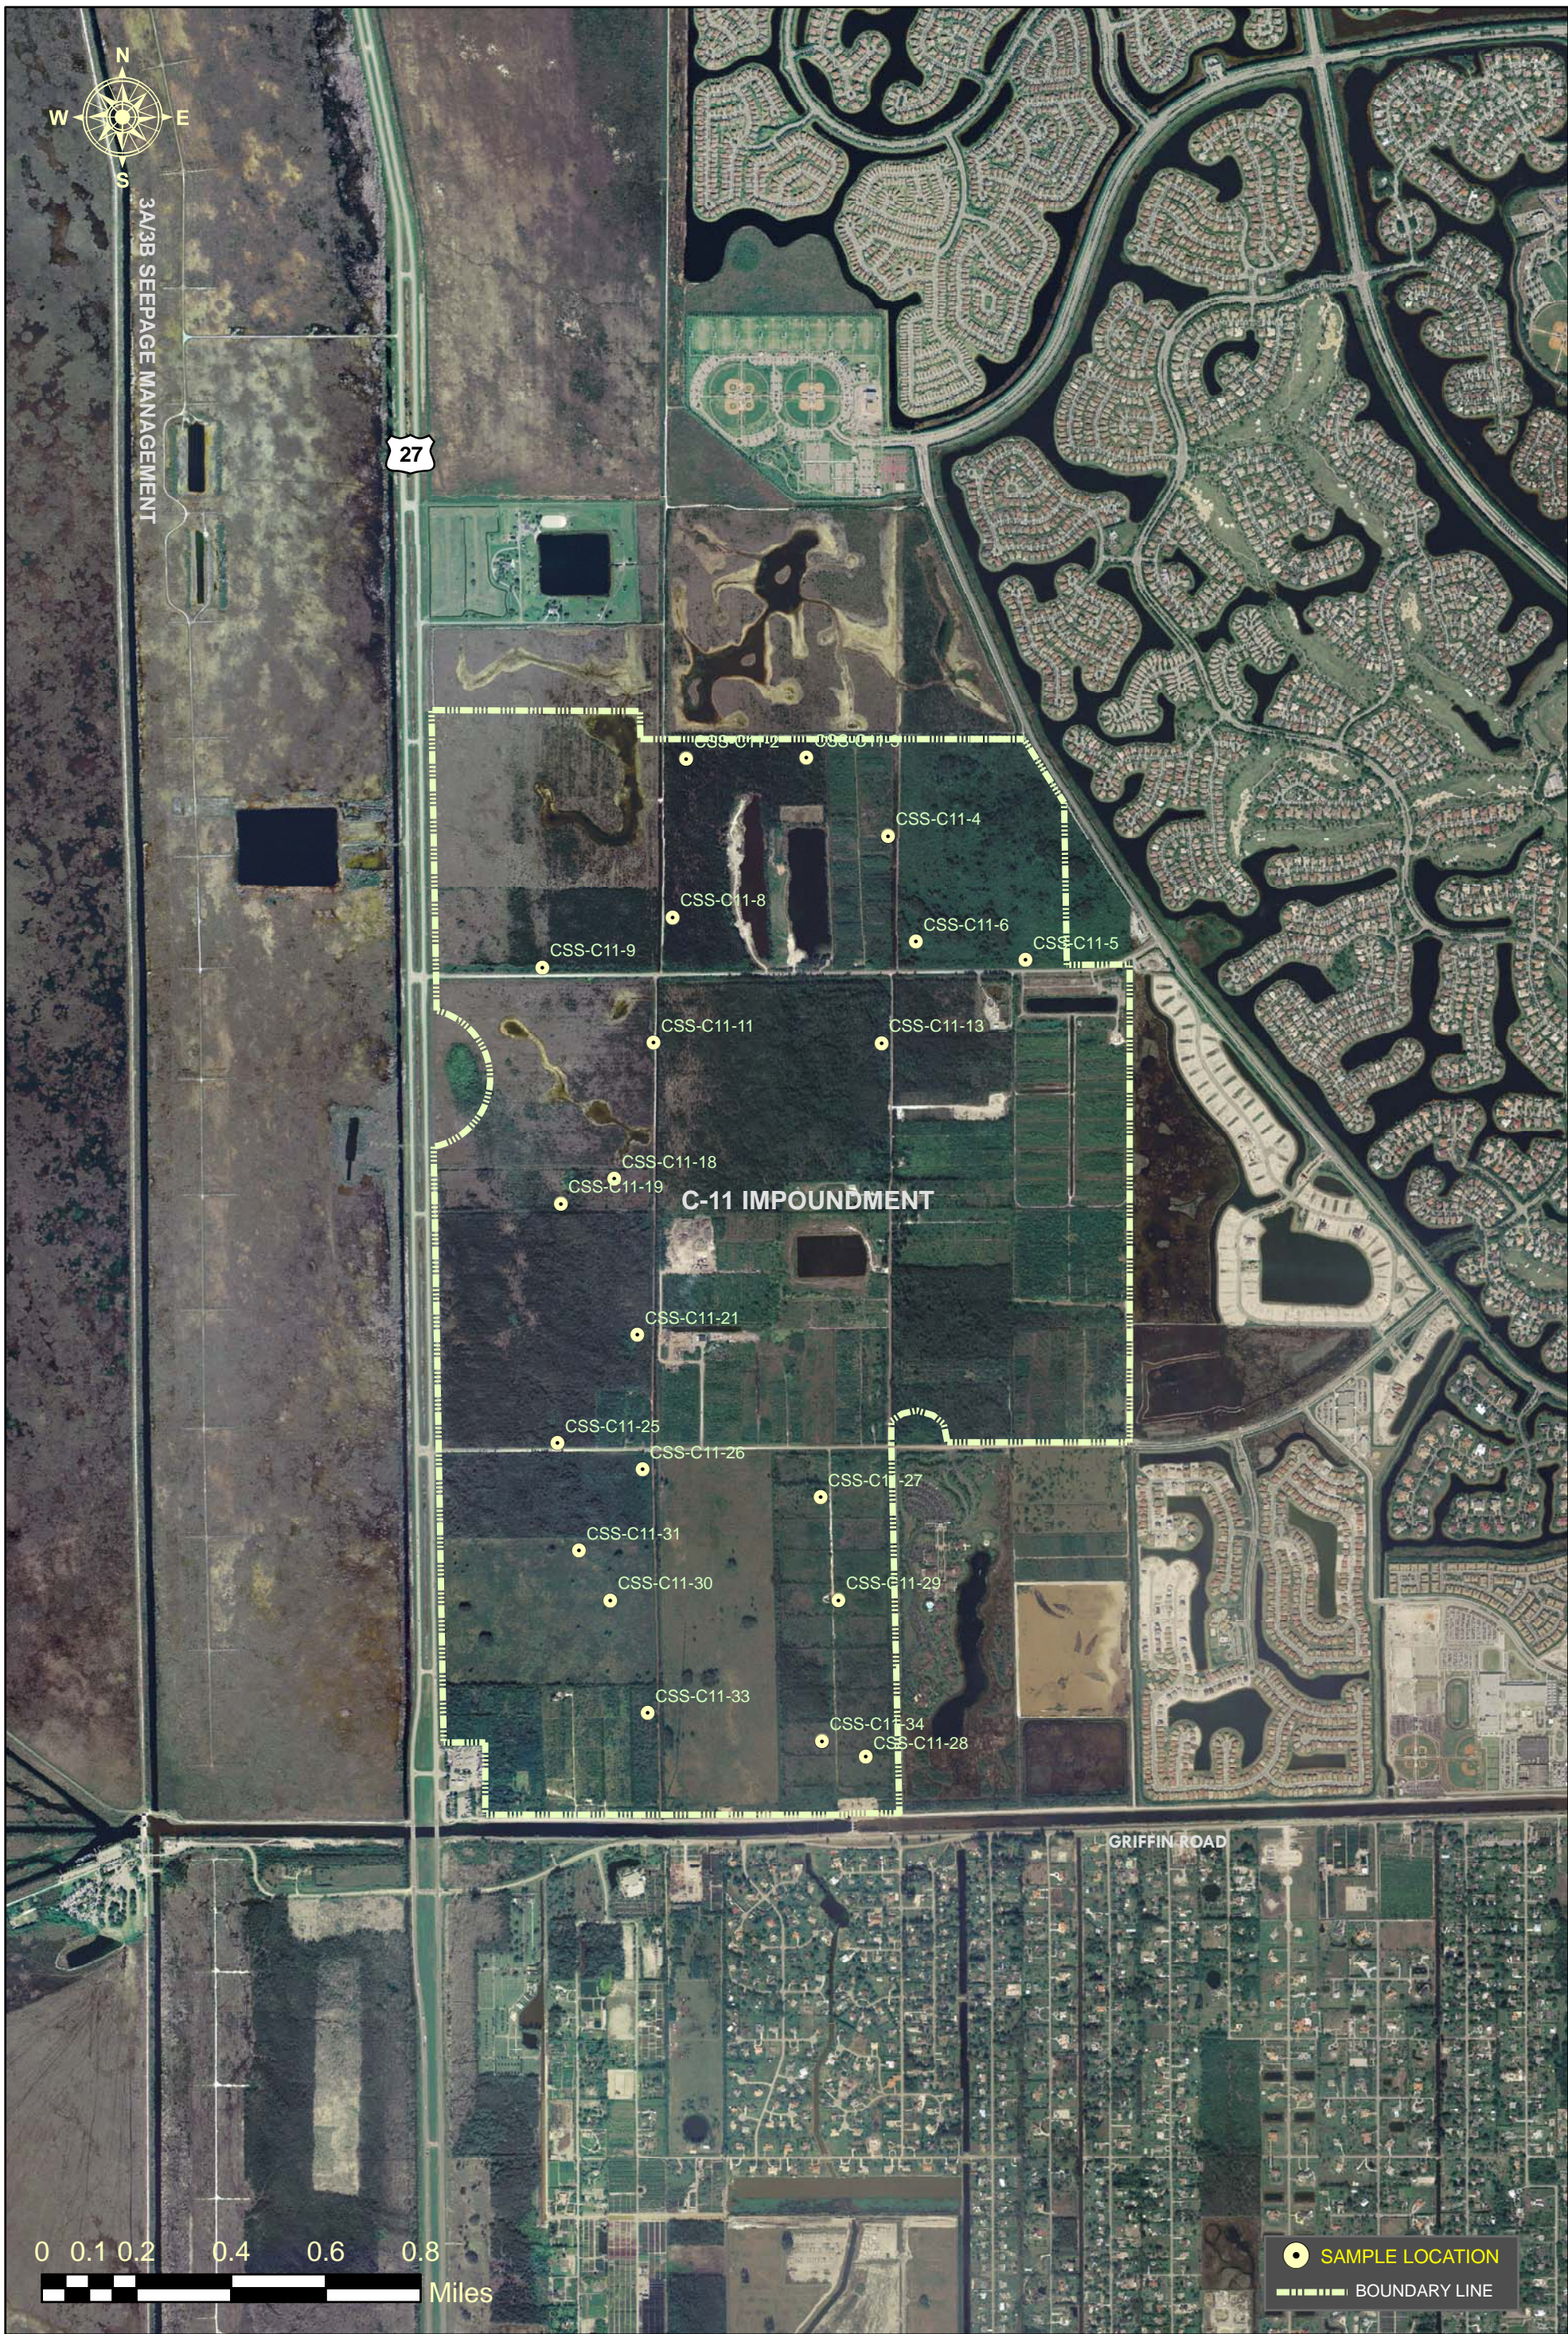
C-11 IMPOUNDMENT
BARIUM EXCEEDANCE

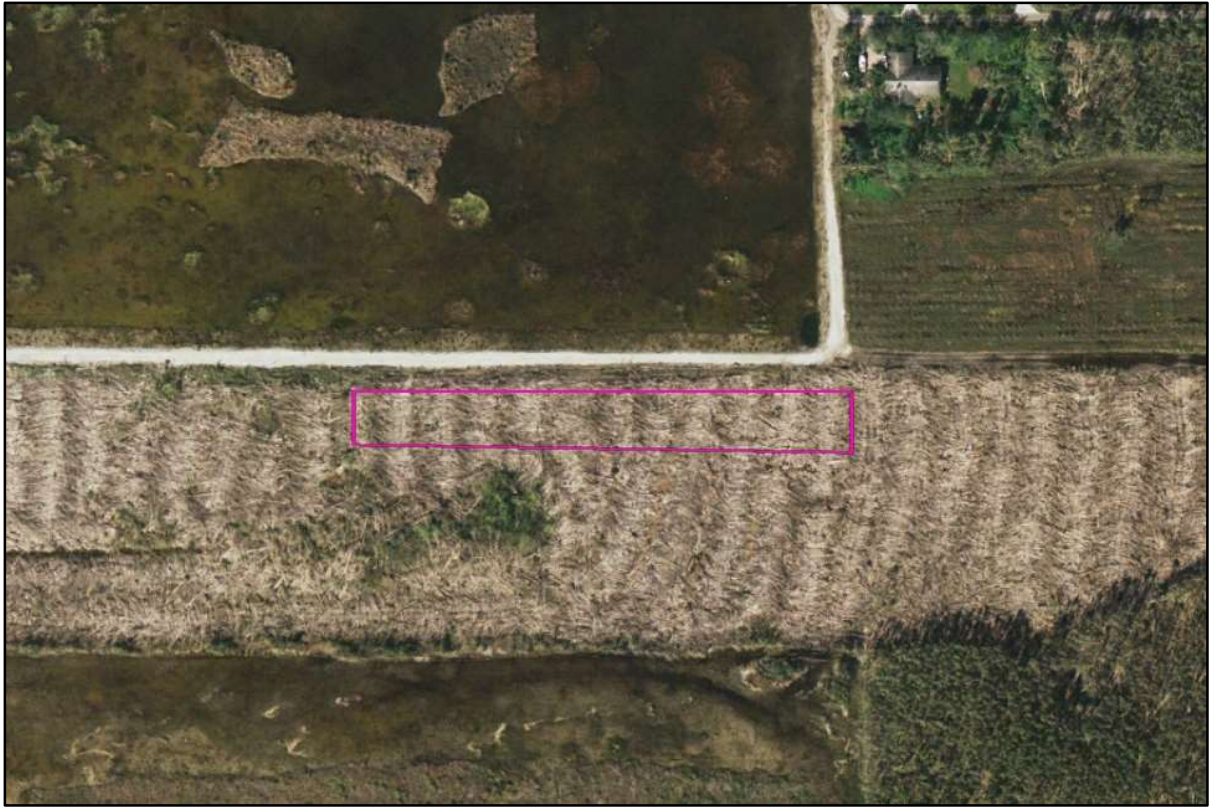
Figure 7: Representative View of Land Modification Within Tract W9200-012 in 2005

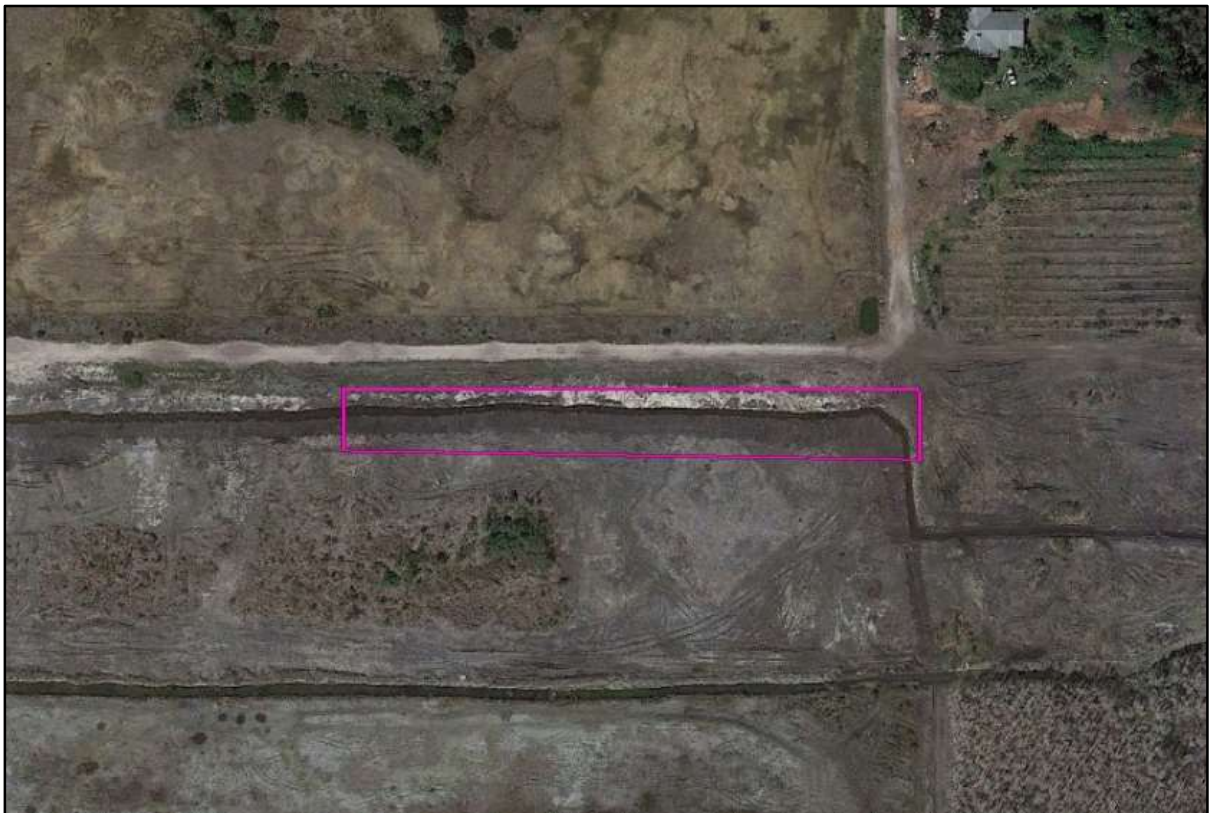
Figure 8: Representative View of Land Modification Within Tract W9200-012 in 2013

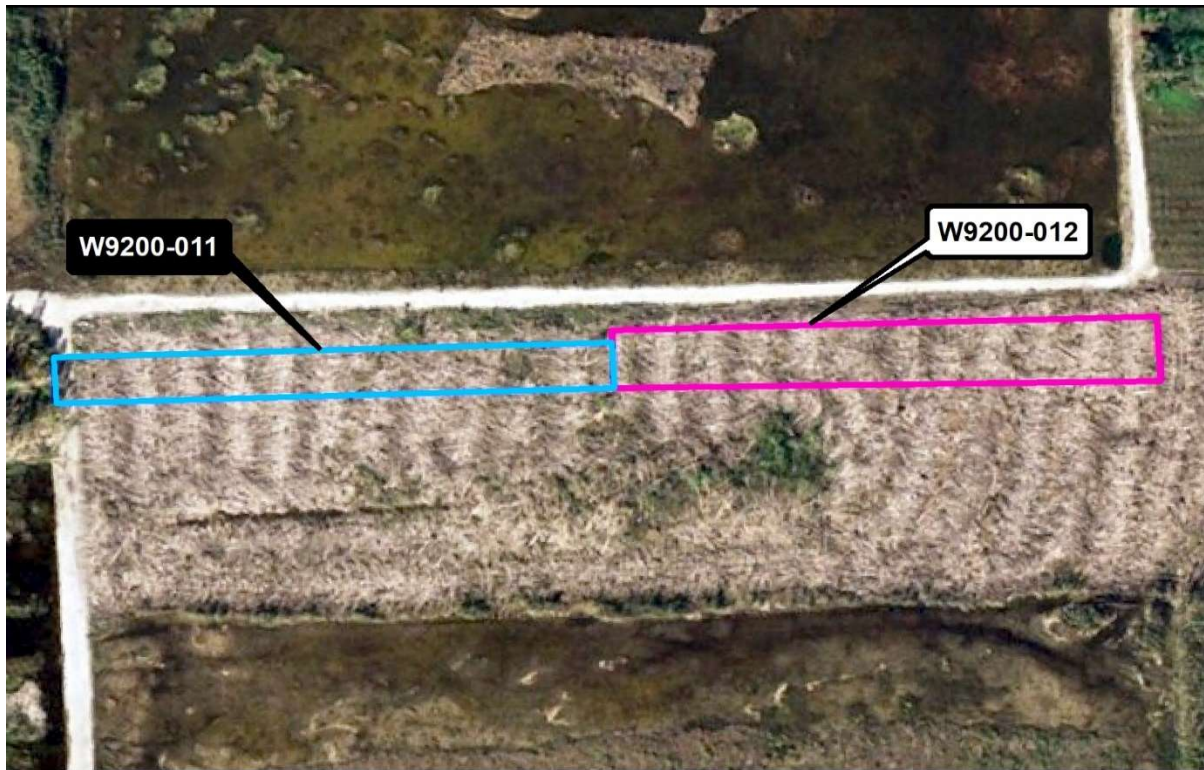
Figure 7: View of Land Modification Within Tract W9200-011 (Current Study Area) and Tract W9200-012 (January 2022 Study Area) in 2005
