FY 2010/2011 SEASONAL OPERATIONS

South Miami-Dade Water Issues Coordination Roundtable Discussion – March 1, 2011

*Maura Merkal, Project Manager
Project Coordination Division,
Everglades Restoration and Capital Projects*

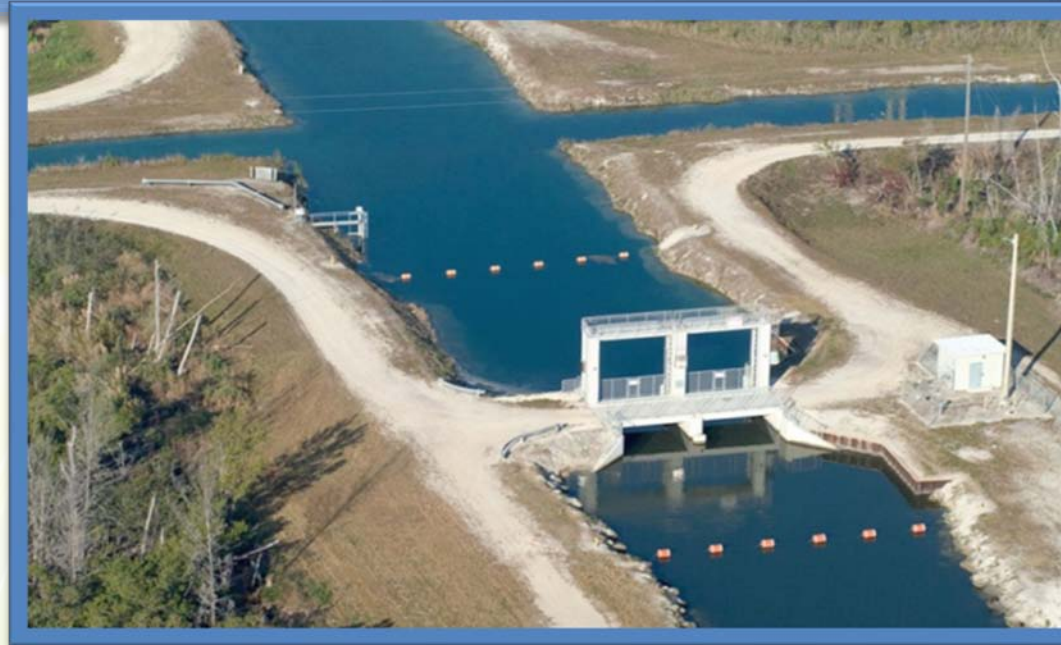
S-21A Operations

**S-21A (Canal 102)
water elevation ranges
(feet NGVD):**

High:	2.2' - 1.8'
Intermediate:	1.8' - 1.4'
Low:	1.4' - 1.0'

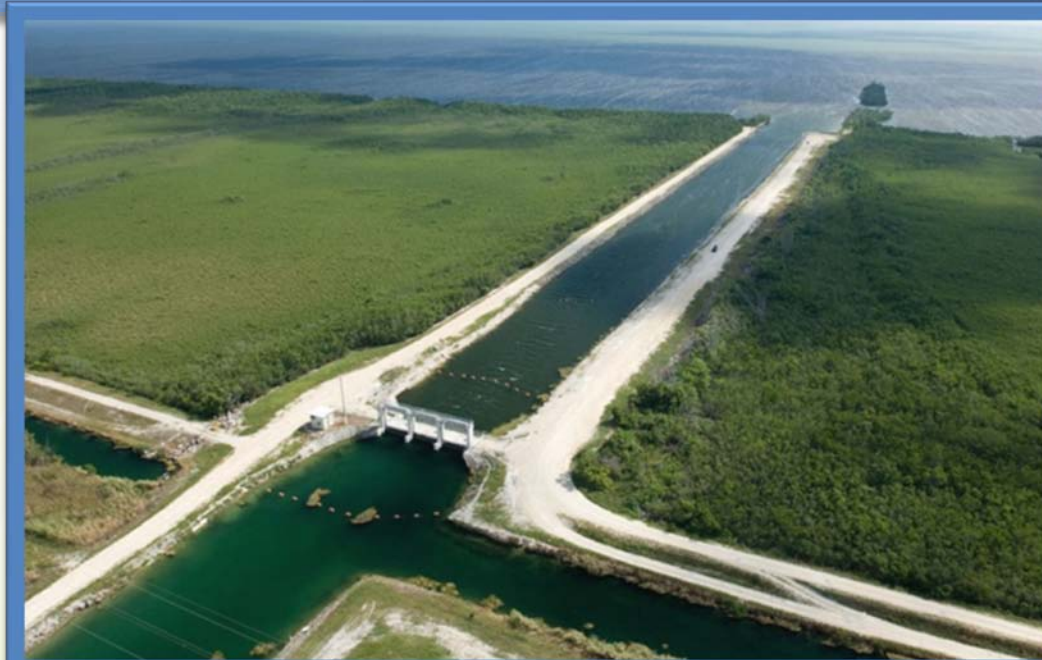
S-20F Operations

**S-20F (Canal 103)
water elevation ranges
(feet NGVD):**

High:	2.2' - 1.8'
Intermediate:	1.7' - 1.3'
Low:	1.4' - 1.0'

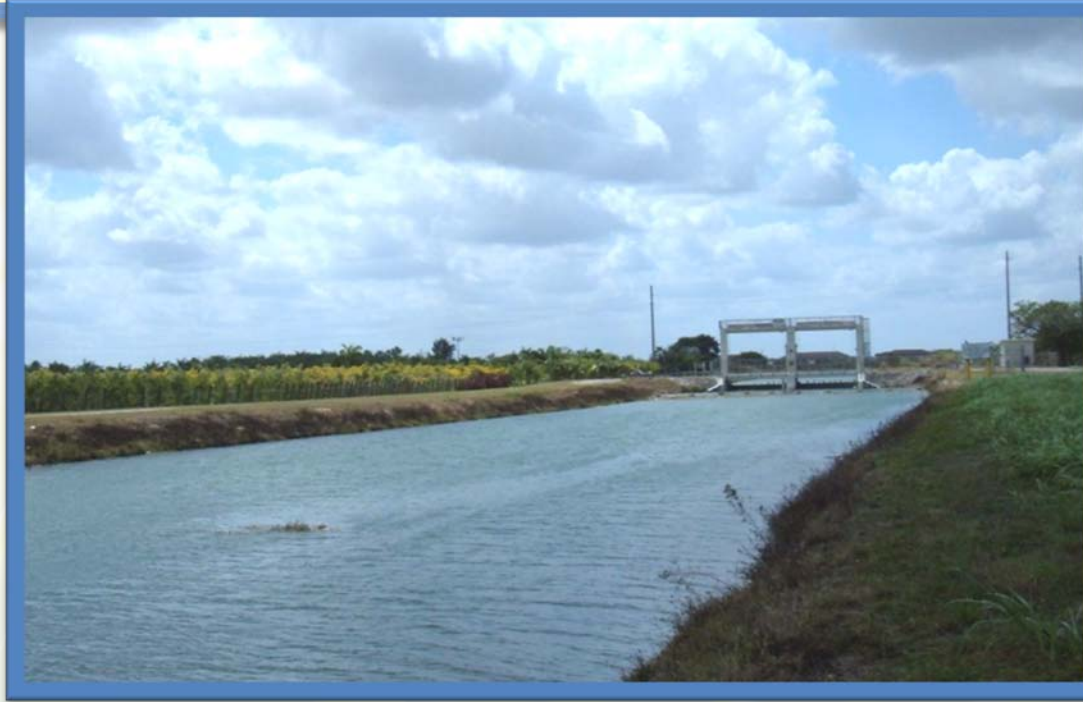
S-179 Operations

**S-179 (Canal 103)
water elevation ranges
(feet NGVD):**

High: 3.9' – 3.1'
Low: 3.1' - 2.7'

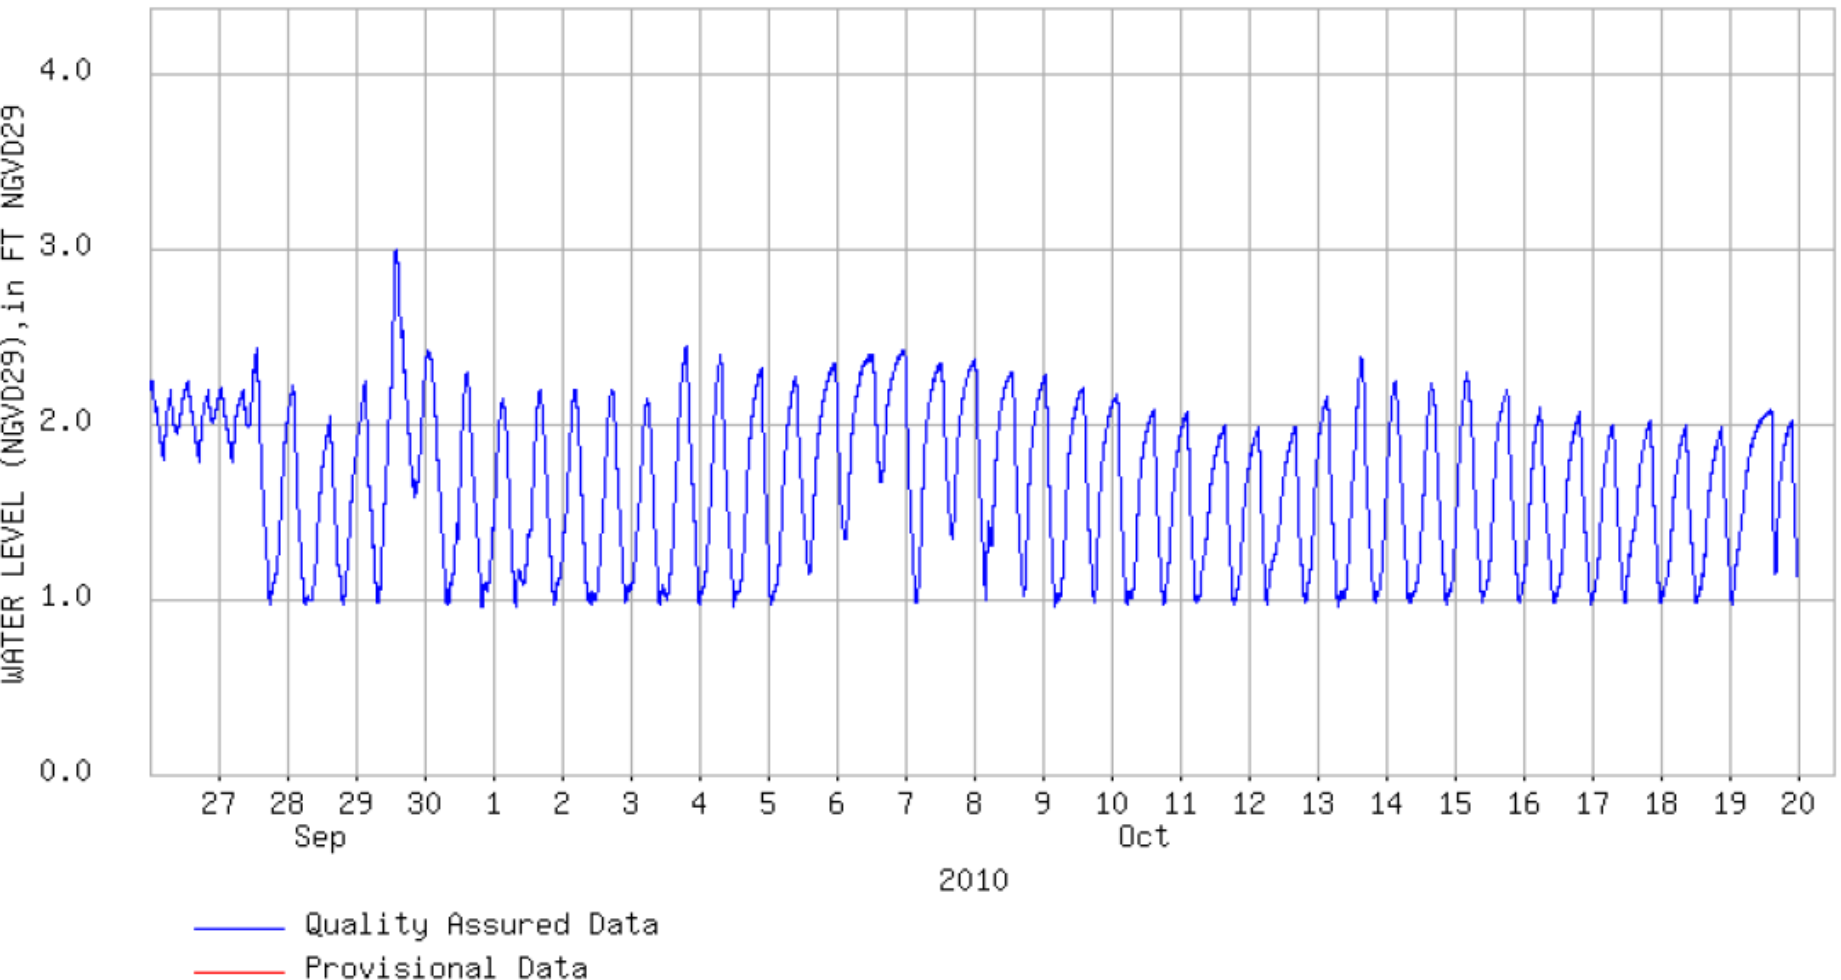
S-20F Headwater Elevations September 29 to October 19, 2010

S-20F SPILLWAY ON CANAL C-103 NEAR TIDEWATER (HEADWATER)

Station: S20F_H Freq: BK DataType: STG Stat: INST Agency: WMD Recorder: TELE opNum: Dbkey: 06572

- Operational Range Protocol (Headwater)
 - Ex. Low Range: Gate Opens 1.4', Closes 1.0'
- Tidal Influences (Tailwater)
 - When tides are high, the gates operate to prevent saltwater intrusion sometimes allowing the canal levels to rise higher than the operational gate open criteria
 - During low tides, the gates can open/close based on operational protocol

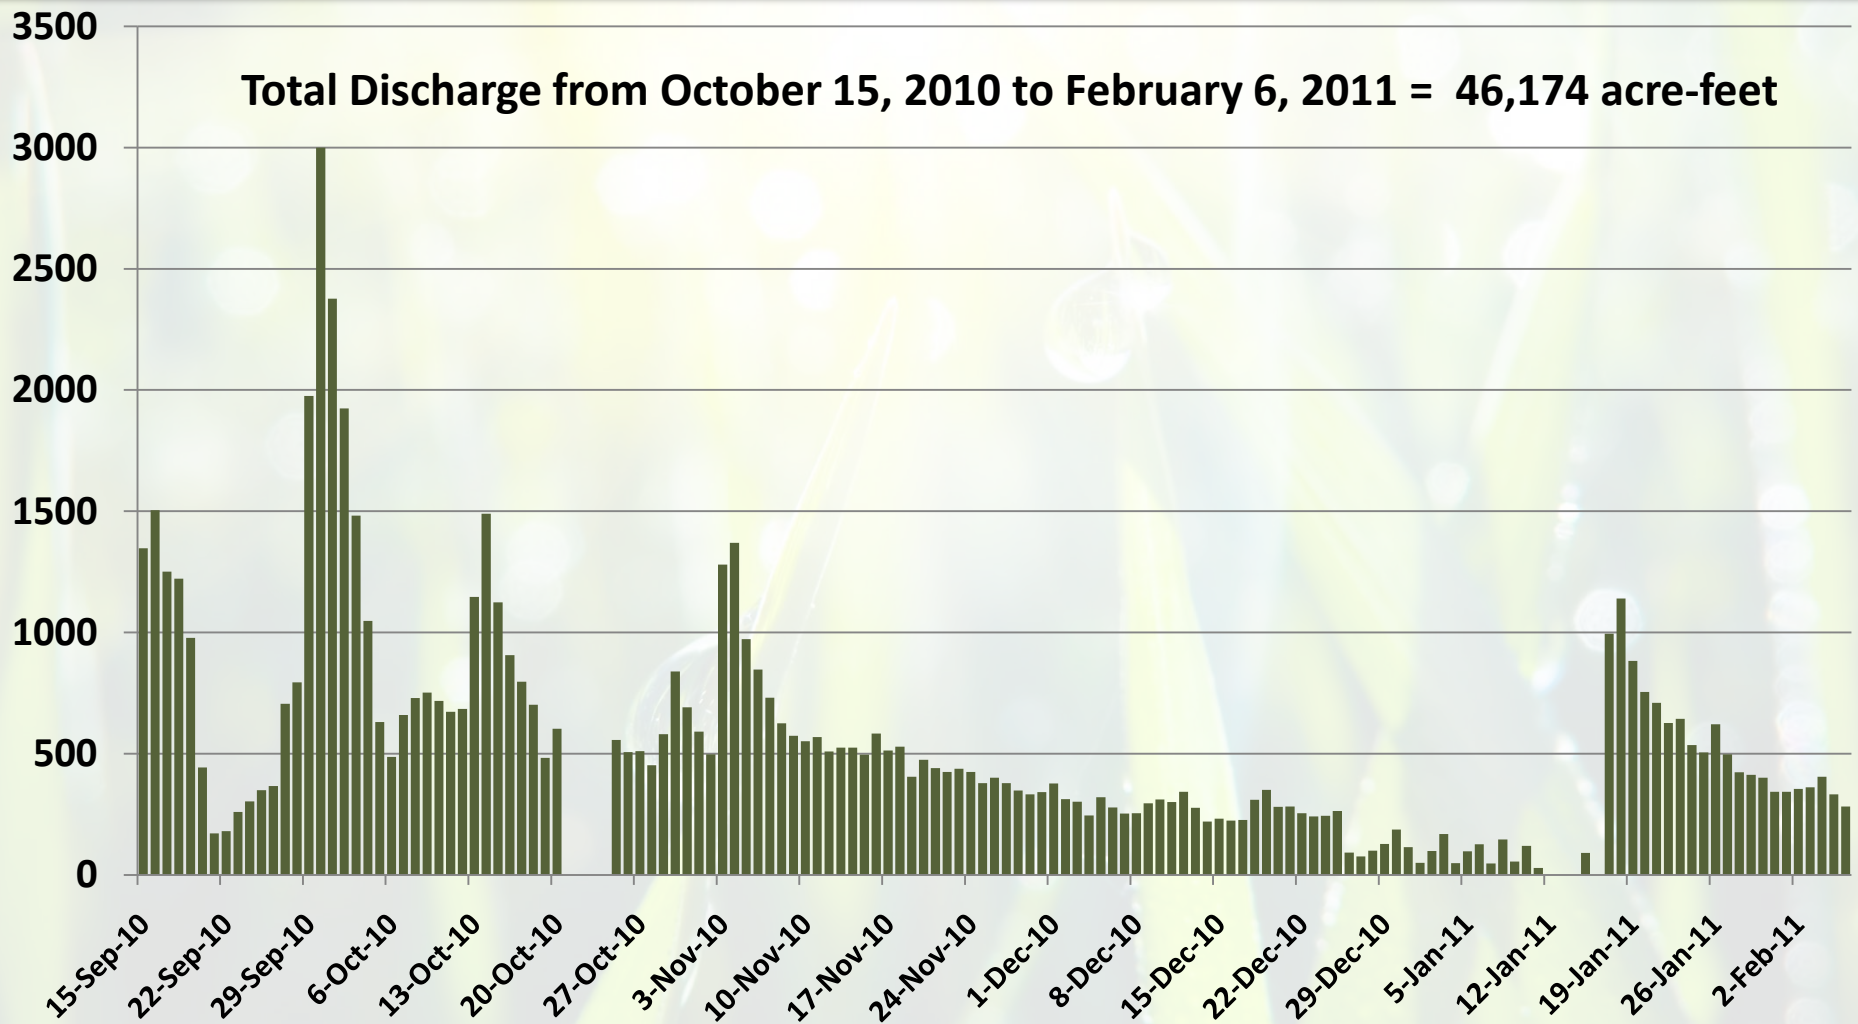
S-20F Daily Flow Volume (Acre-feet)

Total Discharge from October 15, 2010 to February 6, 2011 = 46,174 acre-feet

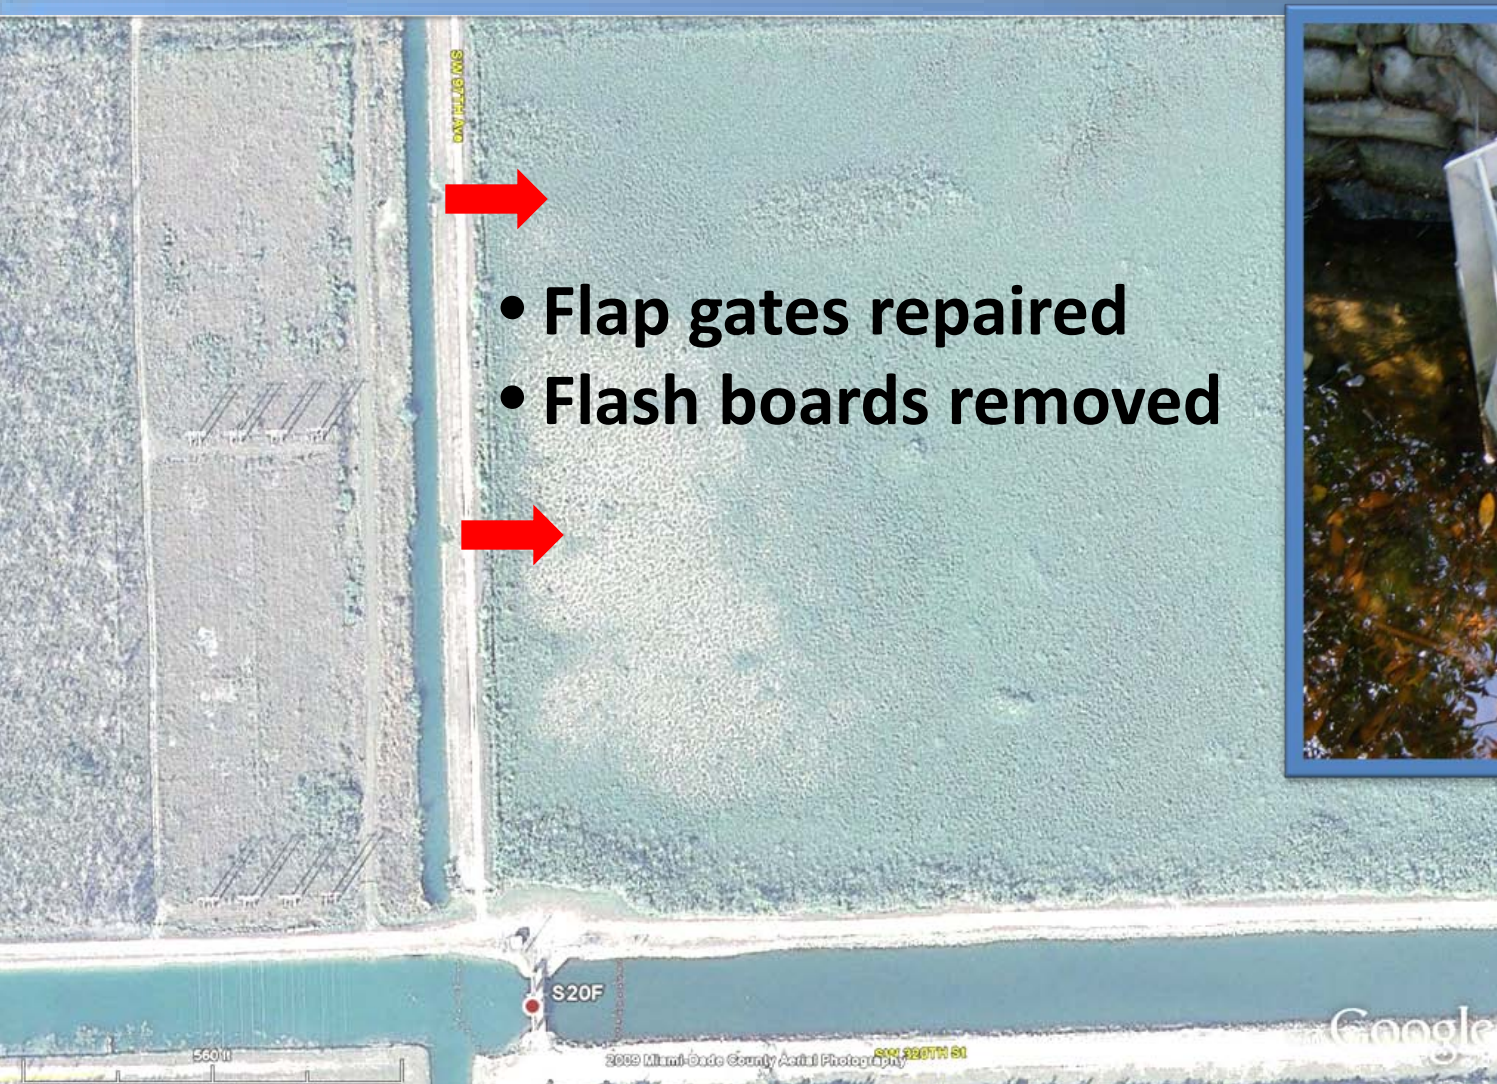
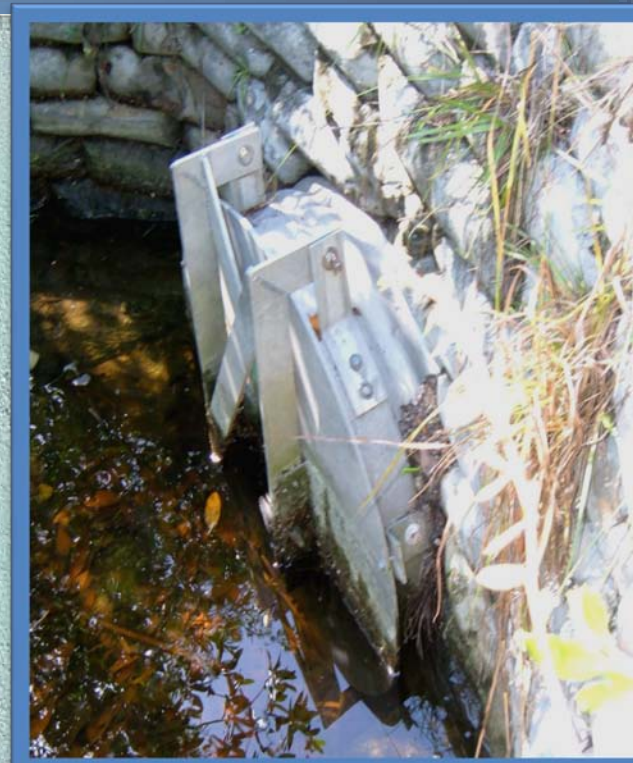
L-31E Culvert Flap Gate Repair

- Flap gates repaired
- Flash boards removed

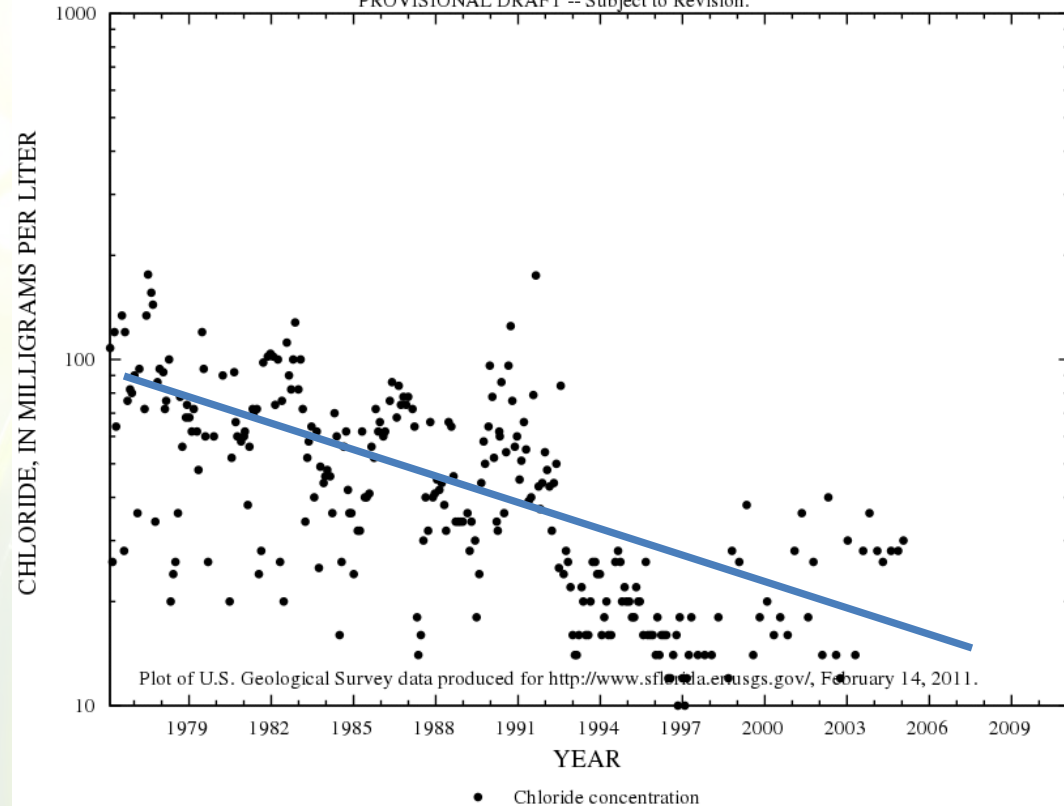
USGS Well G-1183 – Chlorides, 30 Year Period of Record

Chloride measurements from the past 35 years at G -1183 (252918080234201)
PROVISIONAL DRAFT -- Subject to Revision.
