**INVESTIGATION OF OBSERVED DRIER CONDITIONS IN LONG-TERM DATA AT LETTUCE LAKE BY
NATIONAL AUDUBON SOCIETY'S CORKSCREW SWAMP SANCTUARY**

Final Report
February 2021

Prepared for:
South Florida Water Management District
3301 Gun Club Road
West Palm Beach, FL 33406

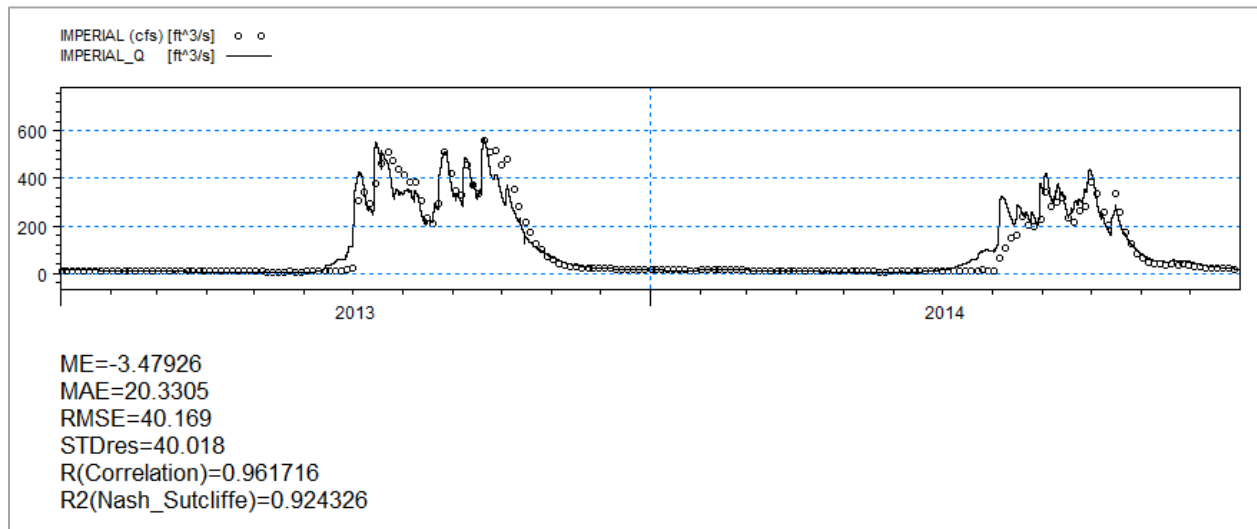
Statistics were not included in **Table 3.1** for the Imperial River USGS gaging station flow calibration. However, calibration was excellent, as shown in **Figure 3.2**. Mean absolute error was 20 cfs, and the correlation coefficient was 0.96.

Figure 3.2 – Calibration Plot for the Flows (cfs) at the Imperial River USGS Gaging Station

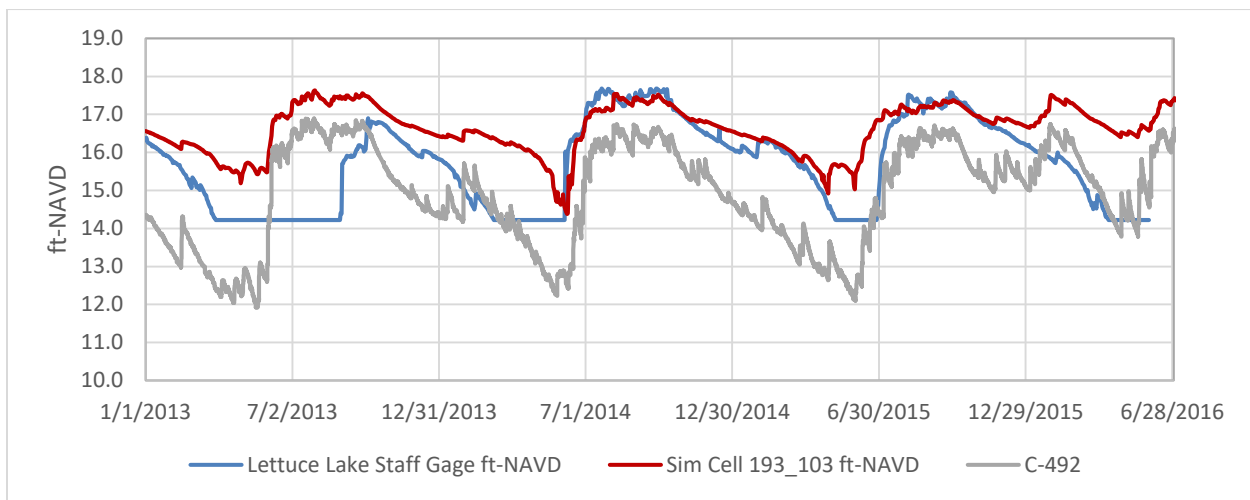
The model calibration effort did not include a comparison of measured water levels at the Lettuce Lake staff gage (also known as the B-Gage) that is located on the Sanctuary boardwalk due to questions regarding measured data and actual ground elevations in the vicinity of the Lettuce Lake gage. In response to that concern, the Water Science Team had two permanent benchmarks established, one near the USGS monitoring well C-492 and one at the start of the Sanctuary boardwalk. Water Science staff attempted to confirm the datum used for the USGS C-492 gage but were not able to confirm the datum. Utilizing the benchmark at the start of the boardwalk, the elevation of the Lettuce Lake staff gage was surveyed, and hand measurements at that staff gage were then converted to elevations relative to the NAVD 1988 datum. This work was completed after the completion of the calibration effort, which prevented the model calibration effort to utilize the information available from the B-Gage. **Figure 3.3** presents a plot of measured data for the B-Gage and C-492 vs. simulated water levels at the B-Gage (location shown in **Figure 3.1**). Simulated peak stages are higher than measured for 2013 and the first half of 2014, and for May – June, 2015 and 2016. Model performance may be affected by the inaccuracies of topography in the vicinity of the Sanctuary boardwalk. Surveyed ground elevations are more than one foot lower than the LiDAR elevation at the B Gage and at the location of the Bald Cypress monitoring station along the Central Marsh Transect that was installed in May 2020. Calibration at the B-Gage should be reviewed once issues with topographic data are resolved, and calibration issues associated with monitoring well C-492 should be addressed once the datum used at that station can be confirmed.

Figure 3.3 – Plot of Measured and Simulated Flows at the CSS B-Gage

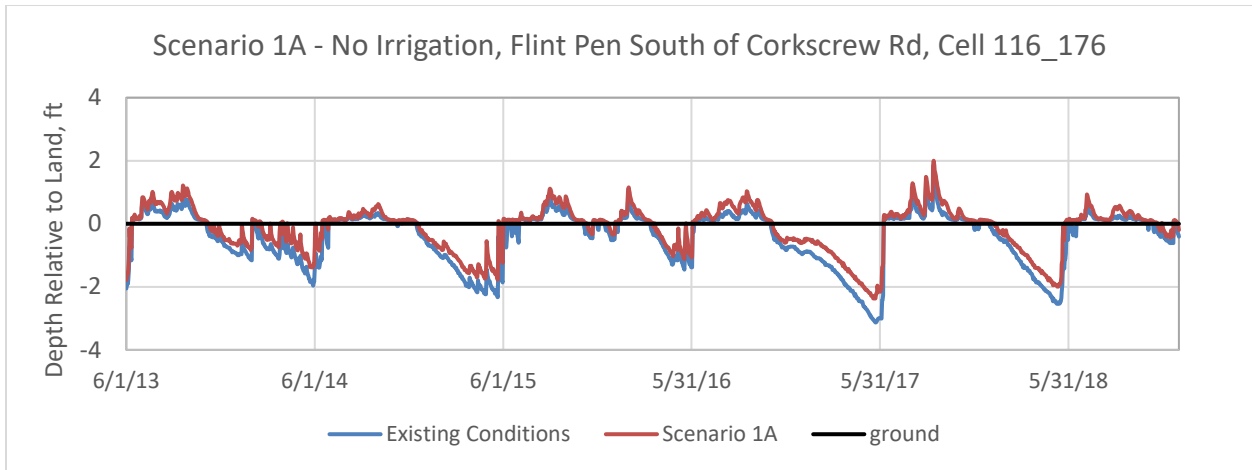
Figures 4.2 through **4.4** present water level changes for Scenario 1A and for the existing conditions simulation. Eliminating agricultural irrigation resulted in slight increases in dry season water levels in cell 116_176, which is in Flint Pen Strand south of Corkscrew Road near the intersection with Alico Road (**Figure 4.1**). In the existing conditions simulation, wetlands one mile south of agricultural lands (cell 226_148) never dry out due to irrigation of upstream agriculture, runoff into ditches, and/or seepage from detention areas. Appropriate seasonal drying is necessary for proper management of this land (e.g., prescribed fire), maintaining natural vegetation communities, and seasonally concentrating aquatic prey communities. Scenario 1A results in lower dry season water levels south of the agricultural lands that will improve ecological function and allow necessary land management activities. There was no response in water levels near the Sanctuary boardwalk from elimination of agricultural irrigation.

Figure 4.2 – Simulated Water Depths Relative to Land Surface for Scenario 1A and Existing Conditions for Flint Pen Strand South of Corkscrew Road, Cell 116_176

- *Elimination of Agricultural Irrigation.* Scenario 1A simulated no agricultural irrigation east of I-75, primarily areas north of the Sanctuary. Elimination of agricultural irrigation resulted in increased dry season water levels in Flint Pen Strand but no hydroperiod changes throughout most of the Sanctuary. An exception to this was seen in wetlands in the northeastern portion of Sanctuary, which lie approximately 1 mile south of agricultural lands. These wetlands currently do not dry out seasonally, exhibiting a hydroperiod that is notably longer than that observed in the 1970s and 1980s (M. Duever, personal communication). Under Scenario 1A, these wetlands had lower dry season water levels (and shortened hydroperiod), more typical of what was observed historically.

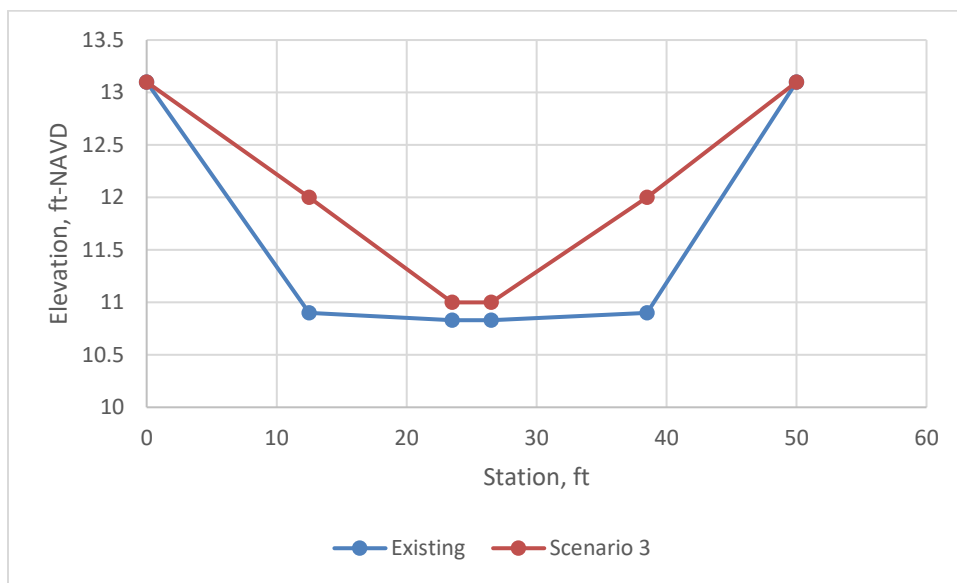
Figure 4.13 – Coco #3 Weir Dimensions for Existing Conditions and Scenario 3

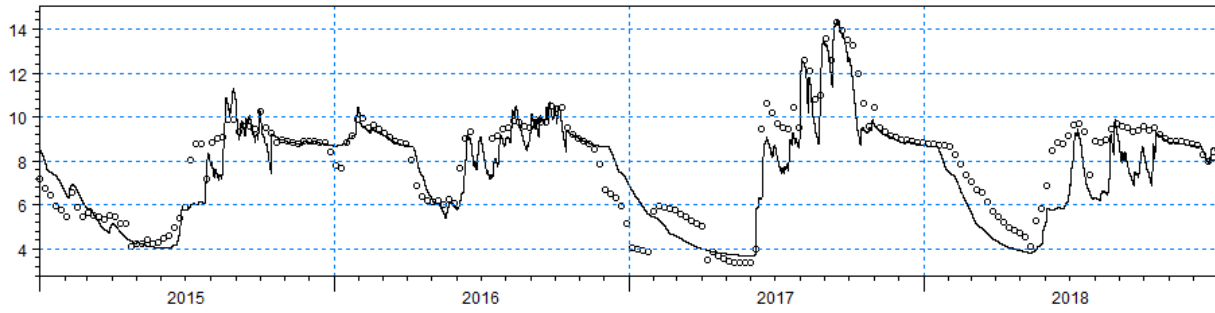
KEHL_H ft NAVD88 [ft] ○ ○
KEHL_H [ft] —

ME=0.390181
MAE=0.780418
RMSE=1.09992
STDres=1.02838
R(Correlation)=0.898441
R2(Nash_Sutcliffe)=0.773567

KEHL_T ft NAVD88 [ft] ○ ○
KEHL_T [ft] —
