TECHNICAL PUBLICATION WR-2019-001

Antecedent Land Use of the Everglades Stormwater Treatment Areas

South Florida Water Management District 3301 Gun Club Road West Palm Beach, FL 33406

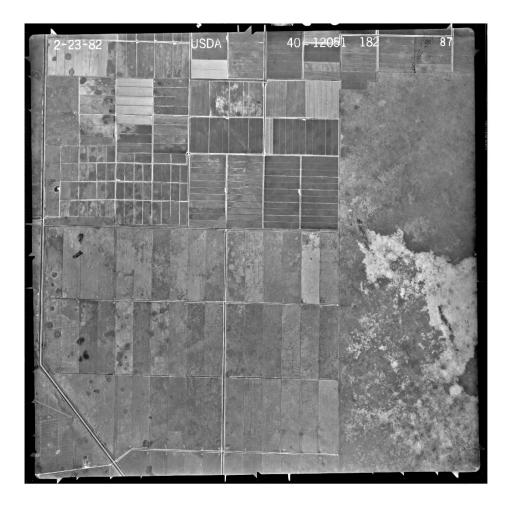
Figure A5. 1982 aerial image of the northern section of STA-5/6 from the USDA's Flight 182. The north-south canal along the left side of the image is the L-3 canal. Image courtesy of the University of Florida's digital collection of aerial photography (http://ufdc.ufl.edu/aerials).

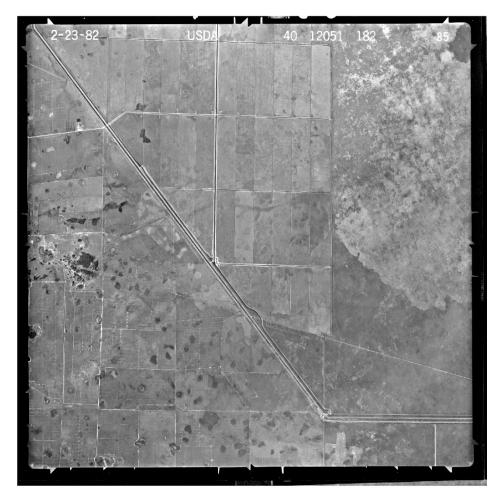
Figure A6. 1982 aerial image of the southern section of STA-5/6 from the USDA's Flight 182. The northwest-southeast canal through the center of the image is the L-3 canal. Image courtesy of the University of Florida's digital collection of aerial photography (http://ufdc.ufl.edu/aerials).
