Everglades STA Vegetation Recovery

Jill King
Science Supervisor
Water Resources Division

16th Annual Public Meeting on the Long-Term Plan
for Achieving Water Quality Goals for the Everglades
Protection Area Tributary Basins
February 25, 2019

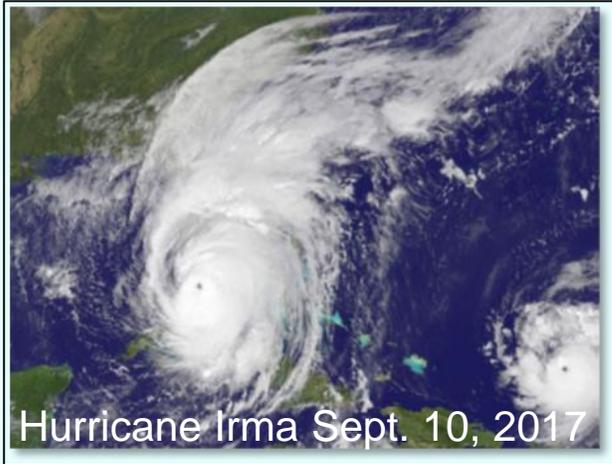
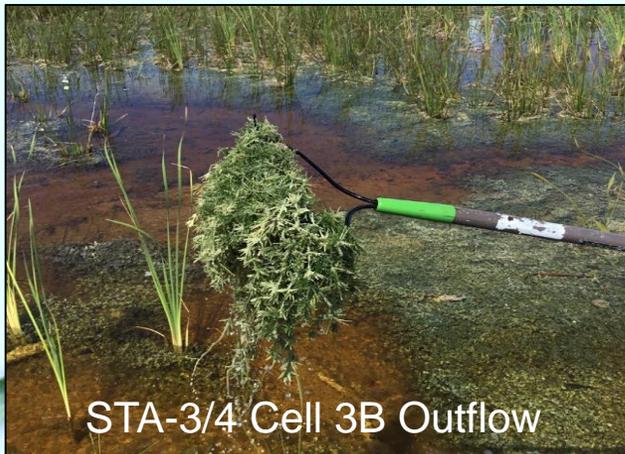
- Unnamed storm – June 2017
- Hurricane Irma – September 2017
 - High inflow volumes and TP loads to all STAs

- Various post-storm assessments throughout STAs
 - Aerial flights
 - Ground surveys
 - Coverage and health assessments
 - Water depths
 - Turbidity measurements

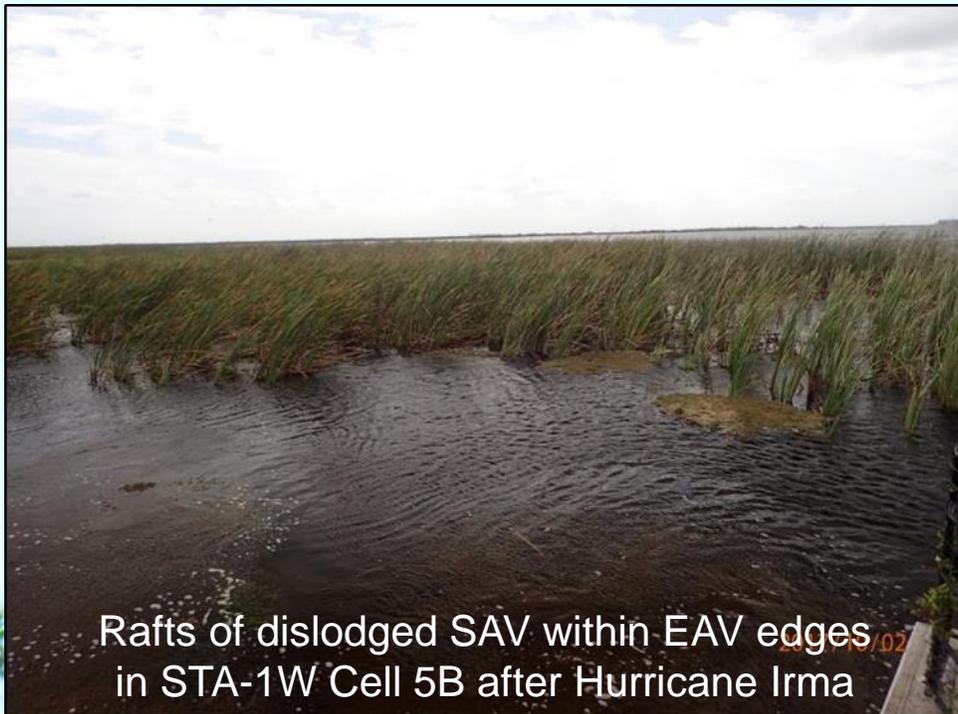
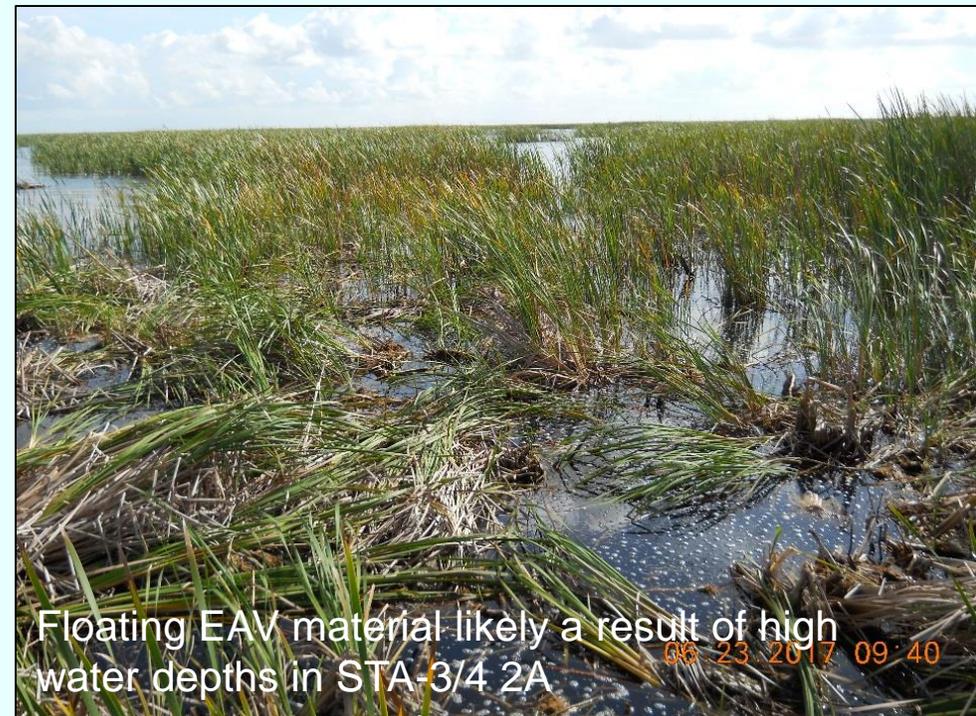
- STAs have been closely monitored since events of 2017
- Storm damage to Submerged Aquatic Vegetation (SAV) observed

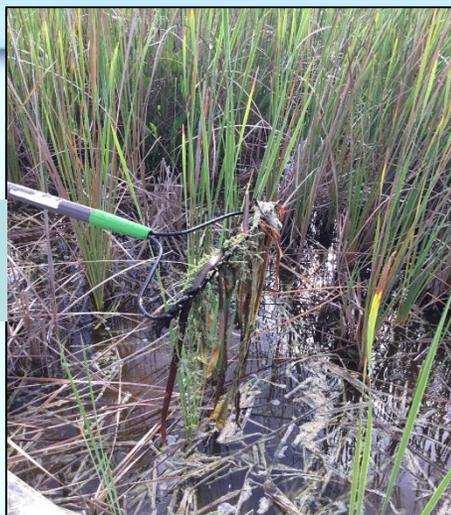
Low SAV

STA-3/4 Cell 3B
Sept 2018

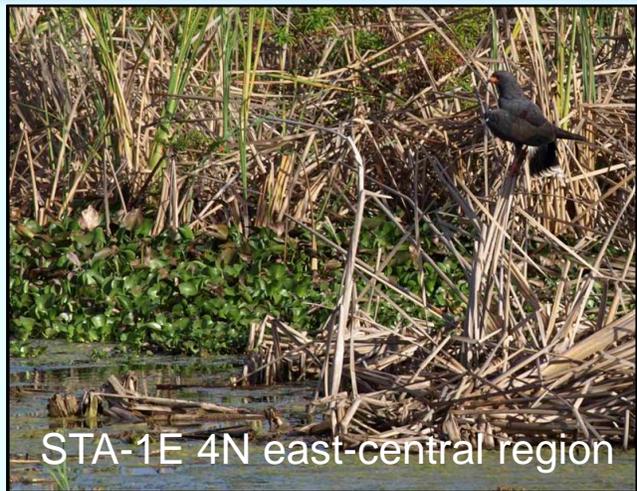
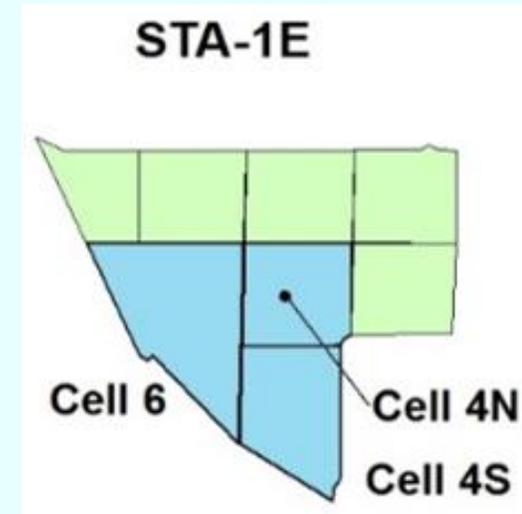
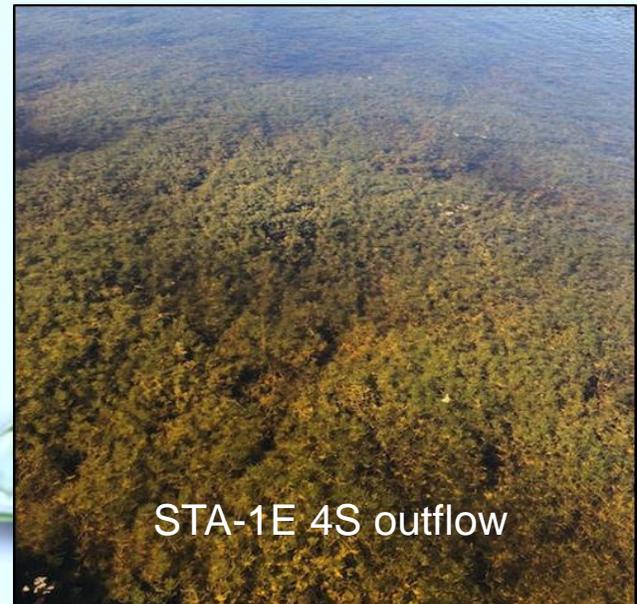
STA-1E Cells 4N and 4S SAV Conditions

- Dominant vegetation types remain as *Hydrilla* and *Ceratophyllum*
- Overall SAV coverages have improved spatially and in relative densities

- Dense *Chara* beds found at outflow of Cell 4S
- *Utricularia foliosa* observed
- Turbidity has declined

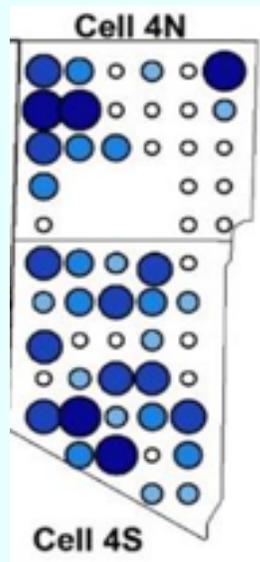
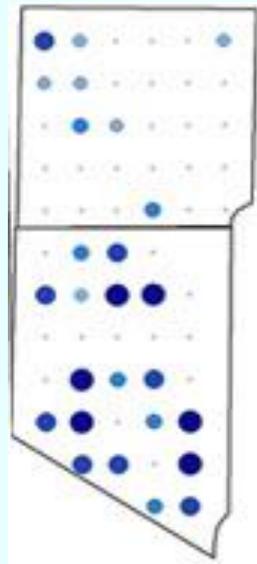
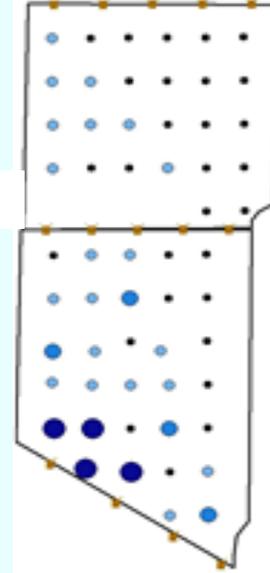
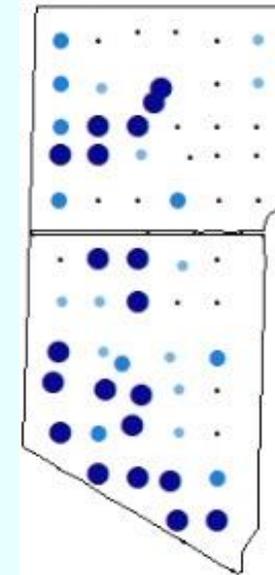
STA-1E Cells 4N and 4S SAV Coverages

- SAV density and coverages have increased
- *Hydrilla* and *Ceratophyllum* remain dominant species
- High coverages have returned to Cells 4N

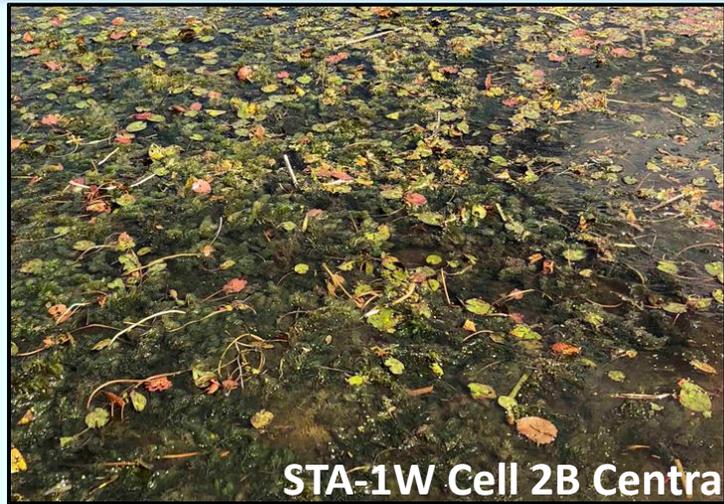
STA-1W Cell 2B Central location

- Cell 2B-Dominant vegetation type remains *Ceratophyllum*, with some *Najas marina*
- Overall SAV coverages and densities have increased

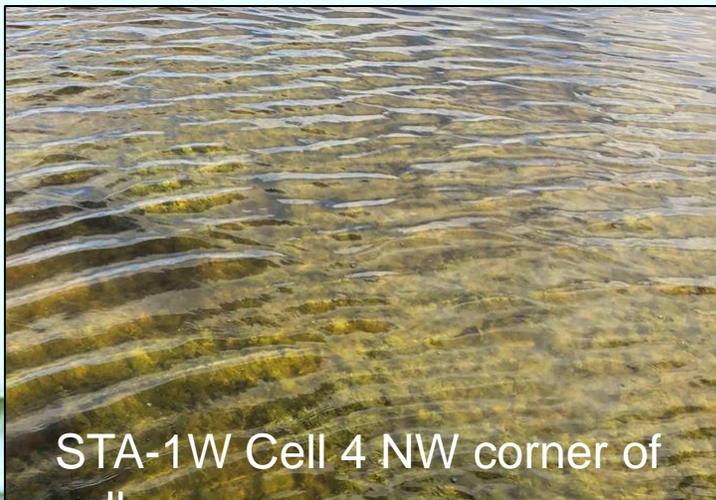
STA-1W Cell 4 NW corner of cell

- Cell 4-Dominant vegetation type remains *Chara*, with some *Najas guad.* and *Ceratophyllum*
- SAV appeared stressed, frequently covered in algae

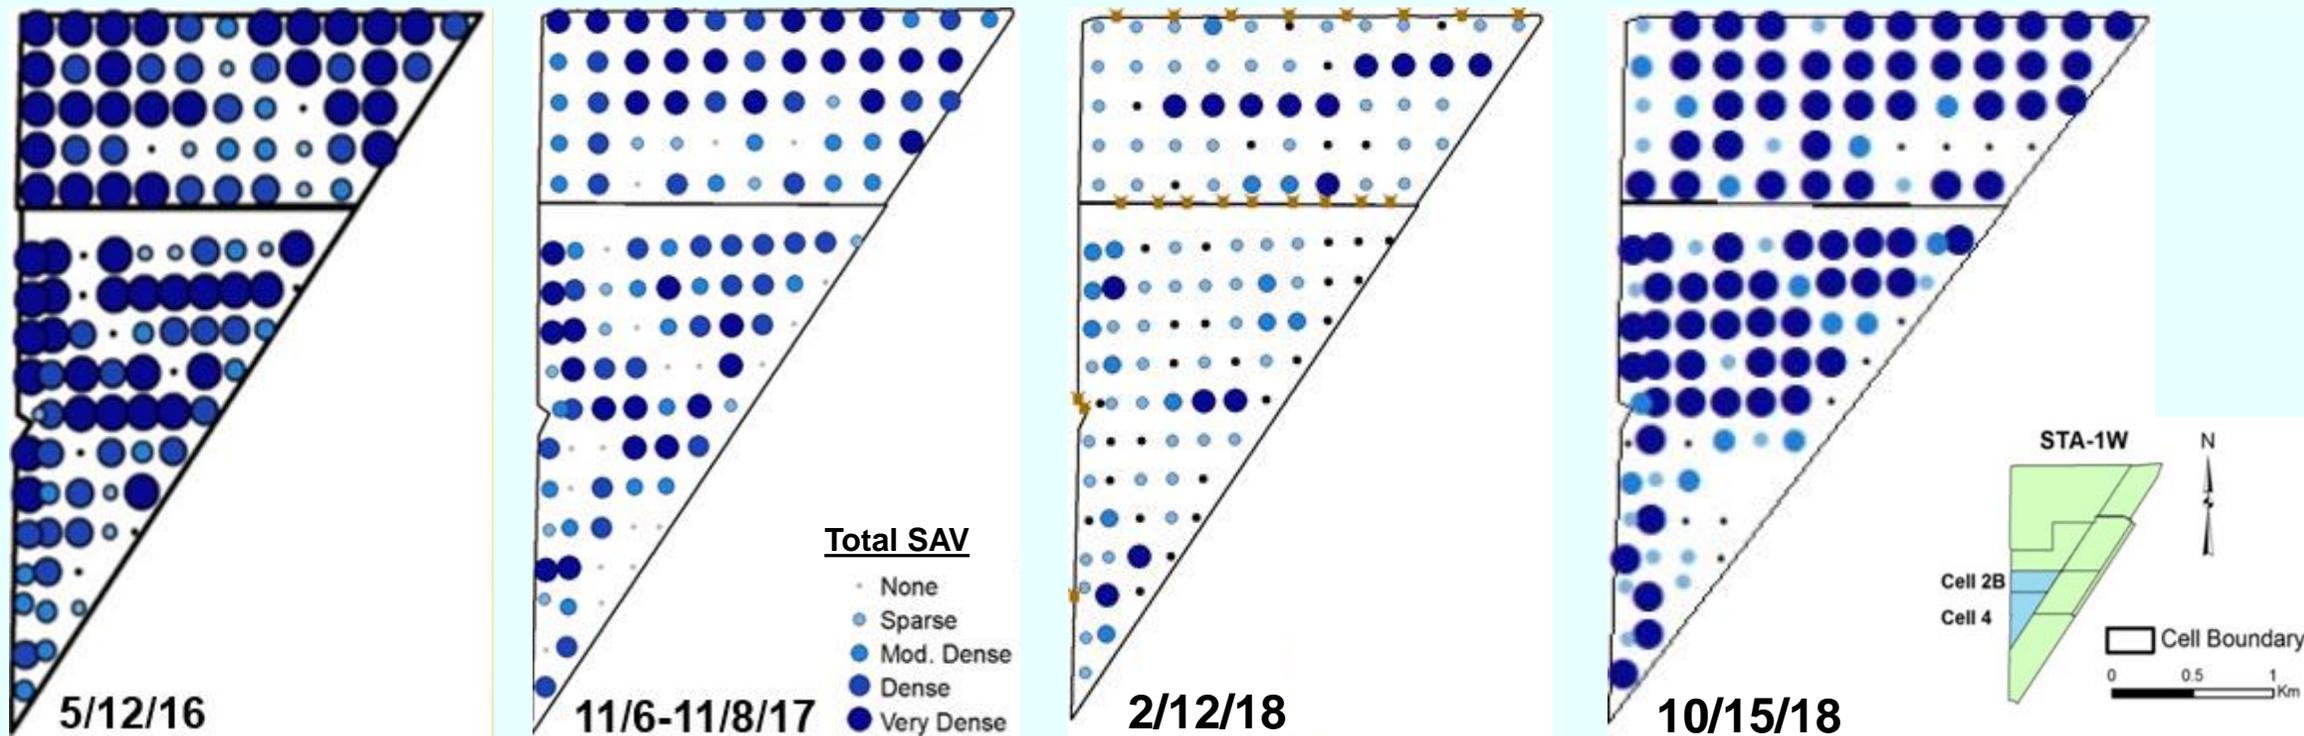
STA-1W Cells 2B and 4 SAV Coverages

- SAV has returned to pre-Hurricane Irma density and coverage
- Ceratophyllum* dominant species in Cell 2B, *Chara* dominant species in Cell 4

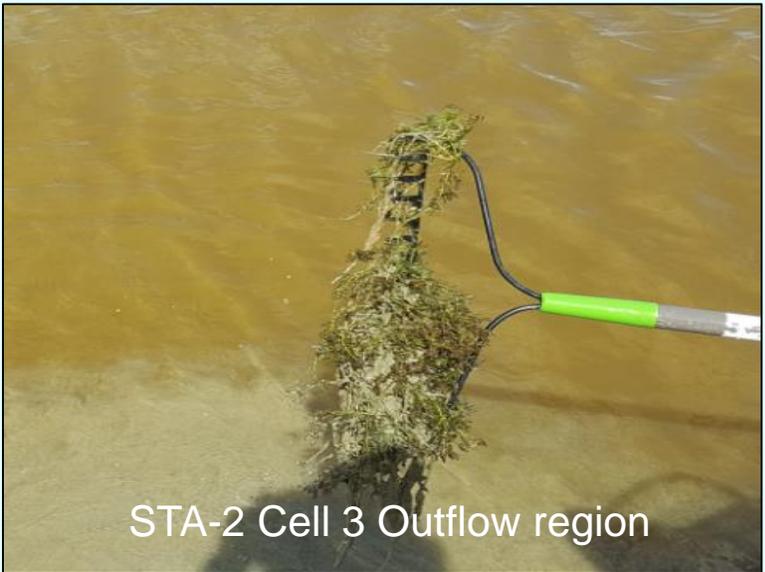
STA-2 Cell 3 Outflow region

- Cell 3-Almost 100% loss of SAV throughout cell
- One location near outflow low coverage of *Najas marina*
- Cell undergoing major rehabilitation to restore SAV and incorporate vegetation strips

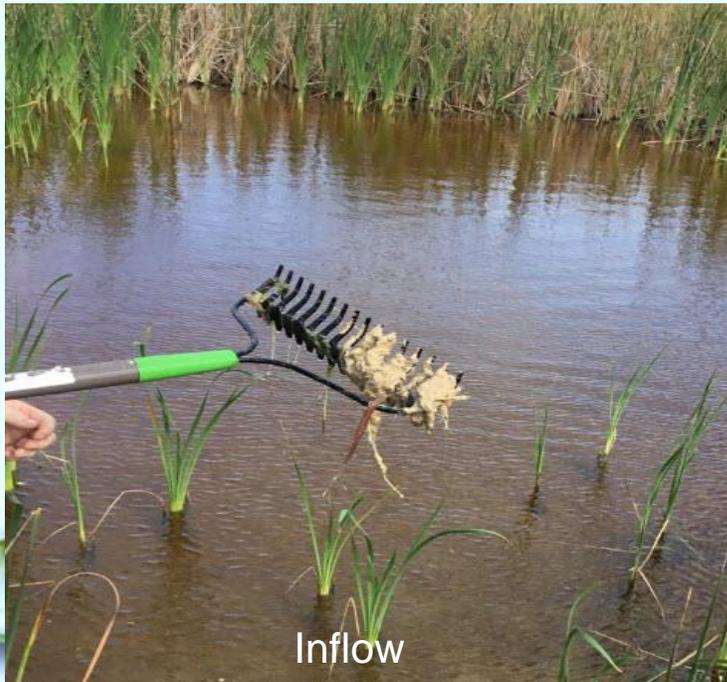
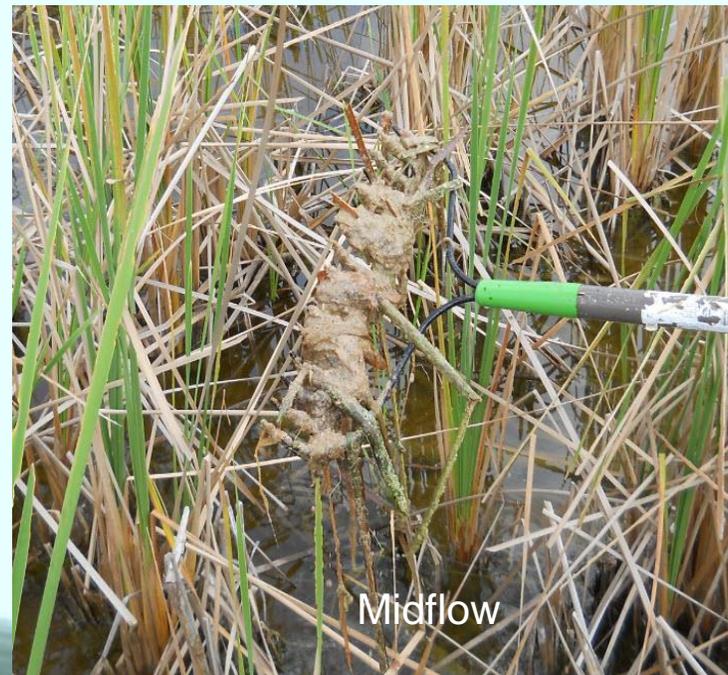
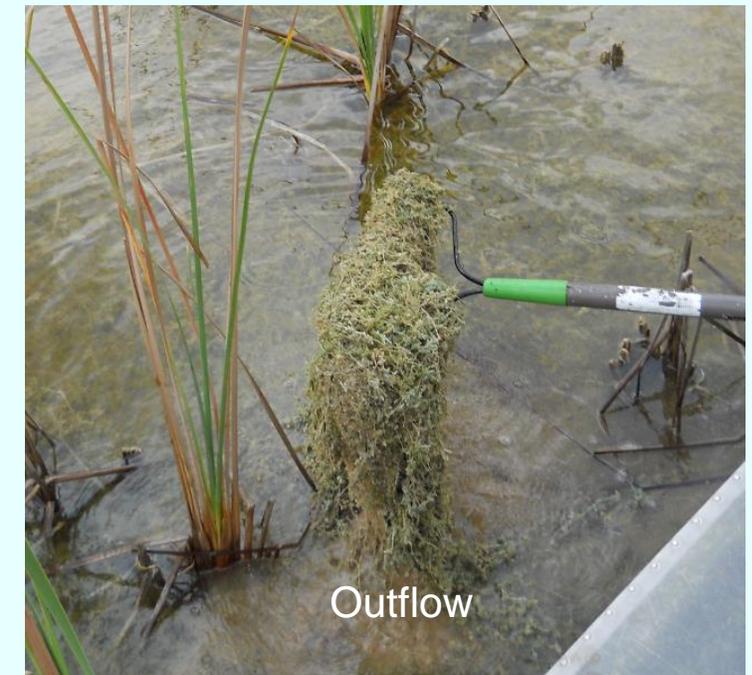
STA-3/4 Cell 3B SAV Conditions

- SAV appears to be recovering well
- *Chara* recovering more quickly than other species
- Highest densities near outflow regions

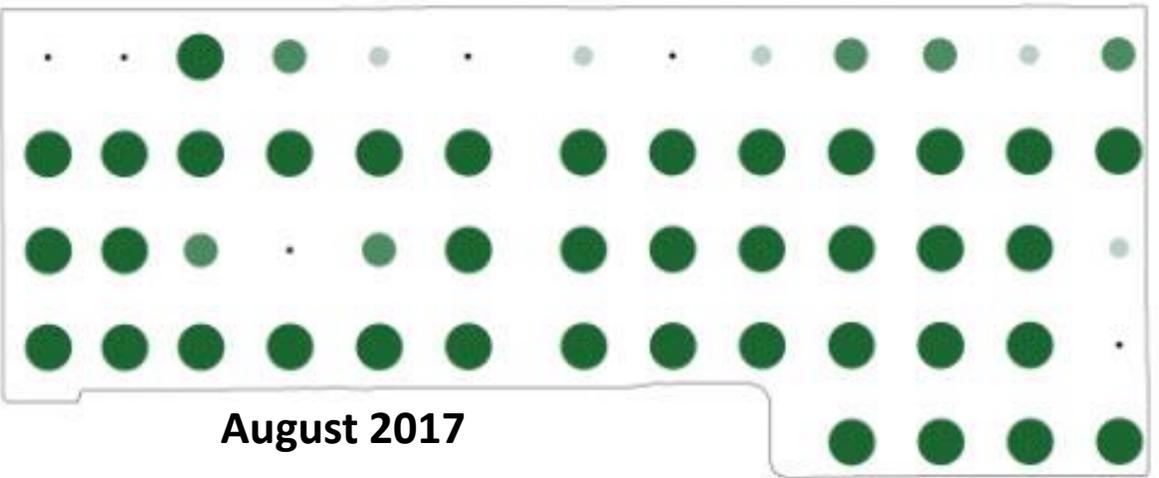
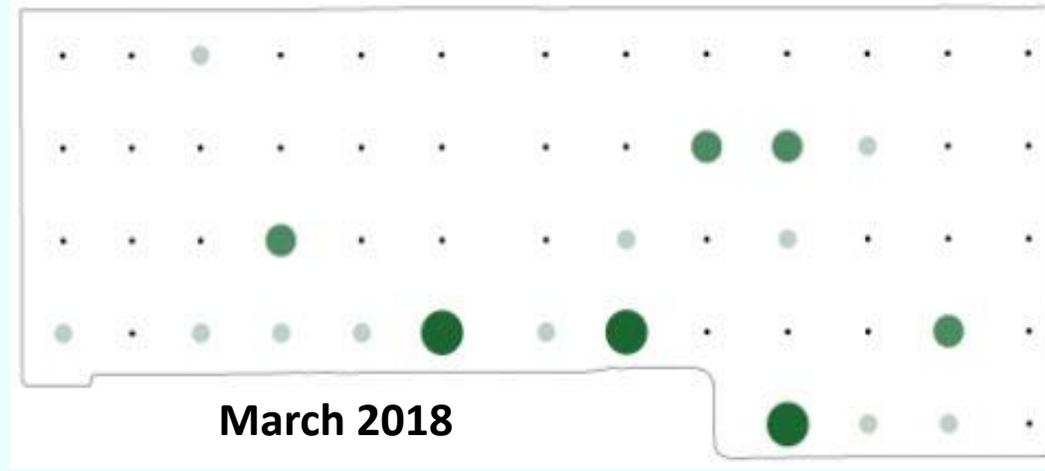
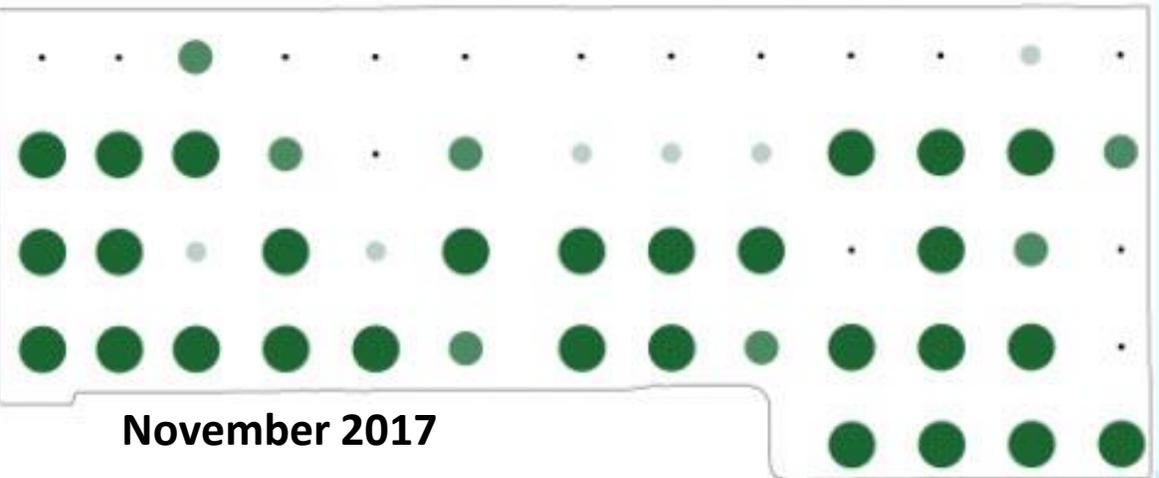
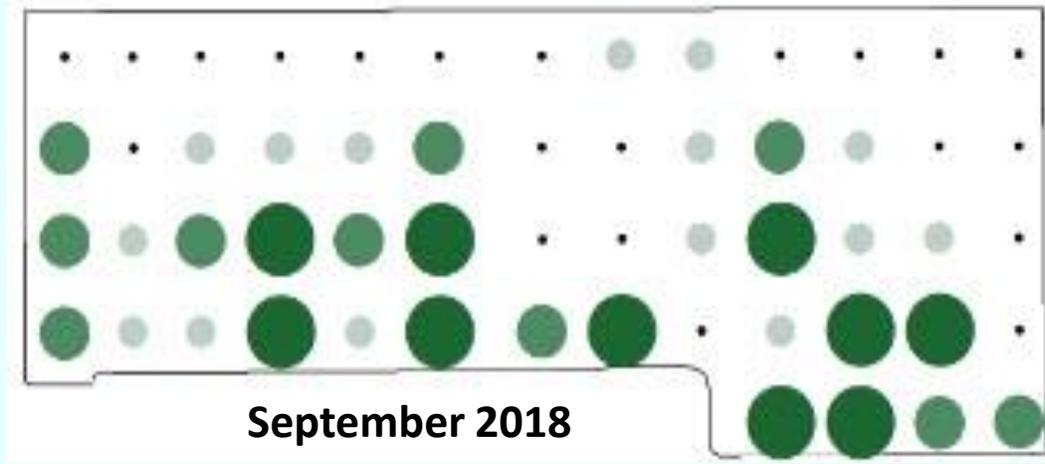
STA-3/4 Cell 3B SAV Coverage

- STA-1E Cells 4N and 4S - Coverages and densities increased
- STA-1W Cells 2B and 4 - Coverages and densities increased
- STA-2 Cell 3 – SAV has not recovered; major vegetation rehabilitation ongoing
- STA-3/4 Cell 3B - SAV is slowly recovering; densities and coverages increased
- STA-5/6 Cell 1B- Coverages and densities increased

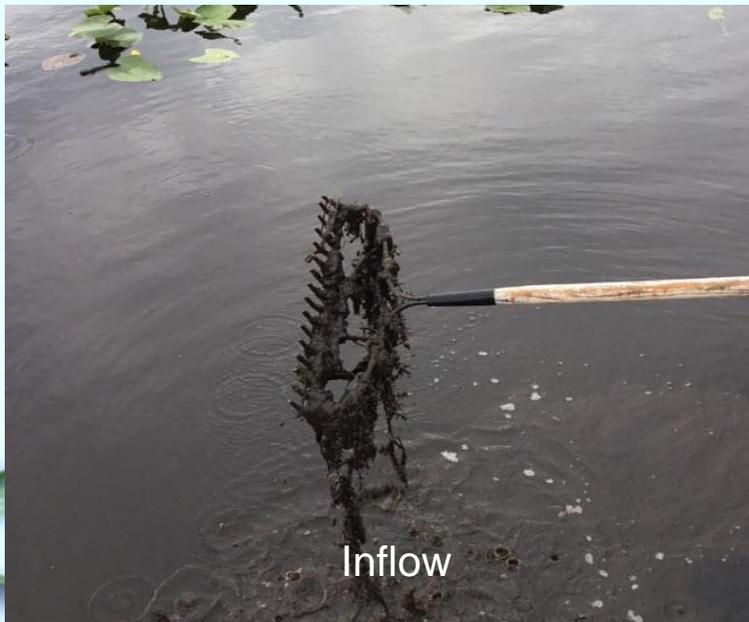
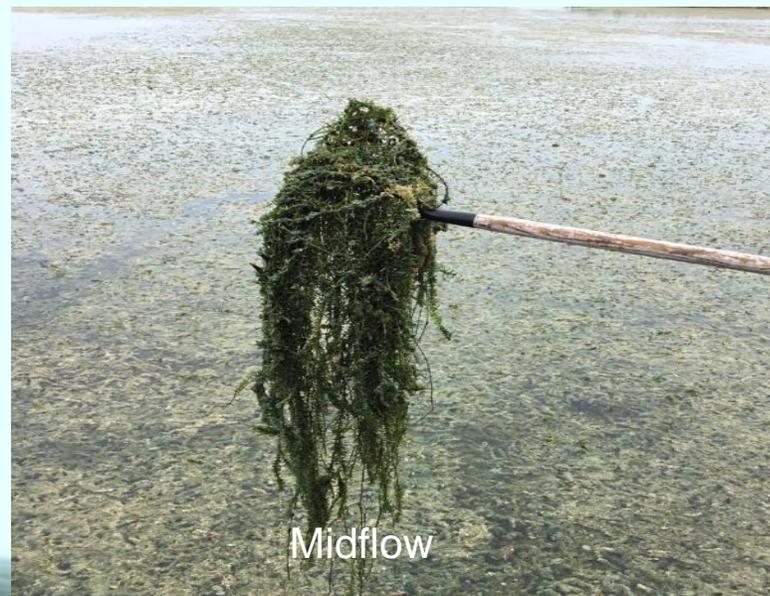
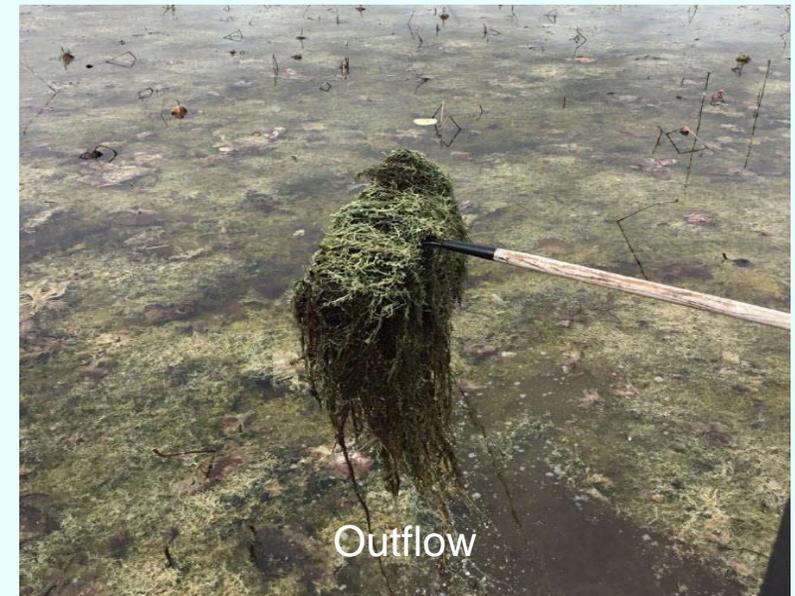
STA-5/6 Cell 1B SAV Conditions

- *Hydrilla* most common, with *Ceratophyllum* and *Najas guad*
- SAV is recovering well
- *Hydrilla* recovering more quickly than other species
- Highest densities near mid-flow and outflow regions
