L-31N Updated Monitoring Program

3 years of monitoring after
completion of 2-mile barrier
plus
5 years of monitoring after
completion of 5-mile barrier

Dade-Broward Levee Project

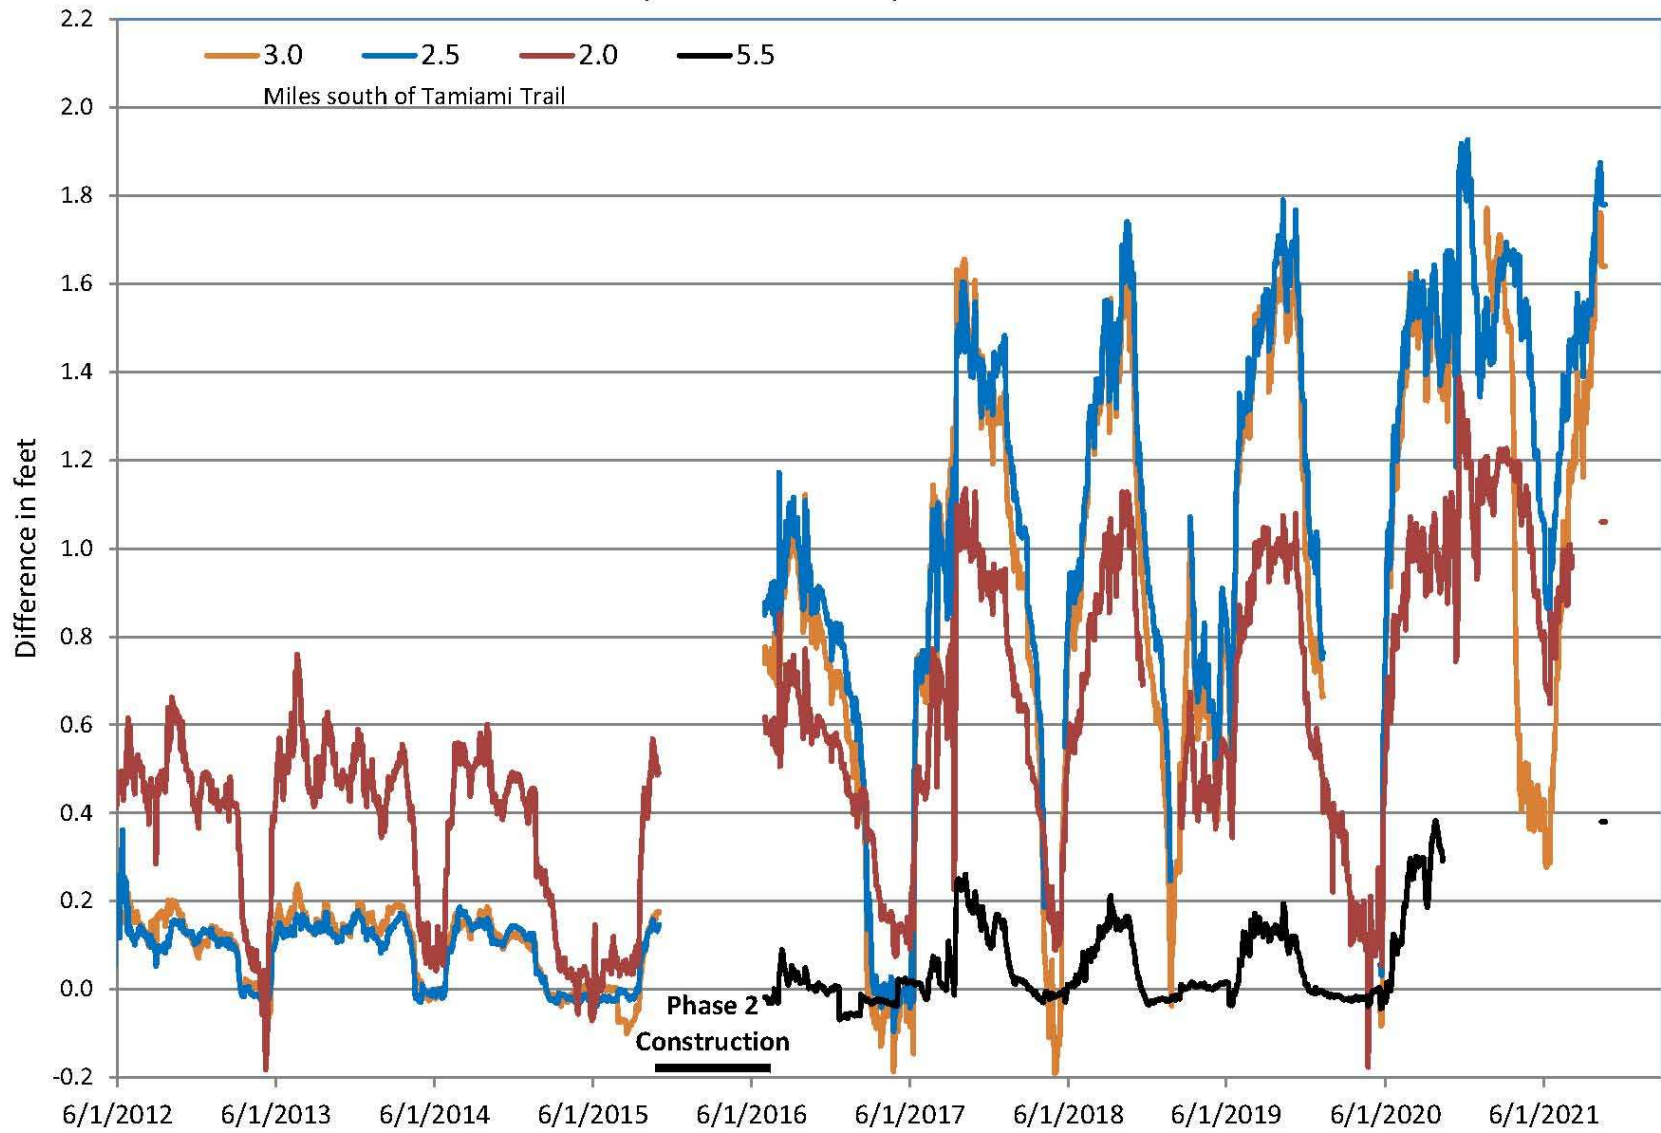
Groundwater Stage Difference Across Barrier (Difference between paired water table wells upstream and downstream of the barrier at each specified location)

The northern 2 miles of barrier were completed in 2012. The remaining 3 miles were completed in April 2016.

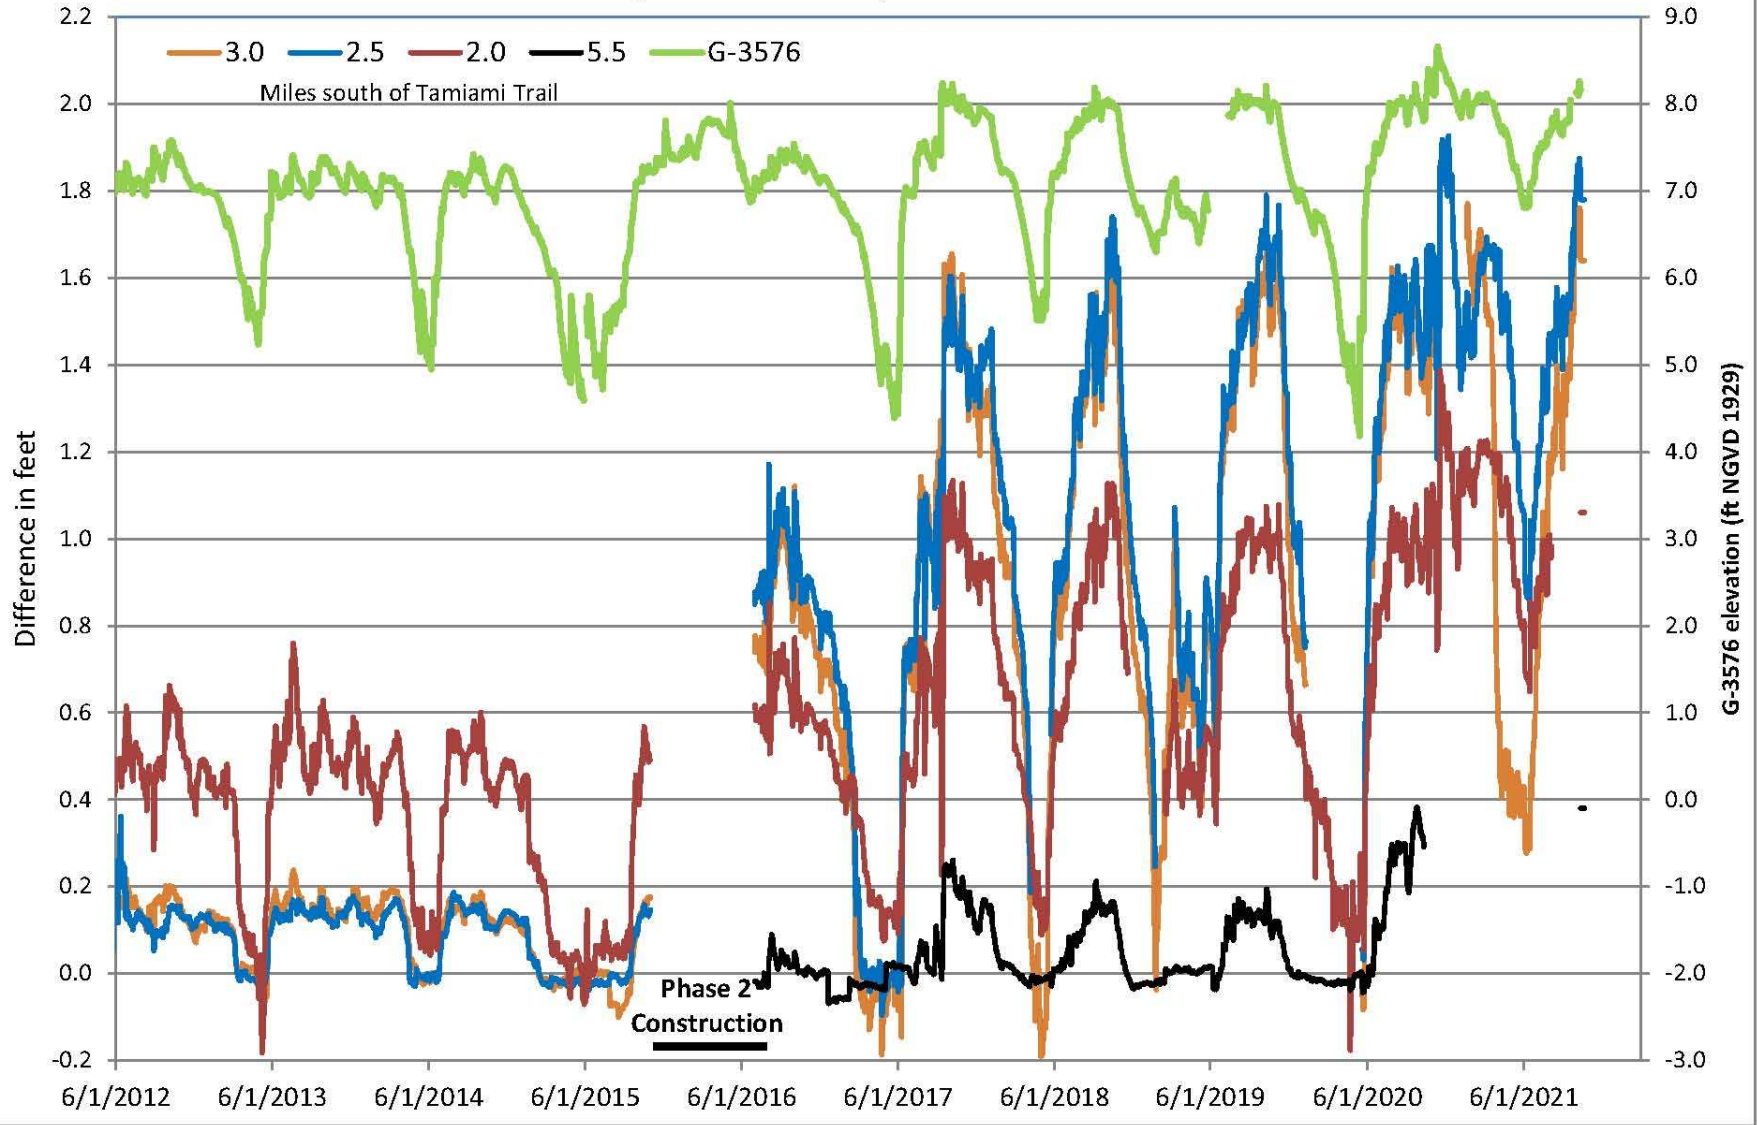
Groundwater Stage Difference Across Barrier

(Difference between paired water table wells upstream and downstream of the barrier at each specified location)

The northern 2 miles of barrier were completed in 2012. The remaining 3 miles were completed in April 2016.

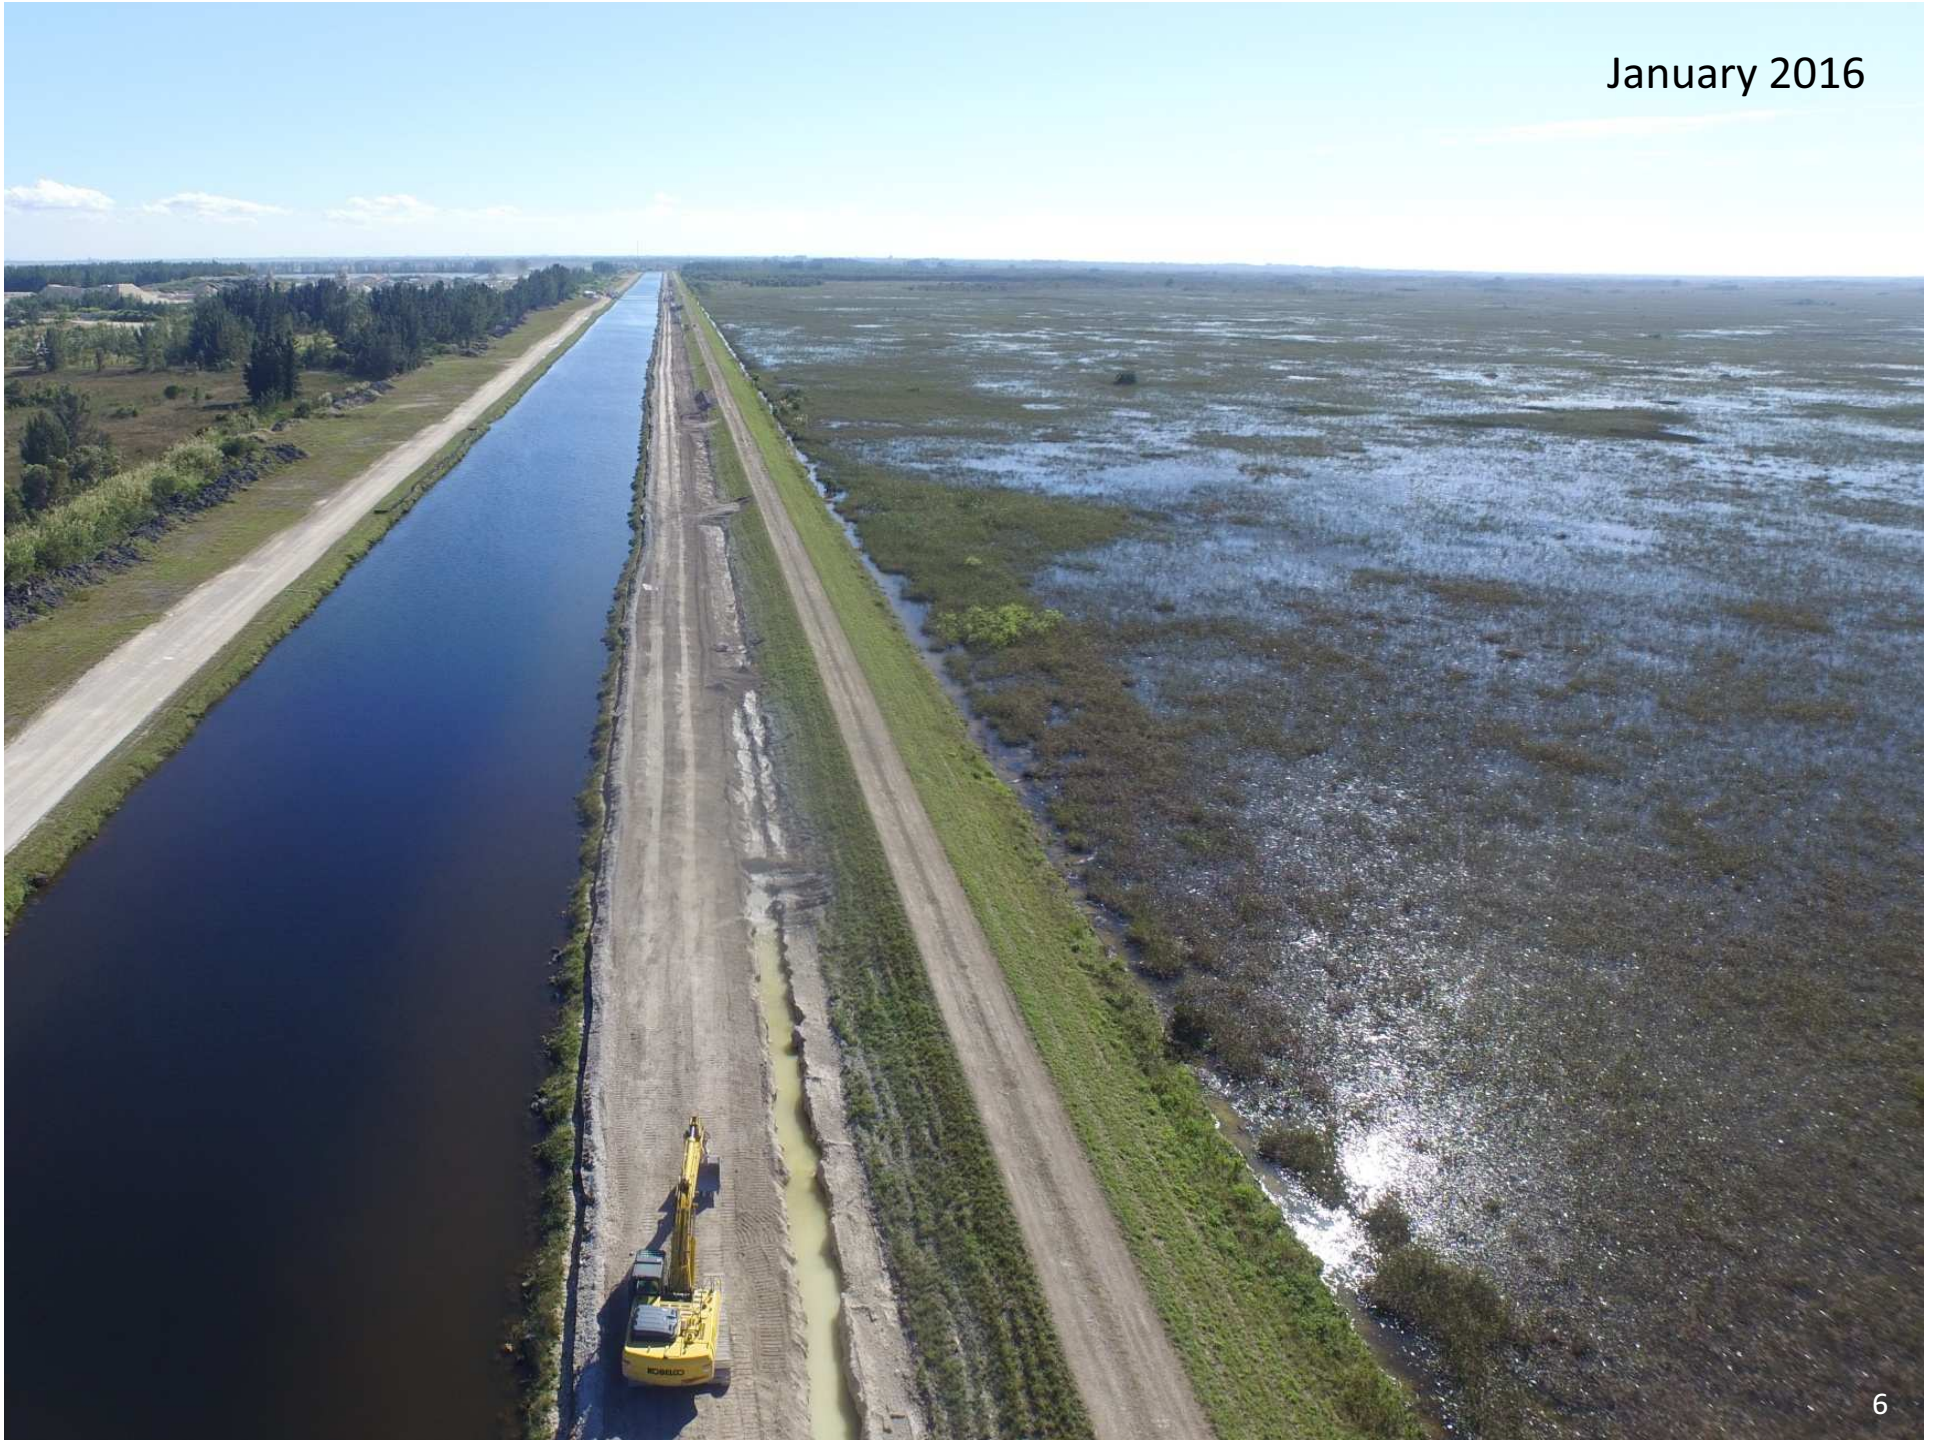
Task 1: 7.5 mile berm repair
completed 2016

Task 2: two proposed water
control structures
completed 2018

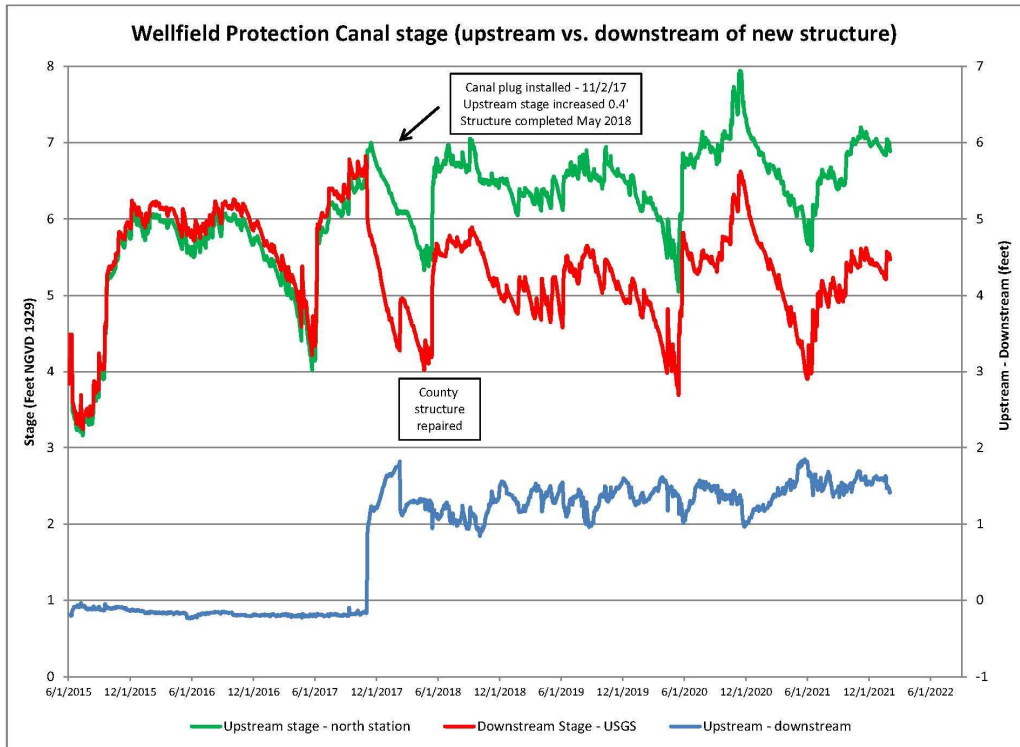
New West WPC Structure (2018)

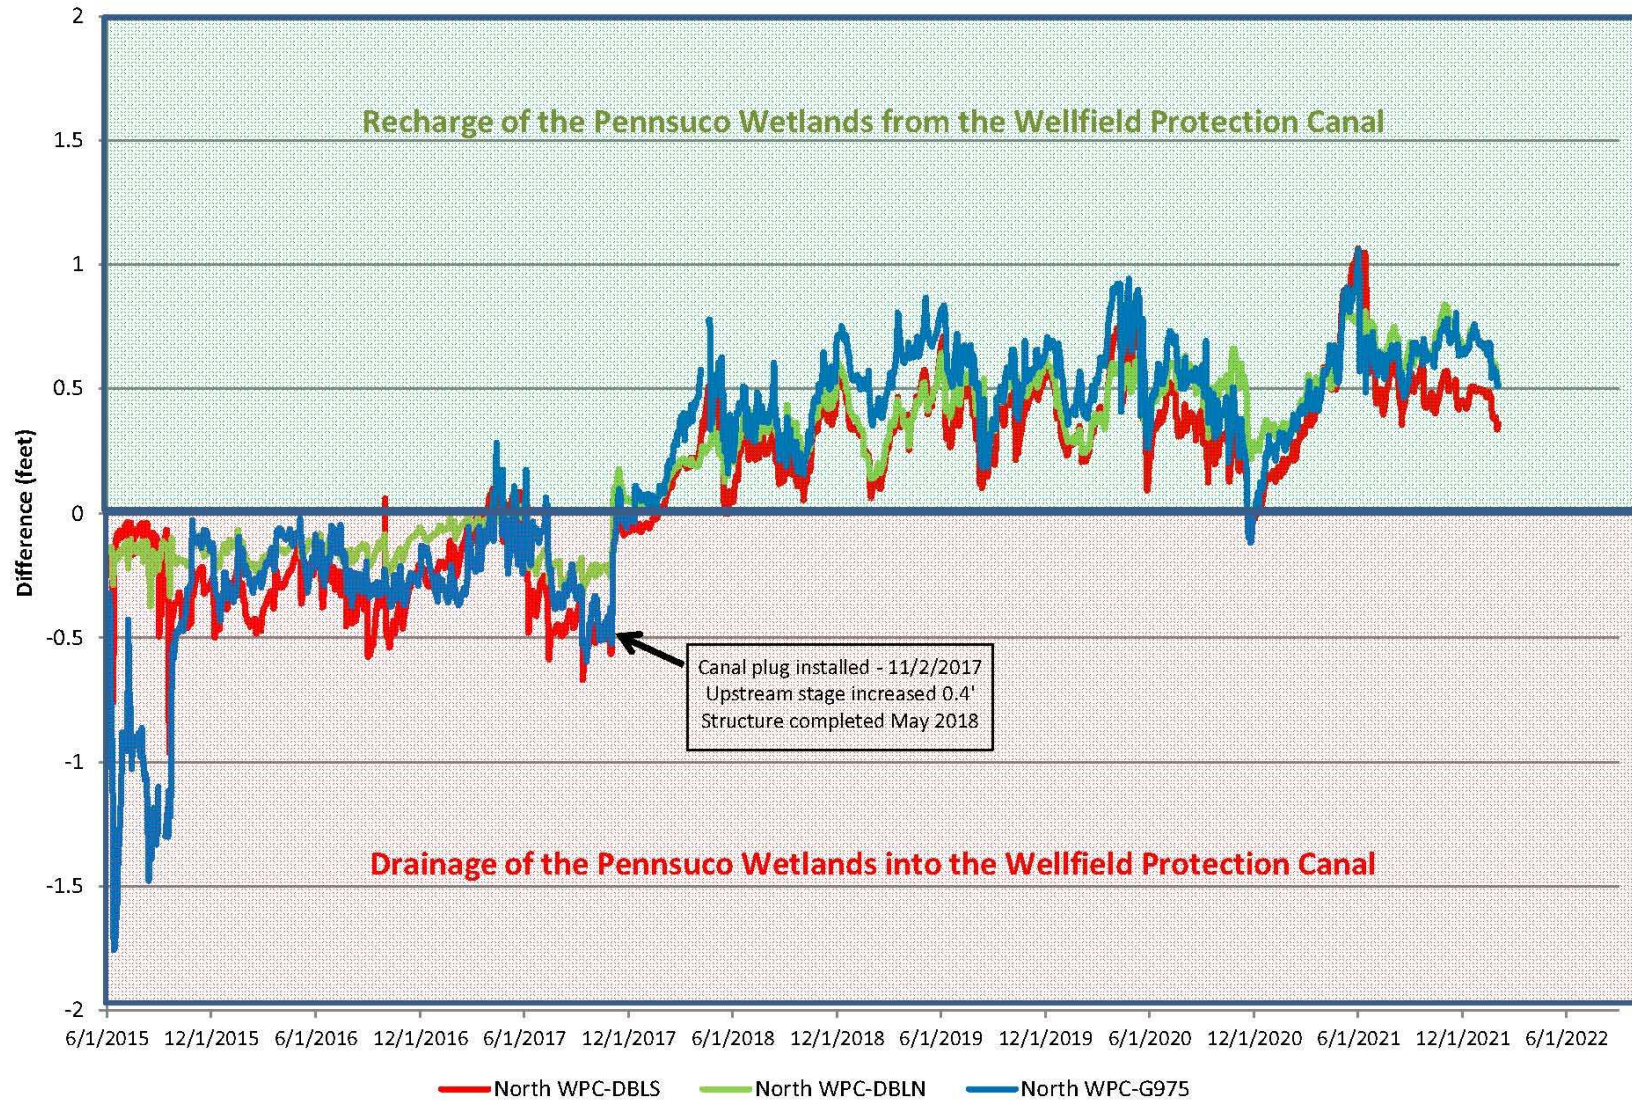
Wellfield Protection Canal vs. Pennsuco wetland water levels
