# Turbidity Control for SAV Recovery in the Lake Okeechobee Littoral Zone

September 30, 2025

Prepared for: South Florida Water Management District

Prepared by: DB Environmental, Inc.

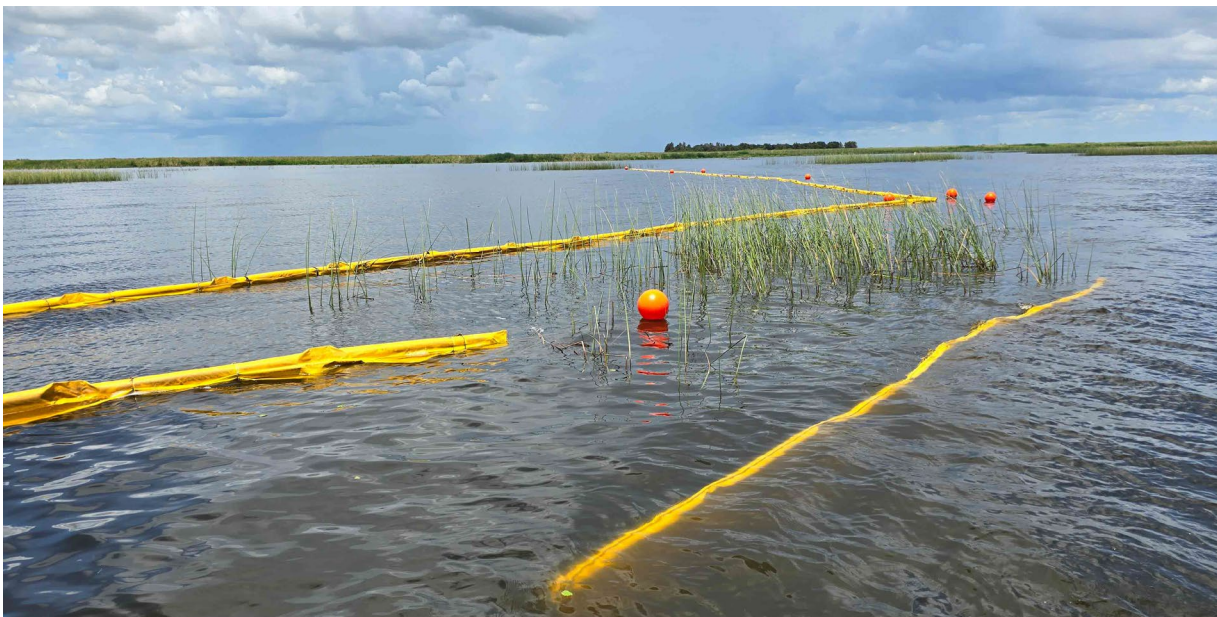
Figure 1. Turbidity controls deployed in Lake Okeechobee. Silt fence in the foreground extends from the lake bed upward, preventing turbid water from moving along the lake bed, but allowing surface water to pass over the fence during storms. The overlapping boom and barriers (“curtains”) in the background float at the water surface and are effective at redirecting surface films and surface water flows, but leave a gap between the bottom of the curtain barrier and the lake bed for water and wildlife to pass through.

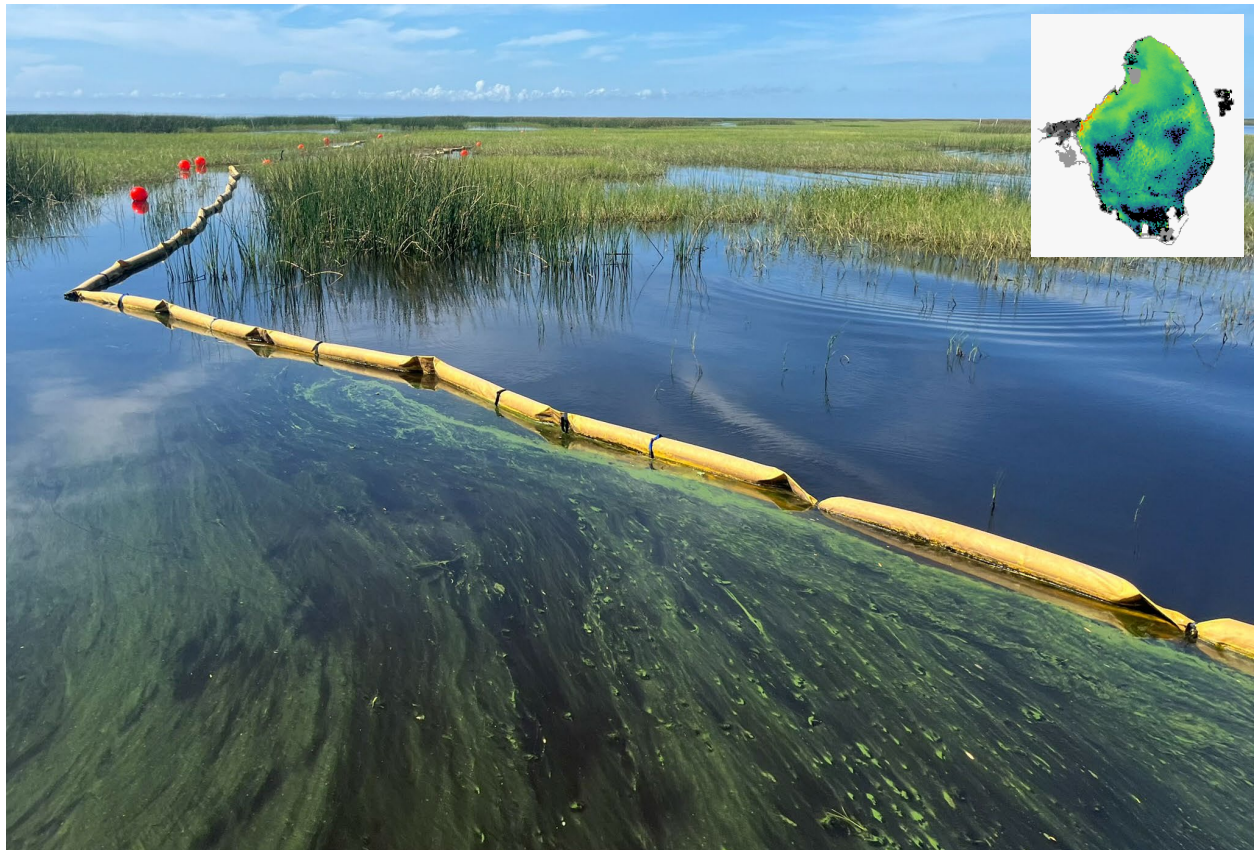
Figure 3. Turbidity controls prevented the movement of surface films and algae blooms from drifting into the area protected by the installation, shown here at the South Site on August 6, 2025. Inset shows the Cyanobacteria algal bloom monitoring image for the same date, with higher cell densities in red along the Indian Prairie shoreline where the project was located. Image derived from Copernicus Sentinel-3 satellite data as processed and available from NOAA Coastal Centers for Ocean Science at <https://coastalscience.noaa.gov/science-areas/habs/hab-monitoring-system/cyanobacteria-algal-bloom-satellite-lake-okeechobee-fl/>

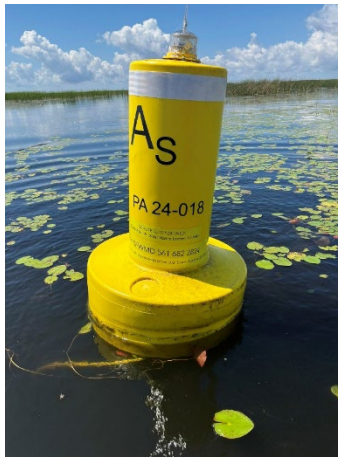
Figure 9. Lighted navigational buoys were deployed around the project area to increase visibility to boaters.

Navigational buoys conforming to the U.S. Aids to Navigation requirements were installed upon receiving U.S. Coast Guard approval of Private Aids to Navigation Application (CG-2554) PA 24-018, which authorized the temporary establishment of (8) special purpose lighted buoys to mark four corners of the two project areas where the study of SAV restoration took place (Figure 9). Additional signage at nearby boat ramps and public recreational forums increased awareness of the project activities (Figure 10).

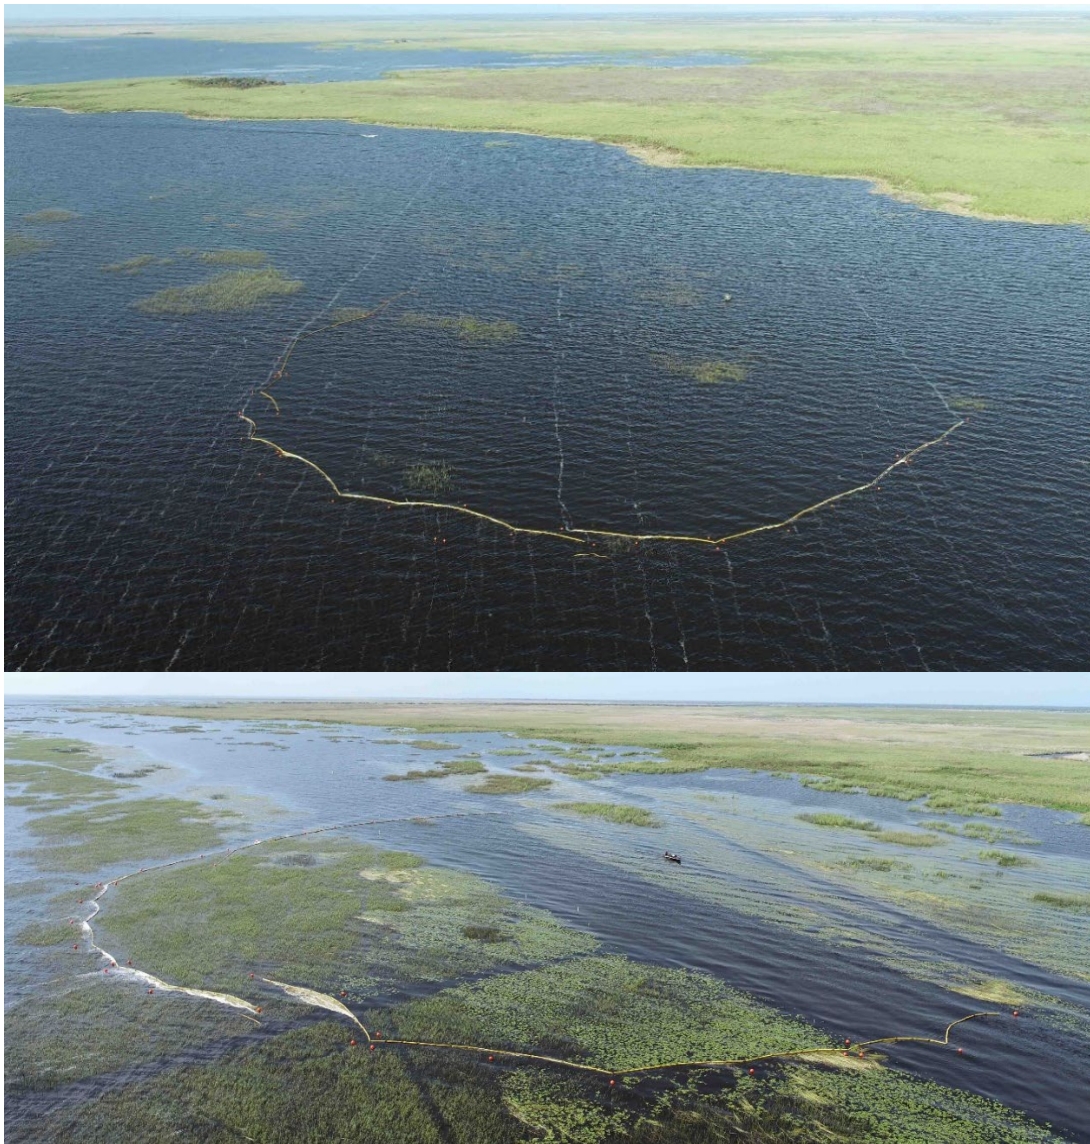
Figure 11. Aerial view of the installed turbidity controls on November 14, 2024, at the North Site (top photo) and South Site (bottom photo) project areas, looking generally southward. Aries Geospatial provided imagery support for this project.

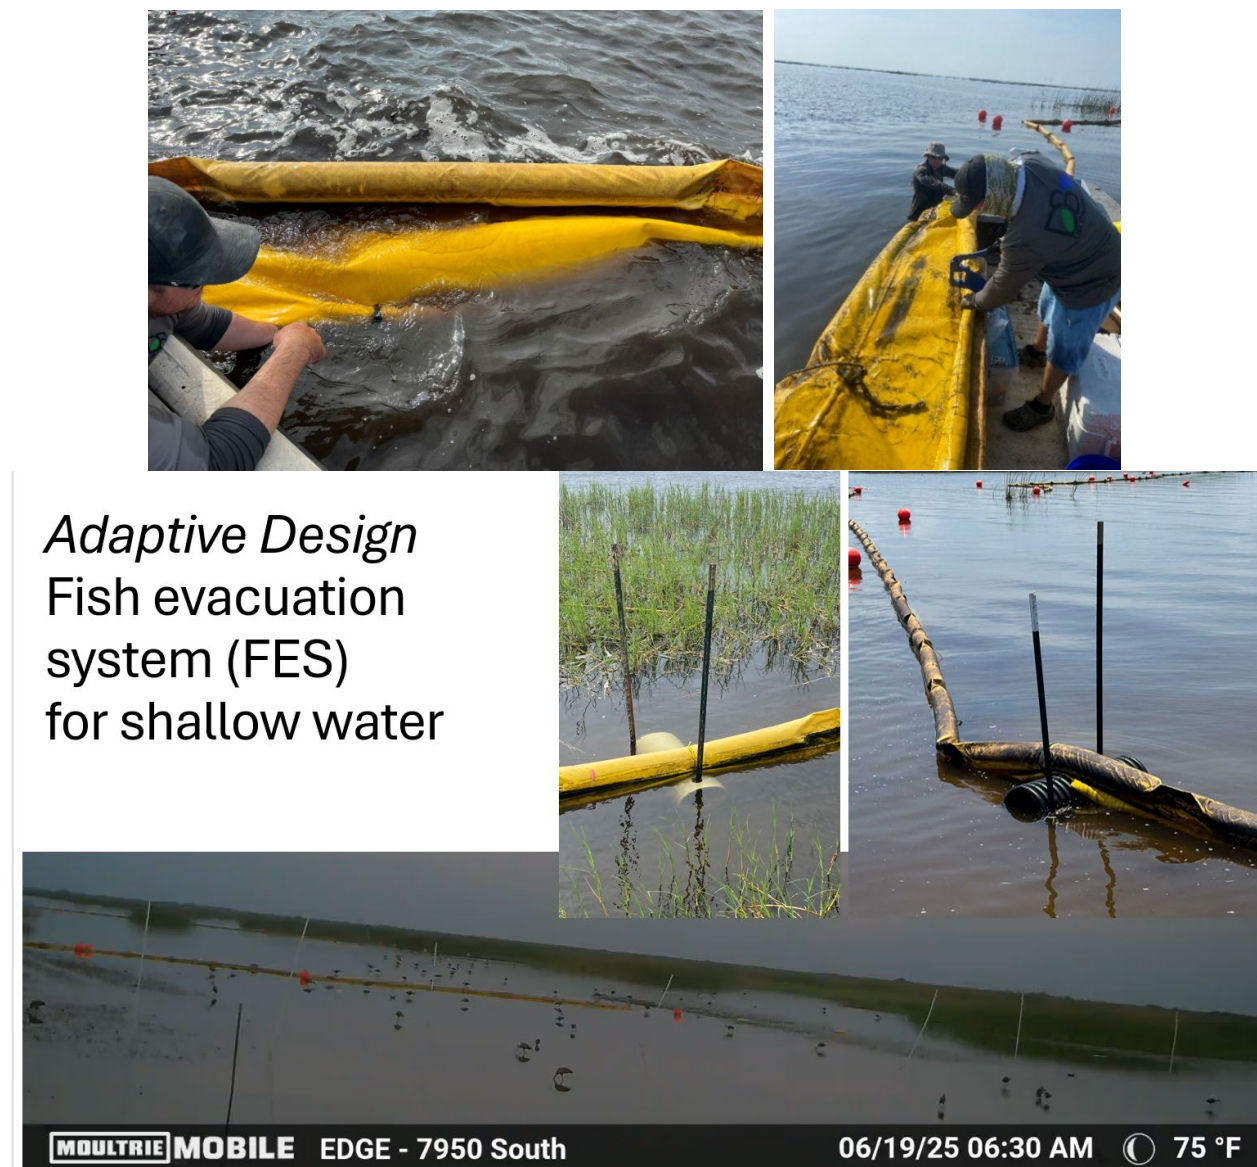
Figure 13. Installation of Fish Evacuation System to avoid entrapment of fish in shallow water when lake levels recede.

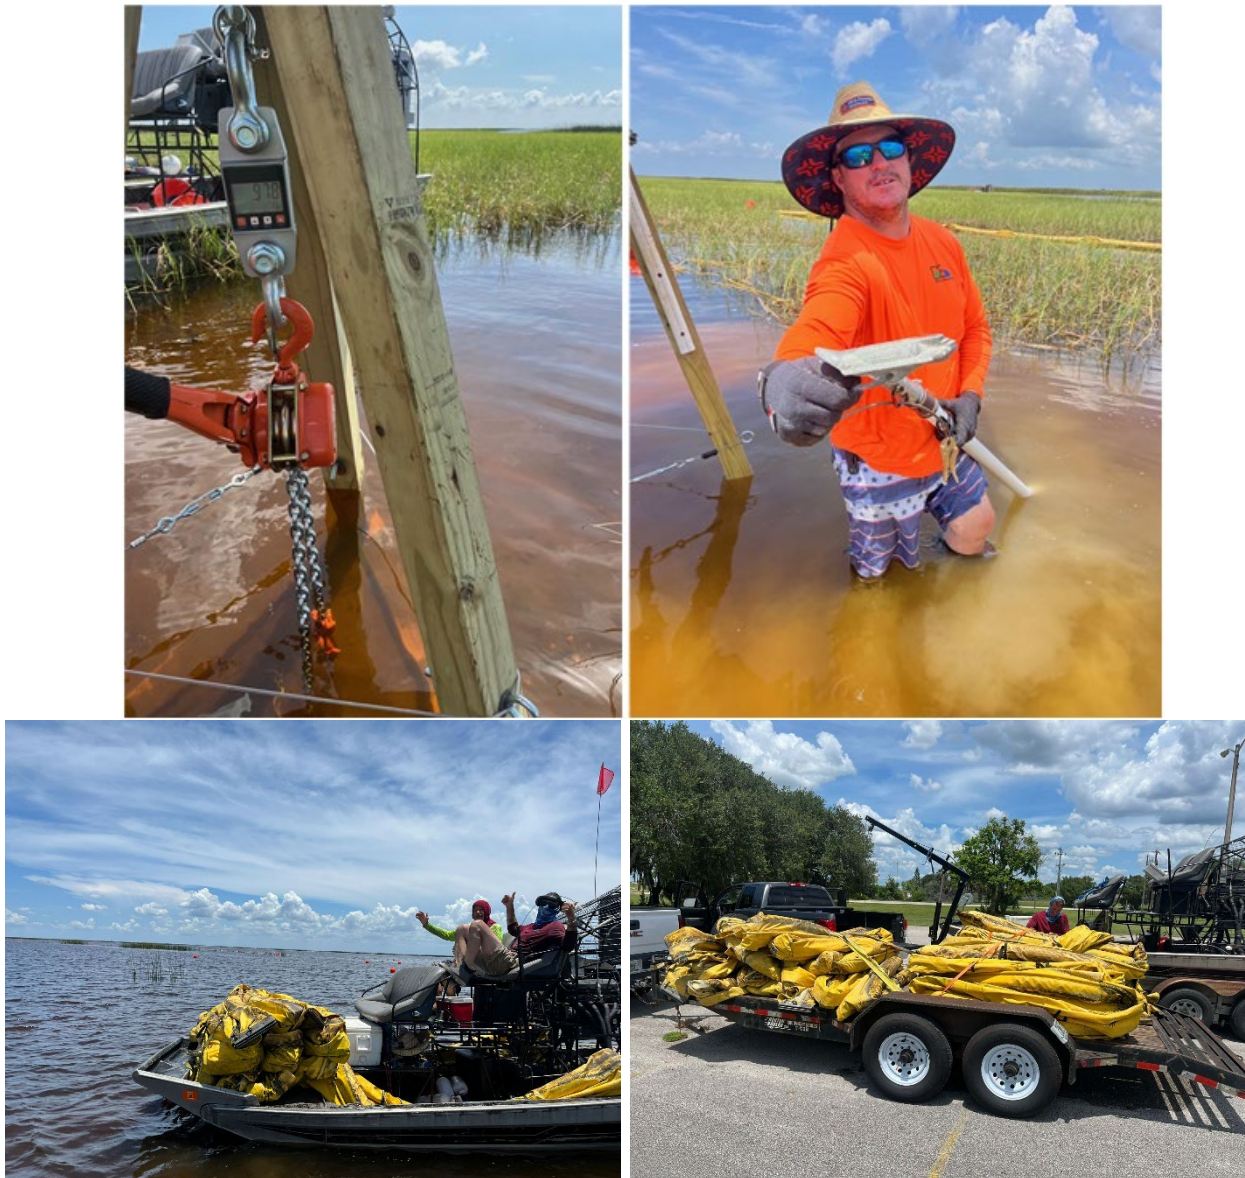
Figure 14. Anchor removal using engine hoist and tripod. Scale confirmed anchor holding power during anchor testing, installation and removal.

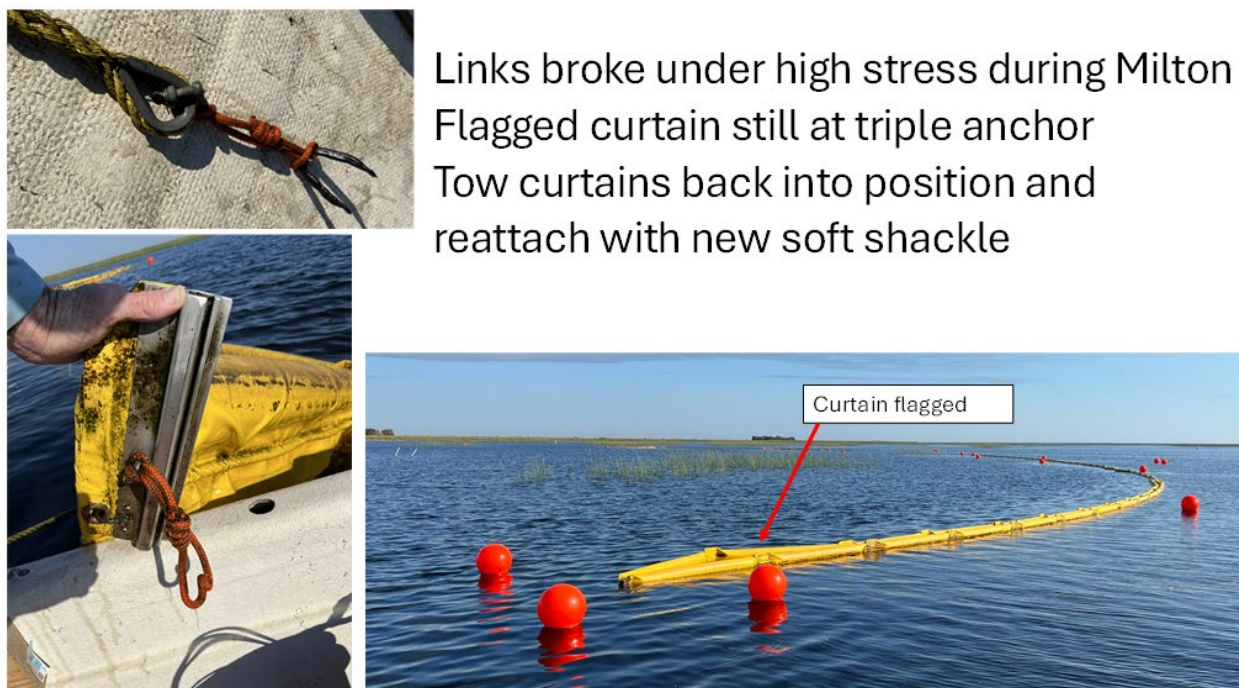
Figure 17. Broken links allowed the turbidity curtain to flag during the passage of Hurricane Milton, and remain anchored at one end for rapid reattachment.

Design features allowed the anchors to hold during major storm events while the tension on the curtains was released at planned fail points using breakaway links. Once released, the curtains were no longer subject to the full force of wave energy, but remained anchored on one end to maintain position. This allowed curtains to flag, or align with the direction of the wind and wave energy, rather than transverse to it. After storm energy dissipated, the team was able to reattach the curtains to anchor points for continued performance of the controls. The overall design performed as intended and no anchors failed during this pilot project.

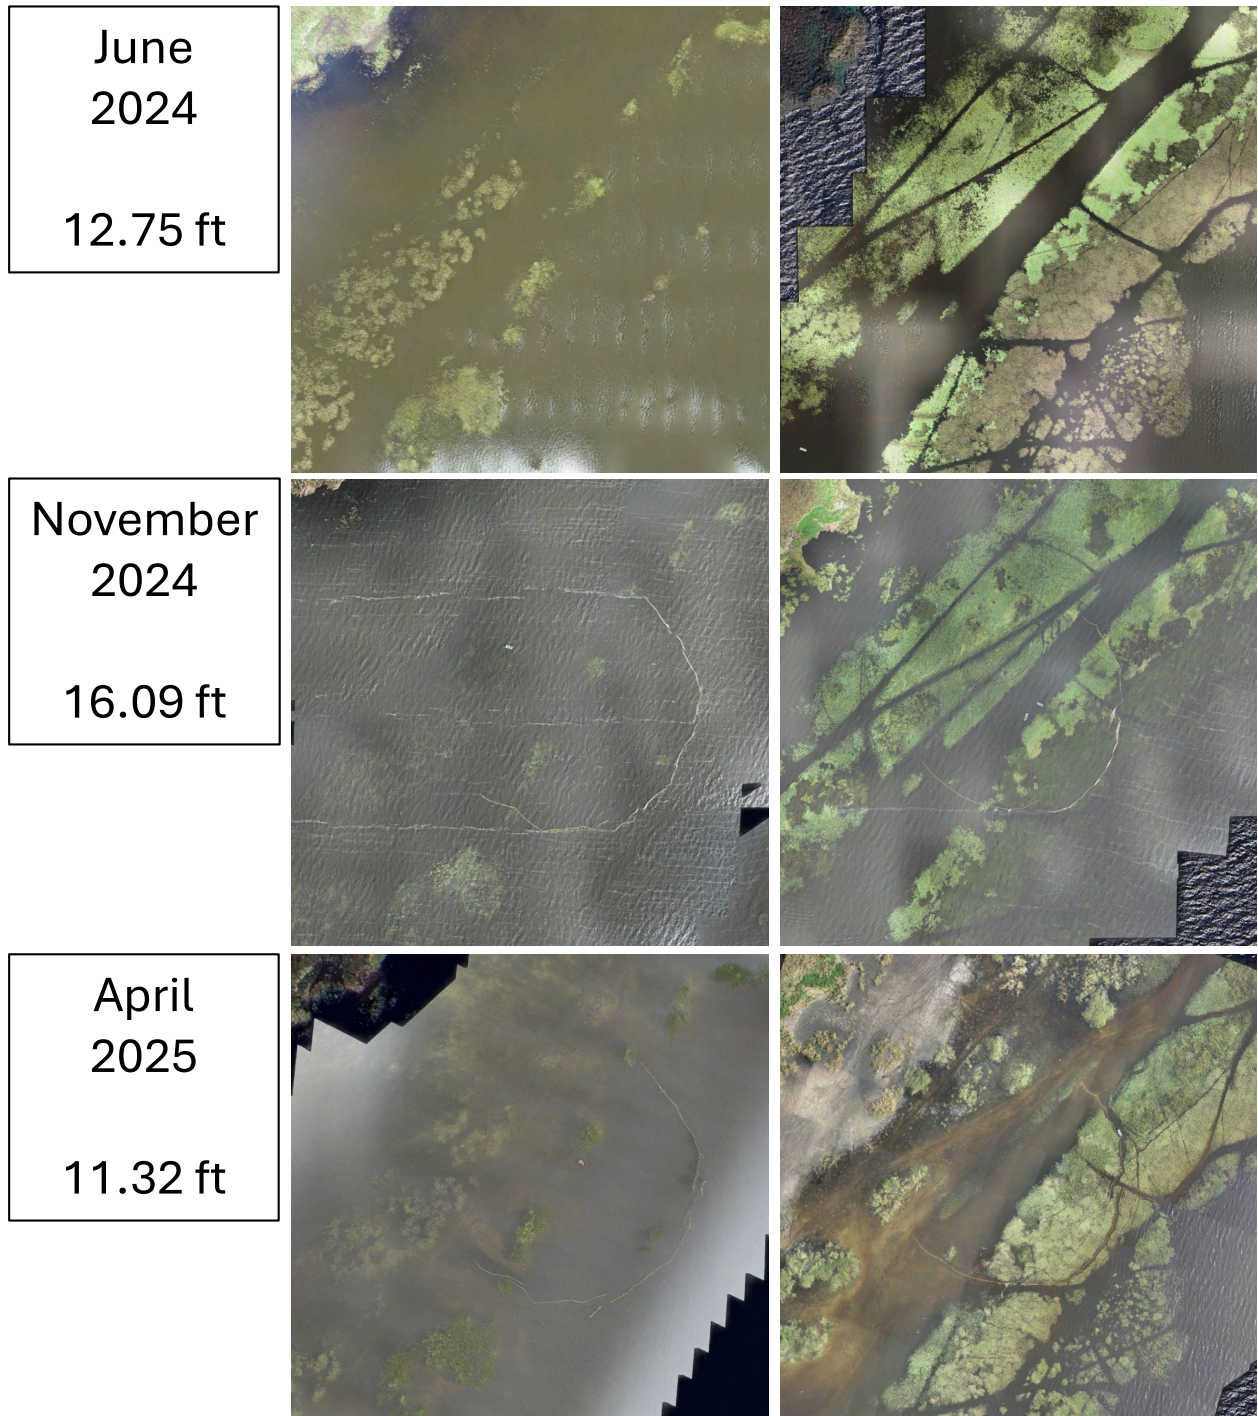
Figure 18. Aerial imagery of the North Site and South Site locations on three dates, corresponding to the initial planning period prior to installation (June 2024), high water conditions (November 2024) and low water conditions at the end of the project (April 2025). Lake stages are daily mean values in NGVD29.

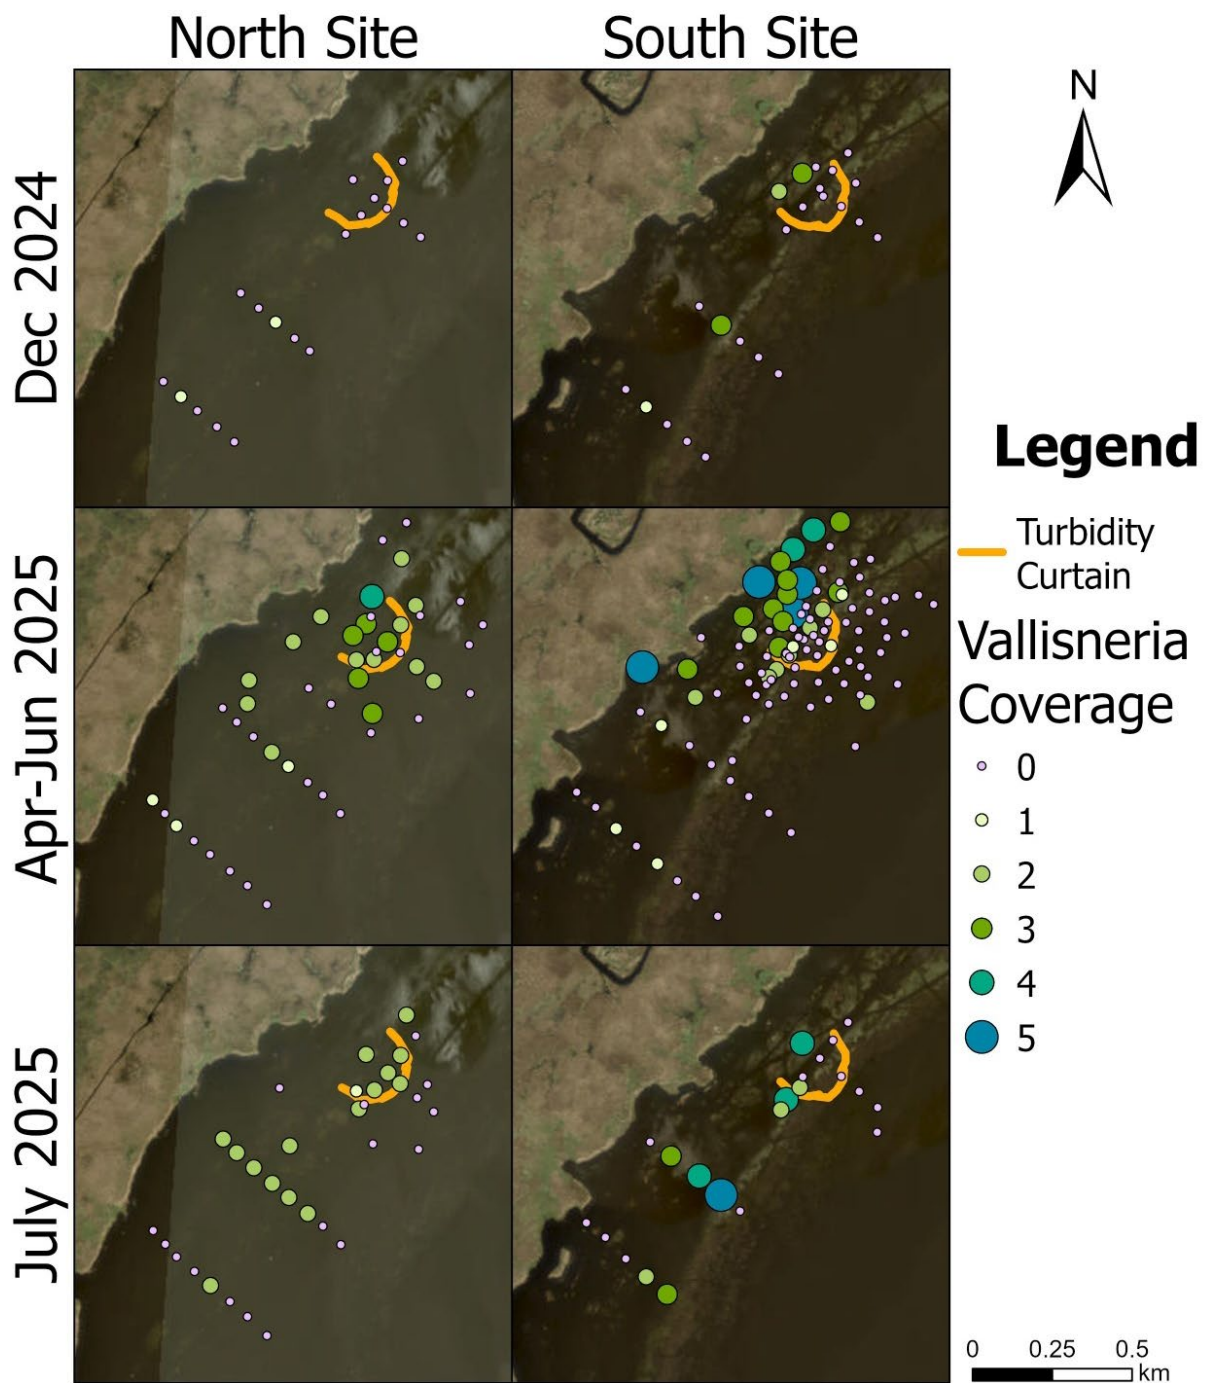
Figure 20. Relative coverage of *Vallisneria* at locations monitored during December 2024, April–June 2025, and July 2025 periods, at two project areas in Lake Okeechobee.

In December 2024, no *Vallisneria* was observed within the primary stations in or around the North Site installation in December (Figure 20). *Vallisneria* was observed only at two locations along the added outer transects at the North Site, and only at minimal coverage (trace, < 1% coverage). At the South Site installation, *Vallisneria* was observed at two locations along the outer transects, and two locations within the turbidity control area.

During the period between April and June 2025, multiple monitoring trips were made to each site as part of the project monitoring plan, and to additional stations to document SAV coverage. During this period, *Vallisneria* was observed at many locations to the north and west of the controls at the South Site, shoreward of the controls (Figure 21. and Figure 22), while only a few observations at trace levels were made along the outer transects there. While not sampled earlier in the study, the additional sample sites added in the spring/summer of 2025 documented a substantial SAV presence within and extending north of the southern project site, some of which was part of a known patch that survived Hurricane Milton (SFWMD staff observations). This area dried out during the low stage period between late April and early July 2025, and a seasonal minimum lake stage of 10.9 ft on May 24, 2025 left many areas temporarily dry and inaccessible for further observations or water sampling.

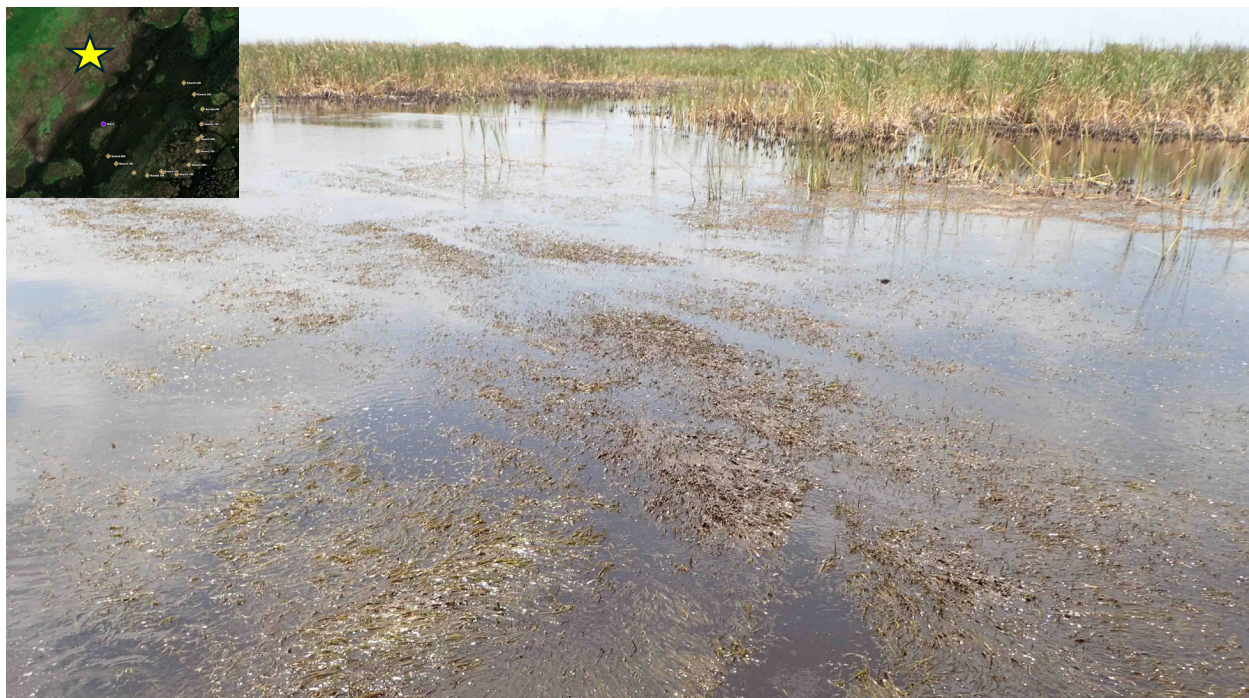
Figure 21. Station SR048 toward the edge of the littoral marsh northwest of the turbidity controls at the South Site, on April 16, 2025, when lake stage was 11.94 ft NGVD29 and water depth was 7 cm. This area was dry within weeks.

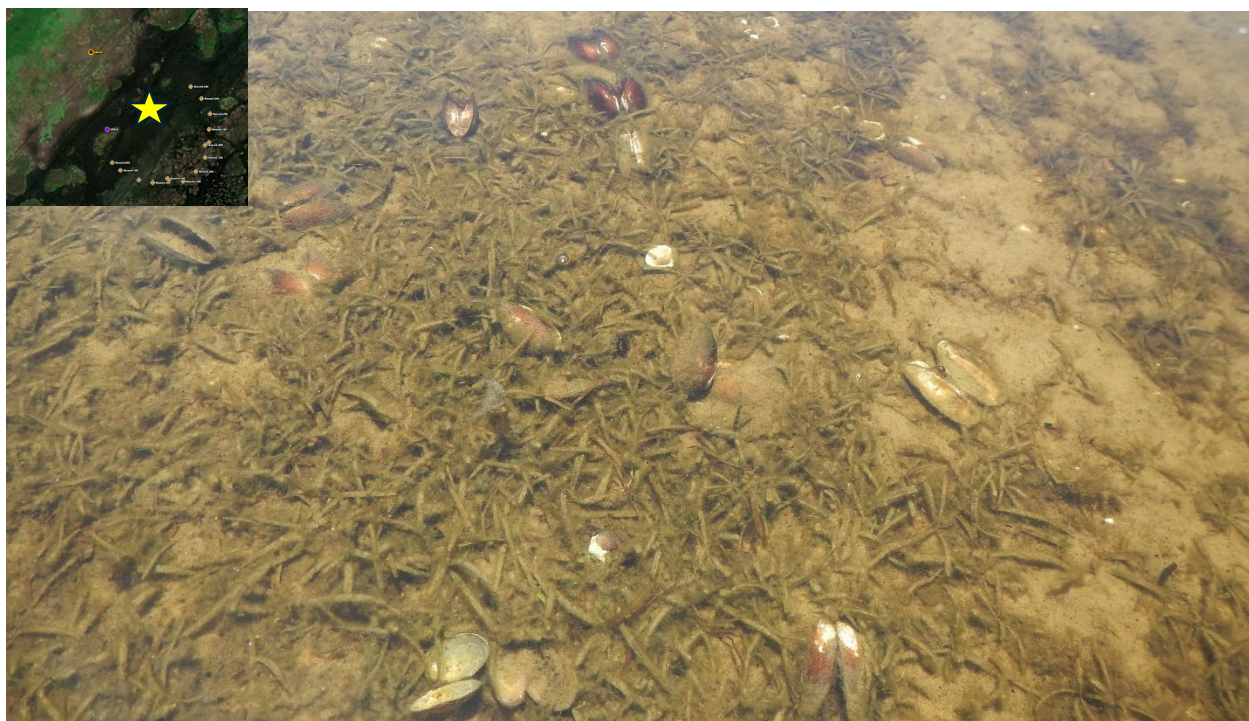
Figure 22. Station S-C1 In at the South Site on June 18, 2025, showing natural recruitment of *Vallisneria* in shallow water (6 cm) when lake stage was at 11.09 ft NGVD29. This location with inside the turbidity controls.

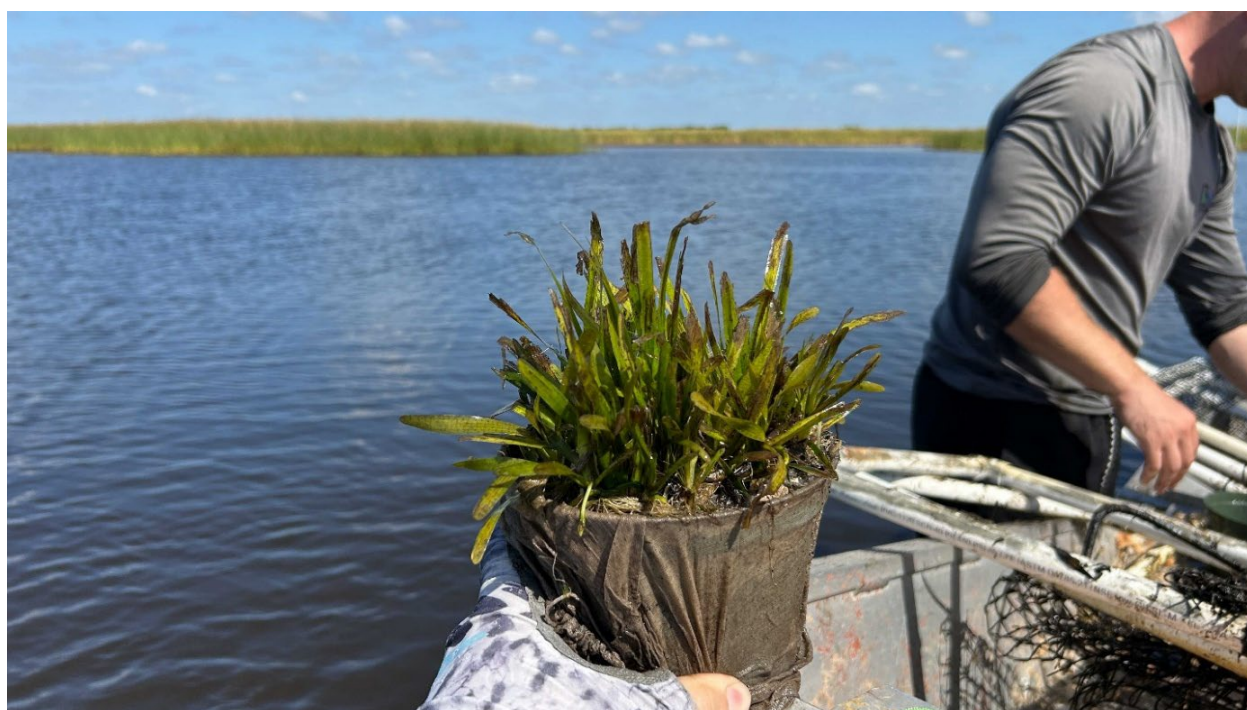
Figure 27. Each planting unit consisted of multiple ramets within a cloth sack containing soil.

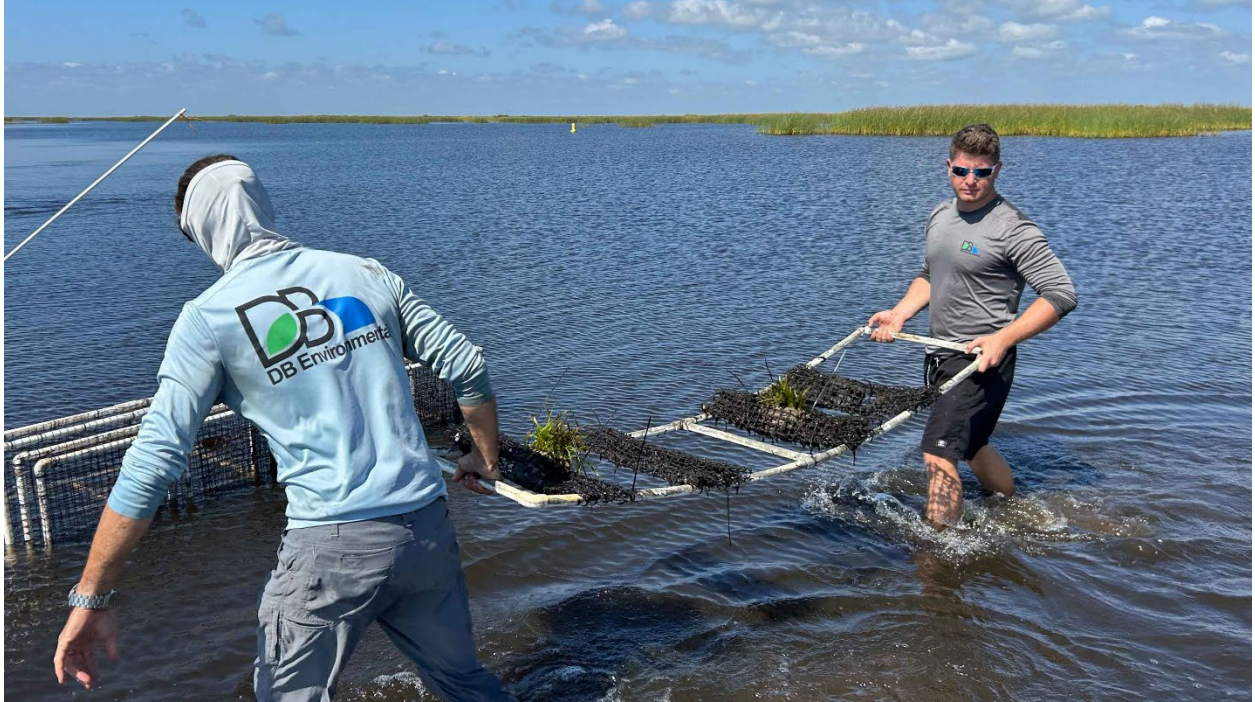
Figure 28. Open Frames with planting units being deployed on April 28, 2025 at the South Site project area.

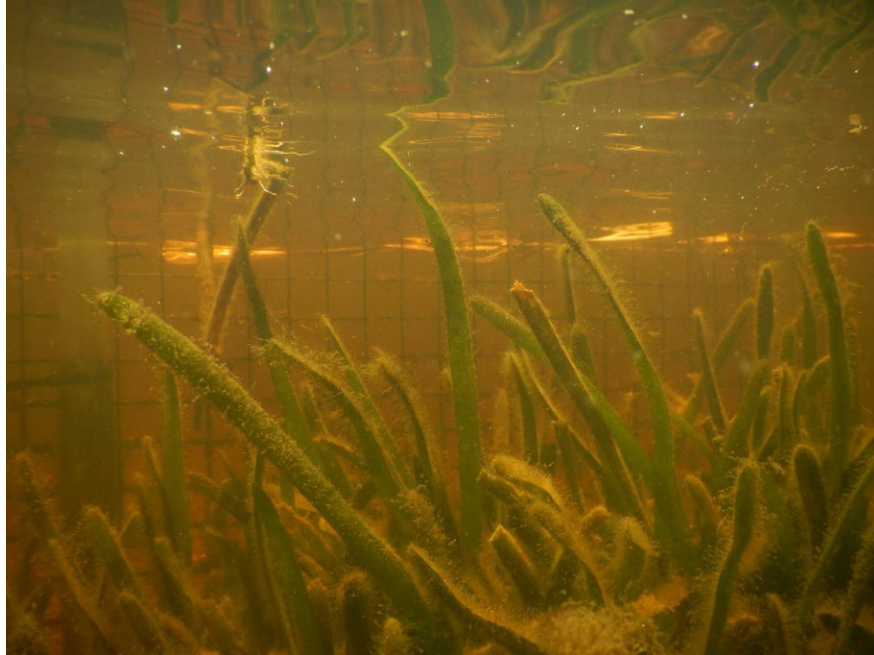
Figure 30. Underwater view of *Vallisneria* within herbivore exclusion cage.

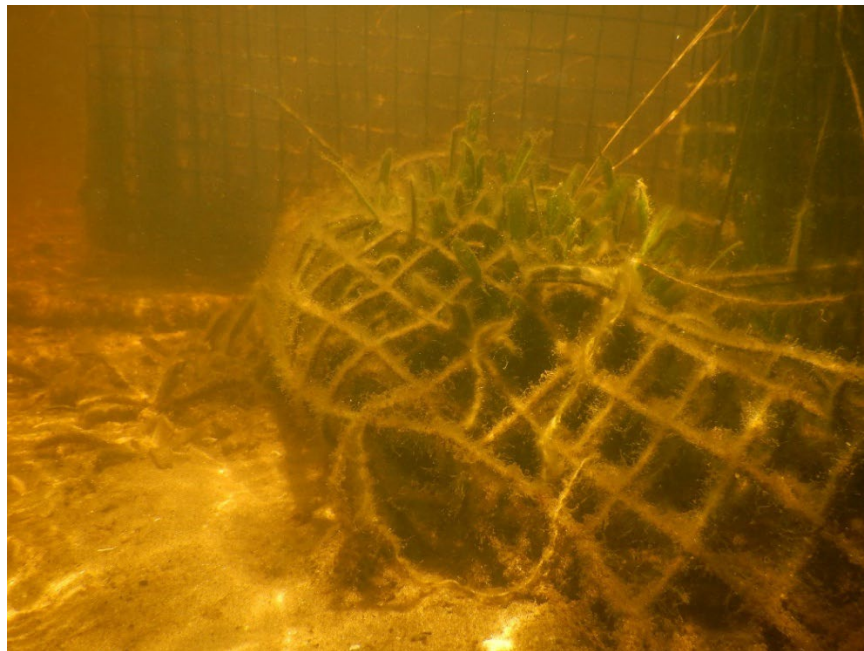
Figure 31. Underwater view of *Vallisneria* within planted Frame, open to herbivory. Mesh held the planting unit, which was comprised of plants rooted within soil in a cloth sack, in place on the lake bed to allow root growth and plant expansion while providing only limited protection from herbivory. Leaves extending beyond the protection of the mesh around the soil sack were subject to grazing.

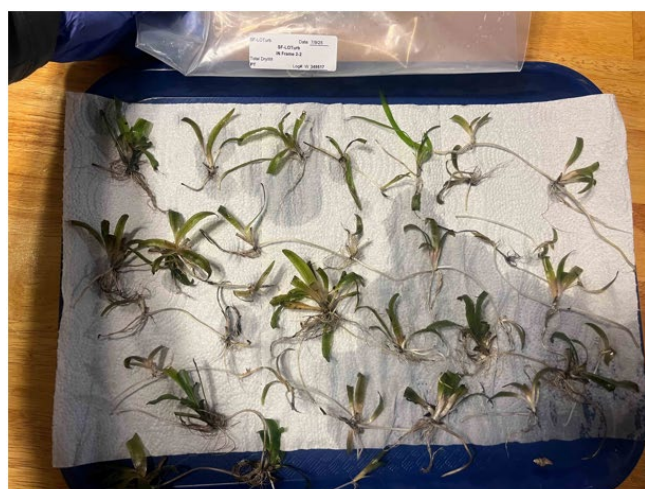
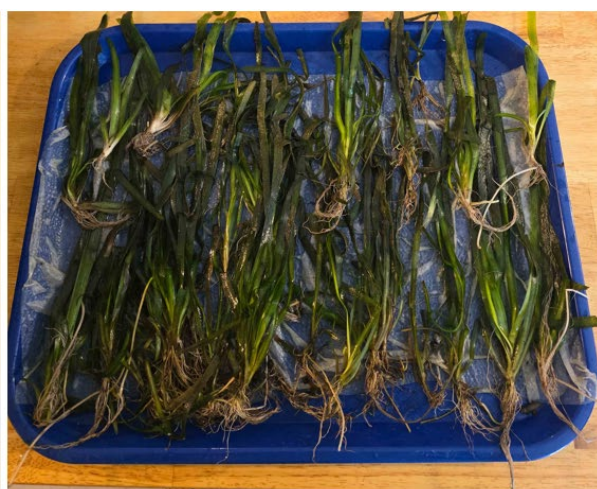
Frame Only (Not Fully Caged)

Figure 33. Plants collected after 72 days of growth in Lake Okeechobee from open Frames (left) and exclusion Cages (right).

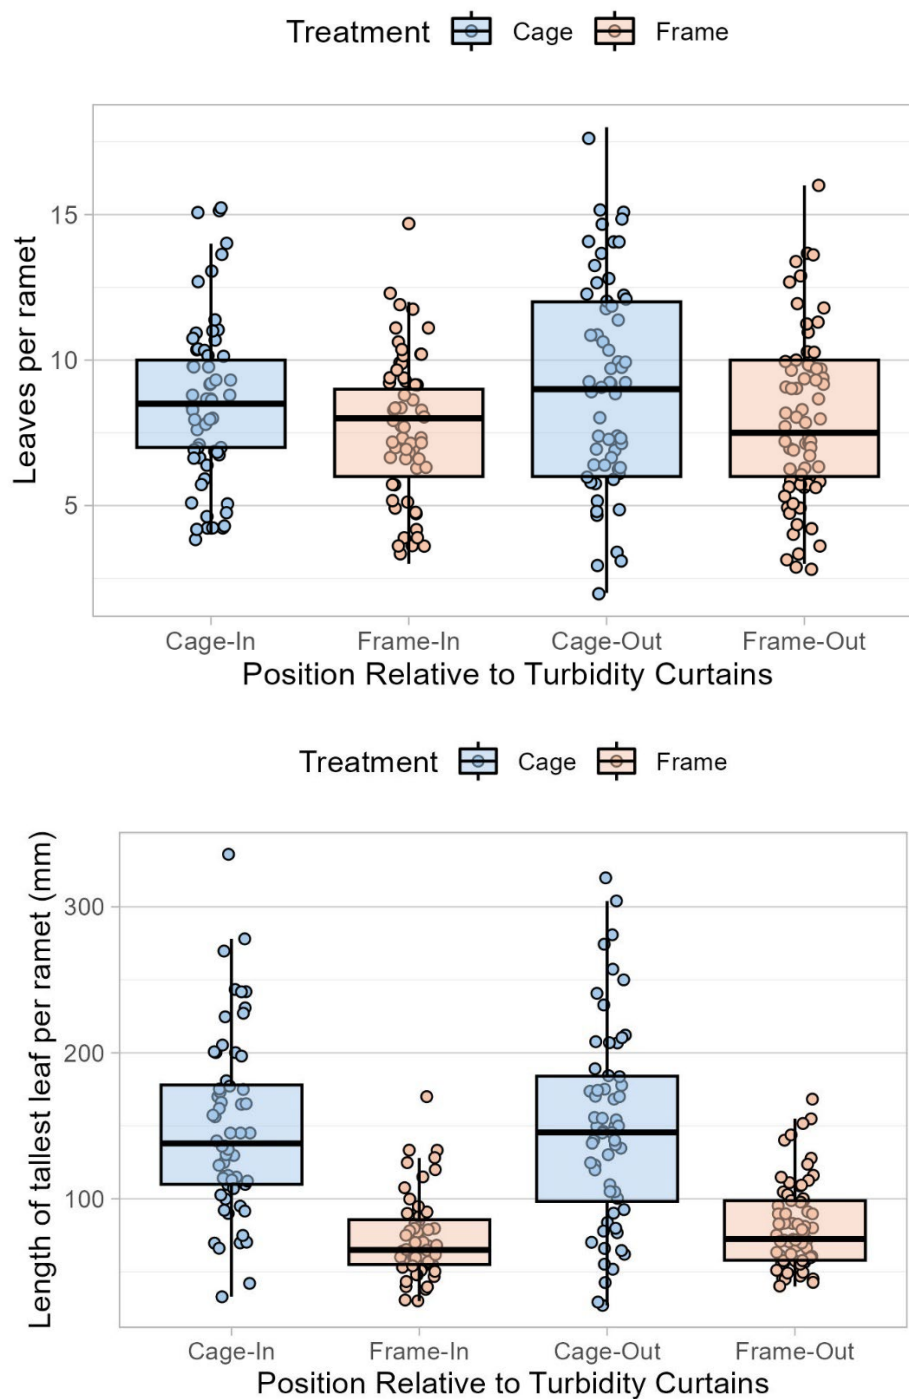
Figure 35. Mean ( $\pm$  SE) number of leaves per ramet (top panel) and length of tallest leaf per ramet (bottom panel) for *Vallisneria* for plants (N=60 per treatment group) recovered from locations inside and outside the turbidity controls.

Quantitatively, initial plant biomass was  $3.0 \pm 1.0$  g dw/pot or 6 g dw per experimental unit (Cage or Frame, which received two pots on Day 0). At the end of the 72-day study, clear differences in plant dry weight were observed between Cages and Frames (Figure 34). These differences were consistent with greater length of the leaves and number of leaves per ramet in Cages than Frames (Figure 35).

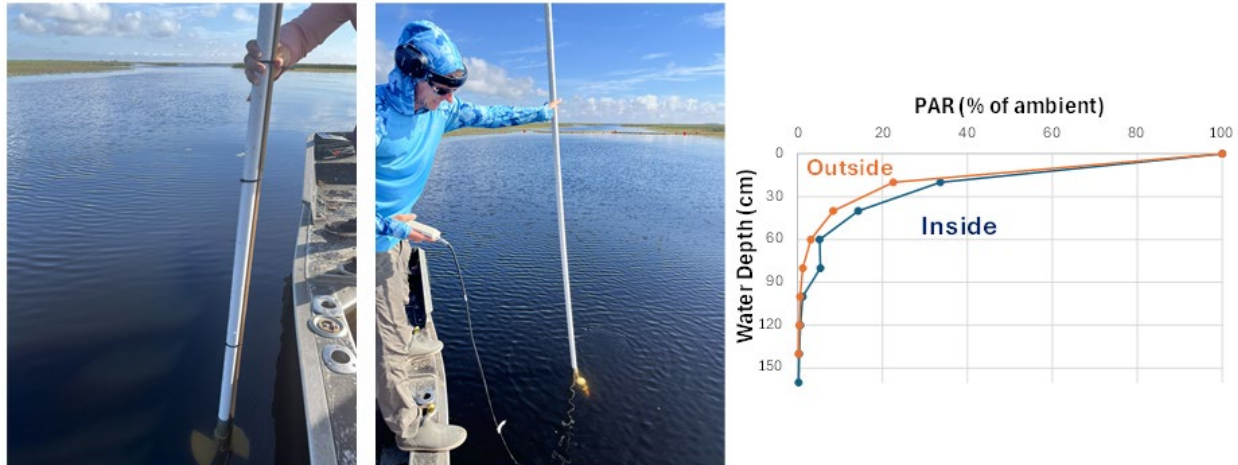
Figure 37. Example of photosynthetically active radiation (PAR) changes with depth at a pair of locations inside and outside the turbidity controls. Secchi depth was measured along with PAR to characterize light conditions within the water column.

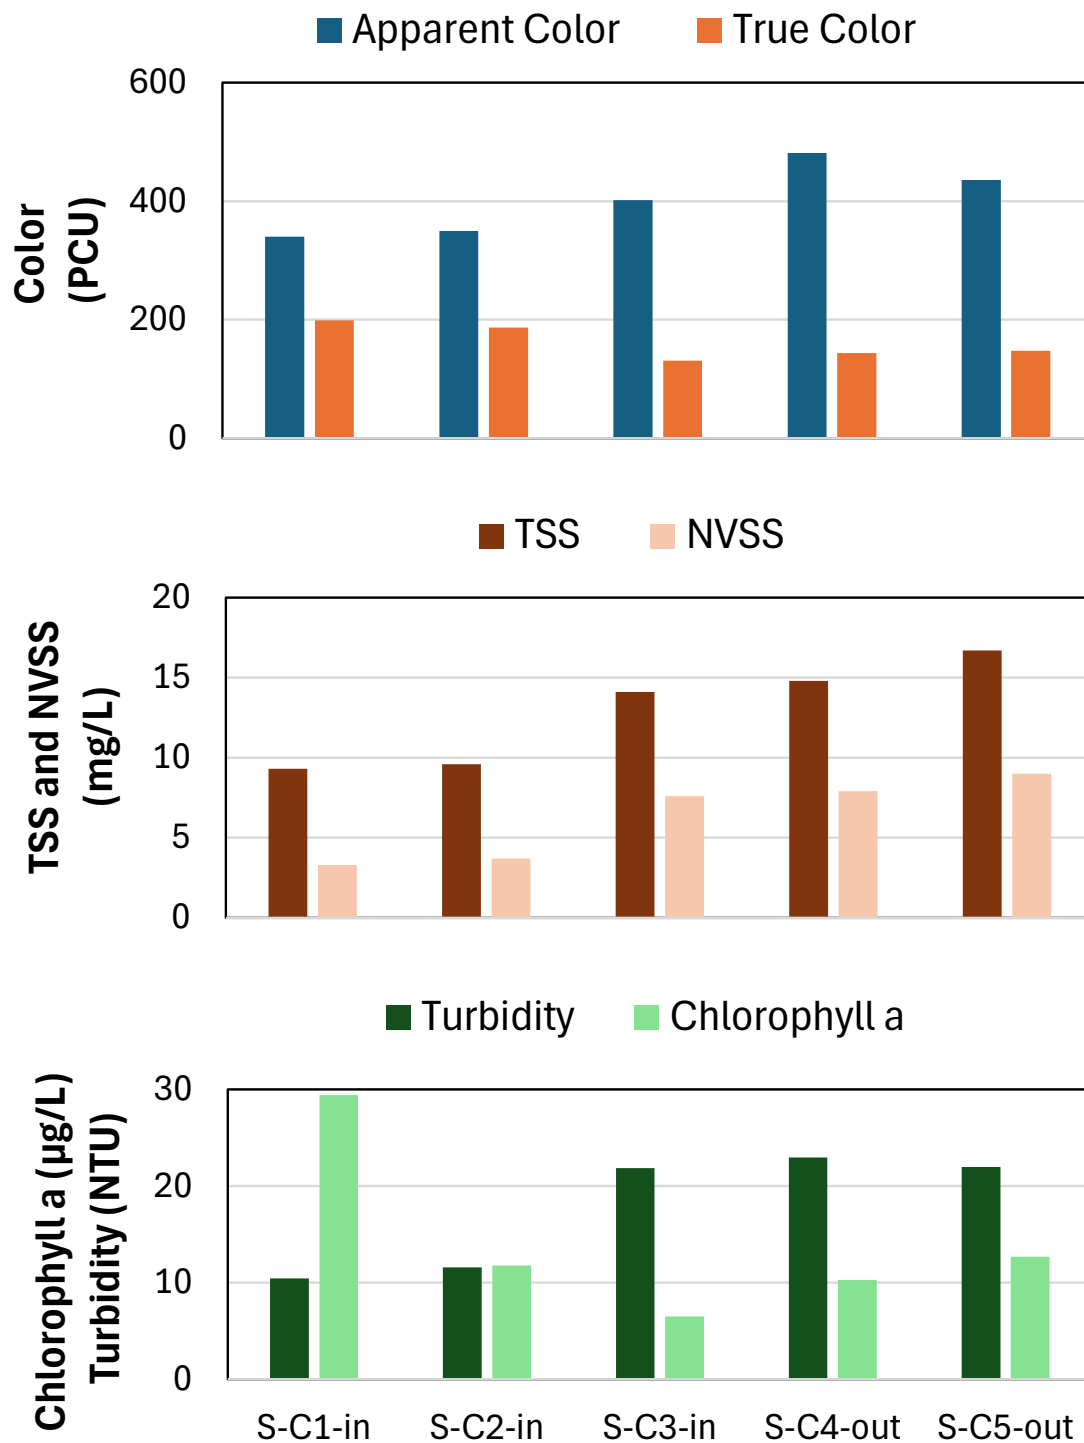
Figure 38. A center-line transect sampling event on November 12, 2024, at the South Site location showed changes in water quality parameters from the station furthest inside the turbidity controls (C1 In), extending lakeward to C5 Out.

For example, at the South Site on November 12, 2024, this trend was observed (Figure 38). At the same time, Chl-a and true color increased along the same transect. True color reflects the contribution of dissolved constituents in the water that absorb light. Phytoplankton is another component of the light-absorbing constituents within the lake water column, but is also a potential response variable to the turbidity controls. Using Chl-a as a proxy for phytoplankton biomass, increasing Chl-a with proximity to the littoral marsh was consistent with a phytoplankton response to the reduced turbidity and increased light availability. As TSS and inorganic NVSS decreased, Chl-a increased in response to the improved light availability.

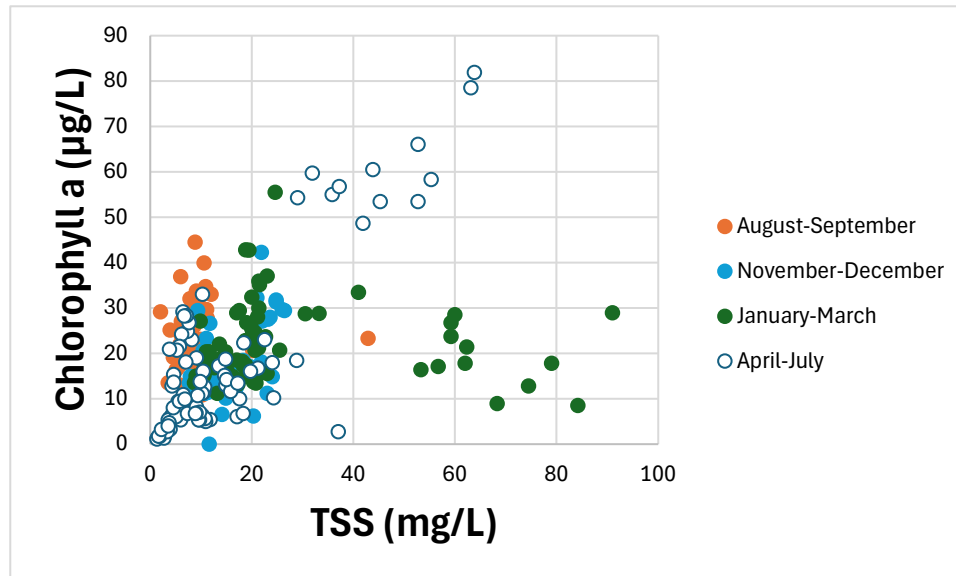
Figure 45. Relationship between total suspended solids (TSS) and Chl-a pigment in surface waters collected from both the North and South project areas over the monitoring period.

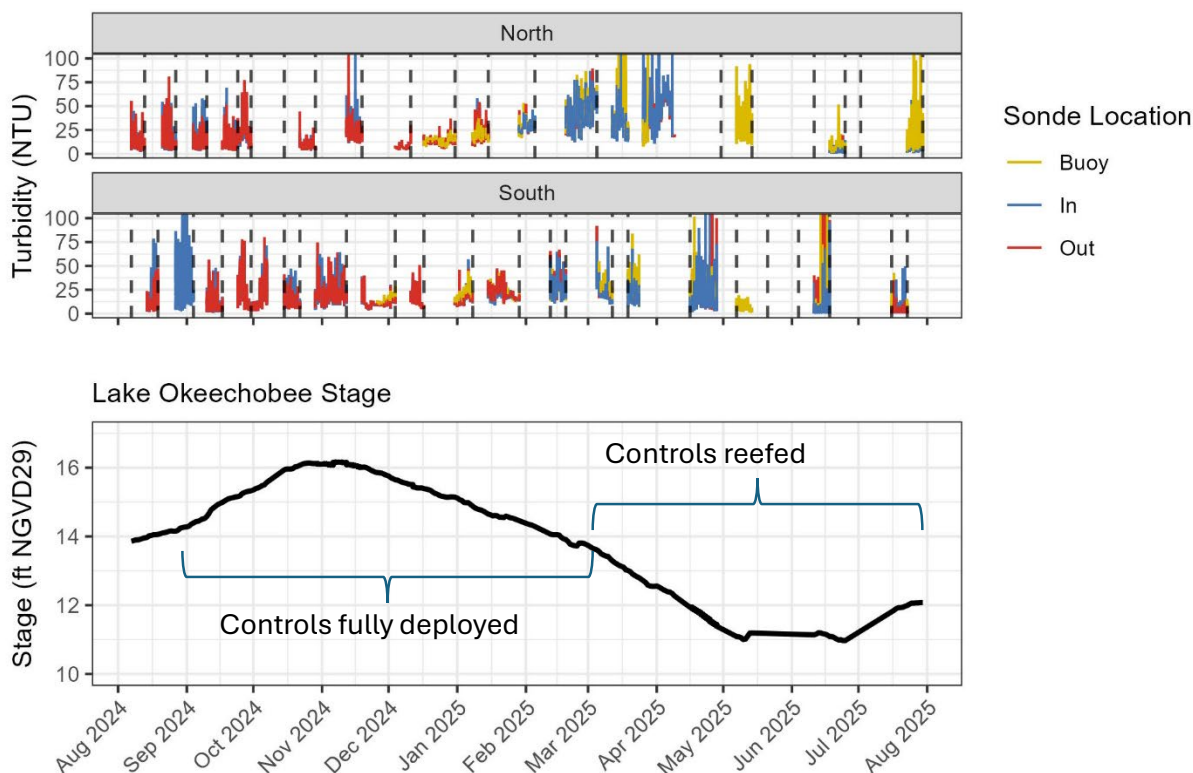
Figure 46. Data availability of high-frequency turbidity measurements recorded during the project period at the North Site and South Site, relative to water sampling events (vertical dashed lines, top panel) and lake stage (bottom panel).
