# Turbidity Control for SAV Recovery in the Lake Okeechobee Littoral Zone

September 30, 2025

Prepared for: South Florida Water Management District

Prepared by: DB Environmental, Inc.

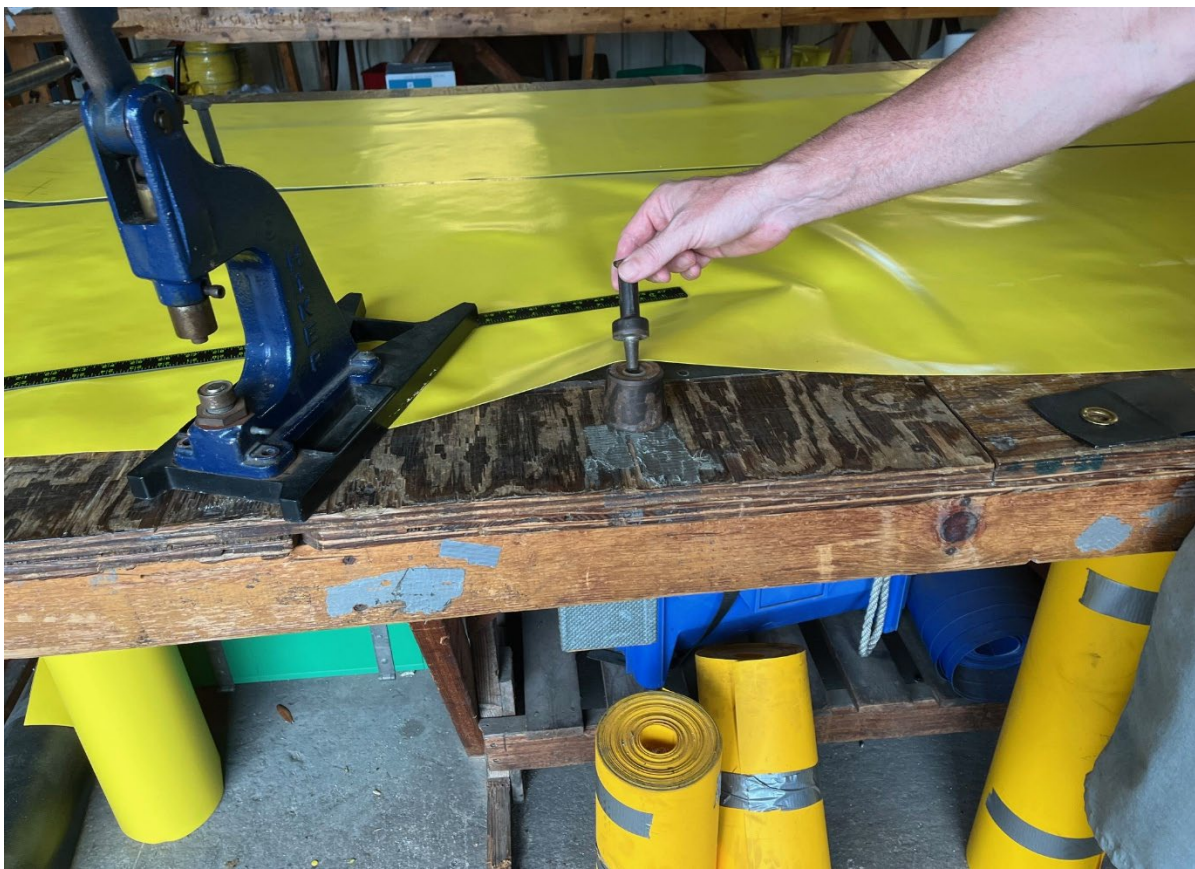
Figure 71. Grommet installation tools at manufacturing facility.

Modifications were completed by a combination of work on and off the water. Initial grommet installation occurred at (and in consultation with) the curtain manufacturing facility to review the

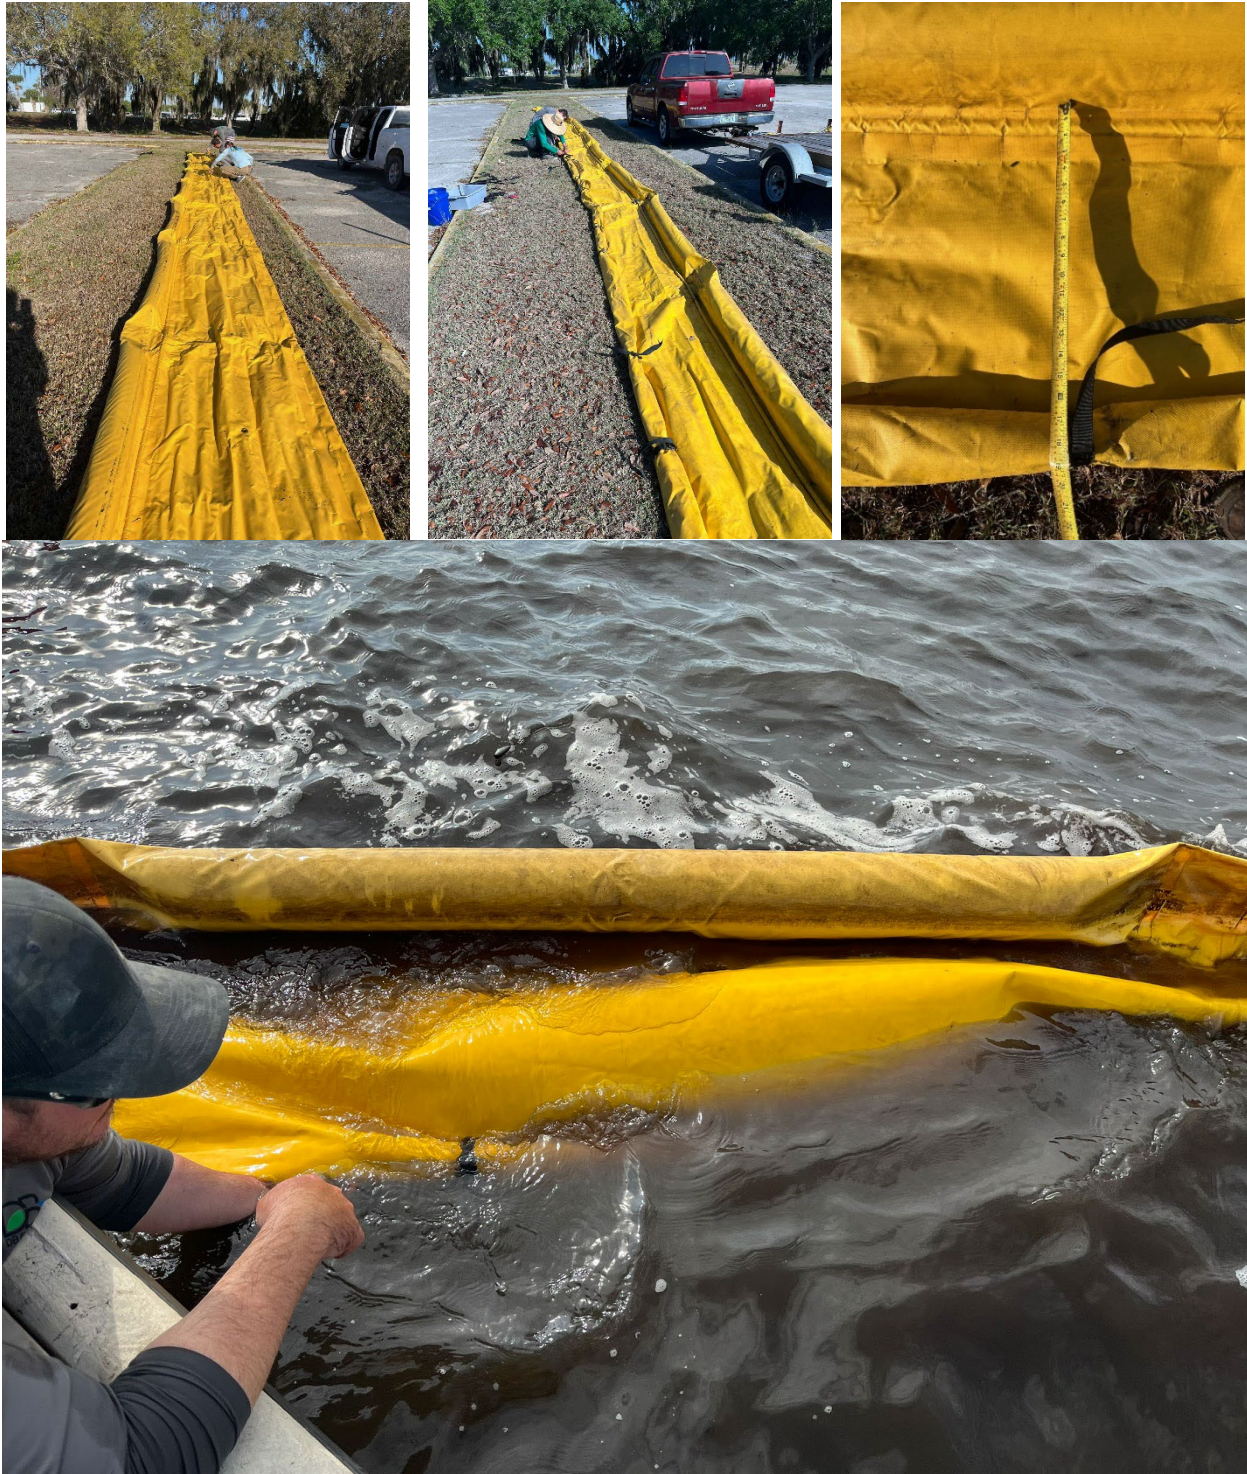
Figure 72. Preparation and deployment of modified controls.

equipment and design (Figure 71). Several curtains were in need of minor repairs to the hardware (metal end plates) or vinyl curtain, and these repairs were completed before grommets were installed every 3-4 ft along the barrier, 18" from the bottom edge (Figure 72). This position allows the curtain to be rolled tight from the bottom edge to shorten the length of curtain to 18" down from the water line and float, rather than full depth curtains at 3' length. The "partially reefed" curtains can operate in water as shallow as 2 ft and maintain 6" clearance below the bottom of the curtain. As lake levels increase to water depths > 4 ft, the curtain can be released to a full depth of 3 ft to provide turbidity reduction, while maintaining 1 ft clearance below the curtain. This design modification was implemented with on-water installation to expedite delivery (Figure 73) and provide operational flexibility in the lake across a range of water depths. Modifications were completed for all 24 curtains (12 at each of two project locations).

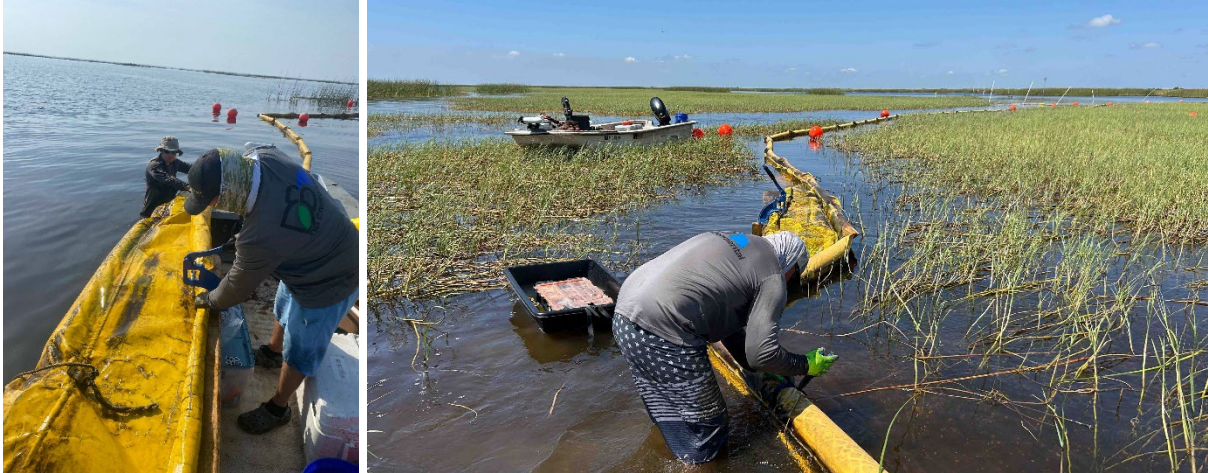
Figure 73. On-water installation of the modifications to expedite delivery of results.
