H.1	A-2 Flow Equalization Basin Lands Hazardous, Toxic and Radioactive Waste Audits

PHASE II ENVIRONMENTAL SITE ASSESSMENT

A-2 FLOW EQUALIZATION BASIN PALM BEACH COUNTY, FLORIDA

PSI PROJECT NO. 05521114

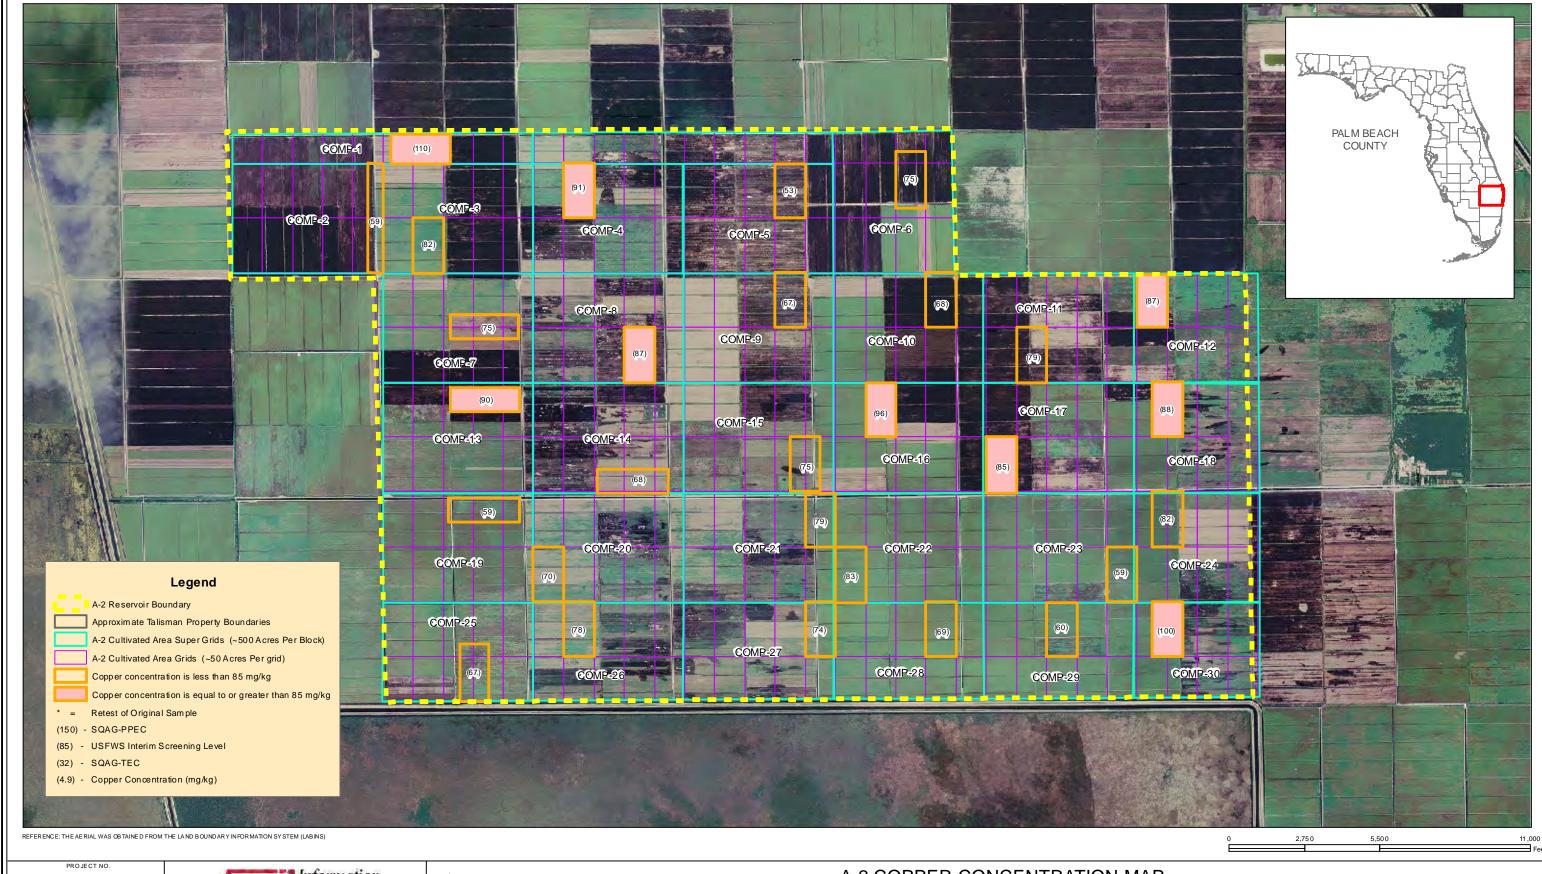
FIGURE 3

- In order to collect the composite samples, PSI further divided each 50-acre grid into ten, 5-acre sub-grids. PSI collected a close-proximity soil sample from approximately the center of each 5-acre sub-grid cell. Within each sub-grid cell, PSI collected a 5-point close-proximity composite sample by collecting equal aliquots from the center of the sub-grid cell, and five feet away in all four cardinal directions. The aliquots were homogenized in a stainless steel bowl using a stainless steel spatula or spoon. A 4-ounce aliquot of each sub sample was placed into a larger mixing bowl which was utilized to collect the composite Once all ten subsamples were collected in the mixing bowl, the samples. sample was further homogenized and a composite sample representing the entire 50-acre grid was collected in a 4 ounce glass laboratory container. The composite samples were labeled as Comp-1 through Comp-30. sampling locations were recorded on a global positioning system (GPS) receiver with an accuracy of +/- 1 meter. The soil sampling locations are shown on Figure 3.
