**Technical Paper**

**ERA # 464**

**Hurricane Effects on South Florida Water  
Management System: A Case Study of  
Hurricane Wilma of October 2005**

**January 2008**

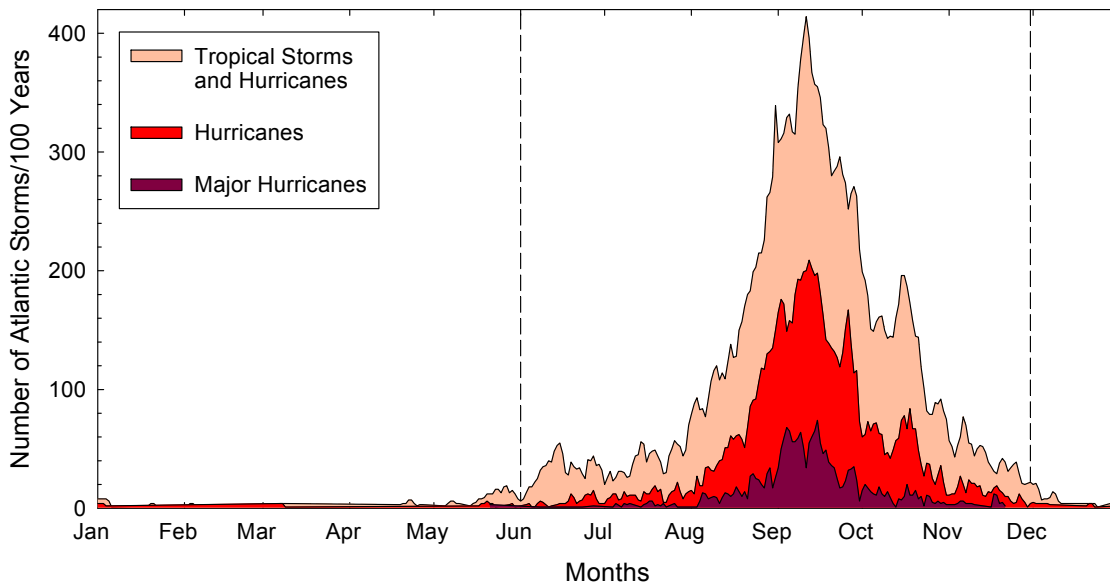
Figure 1. Distribution of North Atlantic tropical storms from 1906 through 2006. Data source (<http://weather.unisys.com/hurricane/atlantic/index.html> accessed on November 15, 2007).

The distribution of tropical systems, excluding depressions, from 1906 through 2006 is shown in Figure 1. Eighty-two percent of tropical storms and hurricanes occurred from the beginning of August through the end of October. There were 114 hurricanes and tropical storms that affected the Florida peninsula between 1871 and 1996, with hurricanes comprising about half of these (Attaway, 1999). A storm is classified as tropical storm at  $56 \text{ km h}^{-1}$  wind speed and as hurricane at  $120 \text{ km h}^{-1}$ .

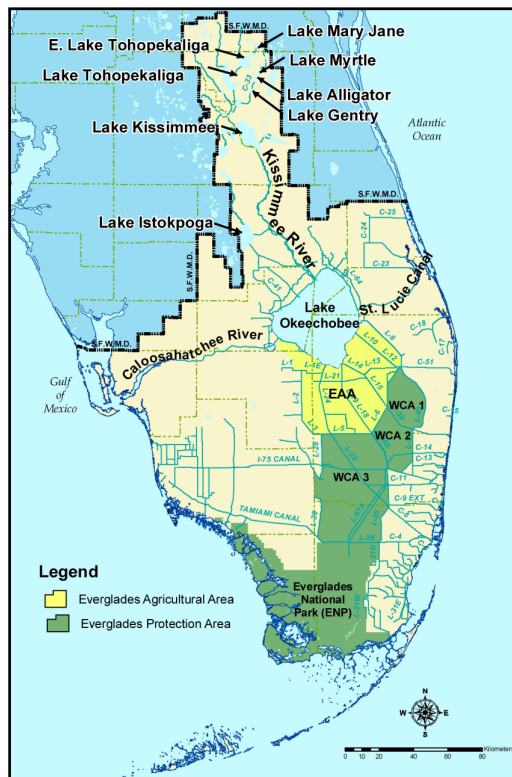
Figure 2. The South Florida Water Management District with water management infrastructure (canals, lakes and impoundments).

The South Florida Water Management System extends from Orlando to the north to the Florida Keys to the south (Figure 2). It covers an area of 46,400 km<sup>2</sup> extending across 16 counties. The SFWMD manages the region's water resources for flood control, water supply, water quality and natural systems needs. The region's water management system consists of lakes, impoundments, wetlands, and canals that are managed under a water management schedule based on flood control, water supply, and environmental restoration. The general surface water flow direction is from the north to the south, but there are also water supply and coastal discharges to the east and the west. The major hydrologic components are the Upper Kissimmee Chain of Lakes, Lake Okeechobee, Lake Istokpoga, the Everglades Agricultural Area (EAA), the Caloosahatchee Basin, St. Lucie Basin, the Lower East Coast and the Everglades Protection Area (EPA). The Upper Kissimmee Chain of Lakes is a principal source of inflow to Lake Okeechobee. The primary source of inflow into Lake Okeechobee is the Kissimmee River (C-38 Canal) which drains the Upper Kissimmee (4,194 km<sup>2</sup>), Lower Kissimmee (1,882 km<sup>2</sup>) and part of the Istokpoga water management basins. Other inflows into Lake Okeechobee include flows from Lake Istokpoga and Lake Istokpoga Surface Water Management Basin, 1,082 km<sup>2</sup> (through C-40, C-41 and C-41A canals), Fisheating Creek, the Taylor Creek-Nubbin Slough Basin and reverse flows from the Caloosahatchee River, the St. Lucie Canal, and the EAA (Abtew et al., 2007).

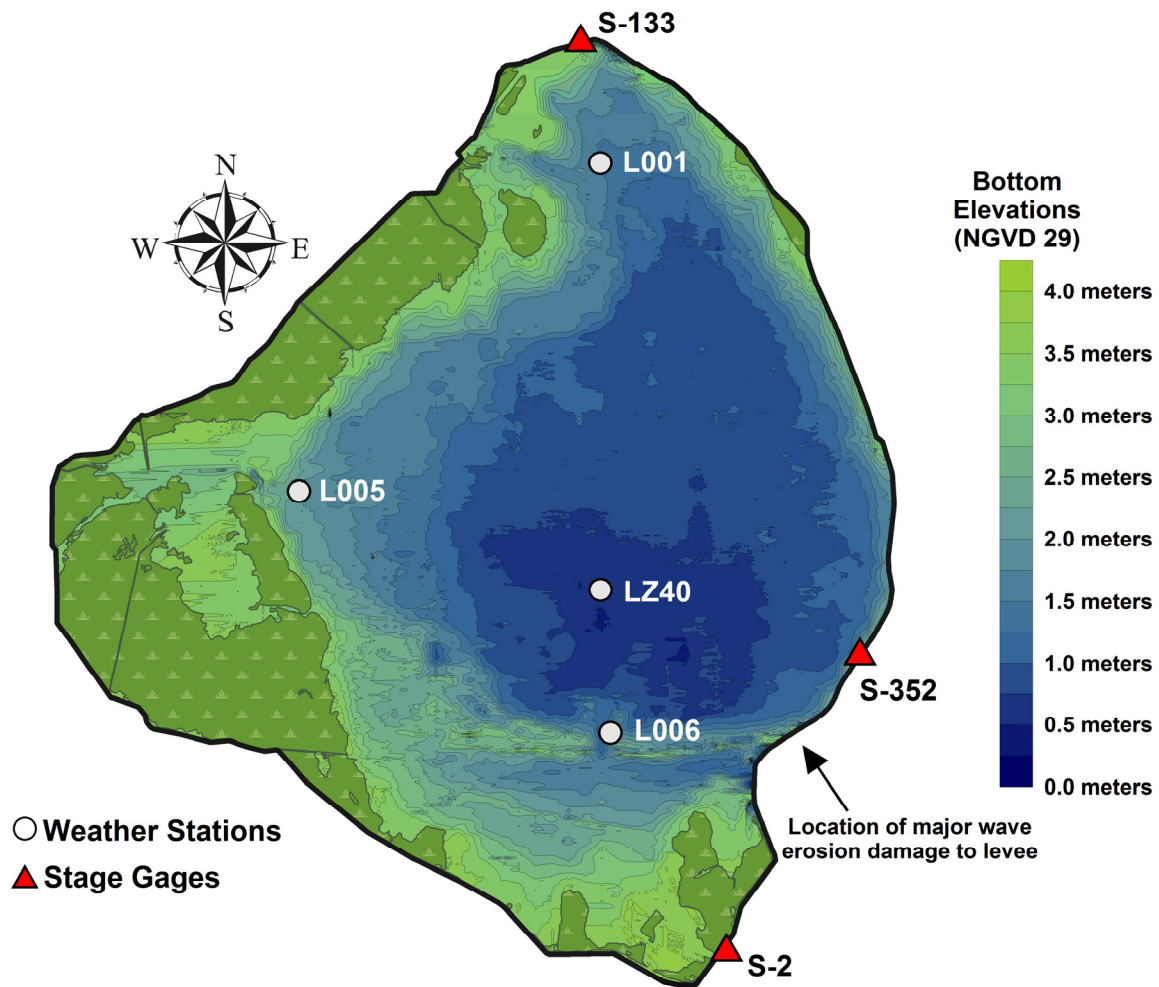
Figure 3. Map of Lake Okeechobee bottom elevations with locations for weather stations (circles), water level measurement sites (triangles), and location of levee erosion.

Lake Okeechobee is the largest lake in the southeastern United States (26° 58'N, 80° 50'W). It is the center of the South Florida hydrologic system, with an area of 1,732 km<sup>2</sup>. It is a relatively shallow lake with an average depth of 2.7 m. A bathymetric map of Lake Okeechobee is shown in Figure 3 with locations of weather stations, water level recording sites and levee damage from

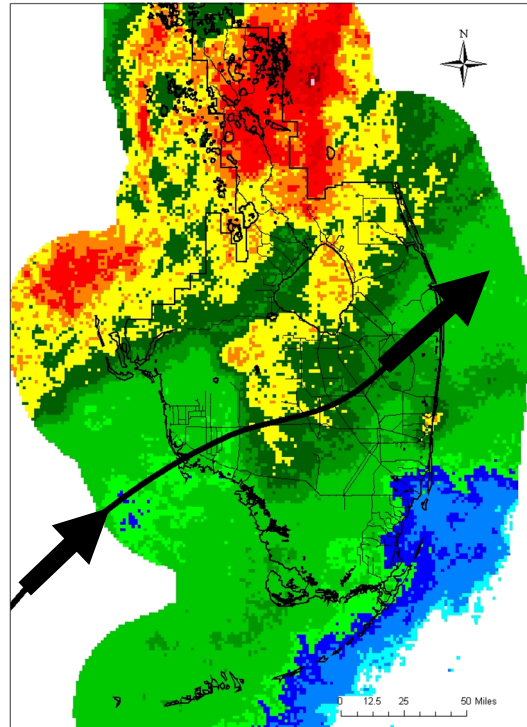
Figure 4. Path of Hurricane Wilma across South Florida on October 24, 2005 and cumulative rainfall amounts generated by the hurricane (October 22-25, 2005).

According to the National Hurricane Center (Pasch et al., 2006), Hurricane Wilma formed as a tropical depression on October 15, 2005, east-southeast of the Grand Cayman Island. On October 18<sup>th</sup>, Wilma became a hurricane moving west-northwestward towards the Yucatan Peninsula. Wilma strengthened to a Category 5 hurricane on October 19<sup>th</sup>, with a record low pressure of 882 mb (661.7 mm mercury), a record for an Atlantic hurricane. The hurricane made landfall on the island of Cozumel, Mexico, as a Category 4 hurricane. A day later, Wilma crossed the Yucatan Peninsula and, after prolonged battering of the northeastern section, it re-emerged in the Gulf of Mexico on October 23<sup>rd</sup> as a Category 1 storm. While being steered toward the west coast of South Florida, Wilma strengthened further and made landfall as a Category 3 hurricane near Cape Romano at the southwest corner of South Florida on October 24<sup>th</sup>. During its swift crossing of South Florida to the Atlantic (4.5 hours), Wilma weakened to a Category 2 hurricane. The path taken by Hurricane Wilma across South Florida and the rainfall coverage are depicted in Figure 4.

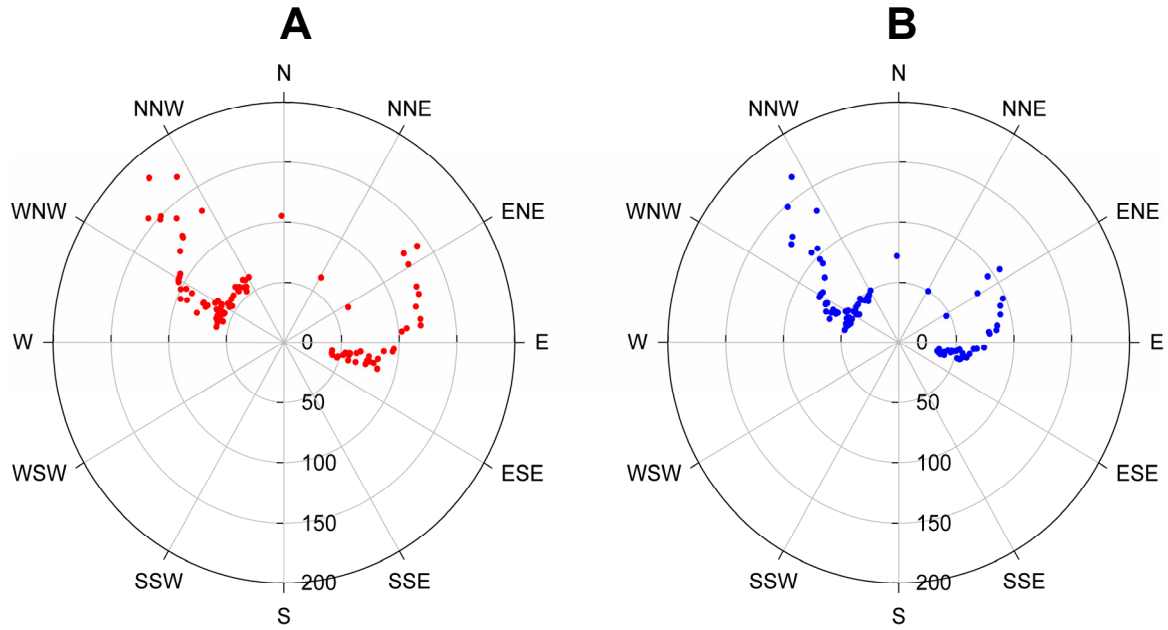
Figure 5. (A) Maximum gust wind speed ( $\text{km h}^{-1}$ ), (B) Average wind speed ( $\text{km h}^{-1}$ ) and wind direction at L006 weather station in Lake Okeechobee during Hurricane Wilma at 15-minute intervals (October 24<sup>th</sup>, 2005).

Four weather stations are located within Lake Okeechobee. Gust wind speed, average wind speed, and wind direction data were collected during Hurricane Wilma at three of the weather stations (L001, LZ40, L006). Weather station L001 (located at the northern side of the lake) registered instantaneous maximum gust wind speed of 172 km h<sup>-1</sup>, while weather station L006 (located in the south-side of the lake) registered instantaneous maximum gust wind speed of 180 km h<sup>-1</sup> (Figure 3). Instantaneous maximum gust wind speed (sampled every 10 seconds; maximum in 15 minutes) and 15-minute average wind speed and direction over the lake correspond with the area of levee erosion and high water levels. Wind direction over the lake is clearly depicted as east-northeast (ENE) from the front side of the hurricane and northwest (NW) from the backside of the hurricane (Figures 5A and 5B). Both the gust and average wind-speed data show that the back side of the hurricane had higher wind speeds than the front side.

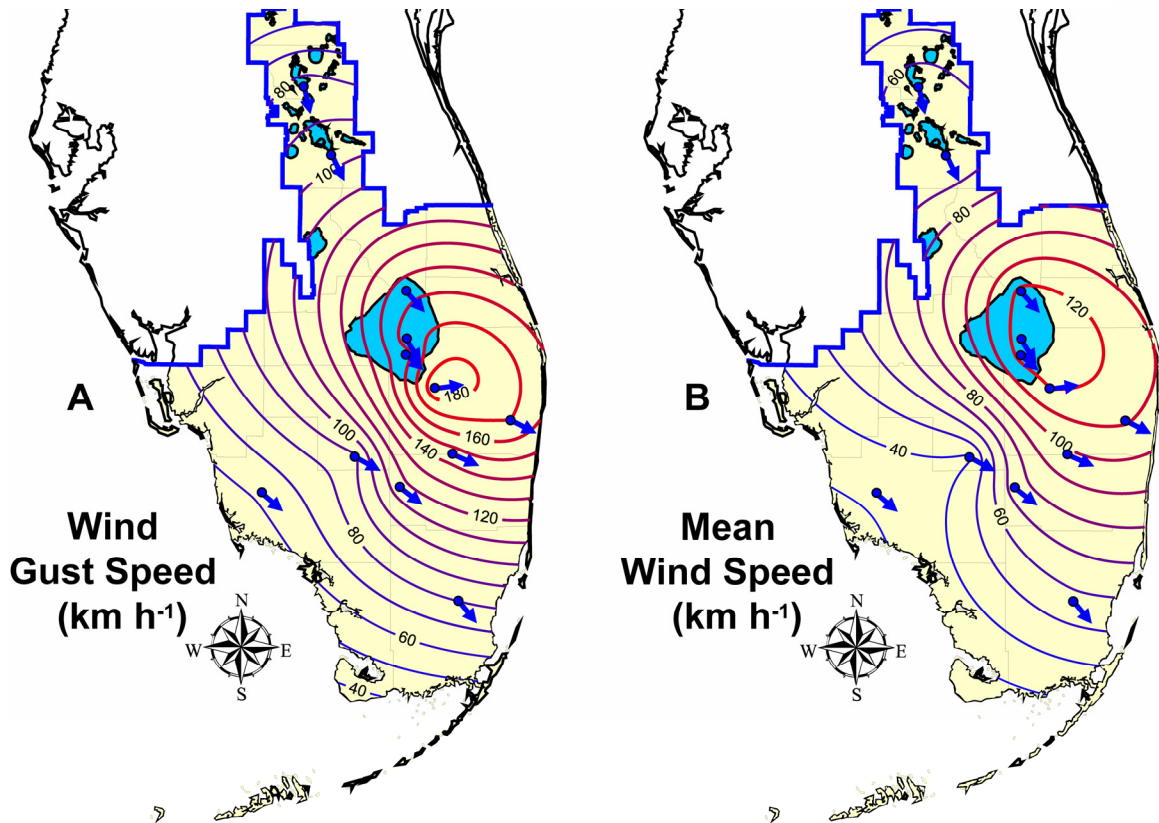
Figure 6. (A) Maximum gust wind speed ( $\text{km h}^{-1}$ ) and (B) 15-minute average wind speed and directions from Hurricane Wilma over South Florida at 10:30 am on October 24<sup>th</sup>, 2005.

Hurricane winds can generate high waves and storm surge, and the energy from the back-and-forth battering of an earthen levee can result in cutting the levee. Also, failure can occur around structures on the levee. Several areas were eroded along the lake levee as Hurricane Wilma passed through the area. If the wave setup and storm surge exceed the height of the levee, then washout could occur to the lake side, top, and outer side of the levee. The wave setup and storm surge from Hurricane Wilma exceeded the maximum reading capacity of water level recorders on the perimeter of Lake Okeechobee. Survey from the watermark preserved by District staff at the S-2 pump station, at the southern levee, indicated the wave setup and storm surge had reached 9.34 m NGVD. The lake water level at the time was 4.76 m NGVD, resulting in a wave setup of 4.58 m at the southern end of Lake Okeechobee. The maximum gust wind speed over the lake occurred at 10:30 am on October 24<sup>th</sup>, 2005 from the back winds of the hurricane. Figures 6A and B depict the spatial pattern and magnitude of the hurricane gust and 15-minute average wind speed at the time of peak and wind directions. Part of the levee was eroded from waves generated by Hurricane Wilma (Figure 7). The maximum wind speed and the direction correspond to this segment of the lake levee that was severely eroded (Figure 3, 6A, 6B and 7). Gust wind speed at the farthest north area of the District was 60 km h<sup>-1</sup> and 40 km h<sup>-1</sup> at the southern tip of the District.

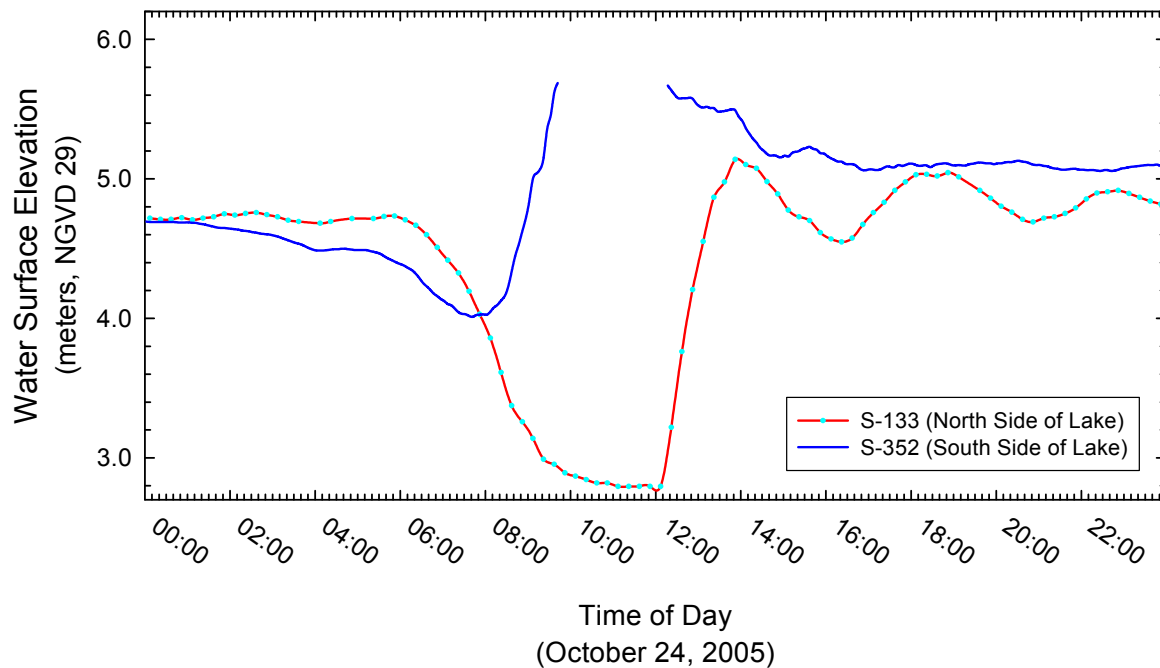
Figure 8. Water surface elevation changes in Lake Okeechobee during the passage of Hurricane Wilma over South Florida at gauge S-133 (upwind) and S-352 (downwind). The break in elevation for the S-352 gauge resulted in wave height exceeding water level sensor maximum reading.

not fitted to record a storm surge maximum water level as it is out of the range of normal operations. Two gauges, one from the north, upwind, (S133) and one from the south, downwind, (S352) depict the water level tilt in a limited way (Figure 8).

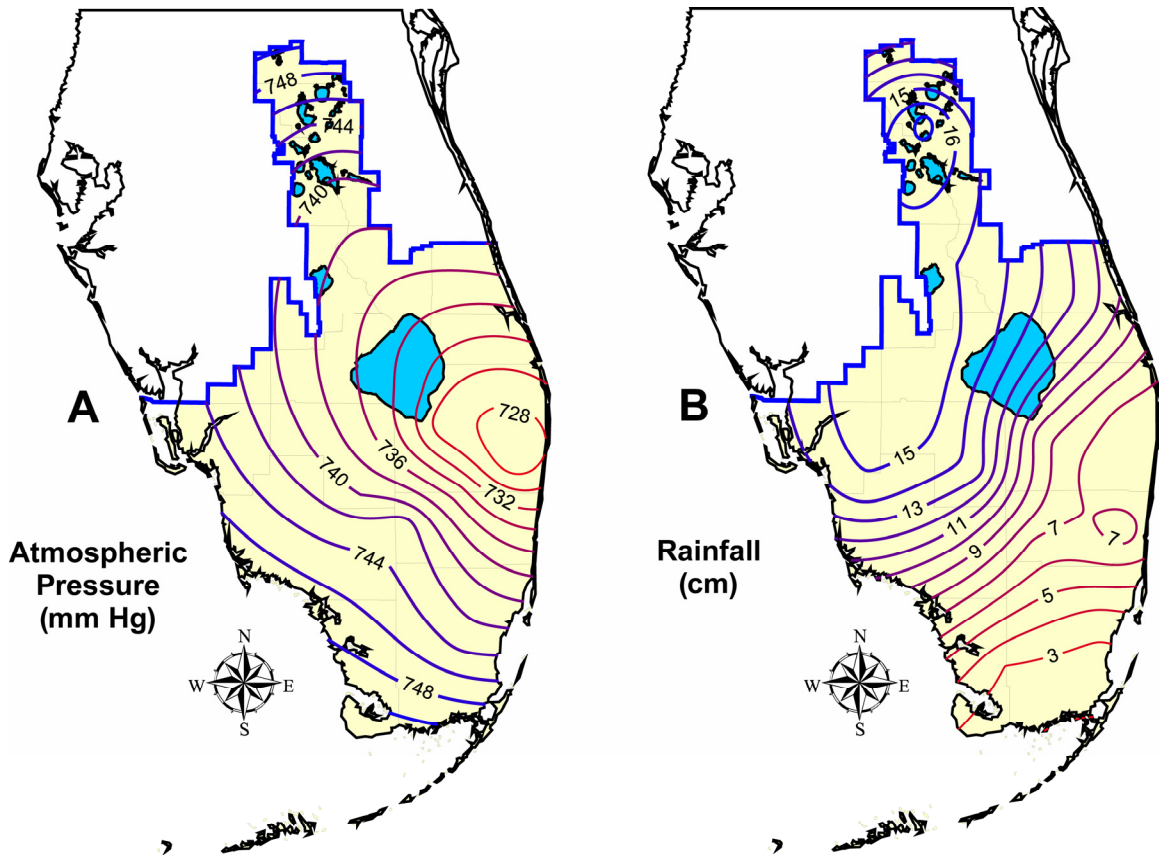
Figure 9. (A) Atmospheric pressure (mm mercury) at peak wind speed over Lake Okeechobee (10:30 am on October 24, 2005) and (B) rainfall (cm) from Hurricane Wilma (October 22-25, 2005).

At peak wind speed over Lake Okeechobee (10:30 am on October 24<sup>th</sup>, 2005), the minimum 15-minute average atmospheric pressure registered by the LOXWS weather station, southeast of Lake Okeechobee, was 726 mm mercury (968 mb). Concurrently, maximum pressure was located on the northern and southern ends of the District (748 mm mercury, 997 mb). Conversion for atmospheric units is shown in the Appendix. The center of the hurricane had moved forward on a path southeast of the lake when the maximum gust wind speed affected the lake (Figures 9A,

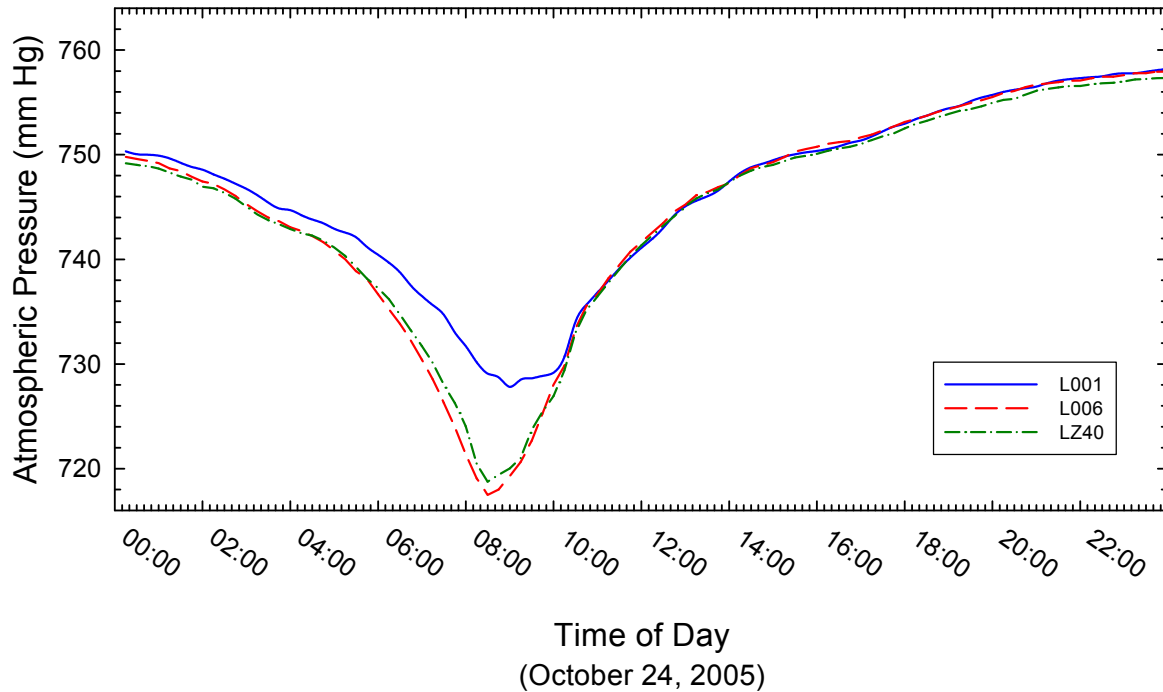
Figure 10. Atmospheric pressure changes (in mm of Hg) over Lake Okeechobee during the passage of Hurricane Wilma over South Florida; L001 (north), L006 (south central) and LZ40 (south).

4). Energy from the wind is a function of the difference in pressure from the center of the hurricane to the outer boundary where the wind profile is asymptotic, the radius of maximum wind, and radius of the point of interest (Myers, 1954). The pattern of the pressure spatial distribution has a similar pattern to the wind speed spatial distribution (Figures 6A, B and 9A). The minimum 15-minute average pressure through the duration of the hurricane over South Florida was 713 mm mercury (950 mb) measured at STA5WX weather station (7:45 am on October 24, 2005) southwest of the lake. Minimum pressure over the lake occurred earlier than the maximum wind speed over the lake (Figure 10).

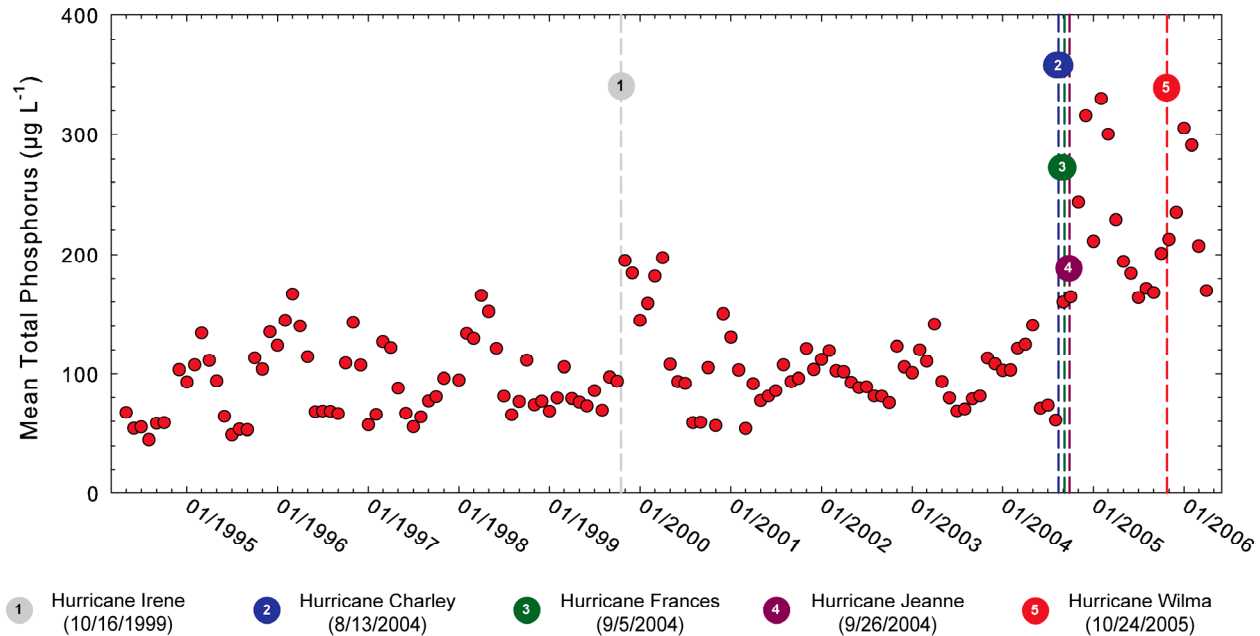
Figure 11. Monthly mean total phosphorus concentrations in Lake Okeechobee from May 1994 through April 2006. Vertical lines show dates when hurricanes have impacted the lake.

Three hurricanes affected the lake between August 2004 and September 2004, with one hurricane affecting the lake in October 2005 (Hurricane Wilma). As a result, TP concentrations in Lake Okeechobee exhibited monthly averages ranging from 61 to 330  $\mu\text{g L}^{-1}$  for the period from August 2004 to April 2006 (Figure 11). It is evident from Figure 11 that mean TP concentrations in the lake did not decrease below 160  $\mu\text{g L}^{-1}$  following August 2004. It is important to note that peaks in monthly mean TP concentrations were not observed until several months after a hurricane had affected the lake. Havens et al. (2001) also reported a similar time lag of increased concentrations following the passage of the 1999 hurricane by the lake.

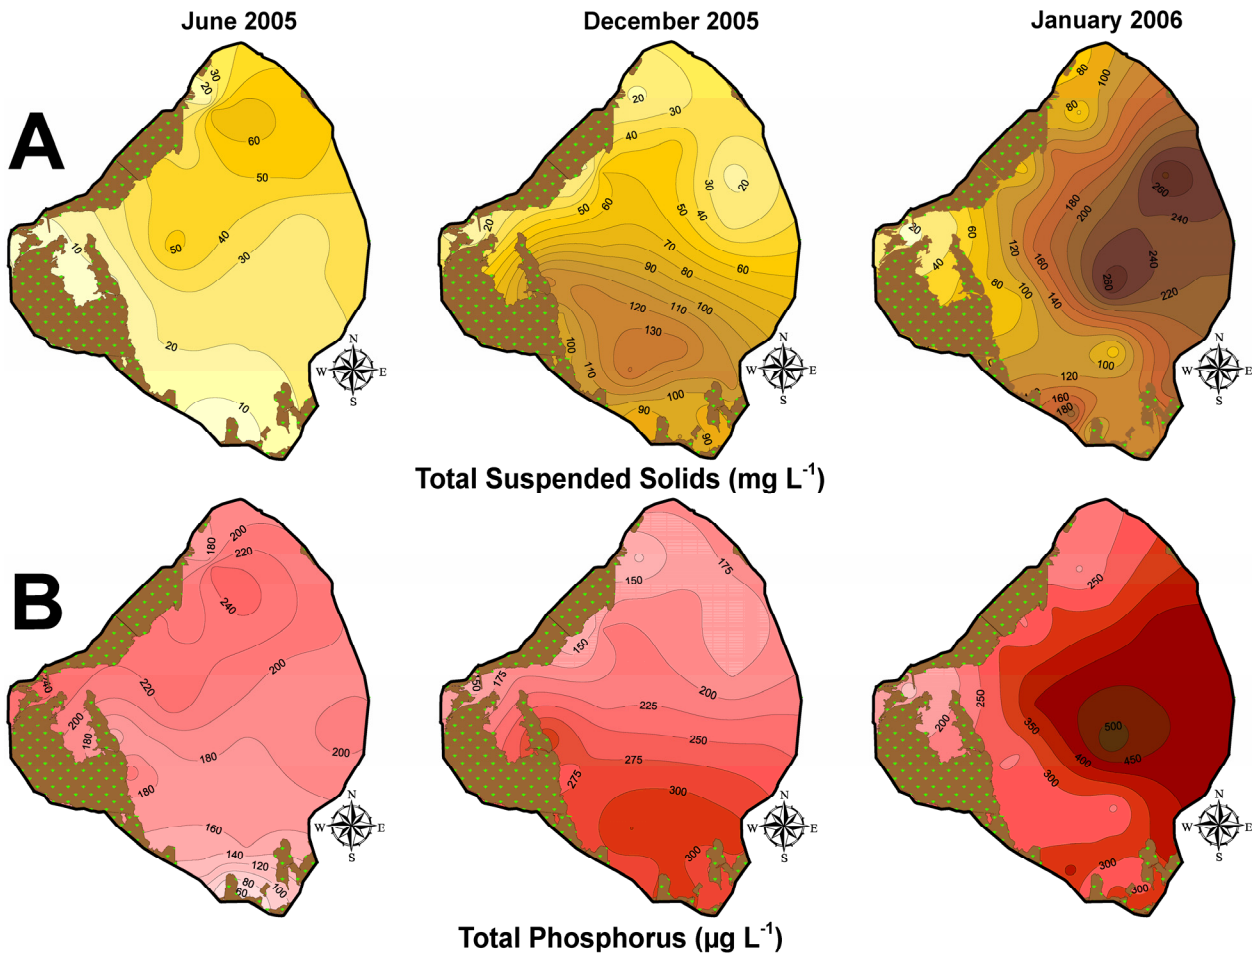
Figure 12. Isoline maps showing lake-wide concentrations of (A) total suspended solids and (B) total phosphorus in Lake Okeechobee starting from the beginning of the 2005 hurricane season (June 2005) to end of the 2005 hurricane season (December 2005) and the following month (January 2006).

Isoline maps were generated from the monthly monitoring data to show the effect of Hurricane Wilma on Lake Okeechobee water quality. Three months were selected to demonstrate these changes in water quality: June 2005 (start of hurricane season); December 2005 (end of hurricane season); and January 2006 (approximately one month following the end of hurricane season). Since previous studies have illustrated the effects of wind on TP and total suspended solids (TSS) in Lake Okeechobee (Havens et al., 2001), monthly isoline maps were generated for these two parameters (Figure 12).

At the start of the 2005 hurricane season (June 2005), TP and TSS levels did not exceed 250  $\mu\text{g L}^{-1}$  and 70  $\text{mg L}^{-1}$ , respectively. In addition, more than 50 percent of the lake (based on the isoline maps) had TP concentrations less than 200  $\mu\text{g L}^{-1}$  (Figure 12). By the end of the hurricane season (December 2005), 38 percent of the lake exhibited TP concentrations less than 200  $\mu\text{g L}^{-1}$  while 77 percent of the lake had TSS levels less than 100  $\text{mg L}^{-1}$ . Nutrient and suspended solid levels

continued to increase with more than 90 percent of the lake exhibiting TP concentrations in excess of  $200 \mu\text{g L}^{-1}$  for January 2006. Additionally, approximately 69 percent of the lake (January 2006) had TSS levels greater than  $100 \text{ mg L}^{-1}$ . These suspended materials limit growth of submerged vegetation by reducing light penetration depth. The hurricane uprooted and dislocated vegetation from wetlands and littoral zones around the lake resulting in increased suspended detritus.

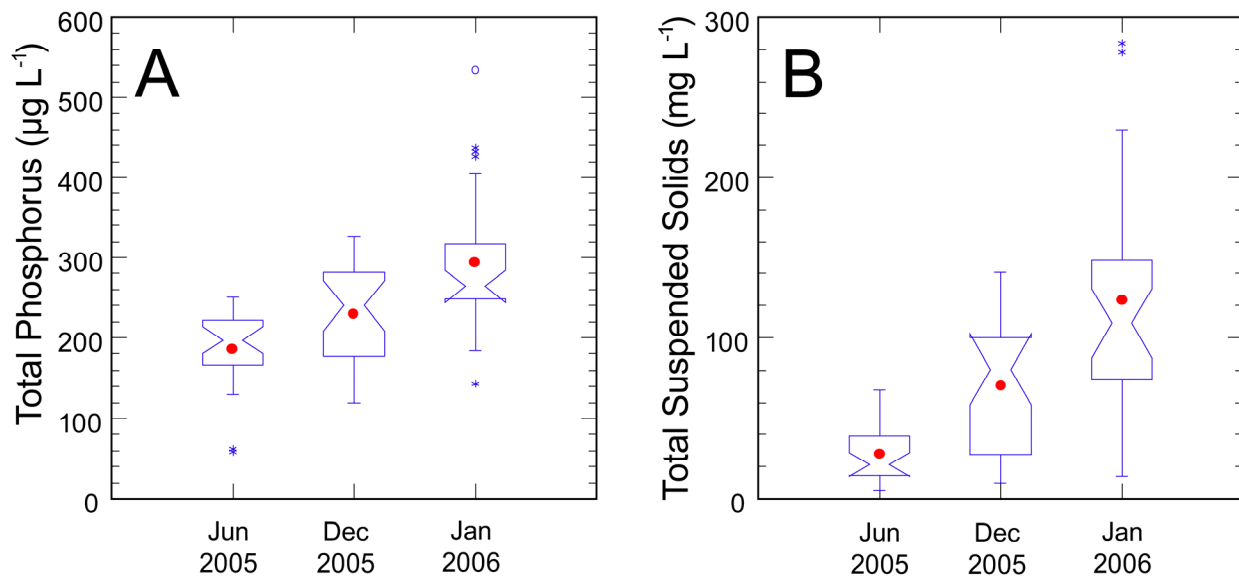
Figure 13. Box-and-whisker plots of (A) total phosphorus and (B) total suspended solids concentrations in Lake Okeechobee at the start of the 2005 hurricane season (June 2005), end of the 2005 hurricane season (December 2005) and the following month (January 2006). The solid circles represent the mean and the notch represents the median concentration. Upper and lower boundaries of boxes are 75<sup>th</sup> and 25<sup>th</sup> percentiles. Upper and lower whiskers represent the highest and lowest values not outside 2 standard deviations from the median.

Summary statistics of monthly TP and TSS data for Lake Okeechobee measured during these three months are depicted in Table 1. Maximum concentrations of TP more than doubled from June 2005 to January 2006, while TSS levels increased more than four-fold. Distributions of monthly in-lake concentrations measured at 30 monitoring stations for these two parameters also show the increase over these three months (Figure 13).
