January - March 2016

# Kissimmee River Restoration Project and Kissimmee Basin Environmental and Restoration Features

Kissimmee River Restoration Project  
Reach 3 C-38 Backfill  
Construction Progress  
February 2016

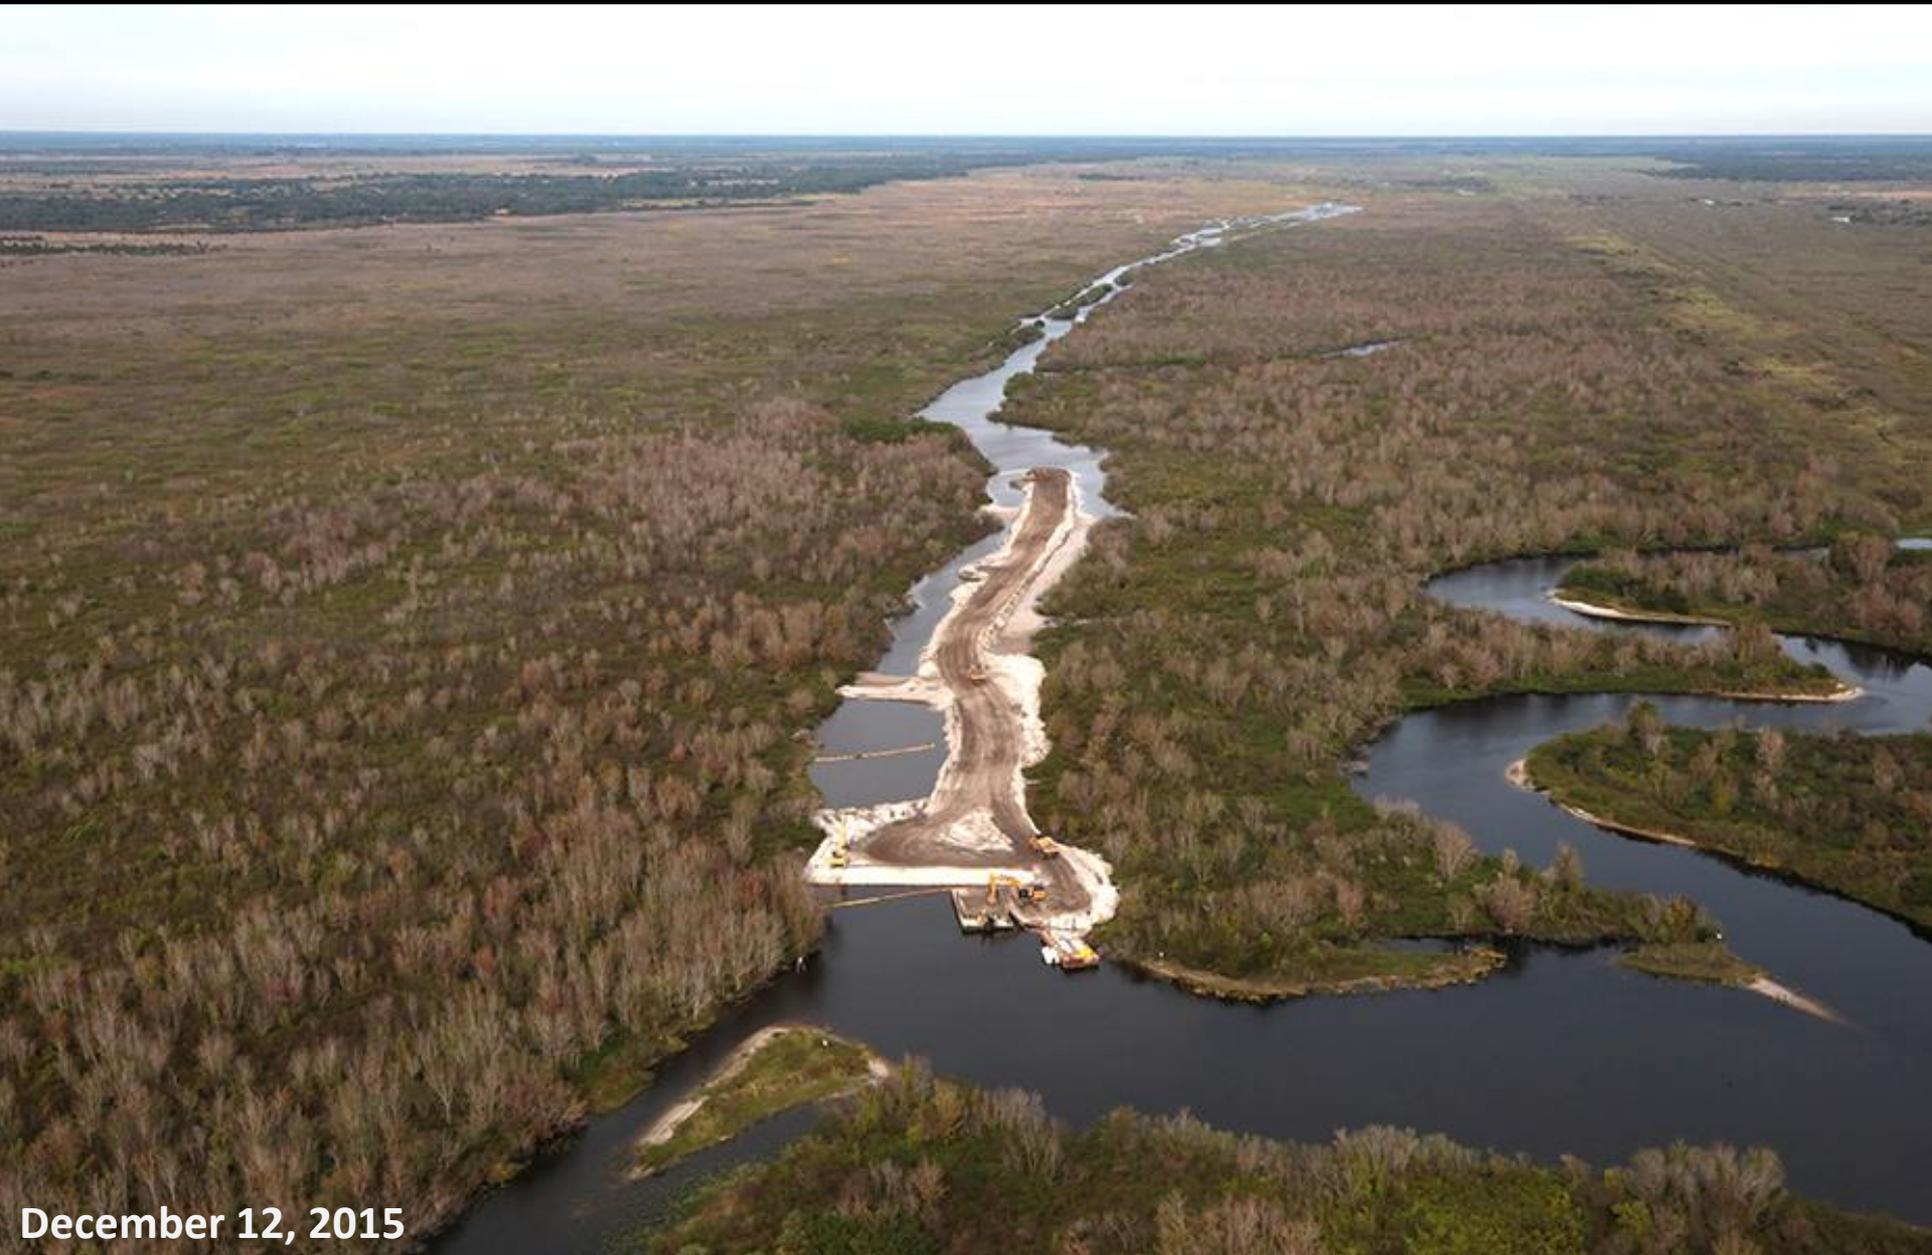
**December 12, 2015**

Looking north (upstream) from the southern end of the MacArthur Ditch backfill project where a rock plug was installed. Backfilling of the ditch has been resumed.

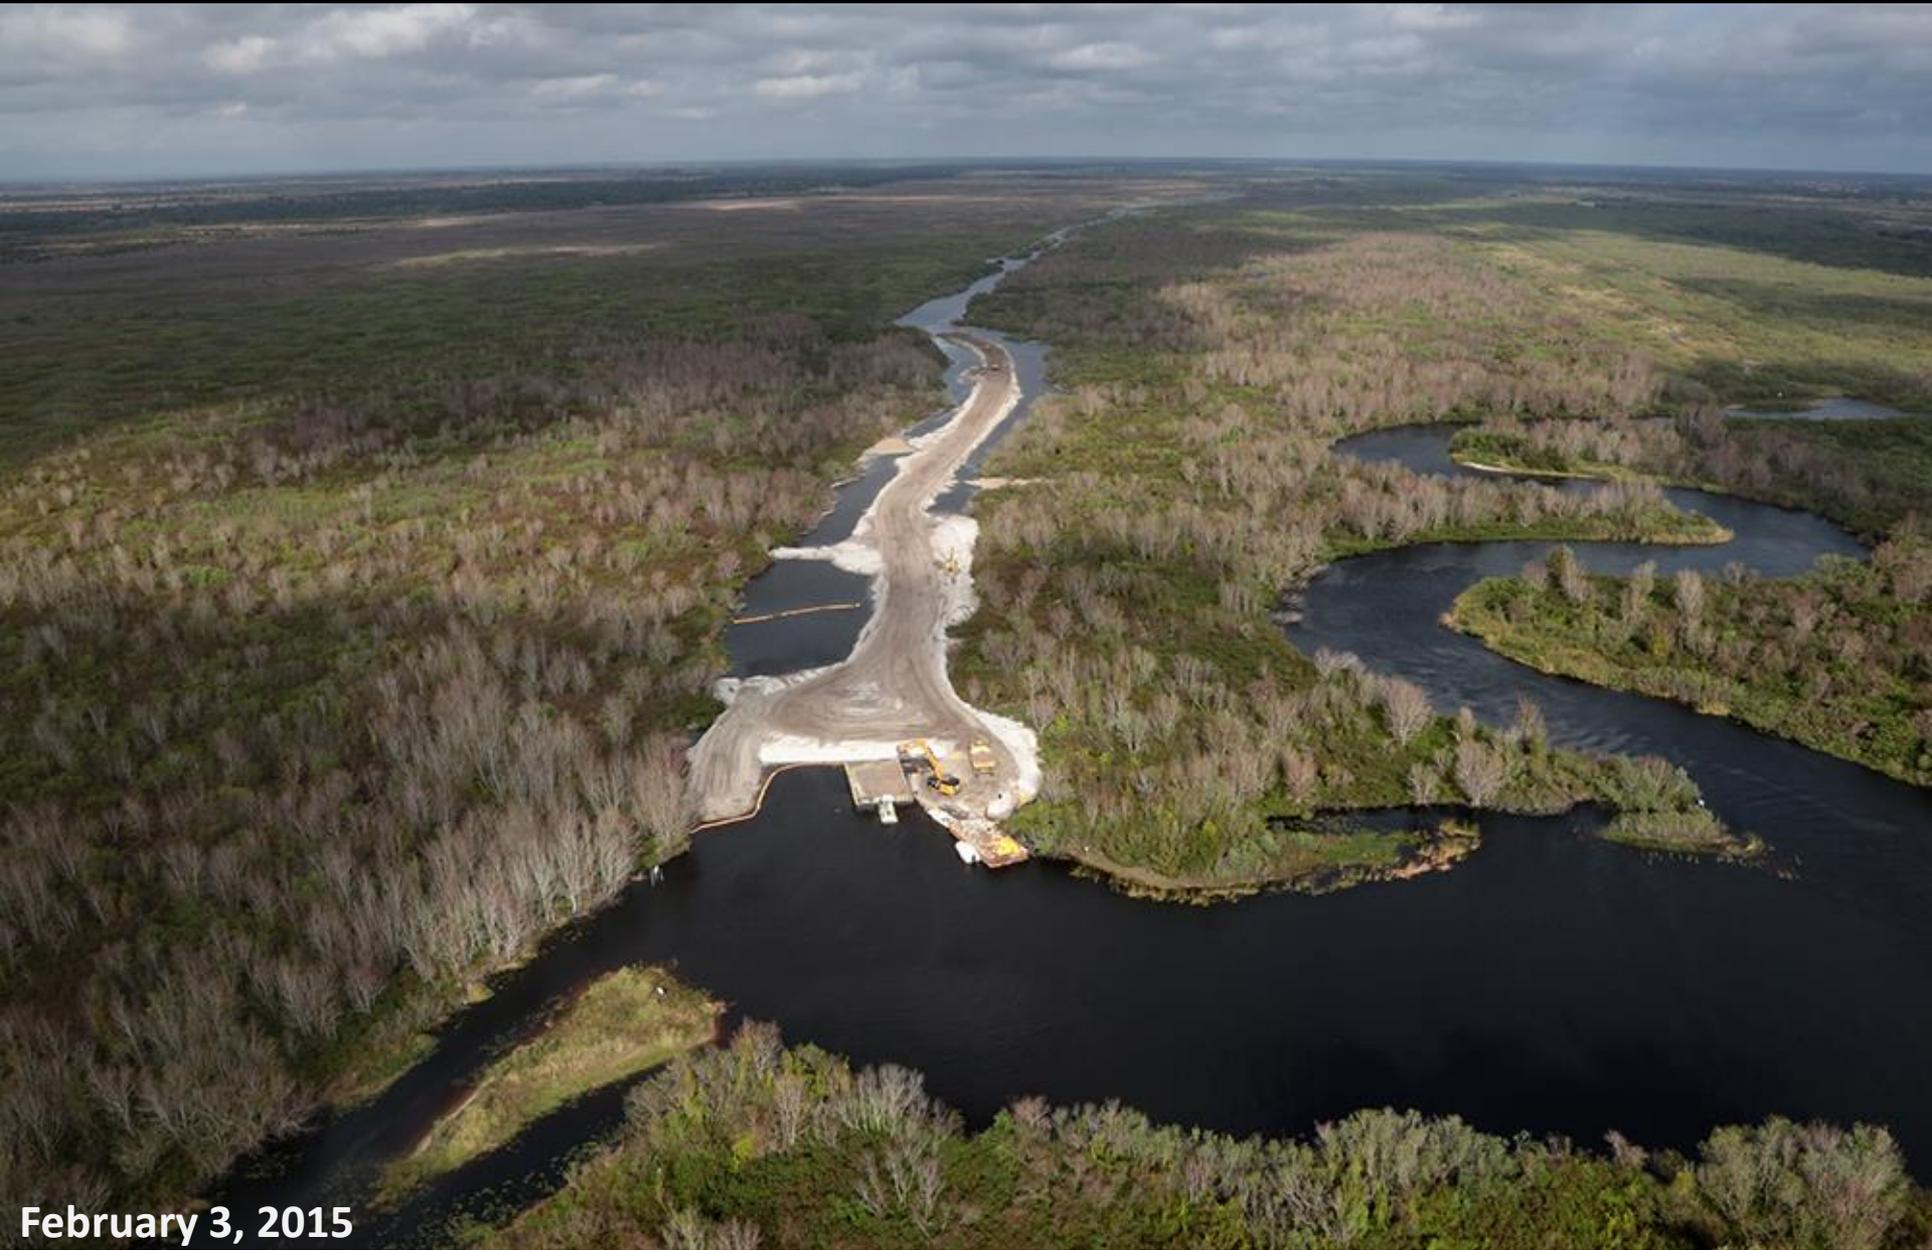
**February 3, 2015**

Looking north (upstream) from the southern end of the MacArthur Ditch backfill project where a rock plug was installed. Backfilling of the ditch has been resumed.

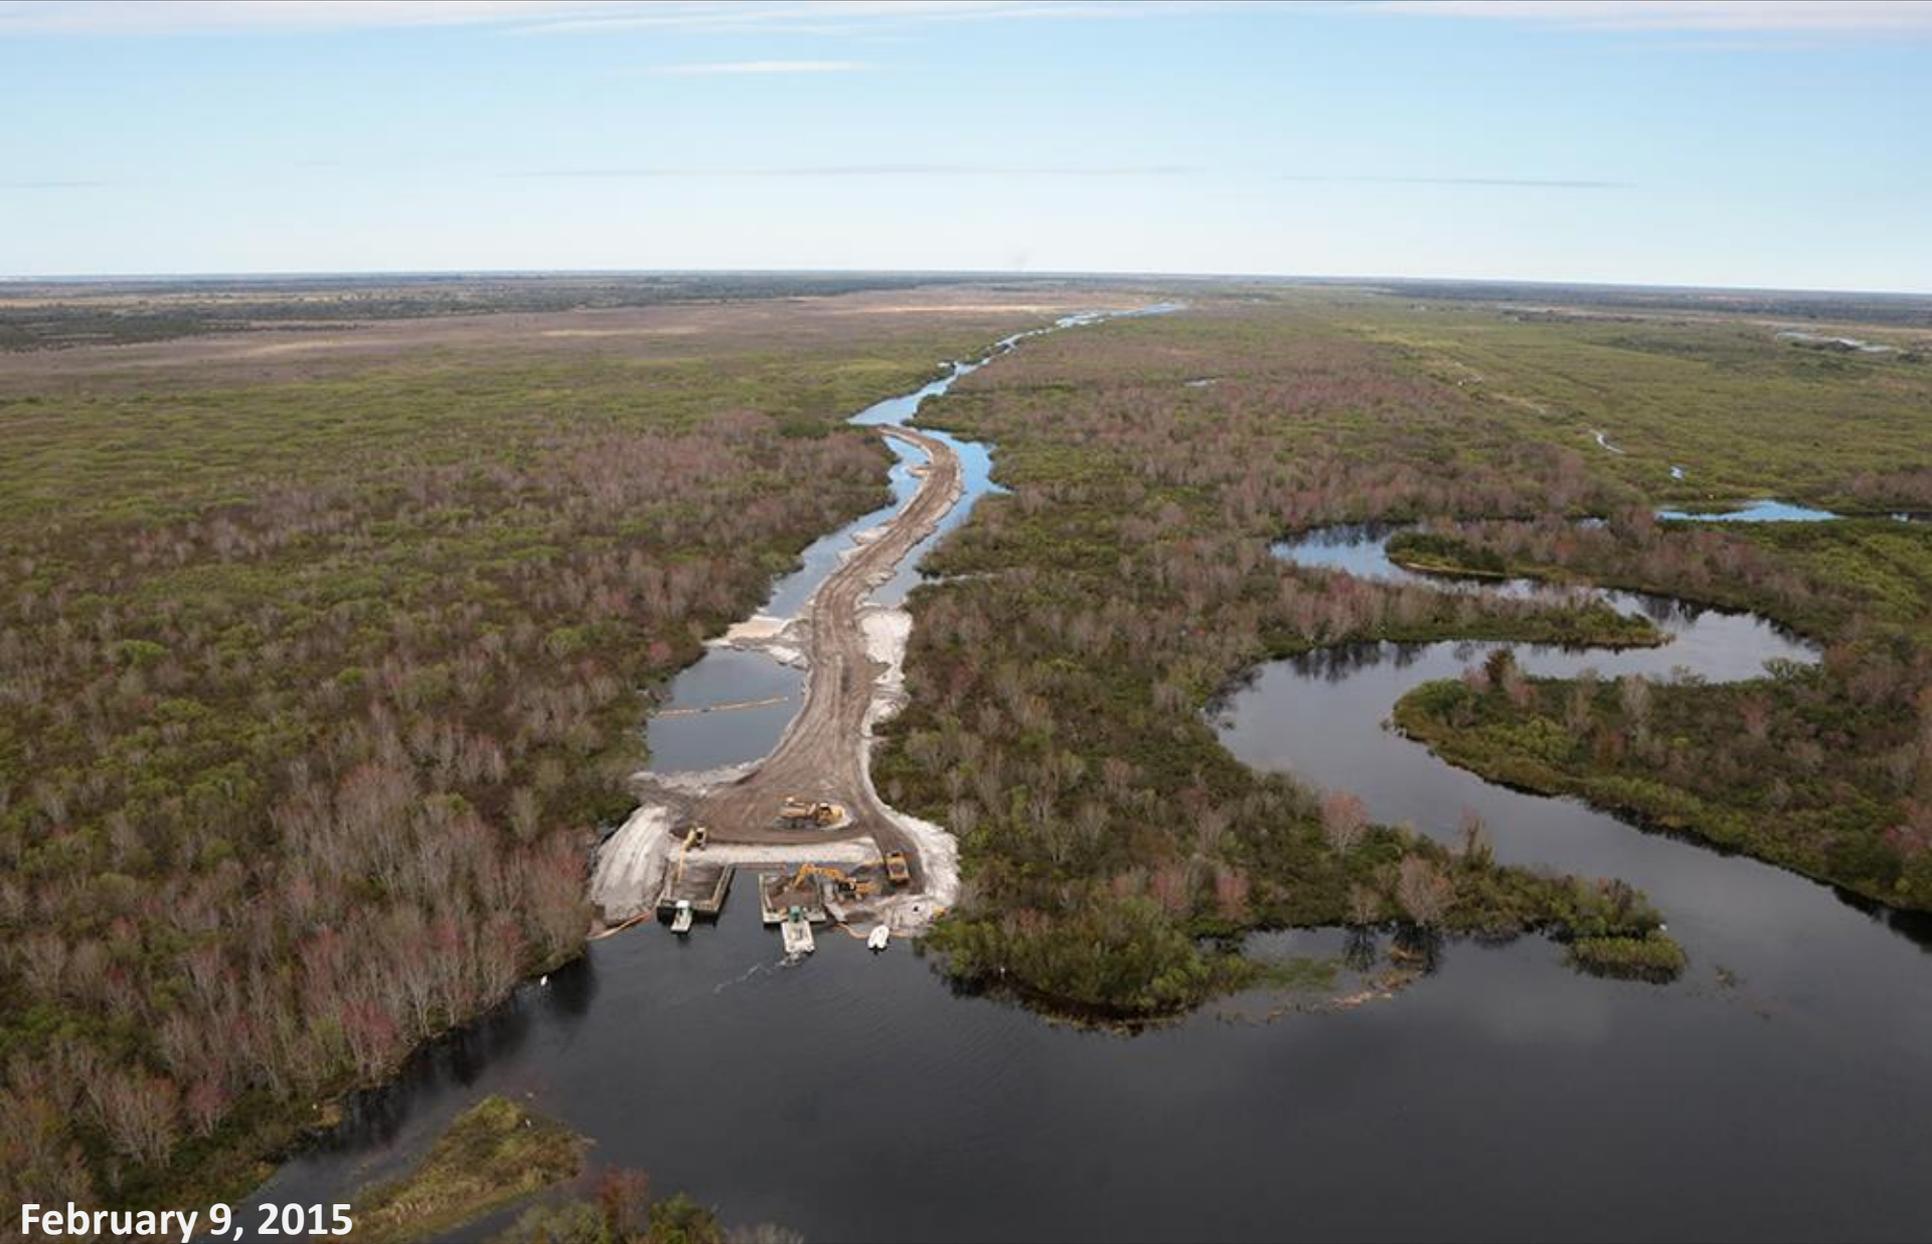
**February 9, 2015**

Looking north (upstream) from the southern end of the MacArthur Ditch backfill project where a rock plug was installed. Backfilling of the ditch has been resumed.

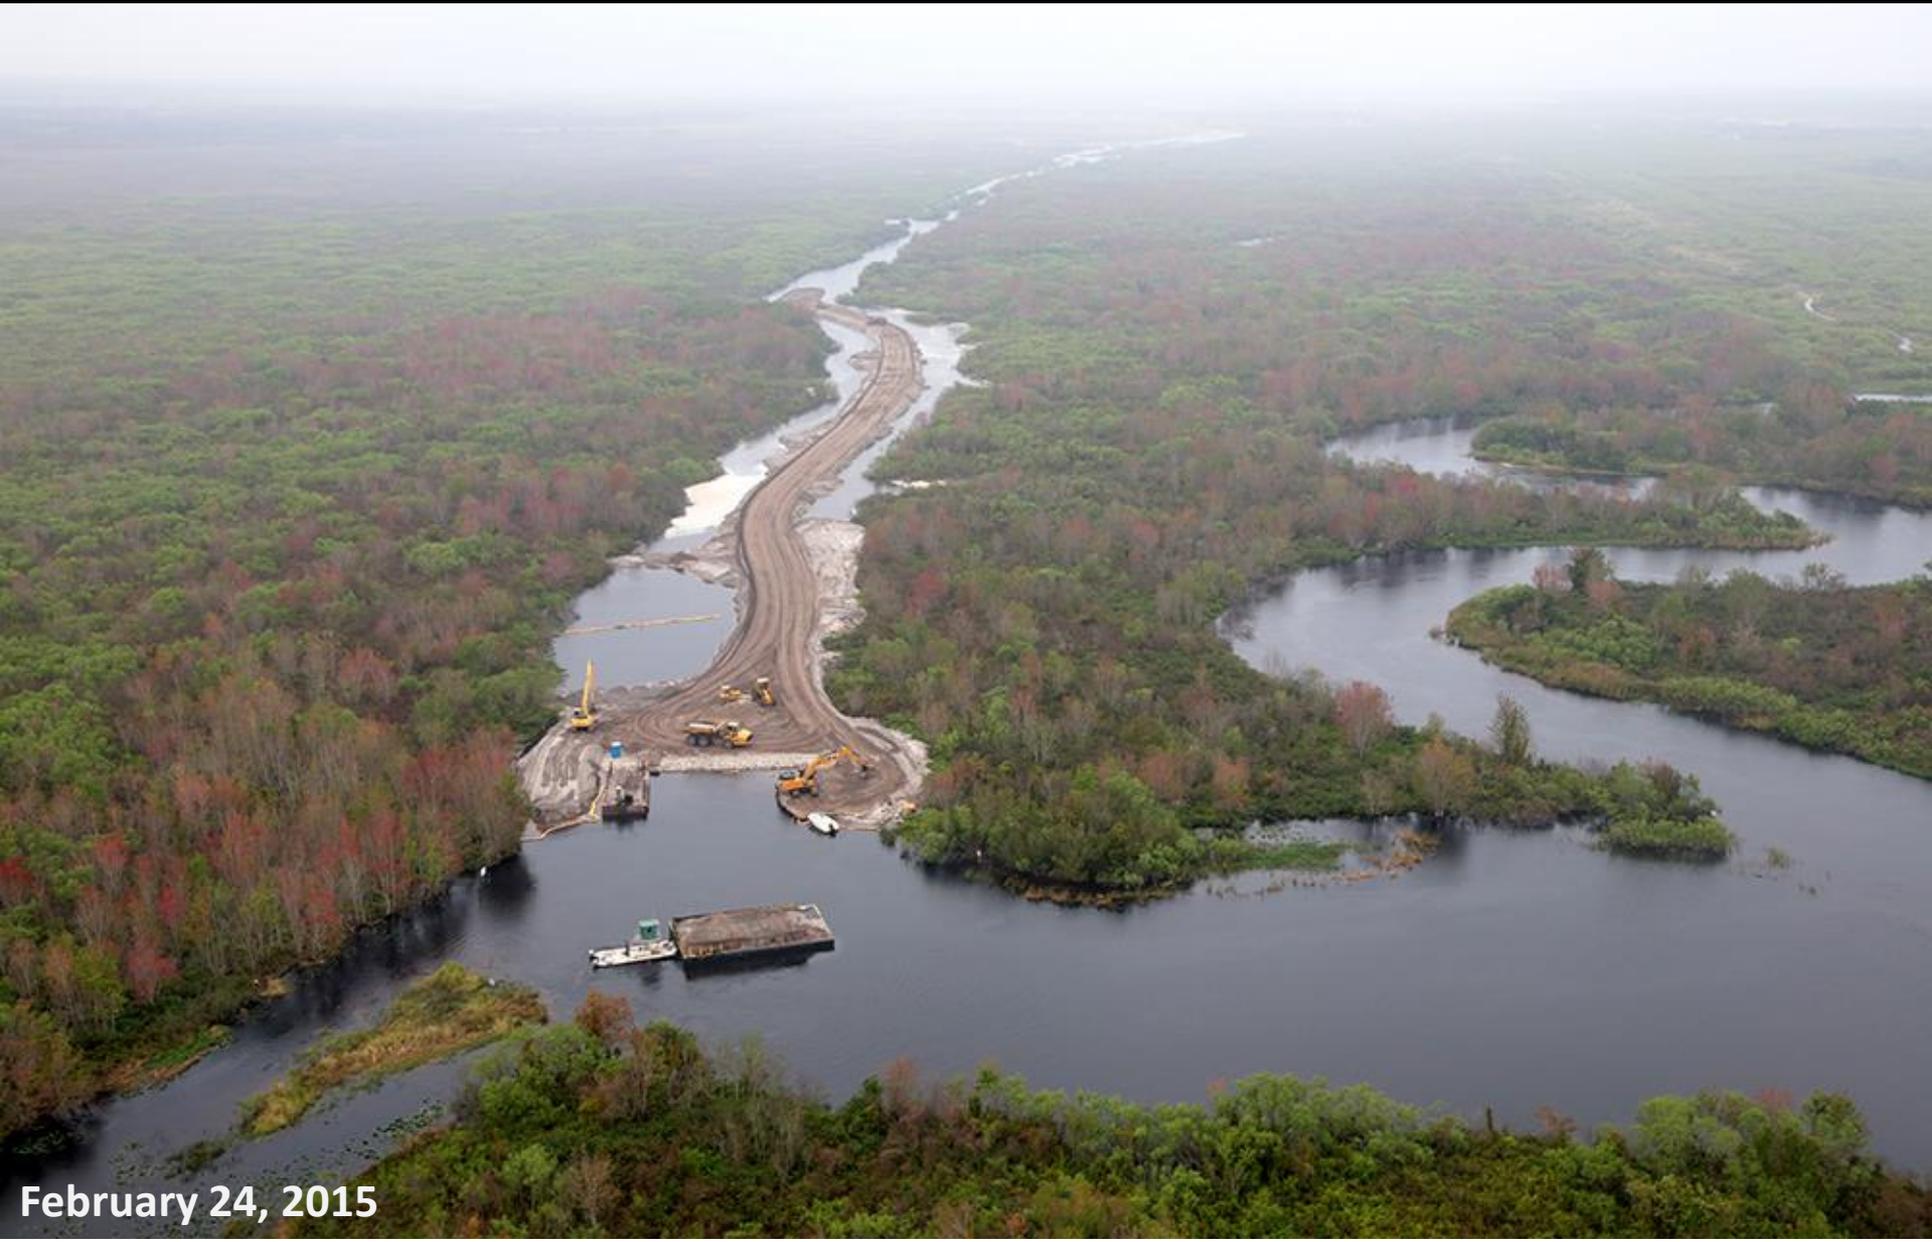
February 24, 2015

Looking north (upstream) from the southern end of the MacArthur Ditch backfill project where a rock plug was installed. Backfilling of the ditch has been resumed.

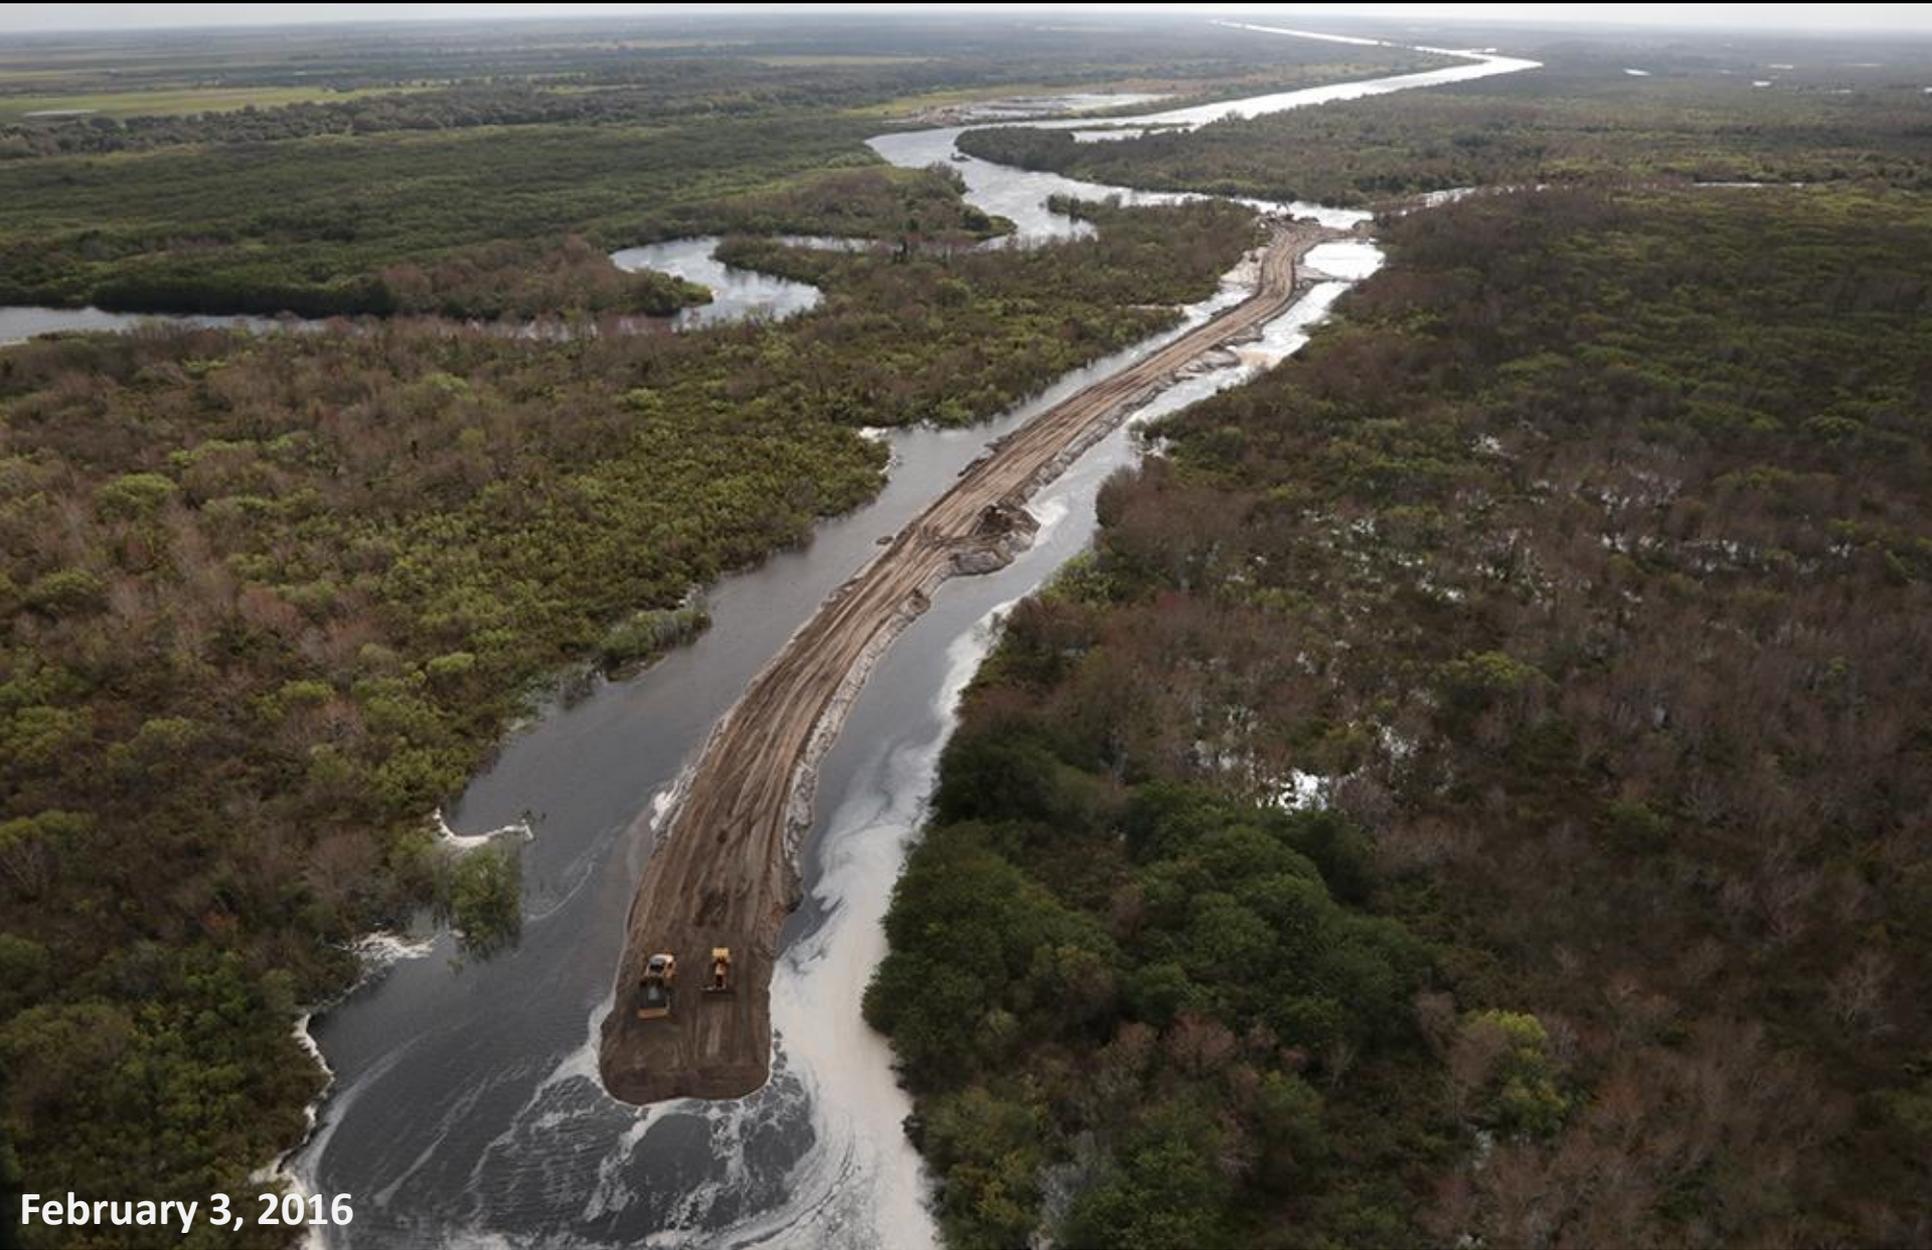
February 3, 2016

Looking south (downstream) at the MacArthur Ditch backfill progress.

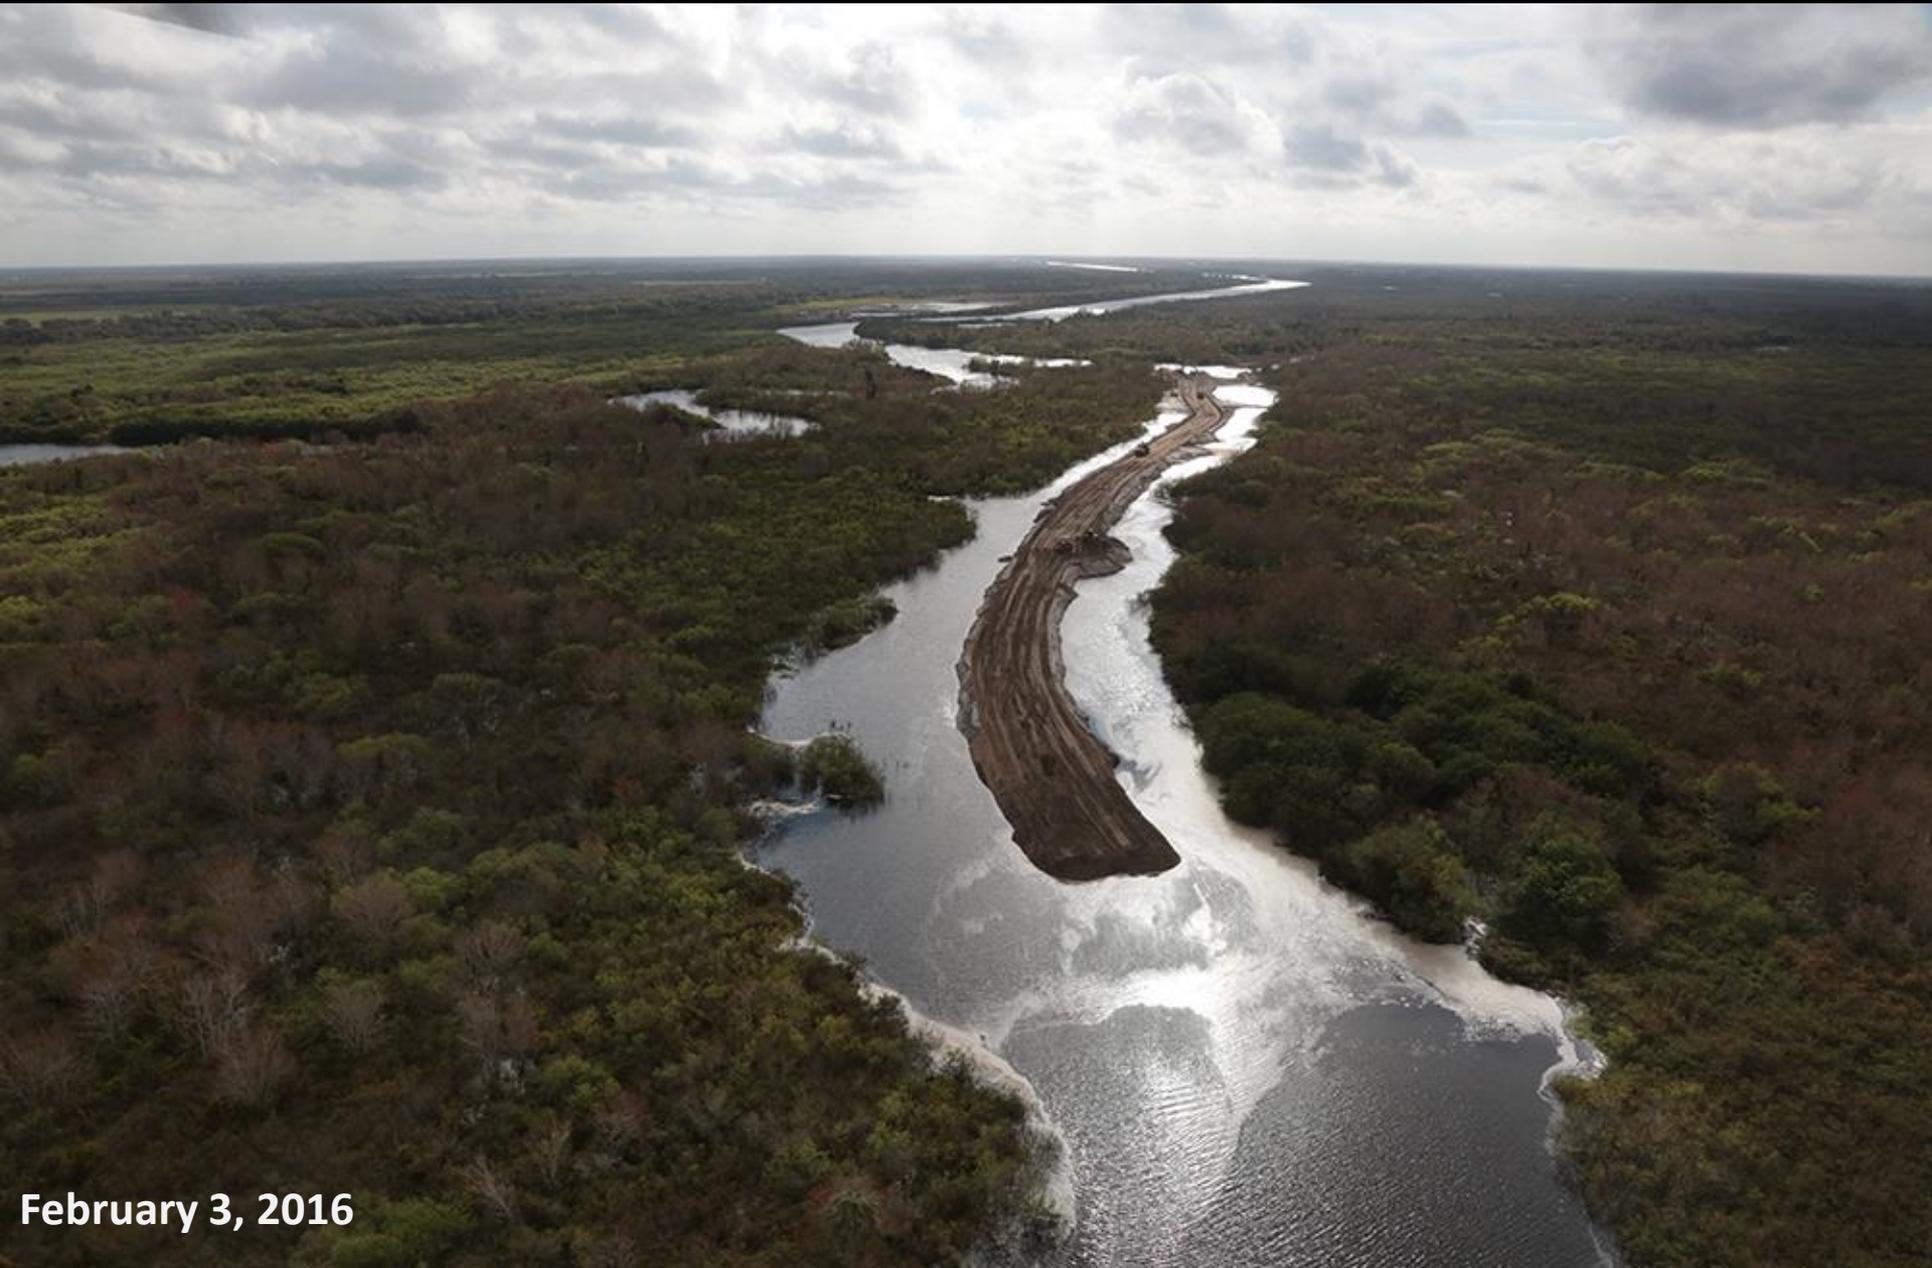
**February 3, 2016**

Looking south (downstream) at the MacArthur Ditch backfill progress.

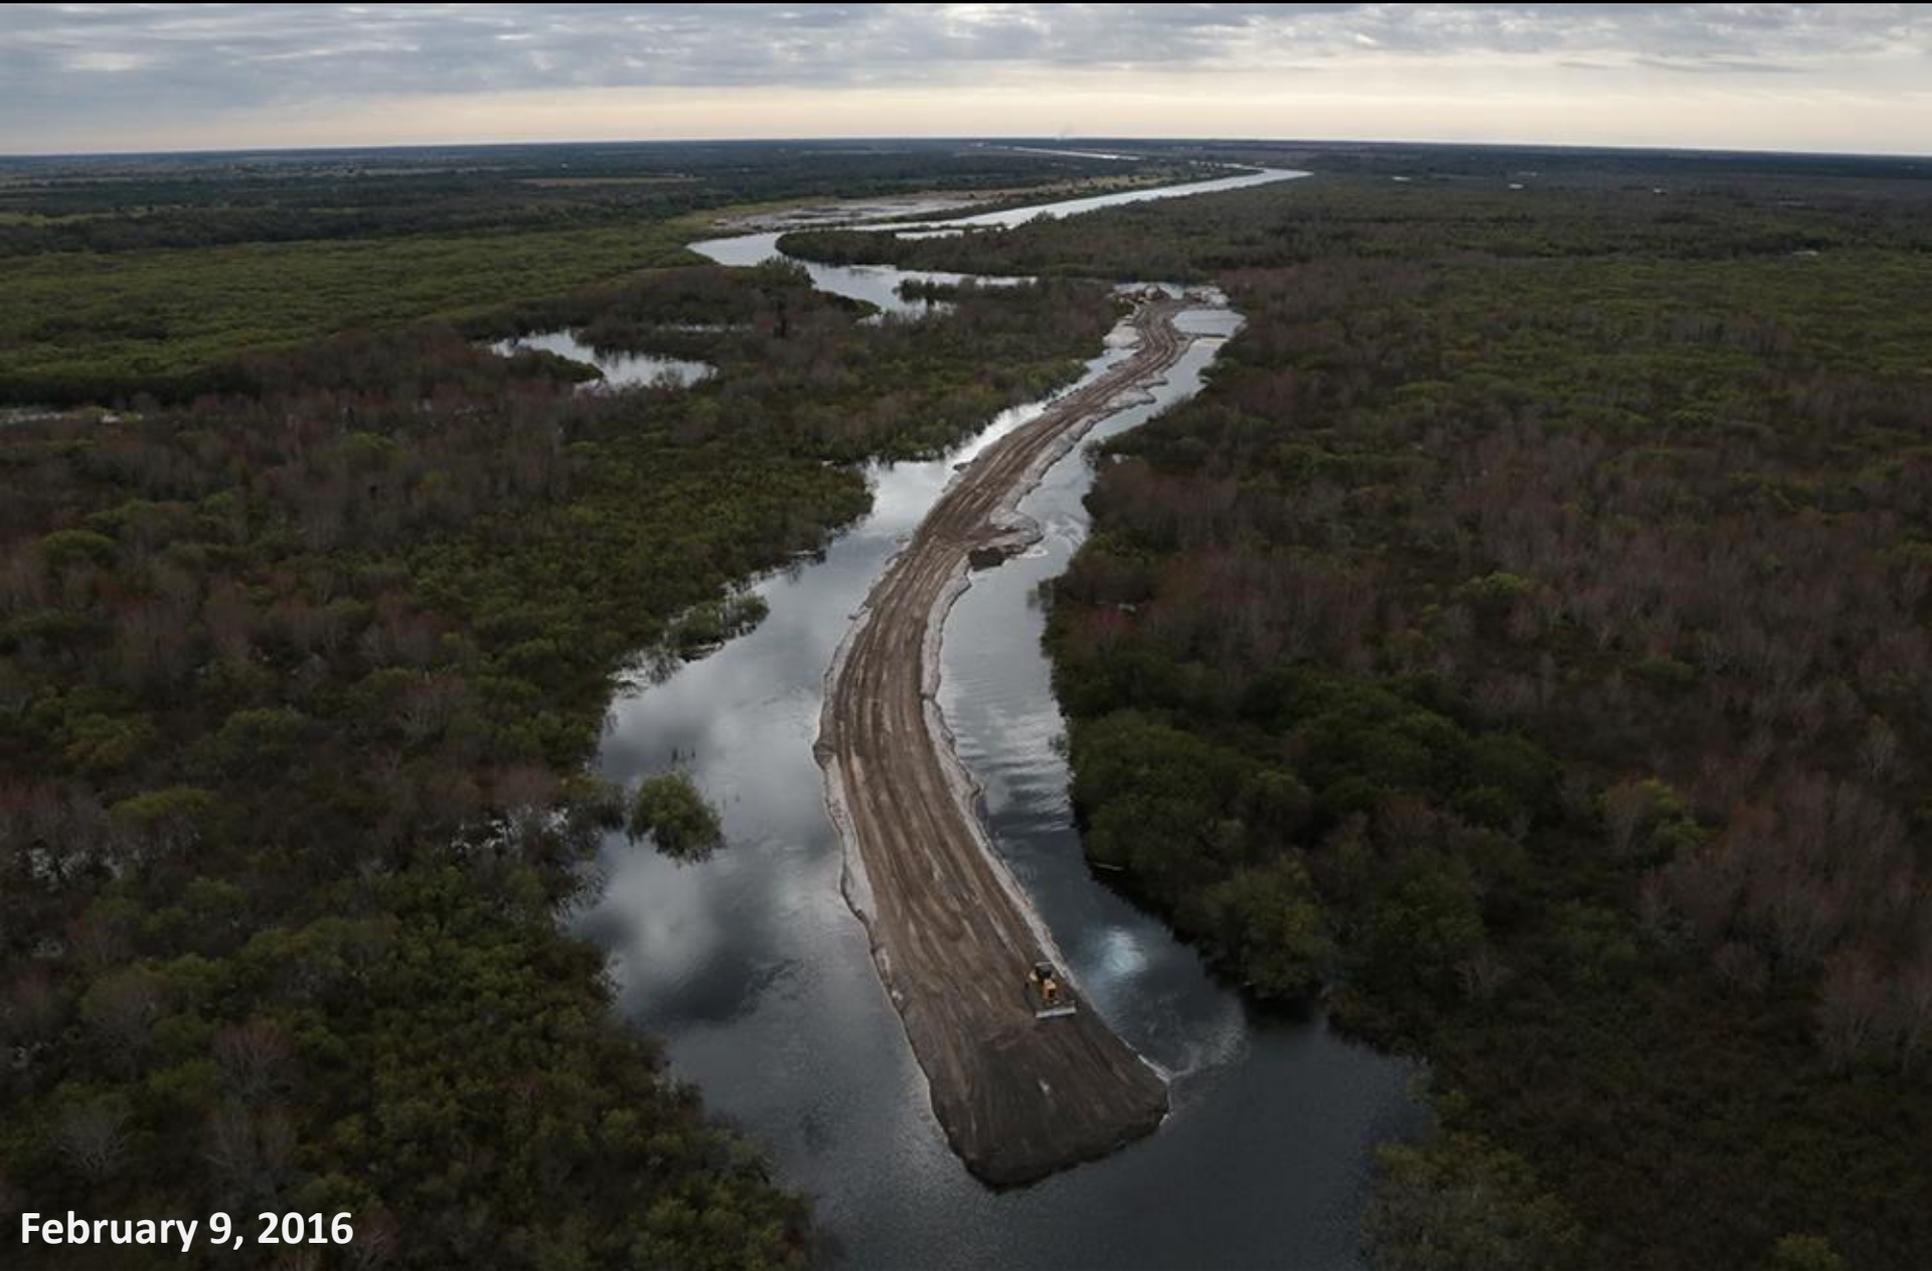
**February 9, 2016**

Looking south (downstream) at the MacArthur Ditch backfill progress.

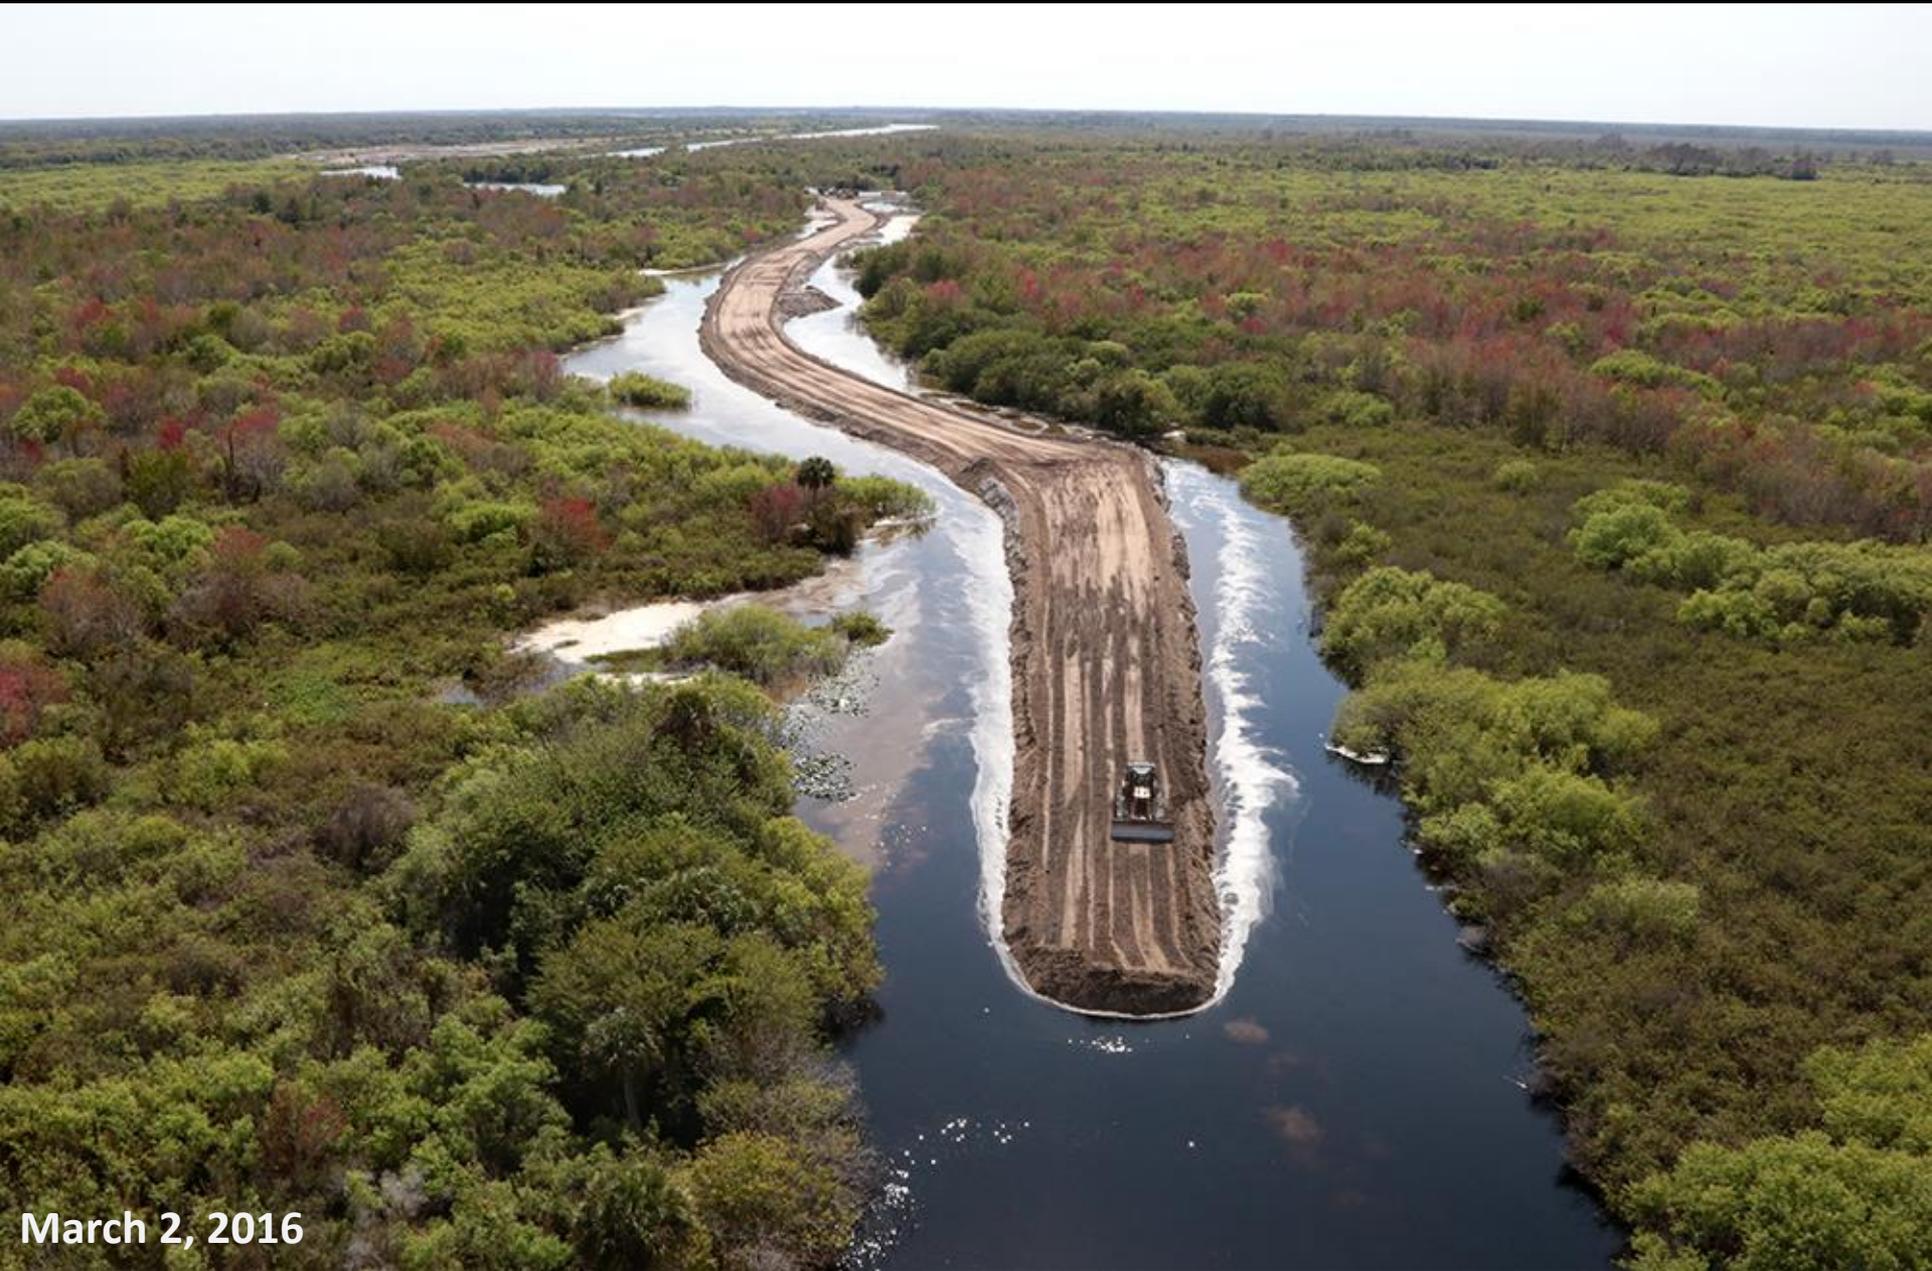
March 2, 2016

Looking south (downstream) at the MacArthur Ditch backfill progress.

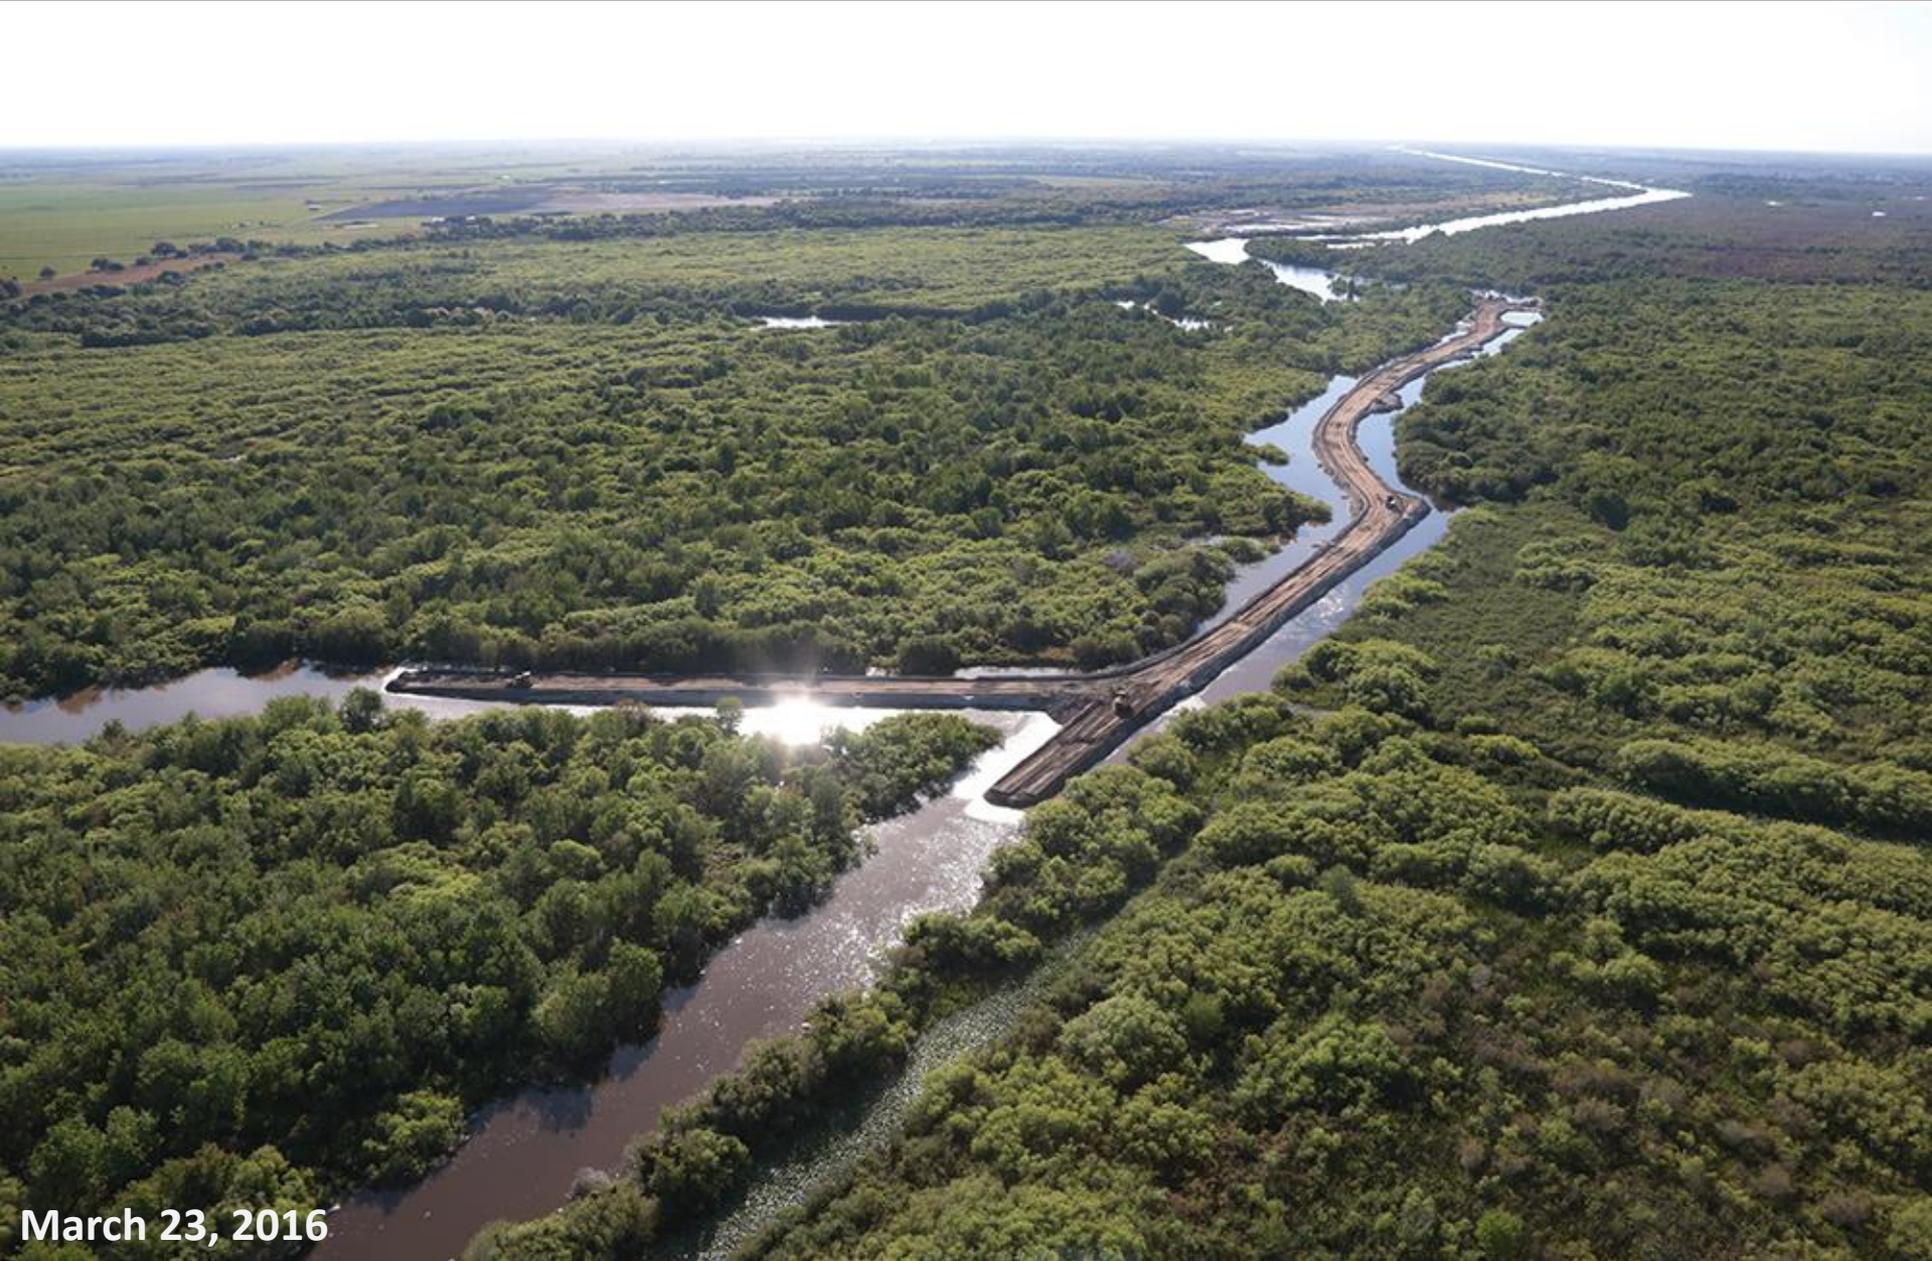
March 23, 2016

Looking south (downstream) at the MacArthur Ditch backfill progress.
