January - March 2016

# Kissimmee River Restoration Project and Kissimmee Basin Environmental and Restoration Features

Kissimmee River Restoration Project  
Reach 3 C-38 Backfill  
Construction Progress  
February 2016

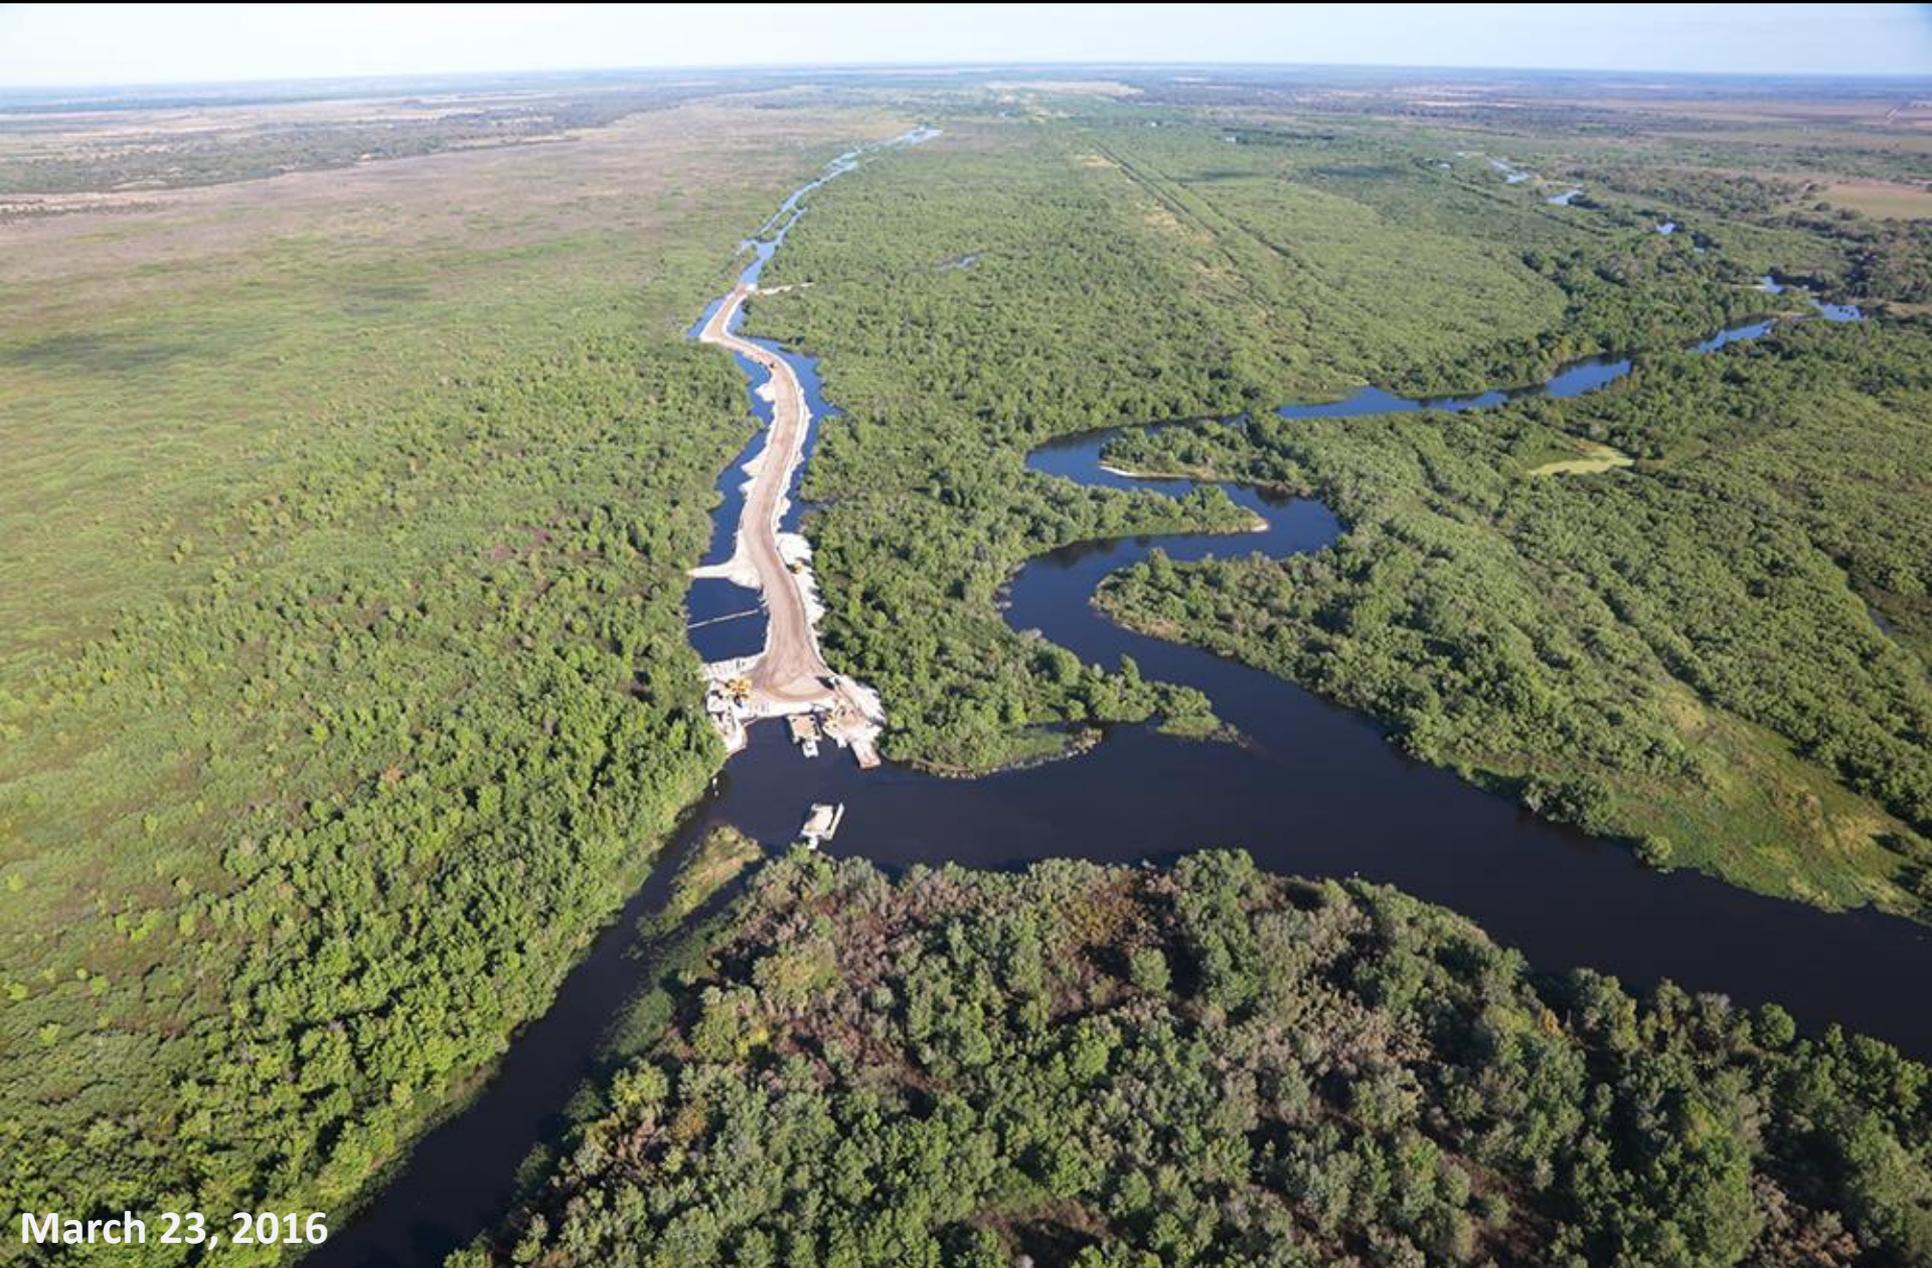
March 23, 2016

Looking north (upstream) at the MacArthur Ditch backfill progress.

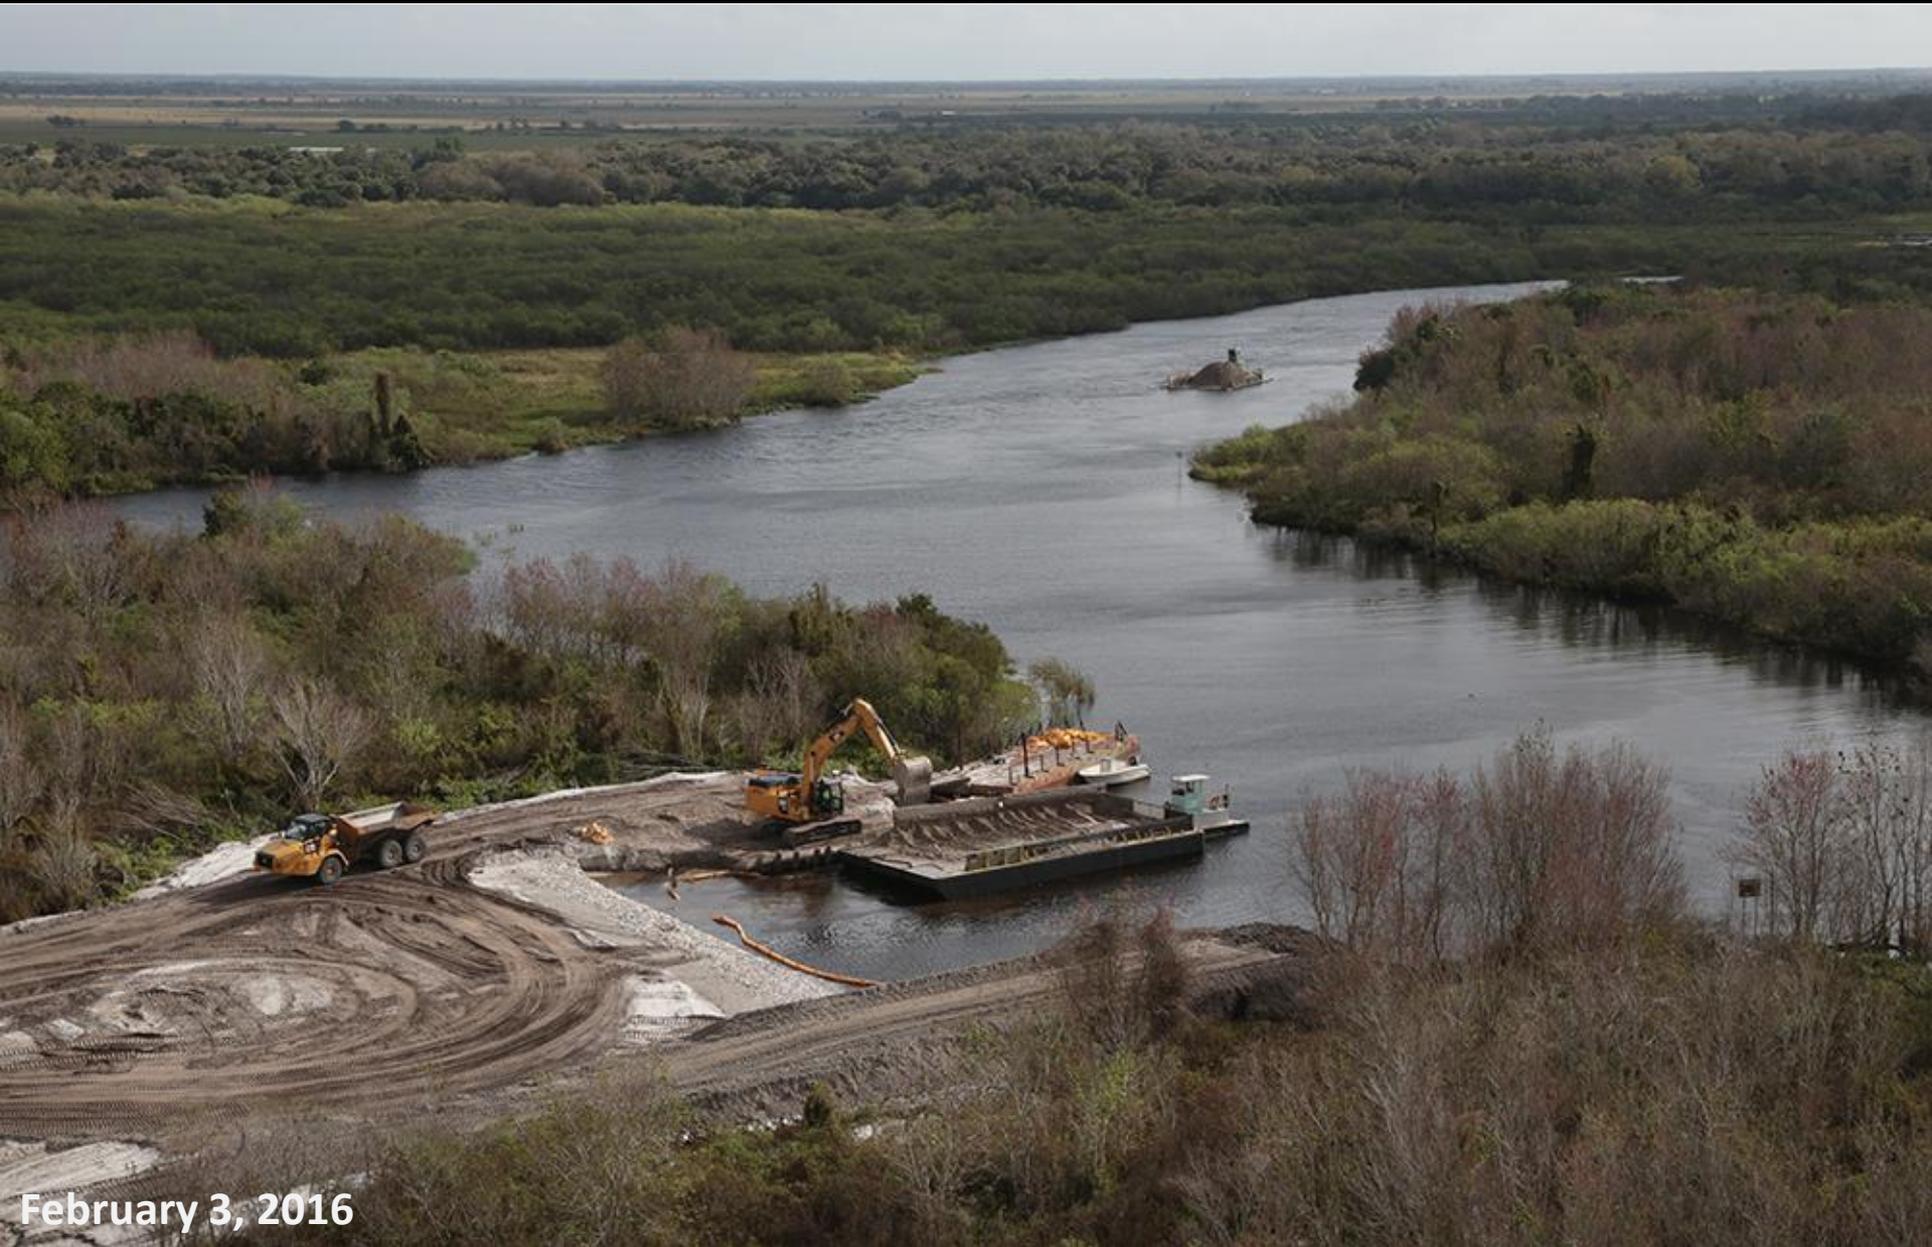
February 3, 2016

Looking southeast (downstream) at the MacArthur Ditch backfill as dirt is barged in from the south along the C-38.

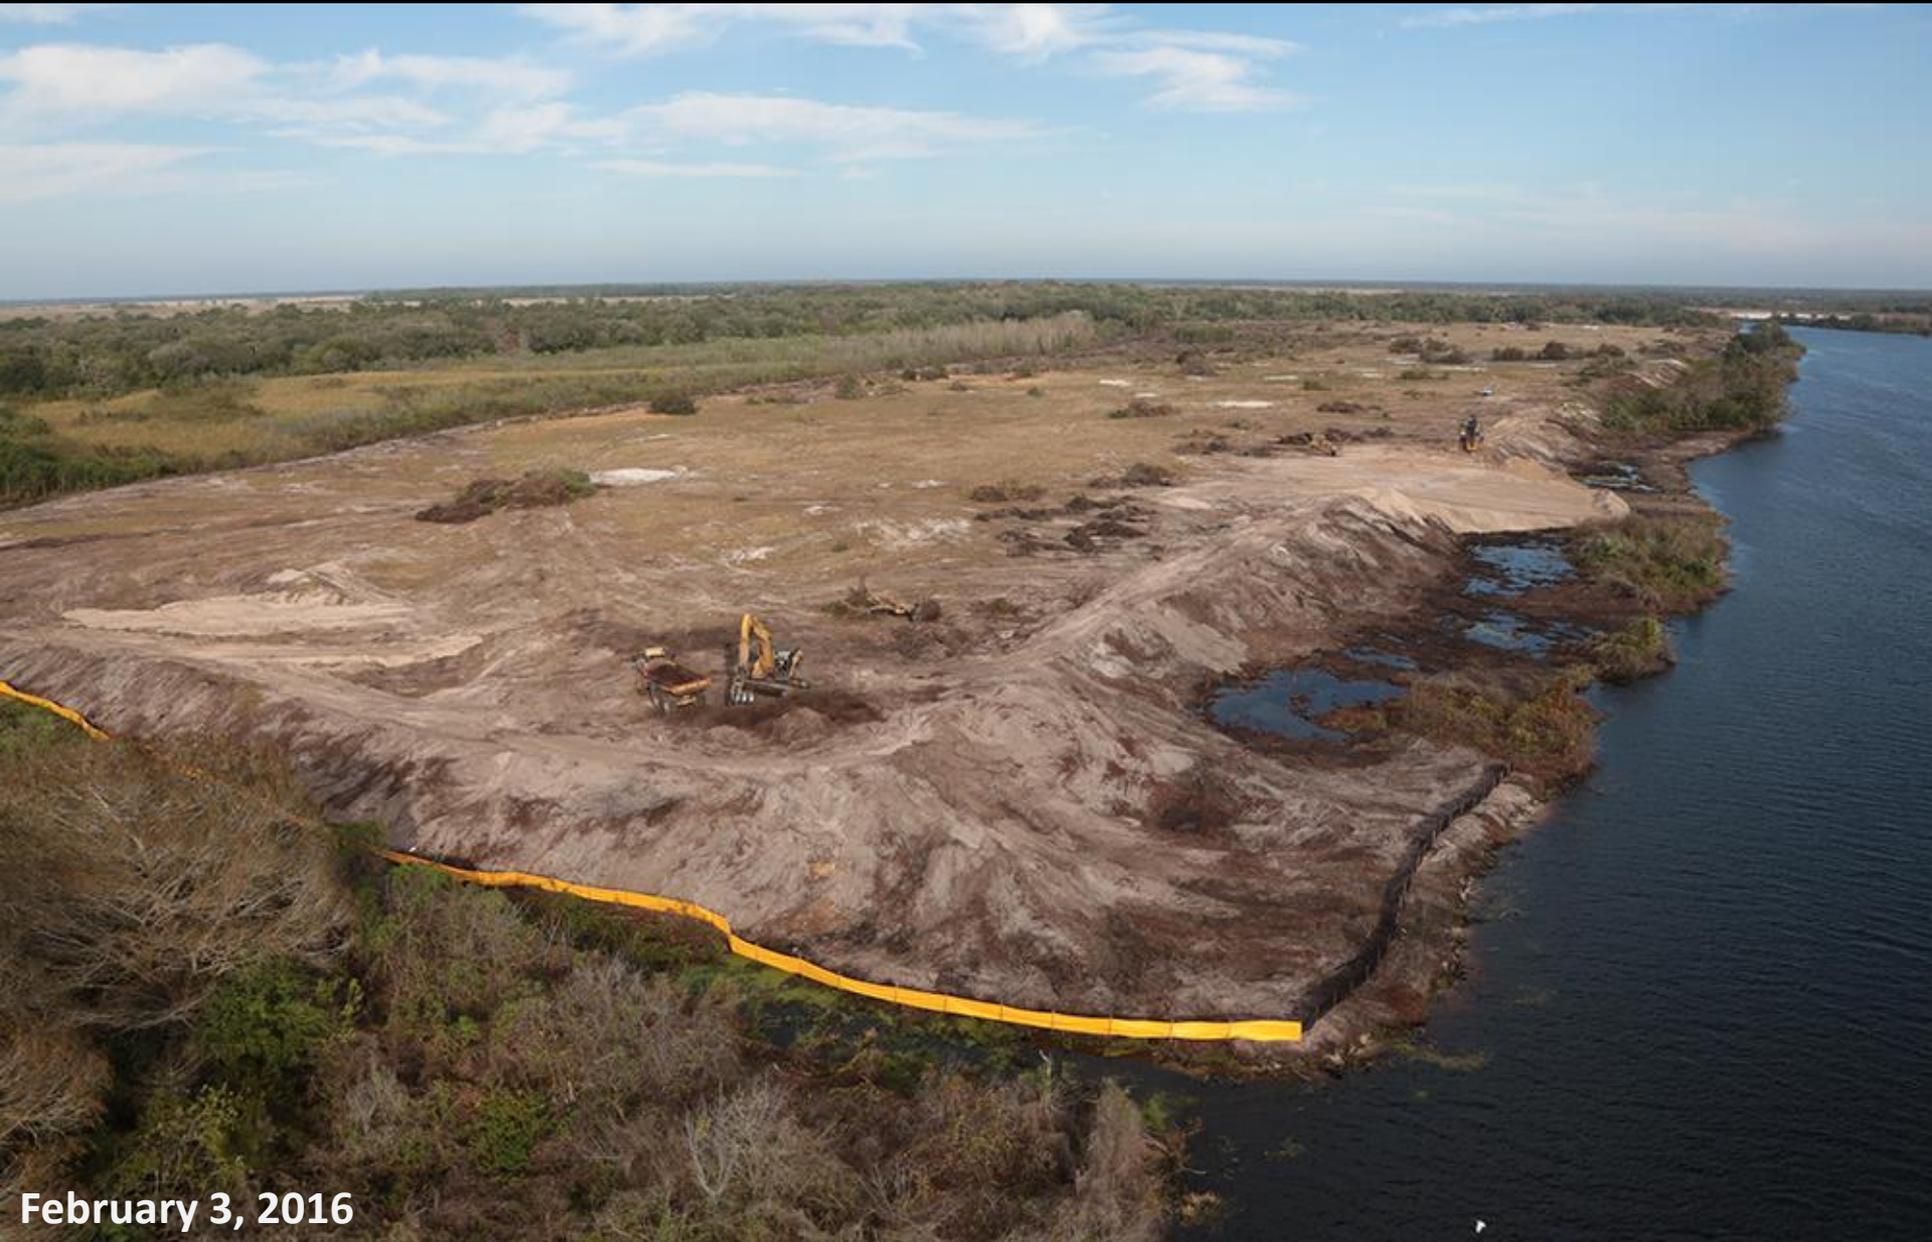
**February 3, 2016**

Kissimmee River Reach 3 restoration area. Contractors are preparing Reach 3 of C-38 backfill by clearing and burning the vegetation from the spoil next to the C-38 canal. The spoil will be used to backfill the canal.

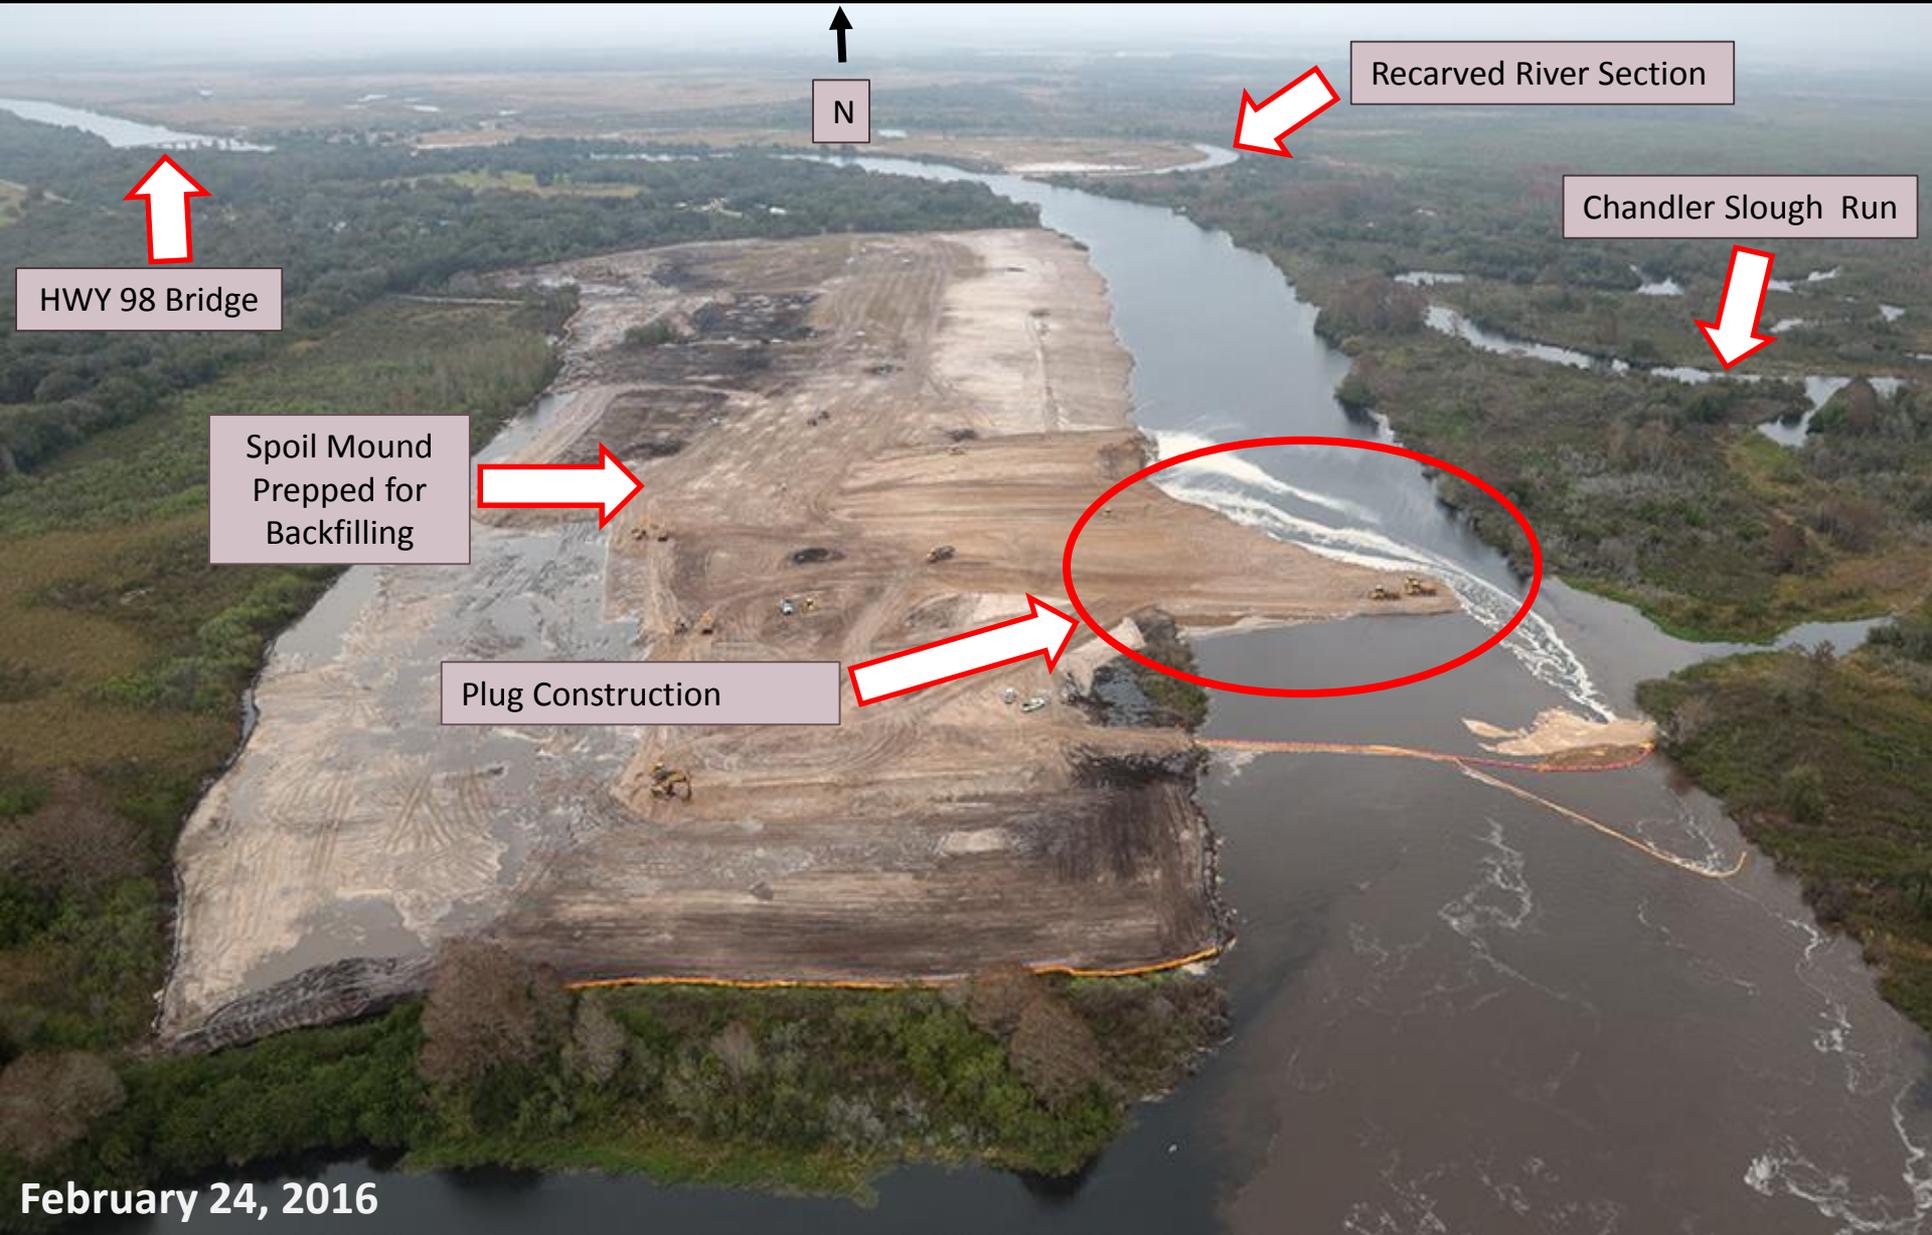
February 24, 2016

HWY 98 Bridge

Spoil Mound  
Prepped for  
Backfilling

Plug Construction

Recarved River Section

Chandler Slough Run

Kissimmee River Restoration Project Reach 3 construction looking north. Contractors have almost finished the initial plug for Reach 3 backfilling.

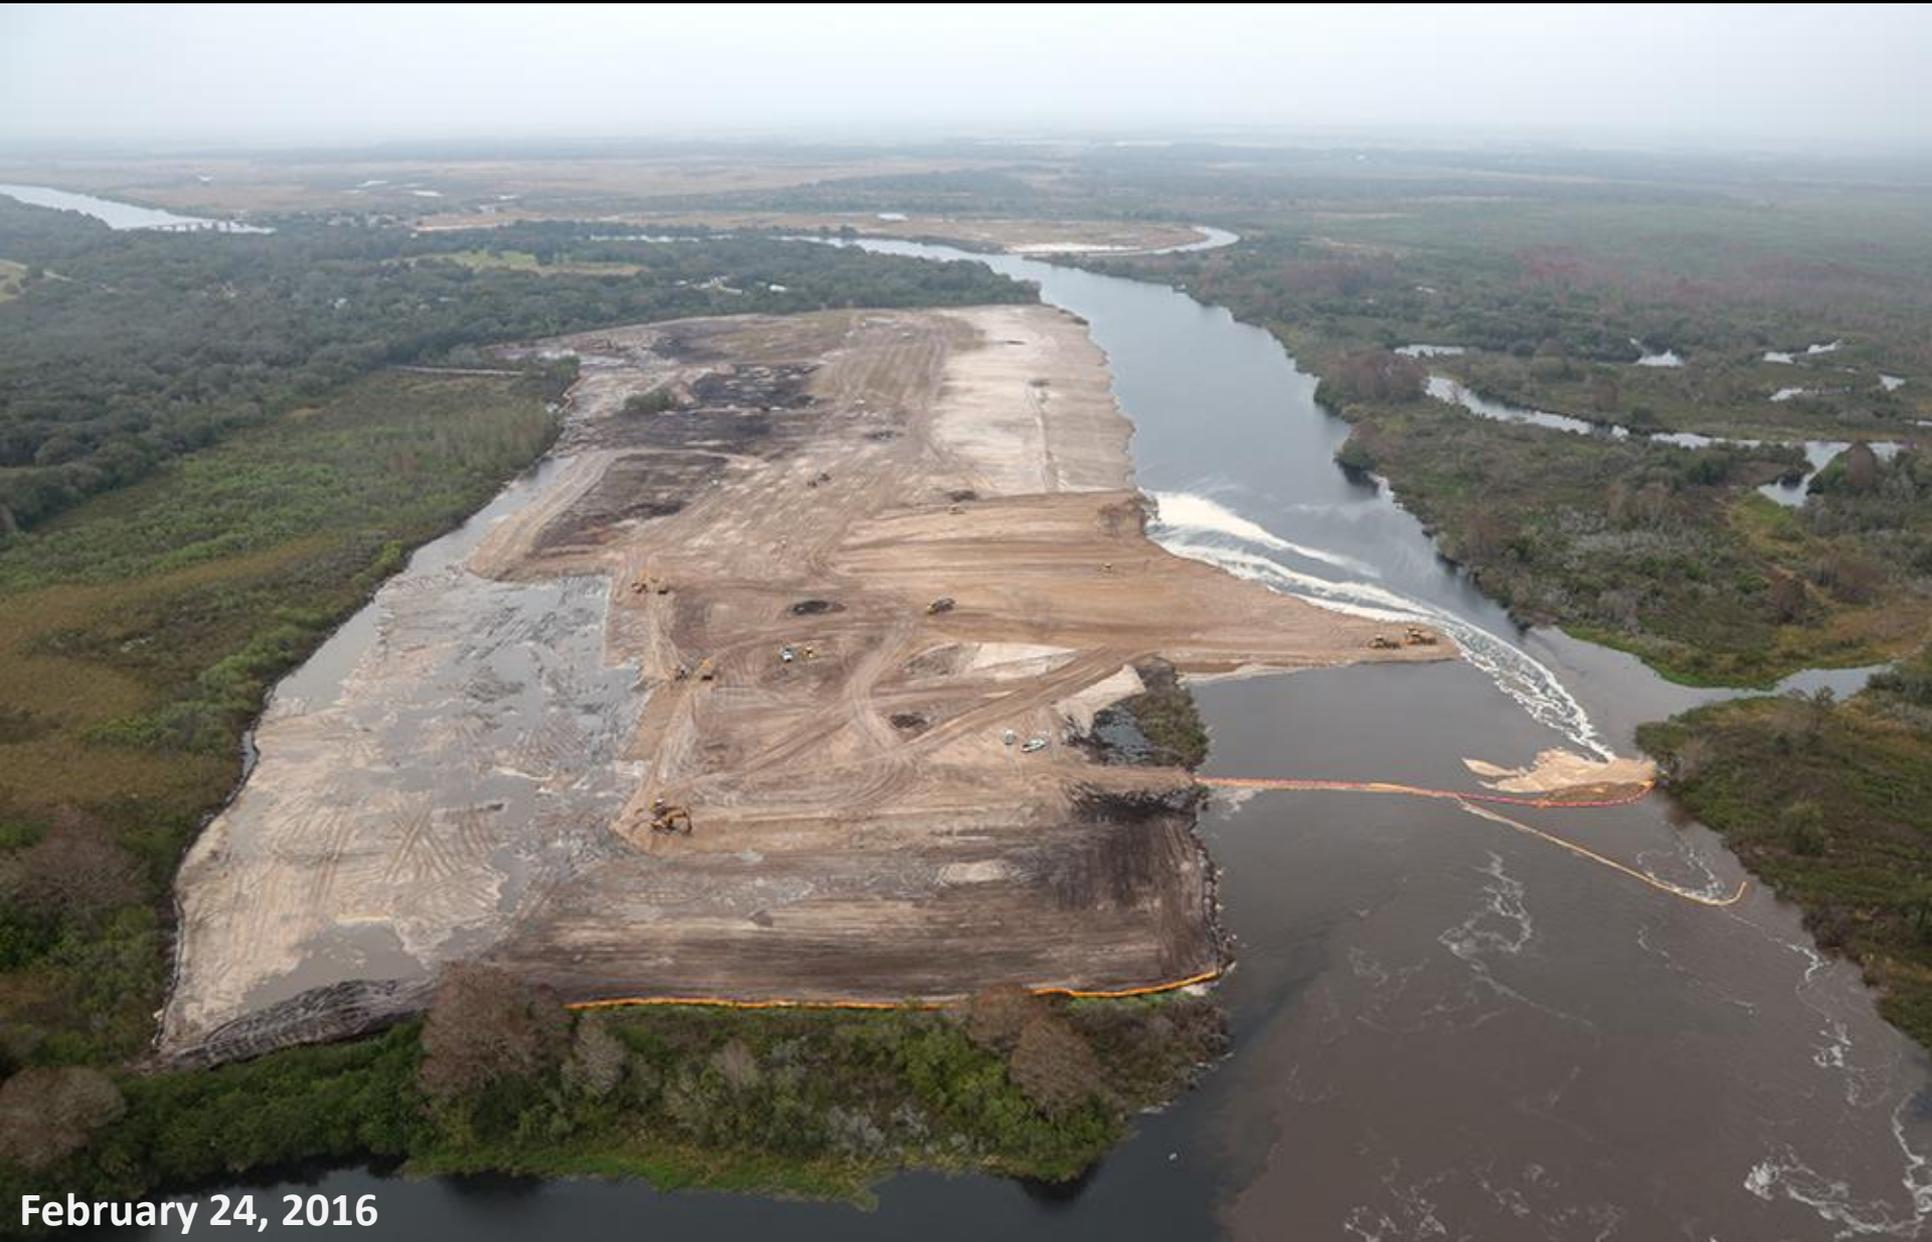
**February 24, 2016**

Kissimmee River Reach 3 restoration area looking north. Contractors are pushing spoil across the C-38 canal to create the initial plug of Reach 3 backfill.

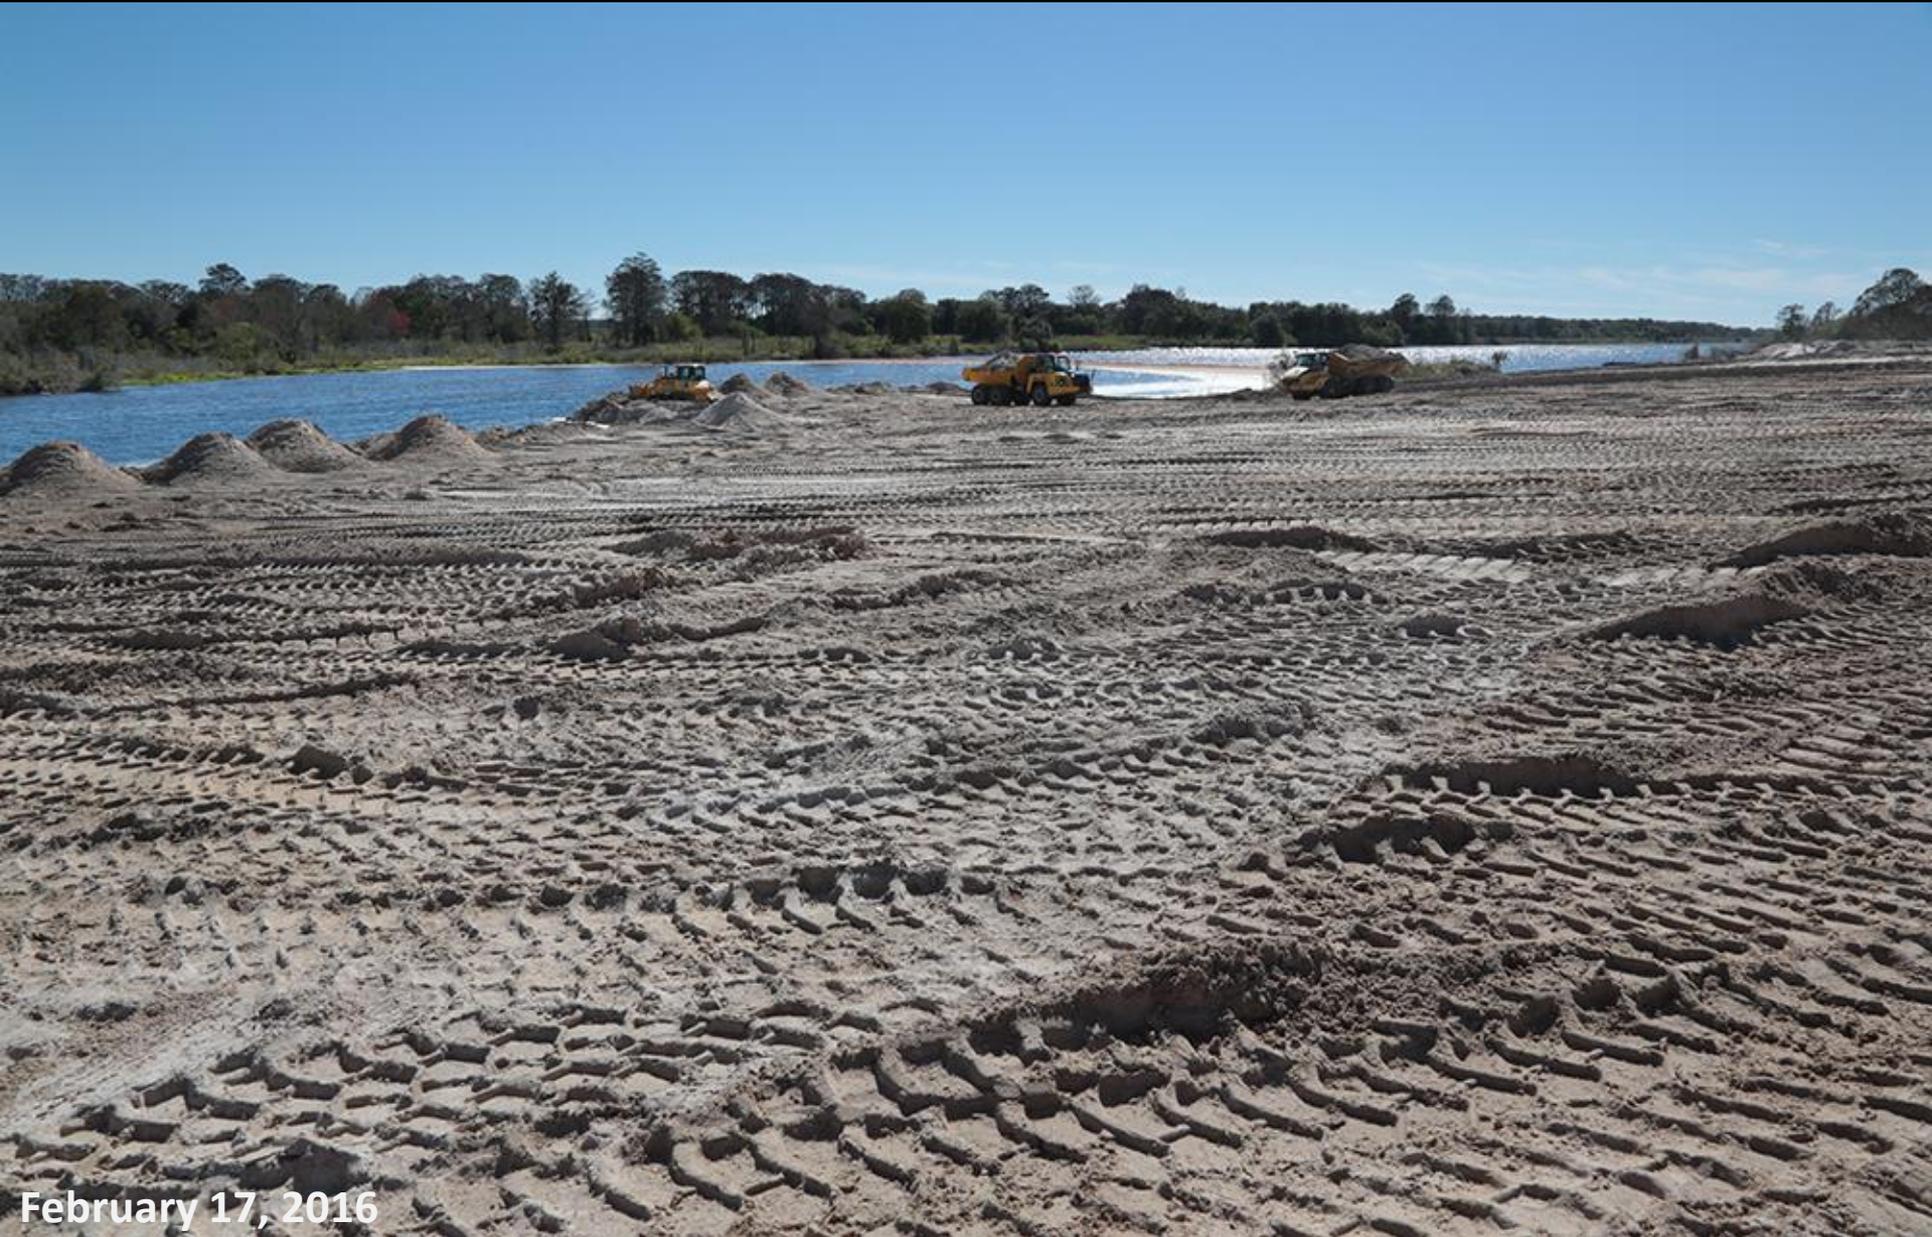
February 17, 2016

Kissimmee River Reach 3 restoration area. Contractors are degrading the spoil pile and preparing for C-38 canal backfill.

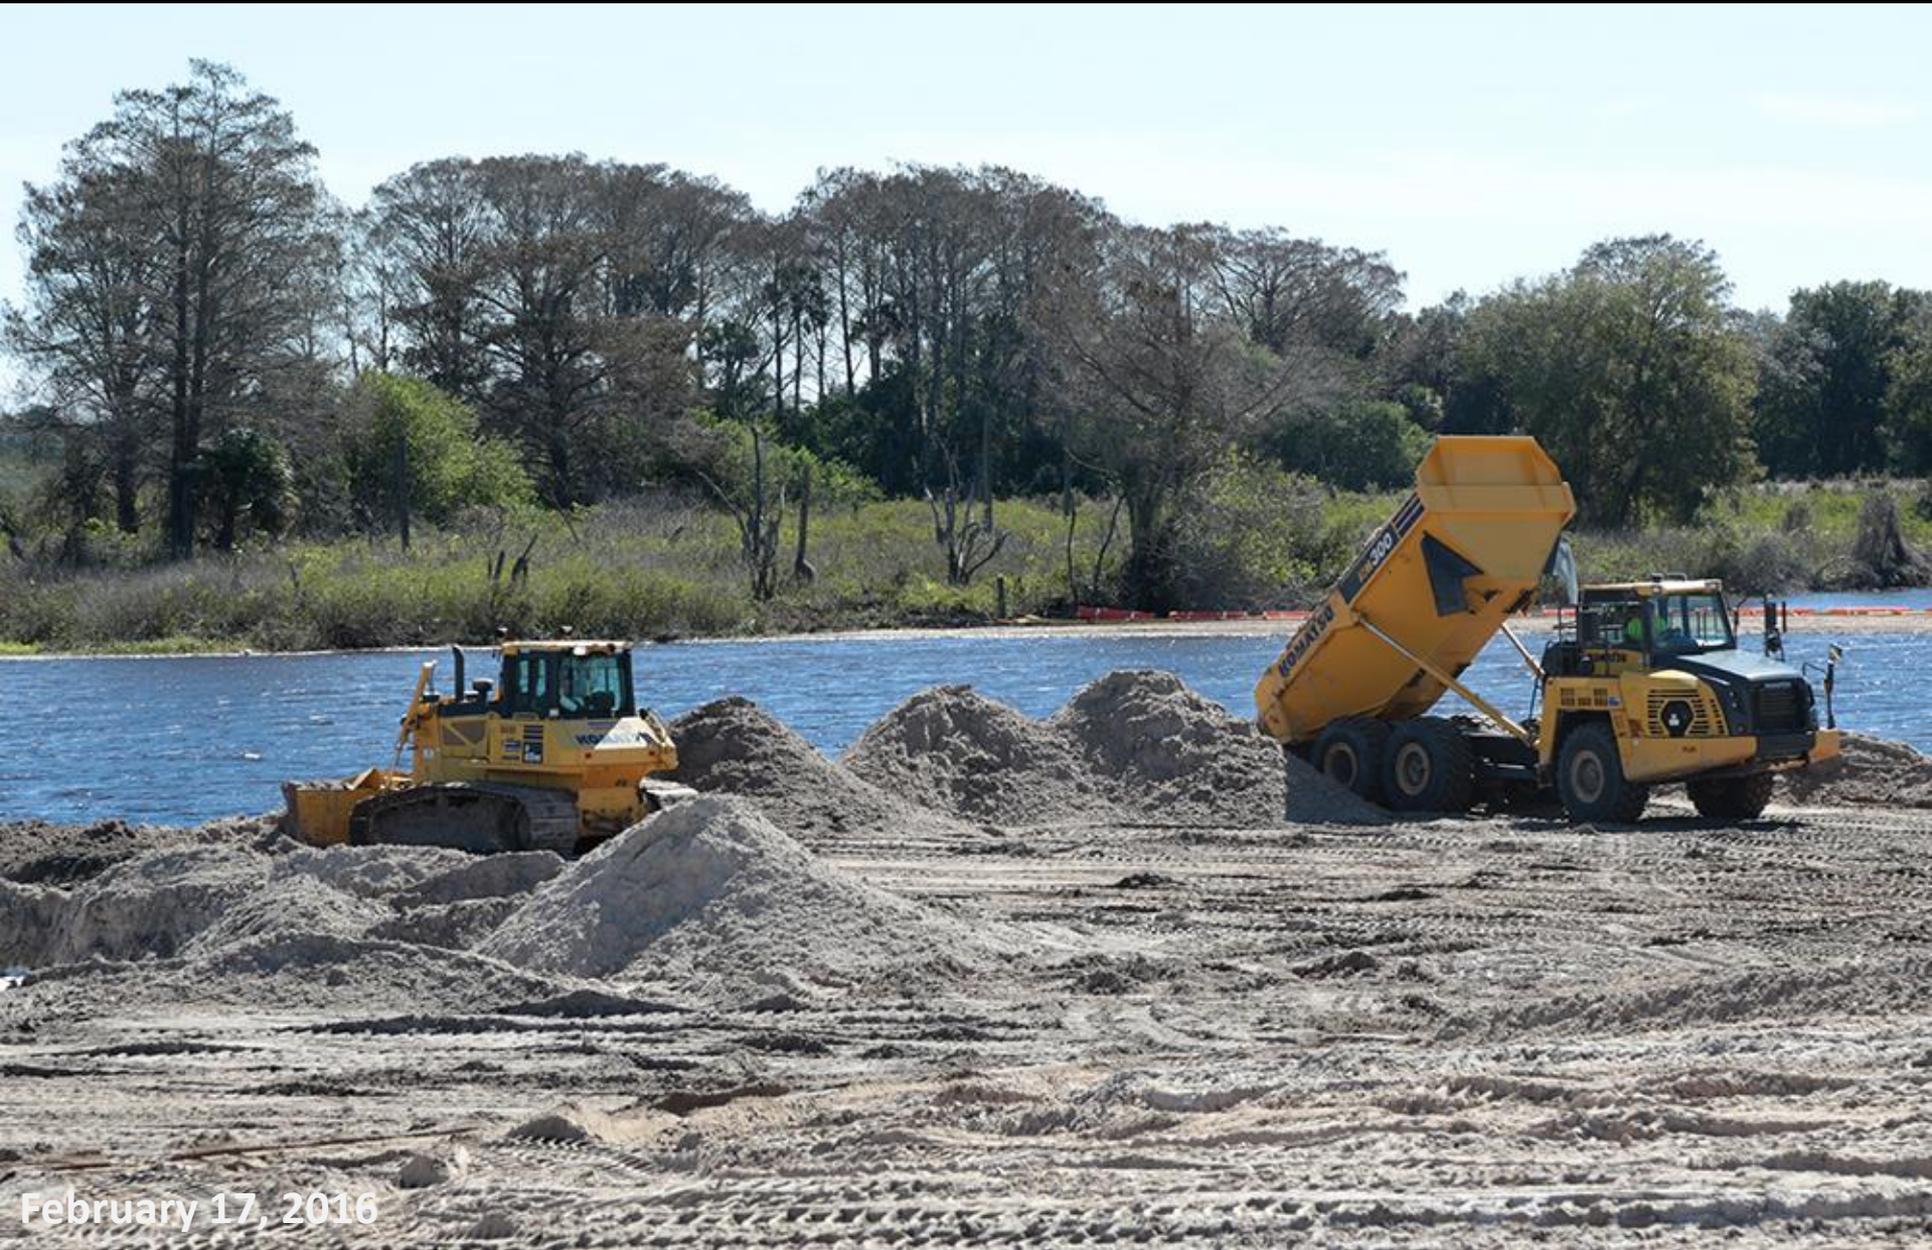
February 17, 2016

Kissimmee River Reach 3 restoration area. Contractors are degrading the spoil pile and preparing for C-38 canal backfill.

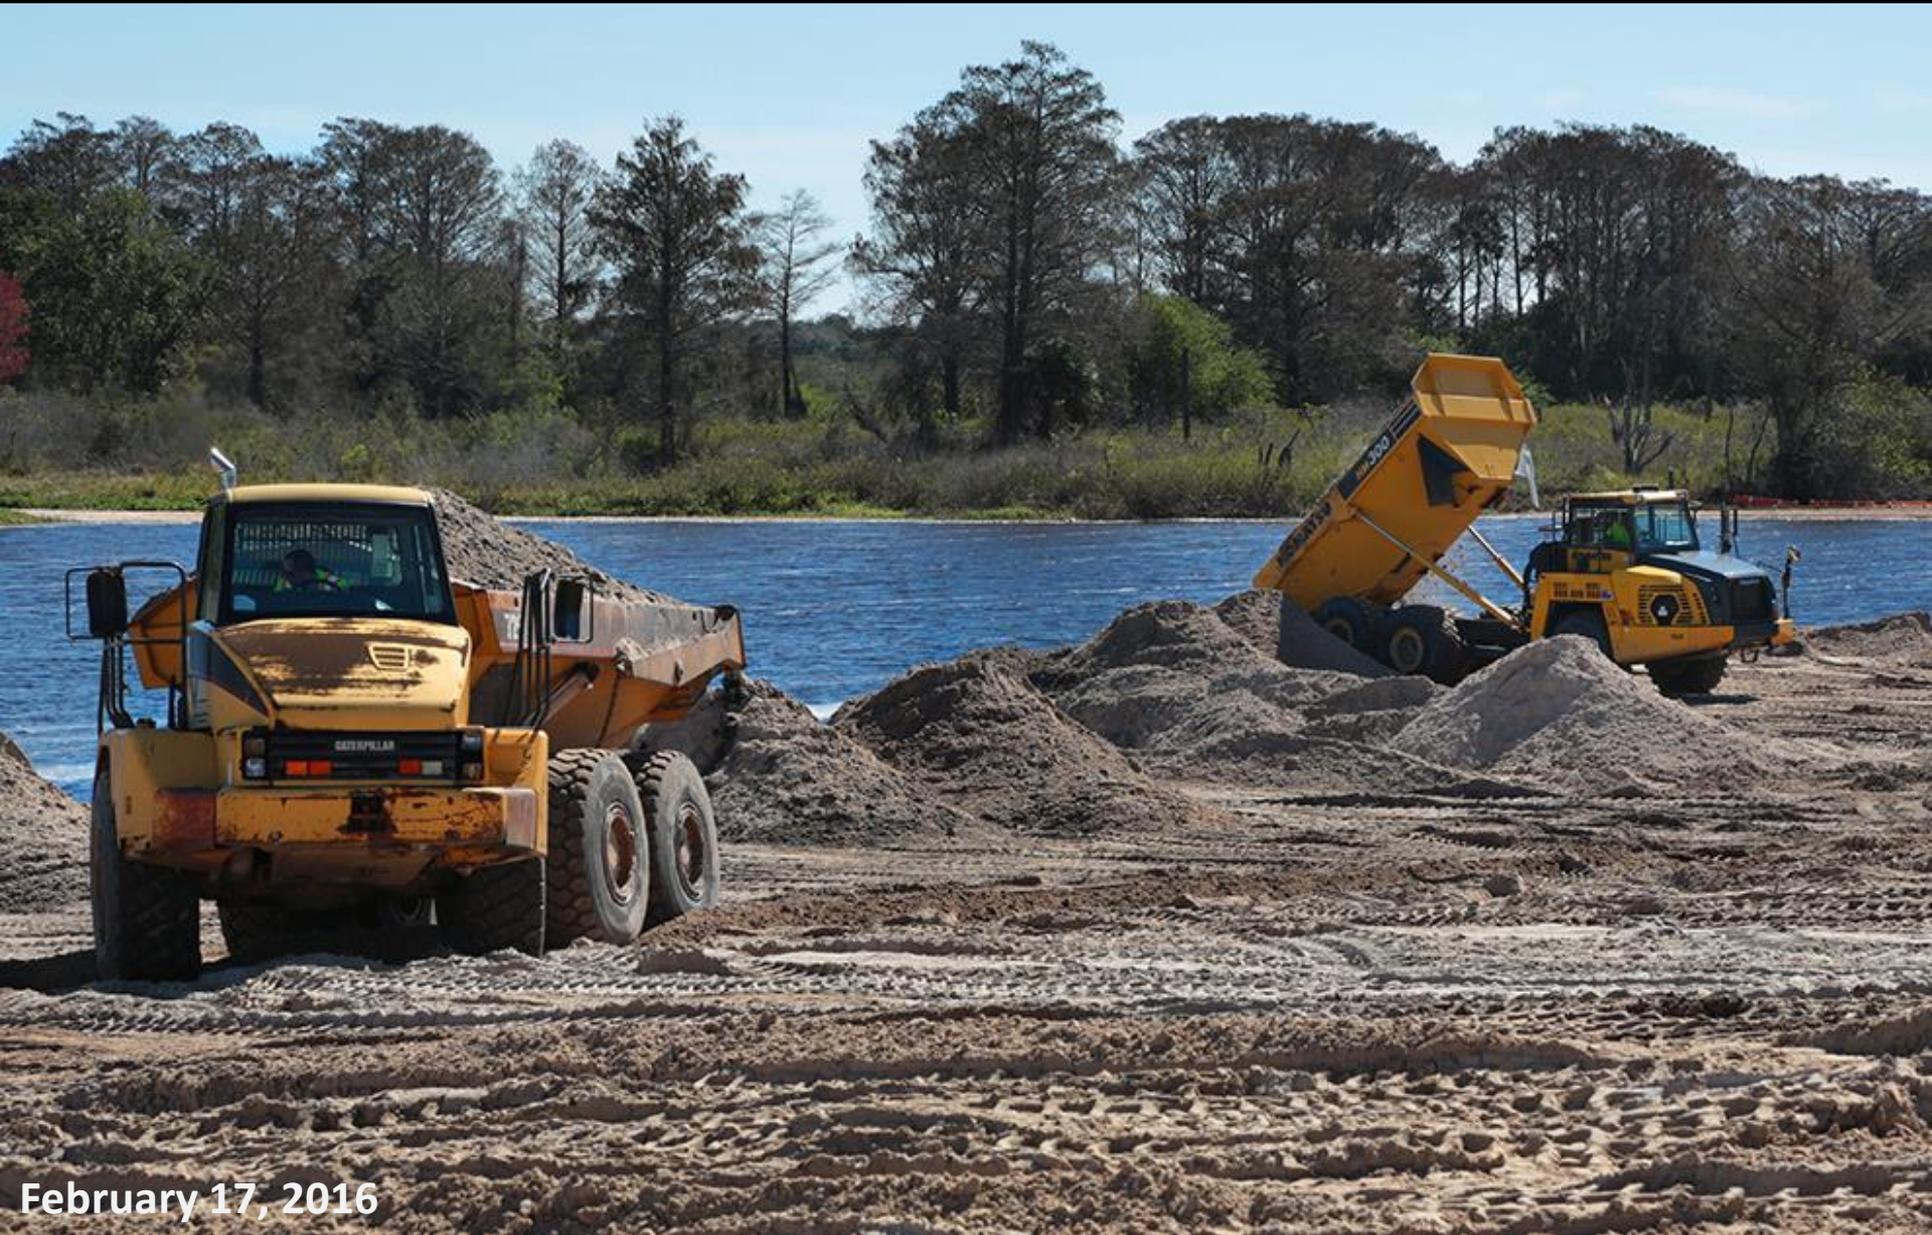
February 17, 2016

Kissimmee River Reach 3 restoration area. Contractors are degrading the spoil pile and preparing for C-38 canal backfill.

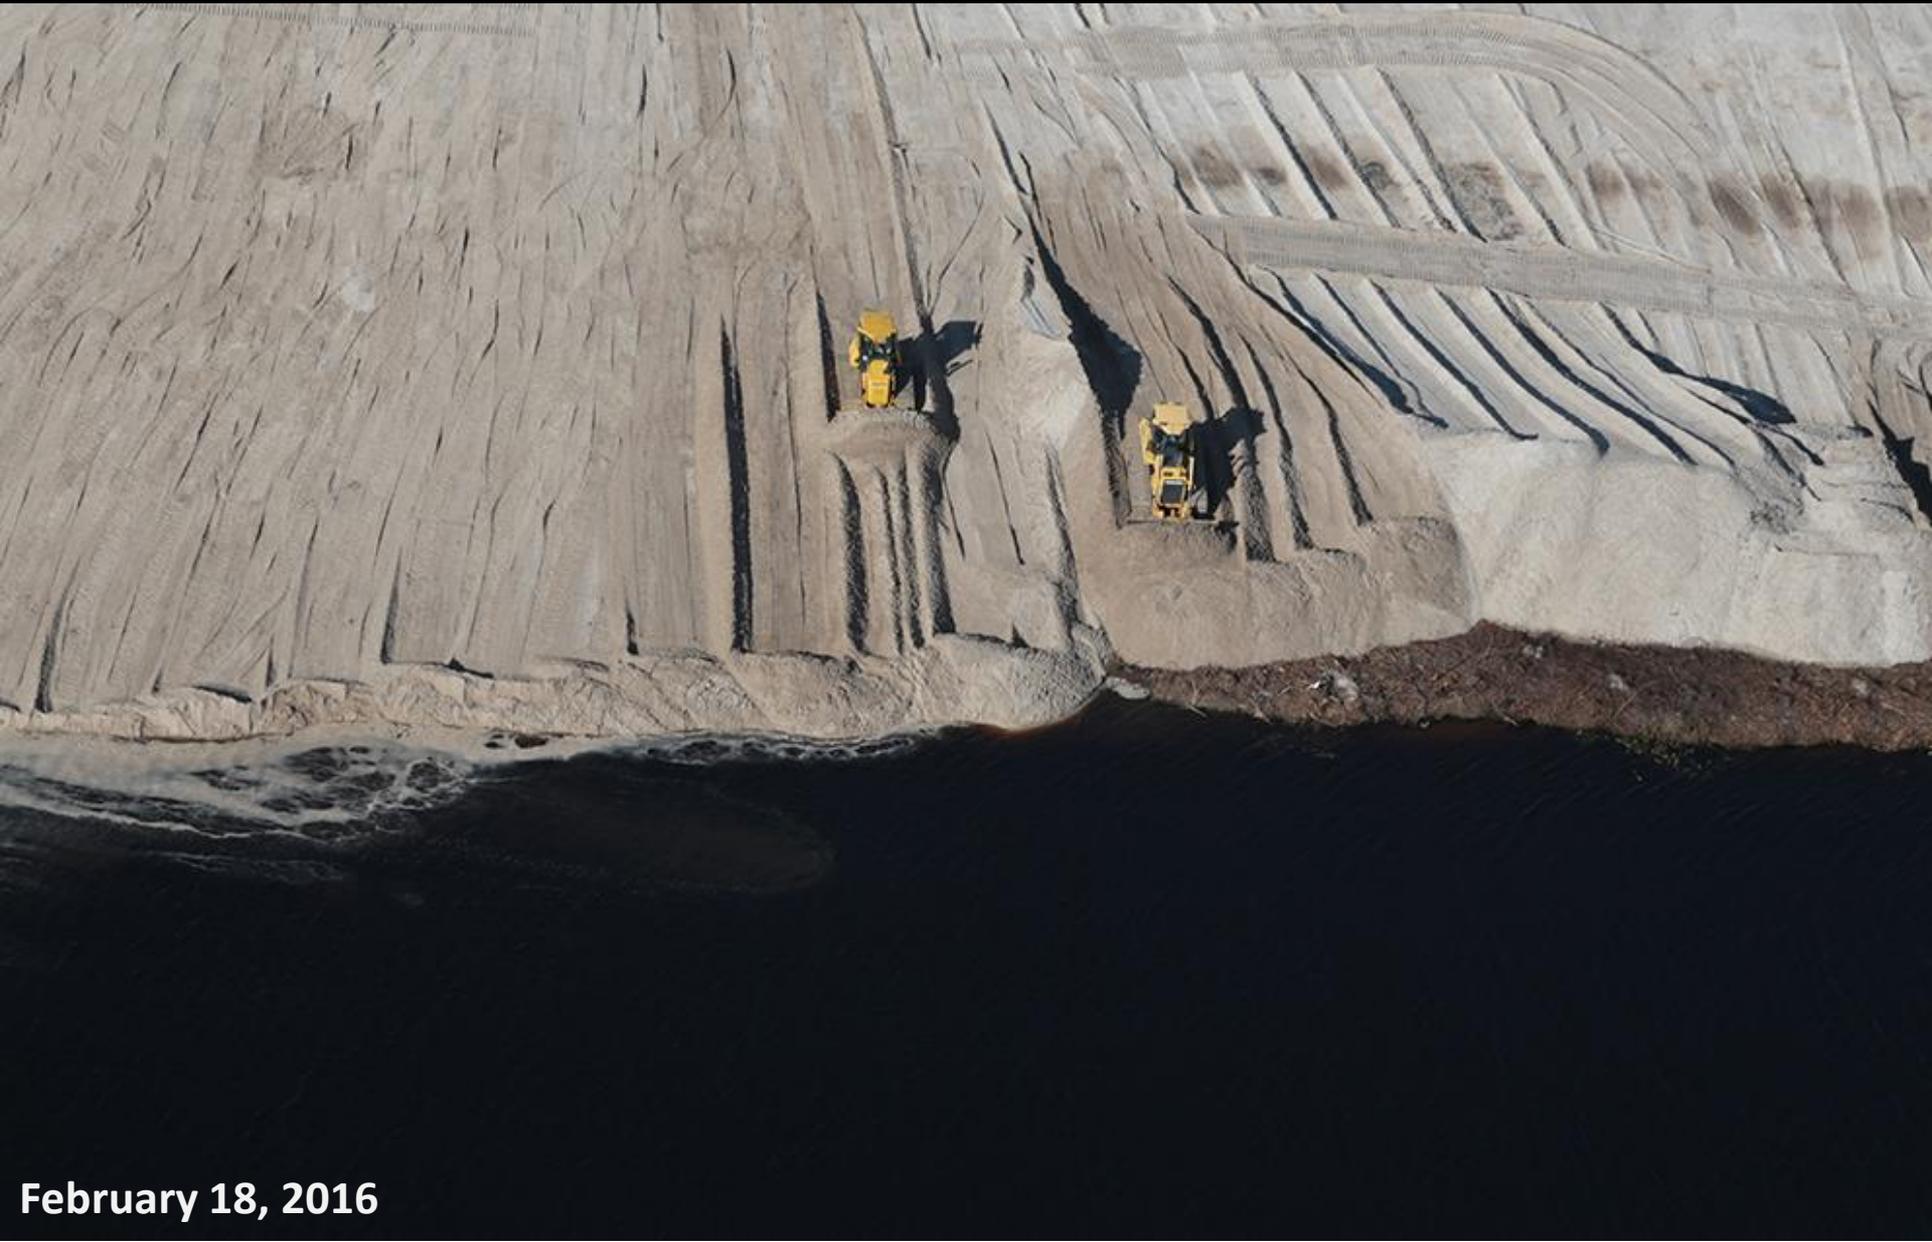
**February 18, 2016**

Kissimmee River Reach 3 restoration area. Bulldozers push spoil to the edge of the C-38 canal in preparation for backfill.
