January - March 2016

# Kissimmee River Restoration Project and Kissimmee Basin Environmental and Restoration Features

Kissimmee River Restoration Project  
Reach 3 C-38 Backfill  
Construction Progress  
February 2016

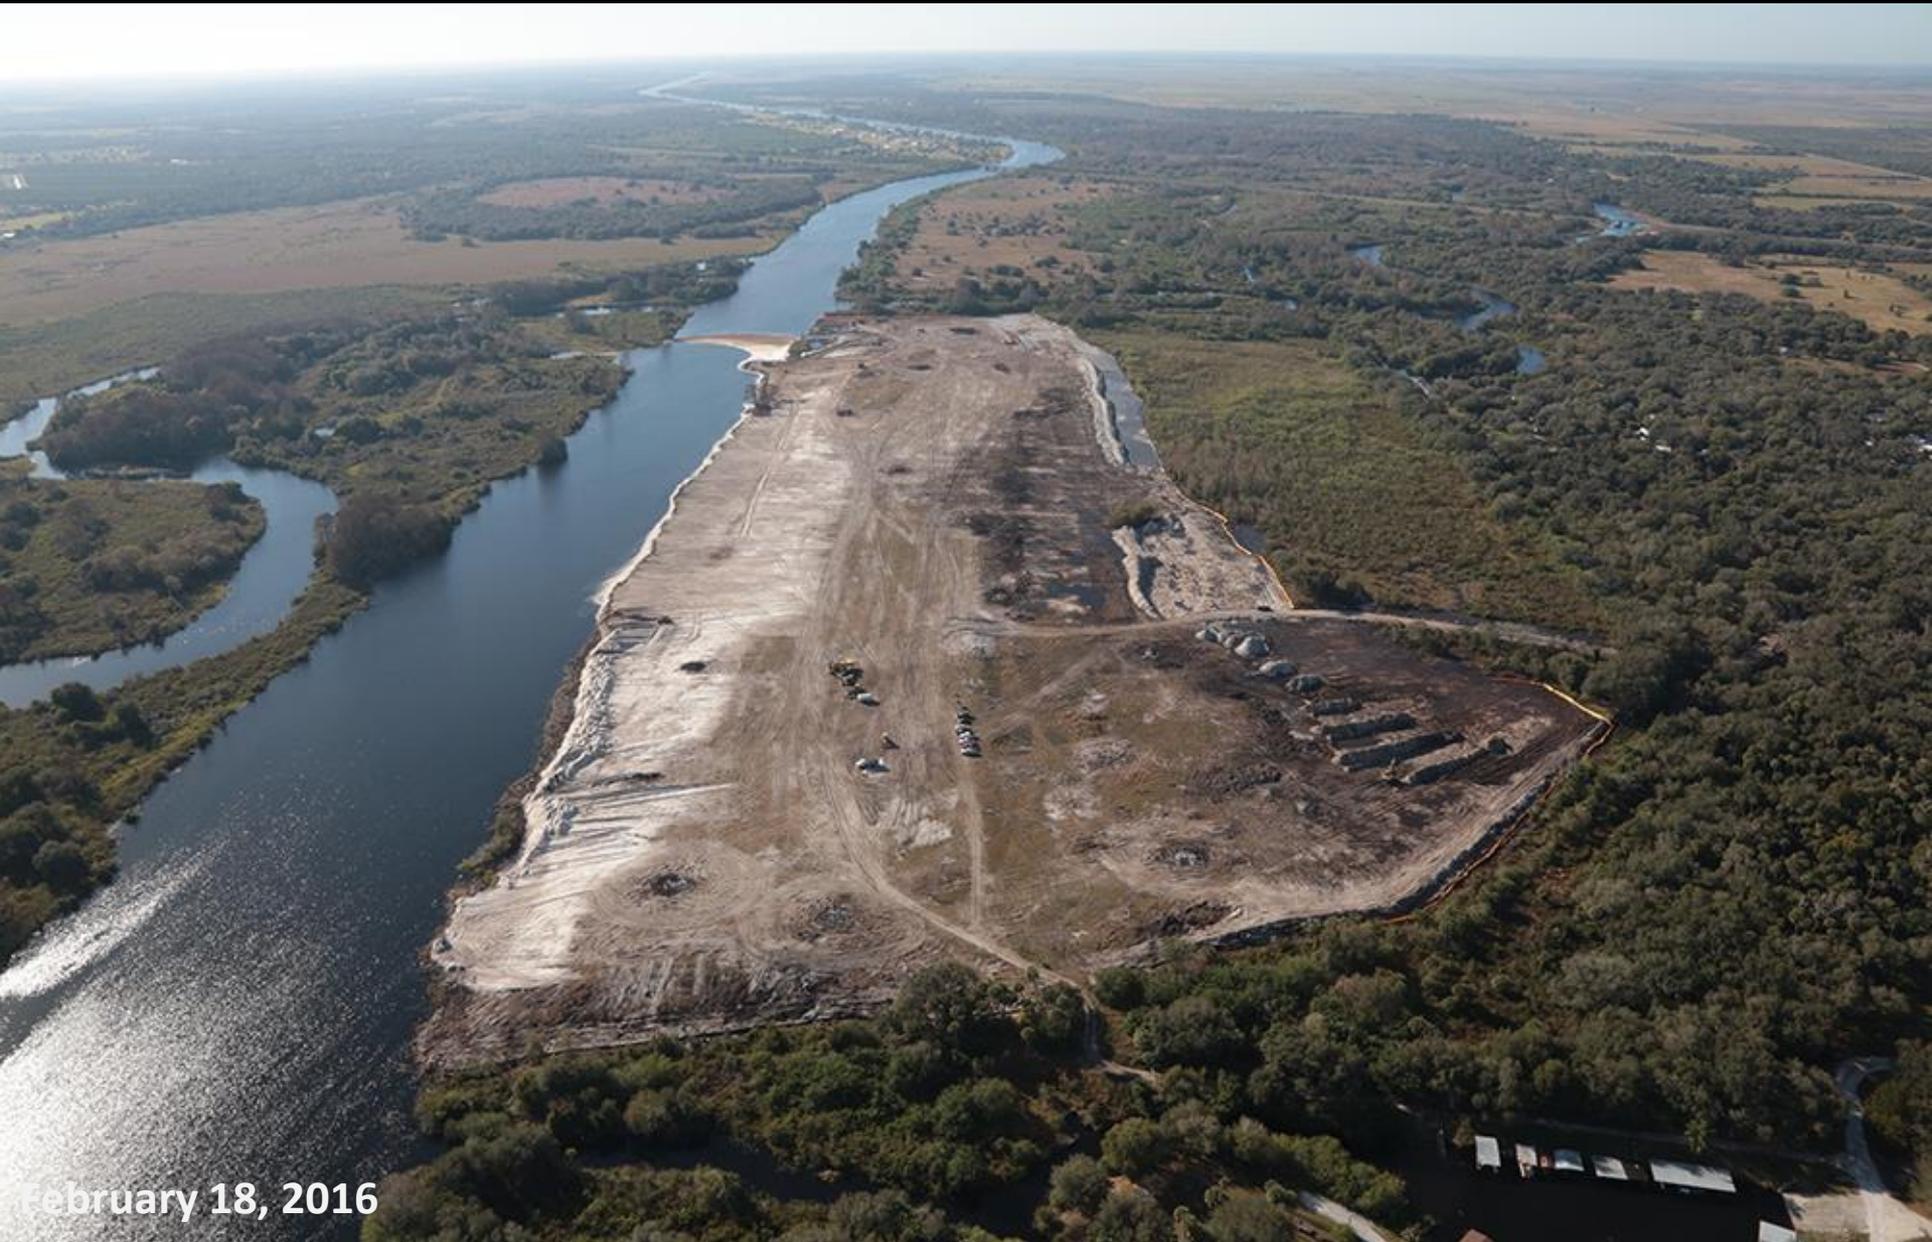
February 18, 2016

Kissimmee River Reach 3 restoration area looking south. Contractors are degrading the spoil pile and preparing for C-38 canal backfill as they begin at the lower reach to use the spoil to construct a plug across the C-38 canal.

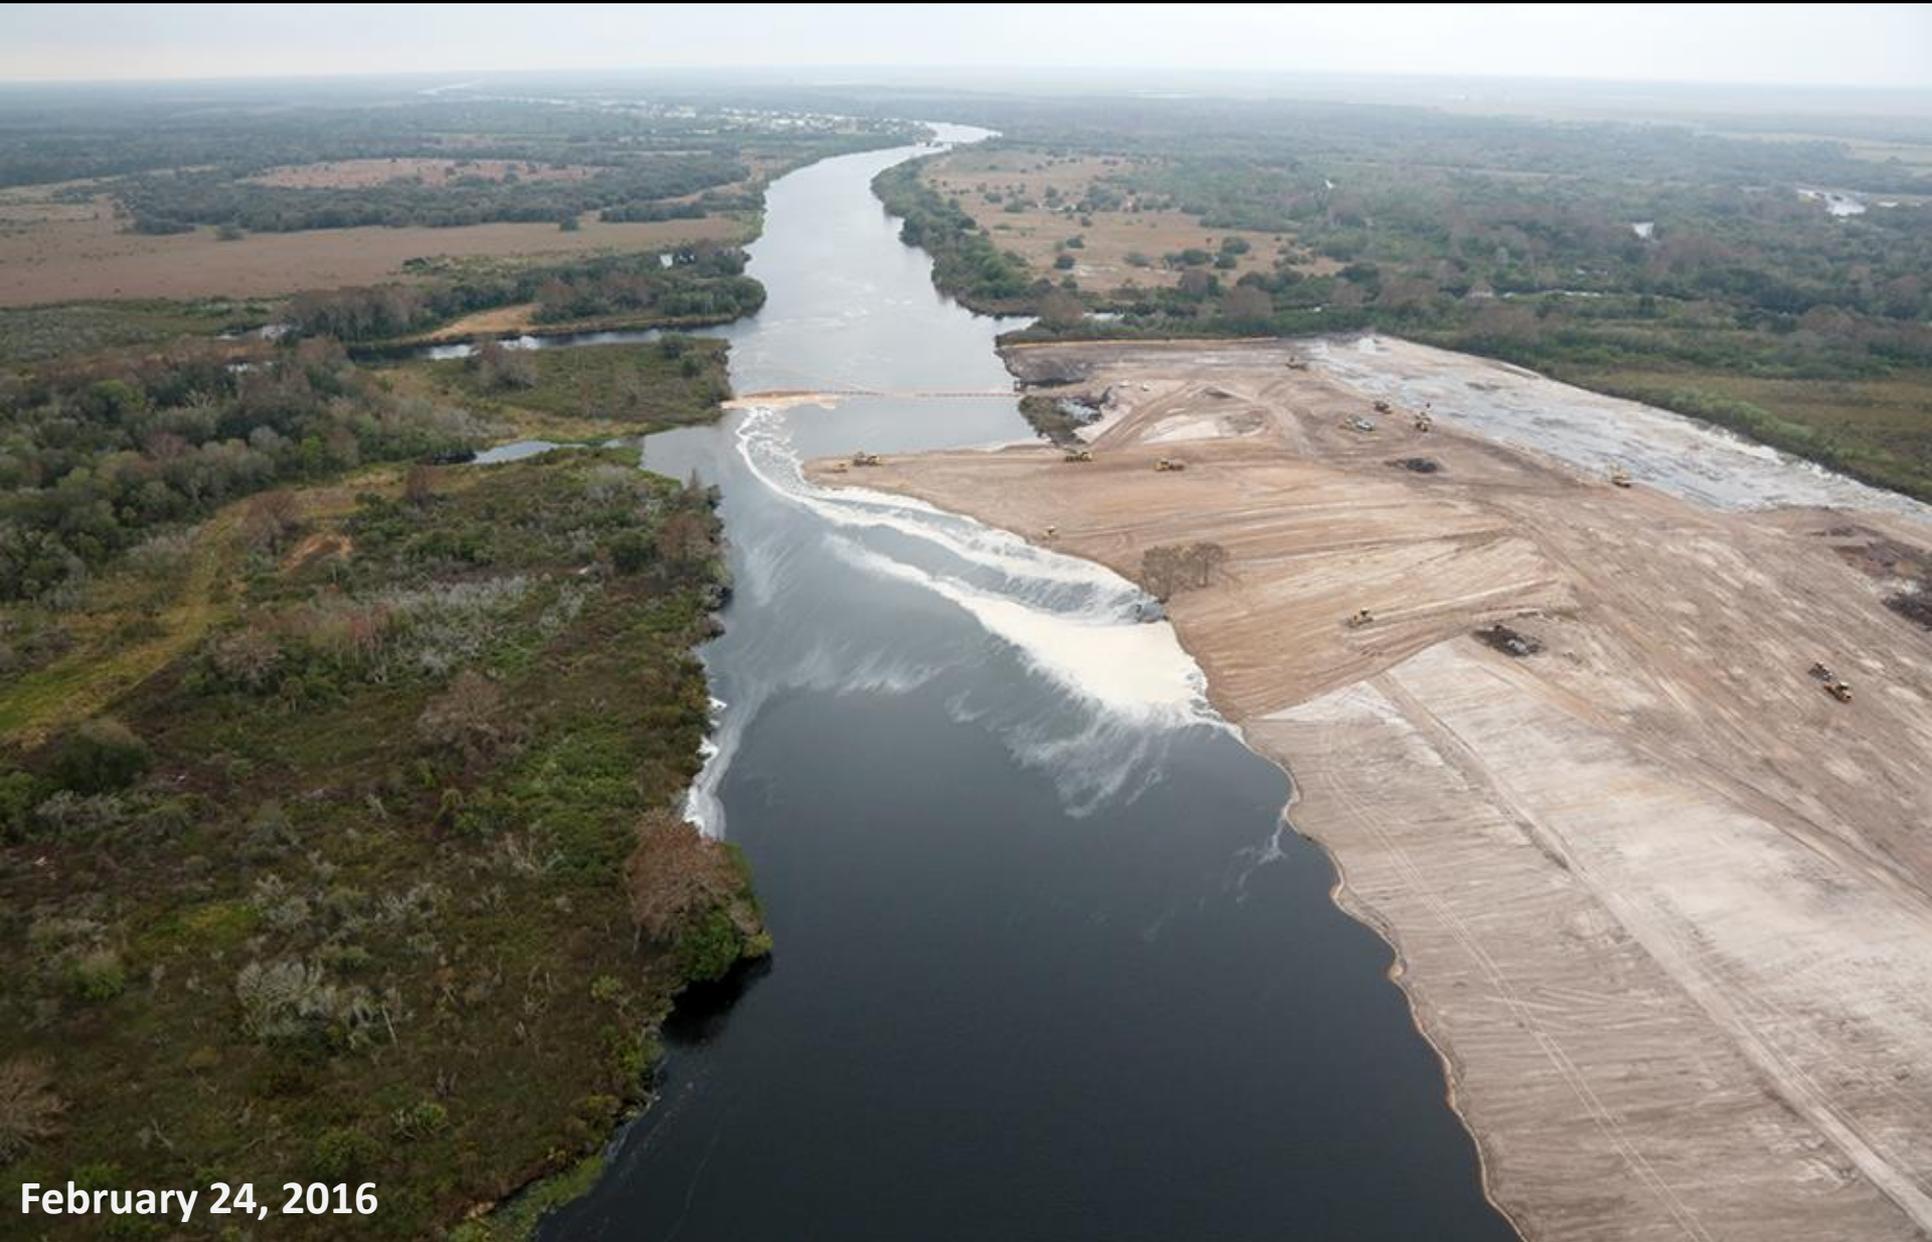
**February 24, 2016**

Kissimmee River Reach 3 restoration area looking south. Contractors are pushing spoil across the C-38 canal to create the initial plug of Reach 3 backfill.

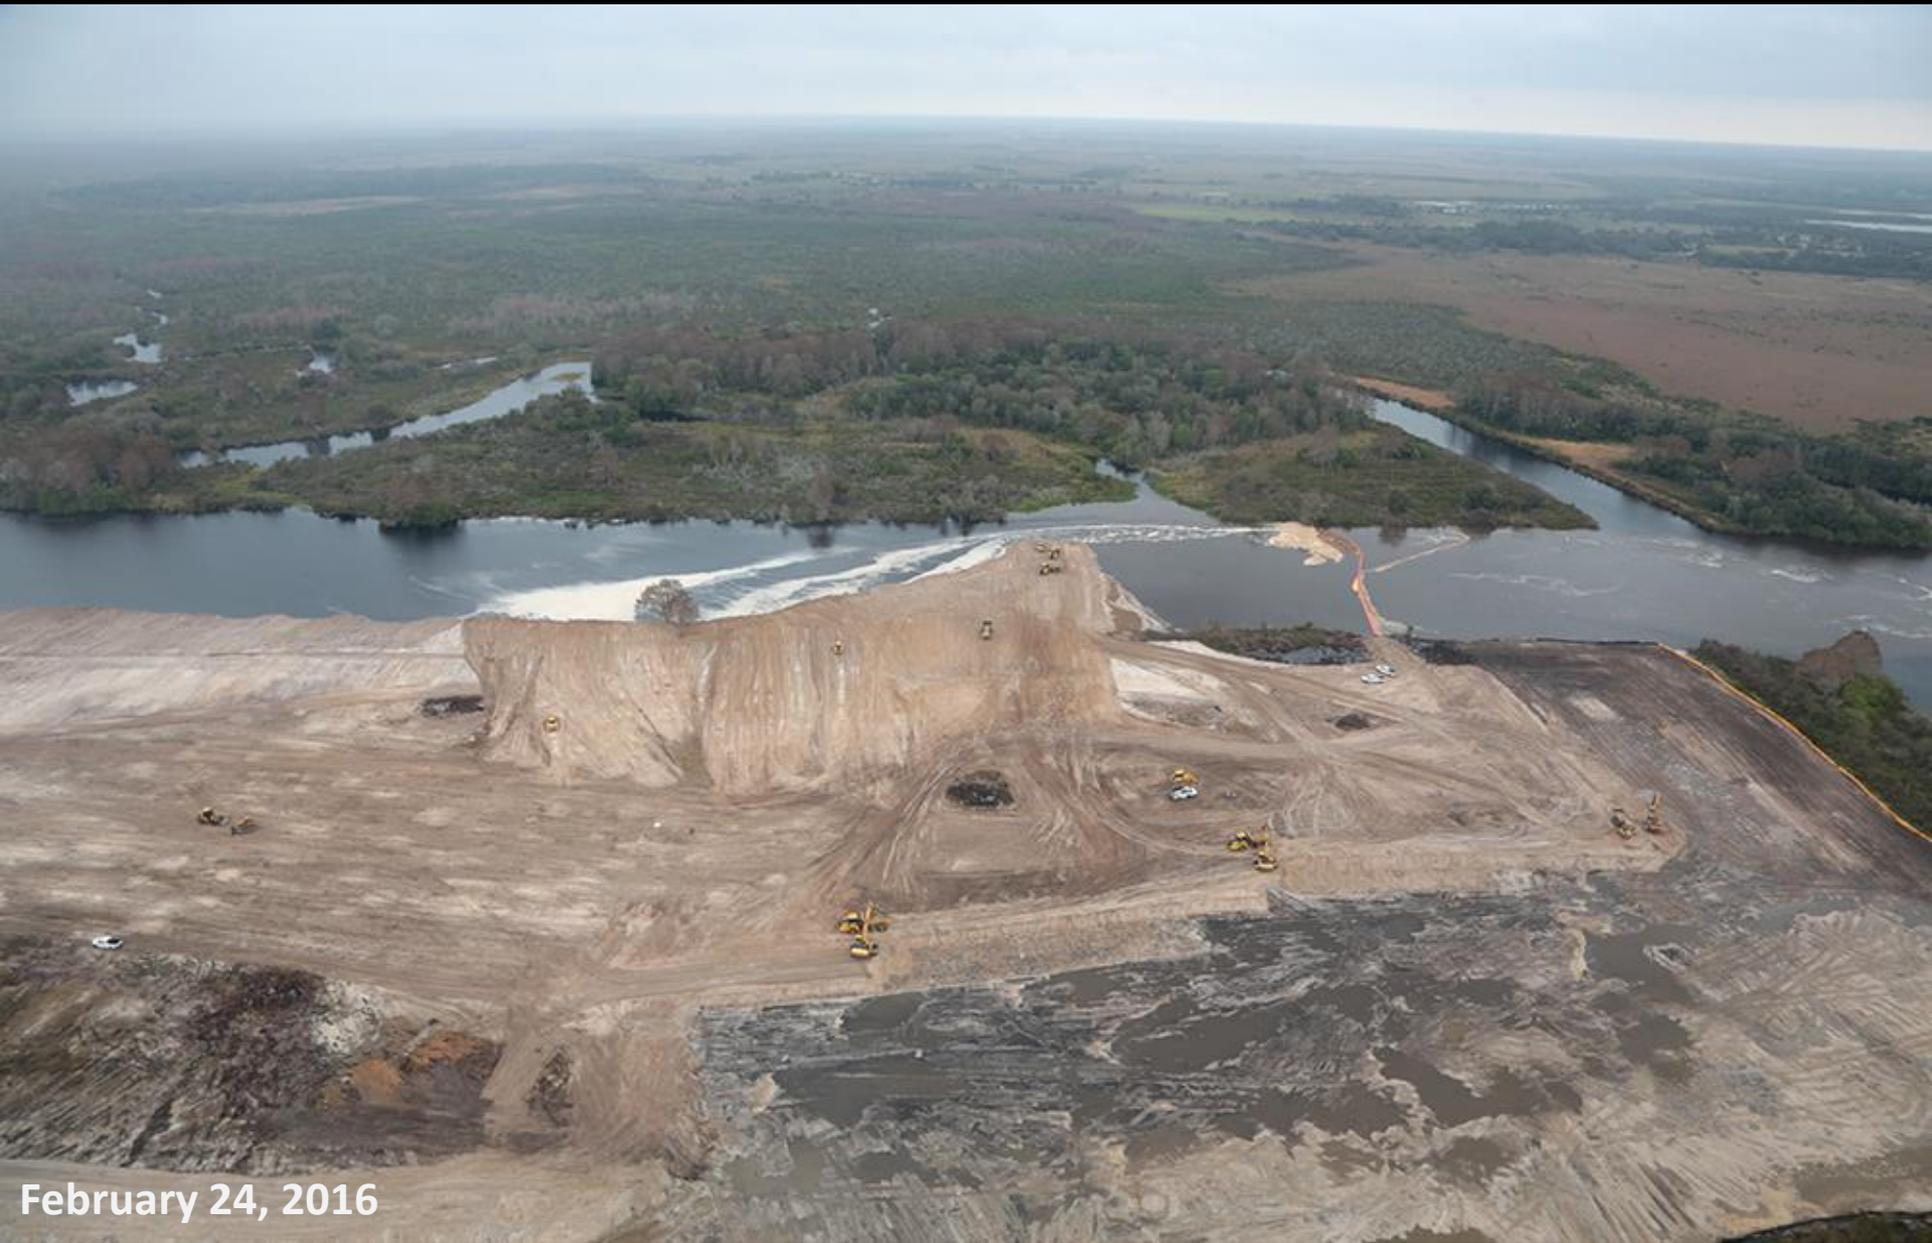
February 24, 2016

Kissimmee River Reach 3 restoration area looking east. Contractors are pushing spoil across the C-38 canal to create the initial plug of Reach 3 backfill.

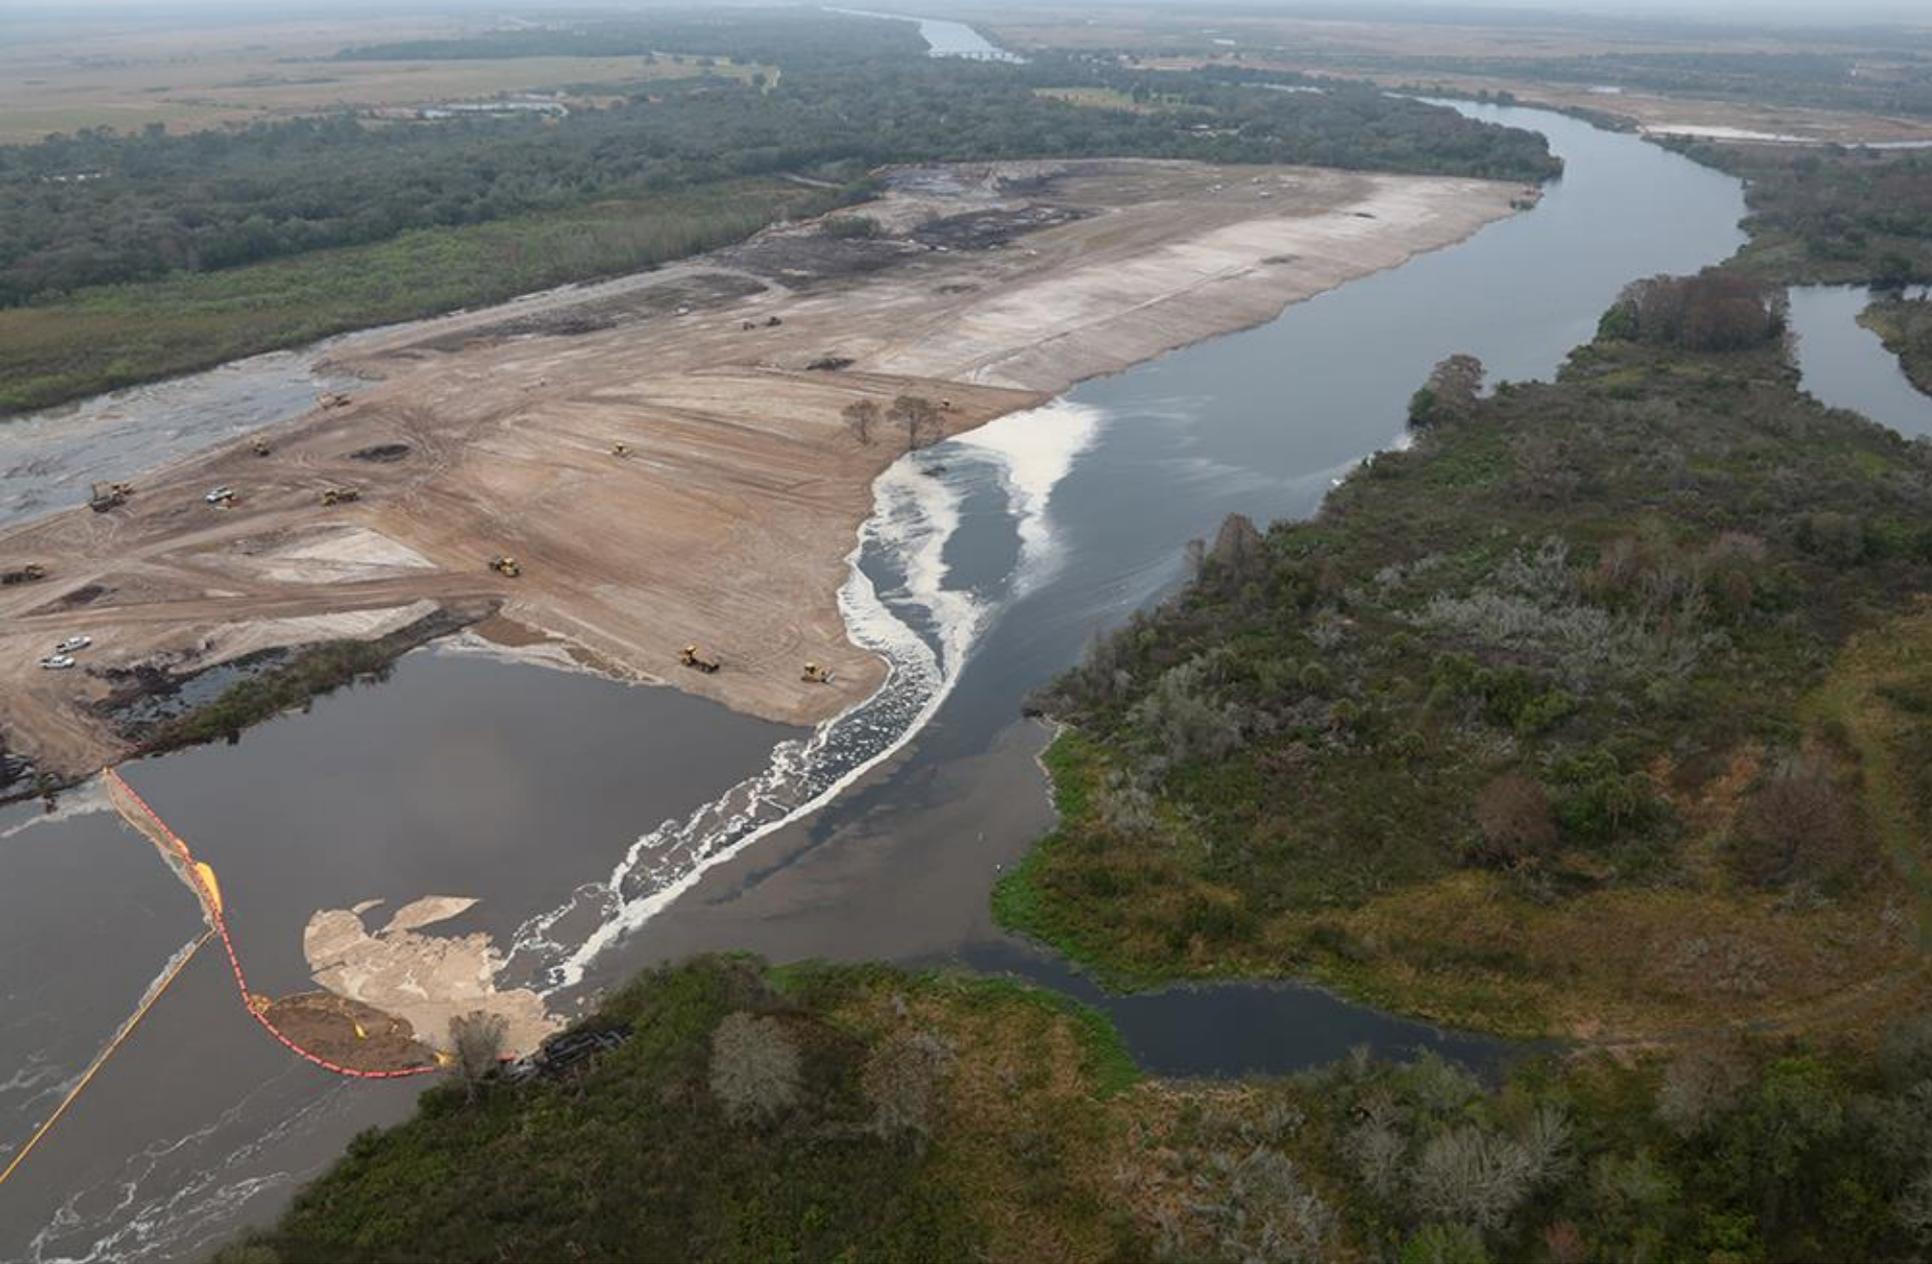
Kissimmee River Reach 3 restoration area looking northwest. Contractors are pushing spoil across the C-38 canal to create the initial plug of Reach 3 backfill.

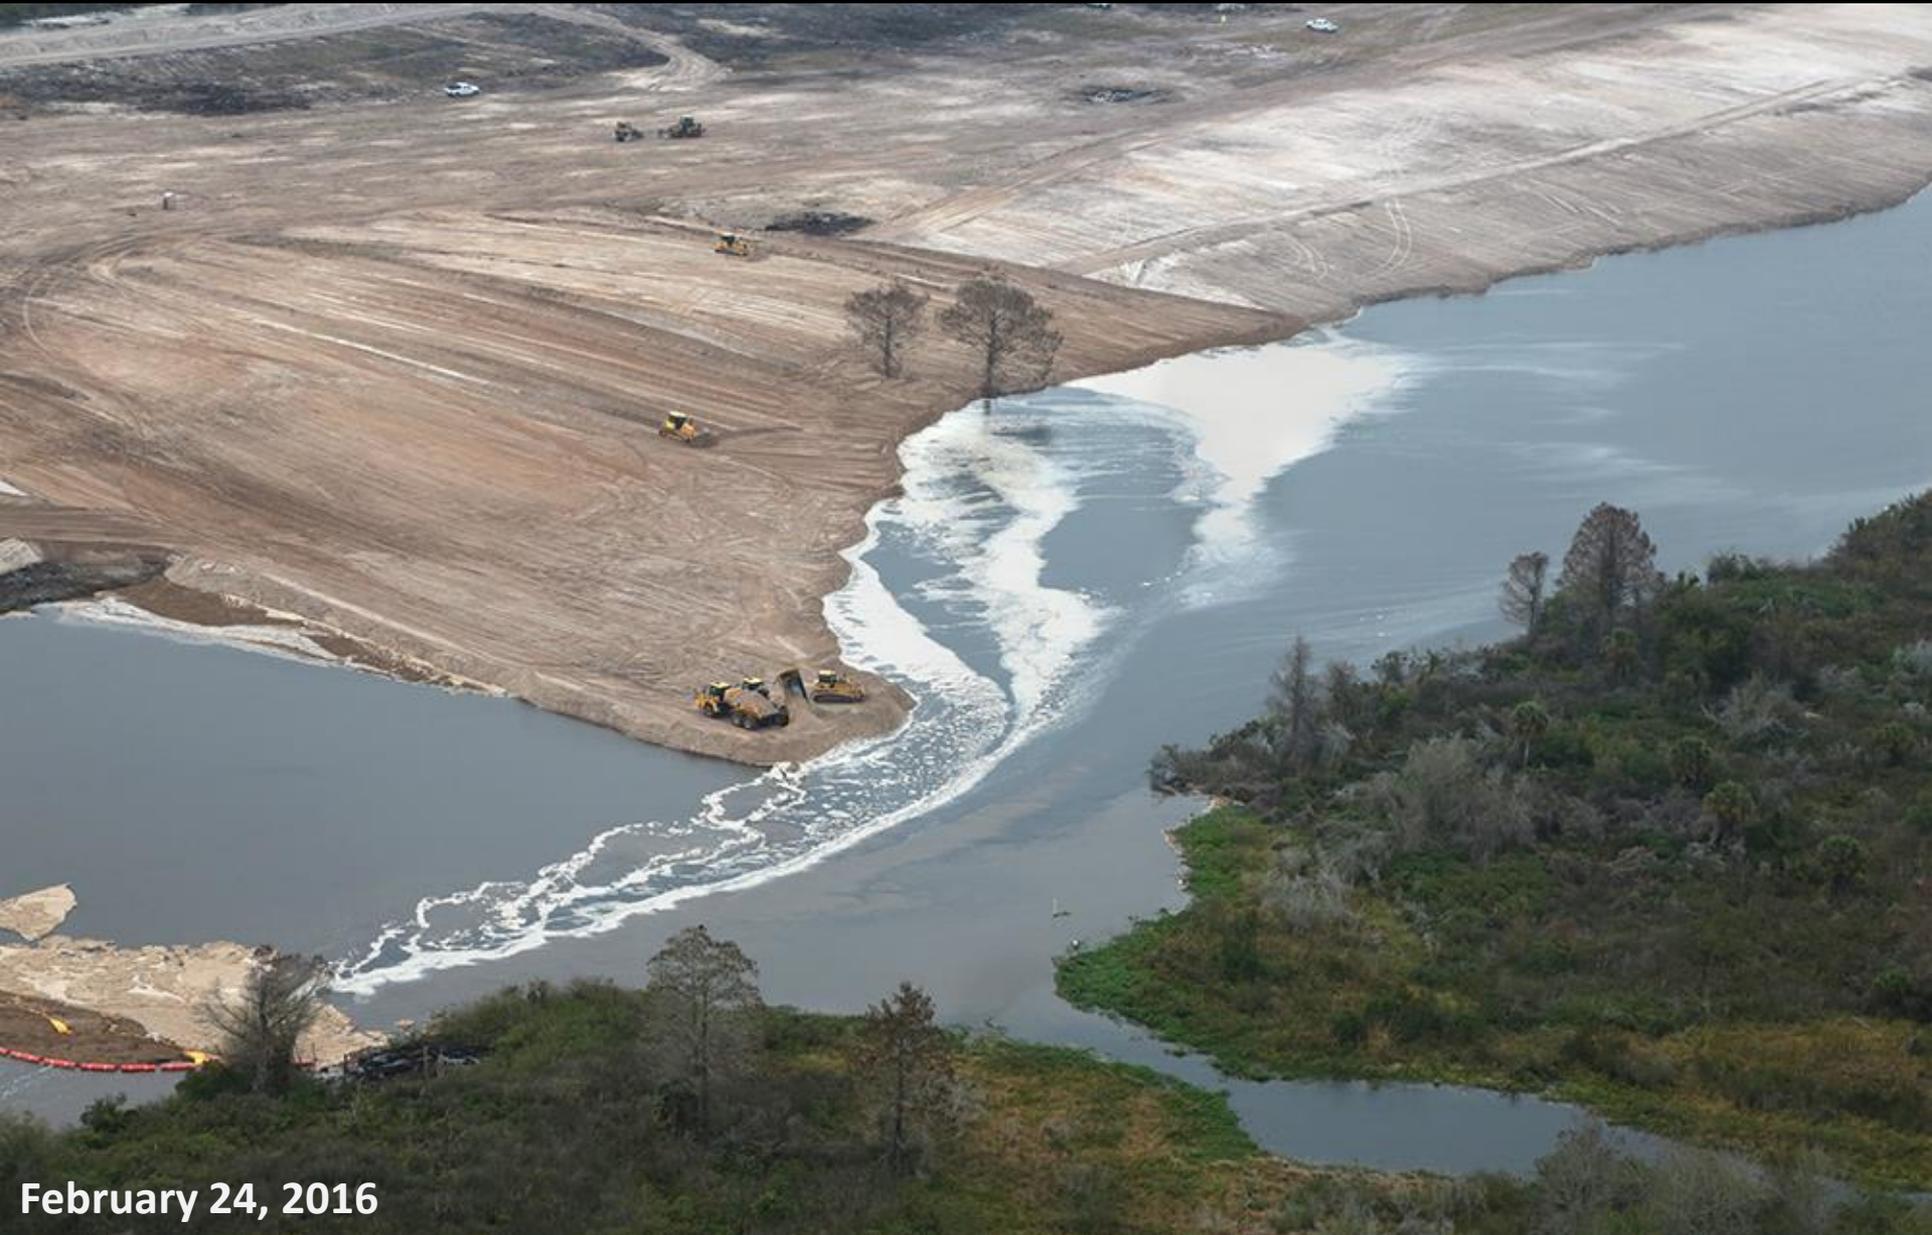
**February 24, 2016**

Kissimmee River Reach 3 restoration area looking northwest. Contractors are pushing spoil across the C-38 canal to create the initial plug of Reach 3 backfill.

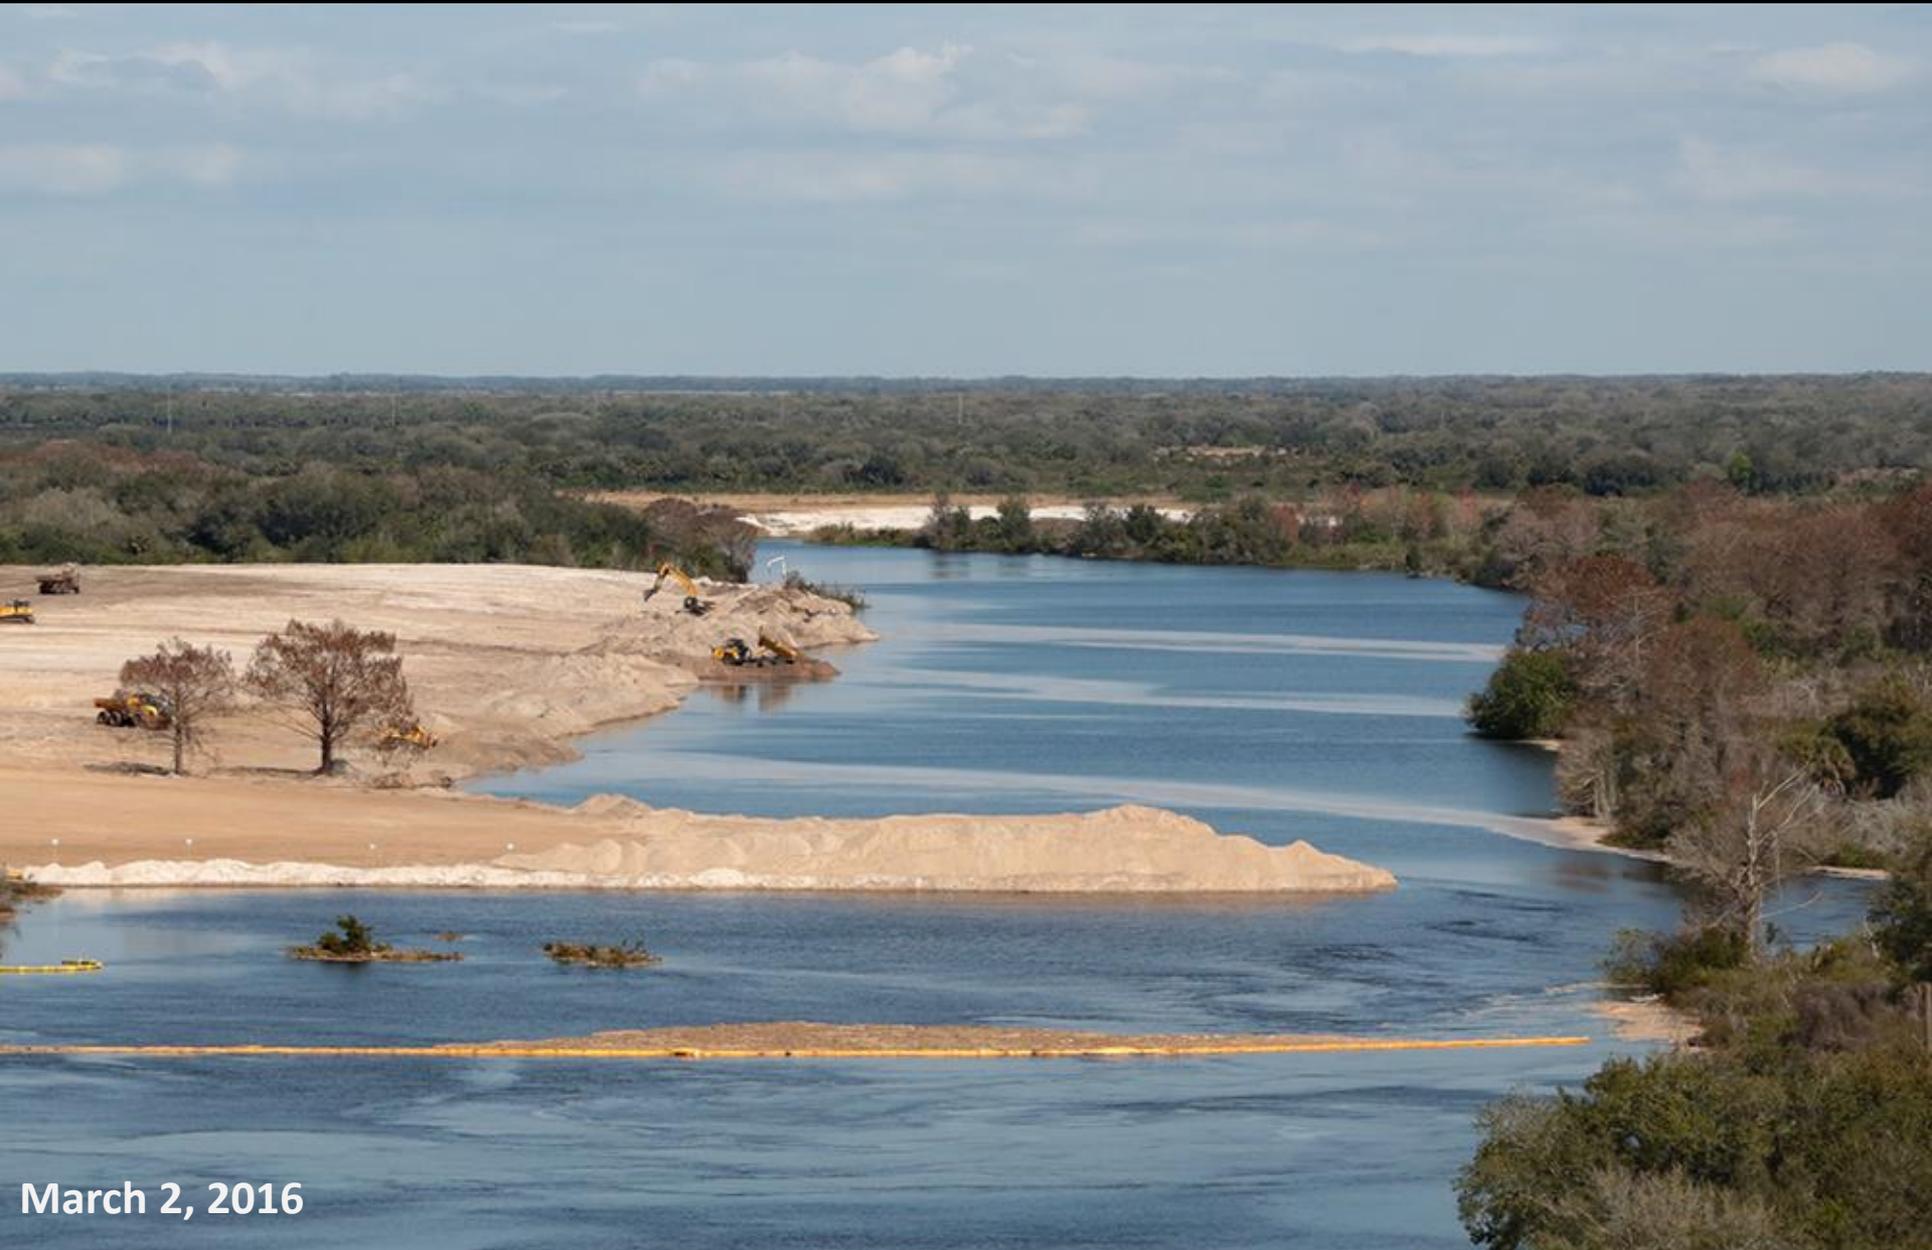
March 2, 2016

Kissimmee River Reach 3 restoration area looking northwest. Contractors are pushing spoil across the C-38 canal to create the initial plug of Reach 3 backfill.

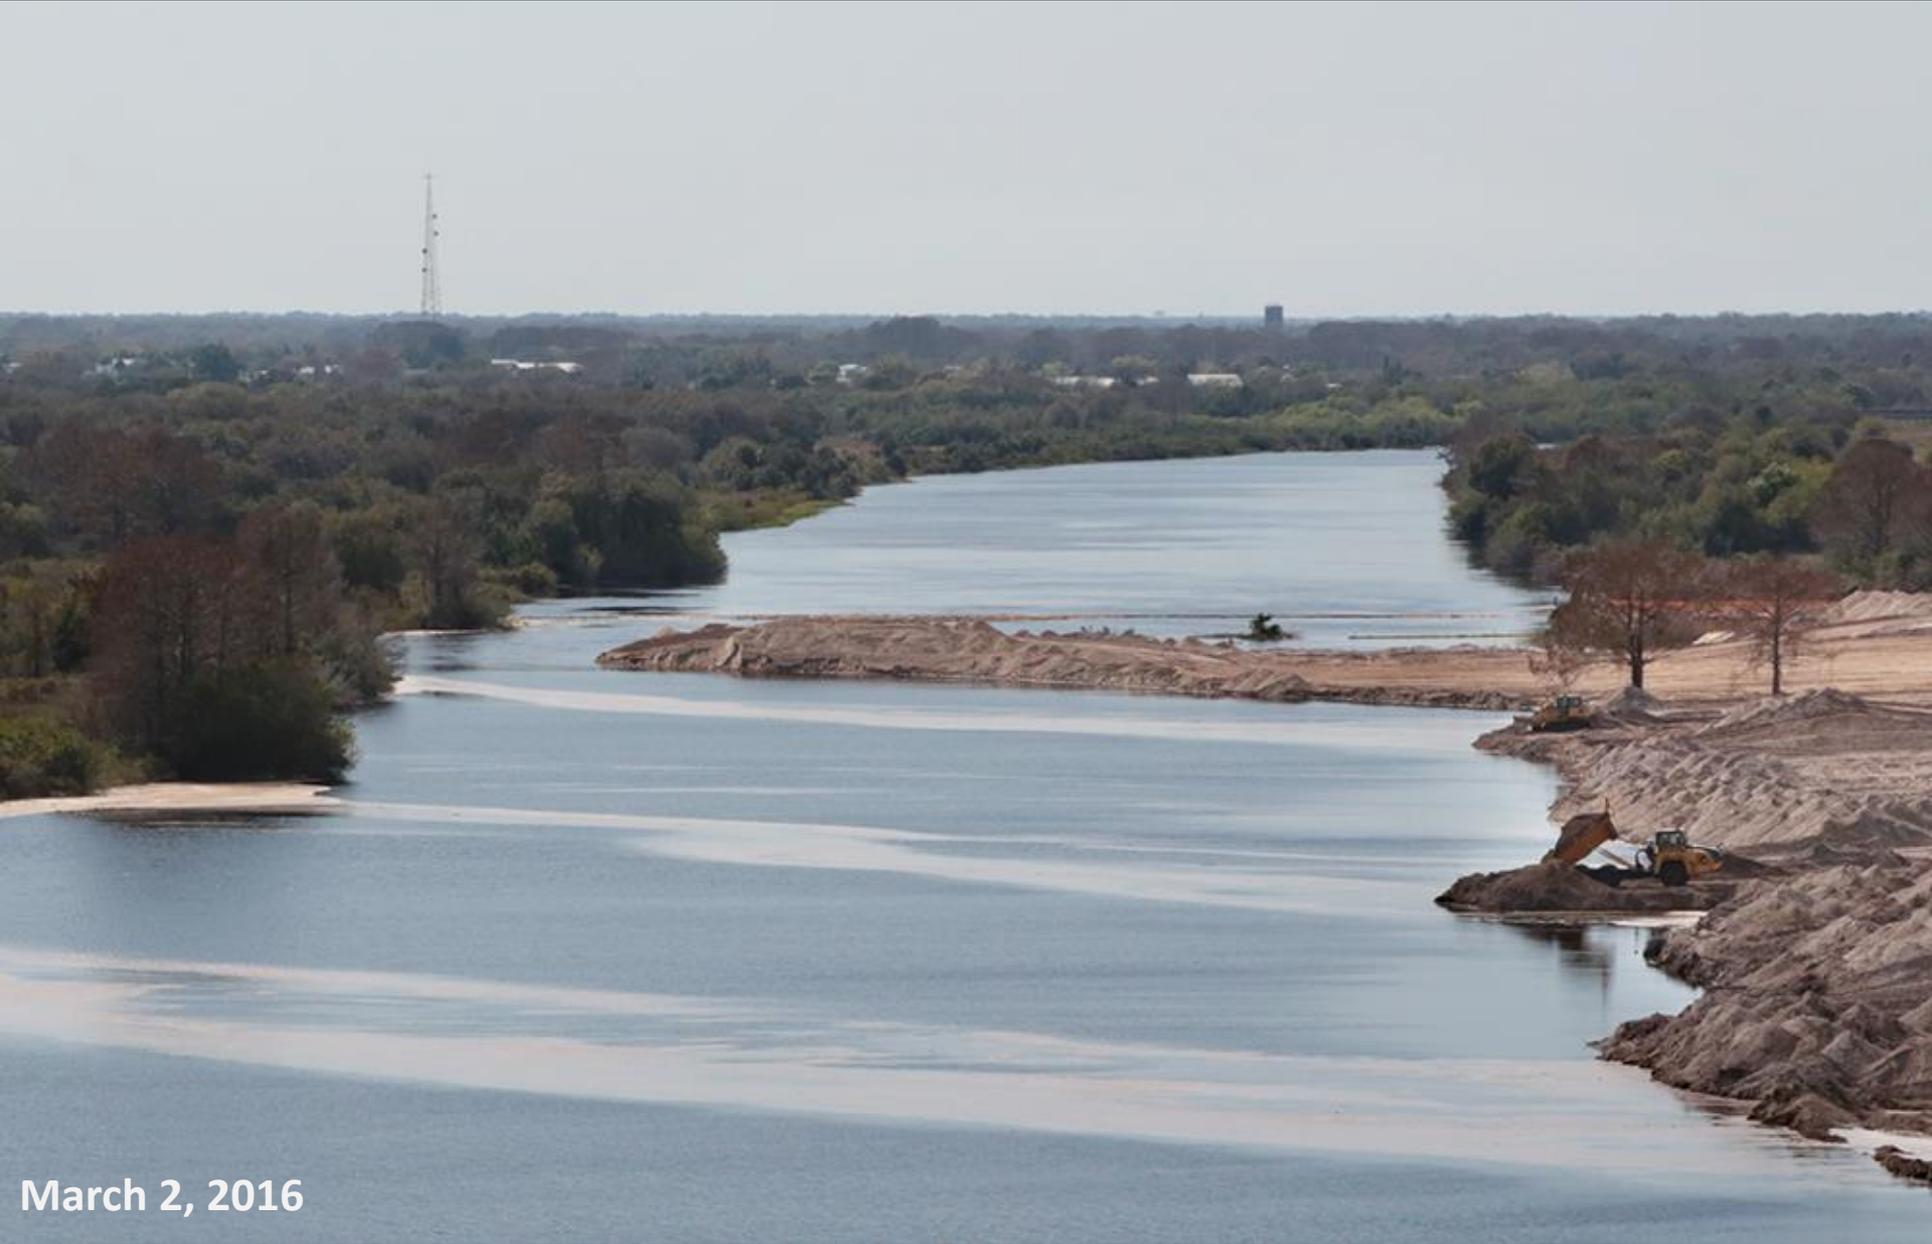
March 2, 2016

Kissimmee River Reach 3 restoration area looking south. Contractors are pushing spoil across the C-38 canal to create the initial plug of Reach 3 backfill.

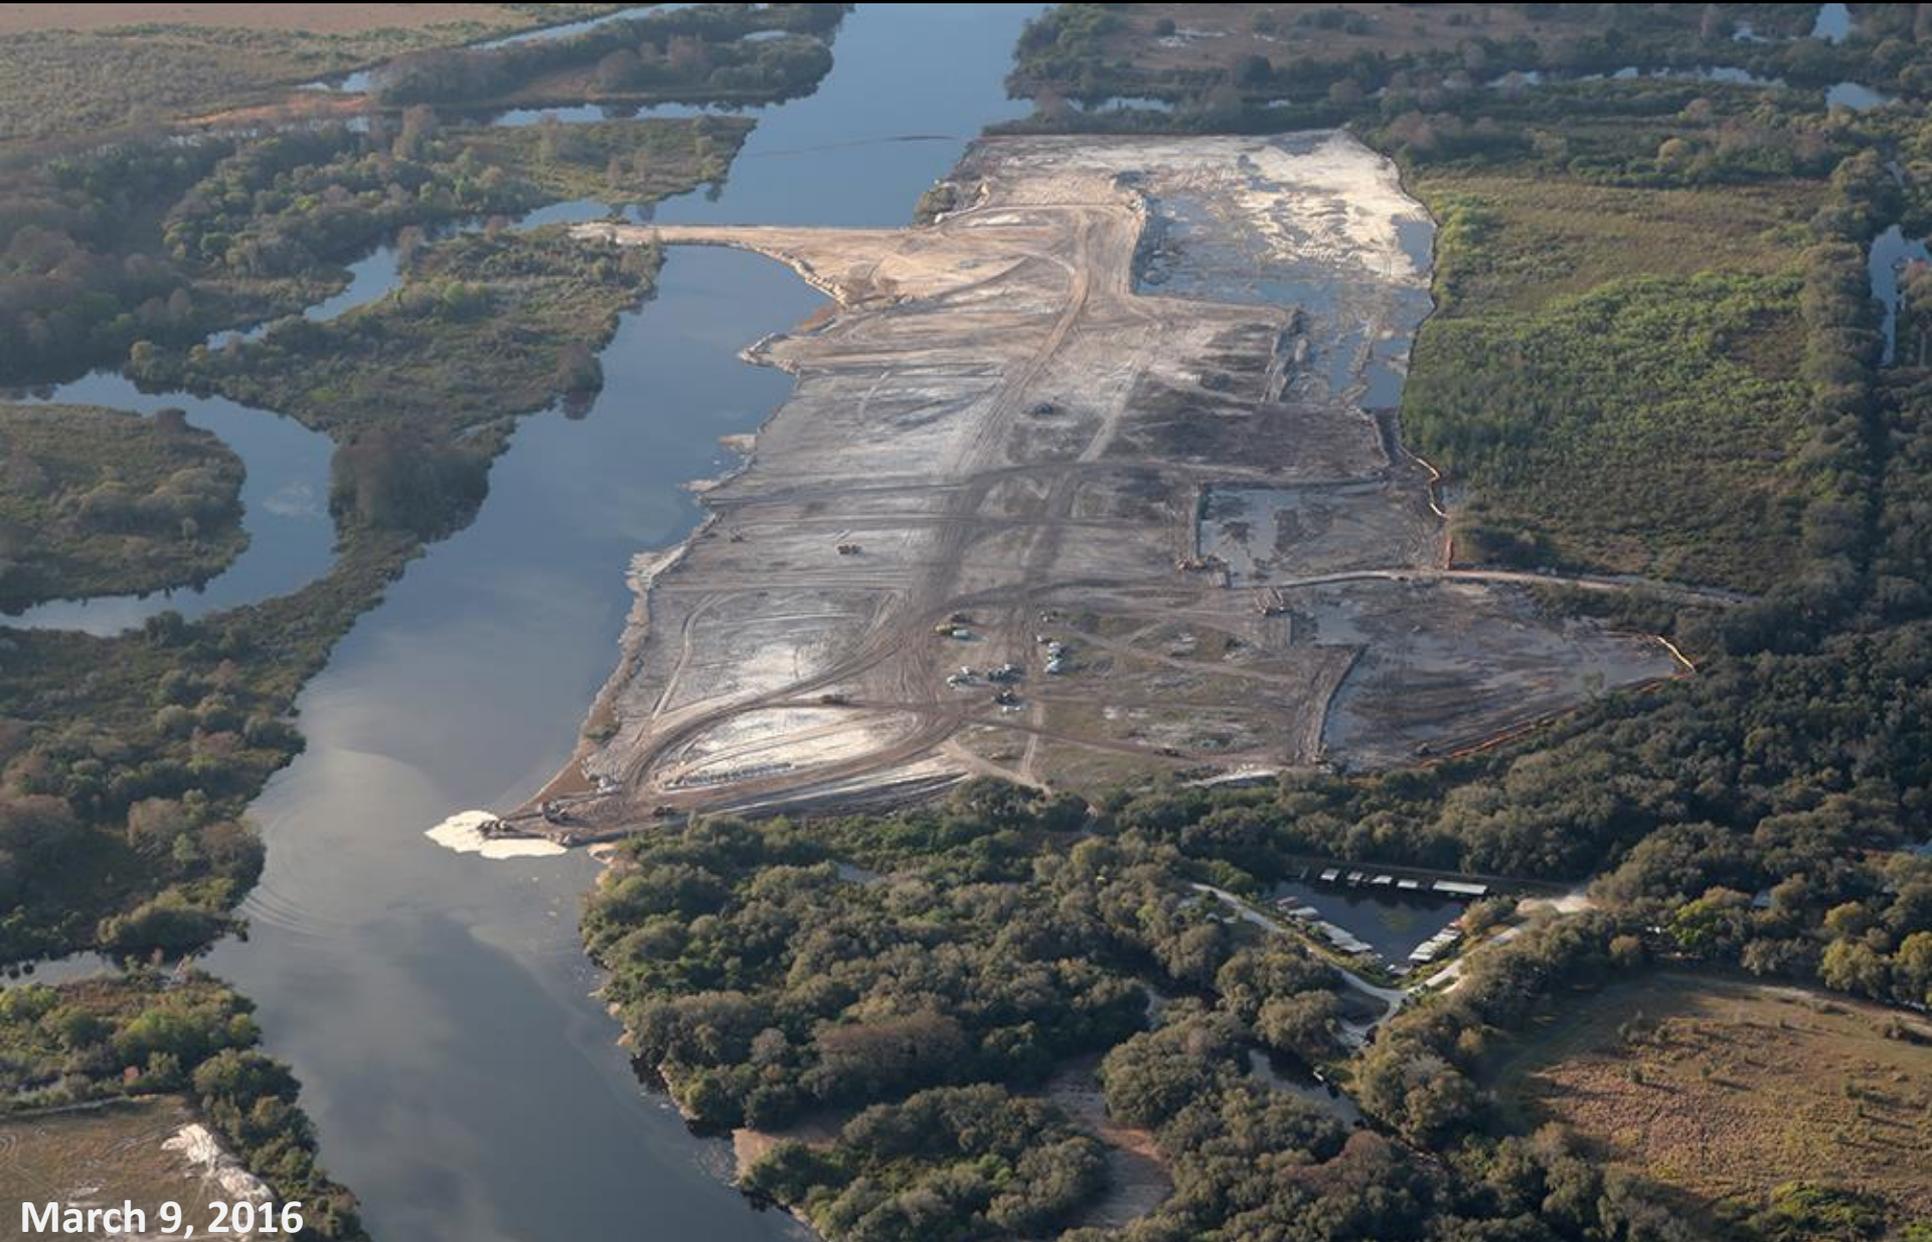
March 9, 2016

Kissimmee River Reach 3 restoration area looking south. Contractors have successfully completed the initial plug of C-38 canal Reach 3 backfill.

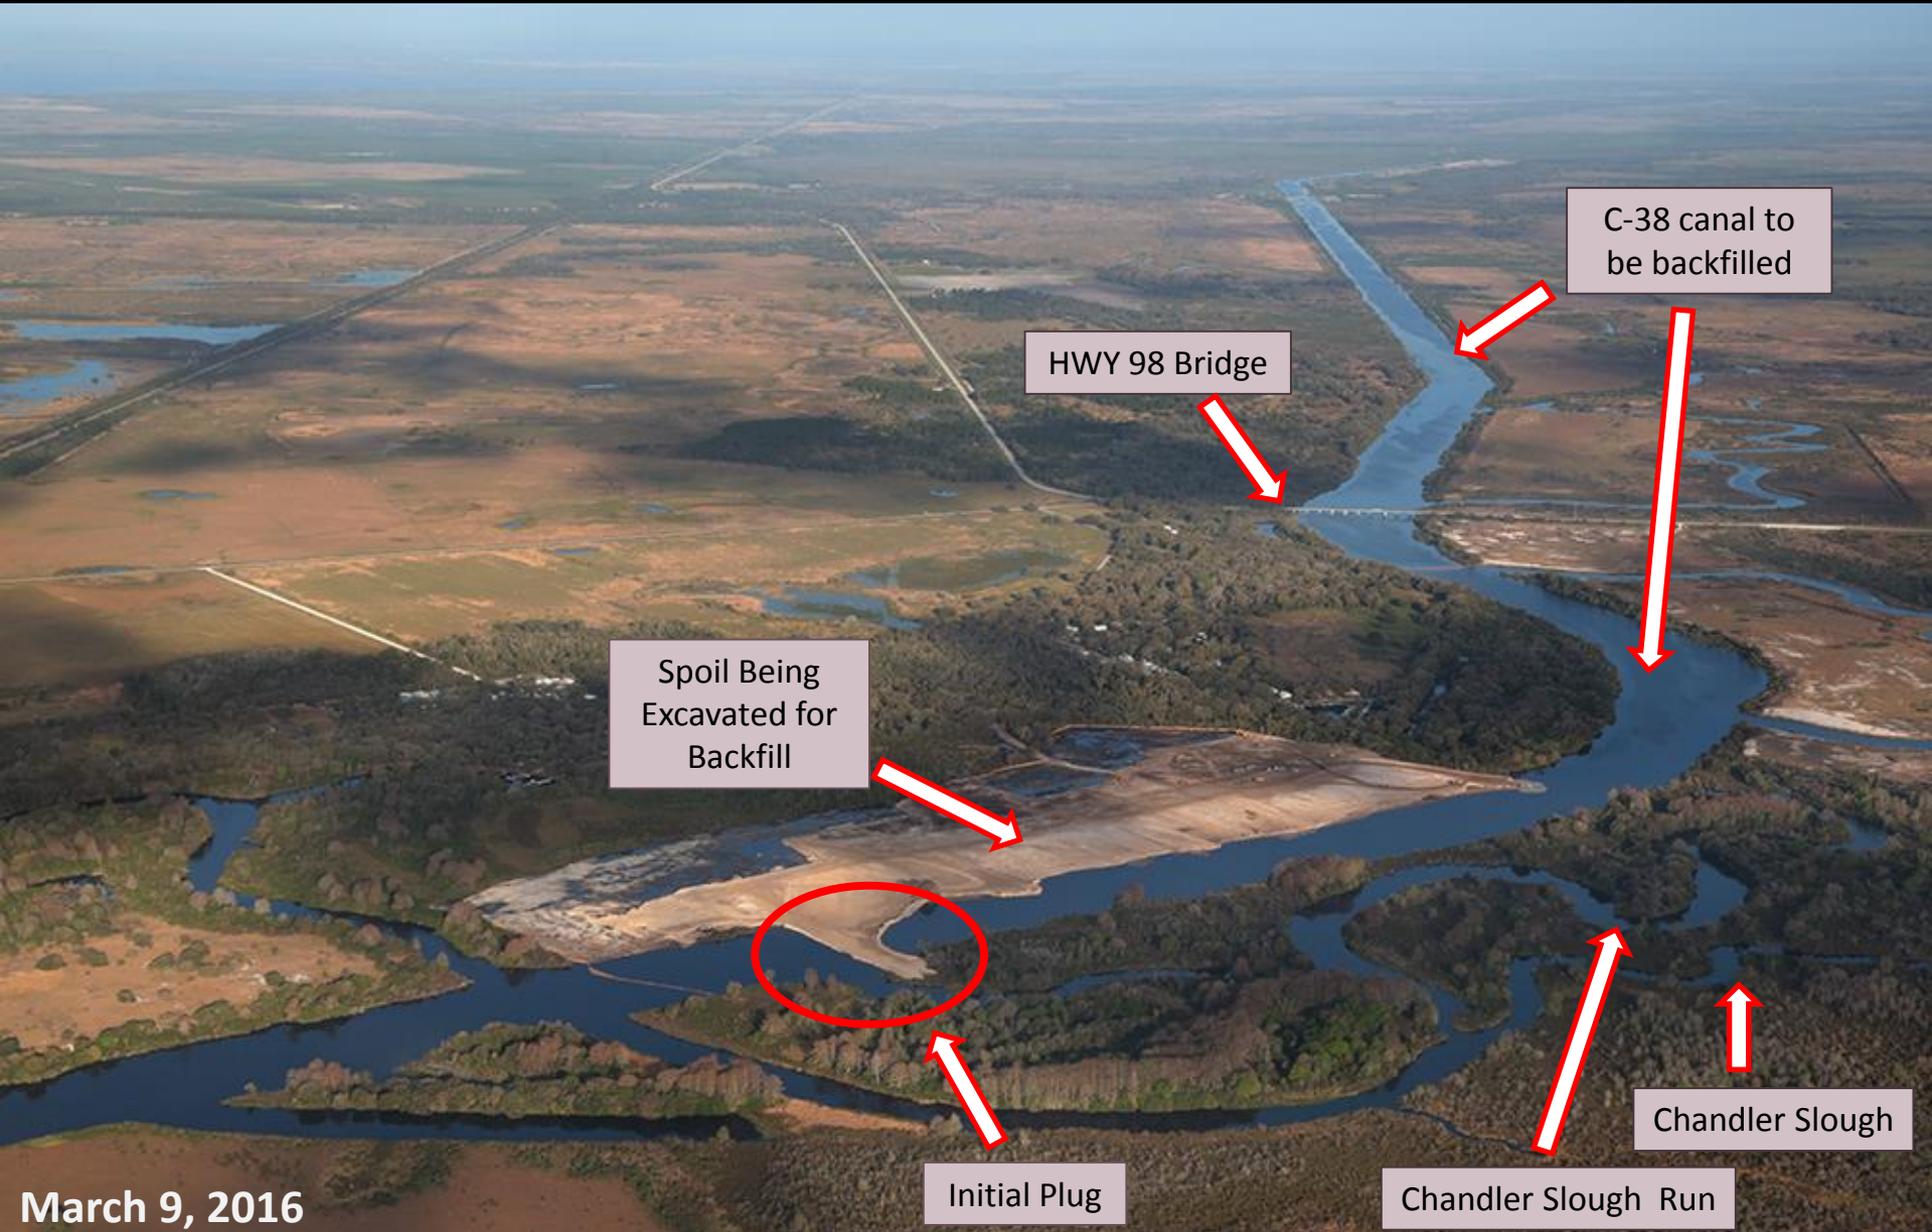
March 9, 2016

Kissimmee River Phase III/Reach 3 restoration area looking northwest. Contractors have successfully completed the initial plug of C-38 canal Reach 3 backfill. They will now continue their way northwest backfilling the canal. Phase III/Reach 3 continues upstream to HW98 bridge. Phase II/Reach 2 will continue further upstream to connect with Phase I/Reach 1 backfill completed in 2001.
