January - March 2016

# Kissimmee River Restoration Project and Kissimmee Basin Environmental and Restoration Features

Kissimmee River Restoration Project  
Reach 3 C-38 Backfill  
Construction Progress  
February 2016

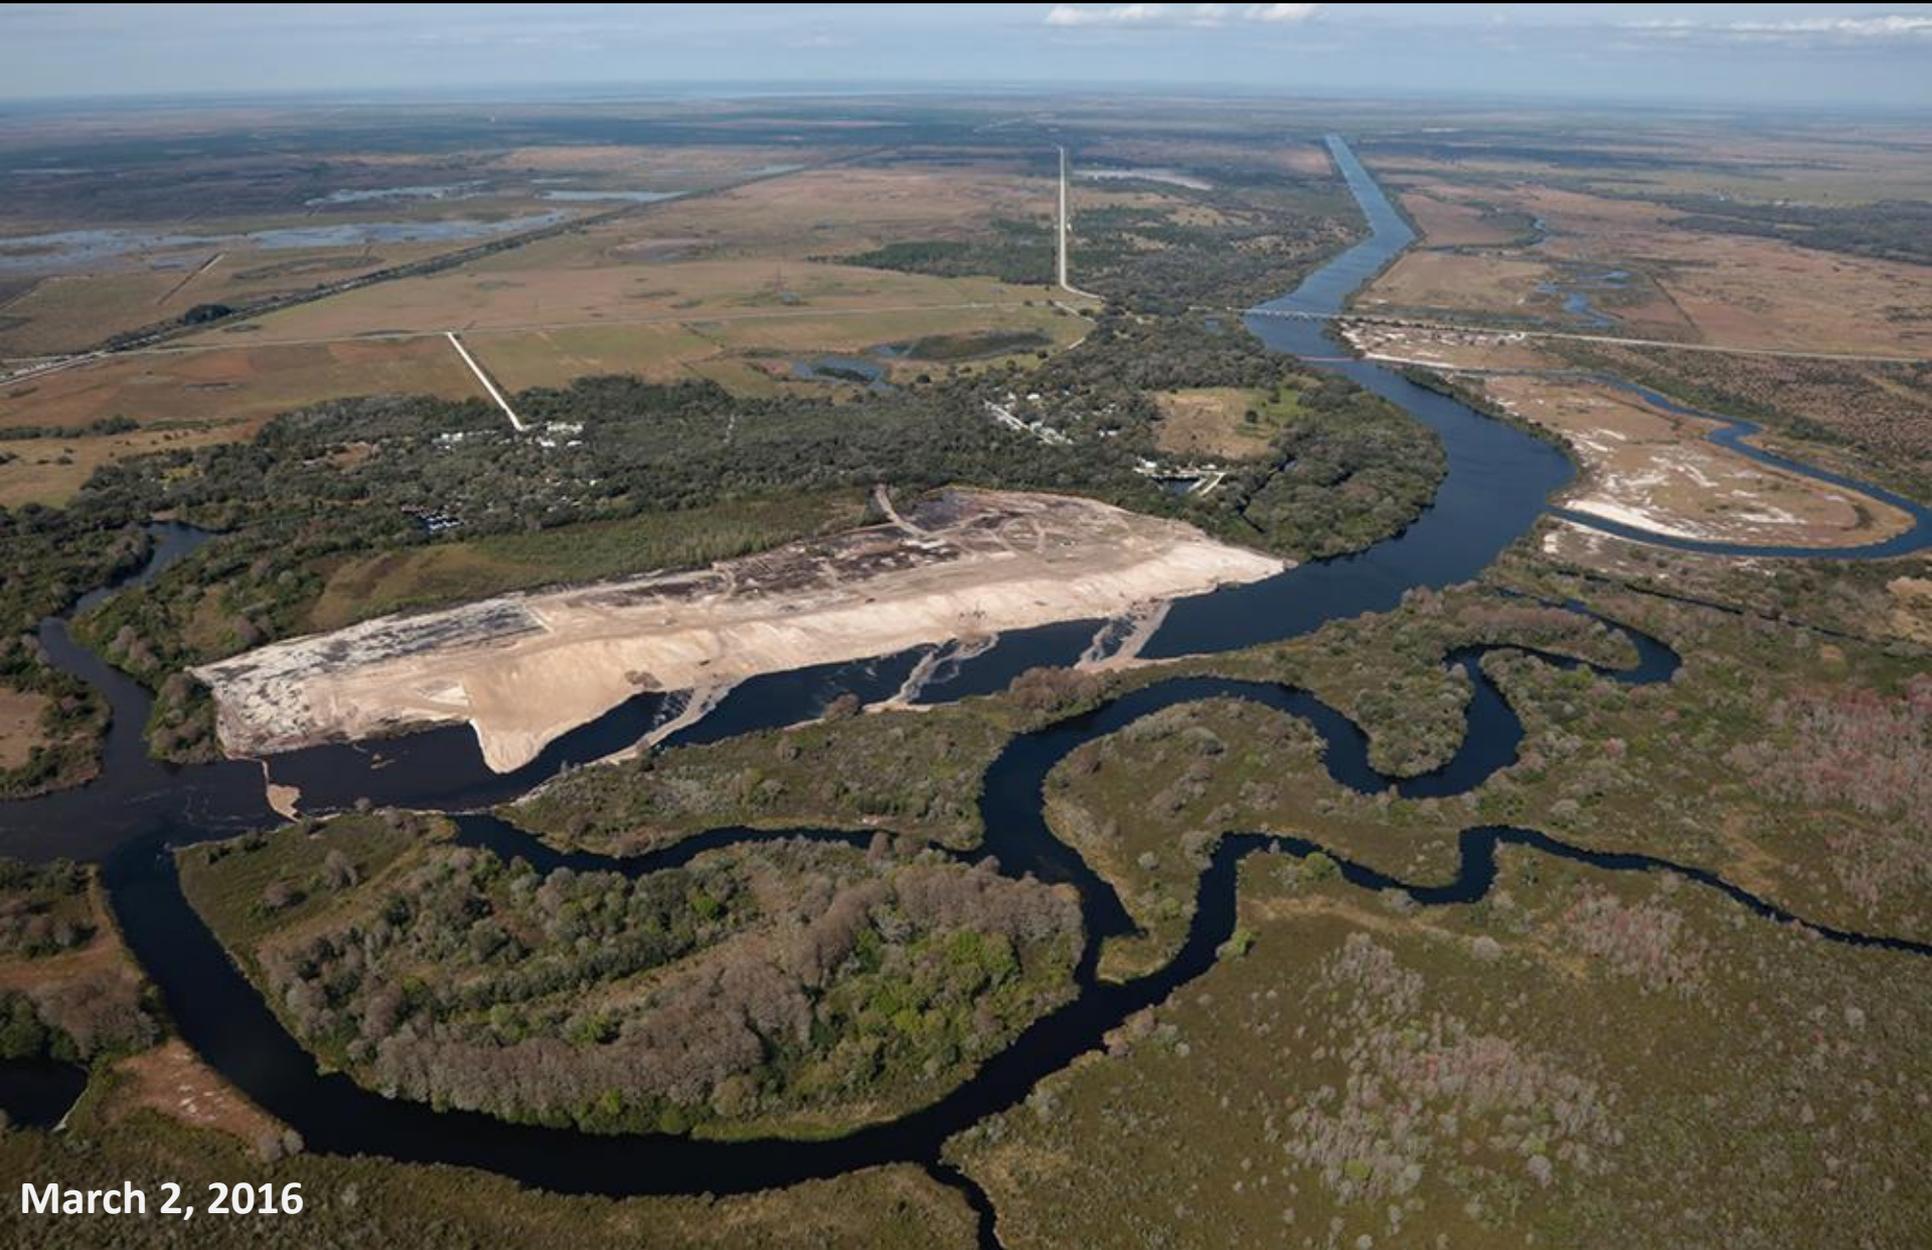
**March 2, 2016**

Kissimmee River Reach 3 restoration area looking west. Contractors are pushing spoil across the C-38 canal to create the initial plug of Reach 3 backfill.

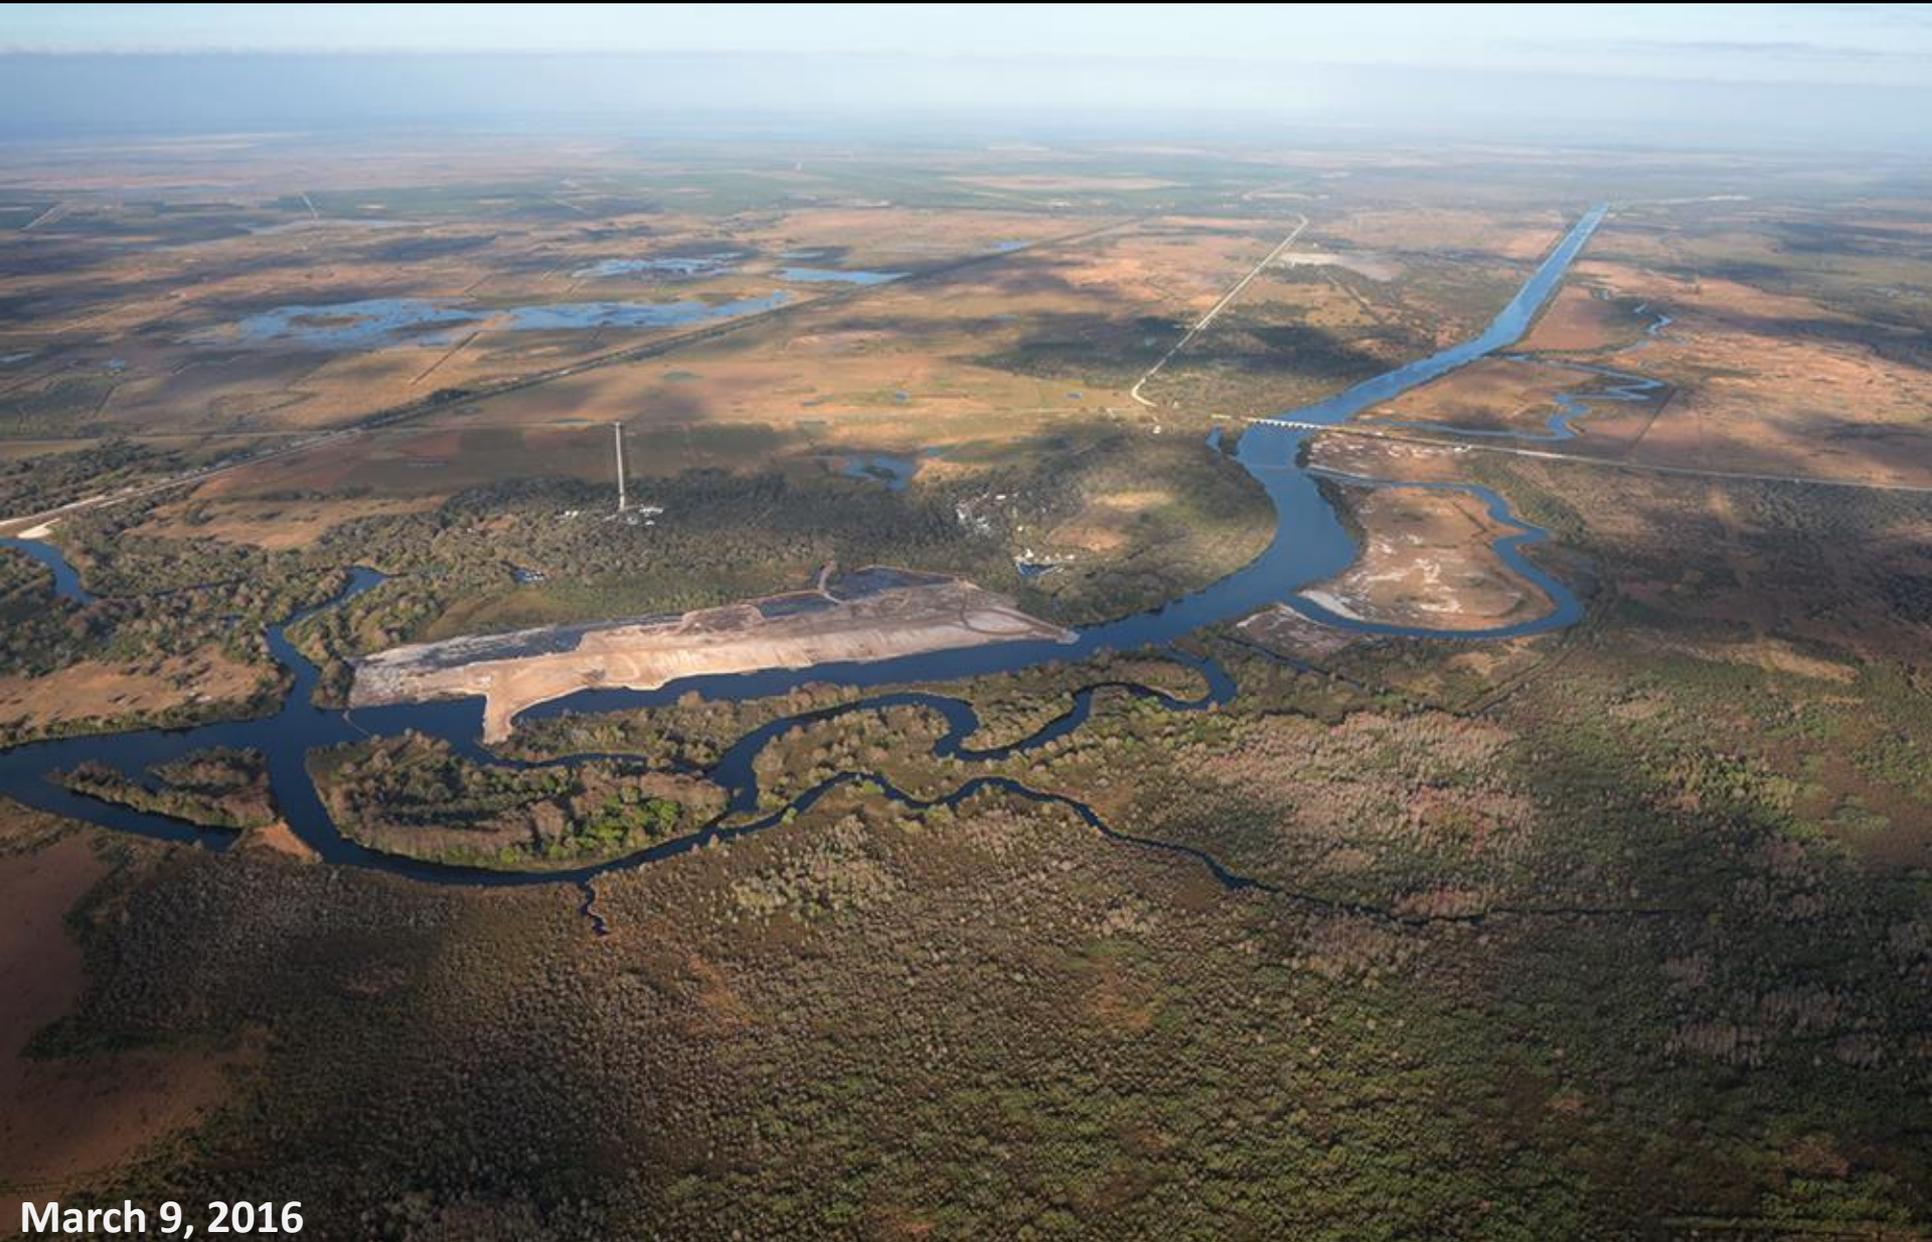
**March 9, 2016**

Kissimmee River Reach 3 restoration area looking west. Contractors have successfully completed the initial plug of C-38 canal Reach 3 backfill. They will now continue their way northwest backfilling the canal.

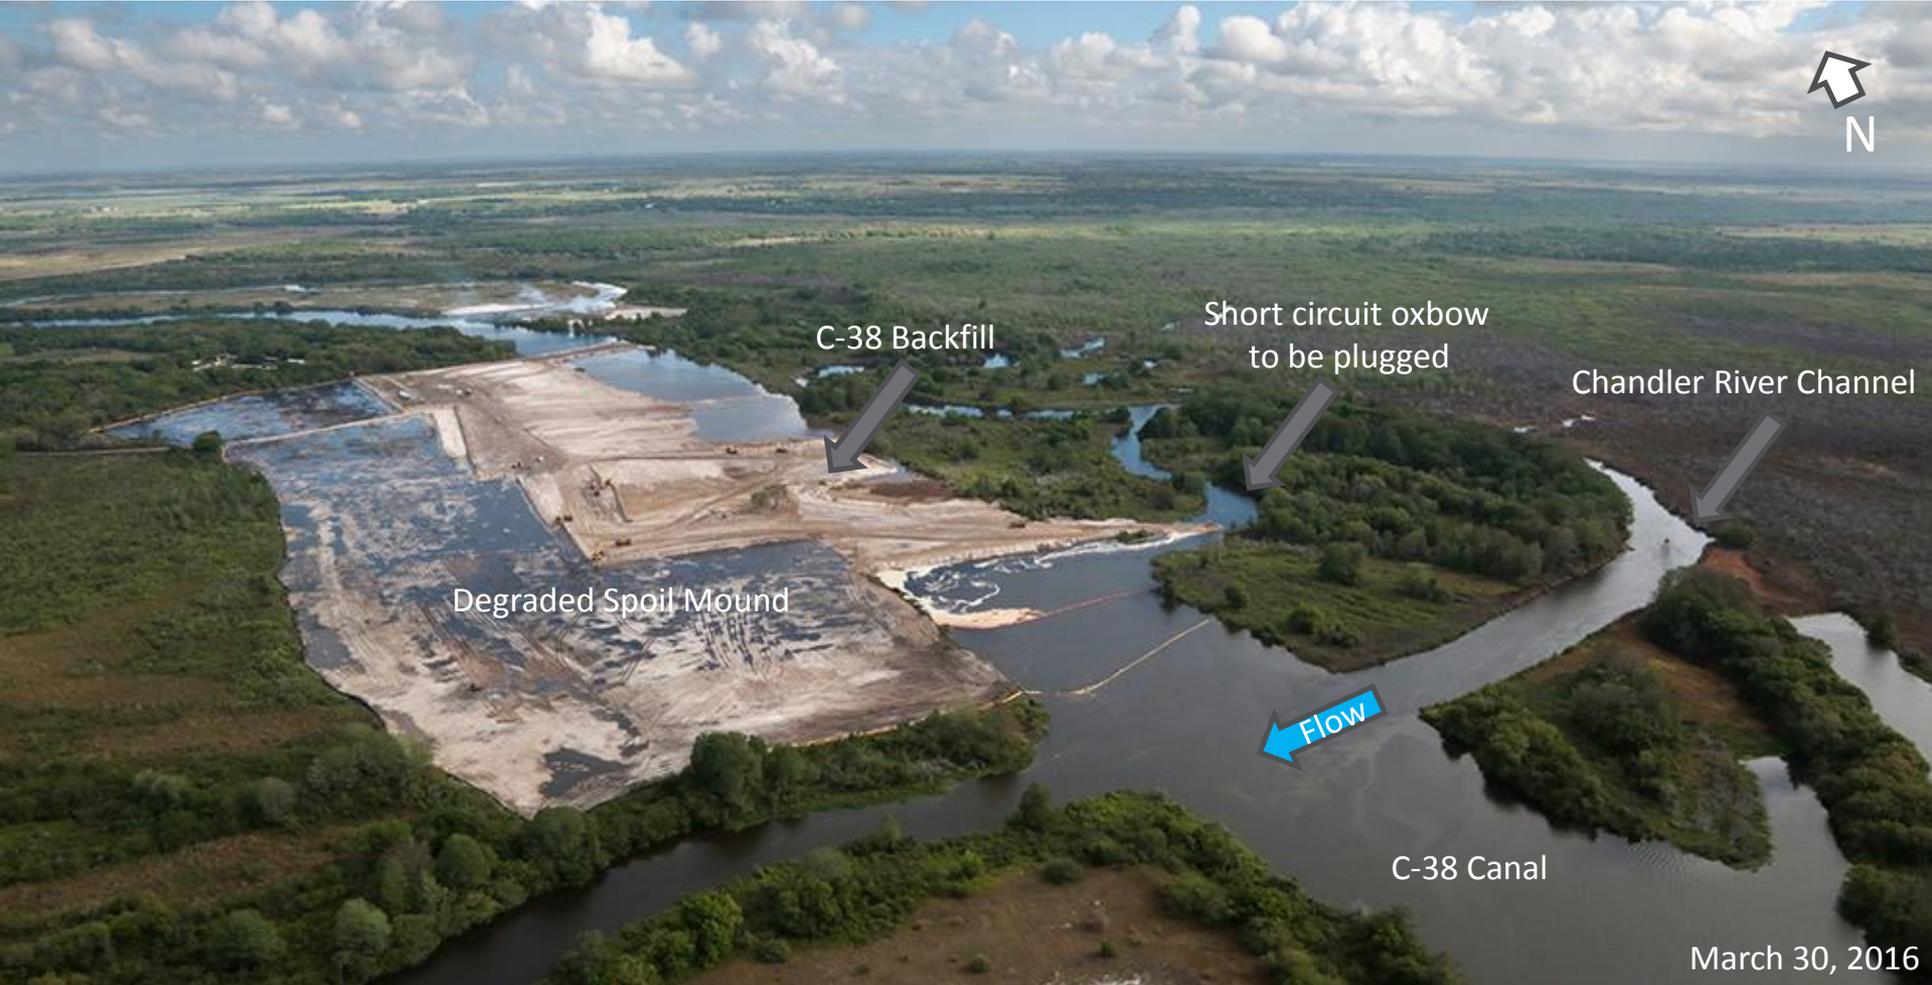
Looking north at Reach 3 restoration area. Contractors are constructing a plug across the short circuit oxbow to divert flows through the main Chandler River Channel.
