SOUTH FLORIDA WATER MANAGEMENT DISTRICT

Quarterly Communications Meeting on the Long-Term Plan for Achieving Water
Quality Goals for Everglades Protection Area Tributary Basins

STA-3/4 Inflow Diversions for Submerged Aquatic Vegetation Re-Establishment, July-August 2011

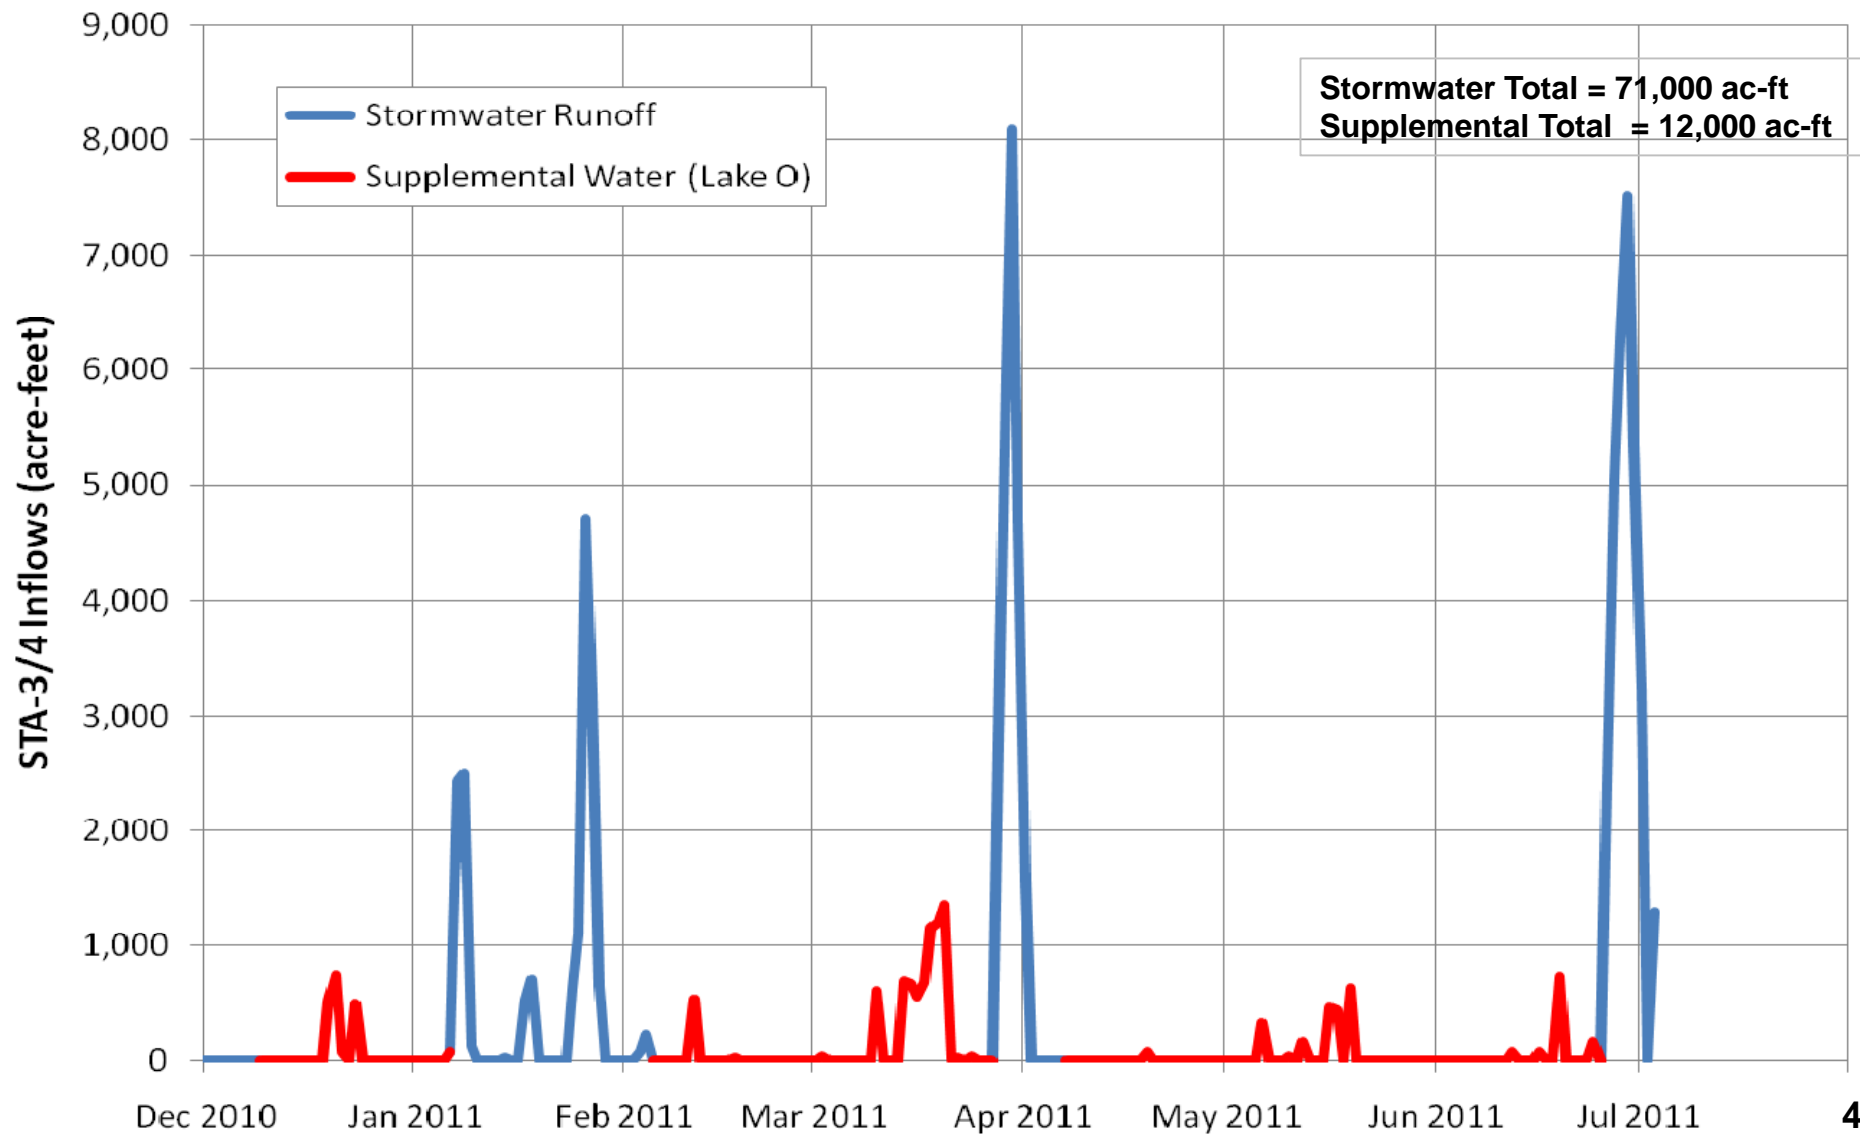
STA-3/4 Inflows

December 1, 2010 – July 3, 2011

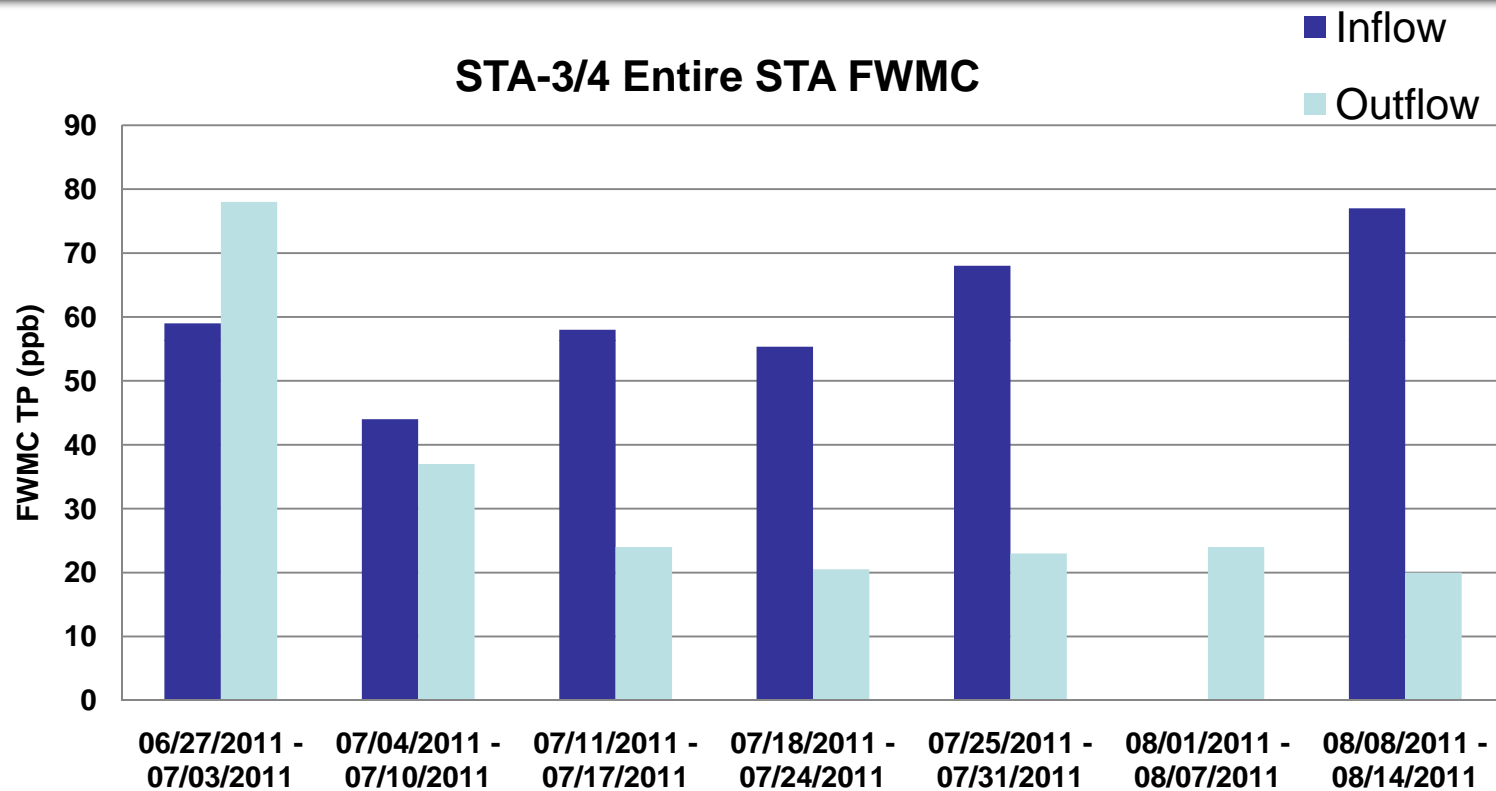
STA 3/4 Inflow and Outflow Concentrations

Flow (ac-ft)	Load (tons)	FWMC (ppb)
STA-3/4 Inflow	53,454	3.7	55.6
STA-3/4 Outflow	80,579	4.1	41.7
G371 + G373	65,042	6.9	86.0

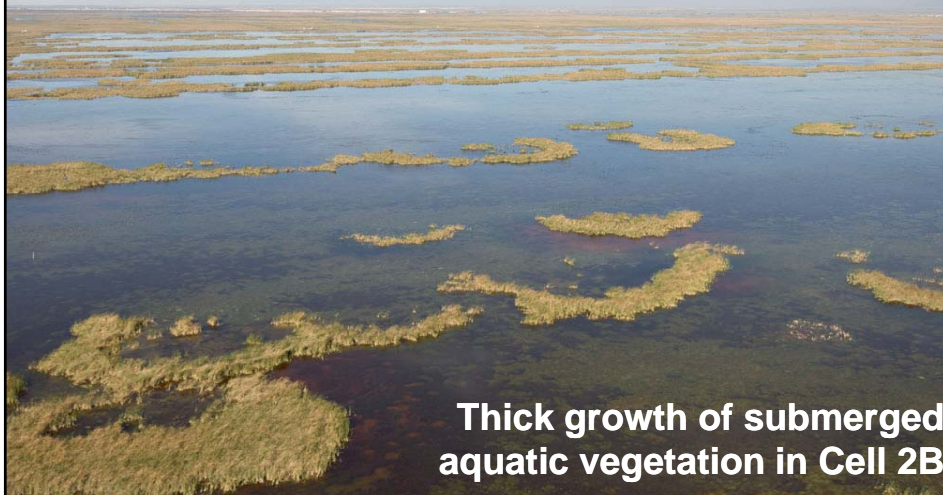
1/27/11

Thick growth of submerged aquatic vegetation in Cell 2B

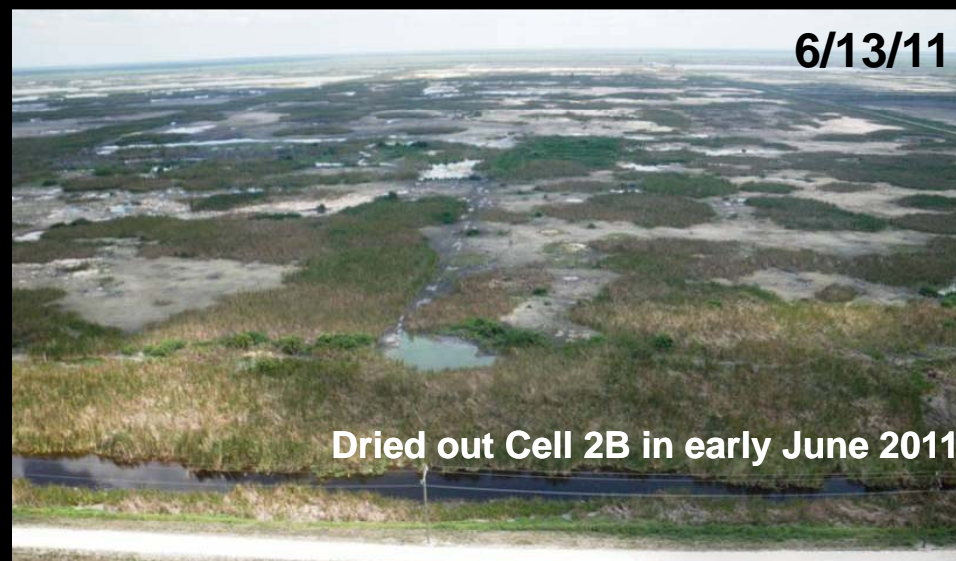
6/13/11

Dried out Cell 2B in early June 2011

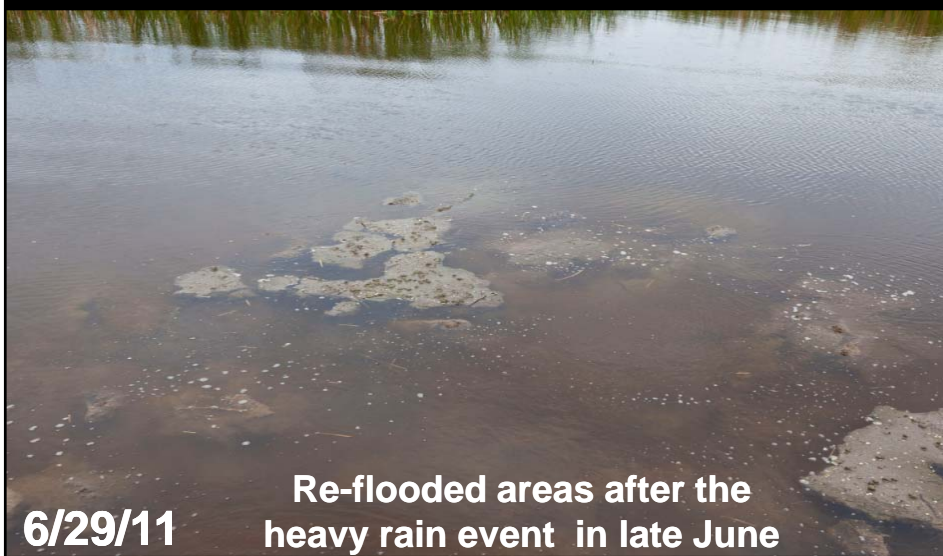
6/29/11

Re-flooded areas after the heavy rain event in late June

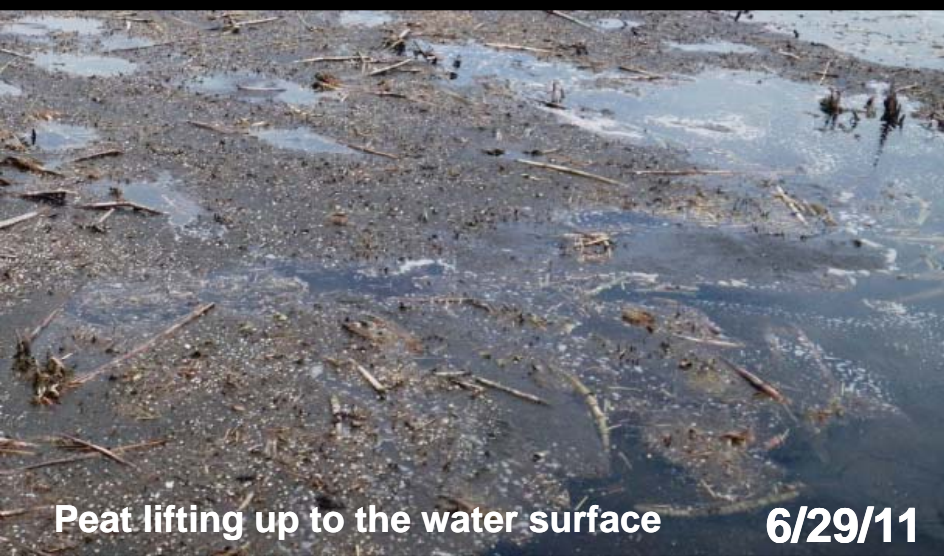
6/29/11

Peat lifting up to the water surface
