Stormwater Treatment Areas Water Year 2014 Performance

Water Quality Treatment Technologies

Long-Term Plan Meeting, May 20, 2014

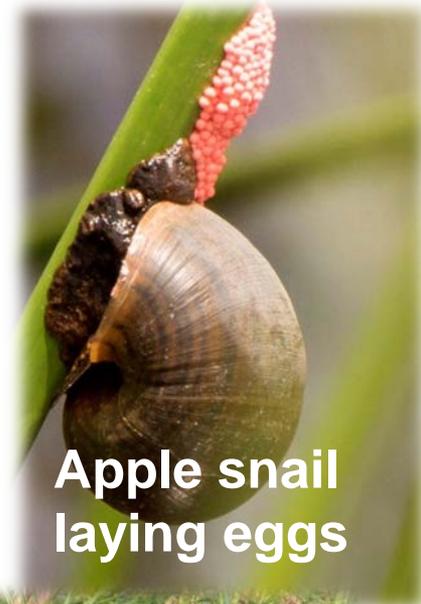
Apple snail laying eggs

- Large number of exotic Apple Snails in STA-1E Cell 4S
- Significant loss of SAV due to foraging
 - Leaves stripped from stems
- STA performance negatively affected
- Multidisciplinary team formed to identify causes for snail population explosion & management options

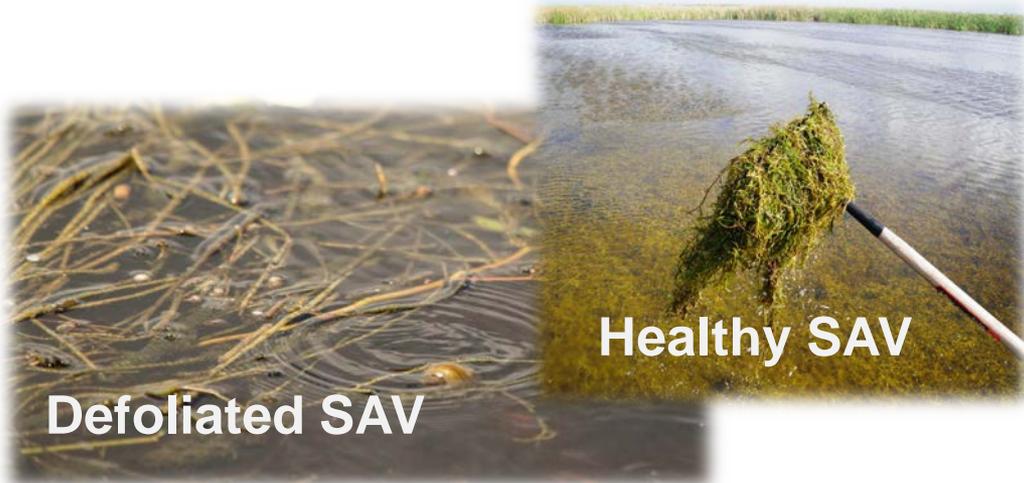
Defoliated SAV

Healthy SAV

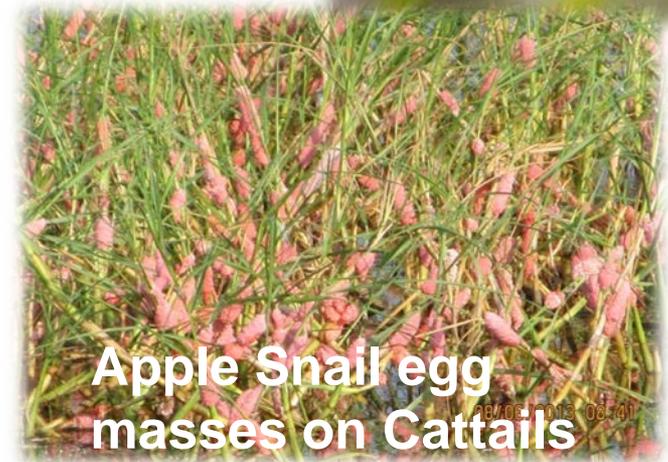
Apple Snail egg masses on Cattails
