Post-Storm Vegetation Assessment in the Everglades Stormwater Treatment Areas

15th Annual Public Meeting on the Long-Term Plan for
Achieving Water Quality Goals for Everglades Protection Area
Tributary Basins

February 23, 2018

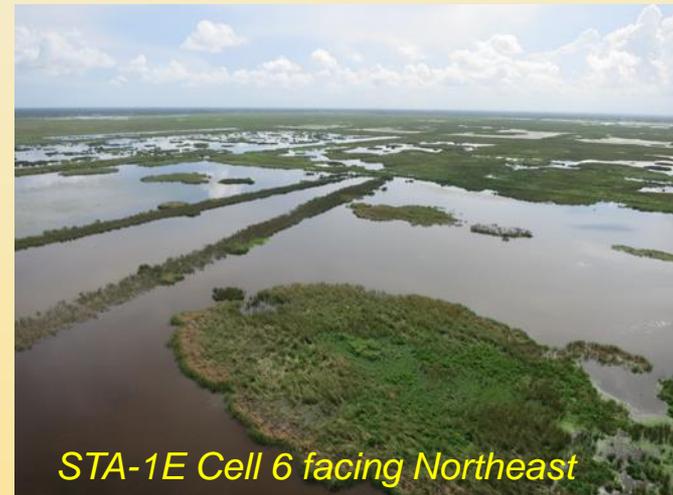
STA-1E Cell 6 Water Depths and Conditions

9/12/17

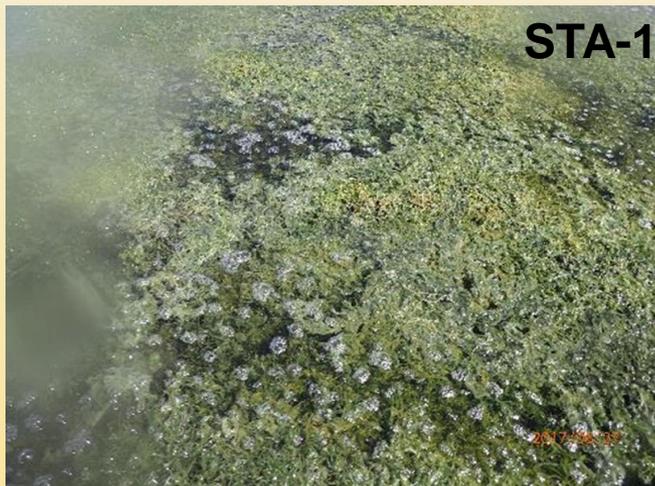
STA-1W Cell 2B

6/27/17

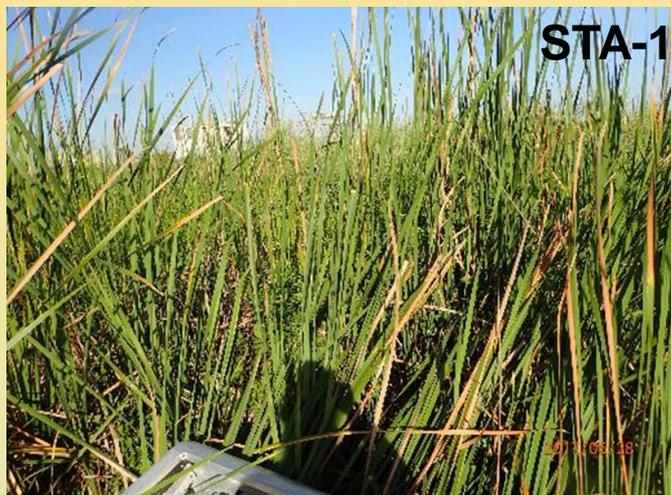
STA-1W Cell 4

6/28/17

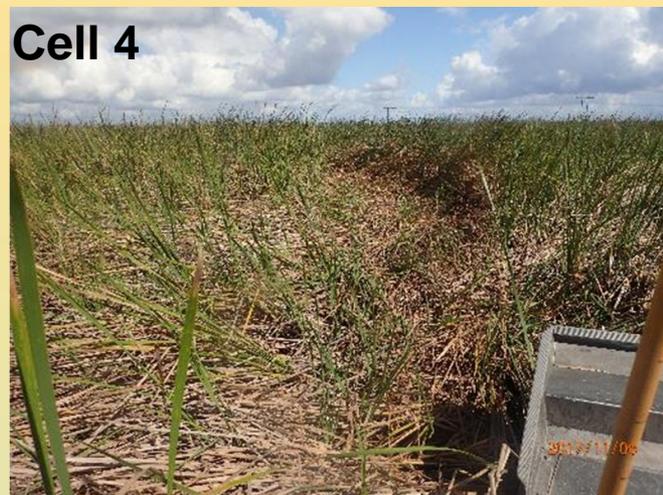
11/6/17

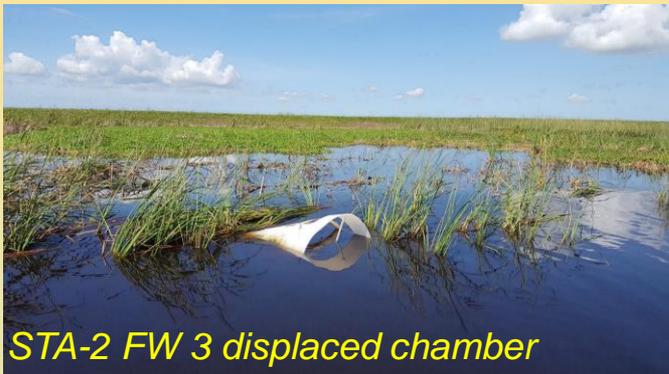
STA-2 Flow-way 3

- Post June rain effects-
 - High water and highly turbid conditions
 - Further declines in SAV
- Post Irma effects-
 - High water and highly turbid conditions
 - Further declines in SAV
 - Impacts on vegetation strips

STA-2 FW 3 displaced chamber

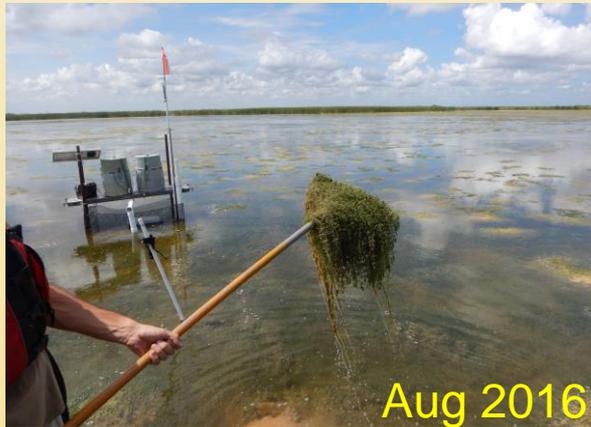
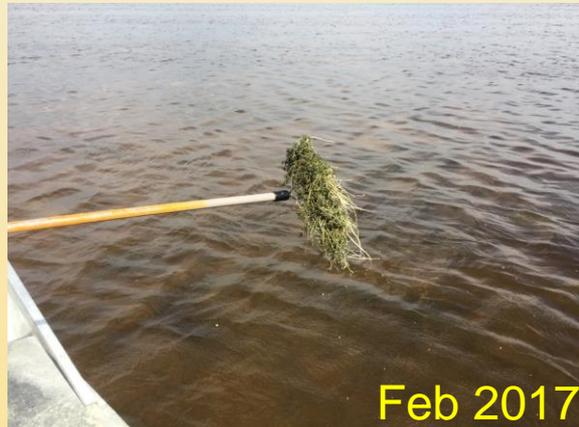
Pre-storm conditions

- SAV coverages excellent pre-storm events
- Primarily *Chara* and *Najas marina*
- Post-storm conditions-cell wide loss of SAV

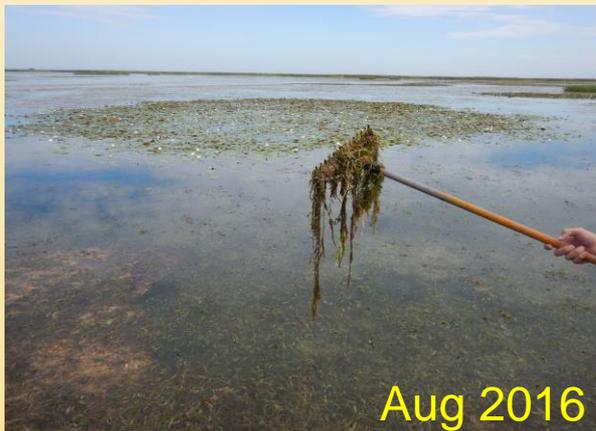
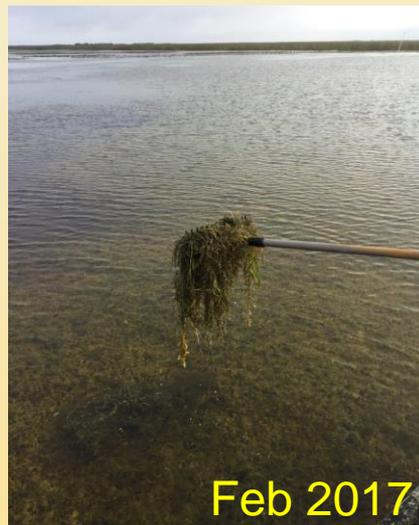
Pre-storm conditions

- Pre-storm conditions-
higher
coverages/densities
and diversity of species
- Post-storm conditions-
coverages/densities
substantially reduced

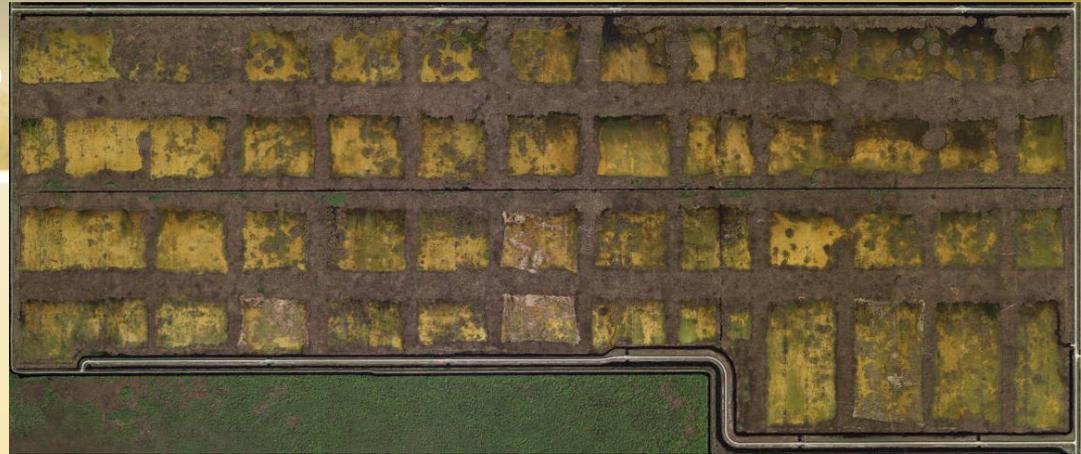
STA-3/4 Cell 3B

- SAV cell
- Dominant species: *Chara*, *Najas guadalupensis*
- Other species present: *Najas marina*, *Ceratophyllum*, *Utricularia*
- Historically high coverage of *Chara* throughout cell

- Gradual decline of overall coverage from Oct 2016 to March 2017
- Most significant decline after rains and after Irma
- Front end impacts
- Other species only found in one place and low coverage

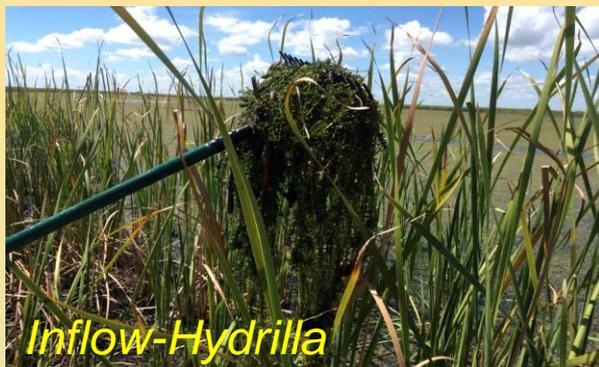
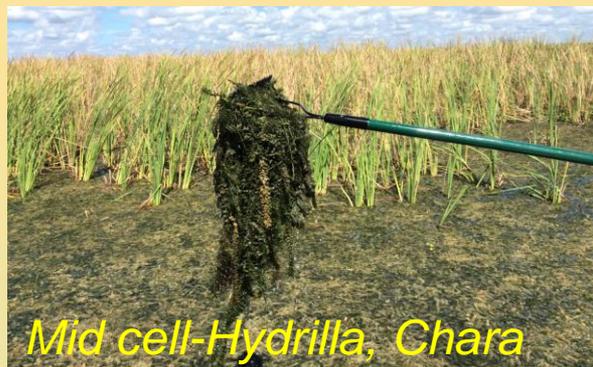
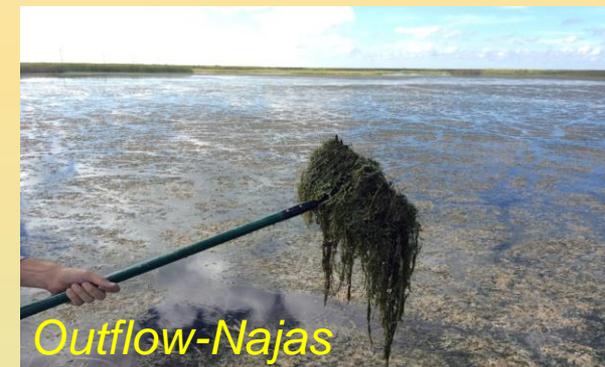
STA-5/6 Cell 1B

- SAV Cell
- Historically dominant SAV species: *Hydrilla*
- High to medium coverages of SAV throughout cell
- Other species: *Ceratophyllum*, *Najas*, *Chara*
- Photos from Sept. 2016 Survey

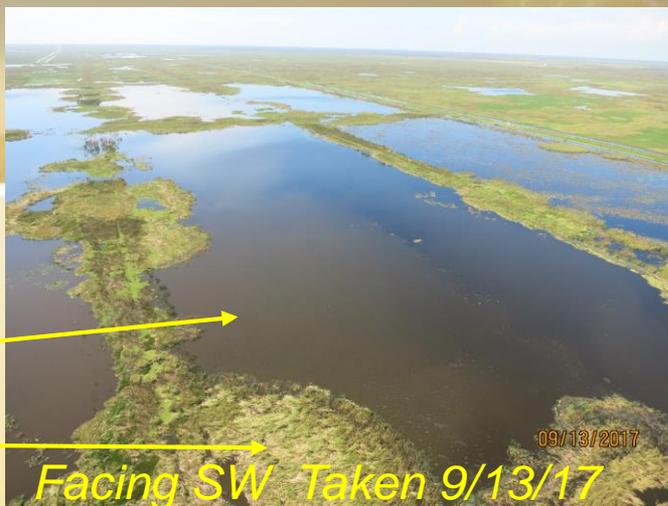
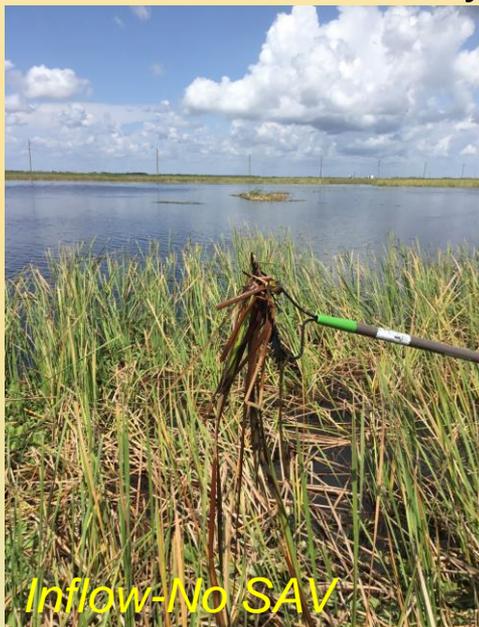
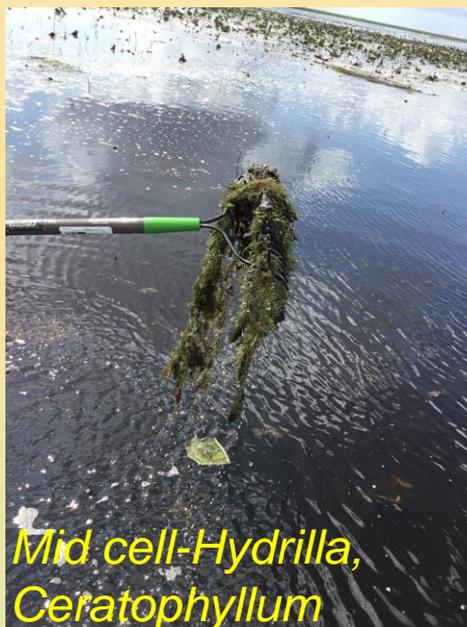
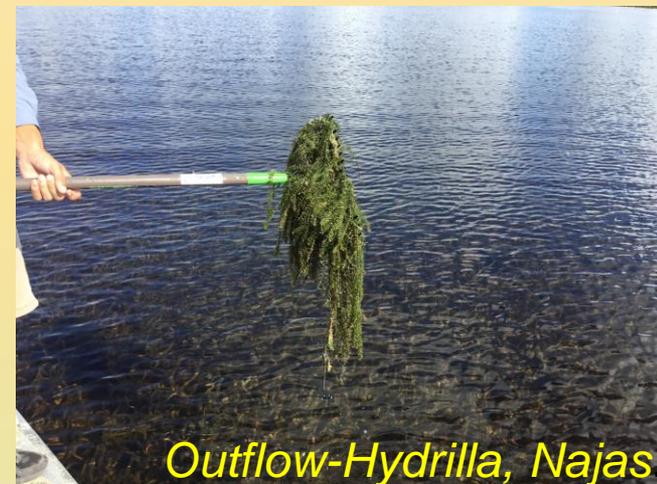
STA-5/6 Cell 1B

■ Post Irma Conditions

- Turbid conditions
- Cattail laid down
- Substantial loss of SAV
- Post-Irma survey 9/14/17
