## Chapter 4 FIGURES

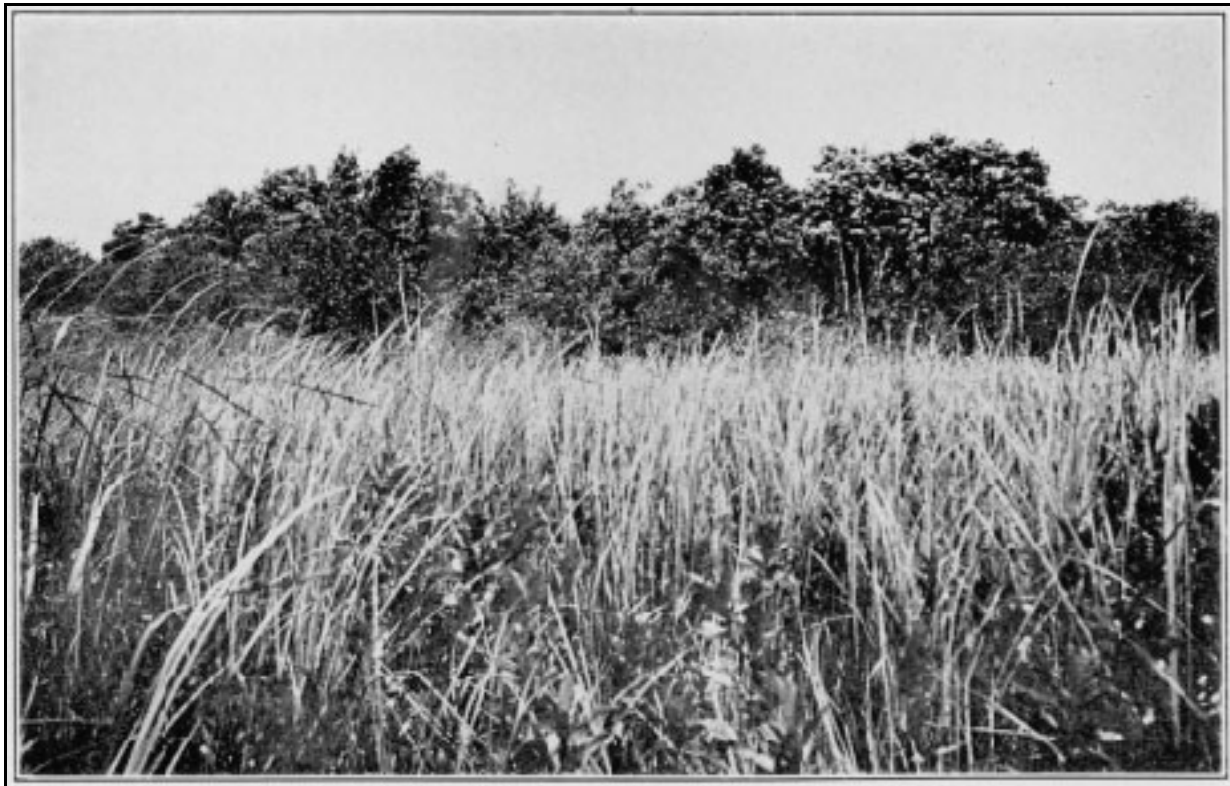
**Figure 4.6** “Tall saw-grass of Everglades and everglade hammock [tree island] at head of the Miami River, August 12, 1912. Original” From Harshberger (1914); in text location is given as “a few kilometers west of the head of the Miami River.” This figure can be thought of as a close-up of the Everglades seen in the background of **Figure 4.5**. Used by permission of the Wagner Free Institute of Science, Philadelphia, PA.

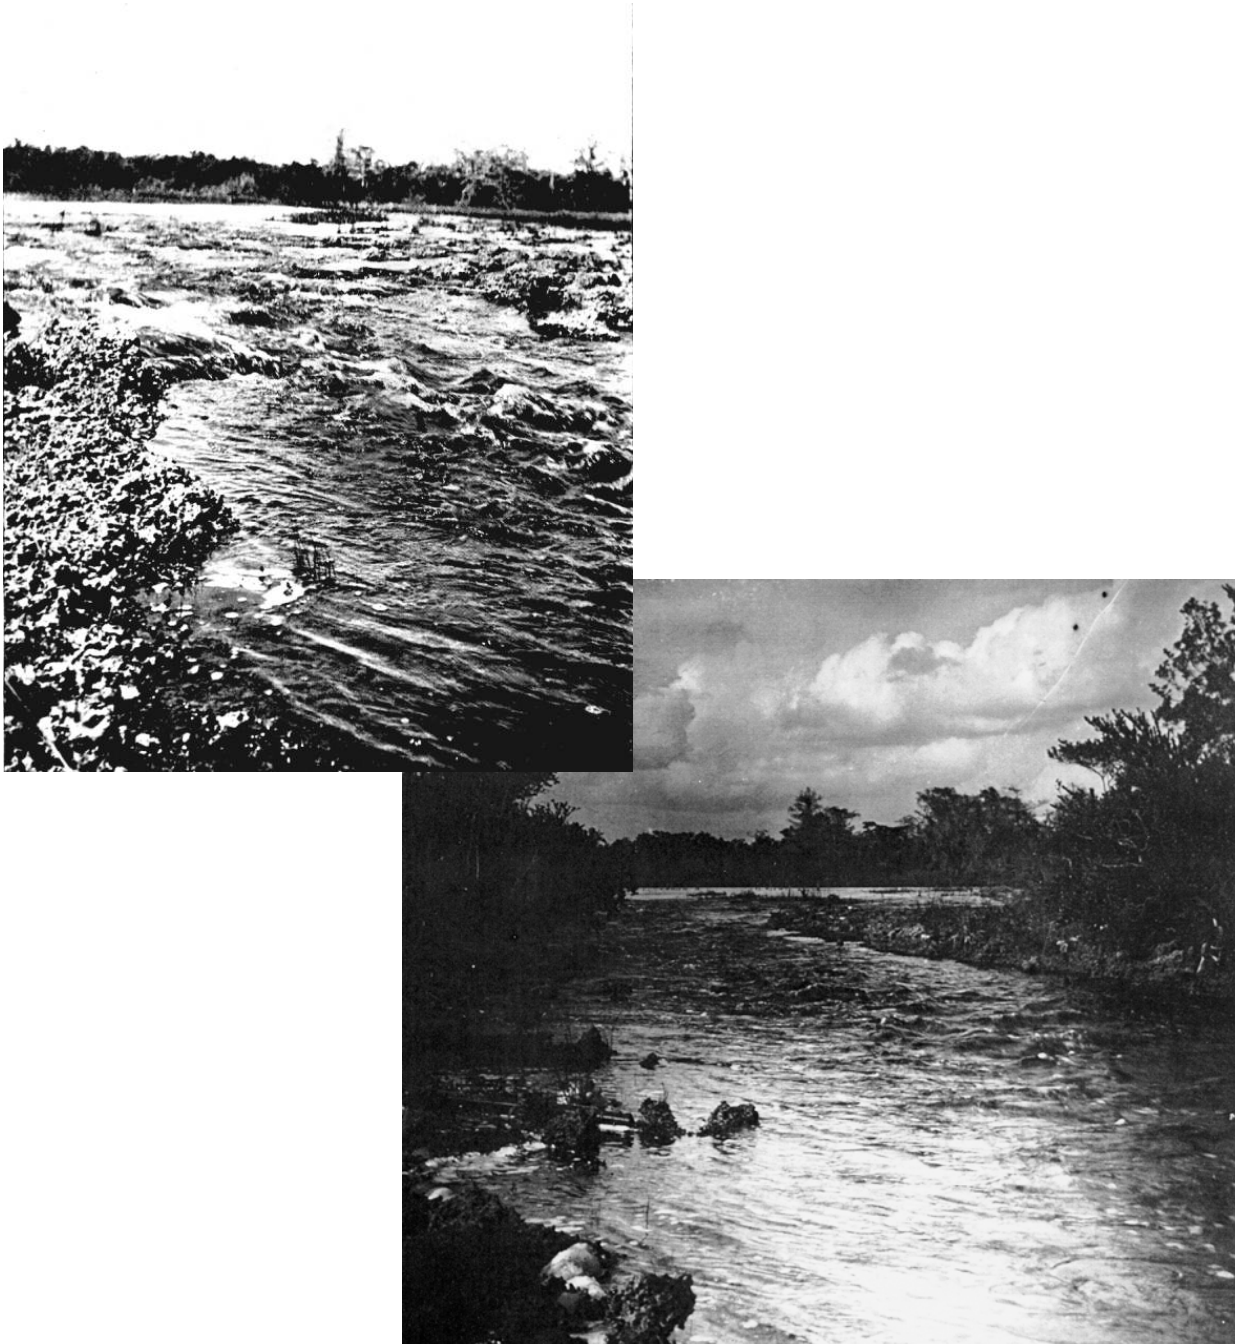
**Figure 4.7** Falls of the Miami River. “These rapids fell about 6 feet in the course of some 450 feet.” (Gaby, 1993). Though hidden in trees, location of these falls is included in the upper left of **Figure 4.5**. Photograph (upper left) dated 1896; courtesy of the Florida Photographic Collection. The rapids on the Miami River, ca. 1890 (lower right) photographed by Ralph M. Munroe. Used by permission of the South Florida Historical Association.

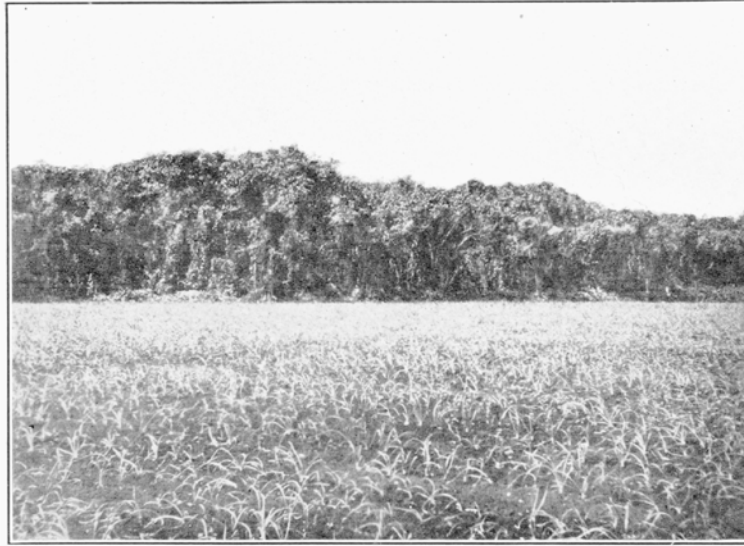
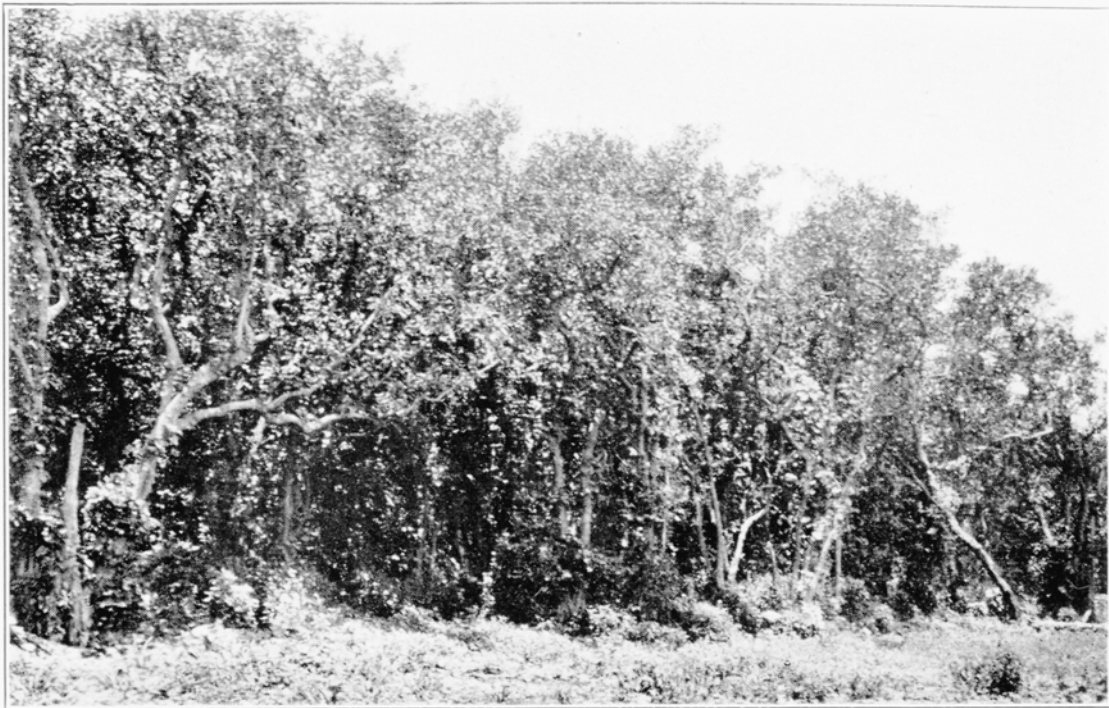
**Figure 4.10** Custard-apple forest: the transition between Lake Okeechobee and the Everglades. Top: “Onions on Muck. Custard Apple in Background. South Shore of Lake Okeechobee [in 1915].” From Baldwin and Hawker (1915). Bottom: “Custard-apple forest, south shore of Lake Okeechobee, June 22, 1912. Original.” From Harshberger (1914); used by permission of the Wagner Free Institute of Science, Philadelphia, PA.

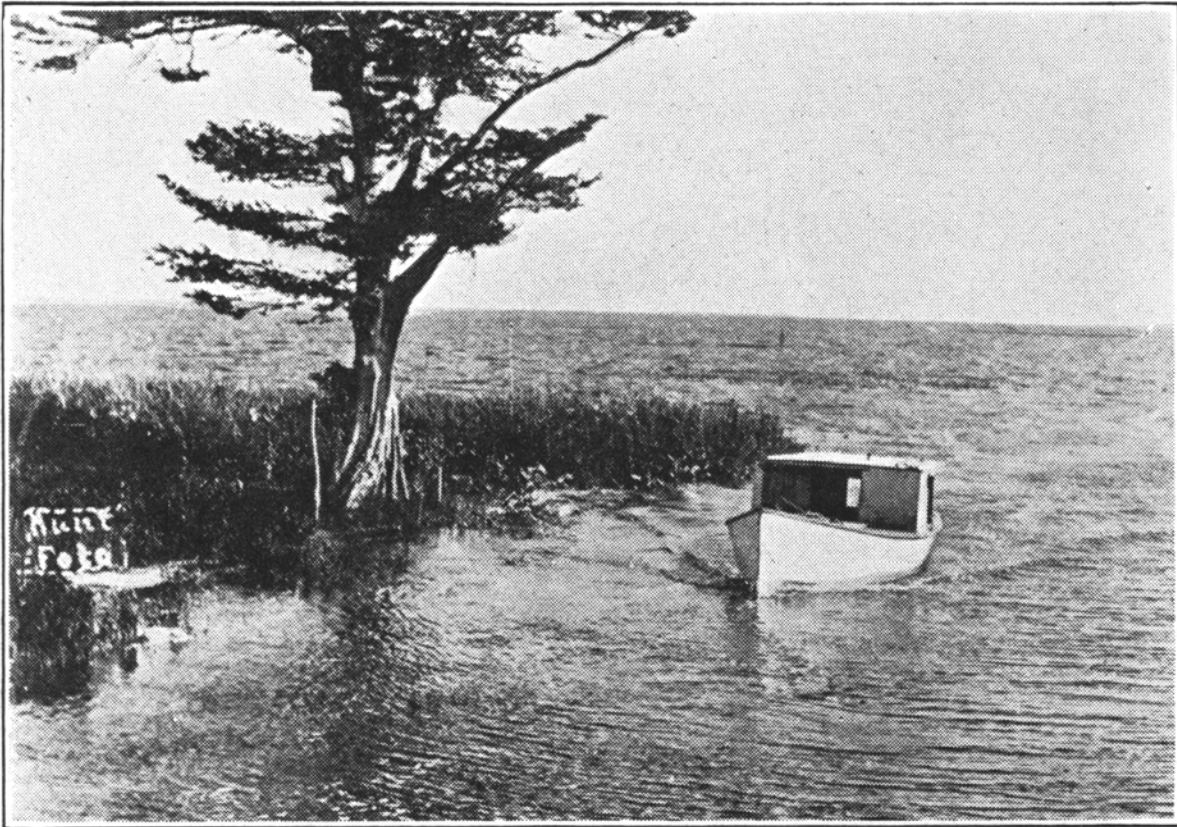
### OUTLET OF LAKE OKEECHOBEE IN 1911.

The cypress tree was for years a landmark for mariners leaving the lake. This spot is now the site of Moore Haven, 12 miles inland from the present waters of the lake.

**Figure 4.14** Southwest shore of Lake Okeechobee in 1911 (Northeast corner of Township 42 Range 32). As late as 1892, the Sawgrass Plains in this area near Lake Hicpochee formed a shallow, indistinct border with the lake, 20 miles long. Waters of the lake and of the Sawgrass Plains were distinguished only by a slight difference in elevation. C.f. Fig. 4.14. Reproduced from Blatchley (1932).

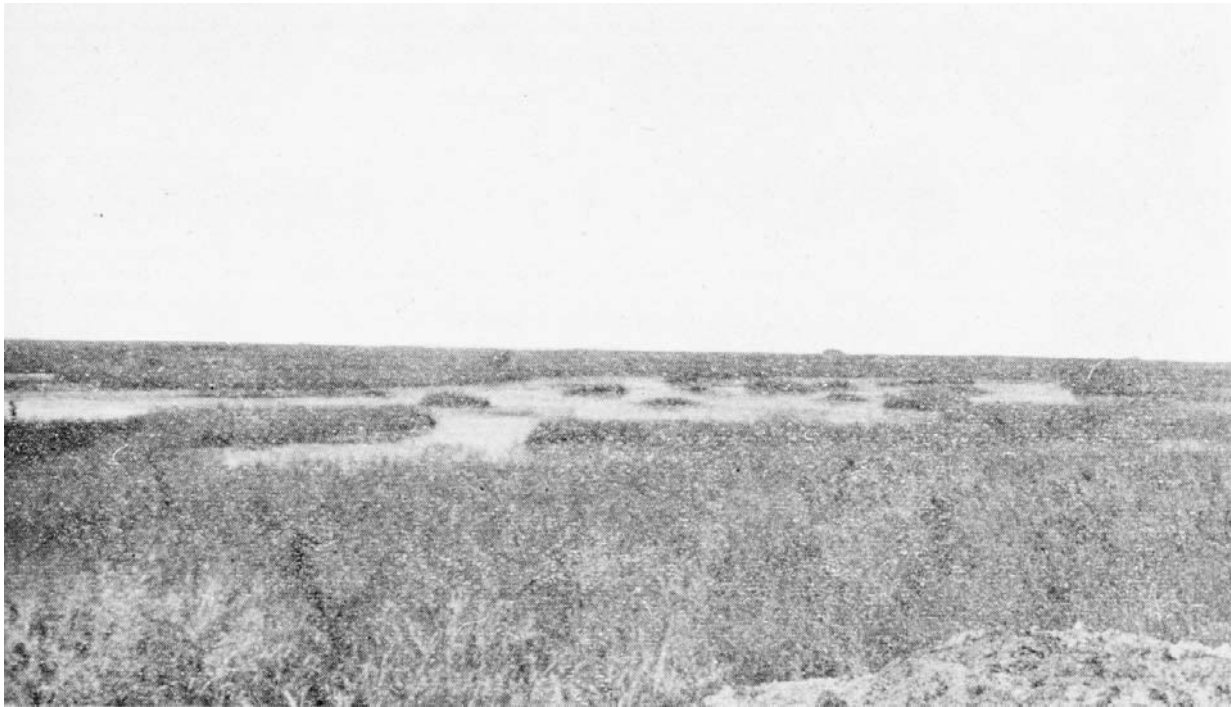
**Figure 4.15** Ridge and Slough landscape, west of Fort Lauderdale, ca. 1911. Sawgrass ridges (dark gray) with distinct edges rise above open water of the sloughs (light gray). Location is likely T 50, R40 or R41. Landscape pattern appears to be similar to **Plates 23, 24, 25 , and 27**, taken further south. Photo by H. Gunther taken from dredge “Okeechobee.” Reproduced from Sellards (1912).

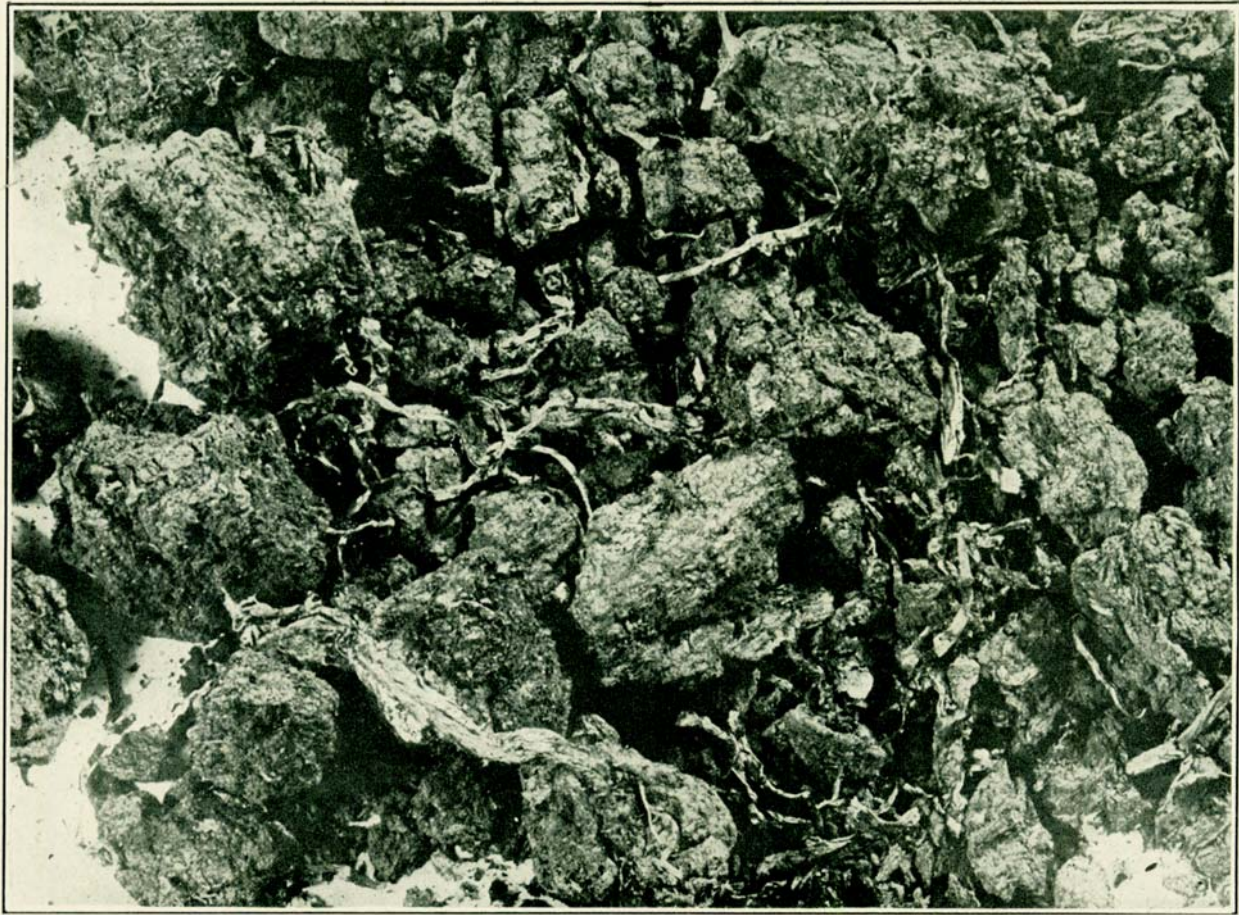
**Figure 4.17** Brown Fibrous Peat. The light, fibrous or felty character and corky texture of the Brown fibrous peat, representative of hundreds of square miles of the Everglades, can be seen in this illustration.” (Baldwin and Hawker 1915, Plate V). In 1915, Brown fibrous peat was mapped across both the Ridge and Slough, as well as the Sawgrass Plains landscapes, from within a few miles south of Lake Okeechobee to a few miles west of the head of the New River. The separation into two different soils, Everglades and Loxahatchee Peats (Jones et al. 1948), did not occur until 1930-1940, when drainage had already oxidized the Brown fibrous peat of the Sawgrass Plains area (c.f. **Figure 3.19**).

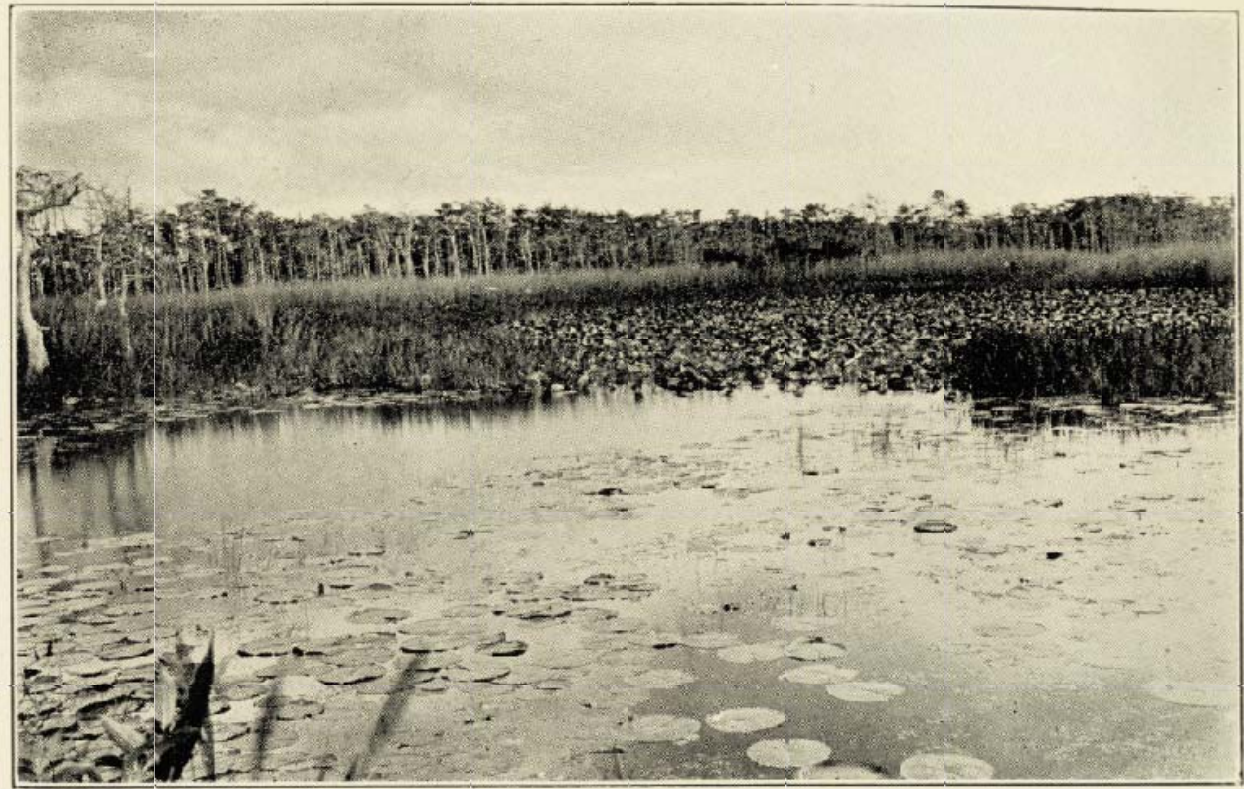
**Figure 4.27** “Cypress swamp and marsh vegetation with open lagoons covered with water lilies, August 11, 1911, west of West Palm Beach. Original.” Photograph taken within the Eastern Flatwoods area, prior to formation of the Lake Worth Drainage District. Together with the West Palm Beach Canal, this District lowered regional water tables by ca. six feet (Austin et al. 1977). Source: From Harshberger (1914). Used by permission of the Wagner Free Institute of Science, Philadelphia, PA.

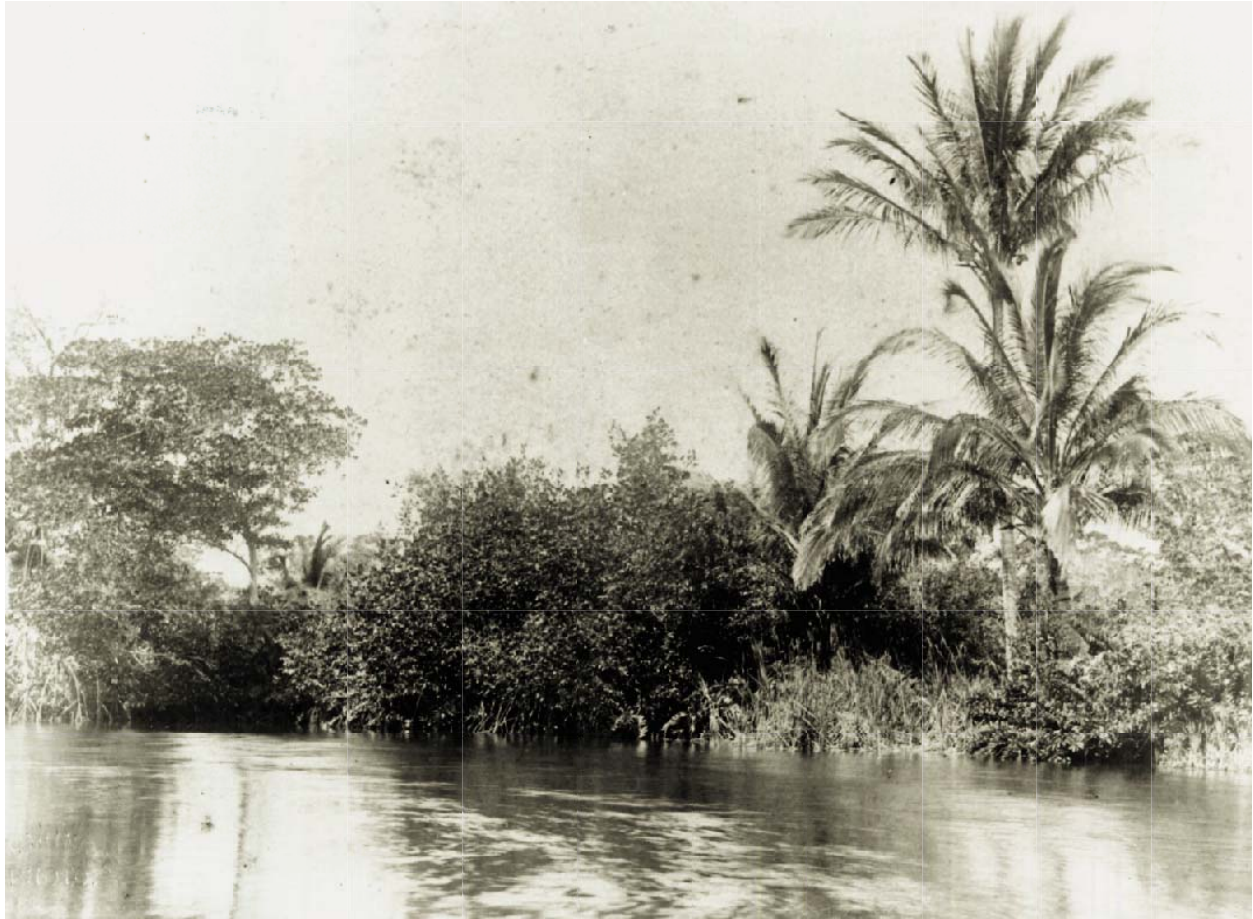
**Figure 4.28** Little River in the 1890s. An expedition by canoe in January 1841 described a trip upstream: “After passing up the bay seven miles, they entered the mouth of Little River, a tortuous and extremely rapid outlet from the Everglades, where they struggled against the current until after midnight, when they reached their first resting-place-the site of an old plantation-where they landed.” (Brooks 1880). Non-native coconut trees indicate a place of settlement. Photograph by Ralph M. Munroe. Source: Used by permission of the South Florida Historical Association.

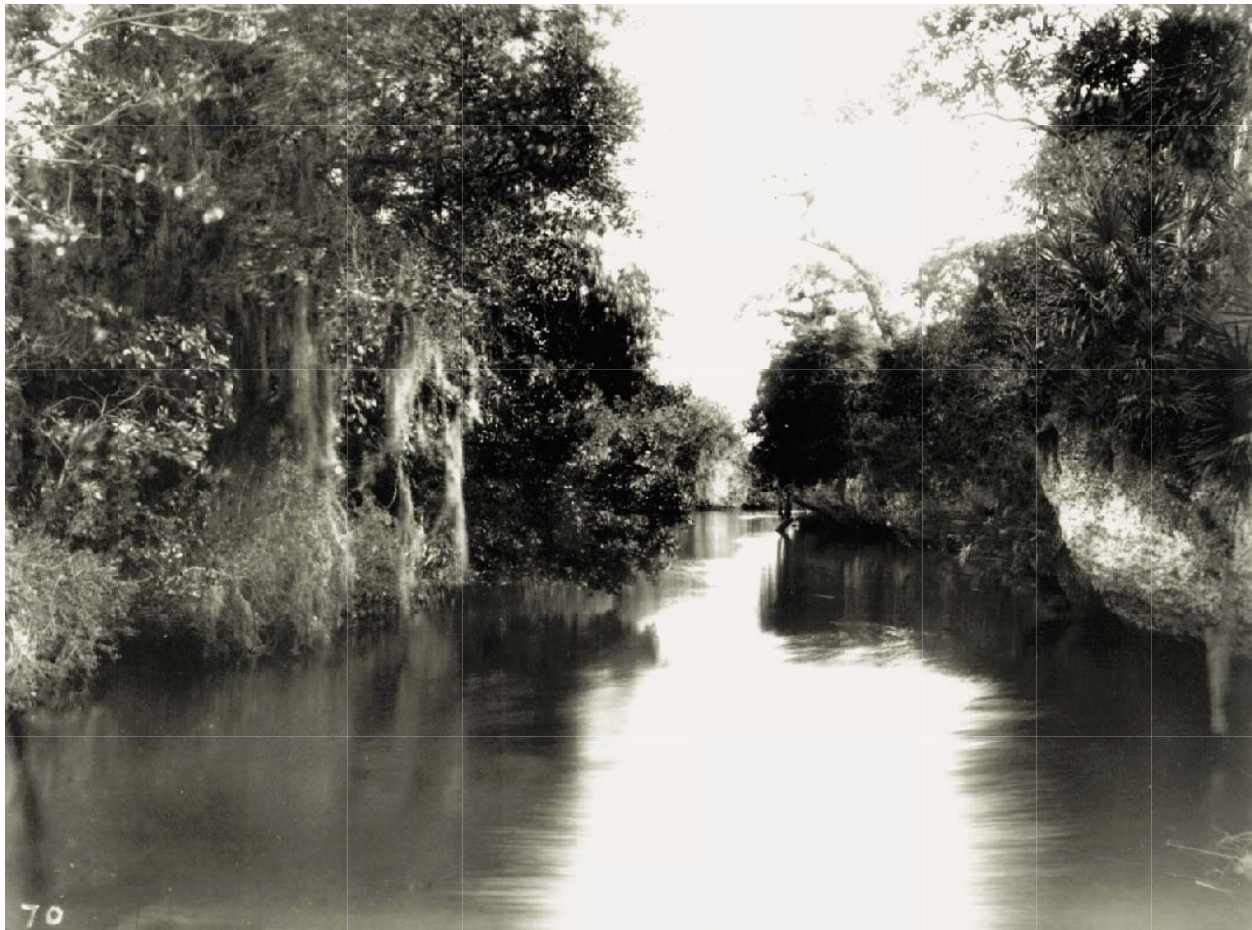
**Figure 4.29** Arch Creek in the 1890s. “The most romantic scene of all was the view from the natural bridge looking up the creek as it continued on to the Everglades, two miles beyond.” (Parks 1977). In 1858, Mr. George Lewis and Mr. Robert Fletcher spent a year attempting to construct a water-powered coontie mill using a ditch diverted from Arch Creek (Dietrich 1987). MacKay and Blake (1839) indicate “Rapids” at the head of Arch Creek. Photograph by Ralph M. Munroe. Used by permission of the South Florida Historical Association.

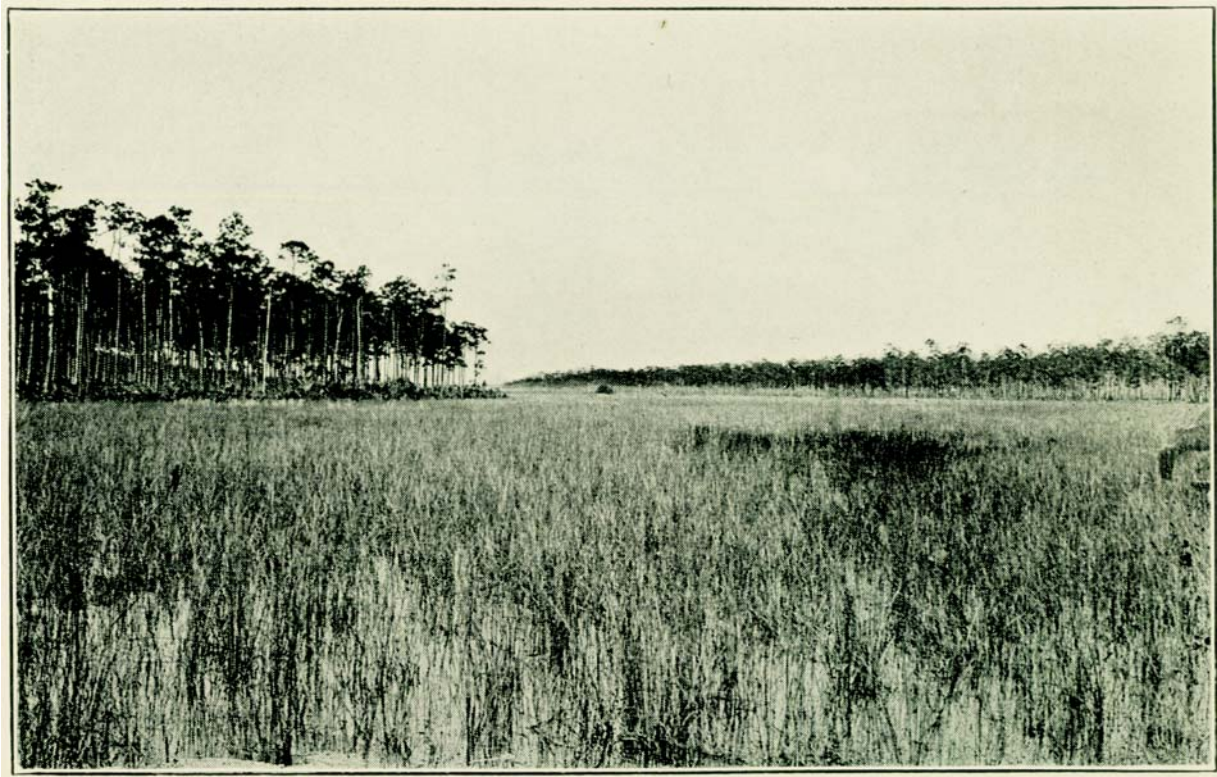
**Figure 4.30** A Marl Transverse Glade in the Everglades Keys. “Transverse marl prairie bordered on both sides by tall pine forest [Everglades Keys] near Princeton, Fla. August 18, 1911. Original.” Vegetation in glade still appears to be sawgrass in water, as it was 60 years earlier (Jackson 1847-T56 R39). From Harshberger (1914); Princeton was in section 23, Township 56 Range 39. Photo probably from section 10, T56 R39. Used by permission of the Wagner Free Institute of Science, Philadelphia, PA.

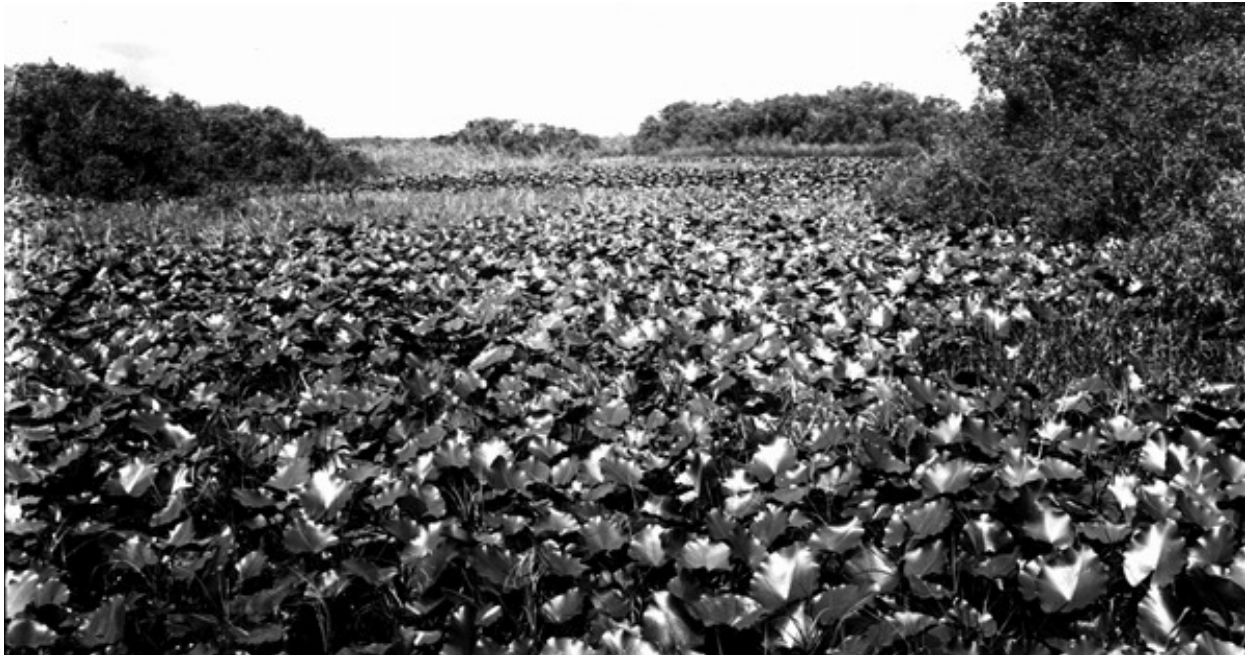
**Figure 4.34** “Deep slough in the Everglades east of Royal Palm Hammock. One of several sloughs that have preserved the hammock from the prairie fires of the Everglades. This channel is seldom perfectly dry. It supports a dense growth of yellow water-lily, pickerel-weed, and maiden-cane. It, like similar places in the vicinity, is a rendezvous for the native amphibians in the dry season. Its edges are fringed with saw-grass, common-reed, and small hammocks of low trees and shrubs.” Caption from Royal Palm Hammock Small, John Kunkel, 1869-1938. *Reclaiming the Everglades*. 8 p. Photographed east of Royal Palm Hammock, Florida. February 1916. Source: Florida Photographic Collection, J.K. Small Collection, courtesy of Florida State Archives.
