CHAPTER 3 EFFECTS OF DRAINAGE ON THE EVERGLADES, 1880'S TO 1940'S

CHAPTER 3 FIGURES

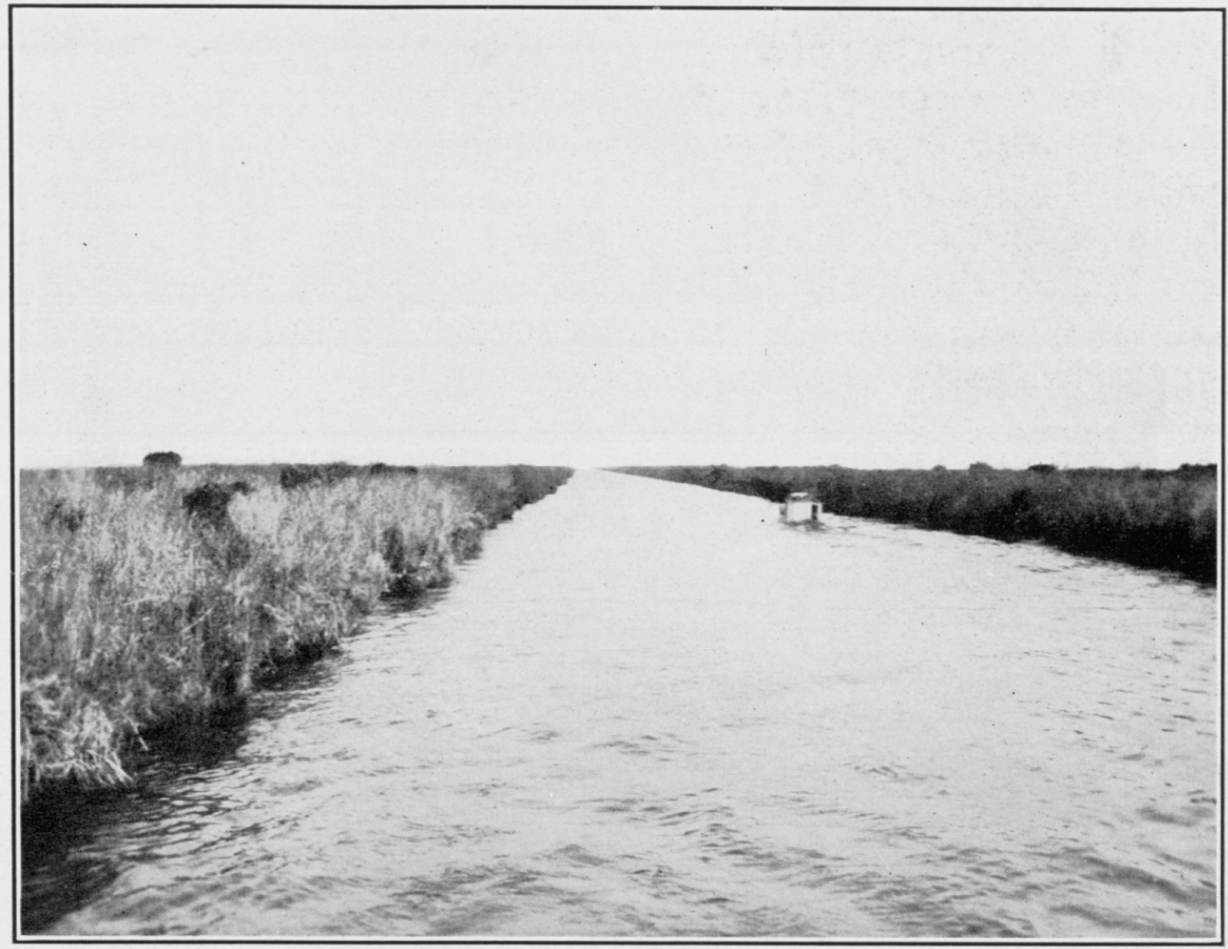
Figure 3.1 View of the North New River Canal, January-March 1915. Note absence of levees and closeness of water level to land surface. (Baldwin and Hawker 1915).

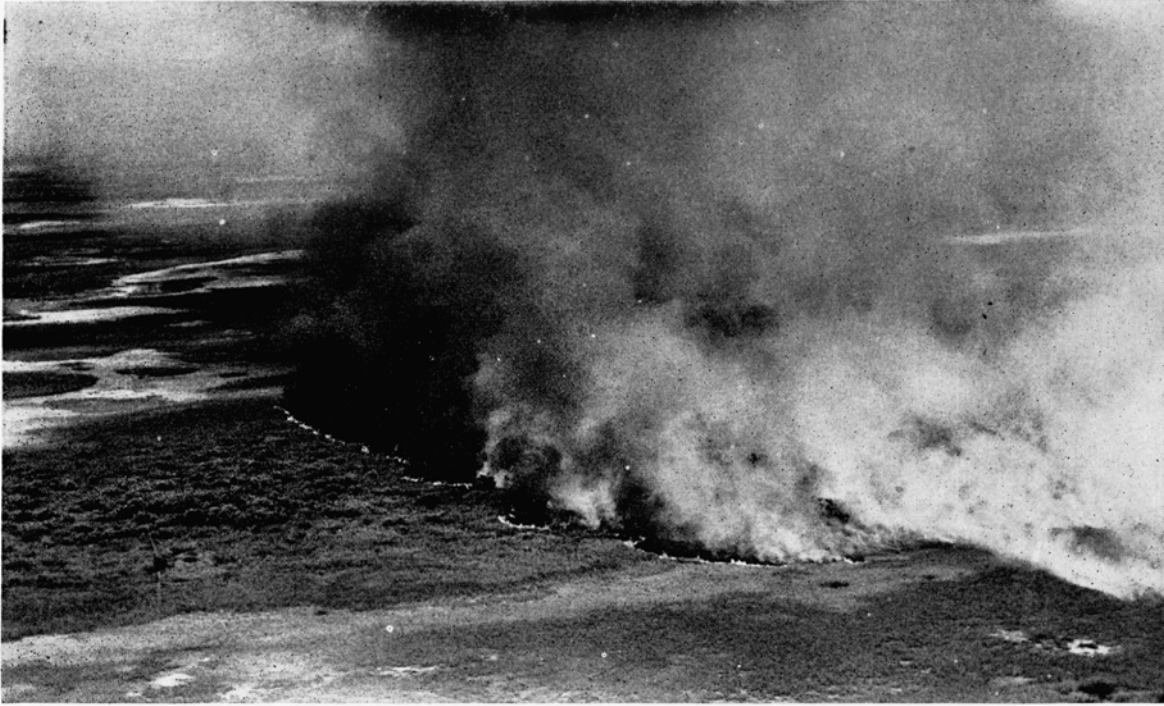
(Courtesy Miami Herald)
Fire in the Everglades burning peat, April 1944. Such fires occur frequently during the dry season and destroy some of the dry, surface peat. If the Everglades were more generously flooded such fires could be reduced and the peat saved.

Figure 3.17 An extensive peat fire, typical of the post-drainage Everglades during the 1920s to 1950s. Frontispiece of *The Peat Deposits of Florida* (Davis 1946).

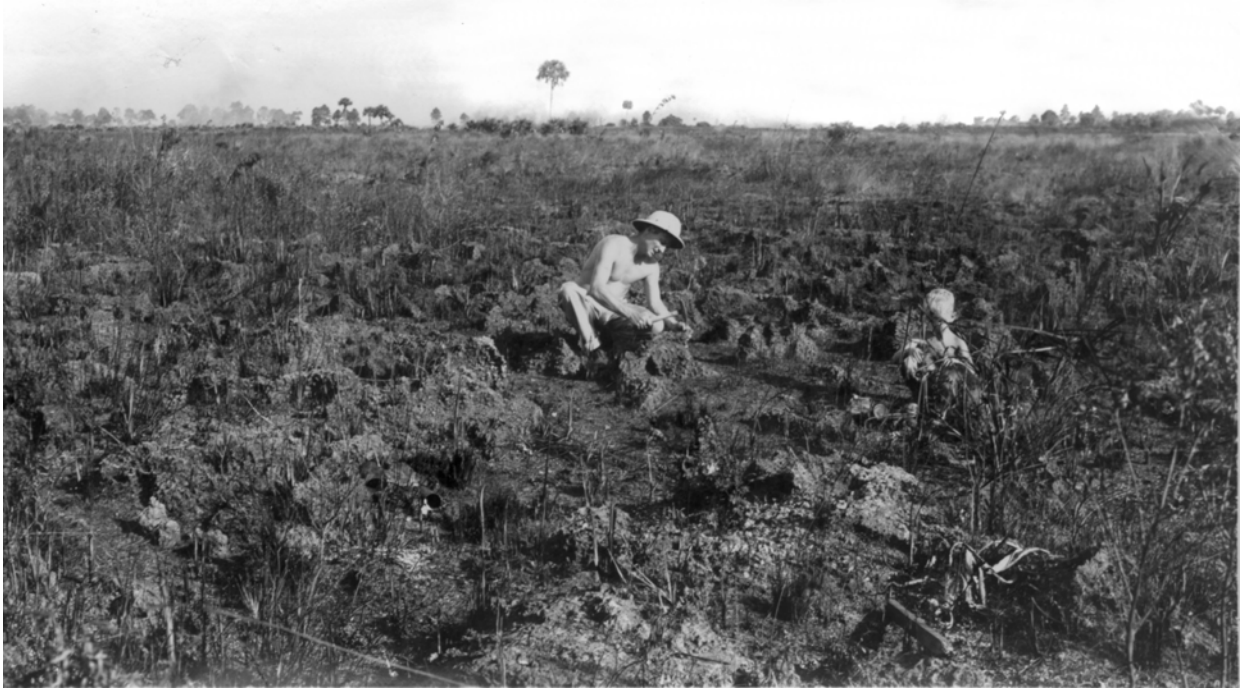
Figure 3.18 “Annual fires have burned off muck to reveal solution pitted top of Miami oolite.” Photo by Mrs. G.G. Parker, July 30, 1940. Location: Coral Way, ½ mile E. of S.W. 102 Ave, Miami (middle of the line between sections 8 and 17, T54 R40). Formerly Ridge and Slough landscape, near border with Rockland Marl Marsh (see **Plate 13**).
