STORMWATER TREATMENT AREAS: Applied Studies and Evaluations

**Technical Oversight Committee Update
September 14, 2011**

David Unsell, P.E.

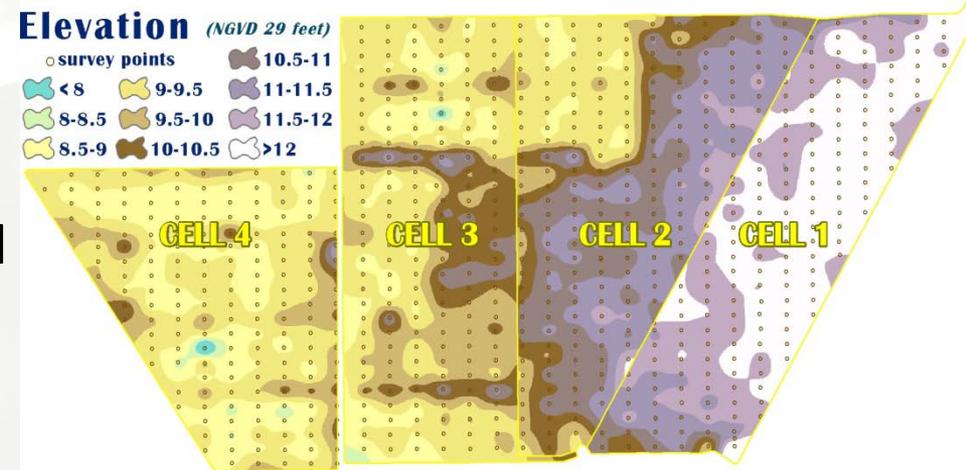
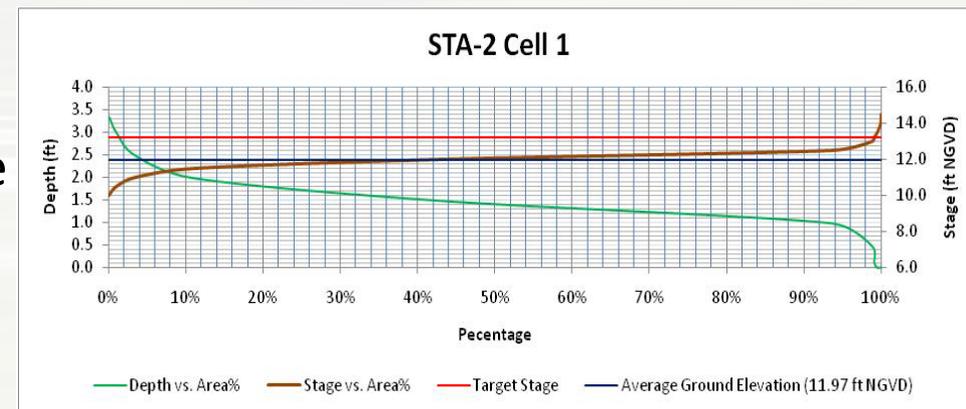
Topographic Surveys

- Survey results are used in setting the target stage levels for each cell, in identifying any areas with potential short circuiting issues, and in other hydraulic analyses
- Cells are surveyed during or after construction and all have been resurveyed after the cells were flooded
- In FY2010 topographic surveys were completed for STA-1W, STA-2, STA-5, and STA-6; final data analysis and report preparation are underway

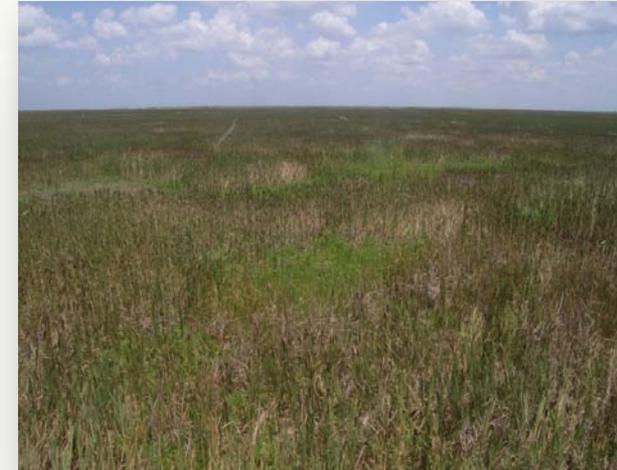
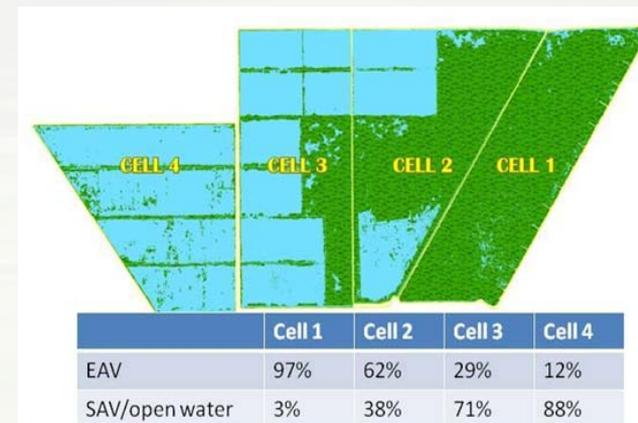
Vegetation Coverage Assessment Through Aerial Imagery

- In selected EAV cells, vegetation density analysis were done to assess temporal trend in cattail density
- 2010 aerial imagery – completed, analyzed, and included in 2012 SFER
- 2011 aerial imagery flight was completed in March, 2011; data analysis is underway
- Future goals include being able to relate coverage and density to STA performance, estimate phosphorus storage in biomass

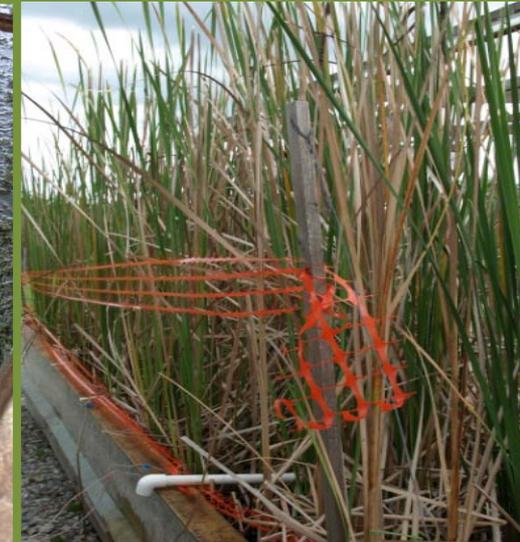
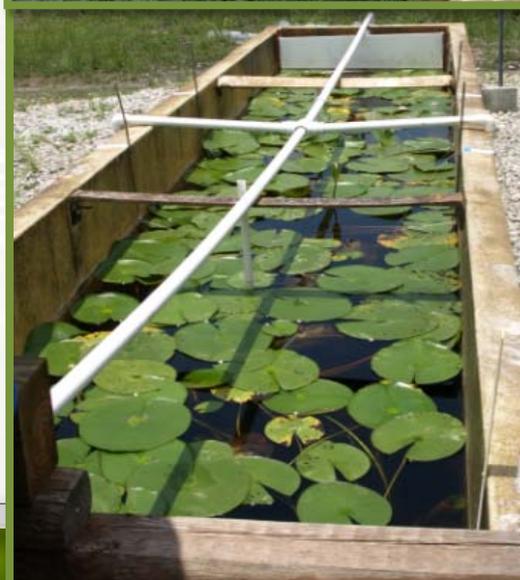
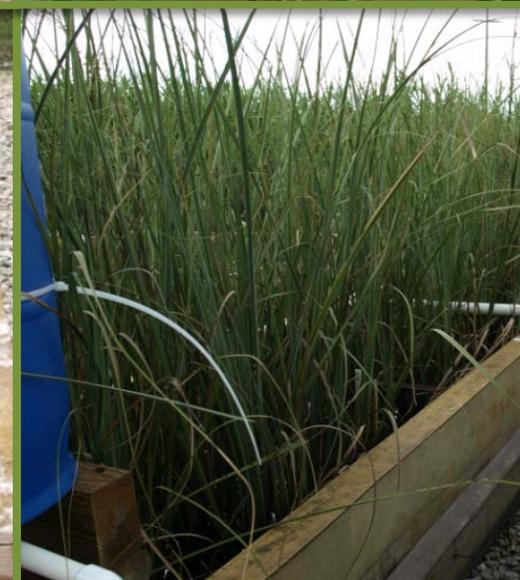
Evaluation of Optimal Plant Composition

- **A three year proof-of-concept study at a mesocosm scale**
- **Examines a variety of native aquatic macrophytes to further enhance the treatment performance of the STAs**
 - quantify P removal of water lily and sawgrass species and compare those with other common vegetation species in the STAs
 - determine the optimum water depth at which water lily and sawgrass achieve maximum P removal

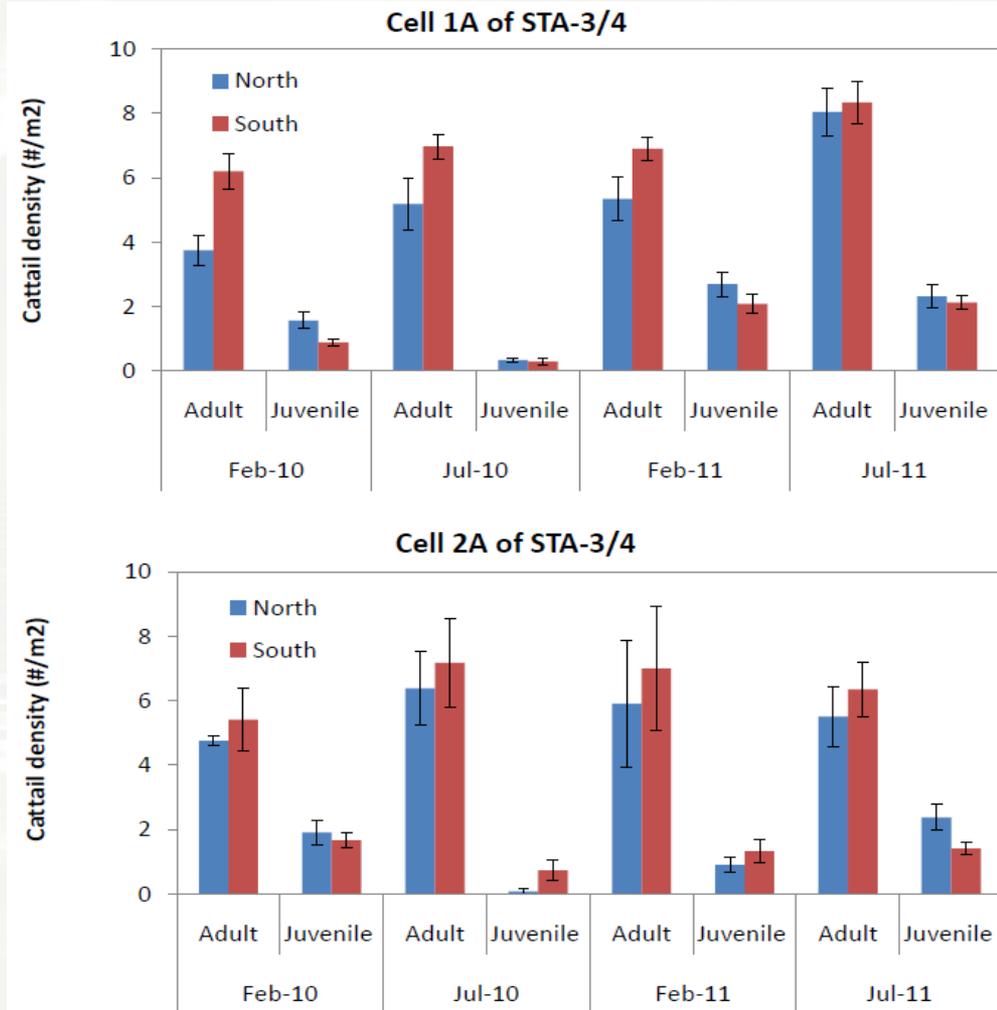
STA-3/4 Cattail Recovery

- Cattails impacted by chronic deep water condition
- Follow-up dewatering in March 2011, and continued until drought took its course
- Objective of study: assess the benefits of lowering water levels to recovery and re-establishment of cattail in an emergent cell
- Initial findings: Adult and juvenile cattail density is higher in July 2011 than in July 2010 in Cell 1A
 - Adult cattail density is slightly higher in Cell 1A than in Cell 2A in July 2011 but there was no big difference in juvenile density between those two cells

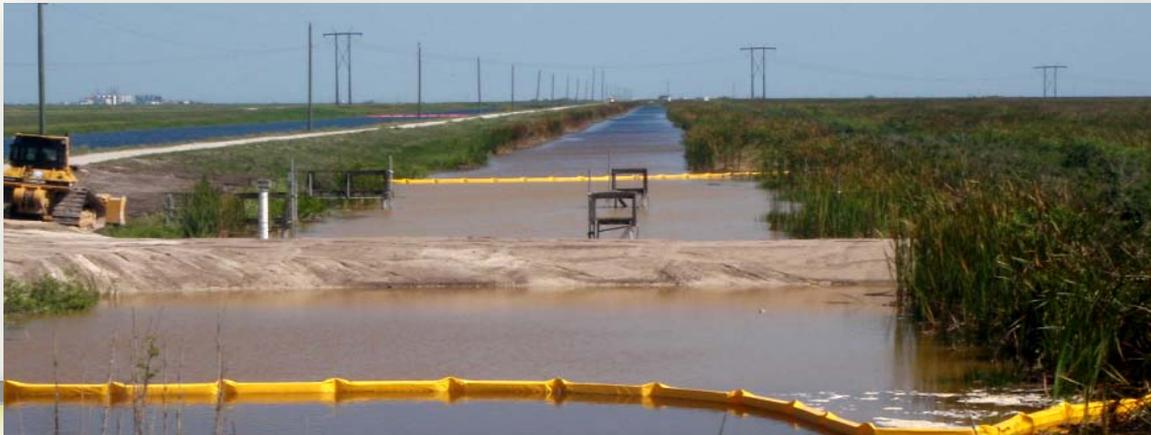
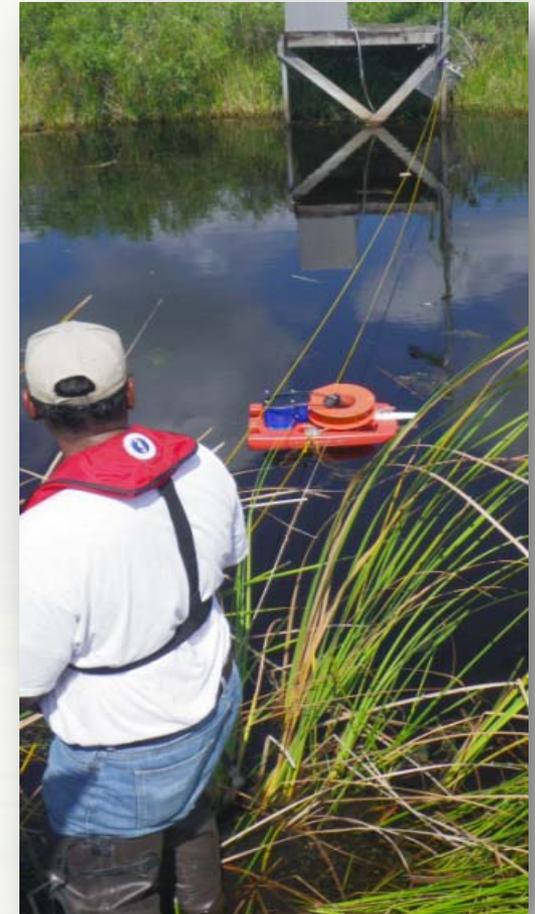
Evaluation of STA-1W Cell 3 Plug

- Background: Visual observations indicated short-circuiting via the remnant (ENR) canal
 - The canal was plugged with soil material just upstream of G-259 on the last week of April
 - The plug was then covered with sod to stabilize the soil
- Flow measurements indicate that the plug is effective in preventing any flow short circuiting through this canal
 - Before plug: approximately 1/2 of the outflow water is short circuited through the remnant canal
 - After plug: no measurable flow in the remnant canal

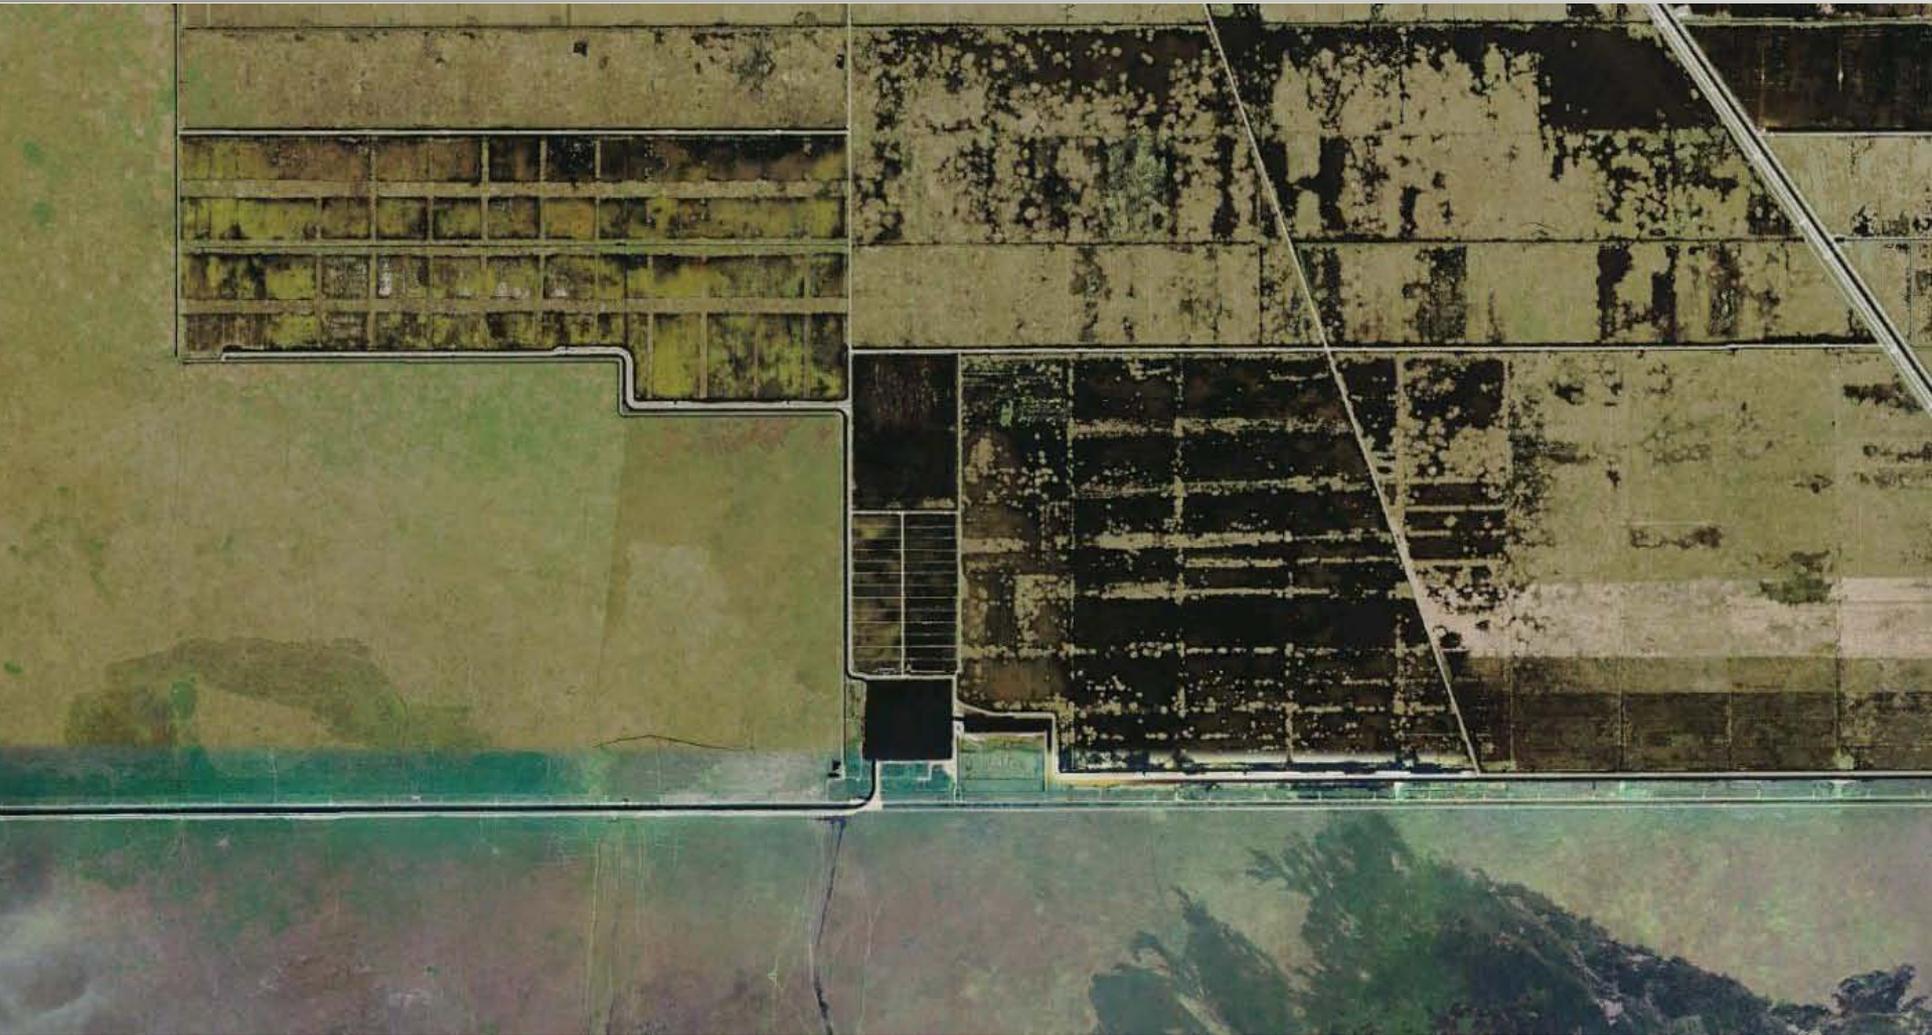
PSTA Cell Improvements

- Objective: Flow/load measurement improvements
- Modify G-390B to improve flow measurements
- Modify one pump at G-388 to reduce pump flow rate
- Resurvey all stage sensors in the flow path in a single loop
- Refurbish existing wells/piezometers on east and west levees
- Other future work to include is improved gauging at S378 and S389 structures

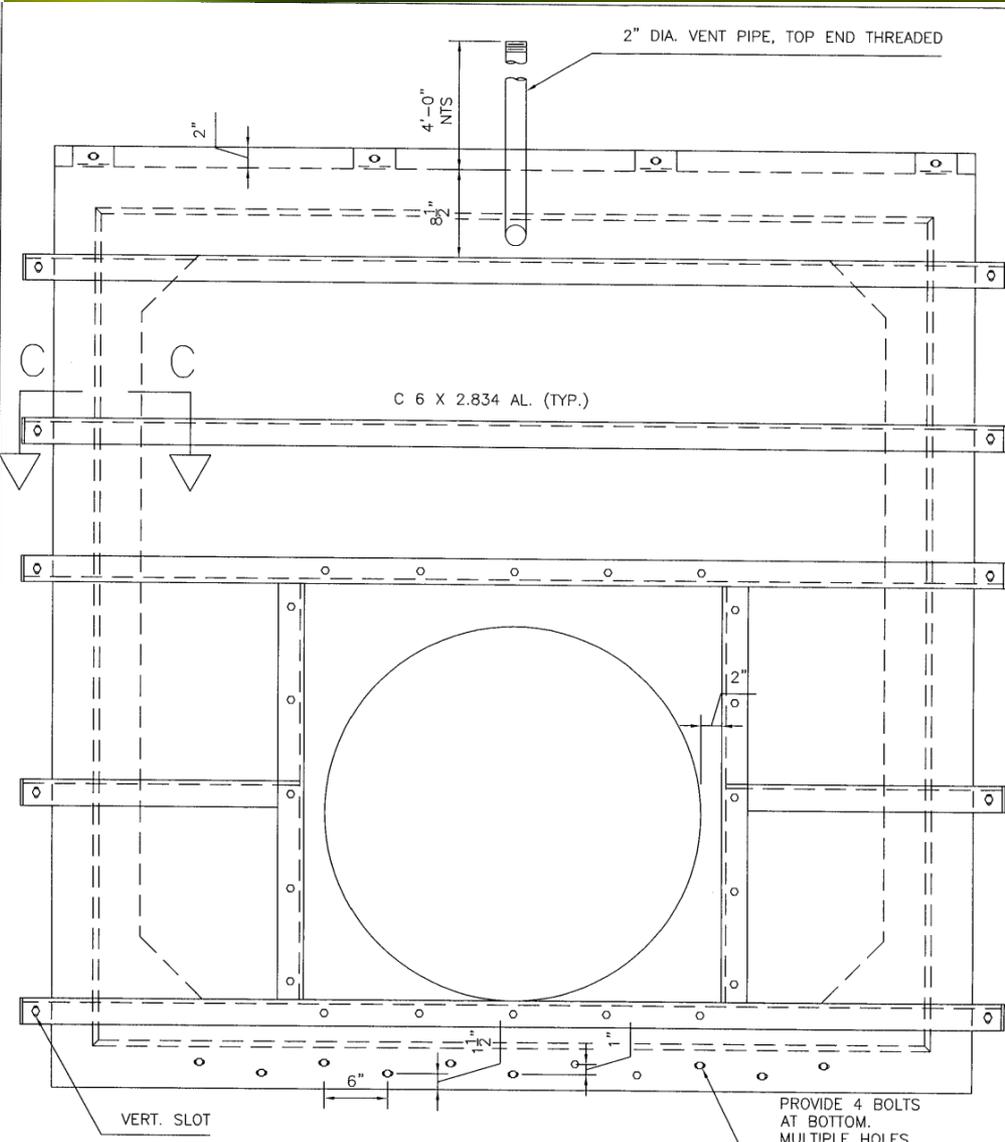
DWG. G-390B SHEET 2
 PROJECT: G-390B FLOW MOD.
 DRAWN BY: V. LOEHRLEIN
 DWG. DATE: 9/1/11

SECTION A-A

PROVIDE 4 BOLTS
 AT BOTTOM.
 MULTIPLE HOLES
 PROVIDED IN CASE
 REBAR ENCOUNTERED
