### **Quarterly Status Report #1**

**Lamb Island Dairy Remediation**

**SFWMD Contract No. C-13410**

**HSA Engineers & Scientists**

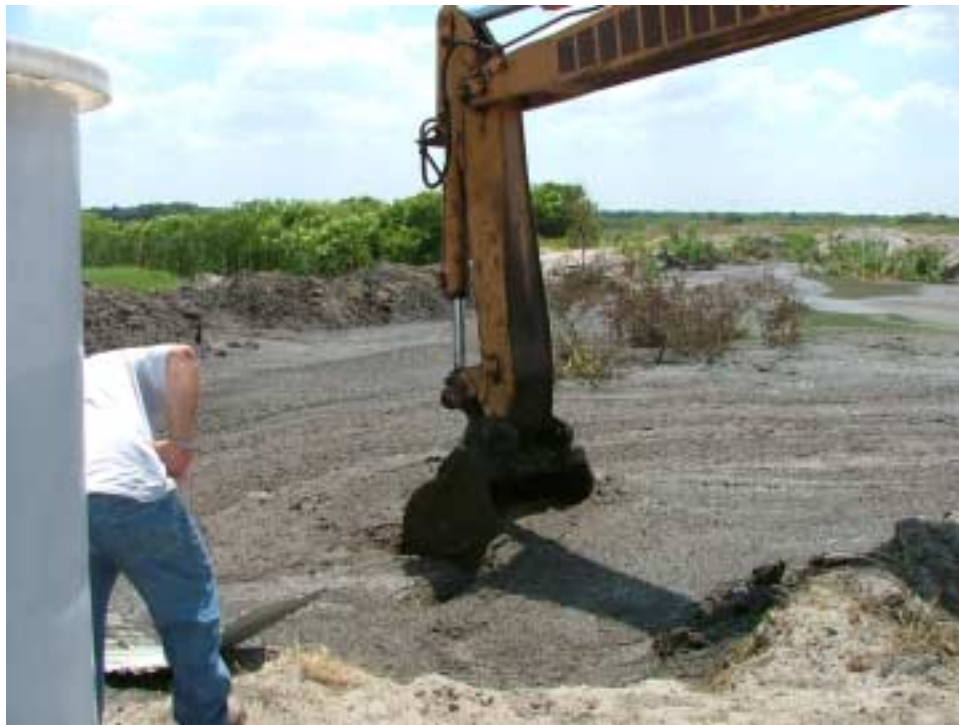
**Figure 5.** Alum amendment and mixing

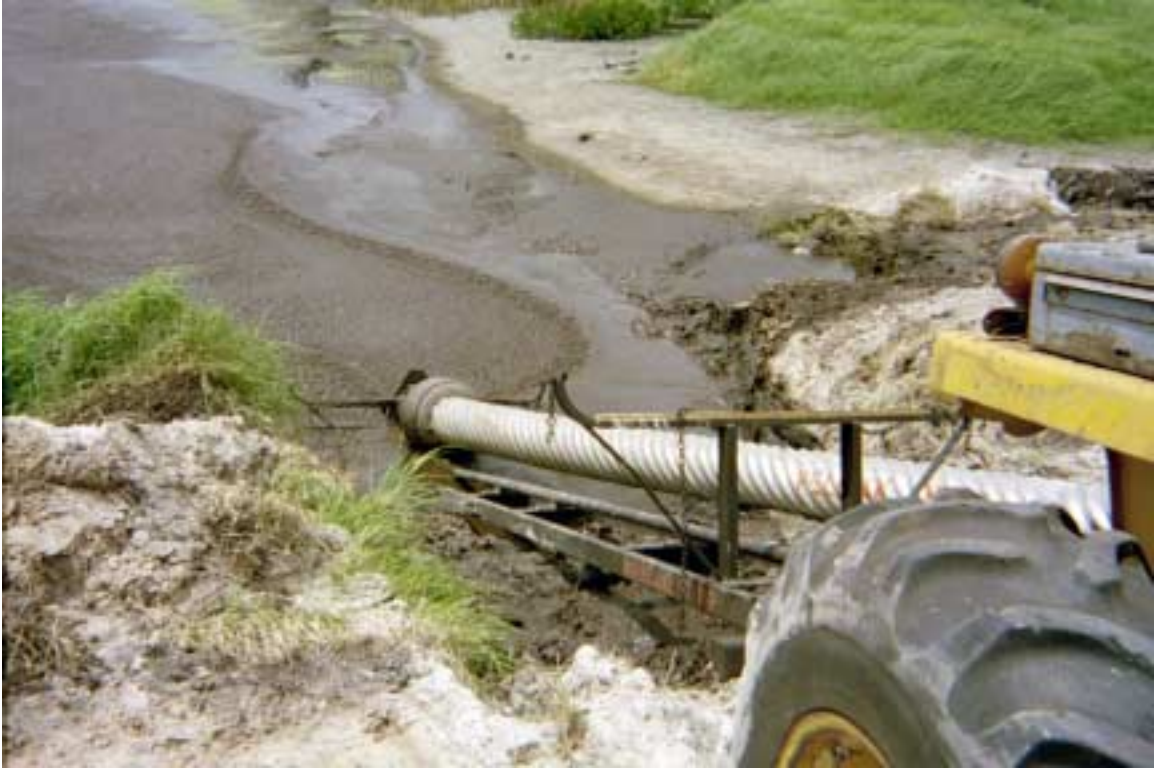
**Figure 6.** Pumping into Pond 1

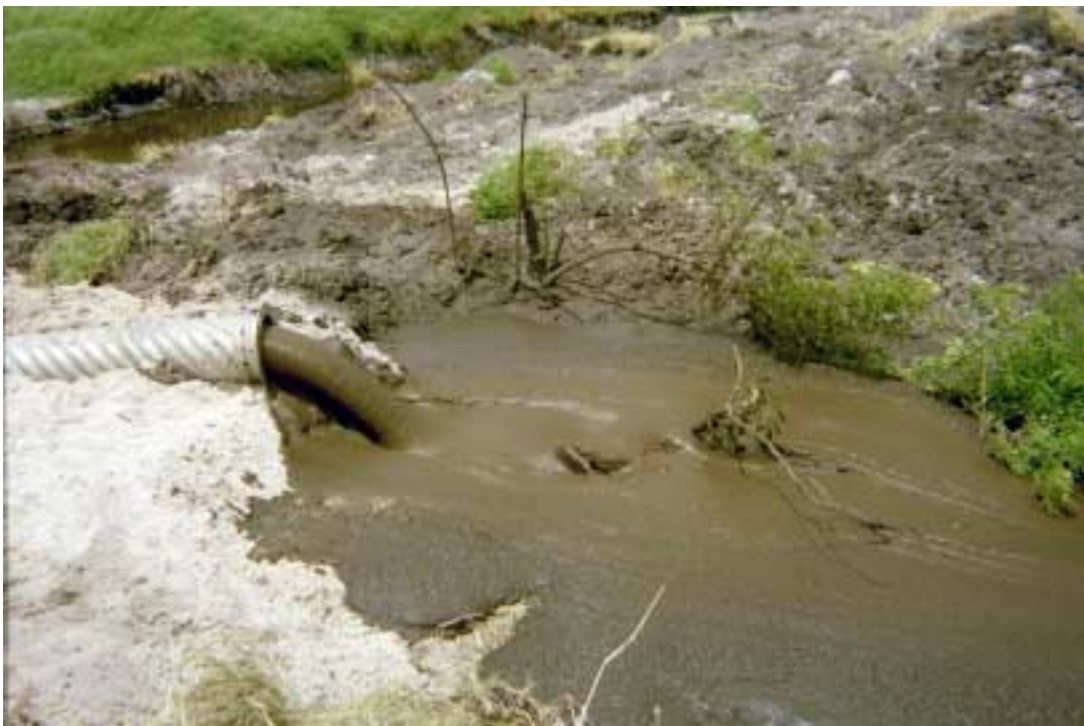
**Figure 7.** Discharge of pump into Pond 1

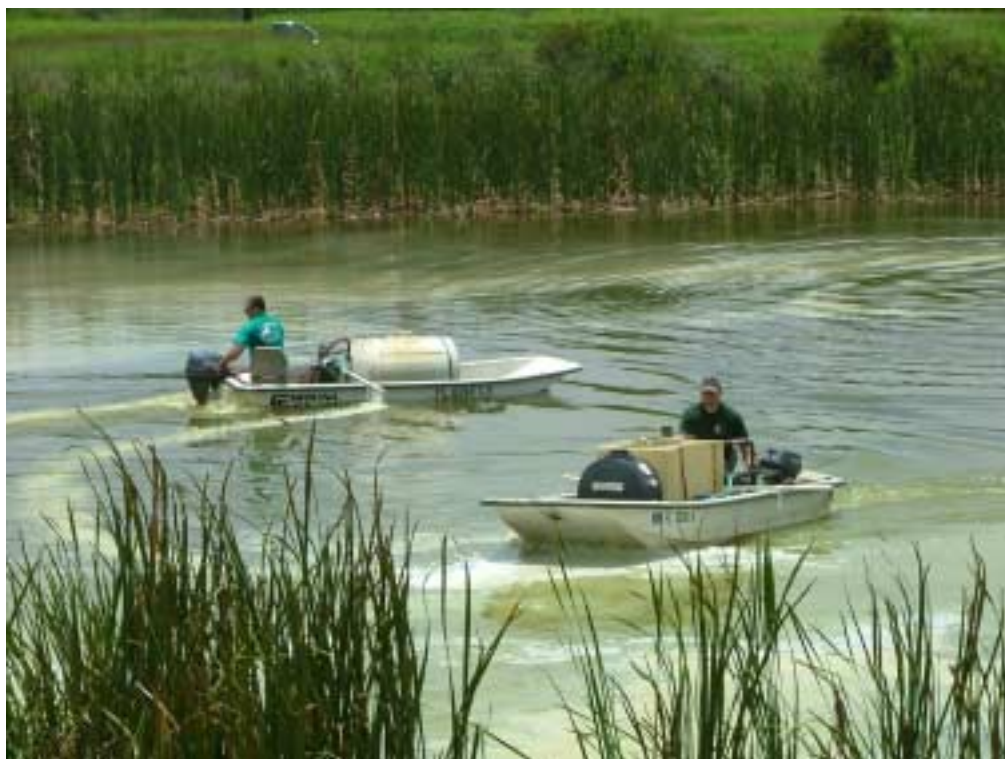
**Figure 8.** Pond 3 Alum amendment

In mid June approximately 3,500 gallons of alum was mixed into Pond 3 by Aquatic Biologists using four small boats equipped with chemical mixing equipment (**Figure 7 and Figure 8**). Pond 4 was treated with approximately 500 gallons of alum in the same manner. SRP testing in the field was performed using a Hach Dr 2100 Spectrophotometer for SRP (ascorbic acid method) and samples were collected for laboratory analysis. Preliminary data as shown in **Table 3** shows that additional alum treatment will be necessary in Pond 3 to achieve the desired SRP results of less than 150 ppb. Sampling Locations are shown in **Figure 3**.

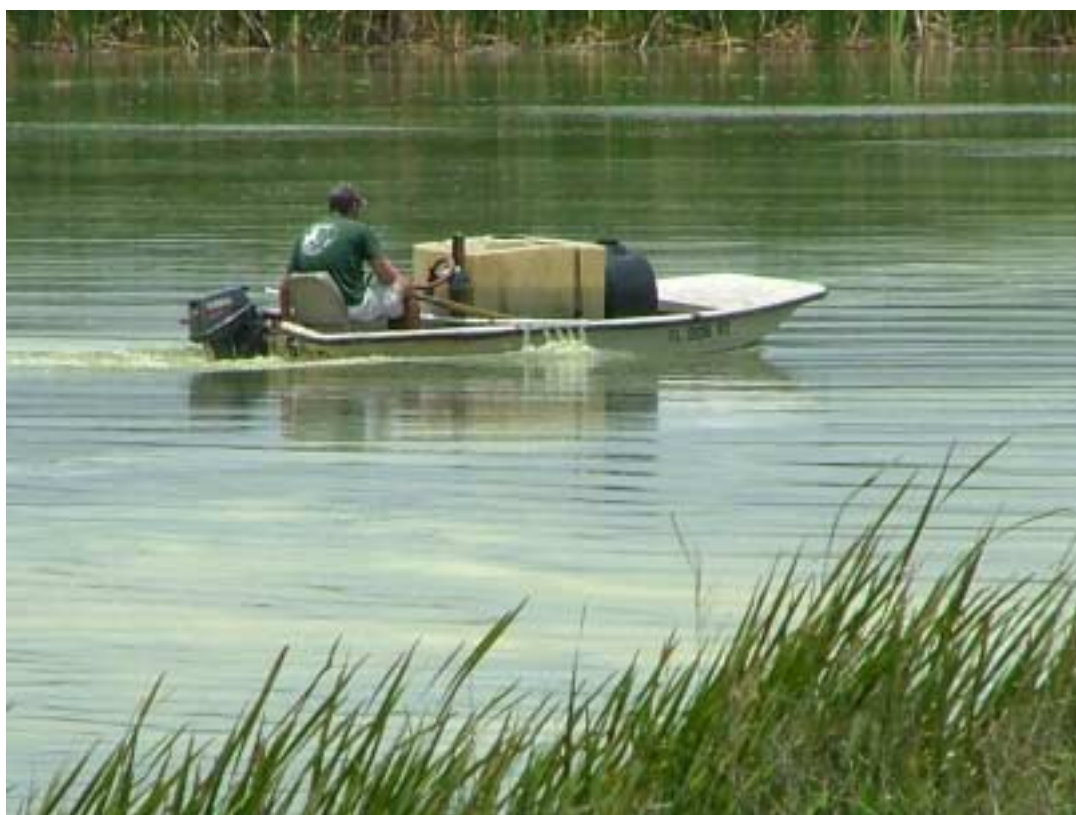
**Figure 9.** Pond 3 Alum amendment
