Quarterly Status Report #2

Lamb Island Dairy Remediation

SFWMD Contract No. C-13410

HSA Engineers & Scientists

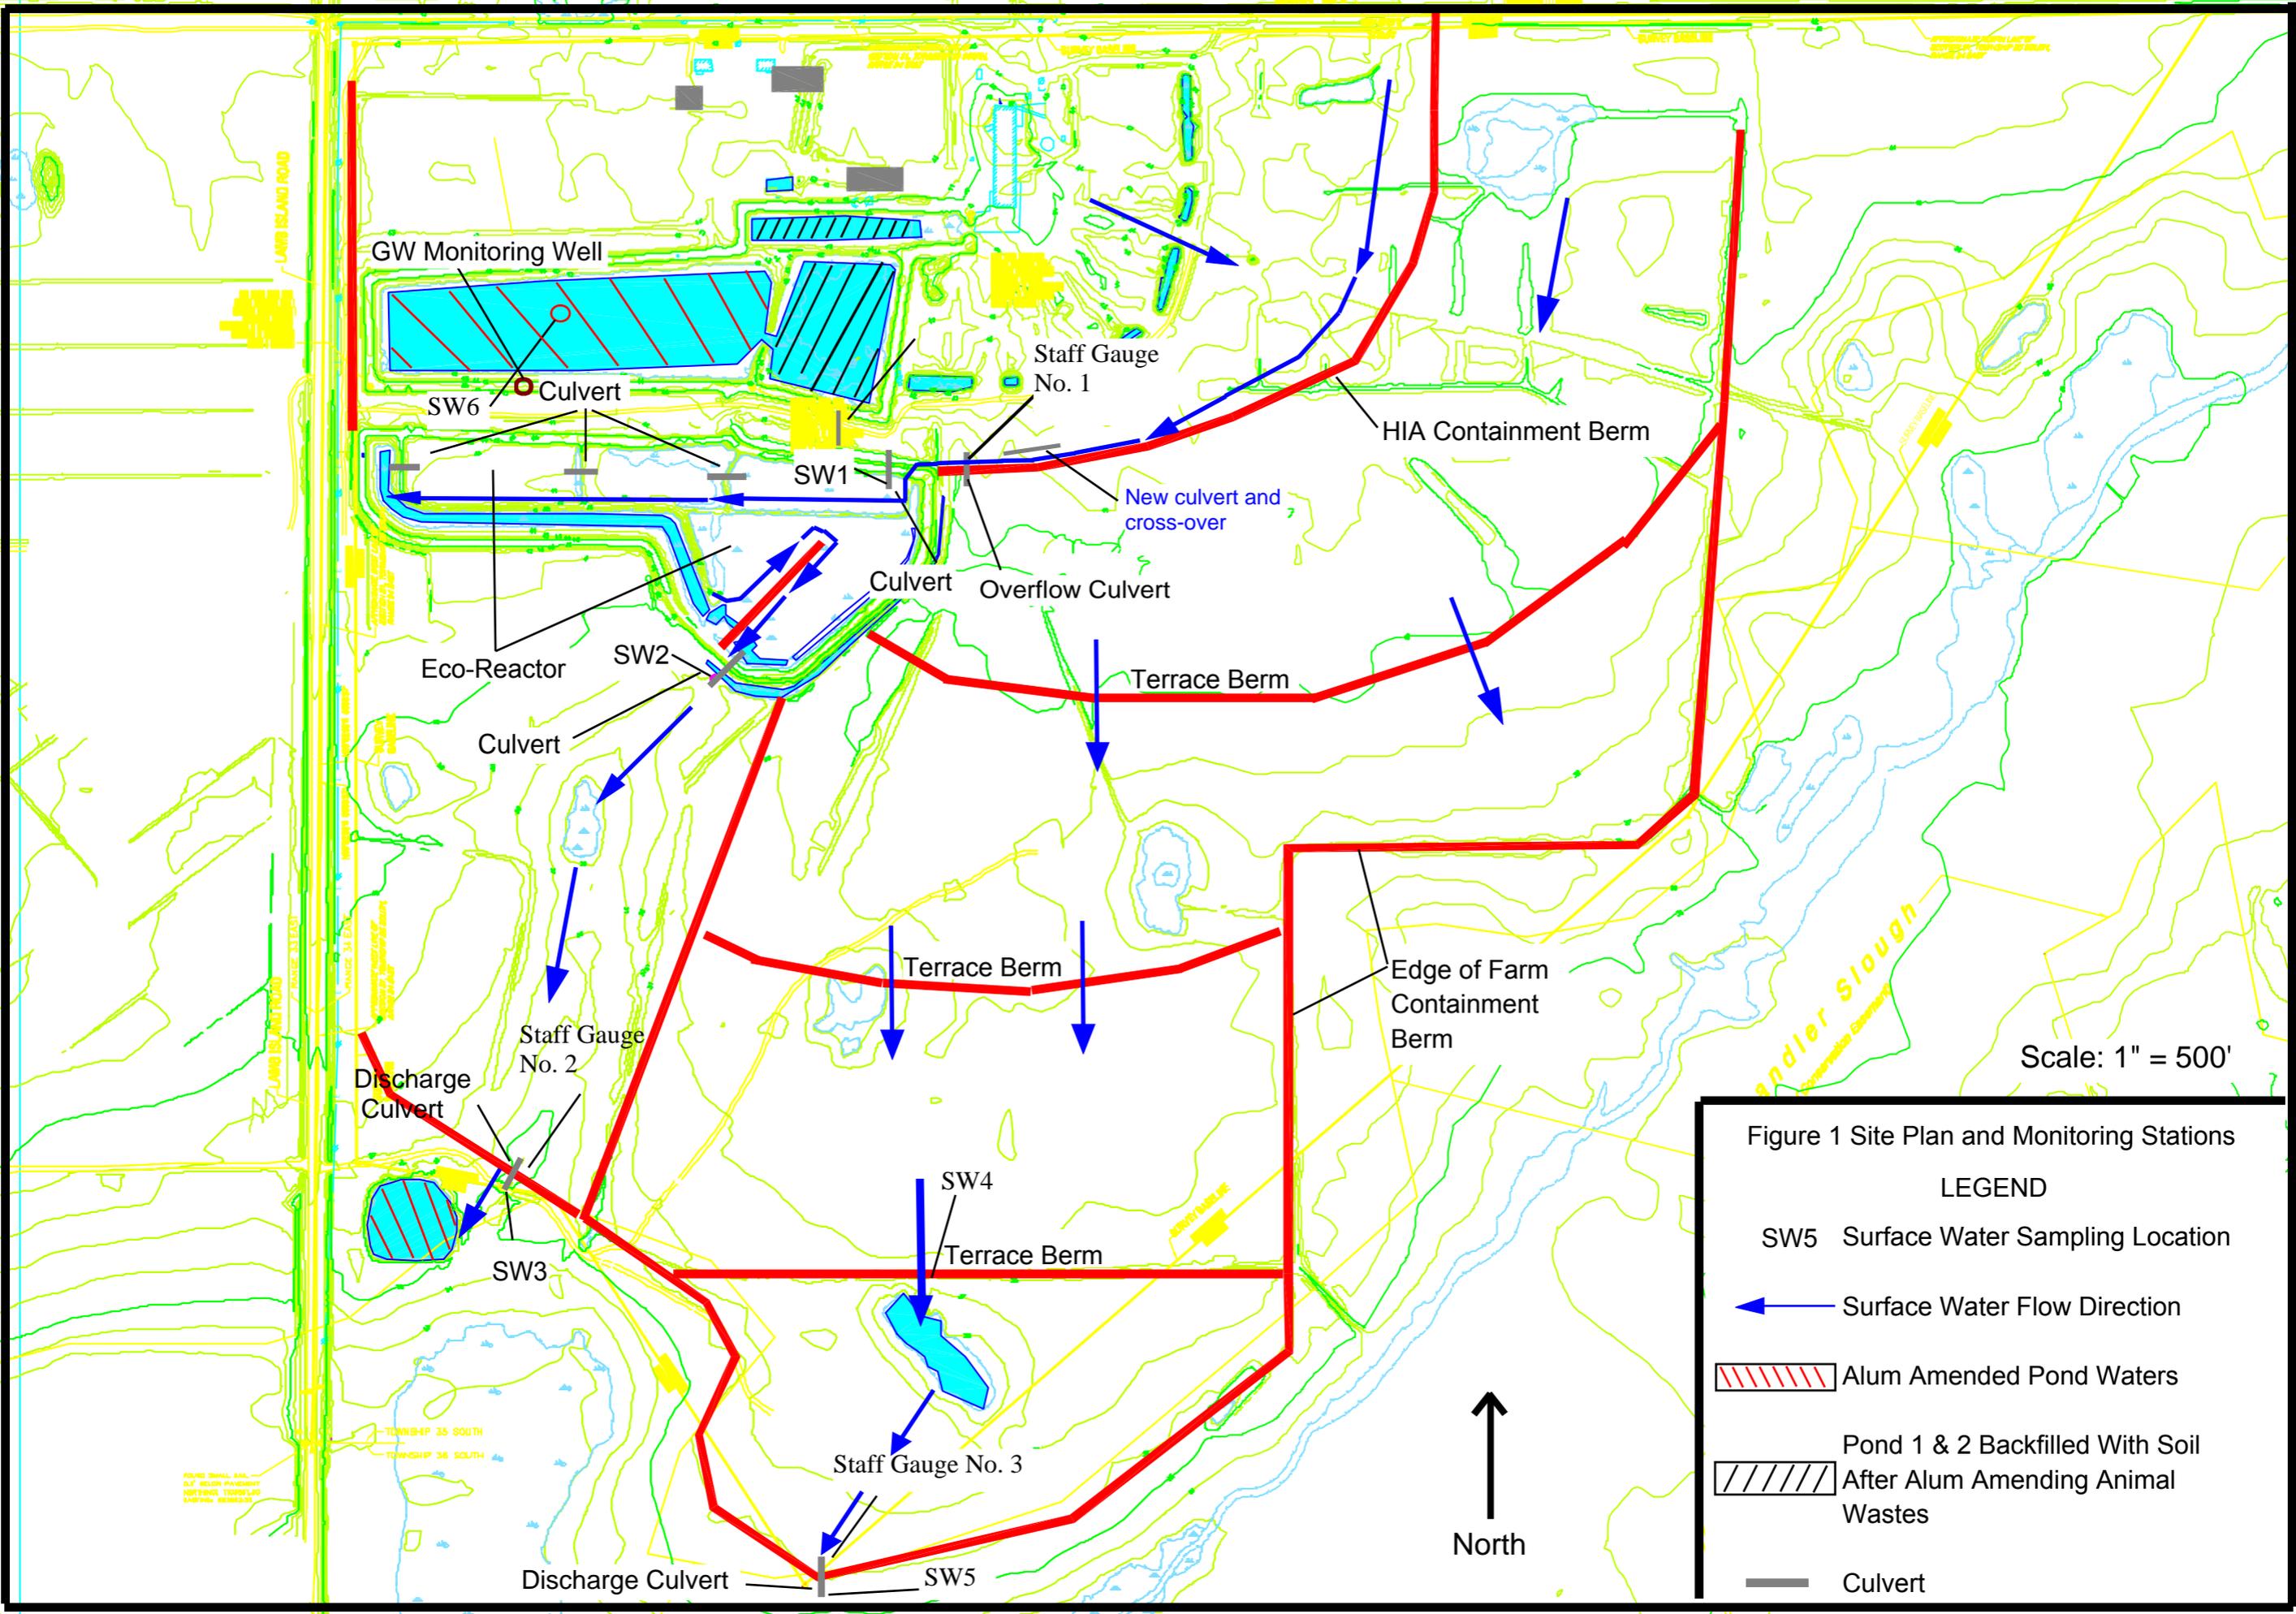
Figure 1 Site Plan and Monitoring Stations

By mid July construction of the HIA containment area berm and ditch, and outer pasture berm and ditch were complete (see **Figure 1**). The cumulative runoff from the HIA flows by gravity through the former eco-reactor(wetland treatment system) and swale system via a series of metal culverts with riser inlets. An emergency overflow culvert and riser was installed just east of the termination of the HIA berm with the eco-reactor wetland treatment system berm to maintain one foot of freeboard and to set the maximum water level within the HIA containment area at 43 feet NGVD before storm waters are allowed to discharge from the HIA containment area. From the 40 acre HIA containment area, water flows by gravity to the existing 6.5 acre wetland treatment system. By late July within the wetland treatment system, a total of four discrete cells were constructed with culverts and risers connecting each cell. Boards were set in each riser to a height of 41 feet NGVD. From the wetland treatment system, water then flows by gravity into a swale prior to discharge off the property. The previously existing discharge culvert was removed and replaced with a new 36-inch diameter culvert and riser. The riser boards were set at 40 feet NGVD. A 36-inch diameter discharge culvert with riser was also placed on the southern most side of the outer pasture containment berm. Board elevations were set at 40 feet. NGVD as well. Three terrace berms were constructed by disking and then grading the areas shown in **Figure 1**. All berm embankments were then compacted and were seeded with Bahia grass. The approximate 16 acre wetland/marsh area created on the southern end of the pasture during quarter 1 activities was cleaned up and graded to a bottom elevation of approximately 36.25 feet NGVD. Due to seasonal weather patterns (ie. Hurricane Jeane, Ivan, Charley and Hurricane Frances) an abnormally large quantity of rain fell on site in late August and early September which resulted in a breach of the outer pasture berm in several places as shown in **Figure 4**. All breaches were immediately repaired and additional areas of the berm were further improved to ensure berm integrity.

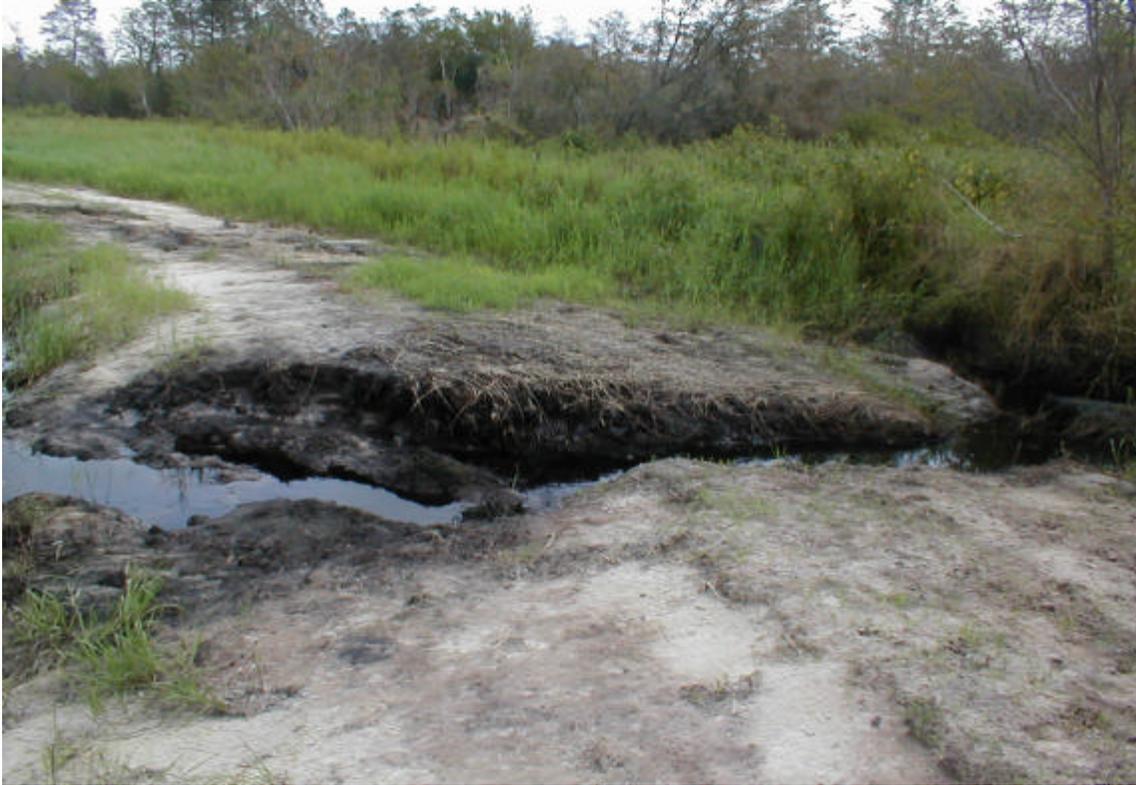
Figure 4. Outer pasture berm breach after Hurricane Frances

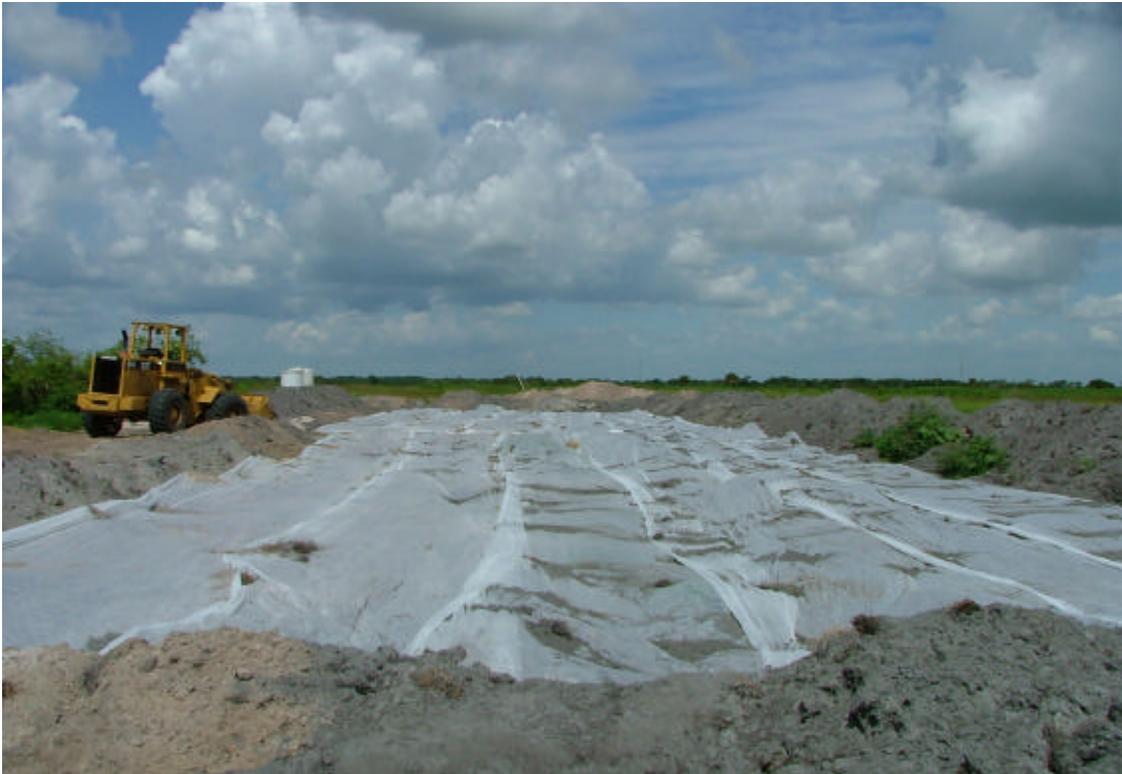
By mid-July the moisture content of Pond 1 and 2 waste material areas were dry enough to cover with a thin layer of soil. A filter fabric material was then applied to the surface of those areas as shown in **Figure 5**. Additional fill material taken from the created wetland area to the south was applied over the filter fabric and compacted, and the area was dressed to conform to the surrounding area.

Figure 5. Filter fabric cover over Pond 1
