# STA-3/4 Diversions To Protect Aquatic Vegetation

Technical Oversight Committee

September 14, 2011

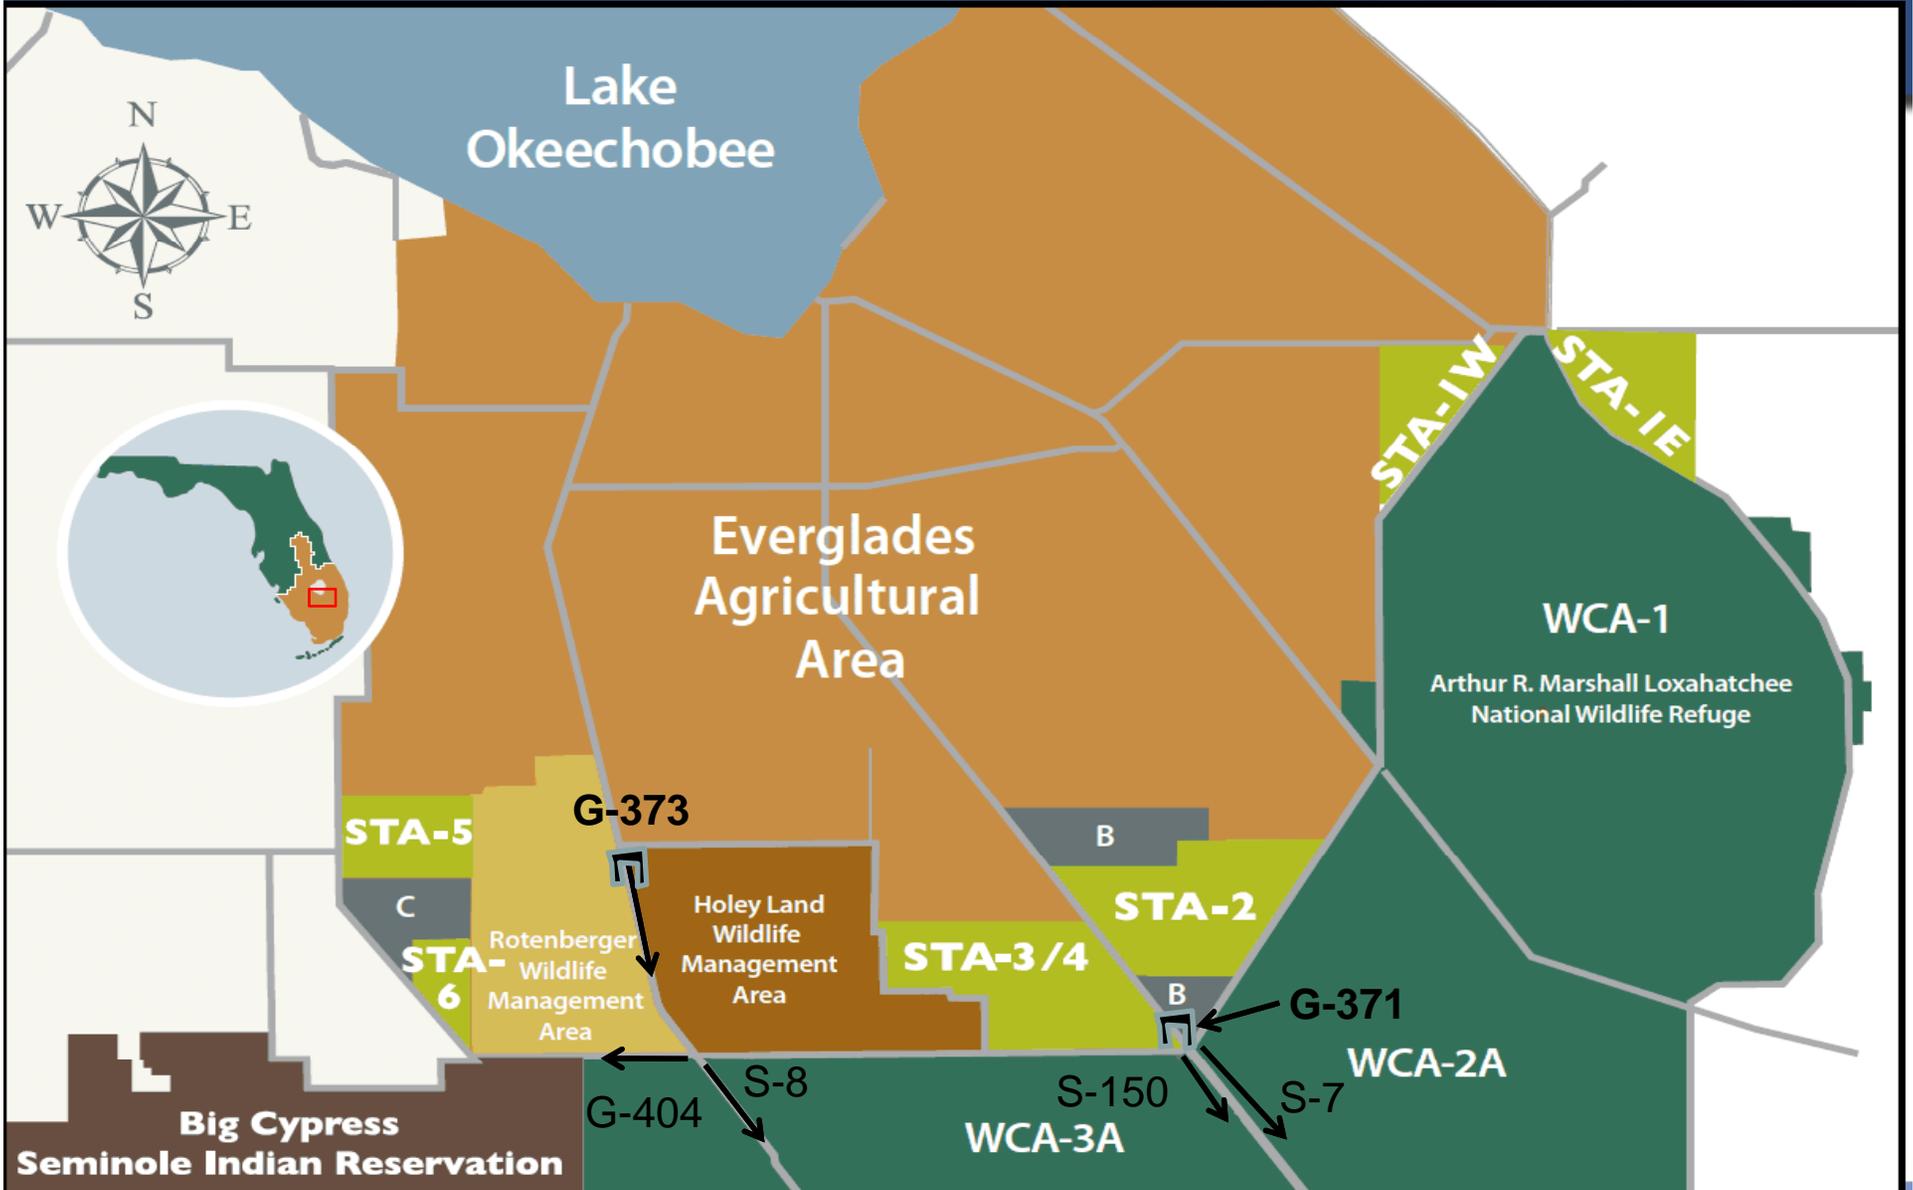
# Everglades Stormwater Treatment Areas

Areas in gray marked with a "B" or "C" represent the current expansion of existing Stormwater Treatment Areas

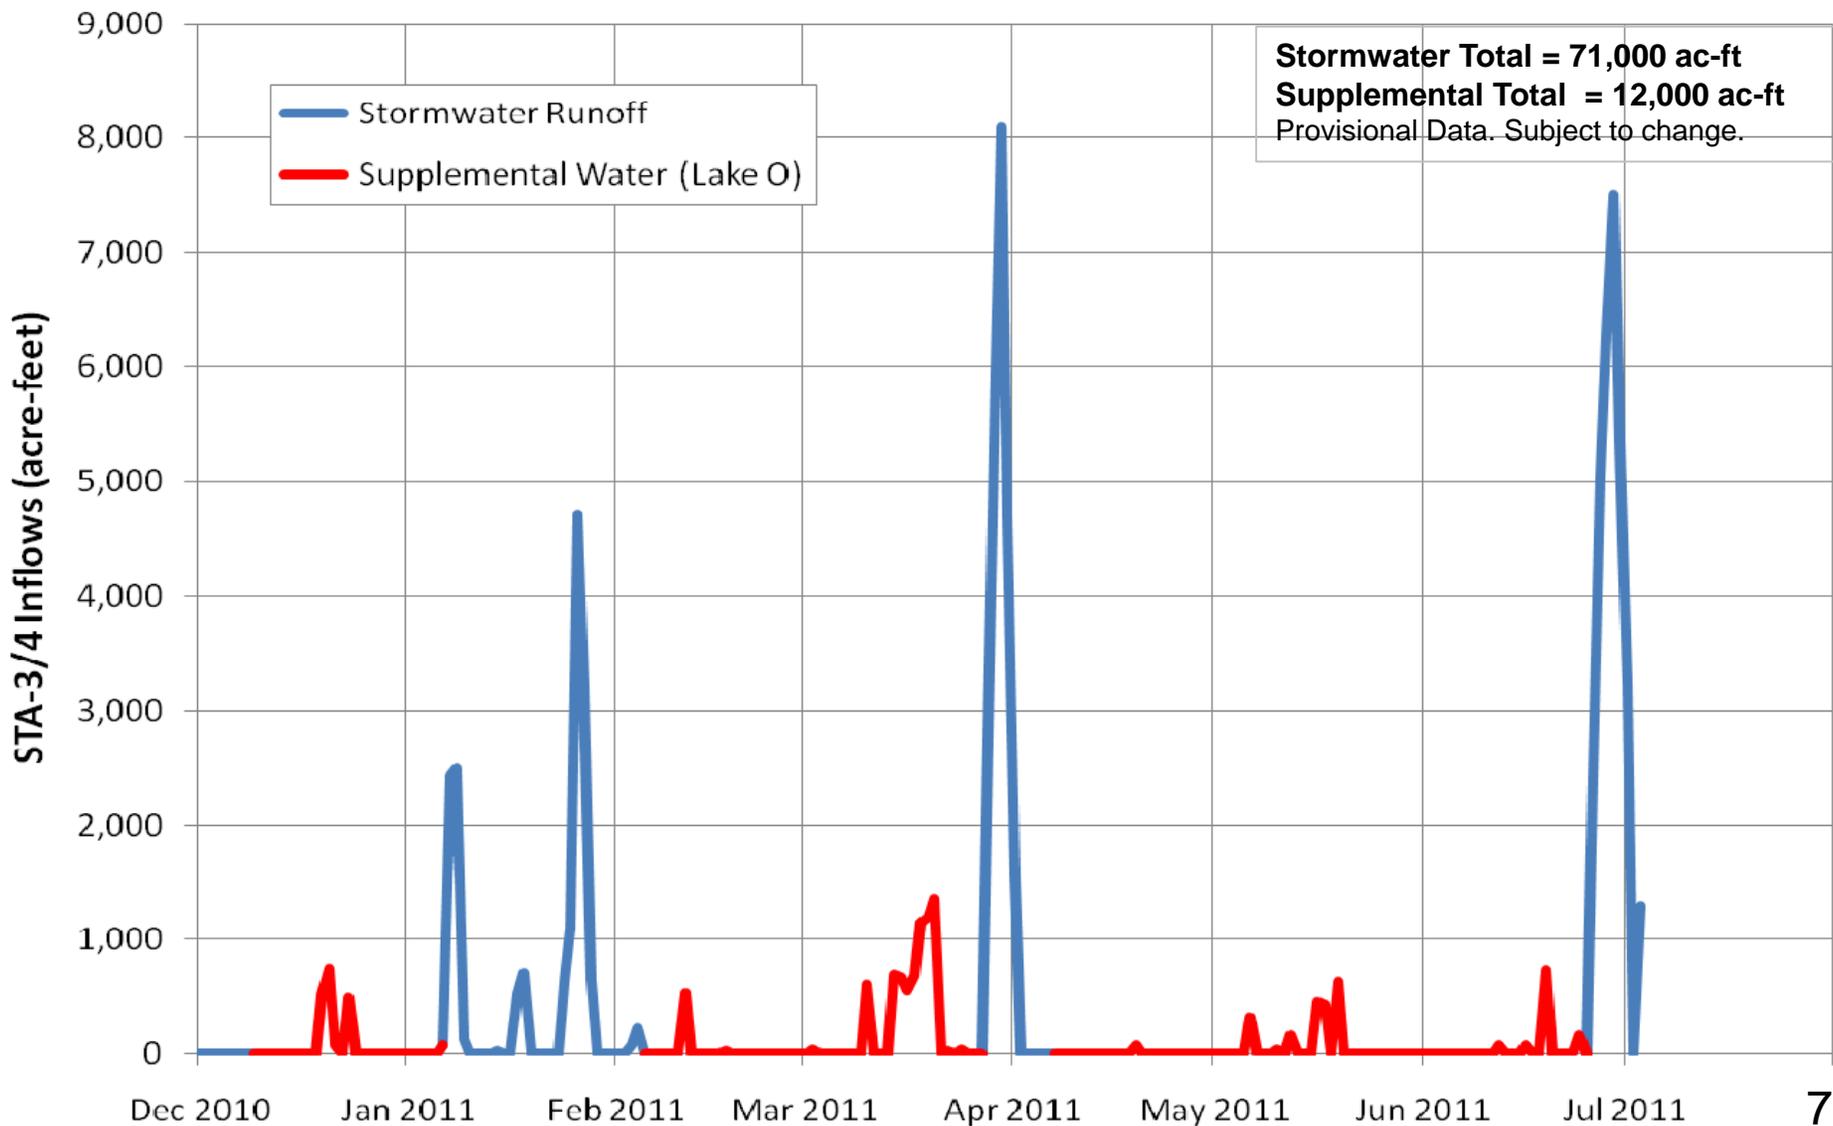
# STA-3/4 Inflows

## December 1, 2010 – July 3, 2011

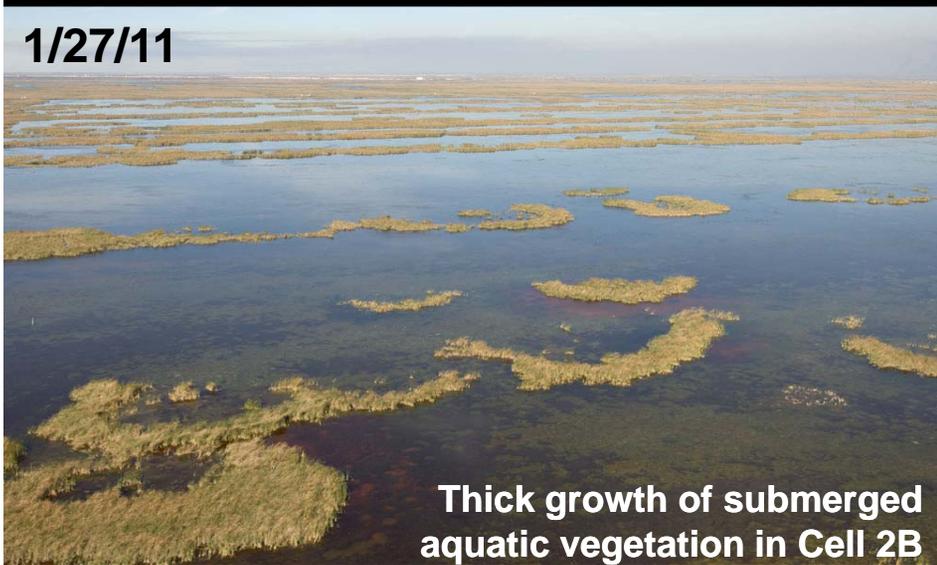
1/27/11

Thick growth of submerged aquatic vegetation in Cell 2B

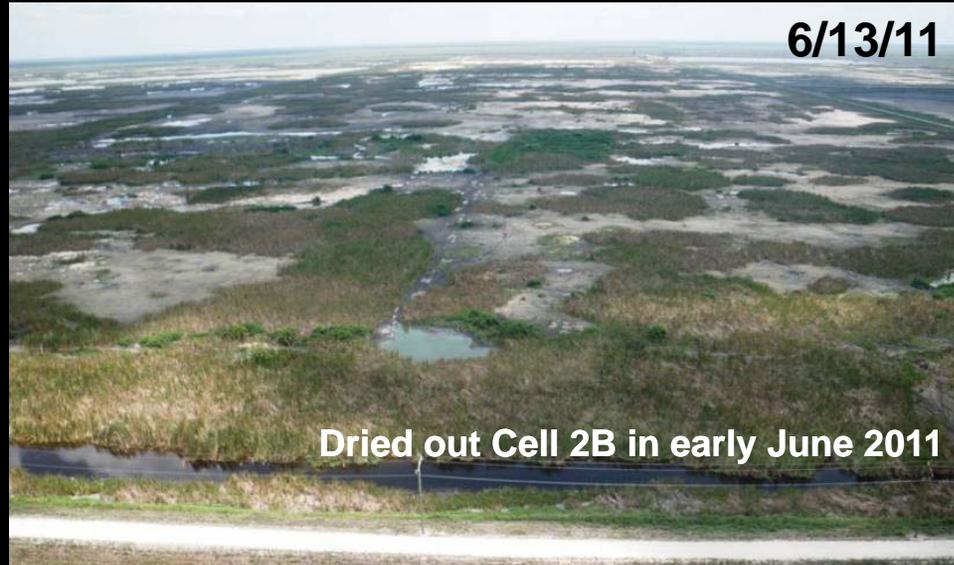
6/13/11

Dried out Cell 2B in early June 2011

## **Dryout resulted in loss of vegetation in all SAV cells**

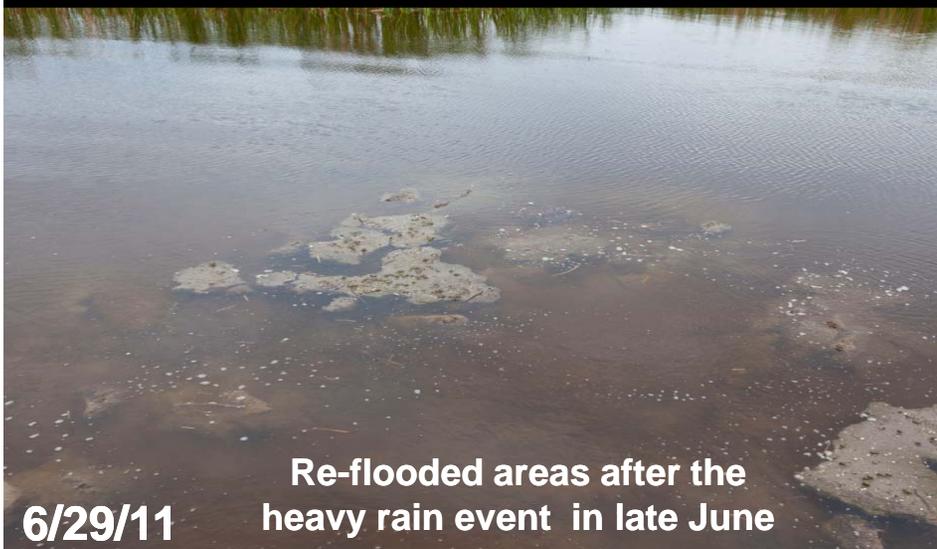
6/29/11

Re-flooded areas after the heavy rain event in late June

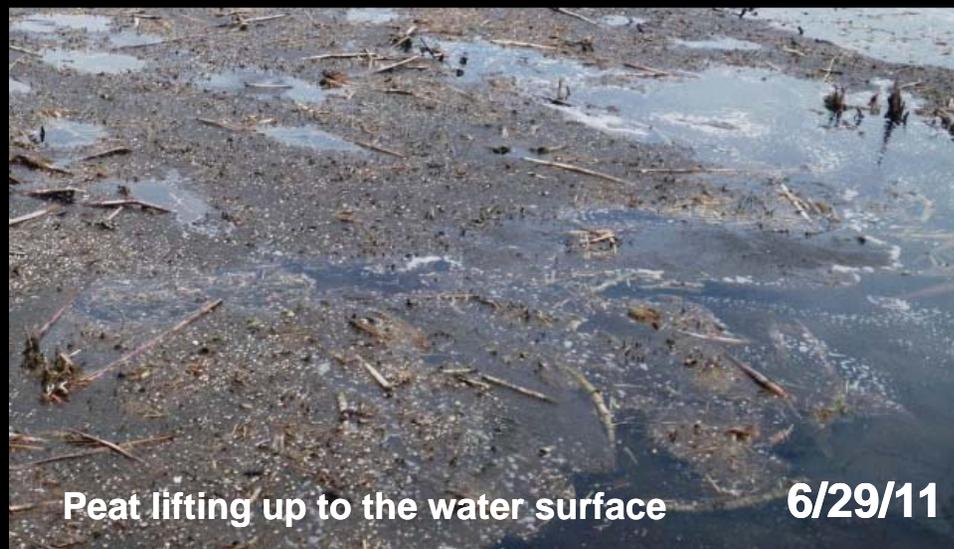
6/29/11

Peat lifting up to the water surface

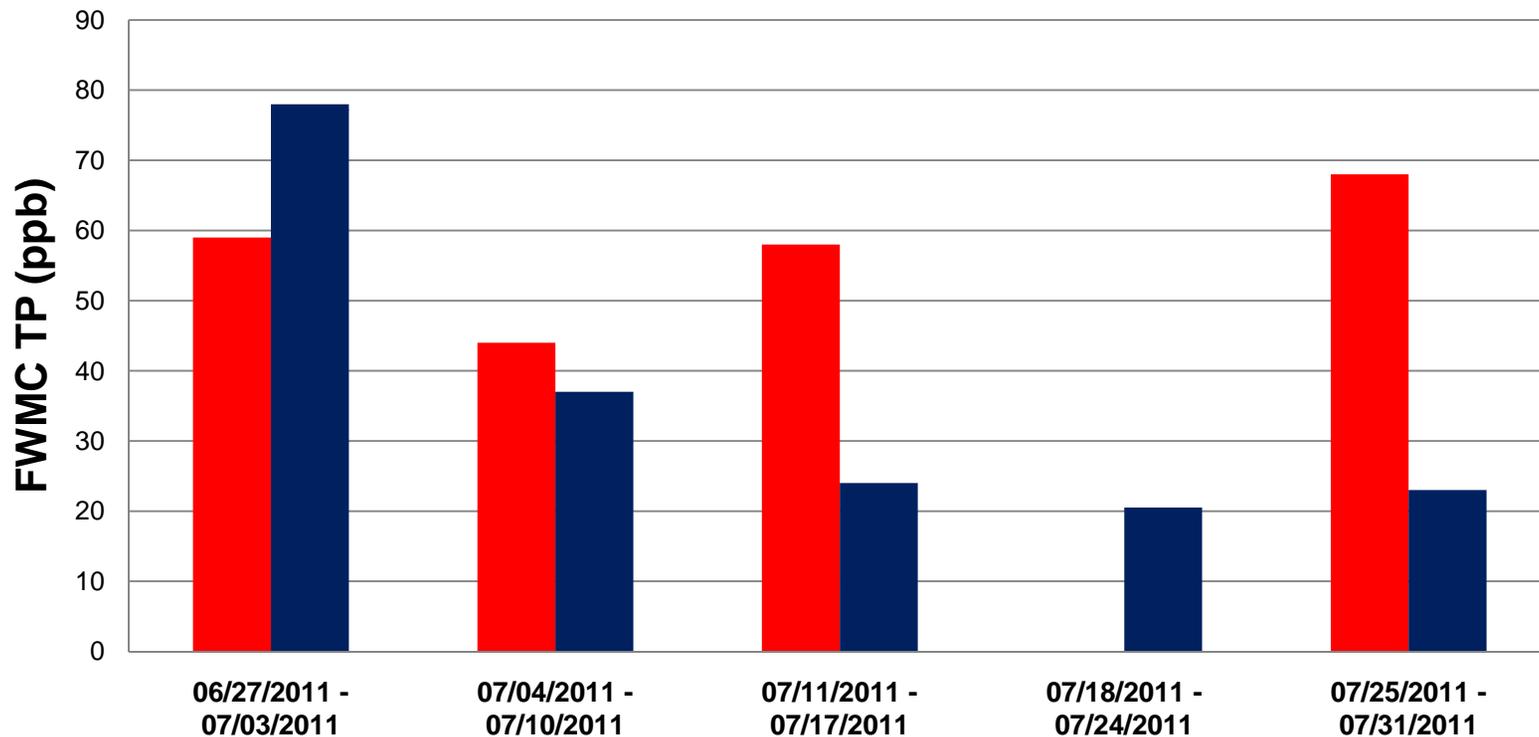
# STA 3/4 Weekly Inflow and Outflow Concentrations

**STA-3/4 Inflow and Outflow FWMCs**  
 (Data is provisional and subject to change)
