**Subject: Submittal of After-Action Report for Emergency Authorization for Temporary Operational Changes to Address High Water Conditions in the South Florida Region (OGC Case No. 00-0889)**

**Emergency Operations After Action Report**  
**High Water Conditions in the South Florida Region**  
**February 12–May 11, 2016**

**South Florida Water Management District**

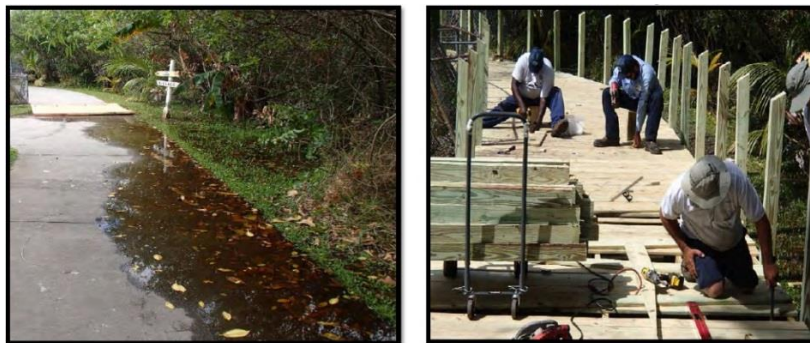
**Figure 3.** SFWMD installation of raised walkway with handrails at Everglades Safari Park.

On February 23, 2016, SFWMD Miami Field Station staff met with a representative of Everglades Safari Park on-site to discuss ways of addressing a large trip hazard on their walkway and reduced dry land for their alligators due to high water on their property resulting from higher L-29 Canal water levels. It was agreed that SFWMD would attach three diamond-plate sheets to the existing hinged walkway. SFWMD purchased the plates that day and fabricated and installed the plates February 25. Also on February 25, 2016, SFWMD Miami Field Station staff moved 400 bags of sand, each weighing 40 pounds, to the alligator enclosures and spread the material in 3.5 hours to provide dry land. SFWMD created a staging area next to Tamiami Trail and used sand bags to transport the sand to the enclosures. The sand bags were loaded onto Jon boats and moved to the side of the island closest to the enclosures. From there the bags were transferred to wheelbarrows and the sand was dumped into the alligator enclosure. This was labor intensive but provided the cleanest and fastest way of getting material to the enclosure.

In April 2016, as the water level in the L-29 canal was approximately 8.3 feet NGVD29, Everglades Safari Park needed more sand placed in their crocodile exhibit. Four hundred more bags of sand were deployed by Miami Field Station staff. Coopertown Airboat had the same issue with their alligator enclosure. High water eliminated any dry land for the alligators. Four hundred bags of sand were spread in the enclosures providing alligators dry refugia (**Figure 3**).

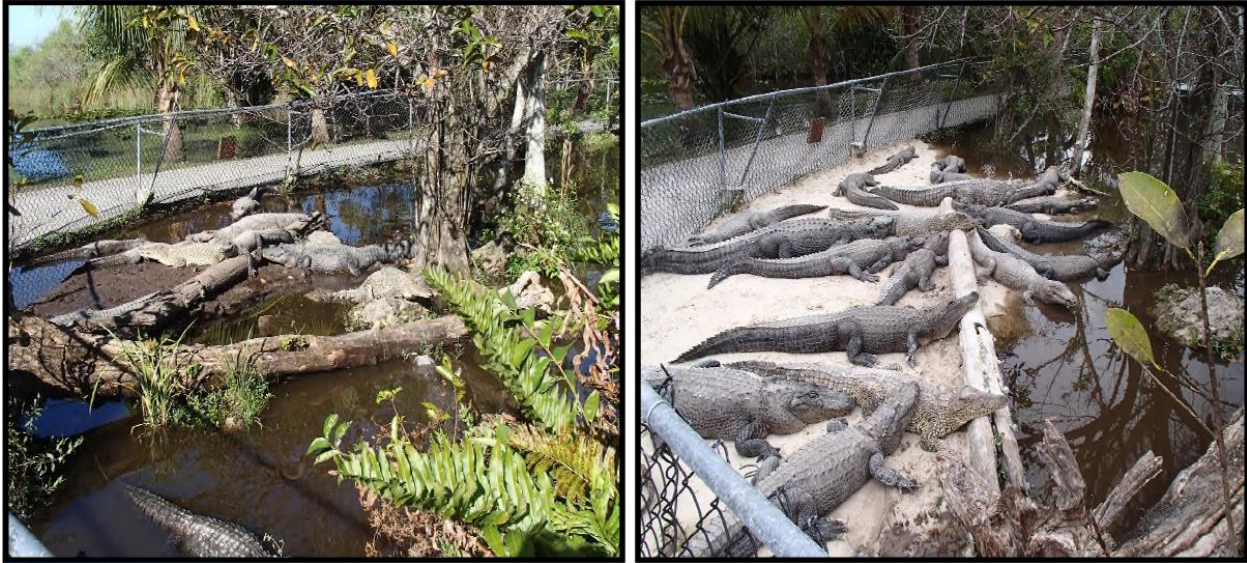
**Figure 4.** Before and after placement of sand to provide dry refugia for crocodiles at Everglades Safari Park.

Gator Park Airboat was concerned with high water near electrical conduit. The electrician from Miami Field Station inspected the conduit and found only security camera wiring in the conduit. It was deemed safe for water to be in the conduit and presented no danger to the public. Gator Park Airboat also had flooding in their pedestrian walk area. The Field Station placed ten sheets of plywood down next to their docks and secured them to the docks. The plywood provided dry, safe access on to which customers walked (Figure 4).

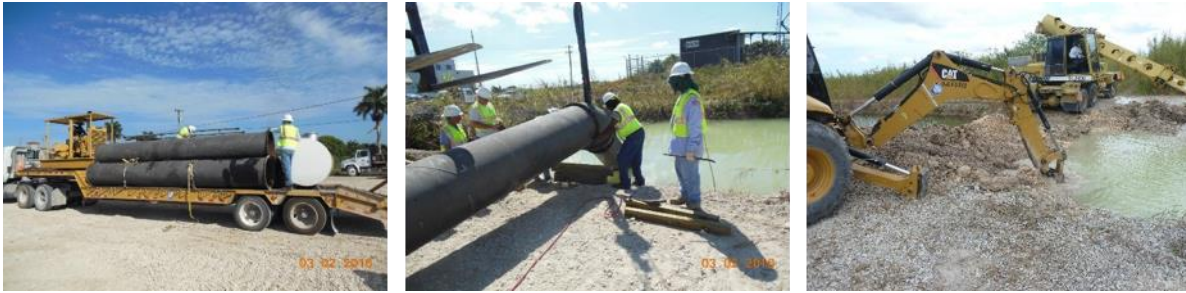
**Figure 5.** SFWMD transportation of power unit, pump, fuel tank, and pipe (left); connecting pipe (center); and removal of earthen plug (right).

pump installation included transportation and deployment of a power unit, pump, fuel tank, and 240 feet of pipe. SFWMD field crews constructed a transition ramp, an earthen bridge over the pipe and removed an earthen plug upstream. Installation was completed within three days.

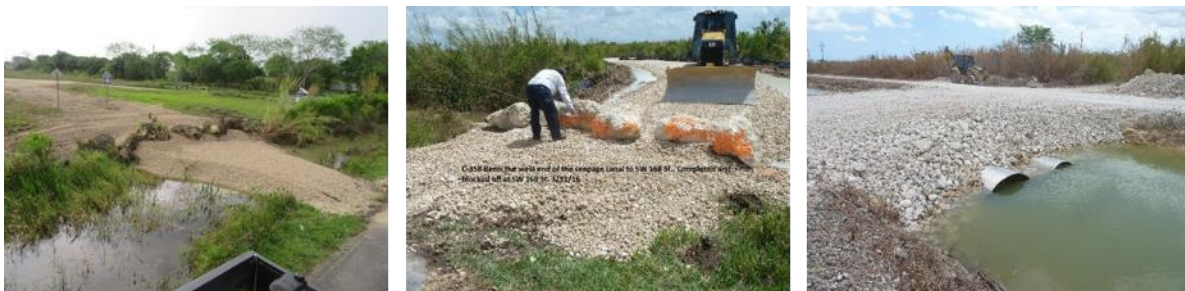
**Figure 6.** Las Palmas community mitigation (left to right): ditch plug on north side of Richmond Drive; berm connecting C-358 seepage collection canal berm to Richmond Drive; and culverted crossing of C-358 seepage collection canal.

SFWMD requested USACE approval to excavate a temporary open channel to connect C-358 to C-357 in lieu of the two deployed temporary pumps. While the temporary pumps were effective in stemming the rate of rise of water levels in the area, they were not able to lower water levels as desired. The USACE Engineering and Design Branch approved the SFWMD request on April 20, 2016, conditioned upon SFWMD restoring the temporary connection and the C-358 canal crossing at SW 207<sup>th</sup> Avenue (USACE contractor haul road to a disposal area) by May 7, 2016. SFWMD created the open connection April 9, 2016. Stages in adjacent areas declined by 0.5 feet NGVD29 or more over the next few weeks with continued operation of the S-357 pump station and the open connection.

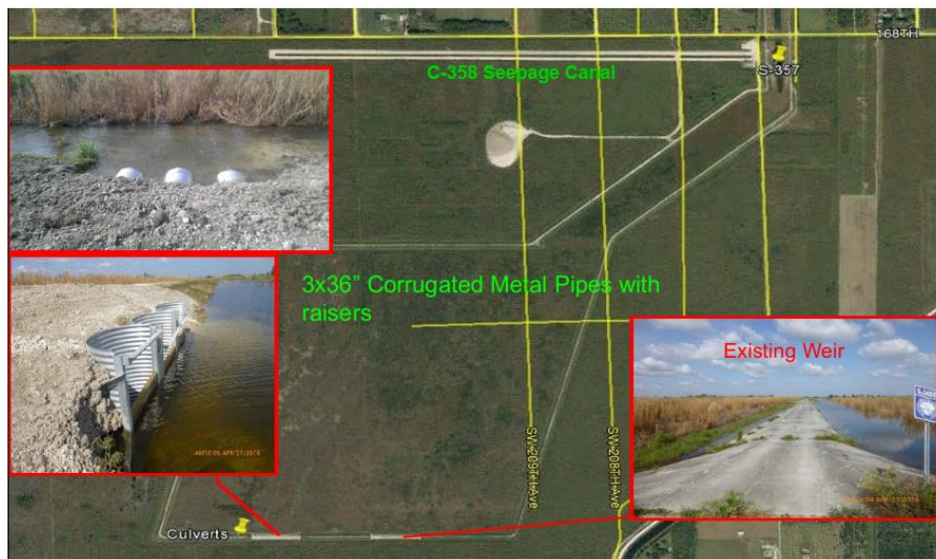
**Figure 7.** Temporary culverts at south end of the 8.5 Square Mile Area detention area.

SFWMD requested approval from USACE on April 11, 2016, to install temporary culverts in the southwest corner of the 8.5 Square Mile Area Detention Area (just west of the S-360W weir). USACE approved the SFWMD request conditioned upon SFWMD discontinuing discharge through the temporary culverts by May 7, 2016. The three 36-inch corrugated metal pipe culverts with removable flash boards were used to maintain the 8.5 Square Mile Area detention area water depths similar to what would occur when construction of the C-111 northern detention area is complete.

**Figure 7** shows the location of the temporary culverts relative to the C-358 seepage collection canal, the S-357 pump station, and the existing concrete weirs at the southern end of the detention area (S-360E and S-360W). The culverts were placed just east of S-360W.

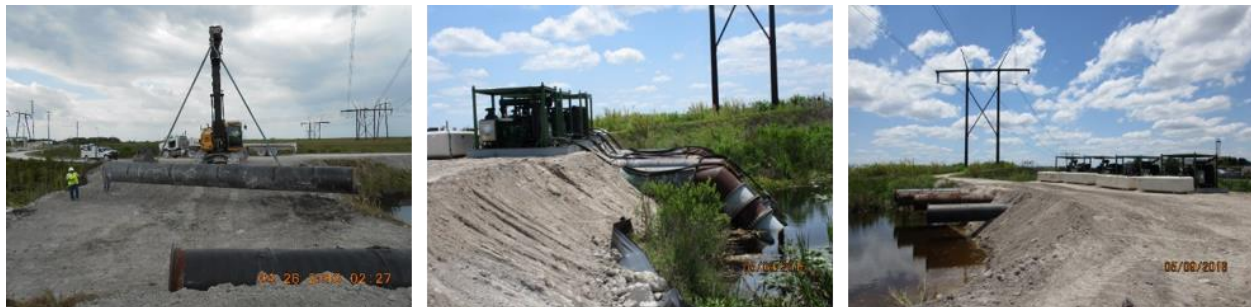
**Figure 8.** Temporary pumps assembly, intake, and discharge near S-7.

On March 18, 2016, SFWMD requested FDEP authorization to install four 42-inch diameter temporary diesel pumps, each with a nominal capacity of 100 cfs, adjacent to the S-7 pump station due to failure of one of the three 830-cfs pumping units. On April 26, 2016, SFWMD transported and unloaded pipes, air compressor, and hardware and completed earthwork for the site. Assembly began April 27. This action reduced the need to use pump station S-8 as a back-up, since use of this facility is currently limited by the high water conditions in WCA-3A. S-7 pumps into WCA-2A as will the four temporary pumps. S-8 pumps into WCA-3A. **Figure 8** shows the temporary pumps assembly, intake, and discharge.

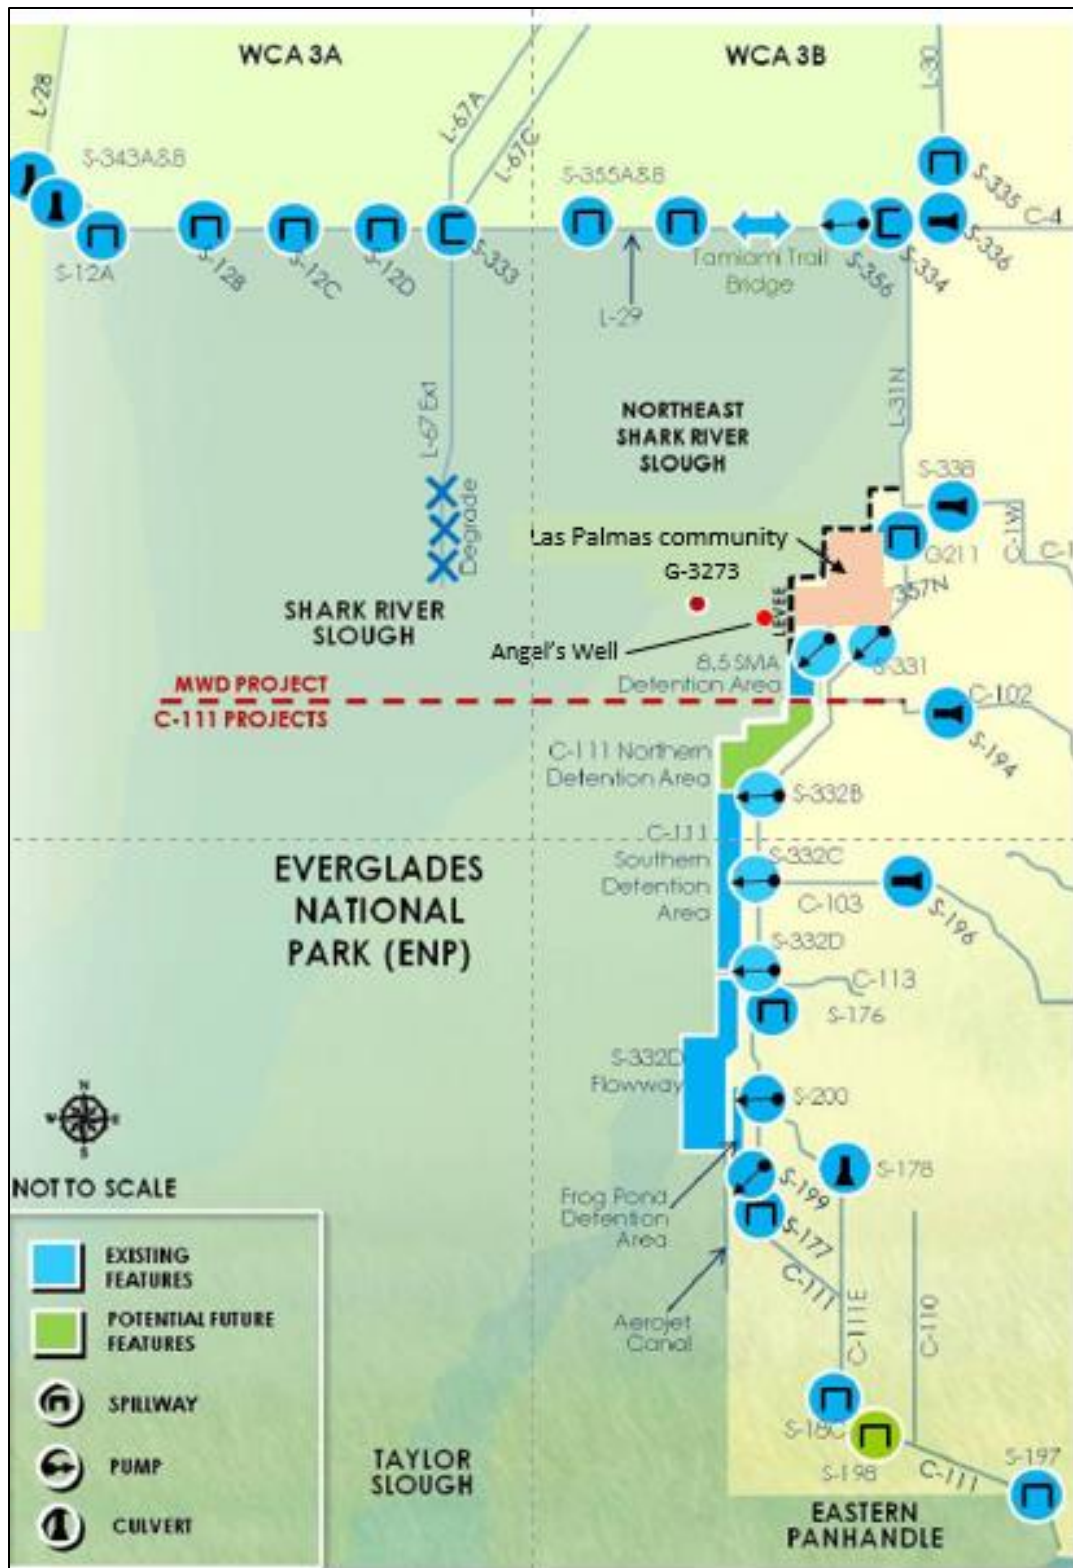
**Figure 17.** Location map of Las Palmas community G-3273 gauge and Angel's Well gauge.

The Las Palmas community, formerly known as the 8.5 Square Mile Area, is located west of Krome Avenue (SW 177<sup>th</sup> Avenue) and north of Richmond Drive (SW 168<sup>th</sup> Street) in southwestern Miami-Dade County. This community experienced high water levels, especially in the southwest corner, due to increased flows to Northeast Shark River Slough. The community also received between four and five inches of rainfall in a 24-hour period on May 4, 2016. Activities undertaken to mitigate for the higher water levels are described in the Emergency Operations section of this report. **Figure 17** shows the location of the Las Palmas community, 8.5 Square Mile Area project features, and two gauges indicative of conditions in the area, G-3273 and Angel's Well.

The G-3273 gauge is approximately 2.5 miles west of the Las Palmas Community and is an indicator of water depths (above and below ground) in Northeast Shark River Slough in ENP. Under the ERTTP water control plan and WCA-3A regulation schedule, the S-333 structure must close if the water stage at this gauge is greater than elevation 6.8 feet NGVD29. This was intended to provide residents of the Las Palmas community the intended level of flood protection afforded by the features of the 8.5 Square Mile Area component of the USACE Modified Water Deliveries to Everglades National Park project. The G-3273 constraint was relaxed as part of the USACE Increment 1 field test and was also not in effect during the emergency operations period. **Figure 18** shows G-3273 being consistently above elevation 6.8 feet NGVD29 after the start of the Increment 1 field test on October 15, 2015. Responses to rainfall events can be seen in December 2015, January 2016, and in early May 2016. The effect of the large Northeast Shark River Slough inflows is also shown with sustained elevations above 7.0 feet NGVD29 and water levels exceeding the 95 percent exceedance band from early January through May 2016.

Angel's Well gauge is closer to Las Palmas, approximately 0.25 miles west of the protective levee surrounding the community, along the theoretical extension of SW 152<sup>nd</sup> Street. **Figure 19** is a similar hydrograph for the Angel's Well gauge and shows more pronounced responses to the noted rainfall events. Water levels began to recede in early April 2016 after SFWMD replaced temporary pumps with an open connection designed to remove water from the C-358 seepage collection canal on the south side of Richmond Drive. The Angel's Well stage steadily declined as a result of SFWMD operations and mitigation efforts in the area (described in the next section), with one reversal due to heavy May 4, 2016, rainfall.

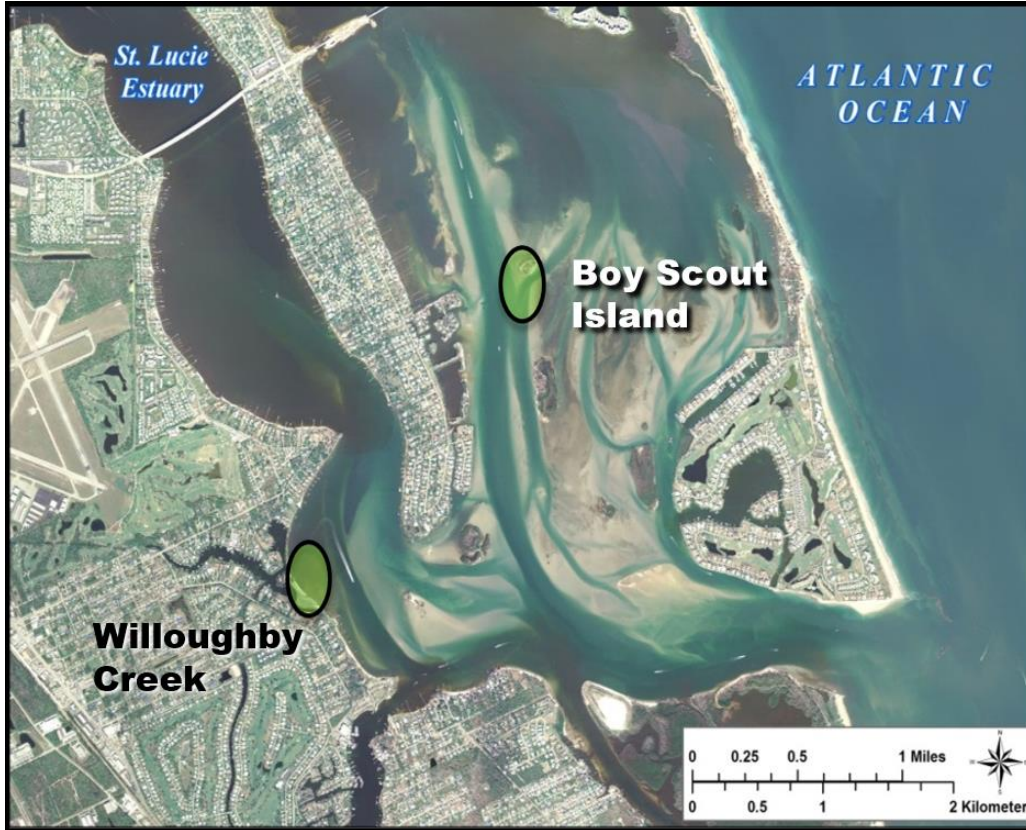
**Figure 40.** RECOVER seagrass monitoring sites in the St. Lucie Estuary.

Seagrasses are also sensitive to salinity; lower salinities cause leaf mortality. Seagrass biomass is routinely monitored in the lower St. Lucie Estuary as part of RECOVER monitoring (**Figure 40**). During the emergency operations period, seagrass biomass was assessed three times at both Willoughby Creek and Boy Scout Island sites (**Figures 41** and **42**, points highlighted in green). The Willoughby Creek site is dominated by Johnson’s seagrass (*Halodule johnsonii*) and shoal grass (*Halodule wrightii*), two low-salinity tolerant species that can recover relatively quickly. The biomass index was relatively high at the beginning of the emergency operations period but then declined (**Figure 40**). However, biomass has begun to recover. It is not known if this variability in biomass is in response to the emergency operations as the measurements fell within what appears to be natural variability of the site.
