M E M O R A N D U M

FROM: SFWMD Staff Environmental Advisory Team

DATE: October 17, 2017

SUBJECT: Weekly Environmental Conditions for Systems Operations

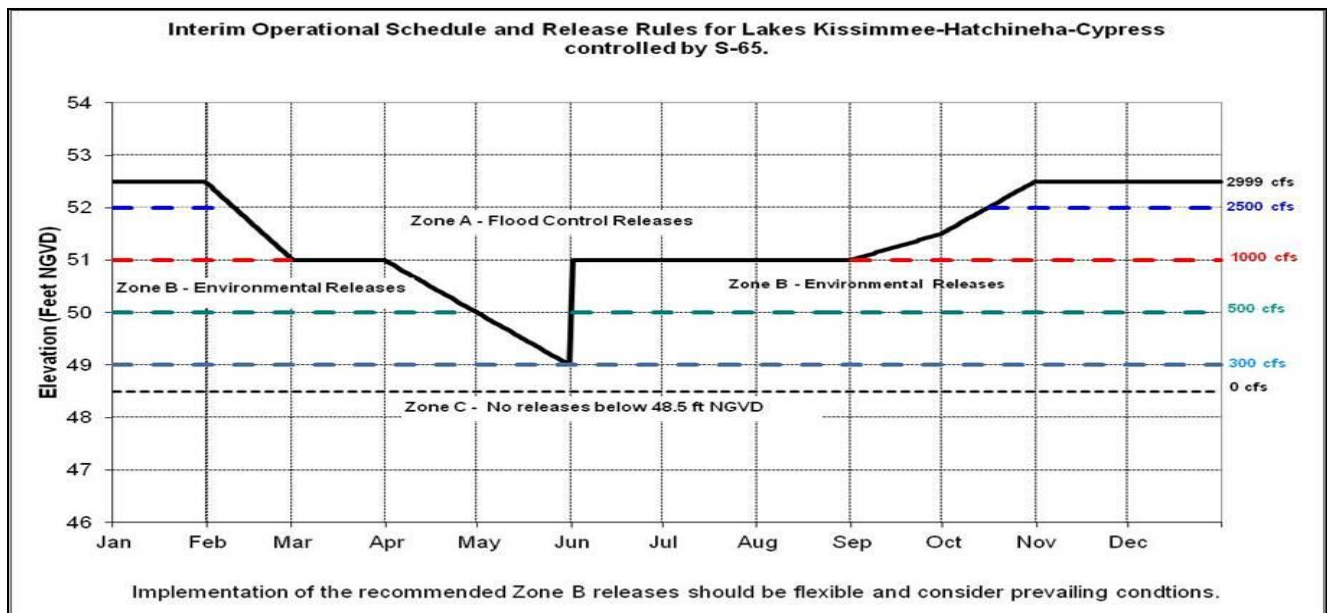
Figure 9. Interim operations schedule for S-65. The discharge schedule shown to the right has not been used in recent years.

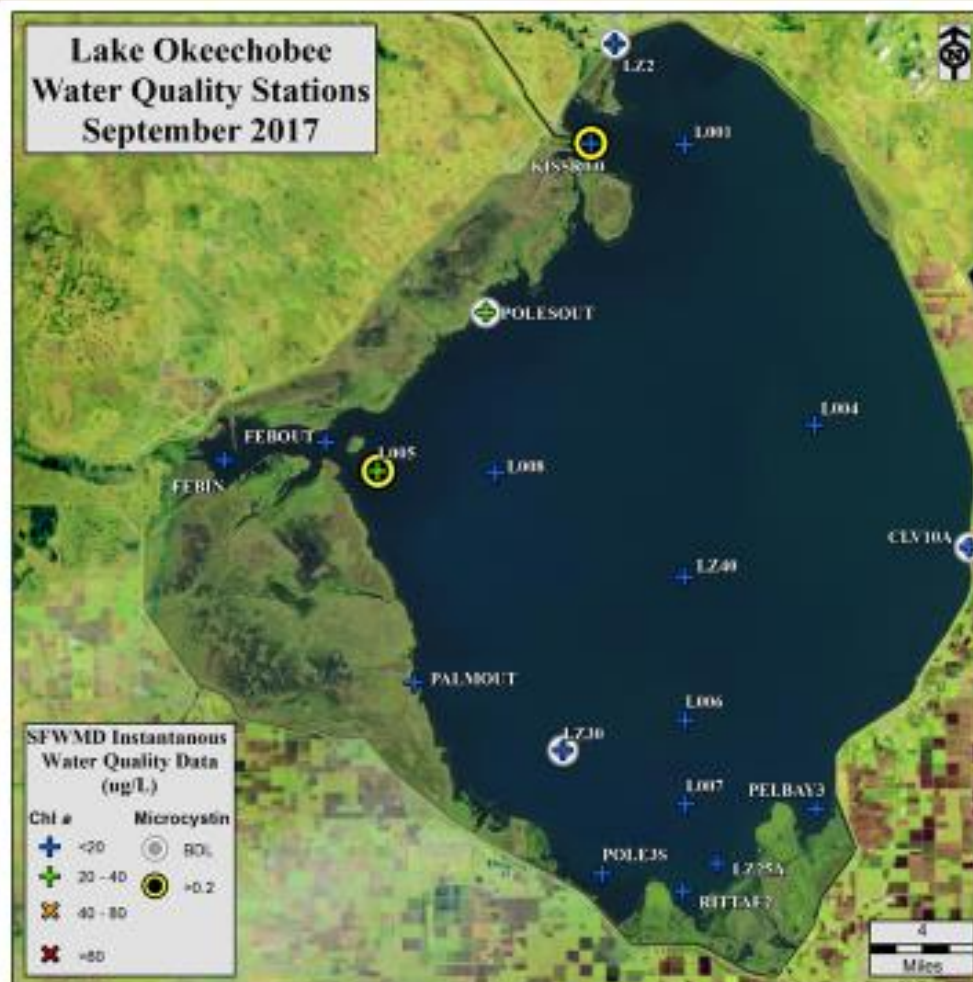
Figure 5

September 18-19, 2017		
Site	Chlorophyll <i>a</i> (ug/L)	Microcystin (ug/L)
Nearshore Stations		
FEBIN	3.3	
FEBOUT	17.3	
KISSR0.0	15.5	0.23
LZ2	18.9	BDL
LZ25A	9.0	
PALMOUT	17.8	
PELBAY3	8.7	
POLE3S	17.1	
POLESOUT	32.6	BDL
RITTAE2	10.6	
Pelagic Stations		
L001	17.5	
L004	8.9	
L005	35.0	0.29
L006	5.0	
L007	10.2	
L008	10.0	
LZ30	10.9	BDL
LZ40	4.3	
CLV10A	6.8	BDL

Hurricane Irma increased total phosphorous (TP) concentrations by resuspending phosphorous-laden sediments from the muddy, pelagic zone of the Lake, and bringing in phosphorous-laden inflows from flooded watersheds. But the algal bloom potential remains low, as evidenced by the post-Hurricane Irma, mid-September Chlorophyll a (Chla) counts and NOAA's cyanobacteria monitoring product derived from the OLCI satellite sensor. None of the 19 sites sampled for Chla were higher than 40 ug/L, the minimum value considered as an algal bloom (Figure 5). Satellite imagery also indicated no areas of the Lake had potential for cyanobacterial blooms, since early September and prior to Hurricane Irma (Figure 6).

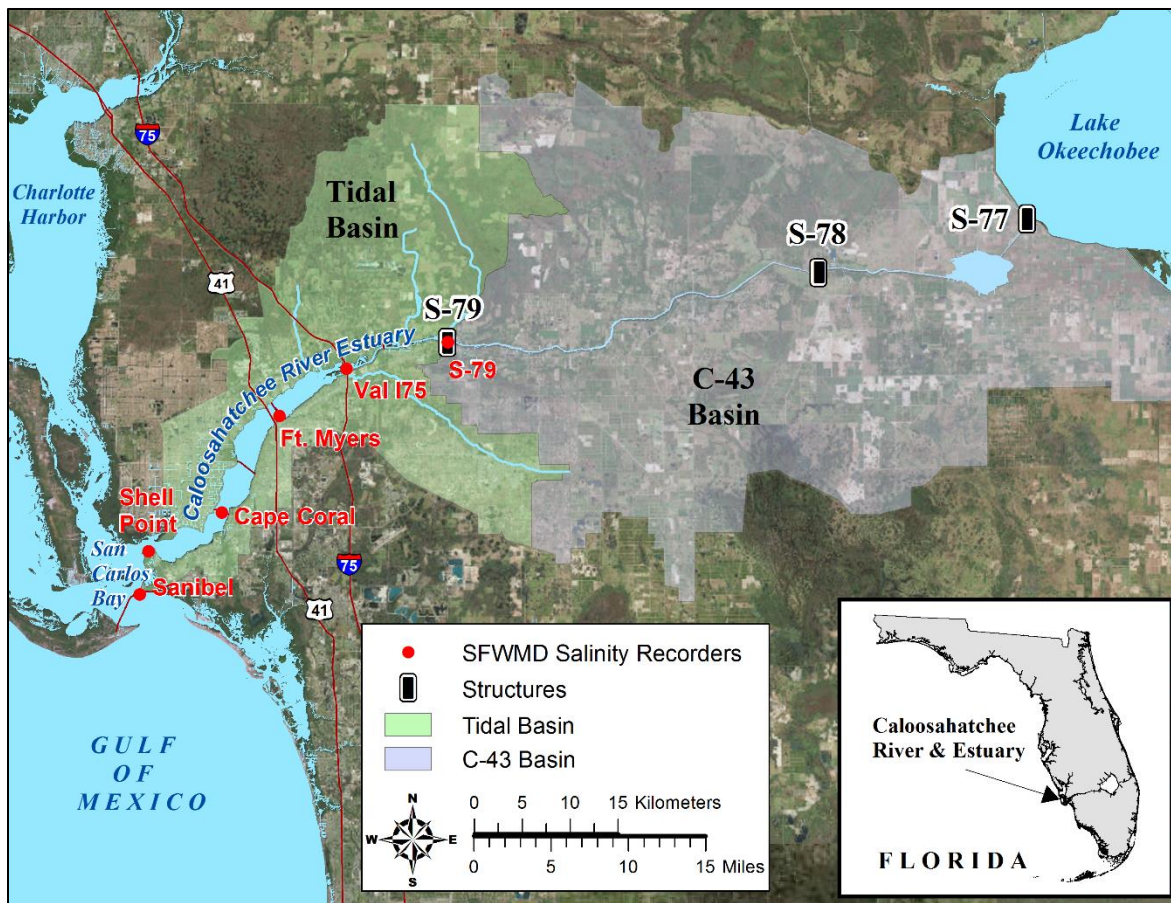
Figure 7. Basins, water control structures, and salinity monitoring for the Caloosahatchee Estuary.

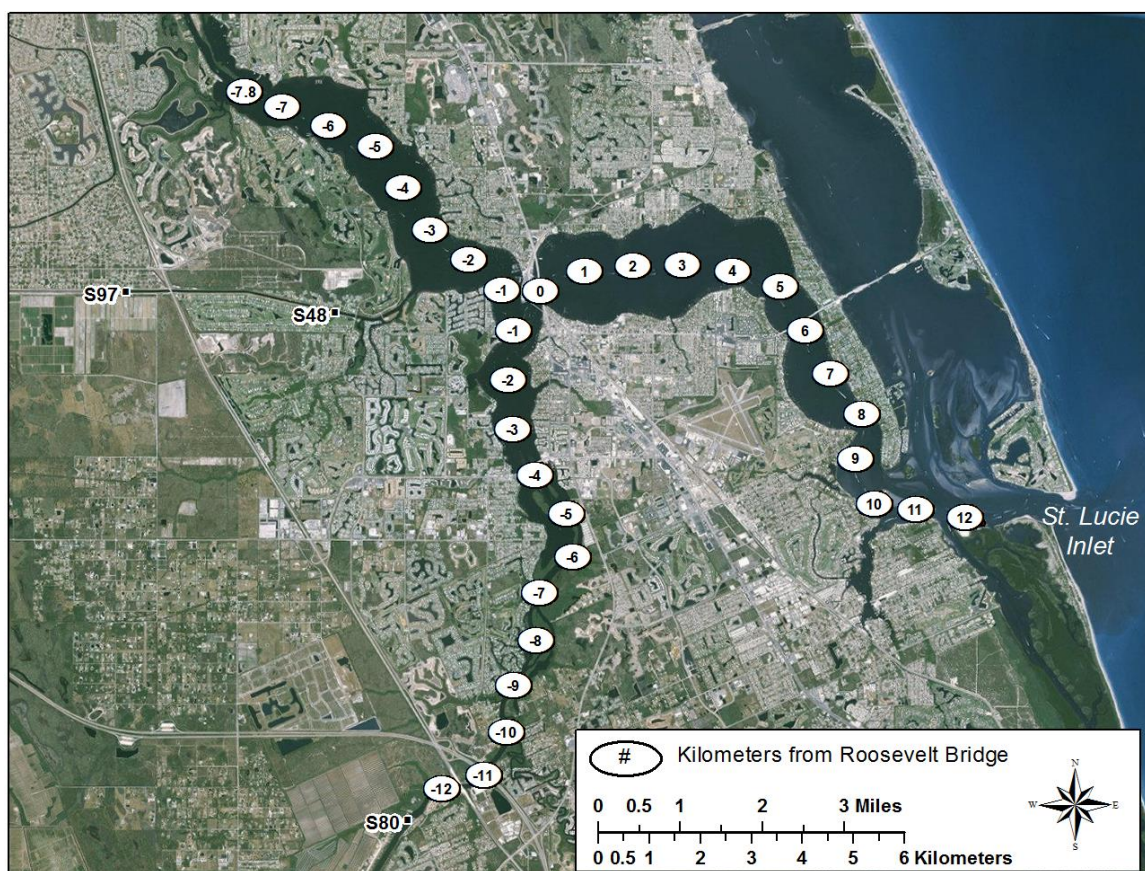
Figure A2. Water quality mapping track with river kilometers away from the Roosevelt Bridge (US1).

The St. Lucie Estuary survey track covers the St. Lucie inlet to the Roosevelt Bridge, the North Fork up to Fork Point, and the South Fork to S-80 (Figure A2). Turbidity is quite high near the S-80 structure and particulate and dissolved material is most likely being flushed down the estuary (Figure A3). Higher flushing time in South Fork combined with low light penetration due to high turbidity are keeping chlorophyll *a* concentrations relatively low in this part of the estuary compared to other parts of the estuary (Figure A4).
