M E M O R A N D U M

DATE: May 8, 2018

SUBJECT: Weekly Environmental Conditions for Systems Operations

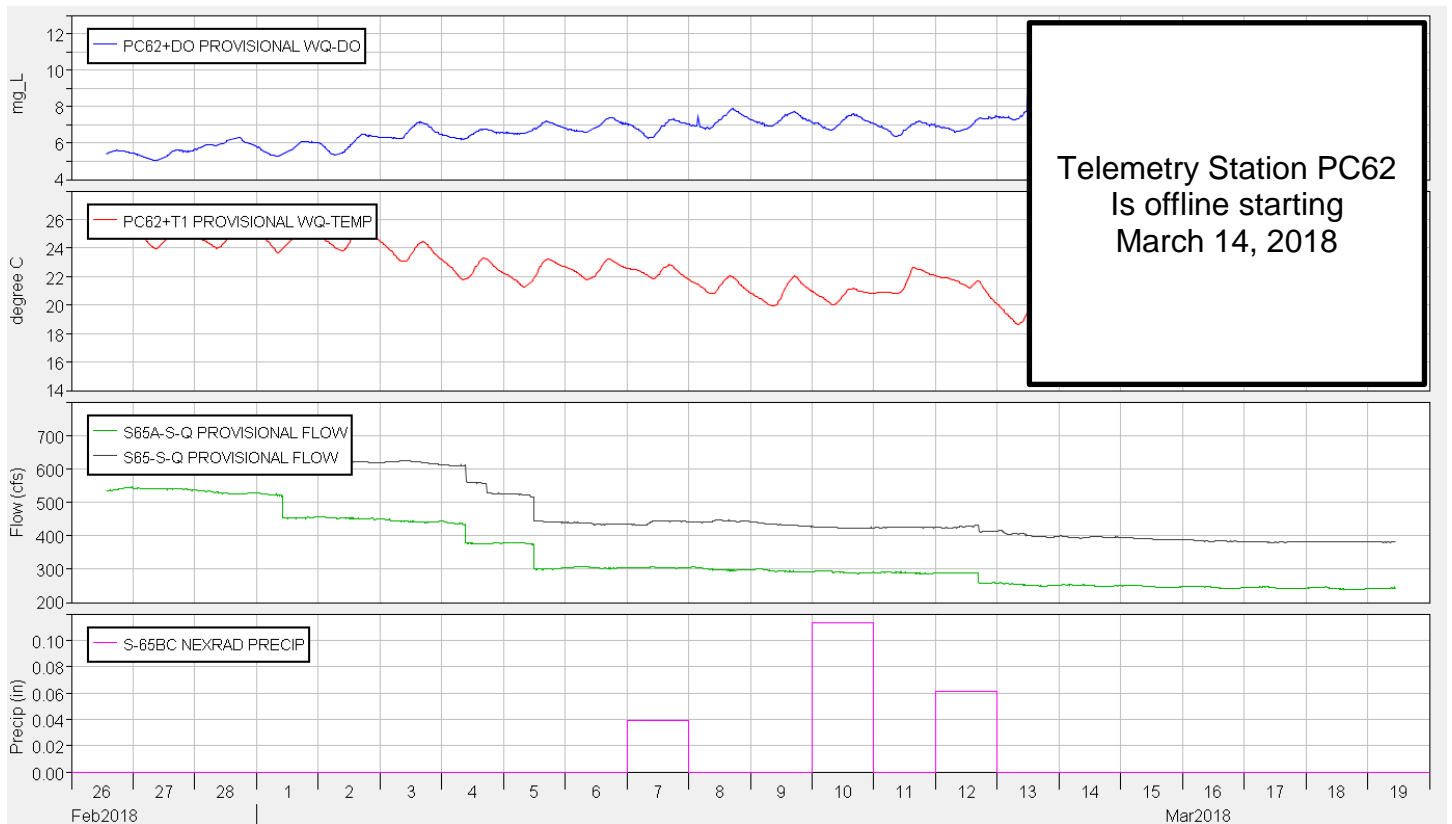
Figure 11. Phase I river channel dissolved oxygen and water temperature (measured at 15-minute intervals) and Pool BC daily rainfall.

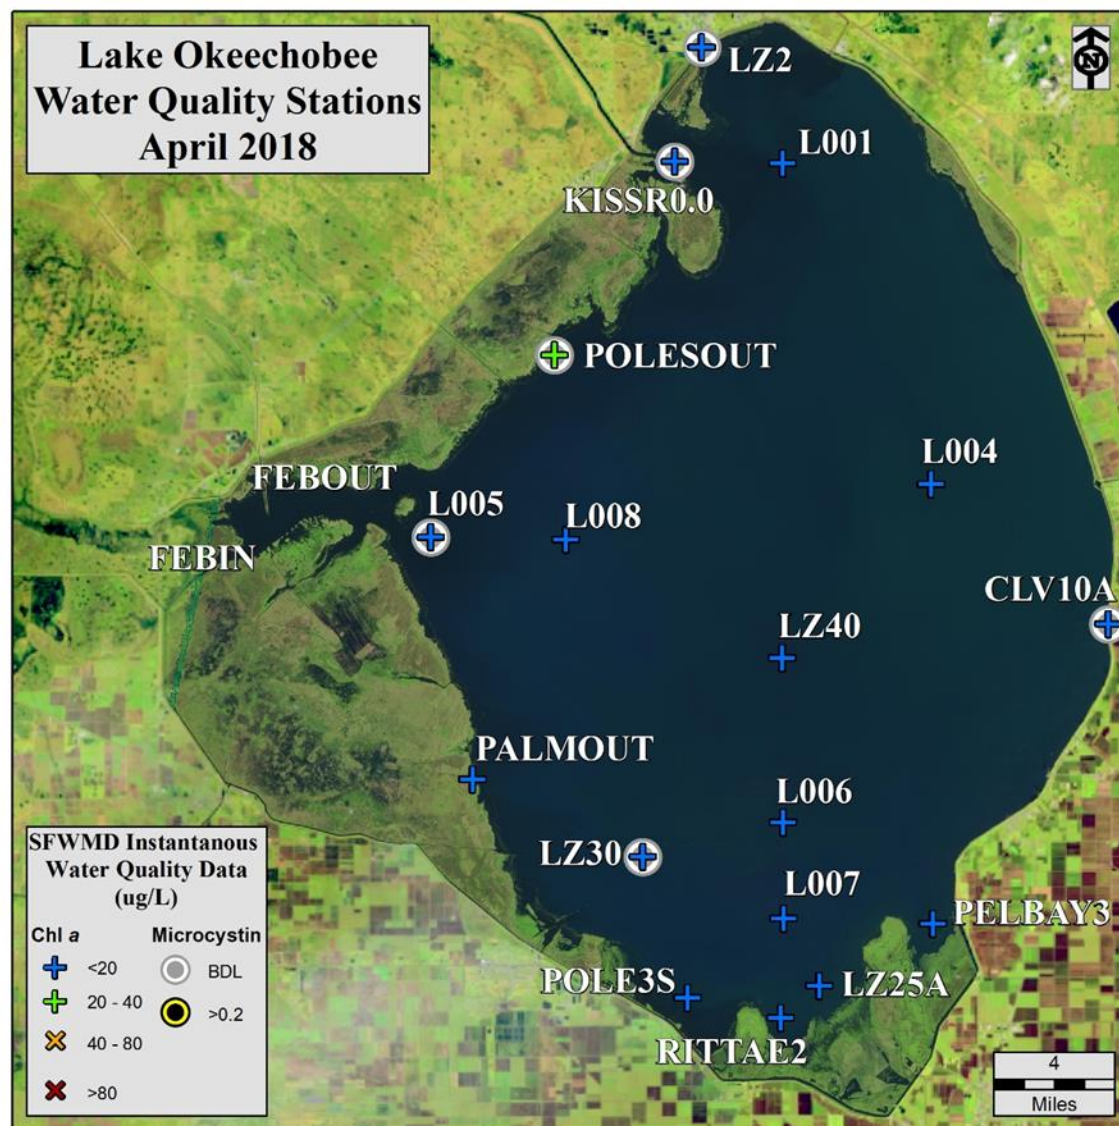
April 3 - 4, 2018		
Site	Chlorophyll <i>a</i> (µg/L)	Microcystin (µg/L)
Nearshore Stations		
FEBIN		
FEBOUT		
KISSR0.0	16.4	BDL
LZ2	19.0	BDL
LZ25A	2.7	
PALMOUT	12.9	
PELBAY3	2.3	
POLE3S	6.4	
POLESOUT	29.2	BDL
RITTAE2	10.9	
Pelagic Stations		
L001	8.3	
L004	5.2	
L005	10.4	BDL
L006	8.4	
L007	4.6	
L008	10.1	
LZ30	6.4	BDL
LZ40	6.6	
CLV10A	6.8	BDL

Figure 7. Chlorophyll *a* (µg/L) and microcystin (µg/L) values for nearshore and pelagic stations for mid-March. Microcystin values below 0.20 µg/L are below detection limit (BDL).

Chlorophyll a (Chla) and microcystin values remain low throughout the Lake, despite relatively high TP values and low turbidity (Figure 7). The highest chlorophyll a occurred in the nearshore zone by Indian Prairie, with a value of 29.2 µg/L. The most recent satellite imagery using the cyanobacteria monitoring product derived from NOAA's OLCI satellite sensor also suggests cyanobacteria bloom potential remains low, although there was some cloud cover over portions of the pelagic zone (Figure 8). Last summer, the potential for elevated cyanobacterial levels increased in early July, when winds subsided and turbidity values plummeted.
