M E M O R A N D U M

DATE: March 24, 2021

SUBJECT: Weekly Environmental Conditions for Systems Operations

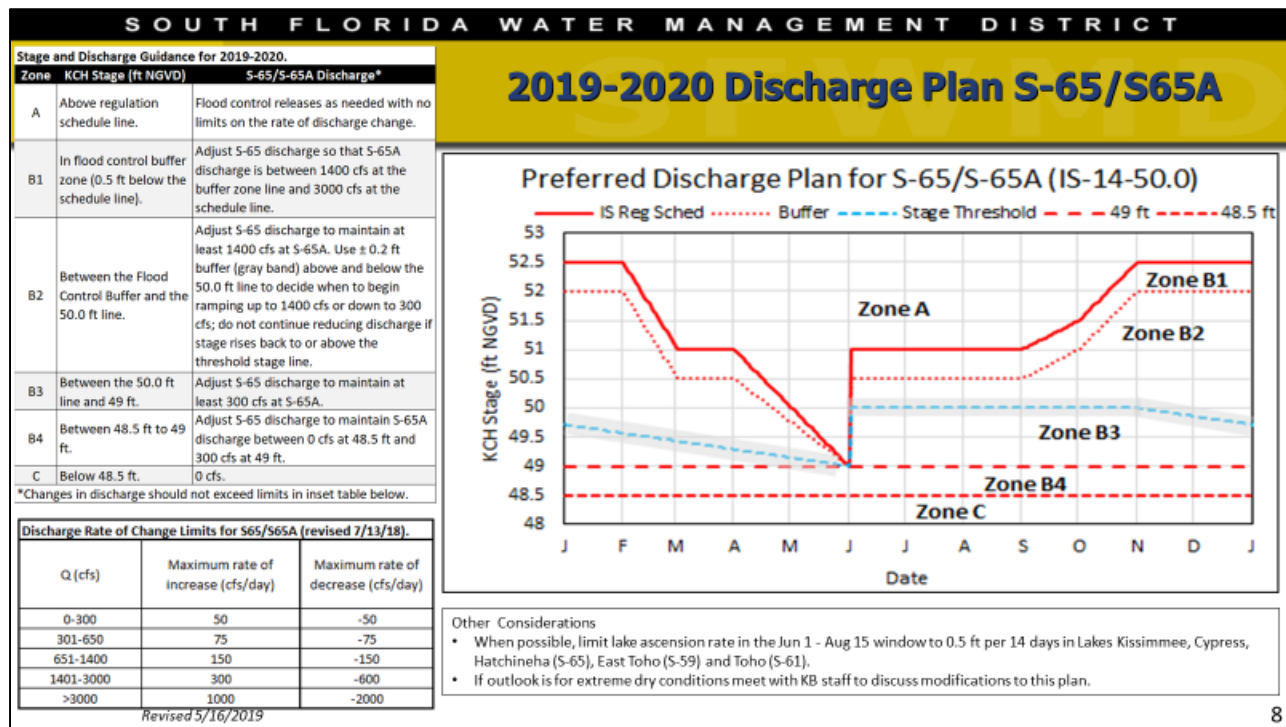
Figure 6. The 2019-2020 Discharge Plan for S-65/S-65A.

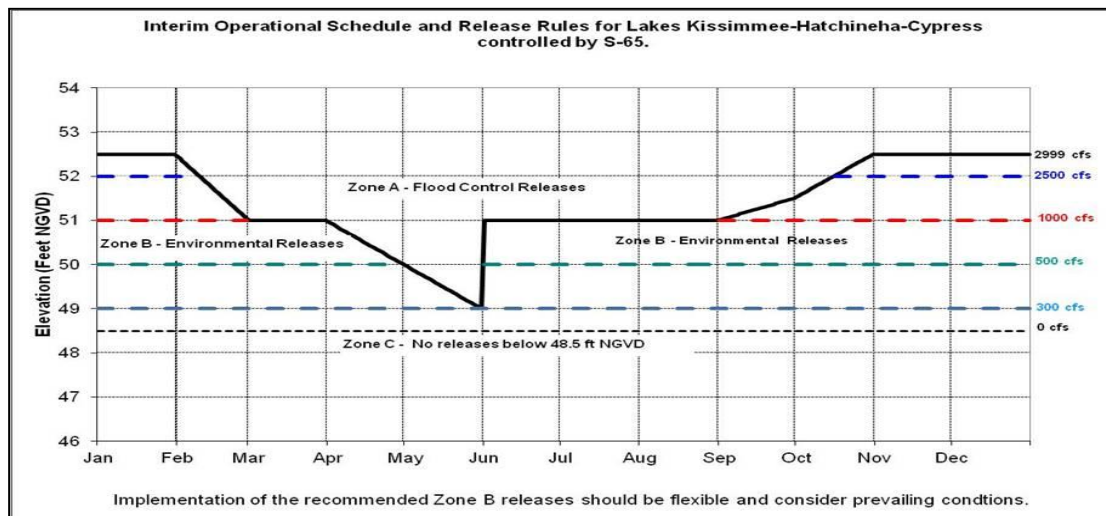
Figure 7. Interim operations schedule for S-65 (solid black line). The discharge schedule shown to the right has not been used in recent years.
