Technical Memorandum

DATE: August 1, 2005

- FROM: Deborah Daigle, P.G, Sr. Hydrogeologist Barry Meyer, P.E., Project Design Director
- SUBJECT: Documentation of Existing Information, Site Conditions and Site History C-44 Reservoir/Stormwater Treatment Area (STA) Porject CN040918, Work Order 6, Task 1, P507.5.1.2.6.1

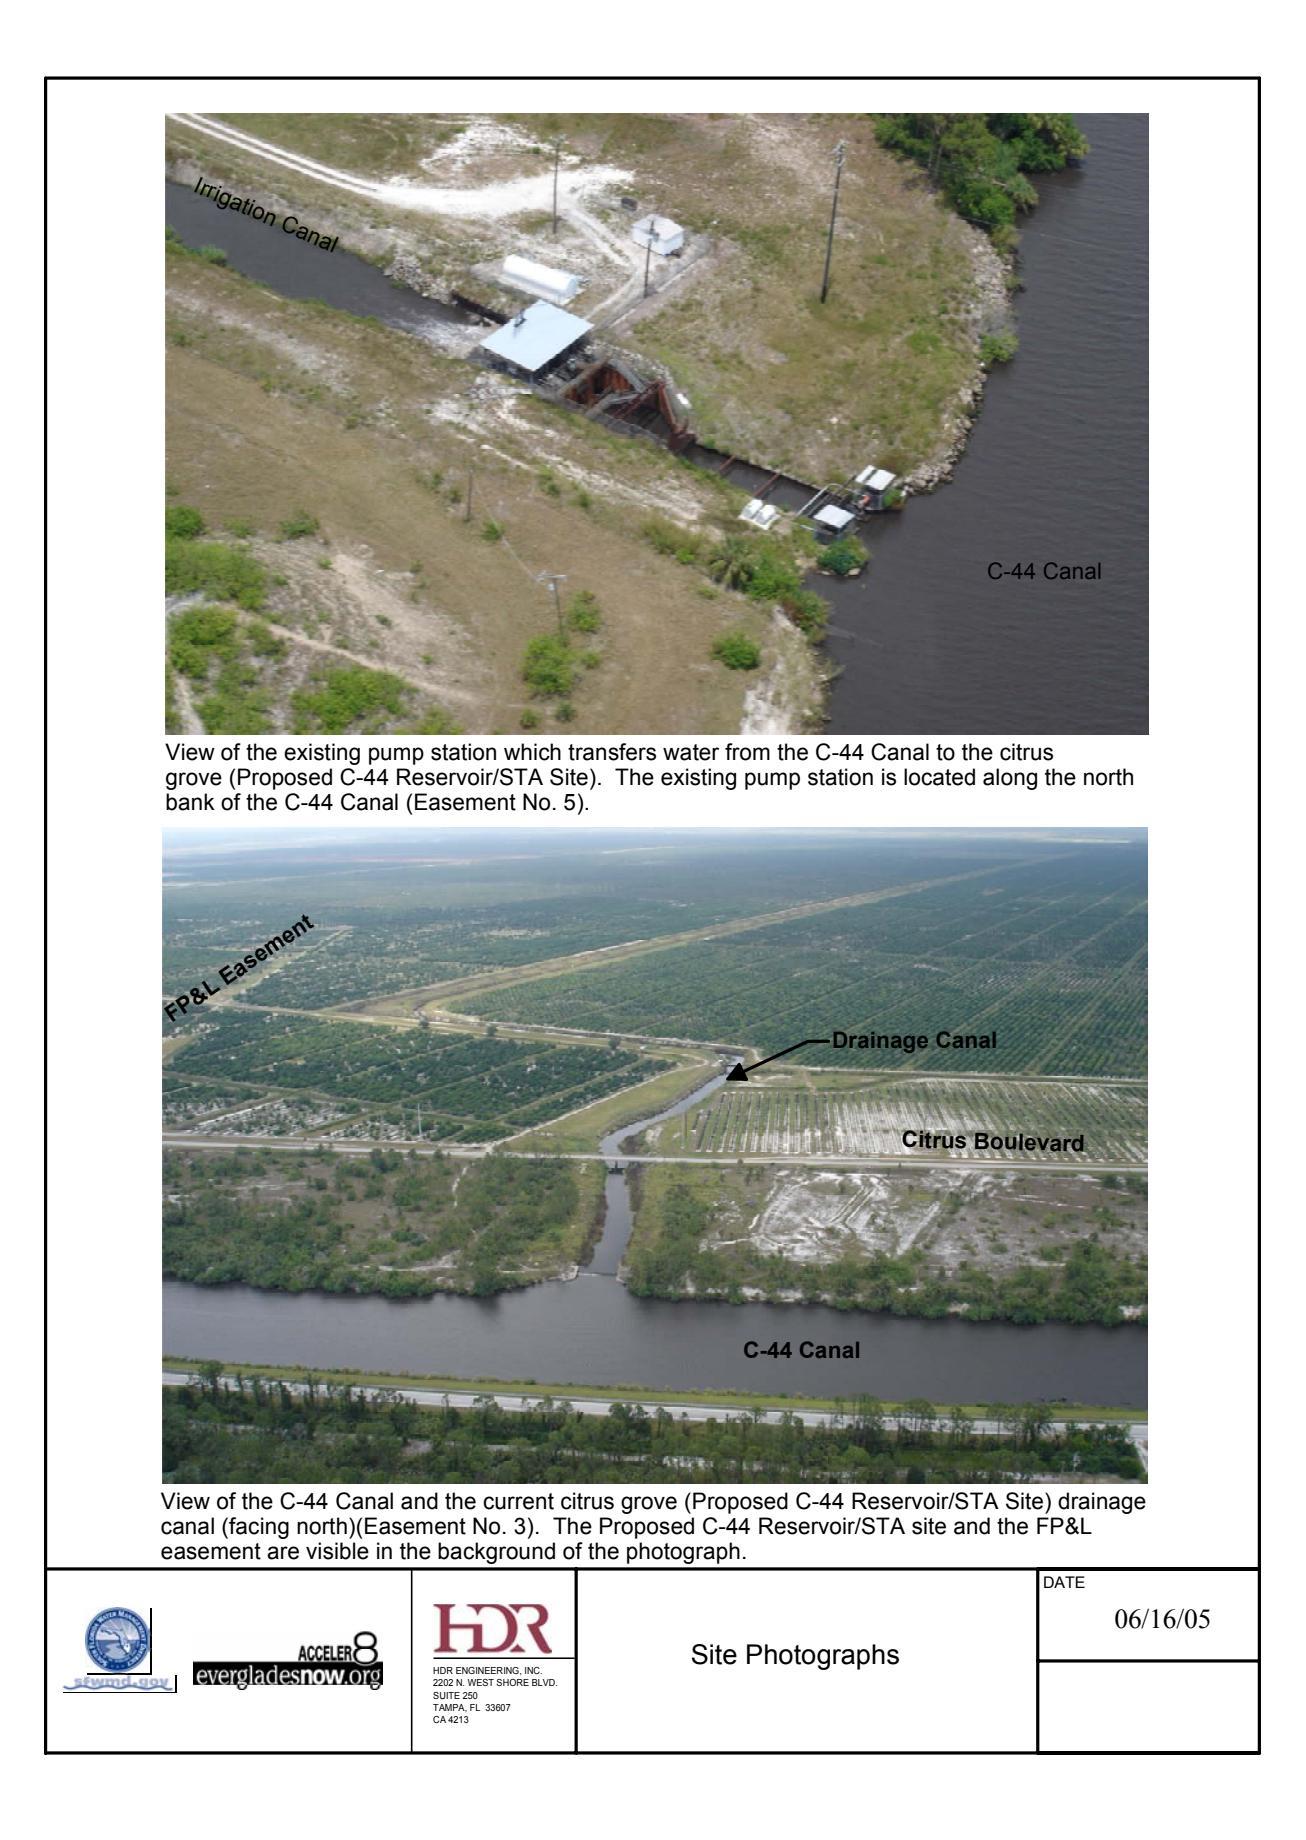
View of the C-44 Canal and an existing citrus grove irrigation canal and pump station located at the southeast corner of the Proposed C-44 Reservoir/STA Site (facing northwest) (Easement No. 1).
