# Evaluation Report

## Repair, Maintenance and Transition Plan

# US Sugar Corporation

# South Florida Water Management District

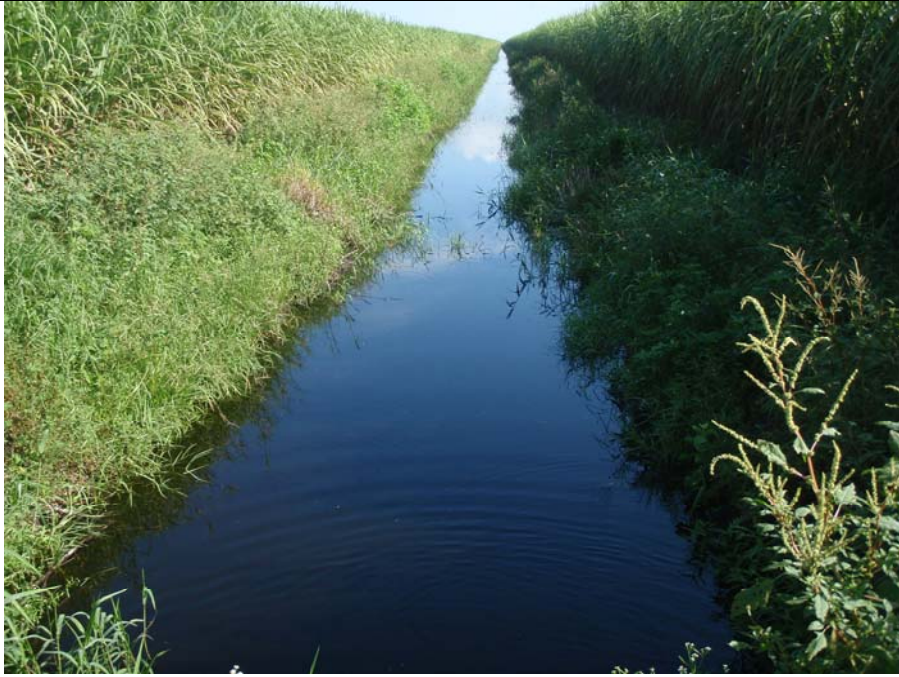
<p><b>Site Name: US Sugar Corporation</b></p>	<p><b>Site Location:</b> Clewiston, Florida</p>
<p><b>Photographer</b> Nicolas Moran</p> <p><b>Date</b> August 6 - August 24, 2008</p> <p><b>Direction</b> North</p> <p><b>Comments</b> A canal with a green grade. Canal banks are clean and stable. The surface is clear of vegetation to allow designed movement of water.</p>

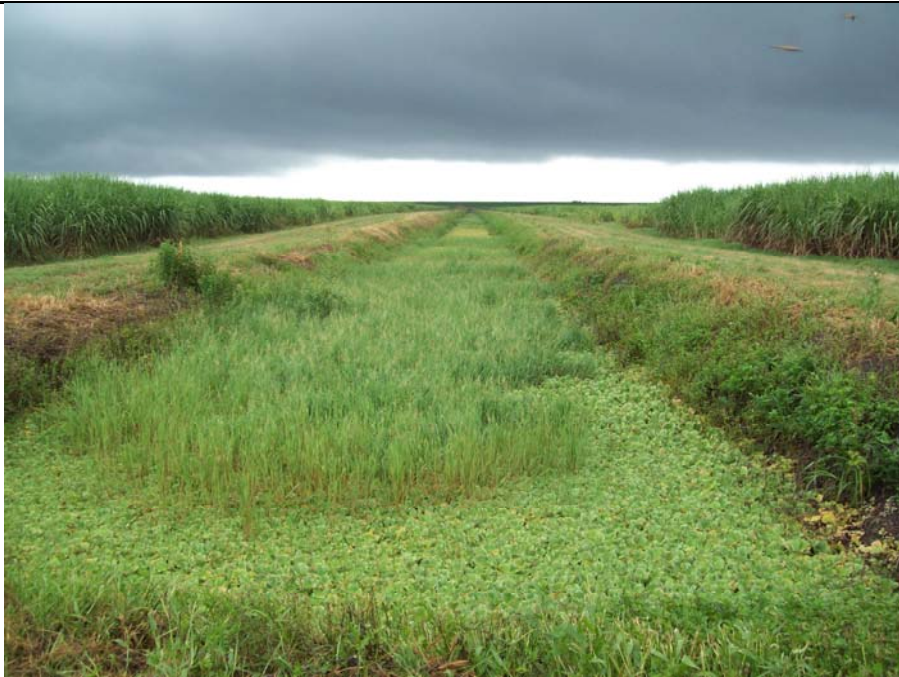
<p><b>Photographer</b> Nicolas Moran</p> <p><b>Date</b> August 6 - August 24, 2008</p> <p><b>Direction</b> East</p> <p><b>Comments</b> <b>A canal with an amber grade. The canal is heavily vegetated with floating plants. Canal still allows water movement below surface.</b></p>

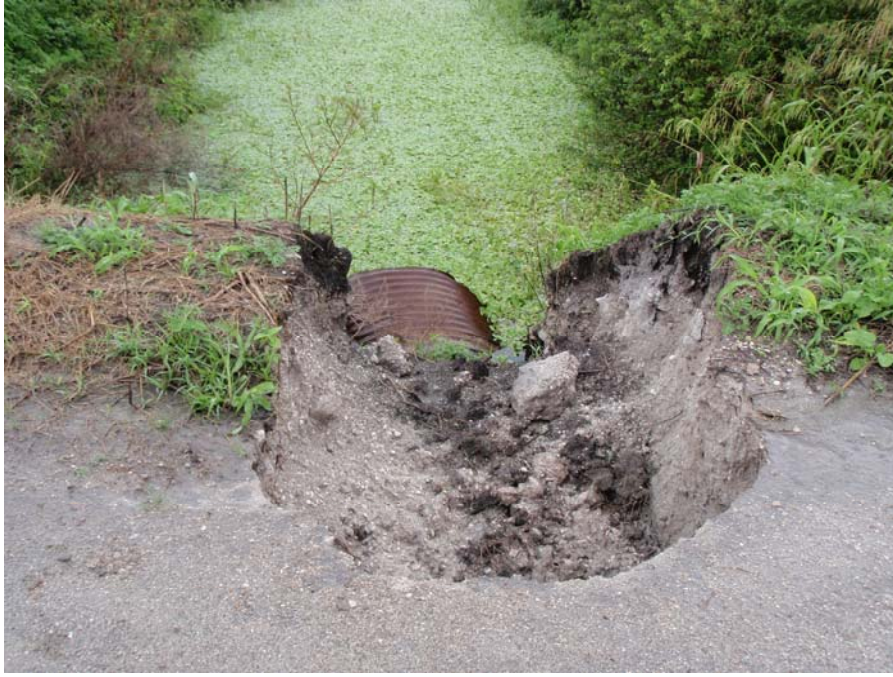
<p><b>Photographer</b> Nicolas Moran</p> <p><b>Date</b> August 6 - August 24, 2008</p> <p><b>Direction</b> South</p> <p><b>Comments</b> A road with a red grade. Soil above culvert has collapsed and eroded compromising the safety of the road.</p>

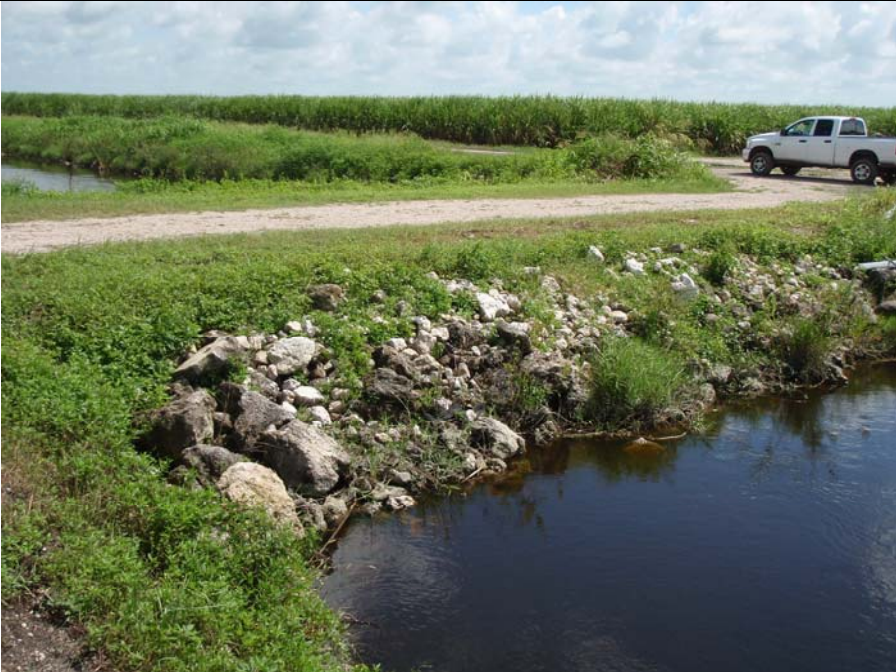
<p><b>Site Name: US Sugar Corporation</b></p>	<p><b>Site Location:</b> Clewiston, Florida</p>
<p><b>Photographer</b> Nicolas Moran</p> <p><b>Date</b> August 6 - August 24, 2008</p> <p><b>Direction</b> North</p> <p><b>Comments</b> A road with a green grade. Road is smooth and stable and does not limit vehicle movement.</p>

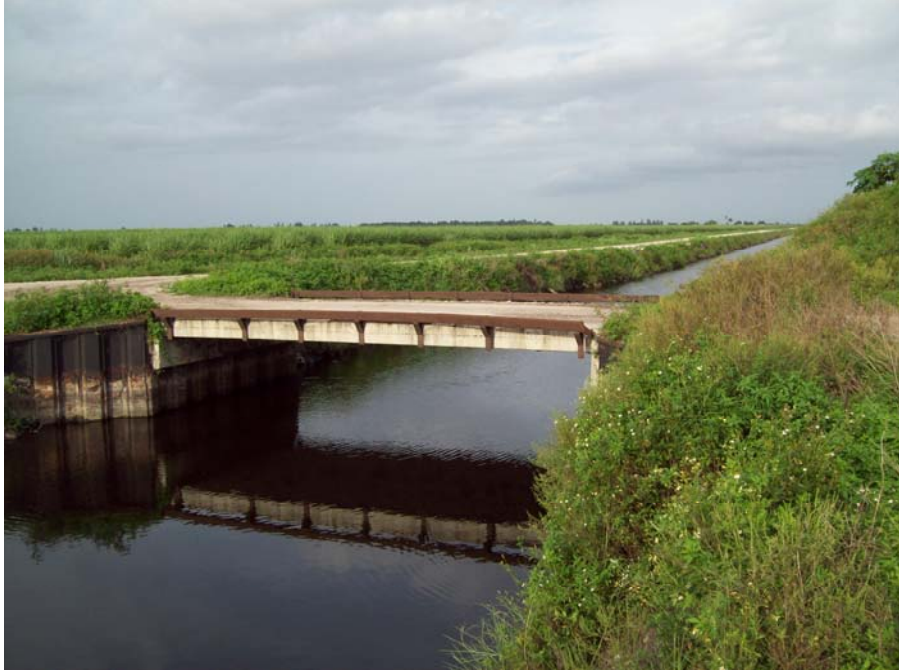
<b>Site Name: US Sugar Corporation</b>	<b>Site Location: Clewiston, Florida</b>
<b>Photographer</b> T.J. Rew <b>Date</b> August 6 - August 24, 2008 <b>Direction</b> West <b>Comments</b> A bridge with an amber grade. Bridge side railing is corroded and bent from vehicle impact.

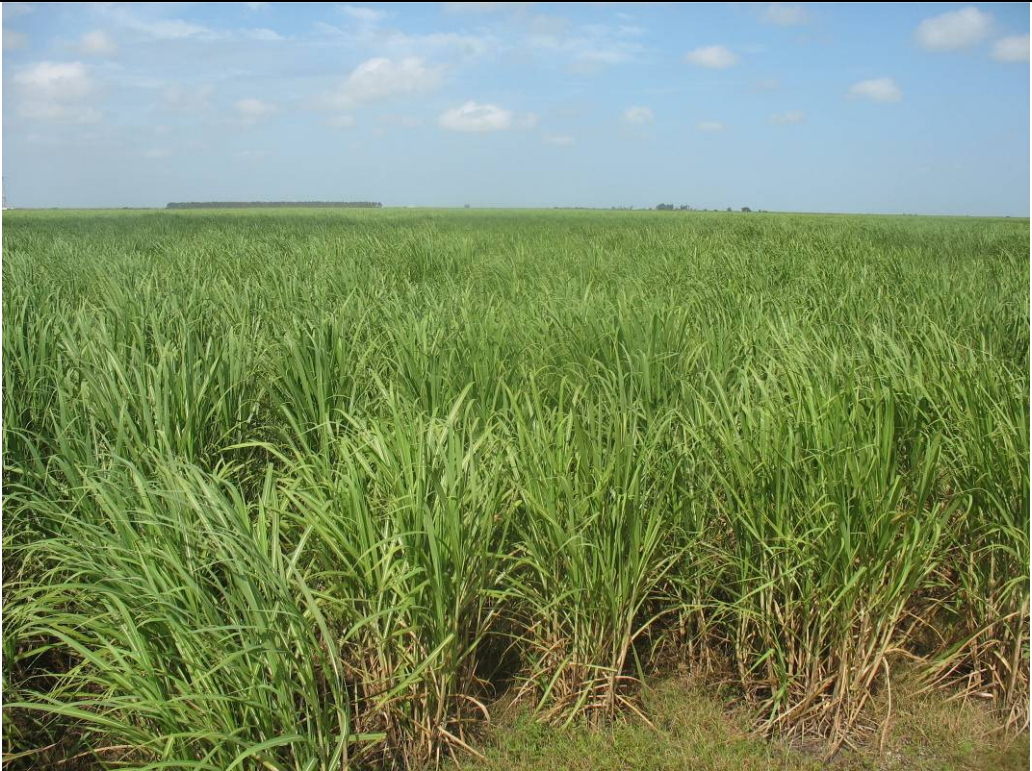
A man wearing a light-colored button-down shirt, blue jeans, a white cap, and sunglasses stands in a field of tall, green sugar cane stalks. The stalks are dense and reach above his head. The ground is sandy and has some low-lying green weeds.
<b>Photographer</b> B. Whiteley <b>Date</b> 9/25/2008 <b>Direction</b> West <b>Comments</b> Poor Cane on Sand. Overview.

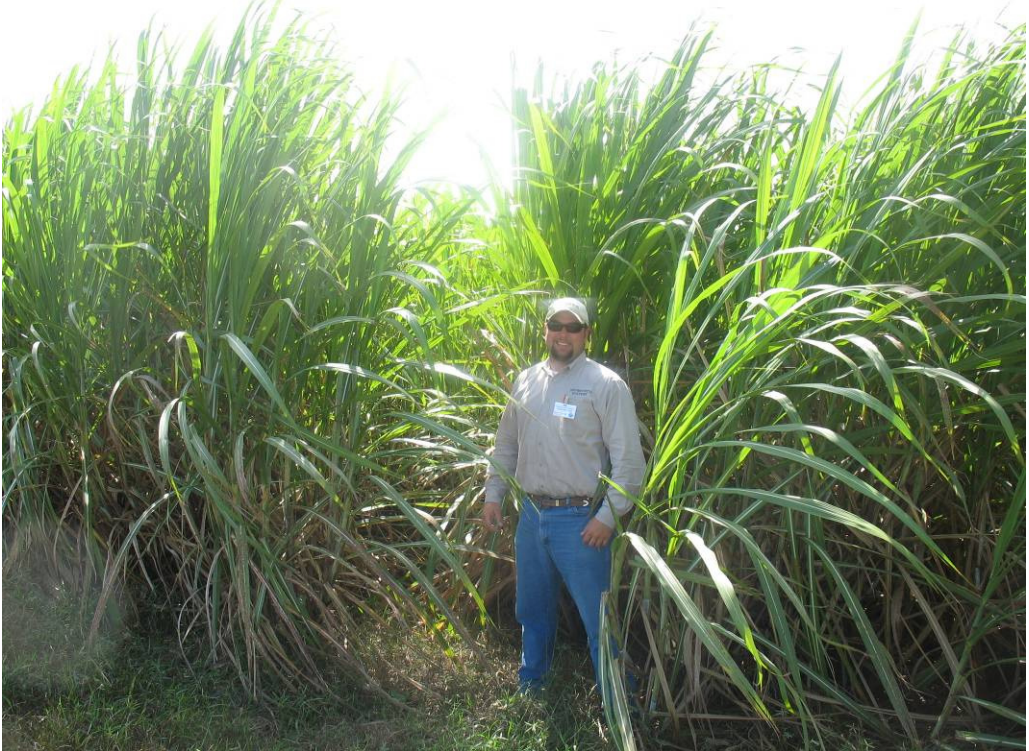
<b>Site Name:</b> US Sugar Corporation	<b>Site Location:</b> US Sugar Corporation Sugar Cane Cropland
<b>Photographer</b> B. Whiteley  <b>Date</b> 9/25/2008  <b>Direction</b> South  <b>Comments</b> Excellent Cane on Sand. Ground-level.

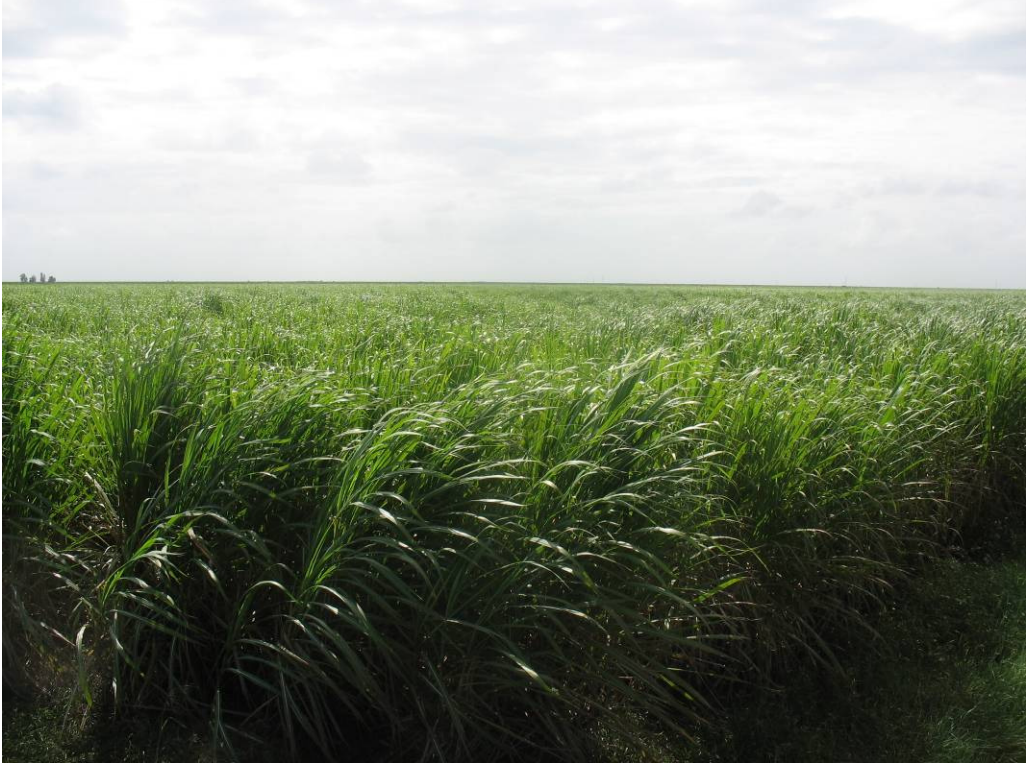
<b>Photographer</b> B. Whiteley  <b>Date</b> 9/25/2008  <b>Direction</b> South East  <b>Comments</b> Excellent Cane on Sand. Overview.

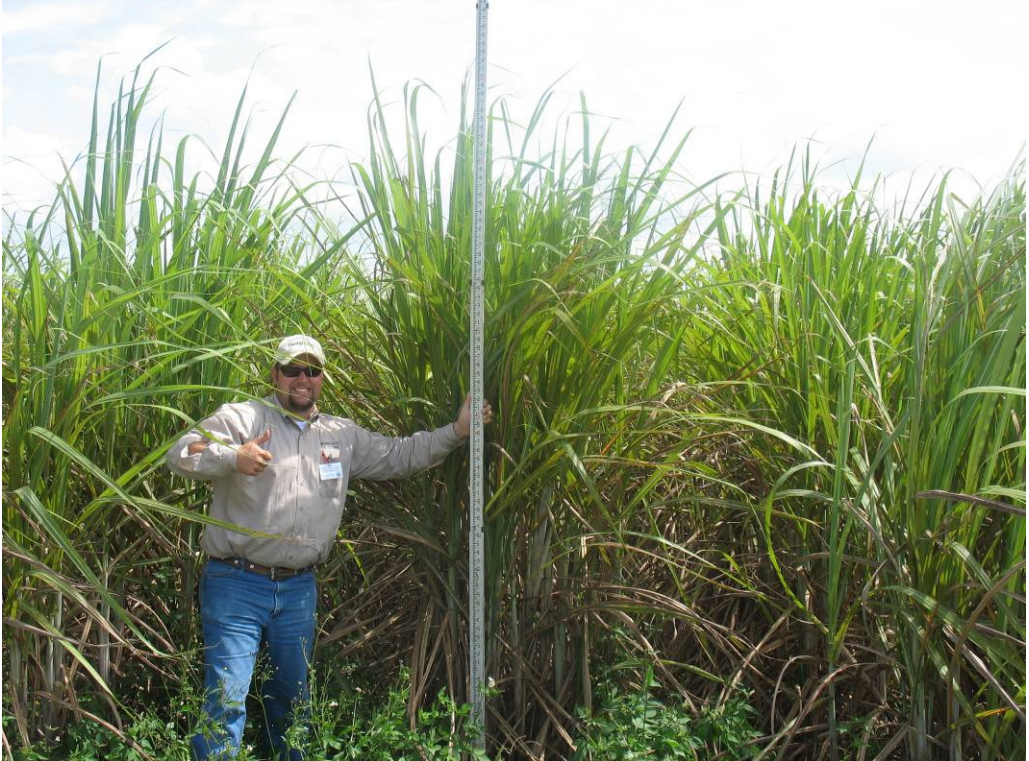
<b>Site Name:</b> US Sugar Corporation	<b>Site Location: US Sugar Corporation Sugar Cane Cropland</b>
<b>Photographer</b> B. Whiteley <b>Date</b> 9/25/2008 <b>Direction</b> North West <b>Comments</b> Poor Cane on Muck. Ground-level.

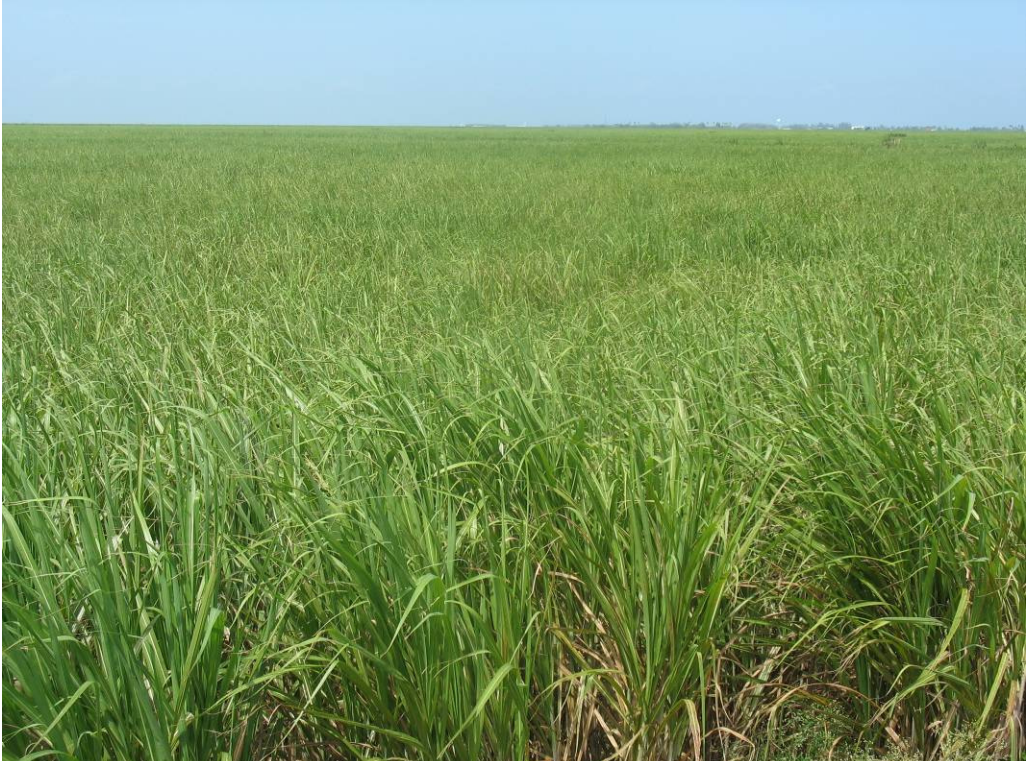
<b>Photographer</b> B. Whiteley <b>Date</b> 9/25/2008 <b>Direction</b> North West <b>Comments</b> Poor Cane on Muck. Overview.

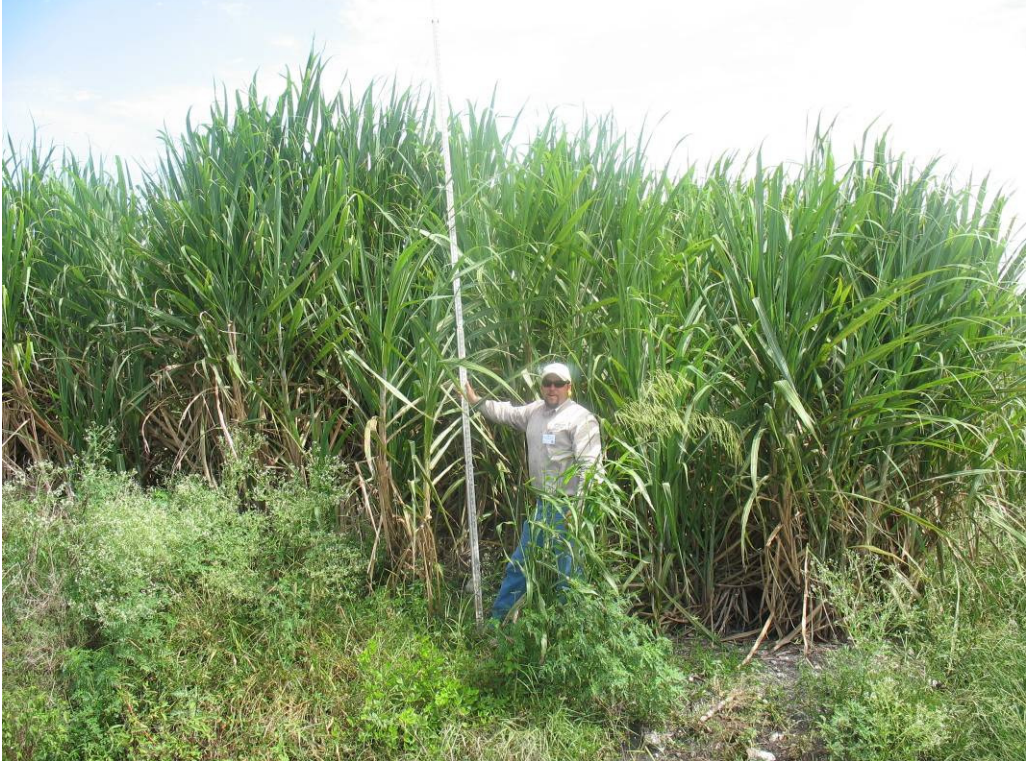
<b>Site Name:</b> US Sugar Corporation	<b>Site Location: US Sugar Corporation Sugar Cane Cropland</b>
<b>Photographer</b> B. Whiteley <b>Date</b> 9/25/2008 <b>Direction</b> North <b>Comments</b> Excellent Cane on Muck. Ground-level.

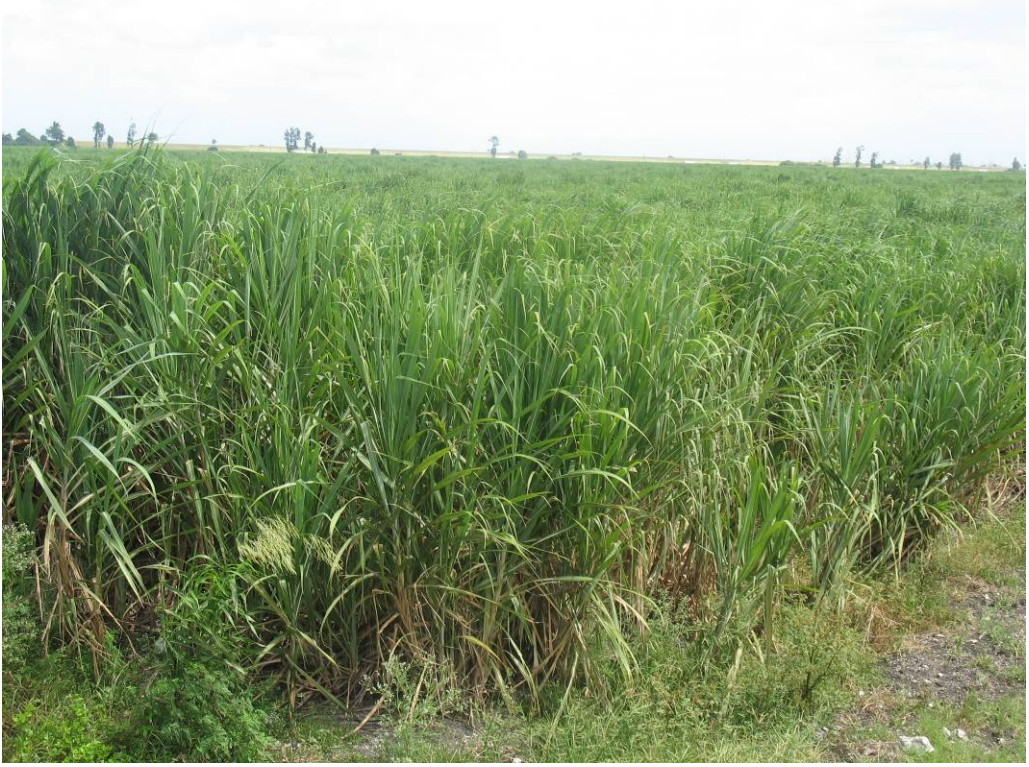
<b>Photographer</b> B. Whiteley <b>Date</b> 9/25/2008 <b>Direction</b> North East <b>Comments</b> Excellent Cane on Muck. Overview.

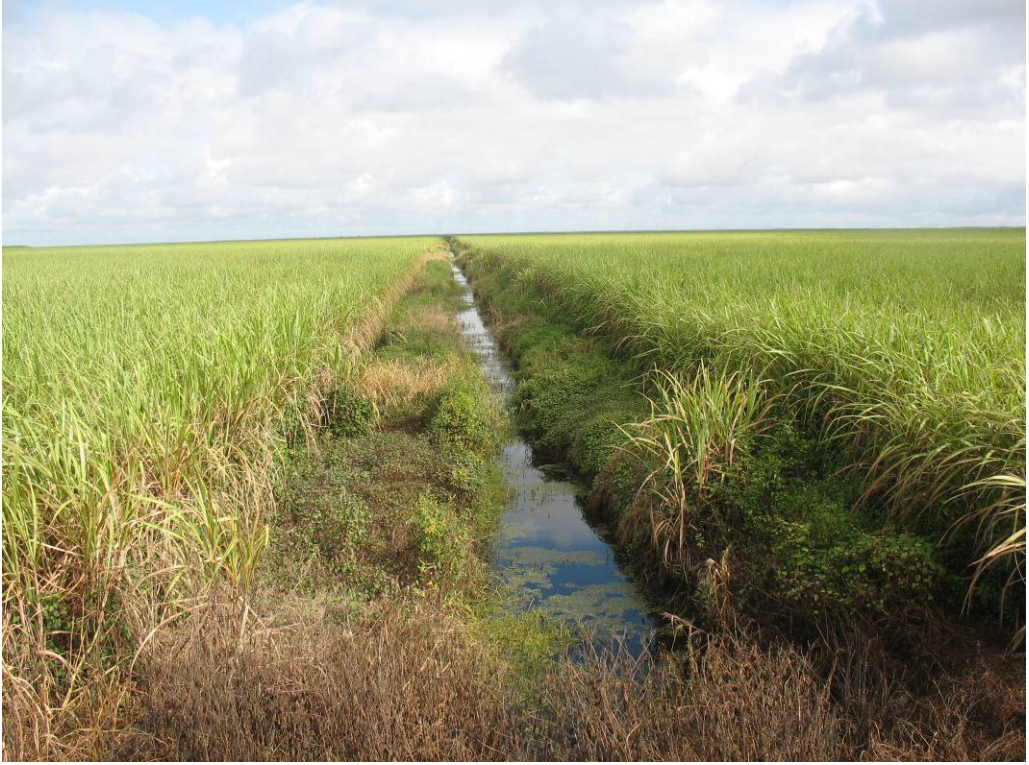
<b>Site Name:</b> US Sugar Corporation	<b>Site Location:</b> US Sugar Corporation Sugar Cane Cropland
<b>Photographer</b> B. Whiteley <b>Date</b> 9/29/2009 <b>Direction</b> North <b>Comments</b> Moderate Cane. Vegetated Lateral.

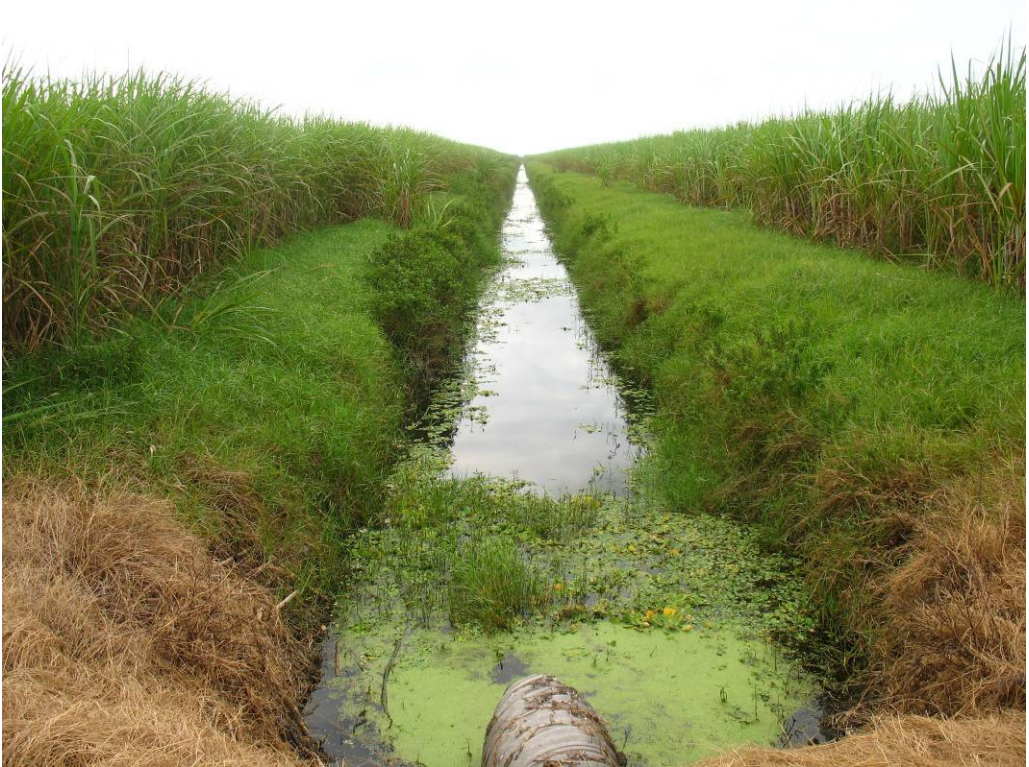
<b>Photographer</b> B. Whiteley <b>Date</b> 9/28/2008 <b>Direction</b> South <b>Comments</b> Moderate Cane. Clear Lateral.

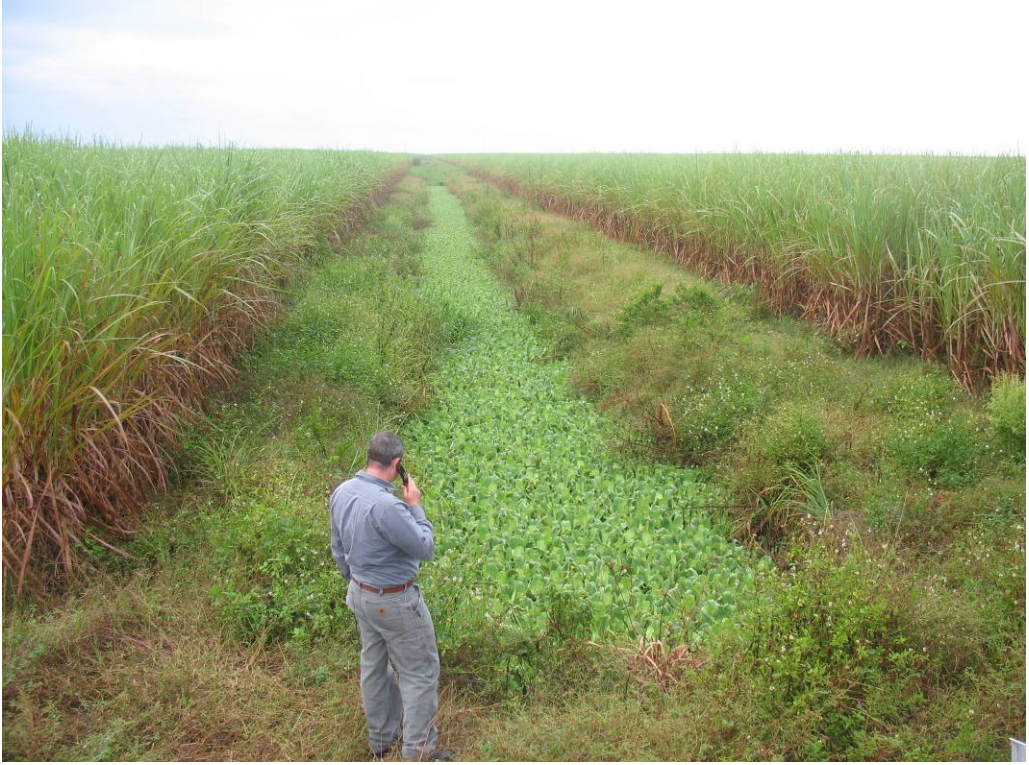
<b>Site Name:</b> US Sugar Corporation	<b>Site Location:</b> US Sugar Corporation Sugar Cane Cropland
<b>Photographer</b> B. Whiteley <b>Date</b> 9/30/2008 <b>Direction</b> South <b>Comments</b> Good Cane. Vegetated Lateral.

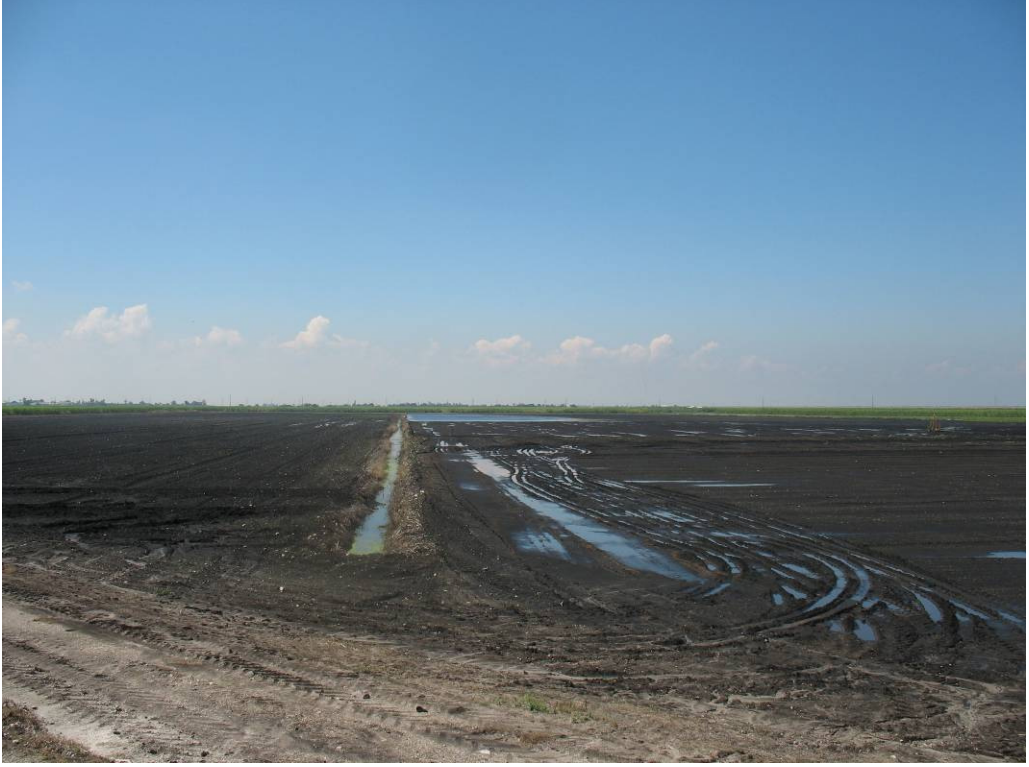
<b>Photographer</b> B. Whiteley <b>Date</b> 10/01/2008 <b>Direction</b> West <b>Comments</b> Ponding Visible on Fallow Field.

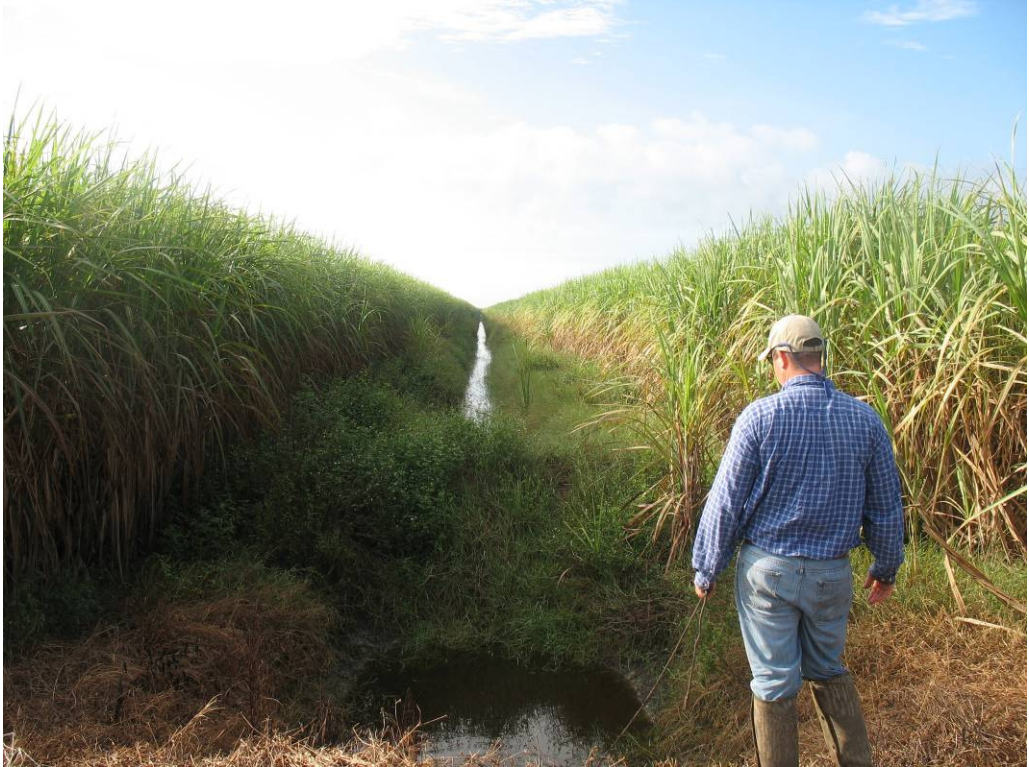
<b>Photographer</b> B. Whiteley <b>Date</b> 9/29/2008 <b>Direction</b> South <b>Comments</b> Excellent Cane. Ditch Blocked.

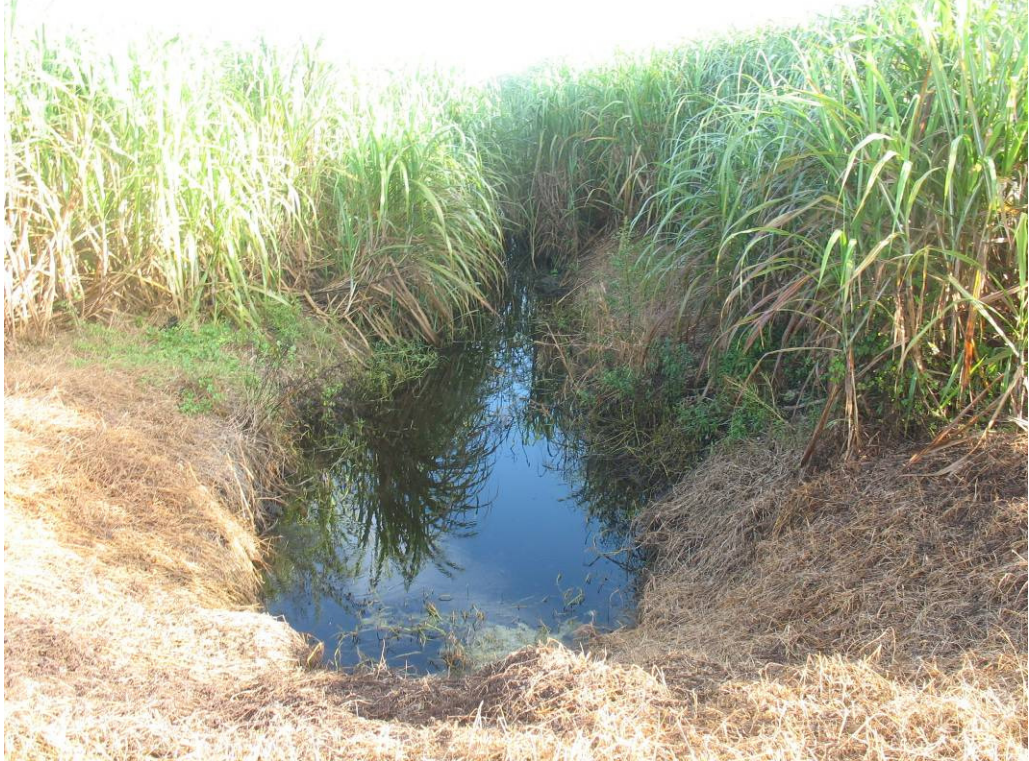
<b>Site Name:</b> US Sugar Corporation	<b>Site Location: US Sugar Corporation Sugar Cane Cropland</b>
<b>Photographer</b> B. Whiteley <b>Date</b> 9/29/2008 <b>Direction</b> North <b>Comments</b> Excellent Cane. No Vegetated Filter Strip

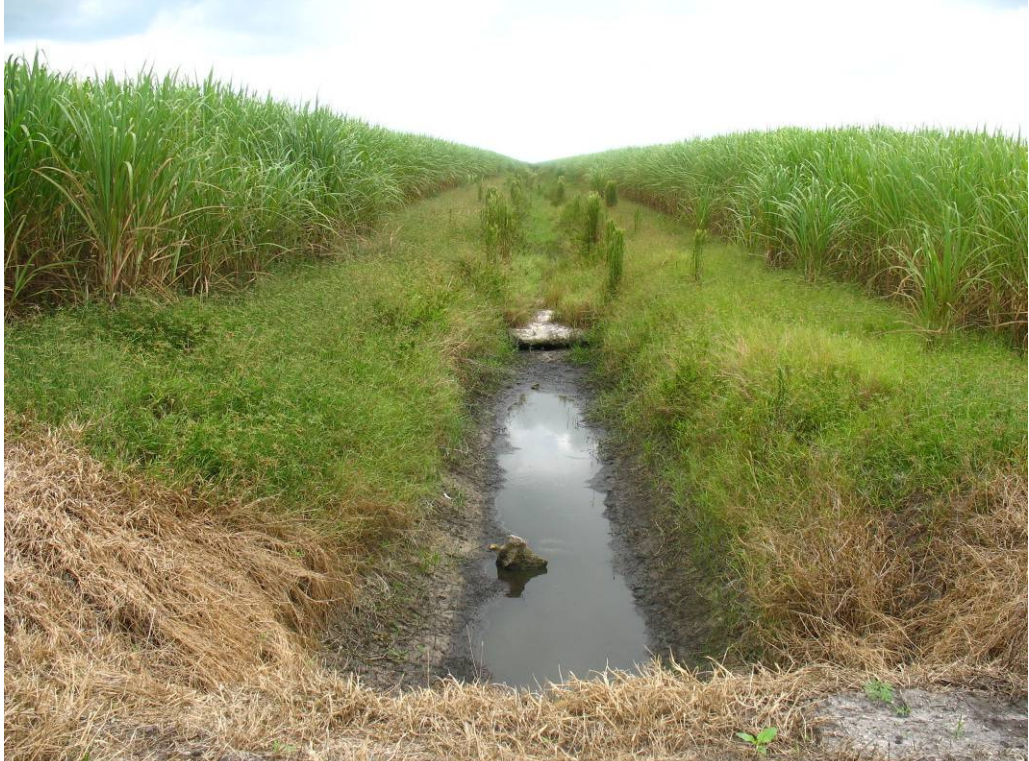
<b>Photographer</b> B. Whiteley <b>Date</b> 9/28/2008 <b>Direction</b> West <b>Comments</b> Good Cane. Lateral Vegetated. Sediment Sump.

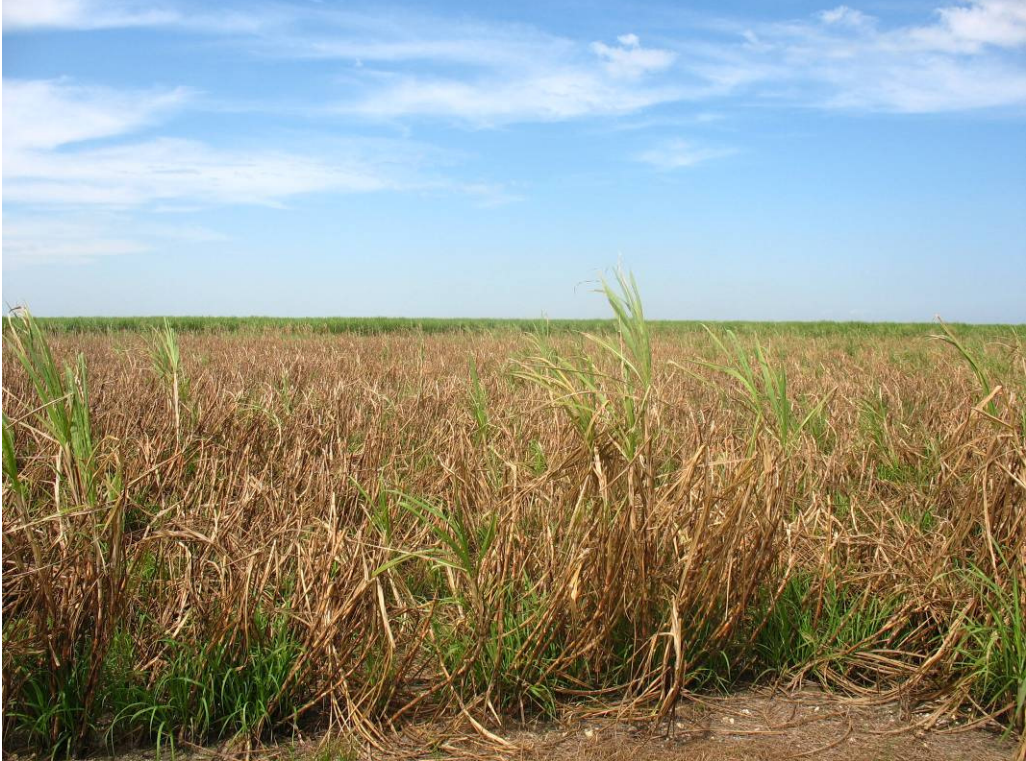
<b>Site Name:</b> US Sugar Corporation	<b>Site Location:</b> US Sugar Corporation Sugar Cane Cropland
<b>Photographer</b> B. Whiteley <b>Date</b> 9/26/2008 <b>Direction</b> West <b>Comments</b> Dead Cane (reason not established)

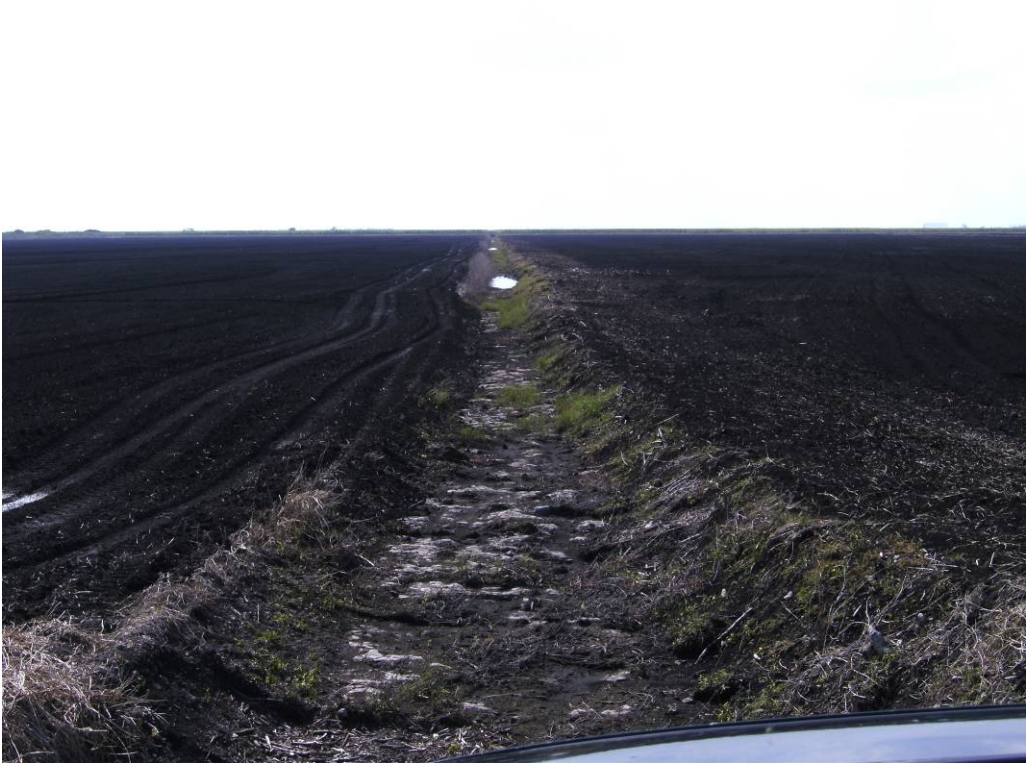
<b>Photographer</b> L. Lewis <b>Date</b> 10/01/2008 <b>Direction</b> West <b>Comments</b> Fallow Field. Shallow Lateral. Rock Exposed.

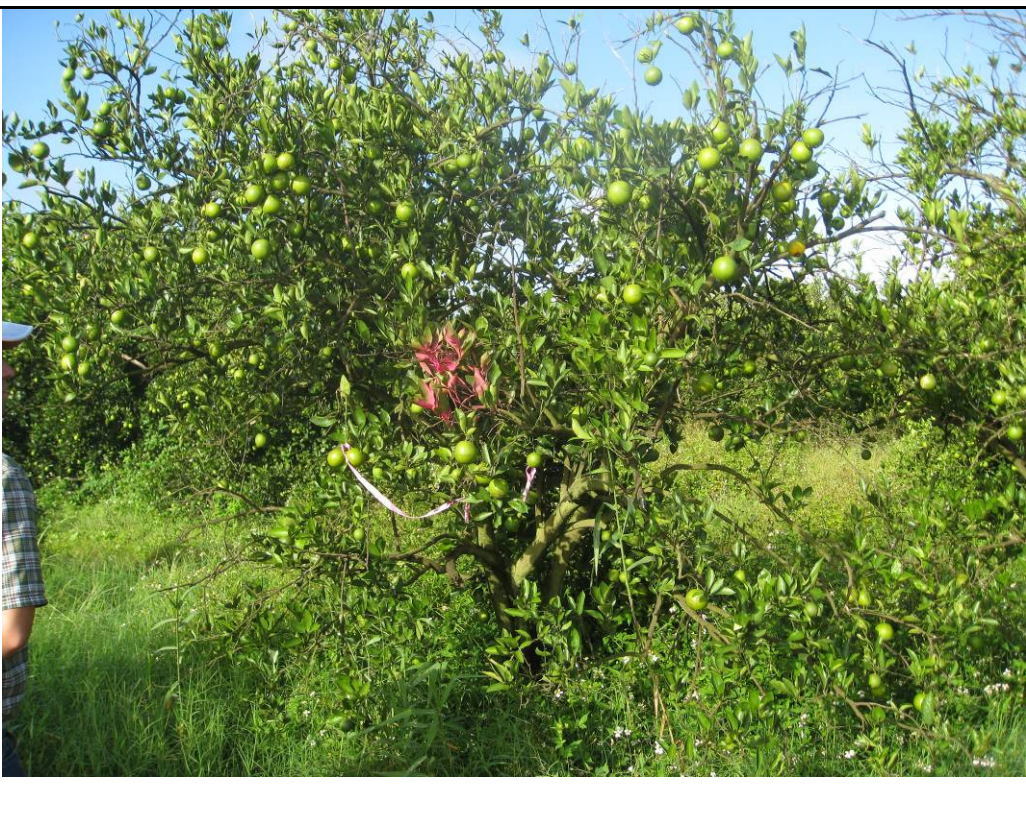
<b>Photographer</b> R. Jackson <b>Date</b> 9/24/2008 <b>Direction</b> South West <b>Comments</b> Greening Identified by Scout Crew, Lead Scout Verified.

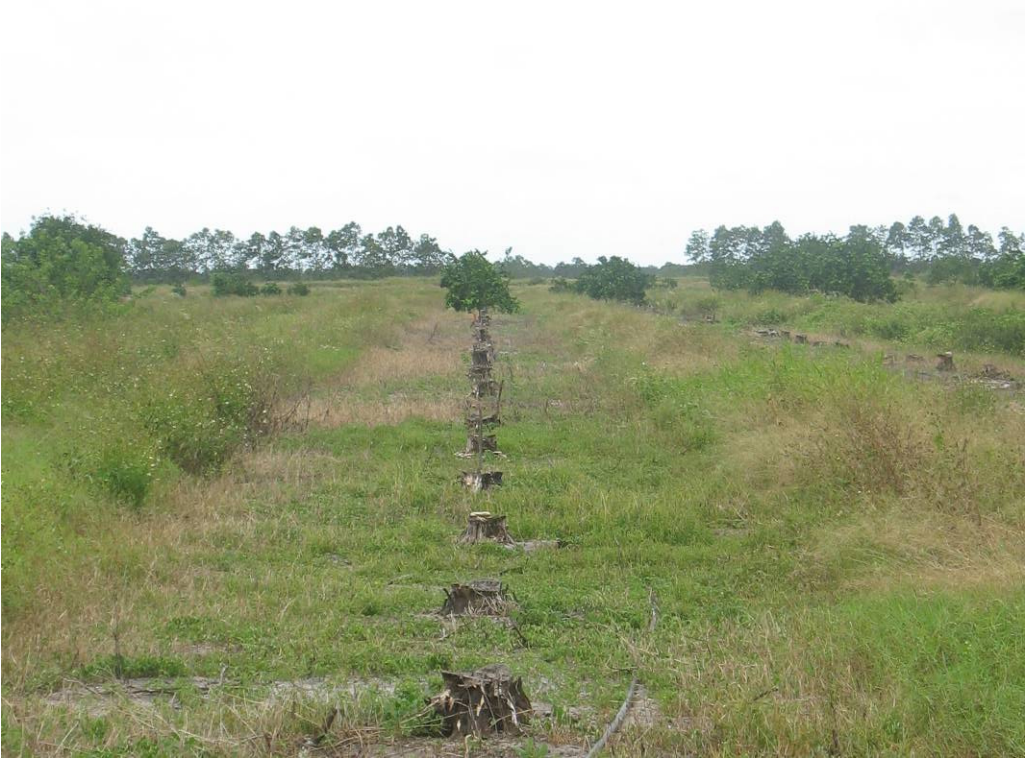
<b>Site Name: US Sugar Corporation</b>	<b>Site Location: Southern Garden Citrus Groves</b>
<b>Photographer</b> B. Whiteley <b>Date</b> 9/24/2008 <b>Direction</b> North <b>Comments</b> Greening Trees Removed. Stumps Remain.

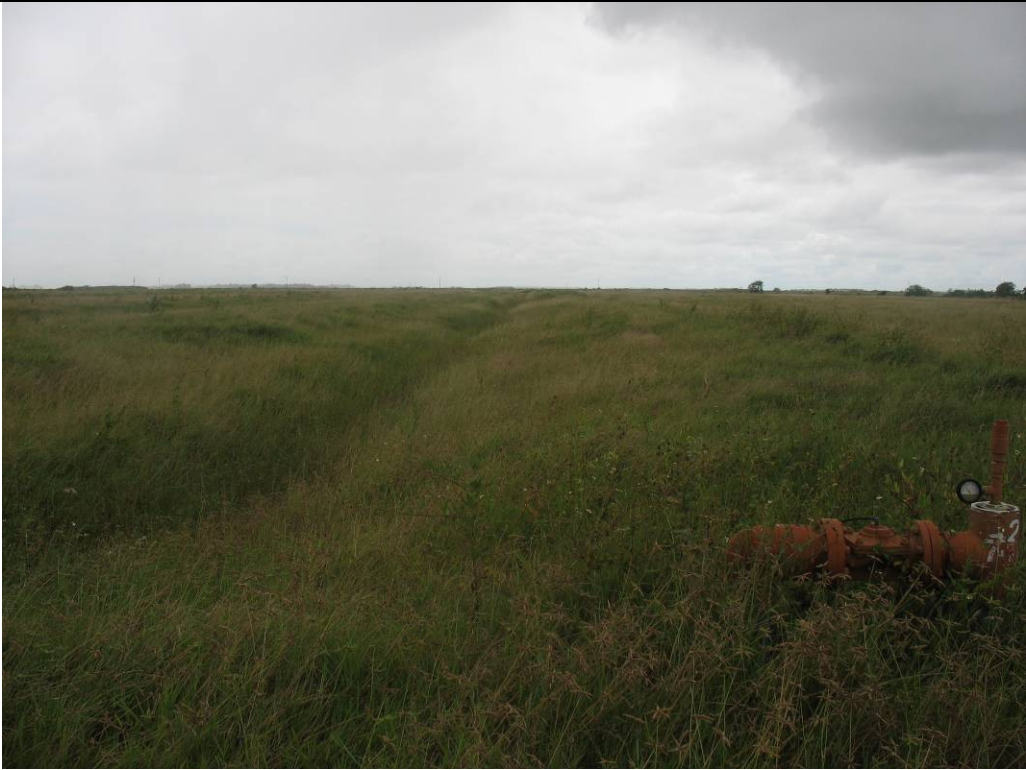
<b>Site Name: US Sugar Corporation</b>	<b>Site Location: Southern Garden Citrus Groves</b>
<b>Photographer</b> B. Whiteley <b>Date</b> 9/24/2008 <b>Direction</b> South <b>Comments</b> Grove Cleared due to Citrus Canker.

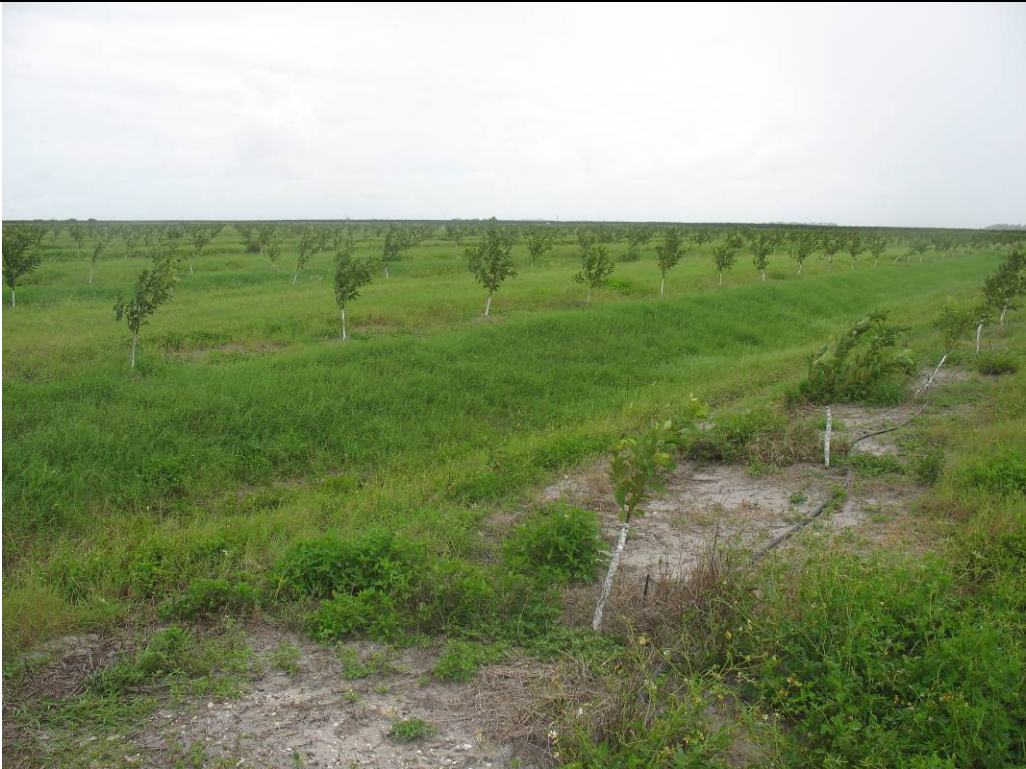
<b>Photographer</b> B. Whiteley <b>Date</b> 9/24/2008 <b>Direction</b> South East <b>Comments</b> Guava Trees planted in Cleared Citrus Canker Infested Grove.

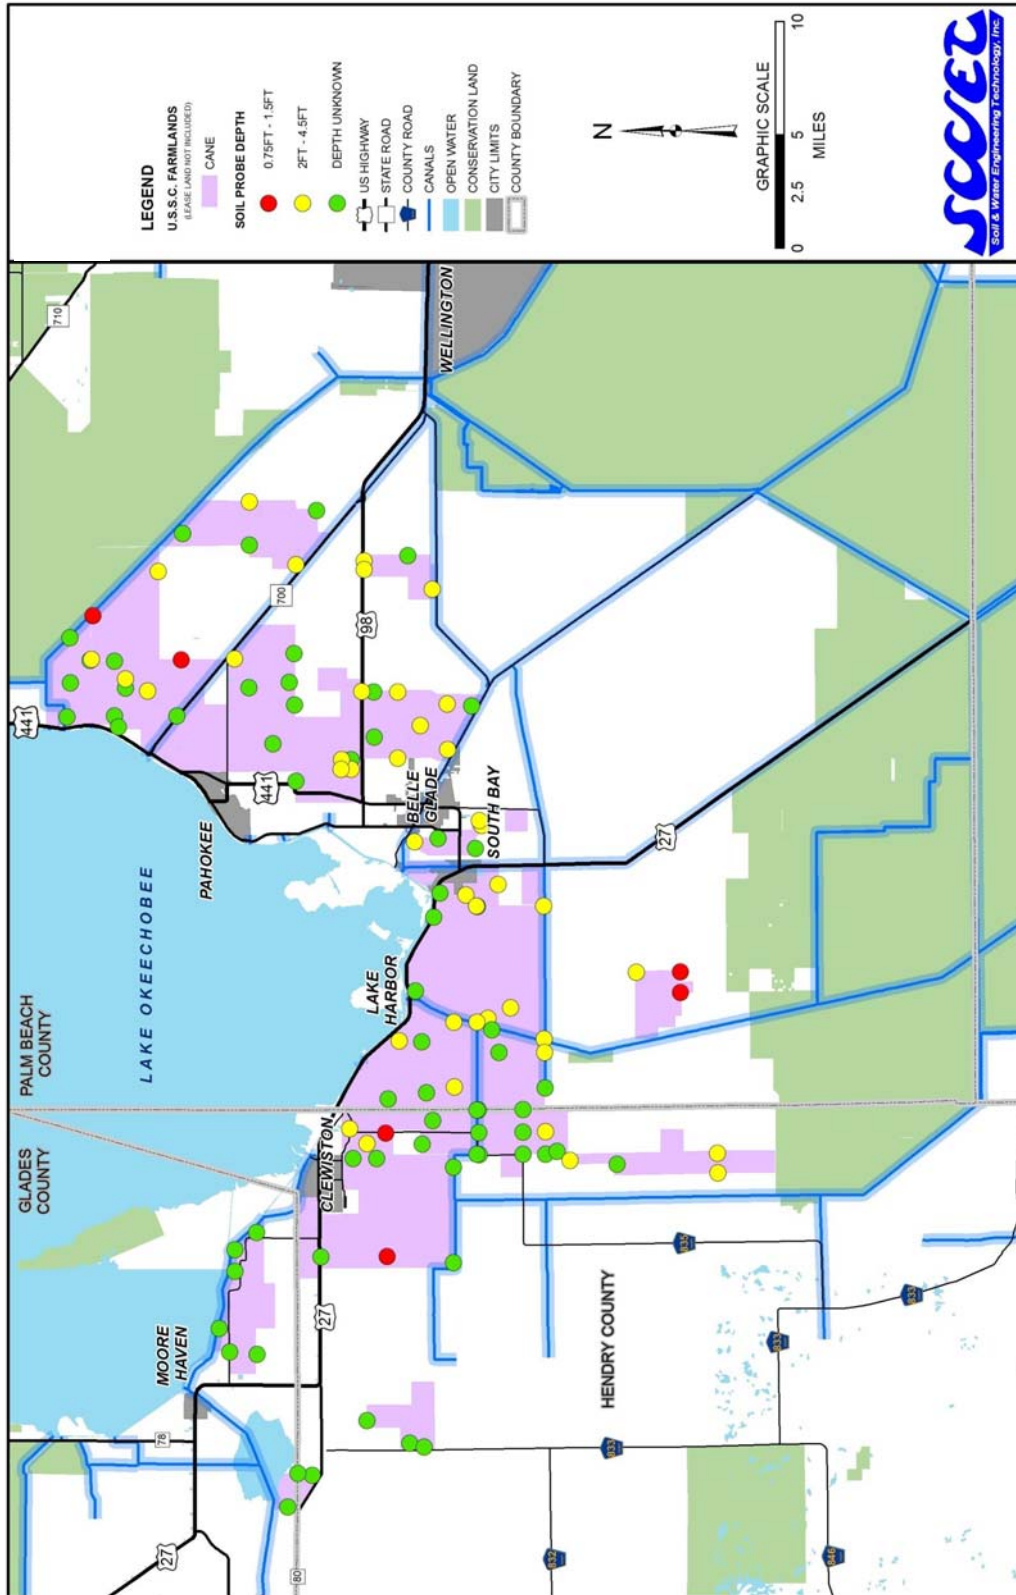
Figure 4-1. Soil Probe Depths

Muck depths as probed using a penetrometer probe were found to range from 0.75 foot to over 4.5 feet (length of probe). (See Figure 4-1, Appendix B, page B-3.) Note that only the sugarcane land was probed for muck depth because the citrus lands are located on sandy soils. A representative photograph of soil probe insertion is included in Appendix A, page A-7.

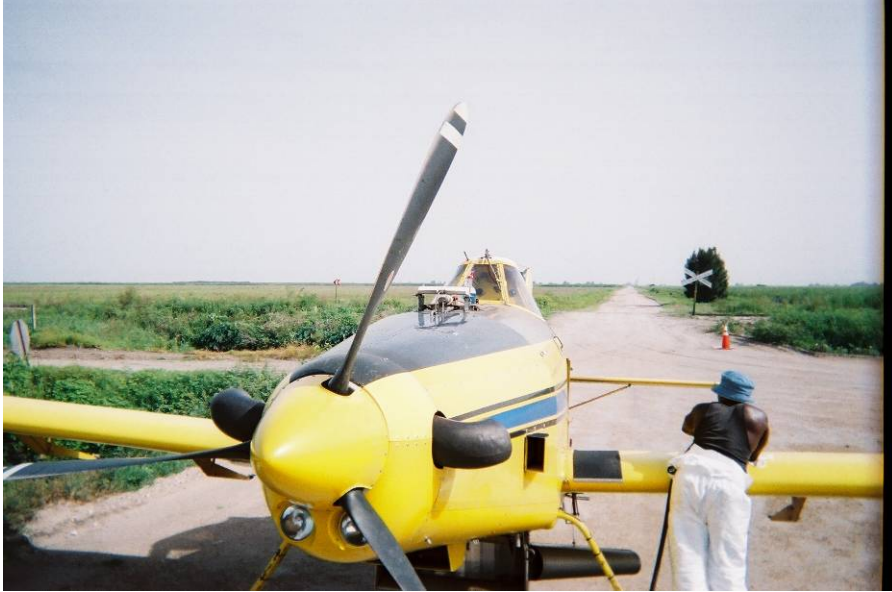
<p><b>Photographer</b>                  Jim Barrack</p> <p><b>Date</b>                  8/13/2008</p> <p><b>Direction</b>                  View NB</p> <p><b>Comments</b>                  View NB with Air Tractor Model 502 refueling. RR tracks behind turnaround pad.</p>

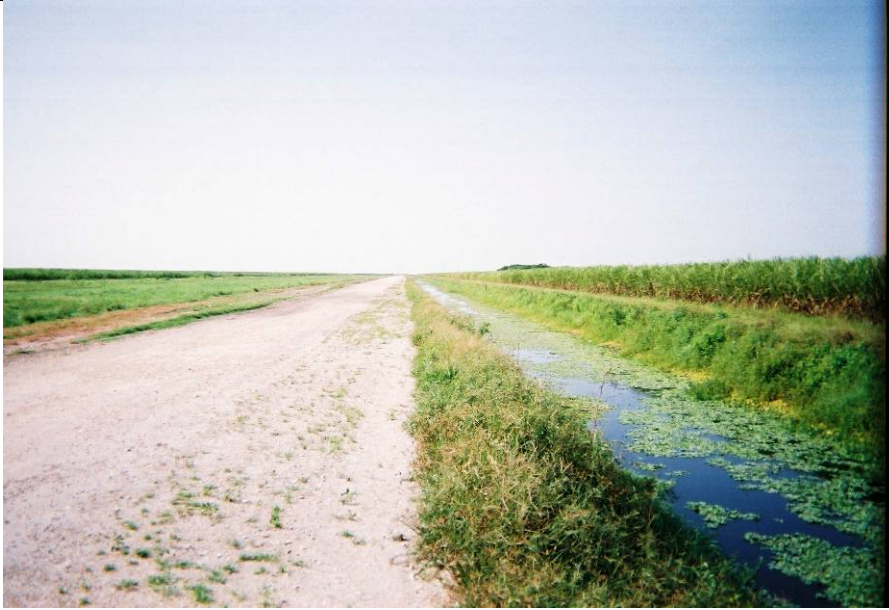
<p><b>Site Name: US Sugar Corporation</b></p>	<p><b>Site Location: Landing Strip #1</b> Area 1, Map Page 10 – North South Center Lane</p>
<p><b>Photographer</b> Jim Barrack</p> <p><b>Date</b> 8/13/2008</p> <p><b>Direction</b> View SB</p> <p><b>Comments</b> View SB with canal in recovery area, and small weeds in gravel bed. Good crown, good drainage.</p>
