# Evaluation Report

## Repair, Maintenance and Transition Plan

# US Sugar Corporation

# South Florida Water Management District

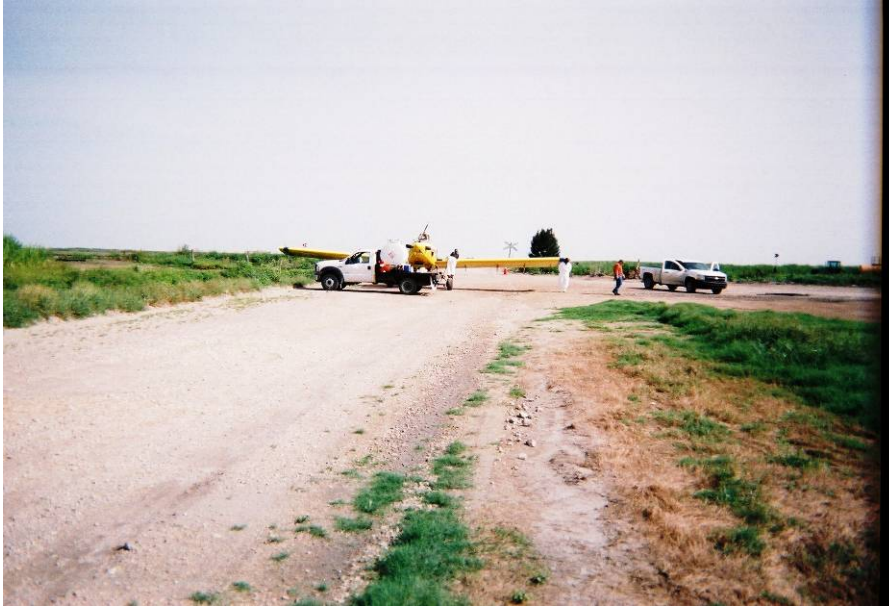
<p><b>Photographer</b> Jim Barrack</p> <p><b>Date</b> 8/13/2008</p> <p><b>Direction</b> View NB</p> <p><b>Comments</b> AT 502 plane being refueled.</p>

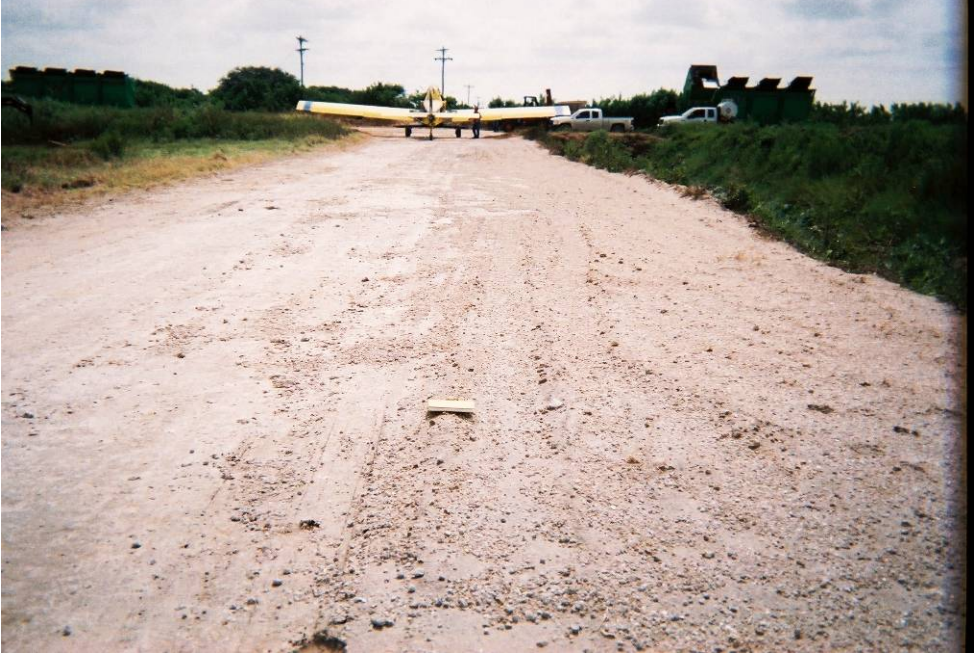
<p><b>Site Name: US Sugar Corporation</b></p>	<p><b>Site Location:</b> Landing Strip # 3 Area 1, Map 1 Section 3209</p>
<p><b>Photographer</b> Jim Barrack</p> <p><b>Date</b> 8/13/2008</p> <p><b>Direction</b> EB</p> <p><b>Comments</b> Soft gravel and sand base with ruts and ridges.</p>

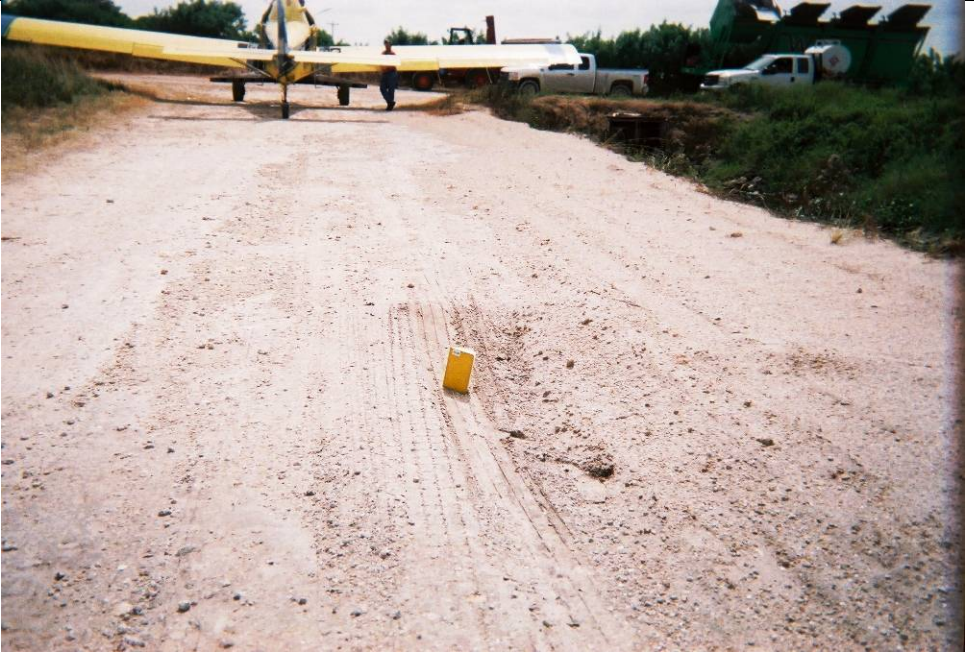
<p><b>Photographer</b> Jim Barrack</p> <p><b>Date</b> 8/13/2008</p> <p><b>Direction</b> EB</p> <p><b>Comments</b> Rut in center of road approx. 2.5 inch depth. Ditch along south side.</p>

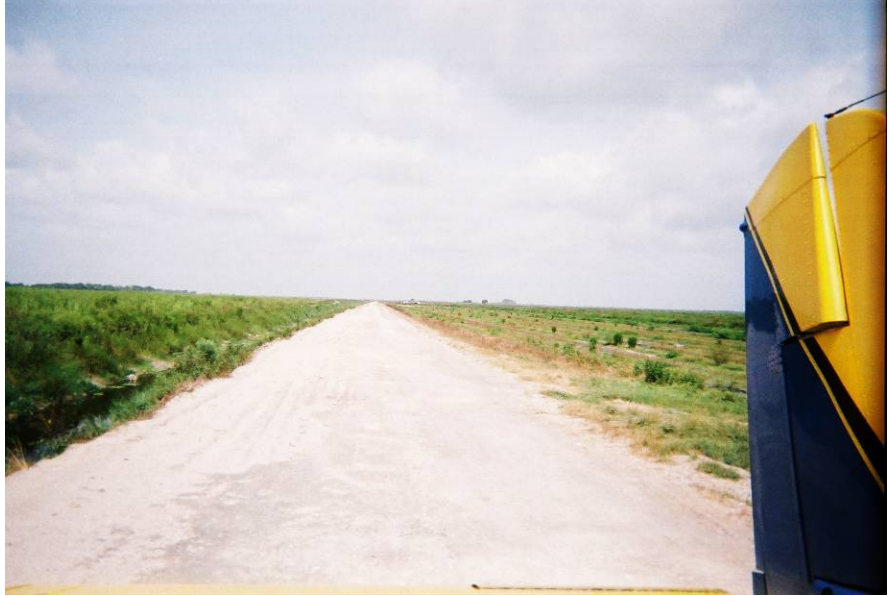
<p><b>Site Name: US Sugar Corporation</b></p>	<p><b>Site Location: Landing Strip # 3</b> Area 1, Map 1 Section 3209</p>
<p><b>Photographer</b> Jim Barrack</p> <p><b>Date</b> 8/13/2008</p> <p><b>Direction</b> WB</p> <p><b>Comments</b> Rut due to truck or farm equipment. Depth of ruts was approximately 2 to 3 inches</p>	 
<p><b>Photographer</b> Jim Barrack</p> <p><b>Date</b> 8/13/2008</p> <p><b>Direction</b> WB</p> <p><b>Comments</b> Long runway with obstruction (ditch) along south side. No power lines.</p>

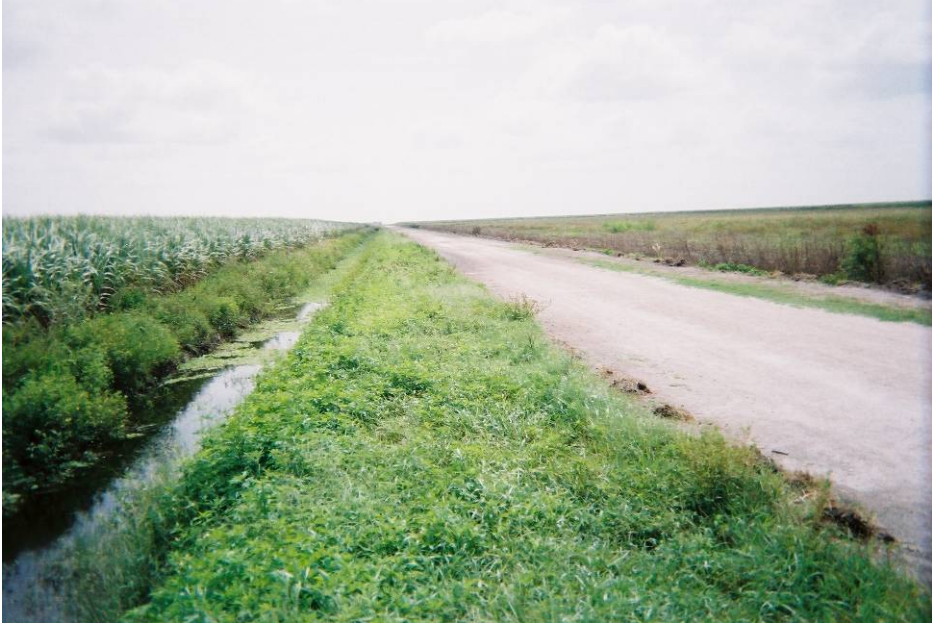
<p><b>Site Name: US Sugar Corporation</b></p>	<p><b>Site Location:</b> Landing Strip # 4 Area 1, Map 5 Section 2321</p>
<p><b>Photographer</b> Jim Barrack</p> <p><b>Date</b> 8/13/2008</p> <p><b>Direction</b> EB</p> <p><b>Comments</b> Gravel roadbed drains from right to left at 2% slope. Left side lateral clearance from CL to ditch is 26 feet.</p>

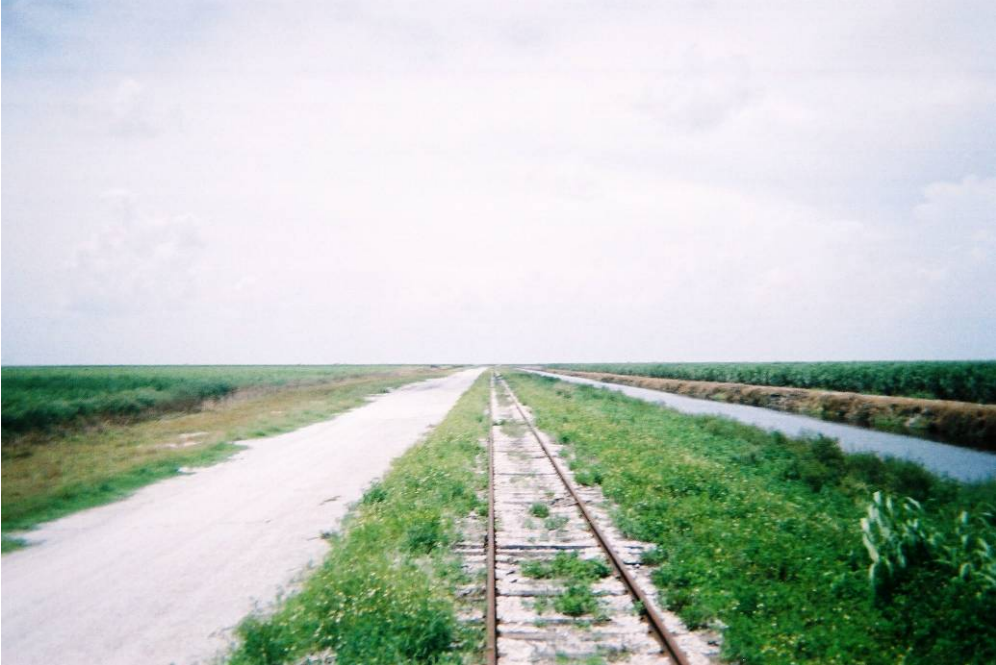
<p><b>Photographer</b> Jim Barrack</p> <p><b>Date</b> 8/14/2008</p> <p><b>Direction</b> WB</p> <p><b>Comments</b> Seems to be more room on left side. Possibly widen, shift runway to the left.</p>

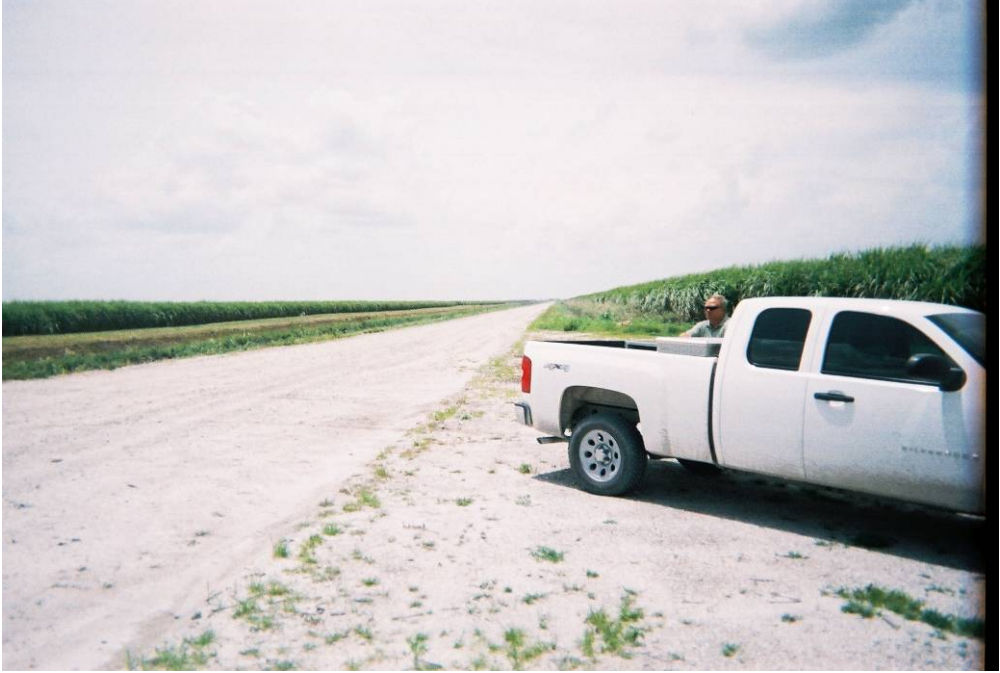
<p><b>Site Name: US Sugar Corporation</b></p>	<p><b>Site Location:</b> Landing Strip # 10 Area 3 – Map Page 26, Section 3710 Main Canal</p>
<p><b>Photographer</b> Jim Barrack</p> <p><b>Date</b> 8/14/2008</p> <p><b>Direction</b> WB</p> <p><b>Comments</b> Good crown on wide roadbed.</p>

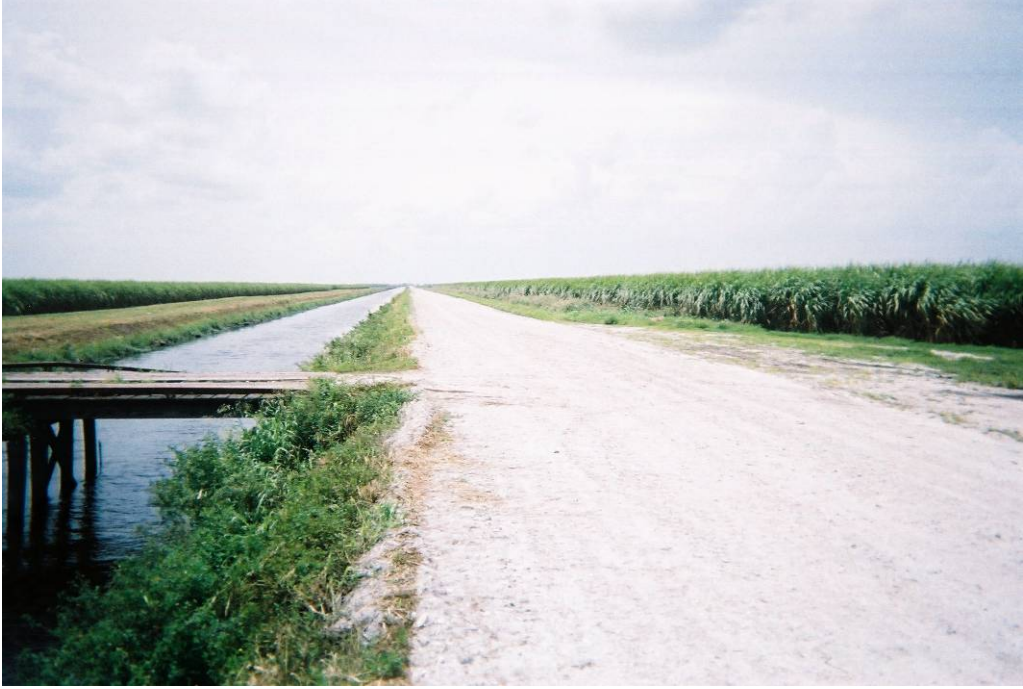
<p><b>Photographer</b> Jim Barrack</p> <p><b>Date</b> 8/14/2008</p> <p><b>Direction</b></p> <p><b>Comments</b> Left edge has immediate drop off into canal.</p>

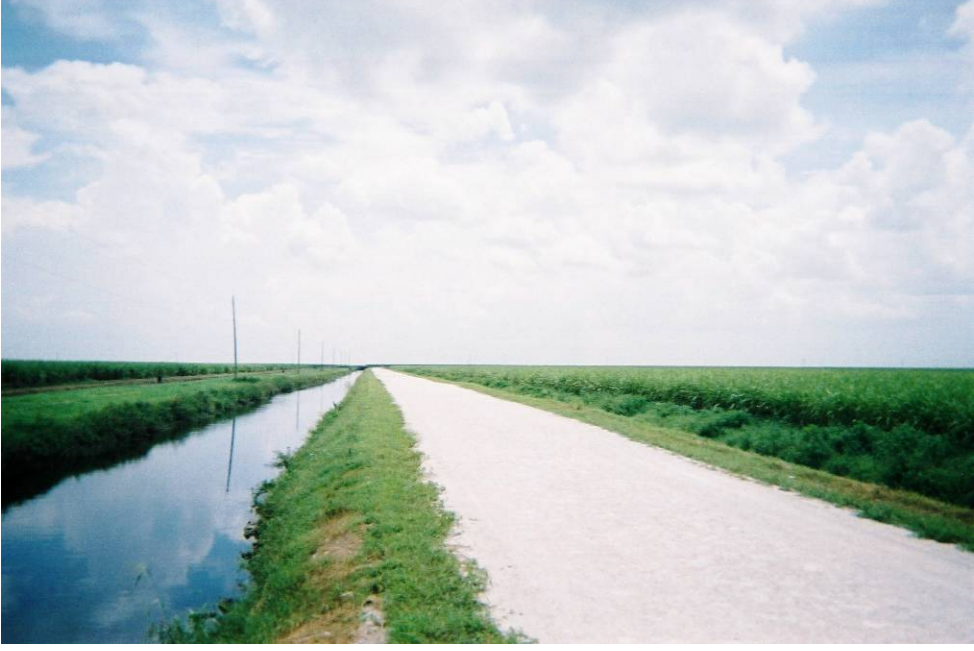
<p><b>Site Name: US Sugar Corporation</b></p>	<p><b>Site Location:</b> Landing Strip # 11 Area 3 – Map Page 28, Section 3725</p>
<p><b>Photographer</b> Jim Barrack</p> <p><b>Date</b> 8/14/2008</p> <p><b>Direction</b> SB</p> <p><b>Comments</b> Canal on left side with a 4 foot shoulder. Road has minimal crown.</p>	 
<p><b>Photographer</b> Jim Barrack</p> <p><b>Date</b> 8/14/2008</p> <p><b>Direction</b> SB</p> <p><b>Comments</b> Short 2600 LF runway. Power lines along canal on the east side.</p>

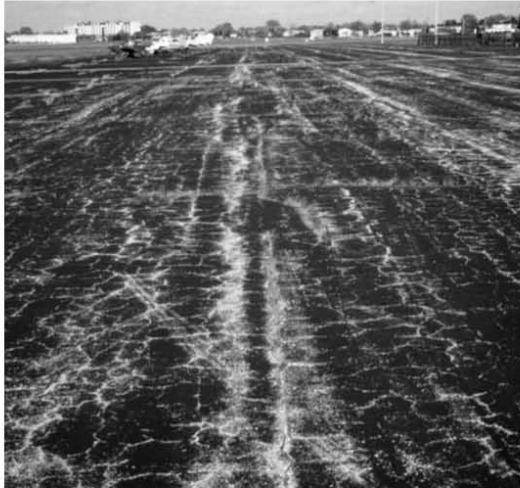
◀ Needs overlay.

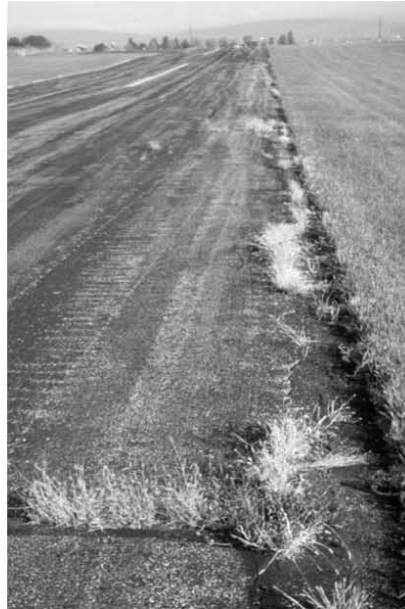
◀ Edge cracking on up to 25% of the pavement.

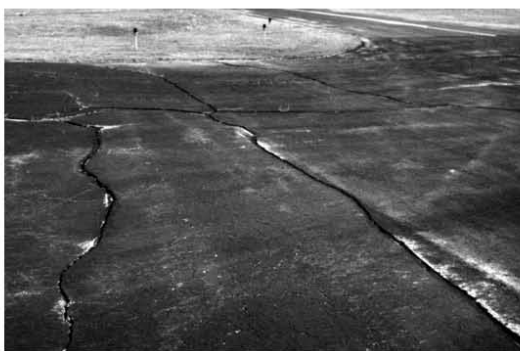
◀ More than 25% of crack sealant needs replacement. Minor settlement over cracking.

▼ Sealant repair needed on more than 25% of cracks.

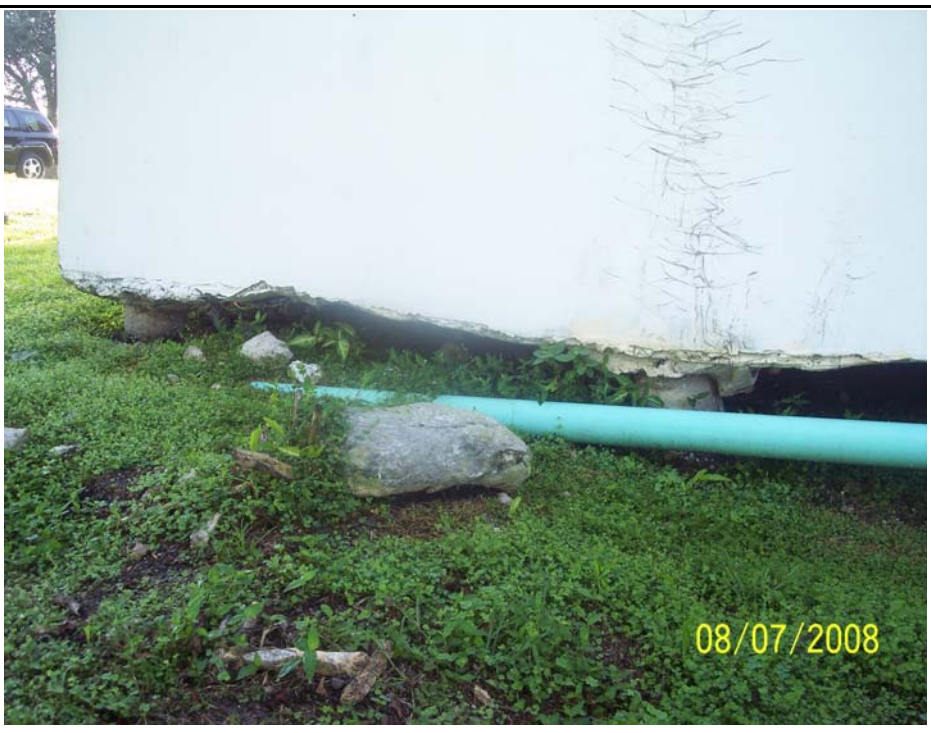
<p>A photograph showing the base of a white building where it meets the ground. The ground is covered with green weeds and grass. A large, light-colored rock is visible in the foreground. A blue pipe runs horizontally across the ground. The building's foundation appears to be settling, with some concrete blocks visible. A yellow date stamp '08/07/2008' is visible in the bottom right corner of the image.</p>

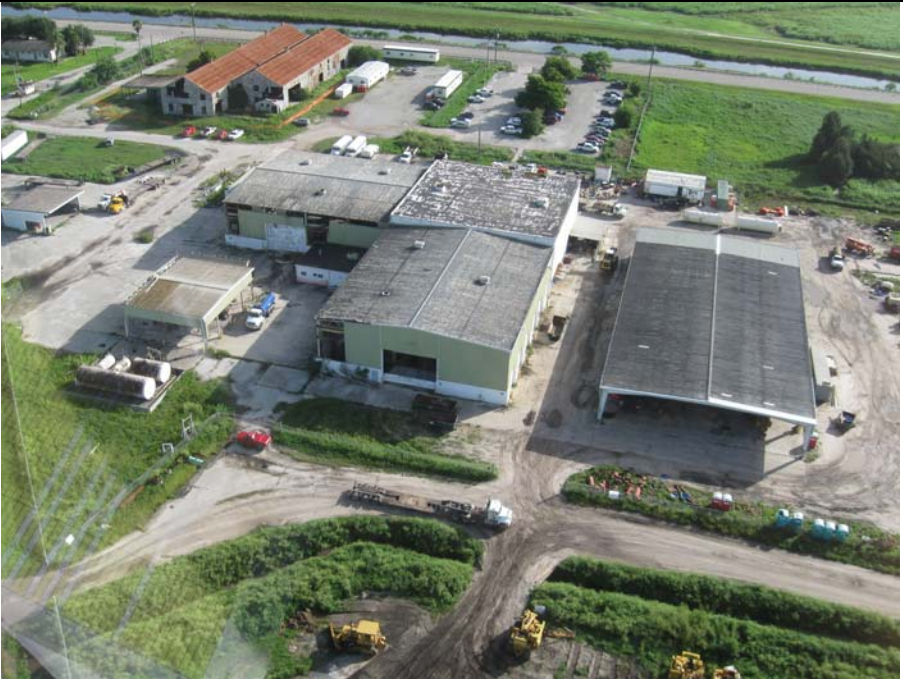
<p><b>Photographer</b> Farrington</p> <p><b>Date</b> Aug. 7, 2008</p> <p><b>Direction</b> North</p> <p><b>Comments</b> <b>(31) East. AES Complex and Parts Storage</b> – 1930s warehouse building showing un- repaired hurricane damage. Demolition is recommended.</p>	  A close-up photograph of a building's exterior. The structure is made of heavily rusted, corrugated metal. The roof is partially collapsed, and the internal wooden truss system is exposed. There are several windows, some of which are broken or missing. The overall appearance is one of significant structural decay and damage.
<p><b>Photographer</b> Farrington</p> <p><b>Date</b> Aug. 7, 2008</p> <p><b>Direction</b></p> <p><b>Comments</b> <b>(31) East. AES Complex and Parts Storage –</b> 1976 building abandoned after 2005 hurricane. Operations moved to West AES. Doors blown in, roof insulation saturated and falling. Demolition recommended.</p>	  A wide-angle photograph of a large industrial building complex. The building has a white and green facade. The roof appears to be damaged, with some sections missing. There are several large doors, some of which are open. A white truck is parked in front of the building. The sky is clear and blue.

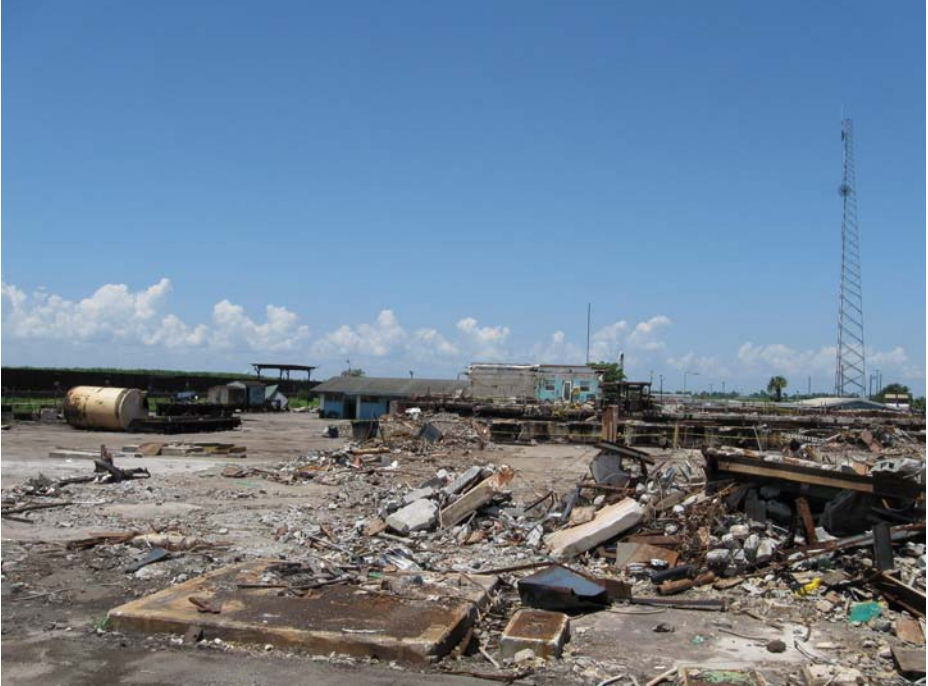
<p><b>Photographer</b> Farrington</p> <p><b>Date</b> Aug. 7, 2008</p> <p><b>Direction</b> Southeast</p> <p><b>Comments</b> <b>(43) Bryant Mill Complex (Demolition Site)</b> Piles of demolition material and growing grass which conceals small piles and metal and concrete pieces. SFWMD needs to inspect with USSC before existing demo contract is completed.</p>

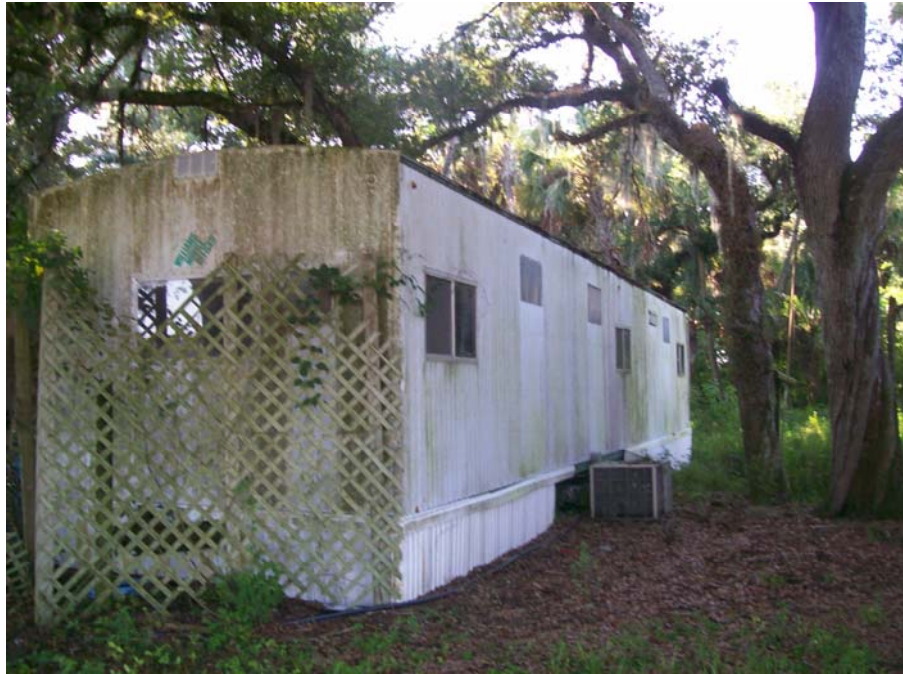
**Comments**  
**(54) Southern  
Division Citrus  
Office.** Abandoned  
deceit trailer  
crudely attached to  
the Citrus Office.

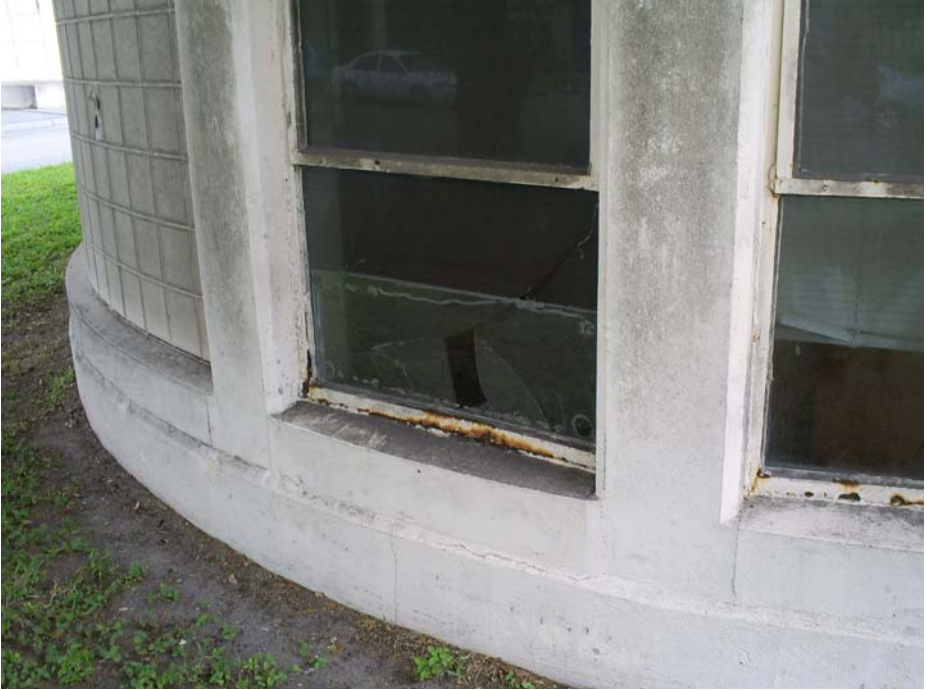
<p><b>Photographer</b> Woodard</p> <p><b>Date</b> 08/08/08</p> <p><b>Direction</b> West</p> <p><b>Comments</b> <b>(63) Clewiston Plant Purchasing Building</b></p> <p>Rusted steel sash windows at east end of building.</p>

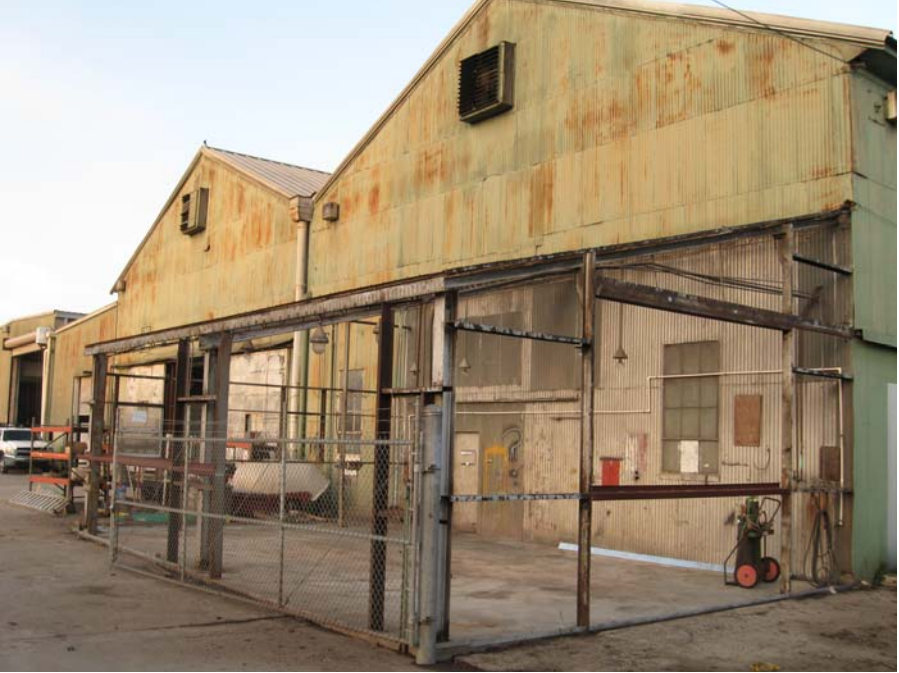
<p><b>Photographer</b> Farrington</p> <p><b>Date</b> Aug. 14, 2008</p> <p><b>Direction</b> West</p> <p><b>Comments</b> <b>(70) West. AES Maintenance Building</b> – operational for all equipment. Repaired after 2005 hurricanes. Roof sections replaced. Needs painting</p>

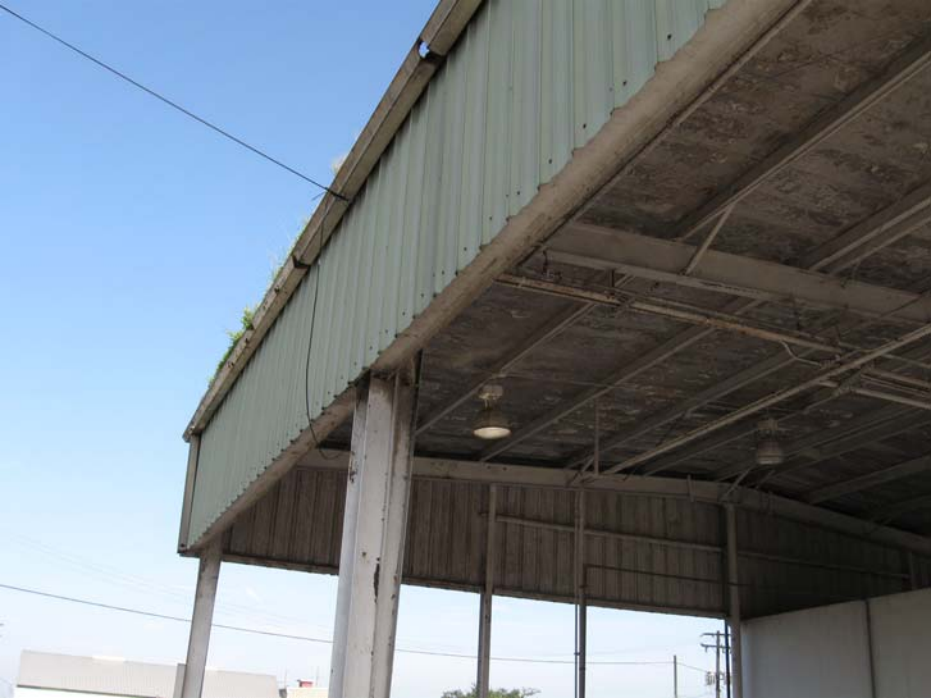
<p><b>Photographer</b> Farrington</p> <p><b>Date</b> Aug. 14, 2008</p> <p><b>Direction</b> South</p> <p><b>Comments</b> <b>(71) West. AES Gas Station</b> – typical roof condition needing repairs, Steel framing needing paint.</p>

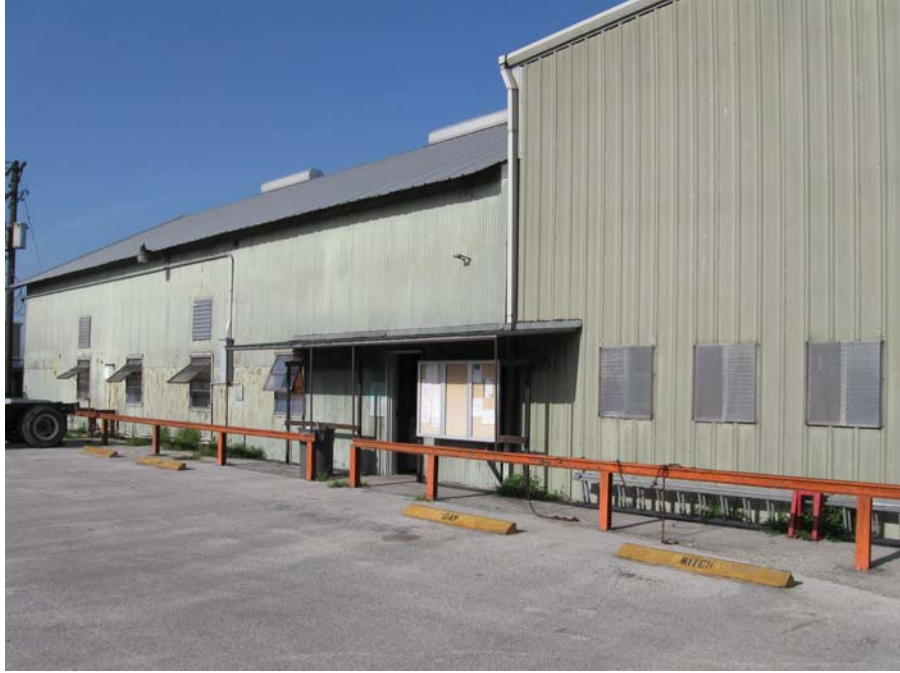
**Comments**  
**(73) West. AES  
Facilities  
Maintenance  
Building.**  
Painting of steel  
building has been  
delayed for  
several years.

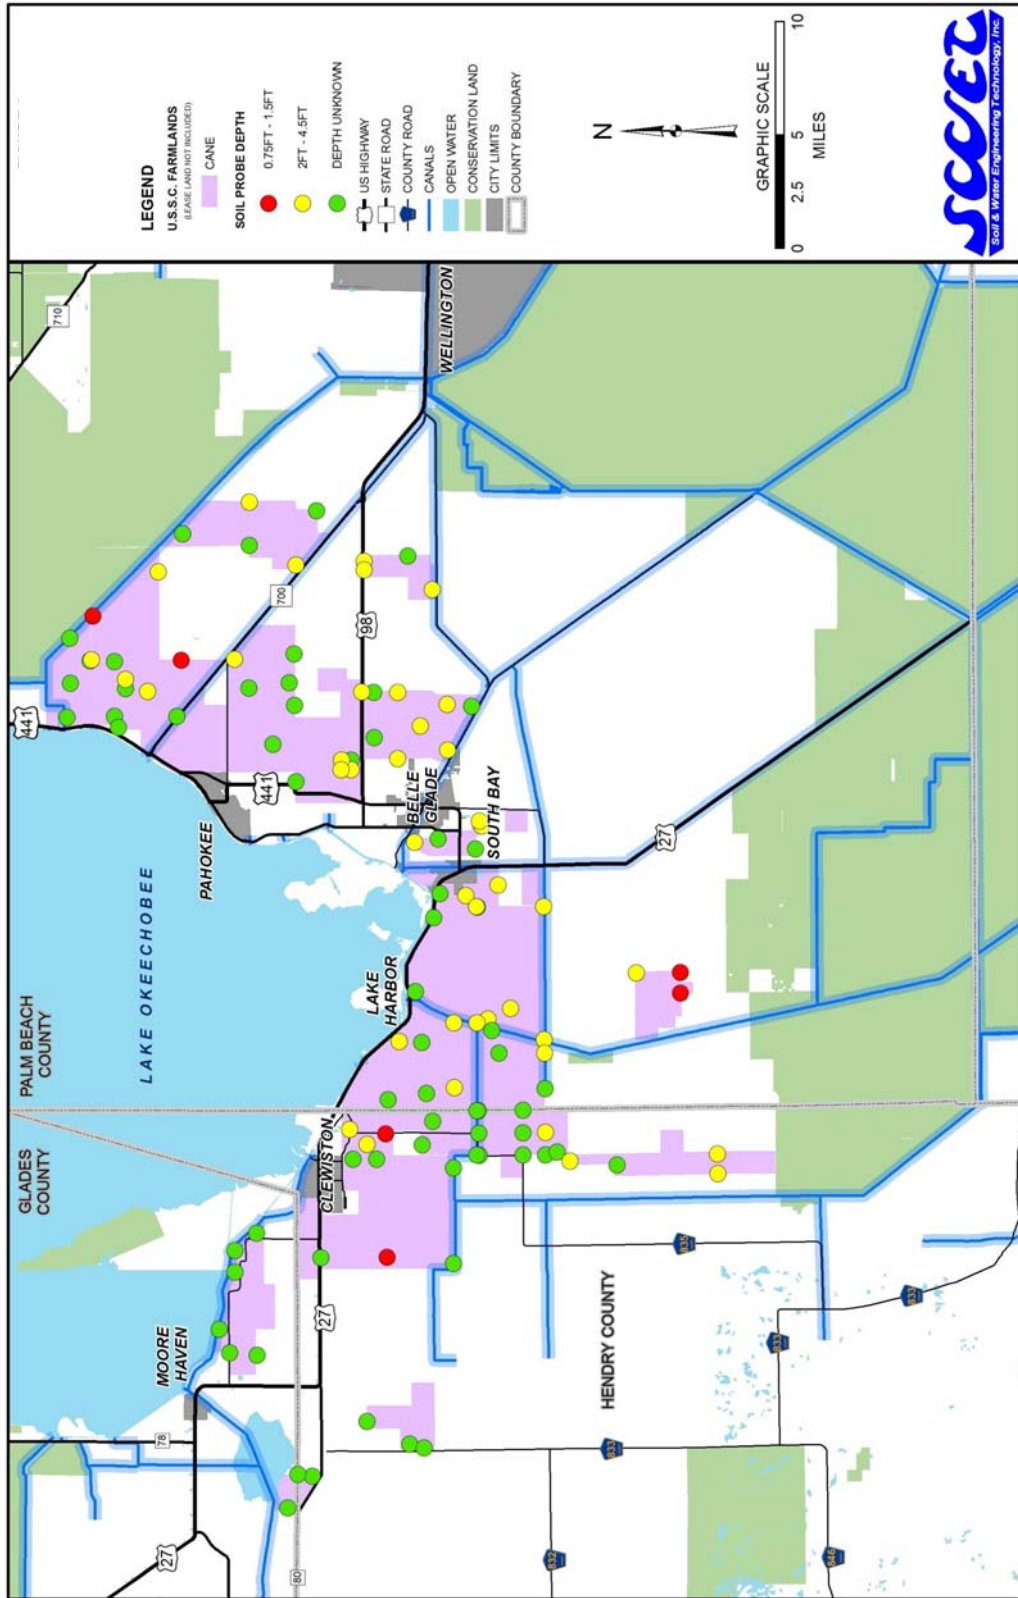
Figure 4-1. Soil Probe Depths

Muck depths as probed using a penetrometer probe were found to range from 0.75 foot to over 4.5 feet (length of probe). (See Figure 4-1, Appendix B, page B-3.) Note that only the sugarcane land was probed for muck depth because the citrus lands are located on sandy soils. A representative photograph of soil probe insertion is included in Appendix A, page A-7.
