# Post-Wilma STA Damage Assessment: Update

# Physical Facilities Assessment Initial Report

# Post-Wilma STA Recovery

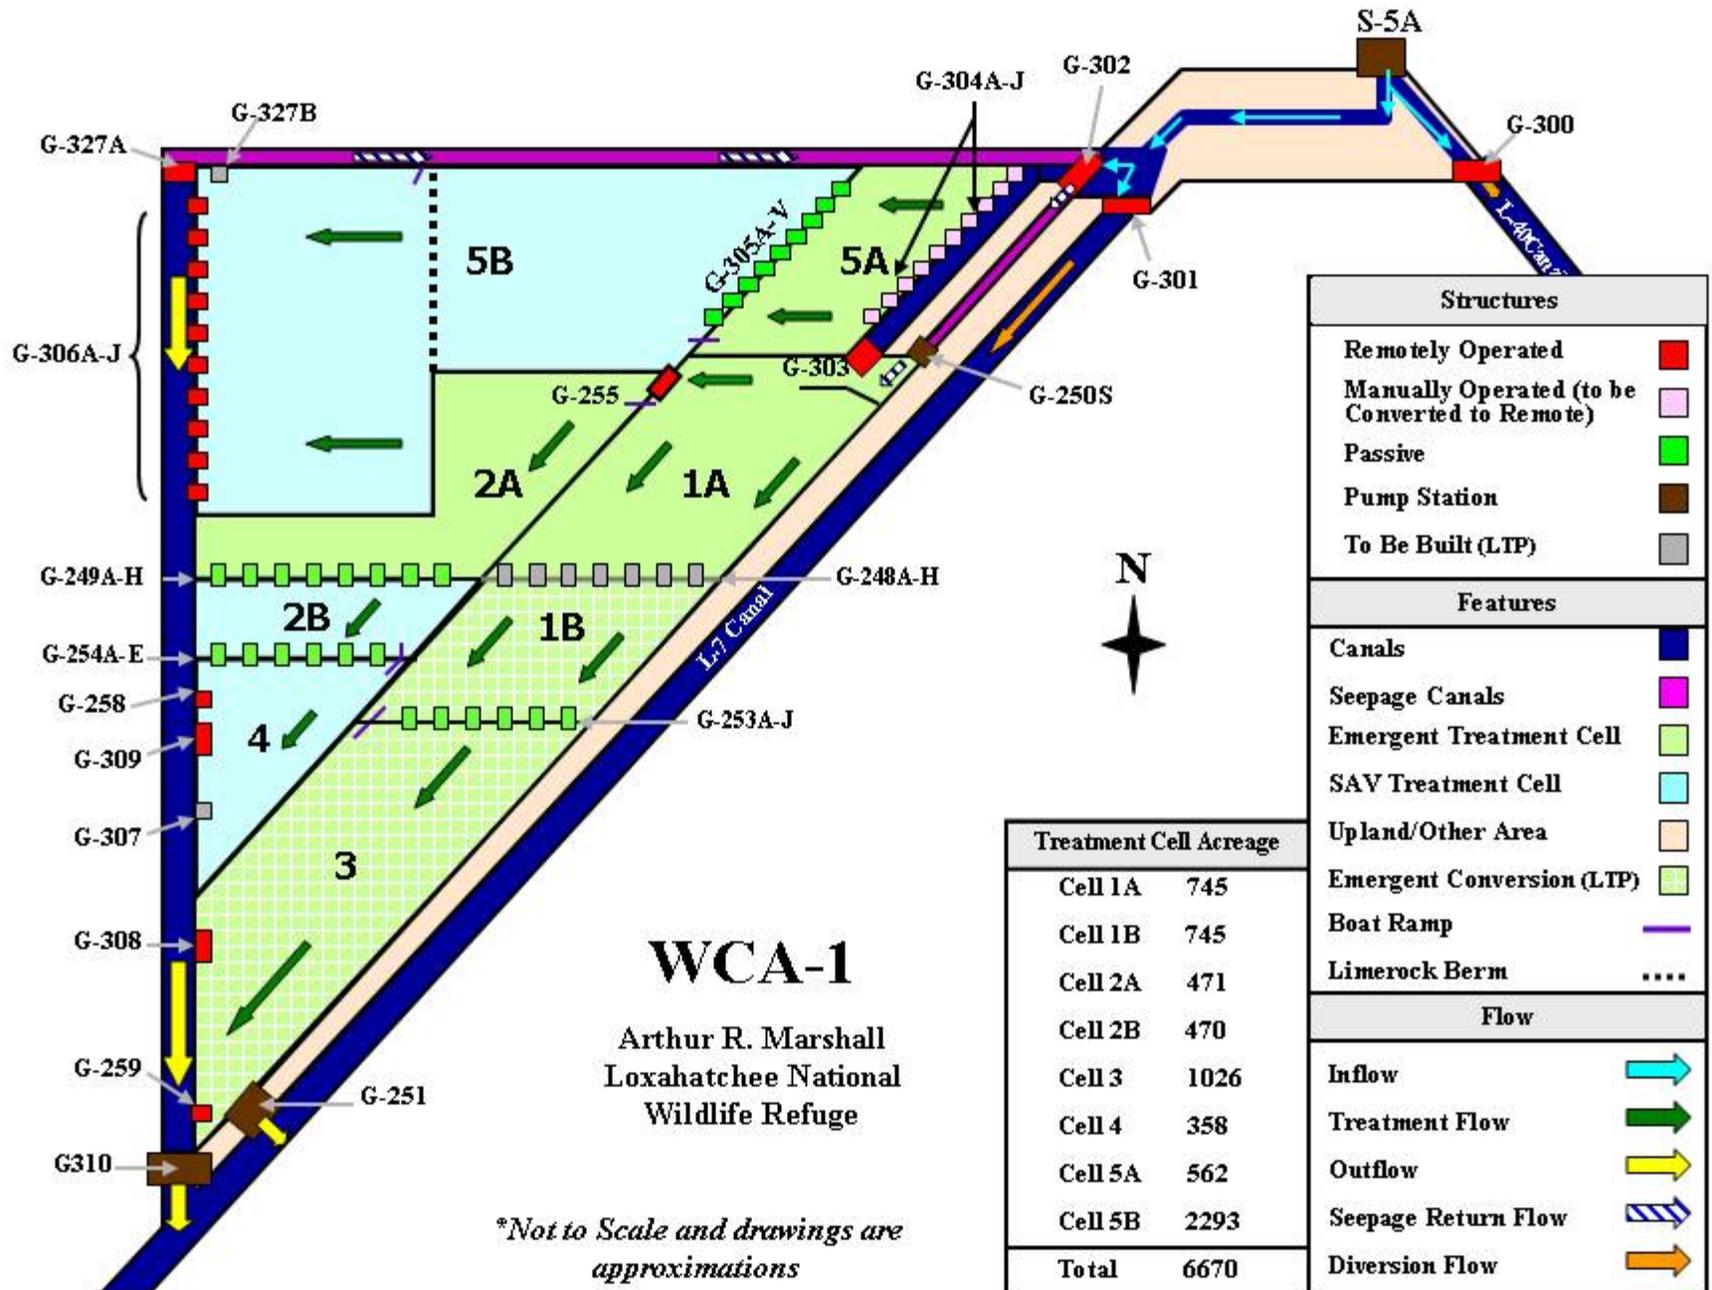
# STA-1W Structures, Flow, & Long Term Enhancements\*

- **STA-1W Vegetation**
  - **Eastern flow-way (Cells 1 and 3) currently on-line**
    - **Cattail vegetation recovering**
  - **Western flow-way (Cells 2A, 2B and 4)**
    - **Off-line for scheduled LTP enhancements**
    - **Vegetation growth in cells 2A and 2B proceeding as expected**
    - **SAV growth in Cell 4 not proceeding as expected; inoculation may be necessary**
