# MEMORANDUM

**FROM:** SFWMD Staff Environmental Advisory Team

**DATE:** October 19, 2022

**SUBJECT:** Weekly Environmental Conditions for Systems Operations

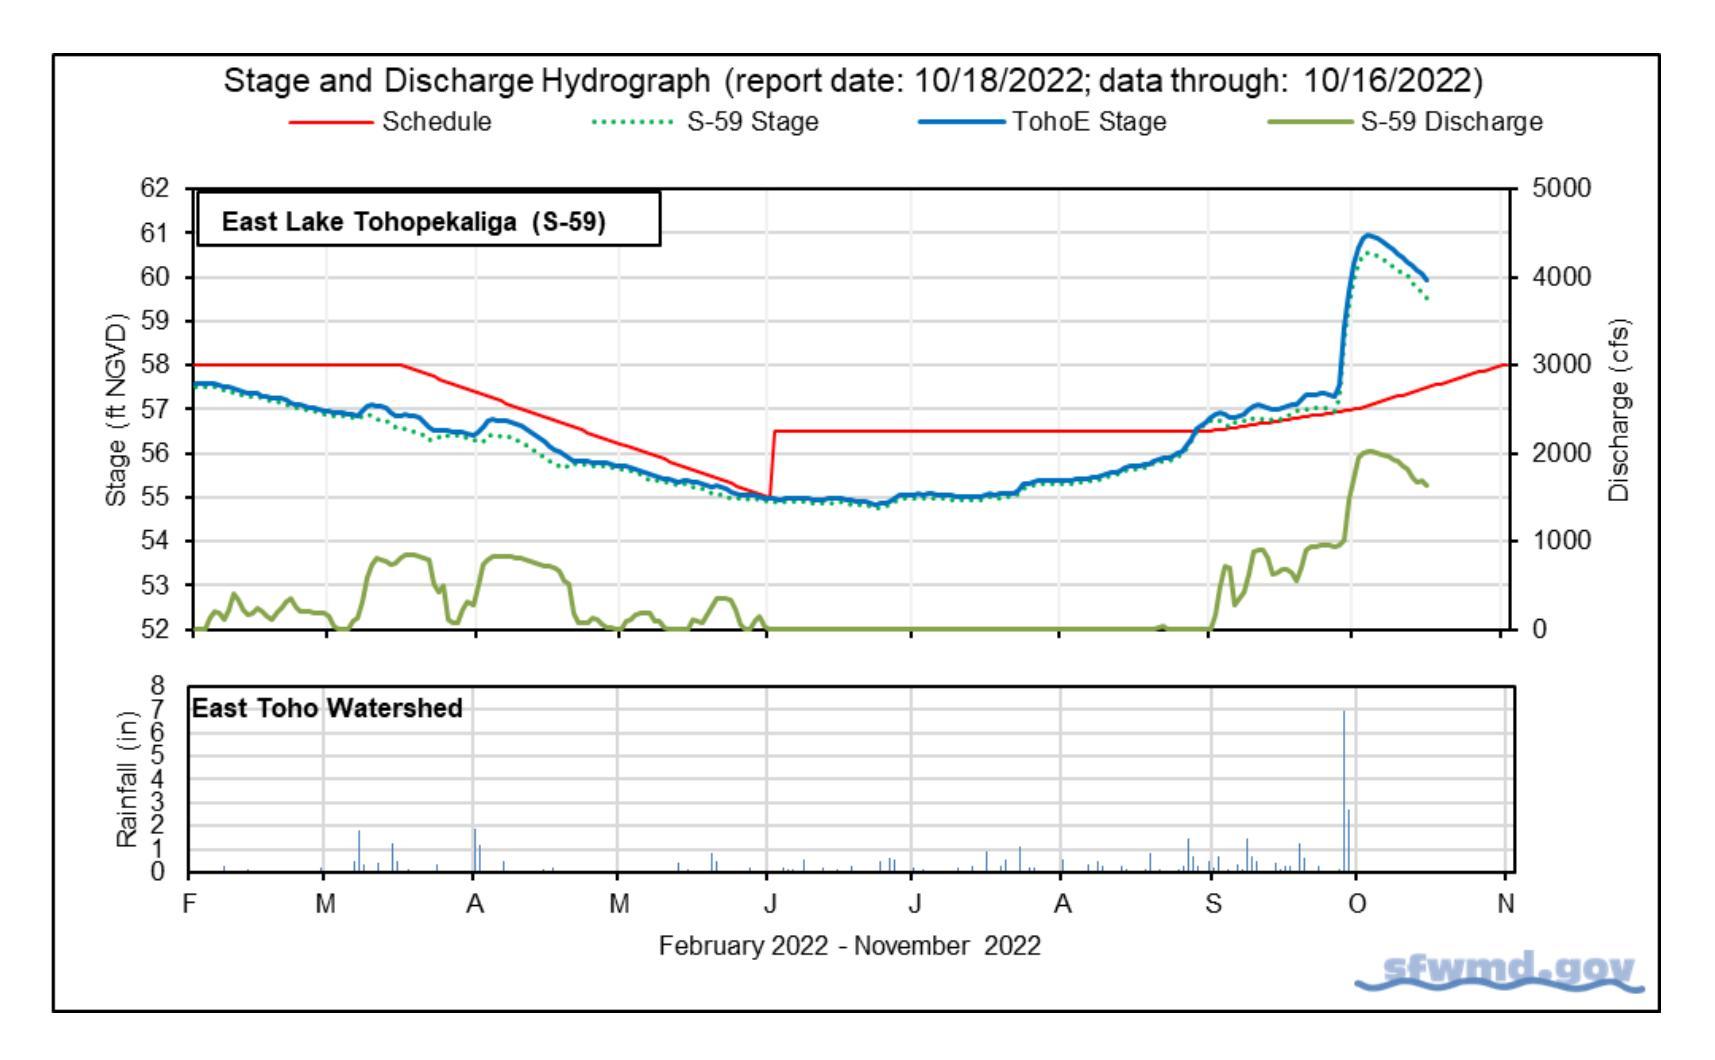
Figure KB-1. East Lake Toho regulation schedule, stage, discharge, and rainfall.

On October 16, 2022, lake stages were 59.9 feet NGVD (2.4 feet above schedule) in East Lake Toho, 55.8 feet NGVD (1.3 feet above schedule) in Lake Toho, and 53.0 feet NGVD (1.0 feet above schedule) in Lakes Kissimmee-Cypress-Hatchineha (KCH) (**Table KB-1**, **Figures KB-1-3**).

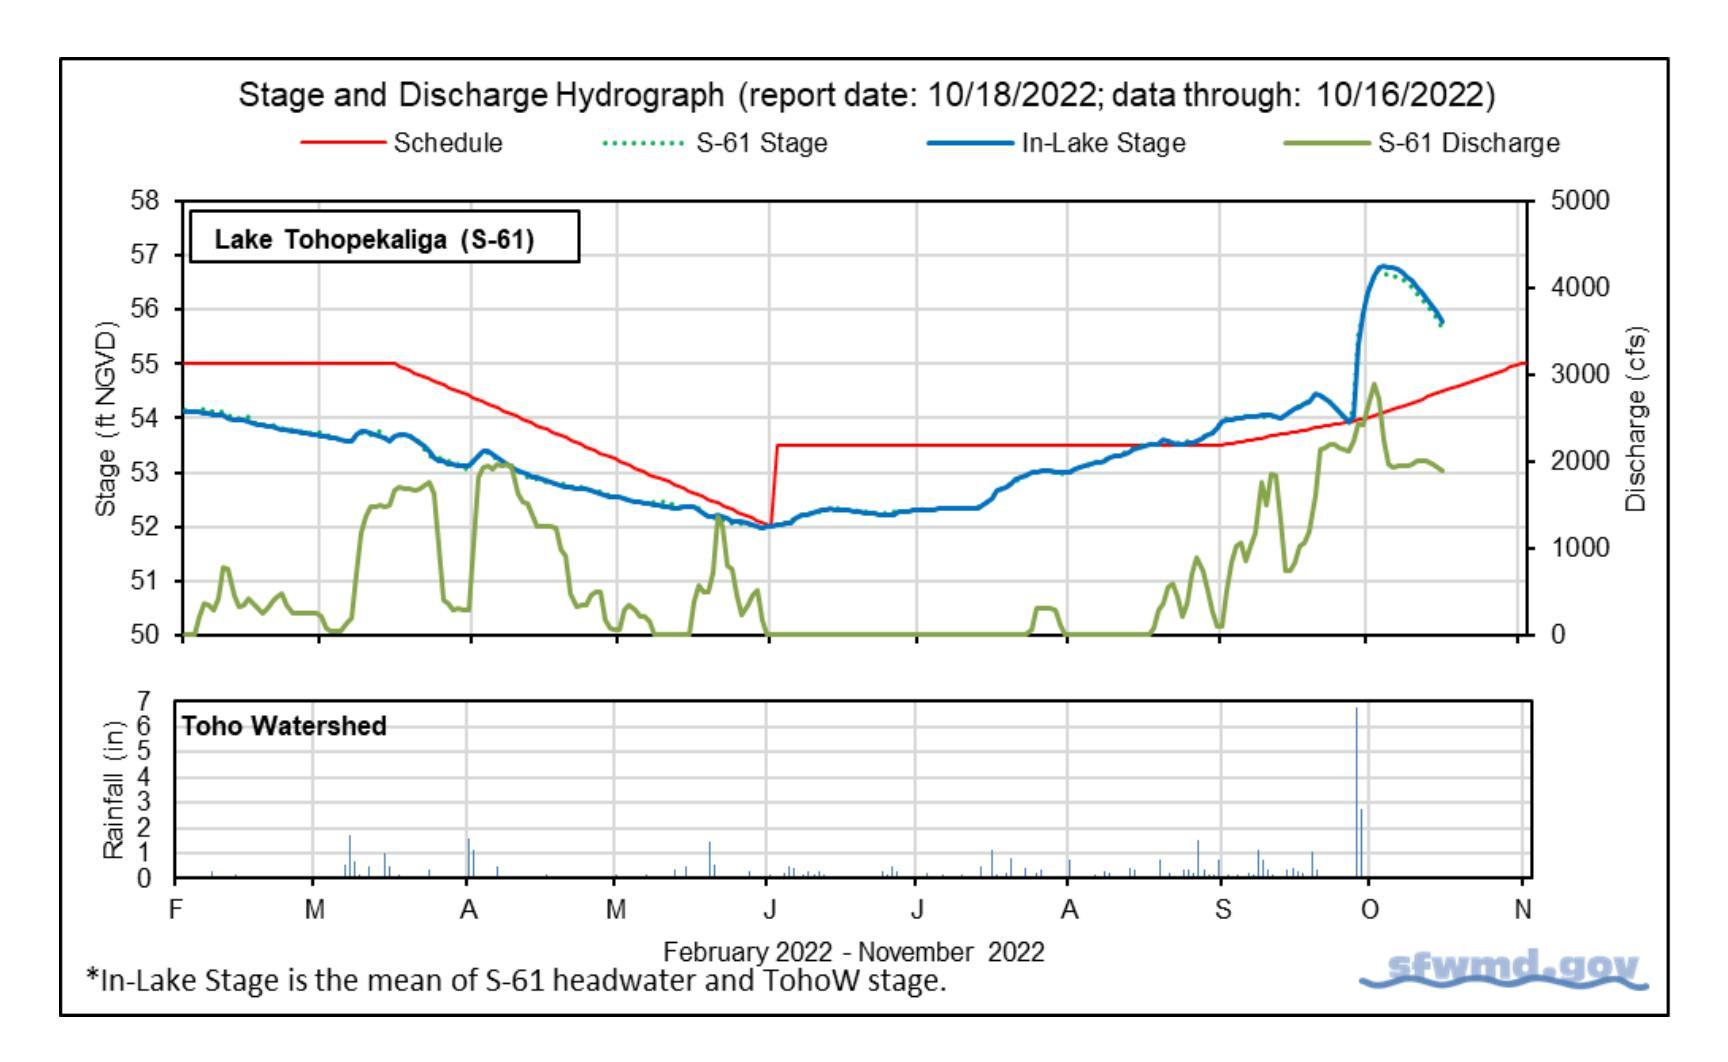
Figure KB-2. Lake Toho regulation schedule, stage, discharge, and rainfall.

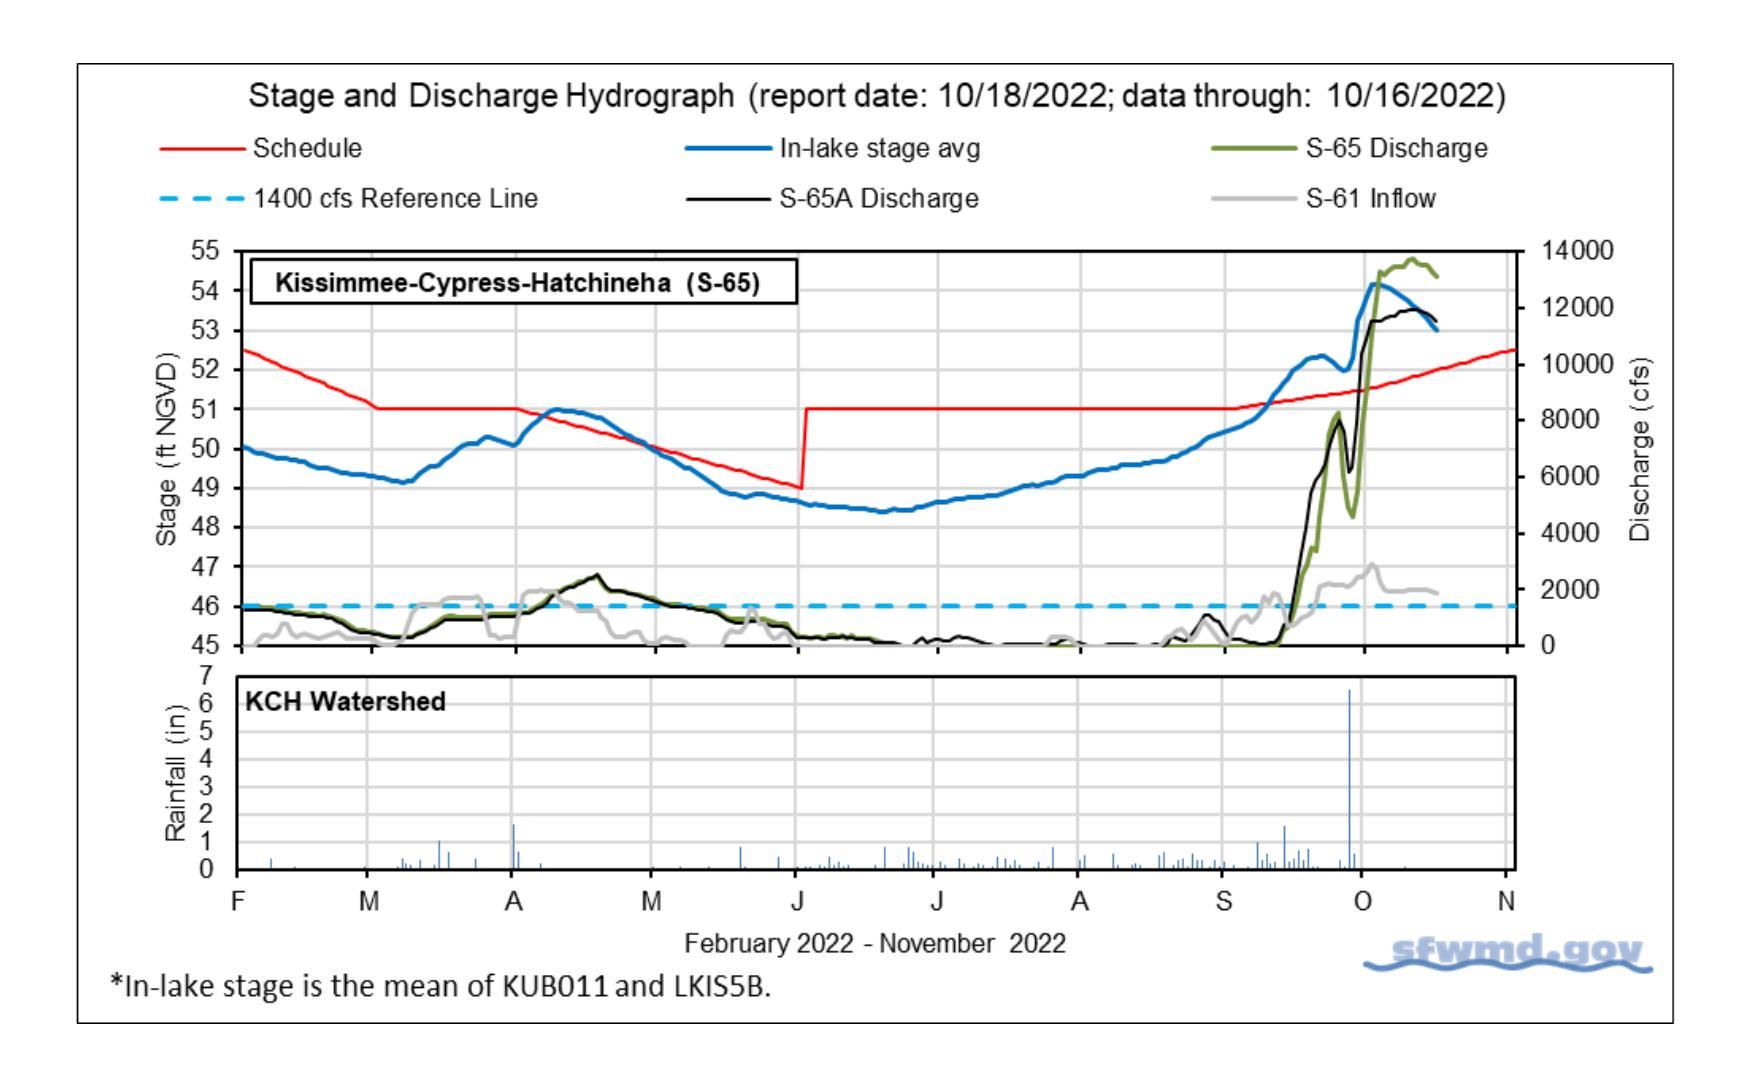
Figure KB-3. Lakes Kissimmee, Cypress and Hatchineha regulation schedule, stage, discharge and rainfall.

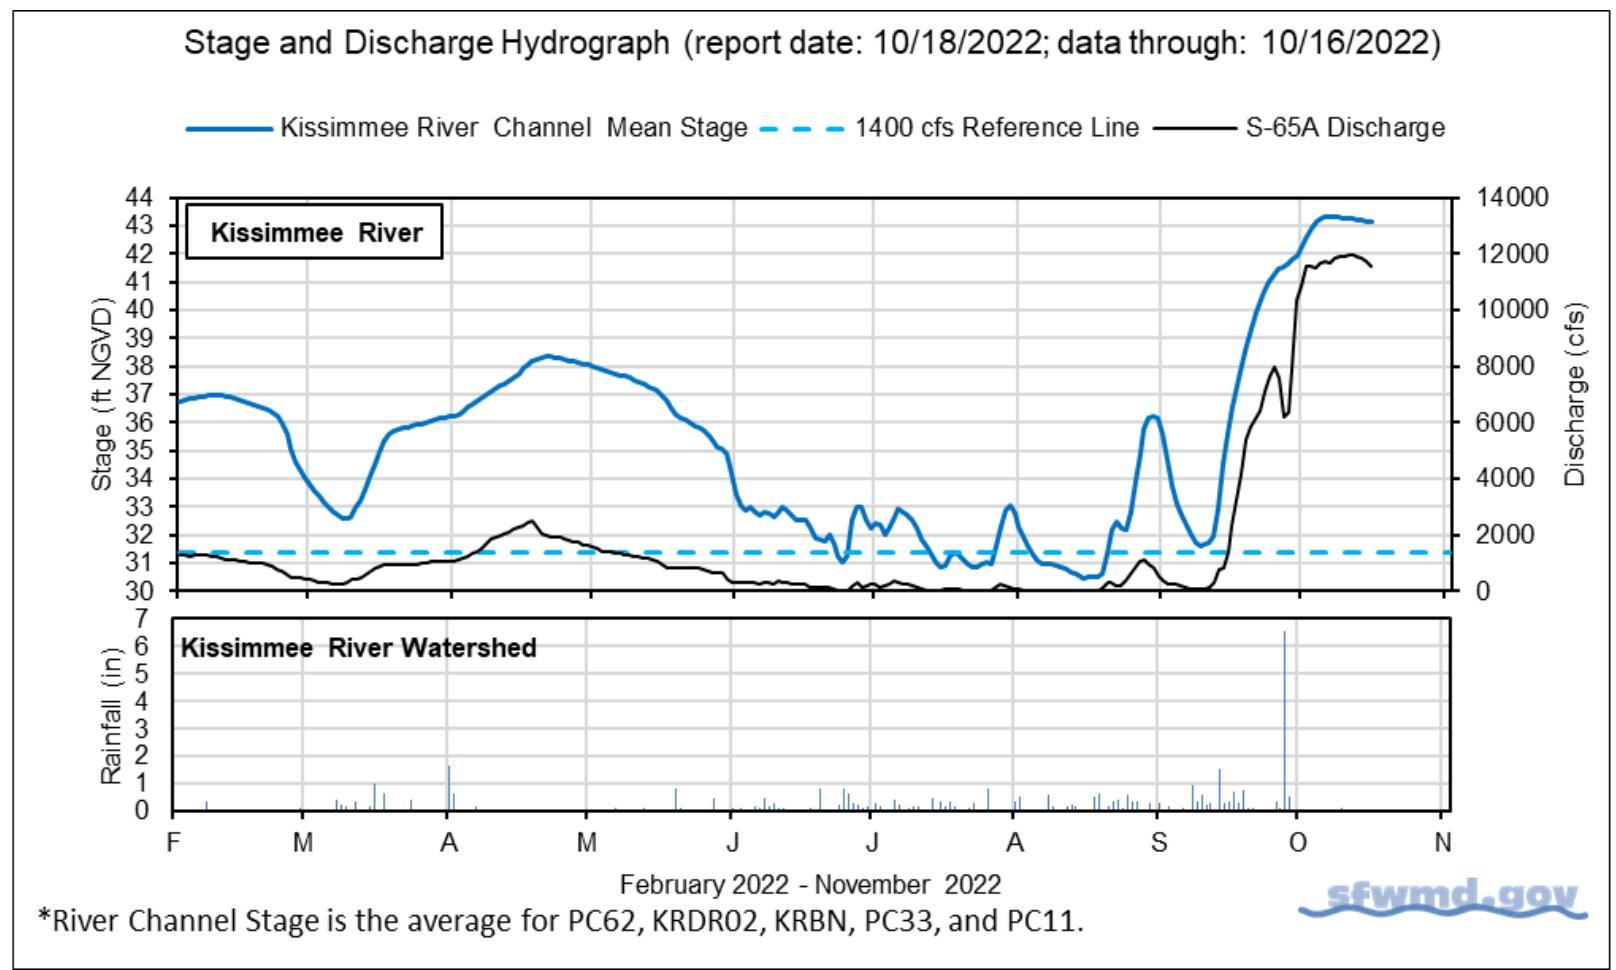
Figure KB-4. Kissimmee River stage, discharge and rainfall.

On October 16, 2022, average daily discharge was maintained at 13,000 cfs at S-65 and 12,000 cfs at S-65A to manage water levels in KCH and Pool A, respectively. Average daily discharge from the Kissimmee River was 14,000 cfs at S-65D and 14,000 cfs at S-65E (**Table KB-2**). Headwater stages were 50.7 feet NGVD at S-65A and 28.1 feet NGVD at S-65D on October 16, 2022. As S-65A discharge was maintained and local runoff decreased, mean river channel stage decreased by 0.12 feet (**Figure KB-4**) through the week, with mean water depth on the Kissimmee River floodplain decreasing to 5.11 feet on October 16, 2022 (**Figure KB-5**). The average concentration of dissolved oxygen in the Kissimmee River decreased from 1.1 mg/L to 1.0 mg/L for the week, with a daily value of 0.9 mg/L on October 16, 2022 (**Table KB-2**, **Figure KB-6**).

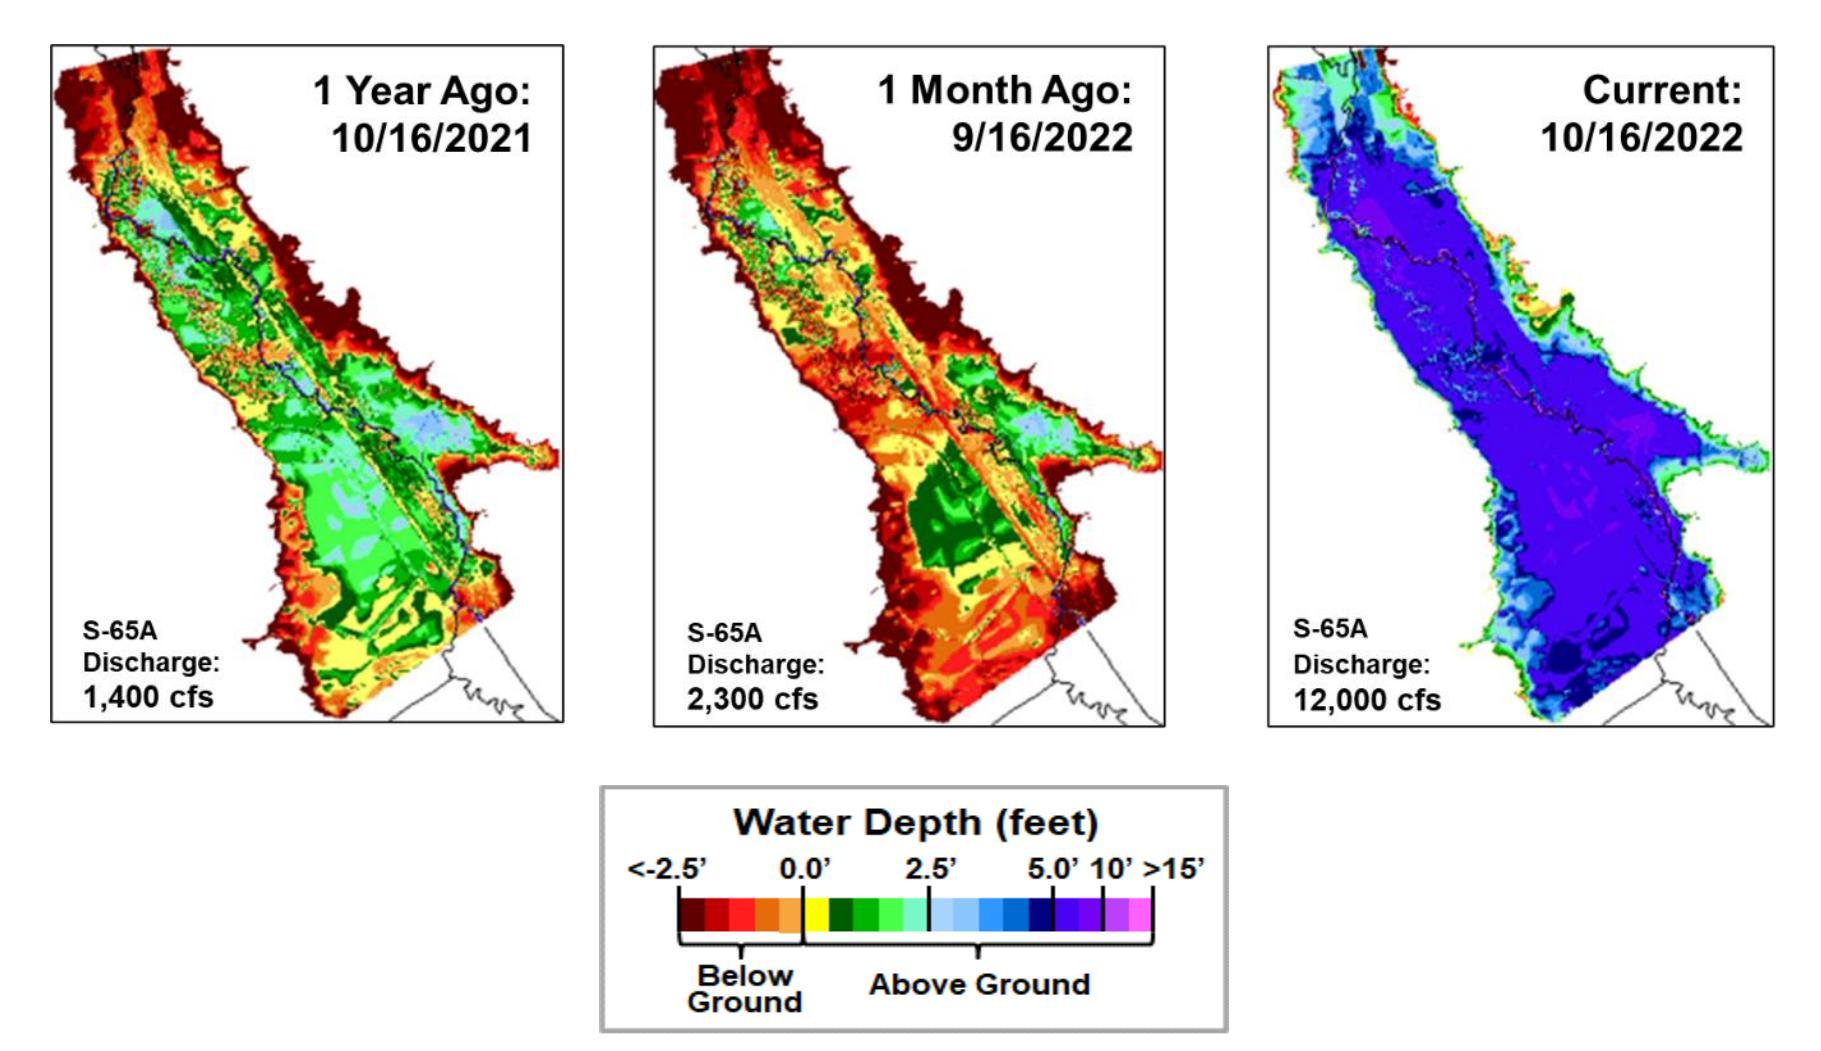
Figure KB-5. Phase I area Kissimmee River floodplain water depths (from left to right) one year ago, one month ago and current.

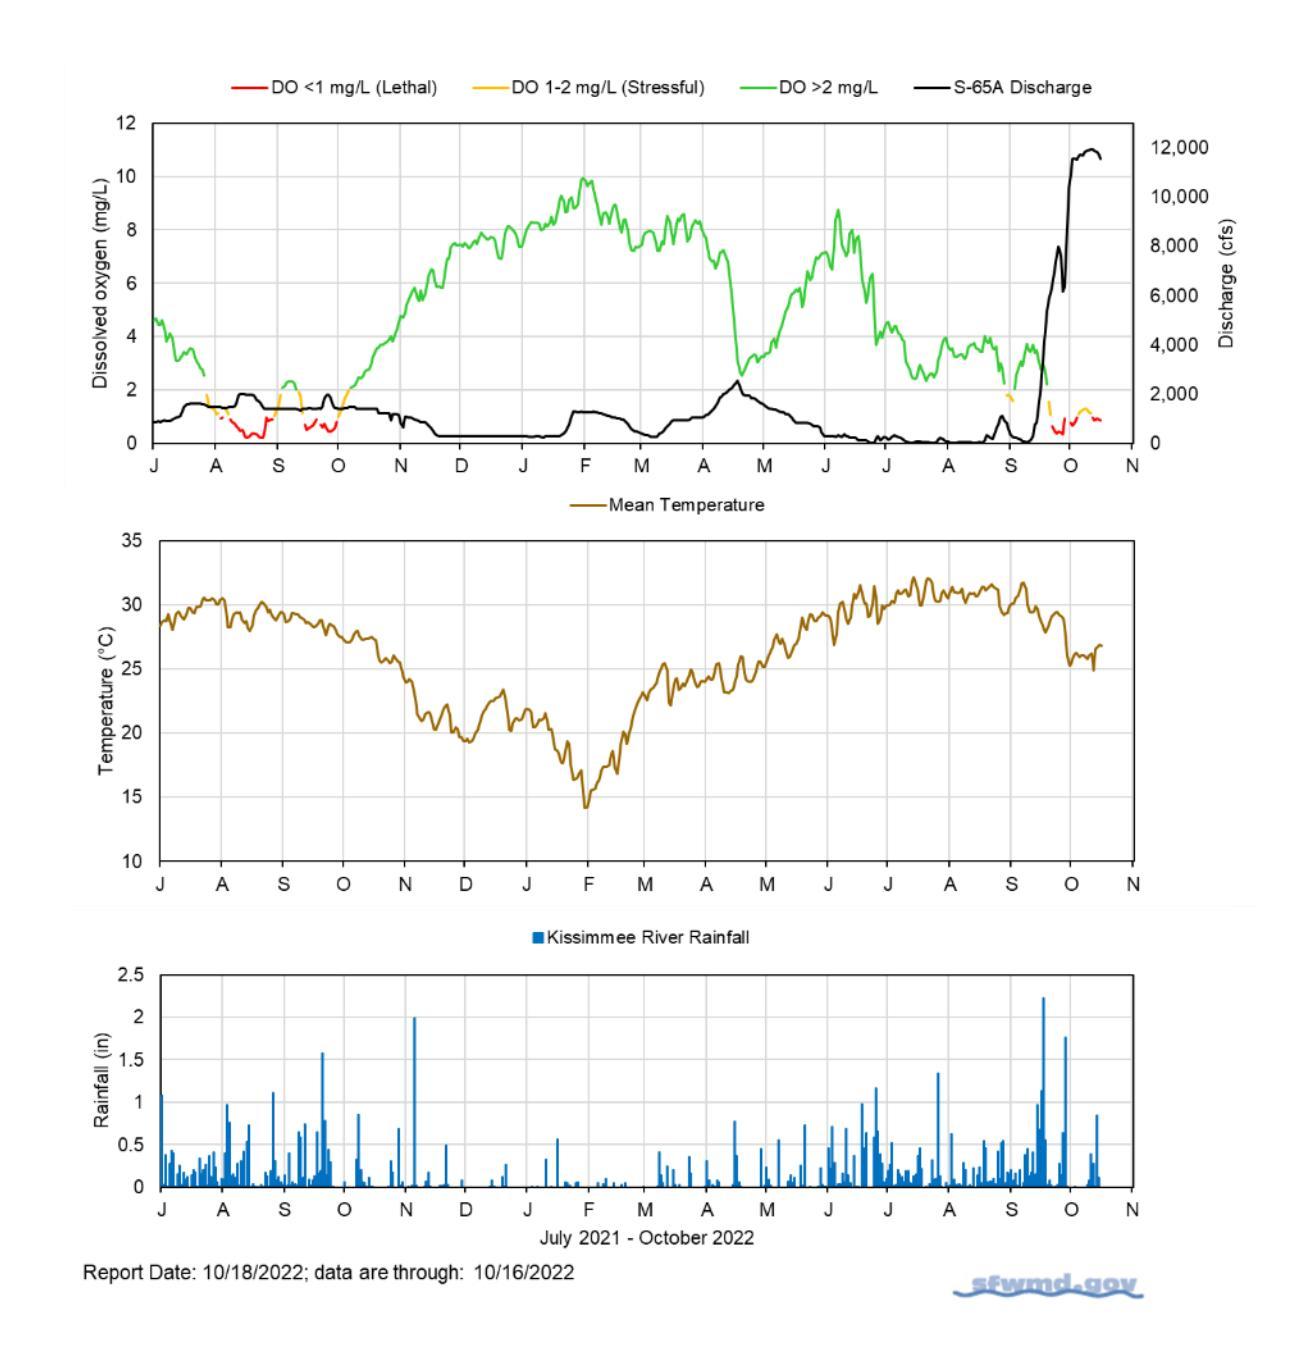
**Figure KB-6.** Restored Kissimmee river channel mean daily dissolved oxygen concentration (mg/L), S-65A discharge (cfs), temperature (°C) and rainfall (inches). Dissolved oxygen (DO) and temperature are mean daily values averaged for PC62, KRDR02, KRBN, PC33, PC11, PD62R, and PD42R with an average of five stations reporting this week. Rainfall values are daily totals for Kissimmee River (Pool BCD) AHED watershed.

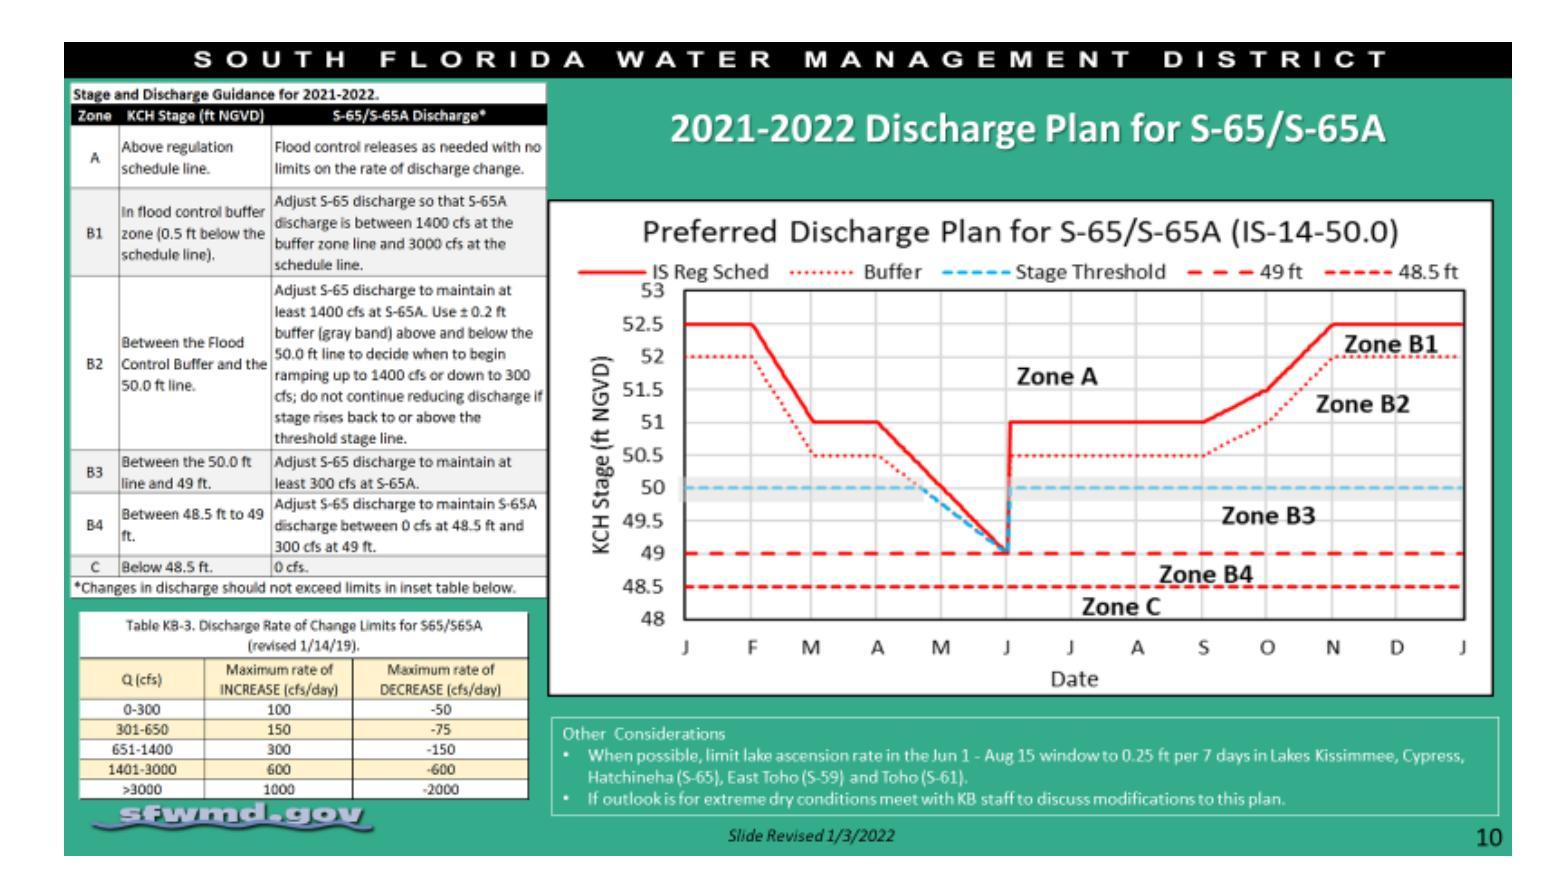
Figure KB-7. IS-14-50 Discharge Plan for S65/S65A with discharge rate of change limits (revised 1/14/19).

Per the IS-14-50.0 discharge plan, adjust S-65 discharge to maintain a minimum flow of at least 1,400 cfs at S-65A to the Kissimmee River. Note general guidance for discharge and maximum rates of change in discharge (**Figure KB-7**).

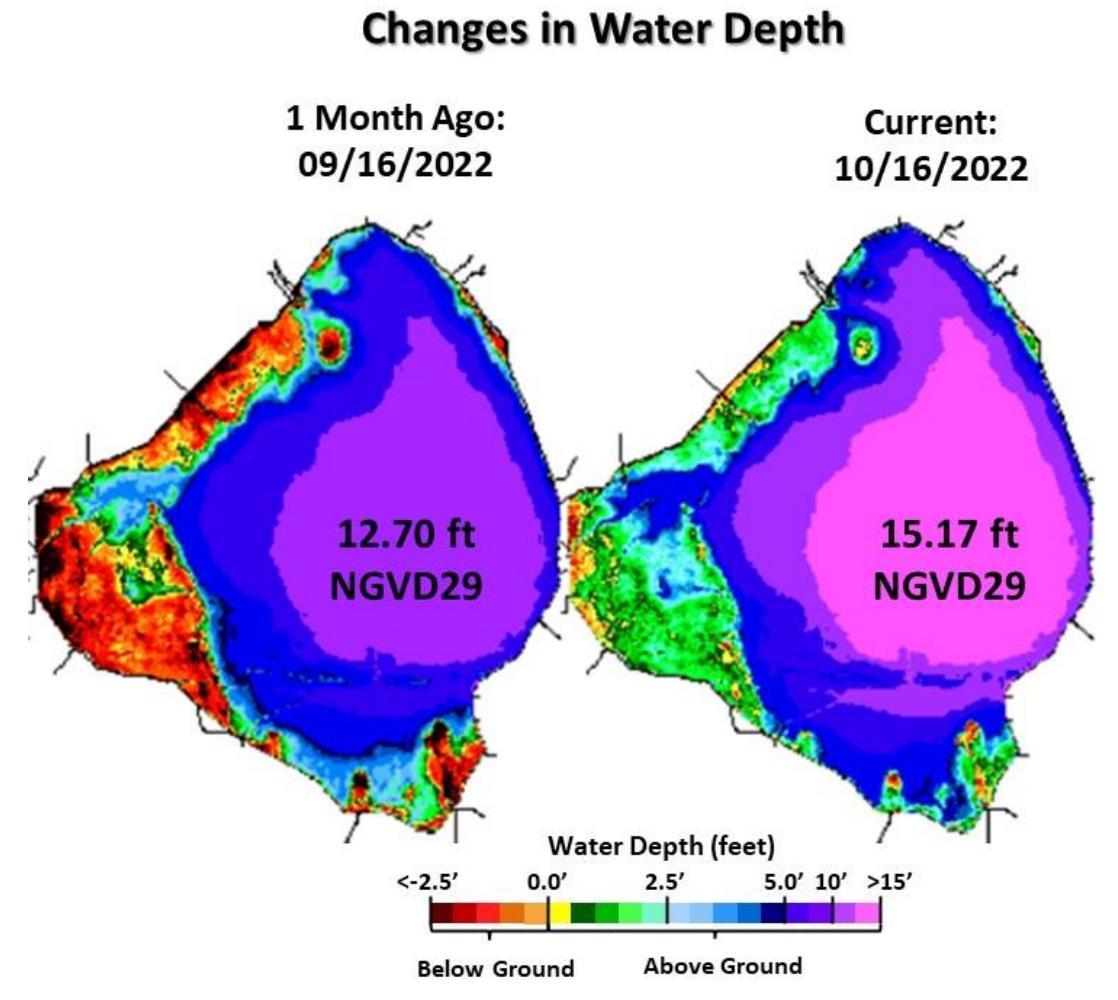
Figure LO-1. Lake Okeechobee water depth estimates based on South Florida Water Depth Assessment Tool (SFWDAT).

Lake Okeechobee stage was 15.17 feet NGVD on October 16, 2022, with water levels 0.64 feet higher than the previous week and 2.47 feet higher than a month ago (**Figure LO-1**). Lake stage remains within the Low sub-band (**Figure LO-2**) and the ecological envelope (**Figure LO-3**). According to NEXRAD, 1.38 inches of rain fell directly on the Lake last week.

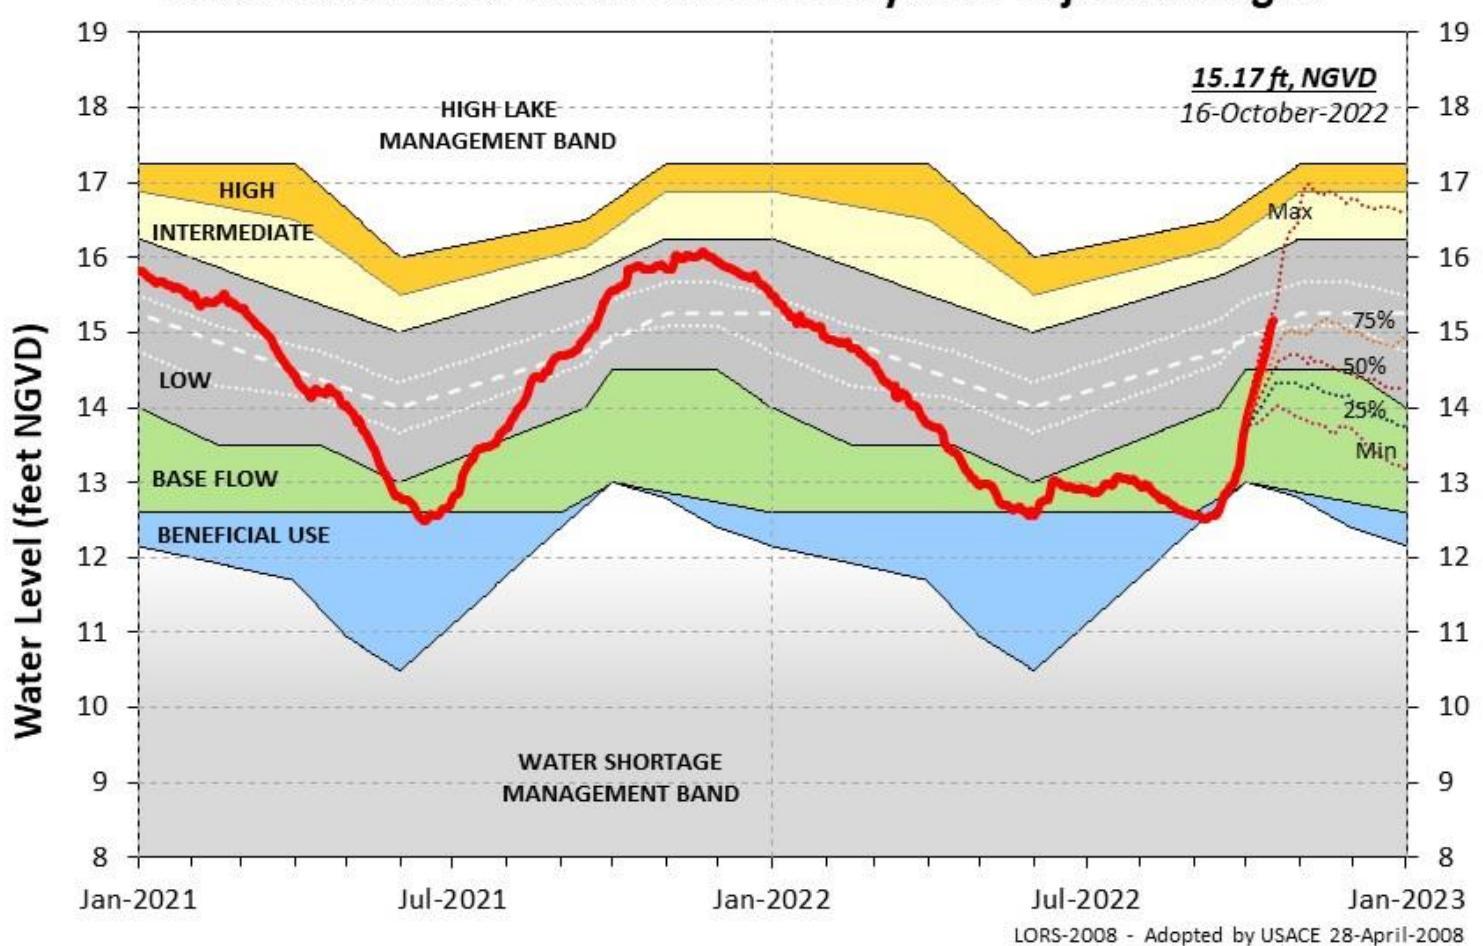
Figure LO-2. Recent Lake Okeechobee stages with projected stages based on a dynamic position analysis.

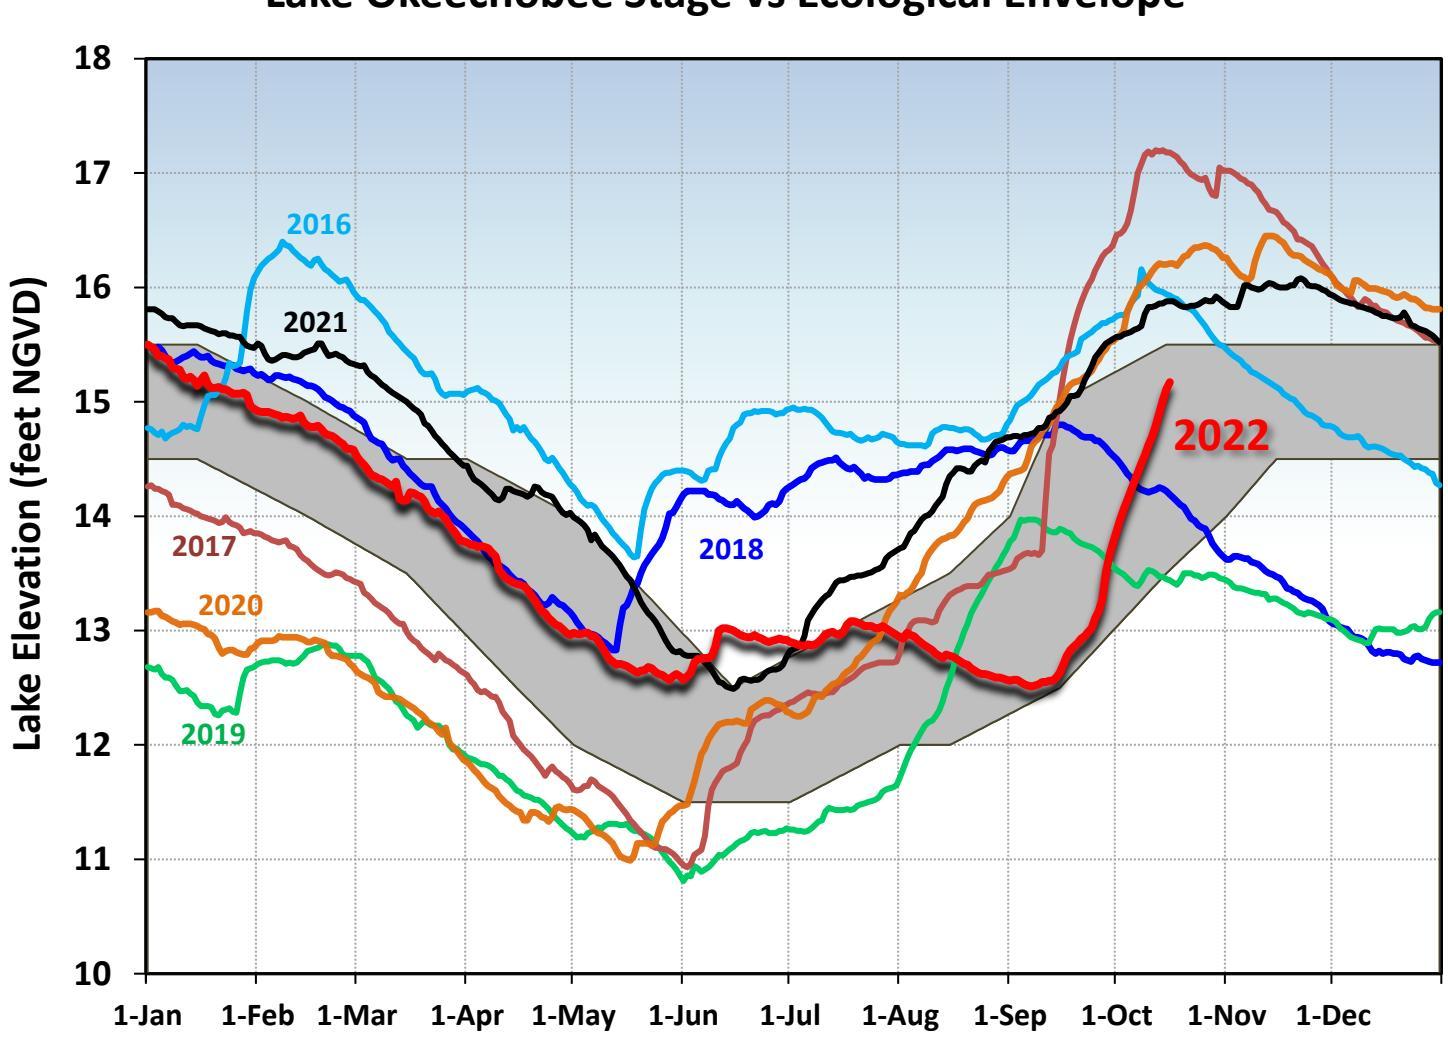
**Figure LO-3.** The prior six years of annual stage hydrographs for Lake Okeechobee in comparison to the ecological envelope.

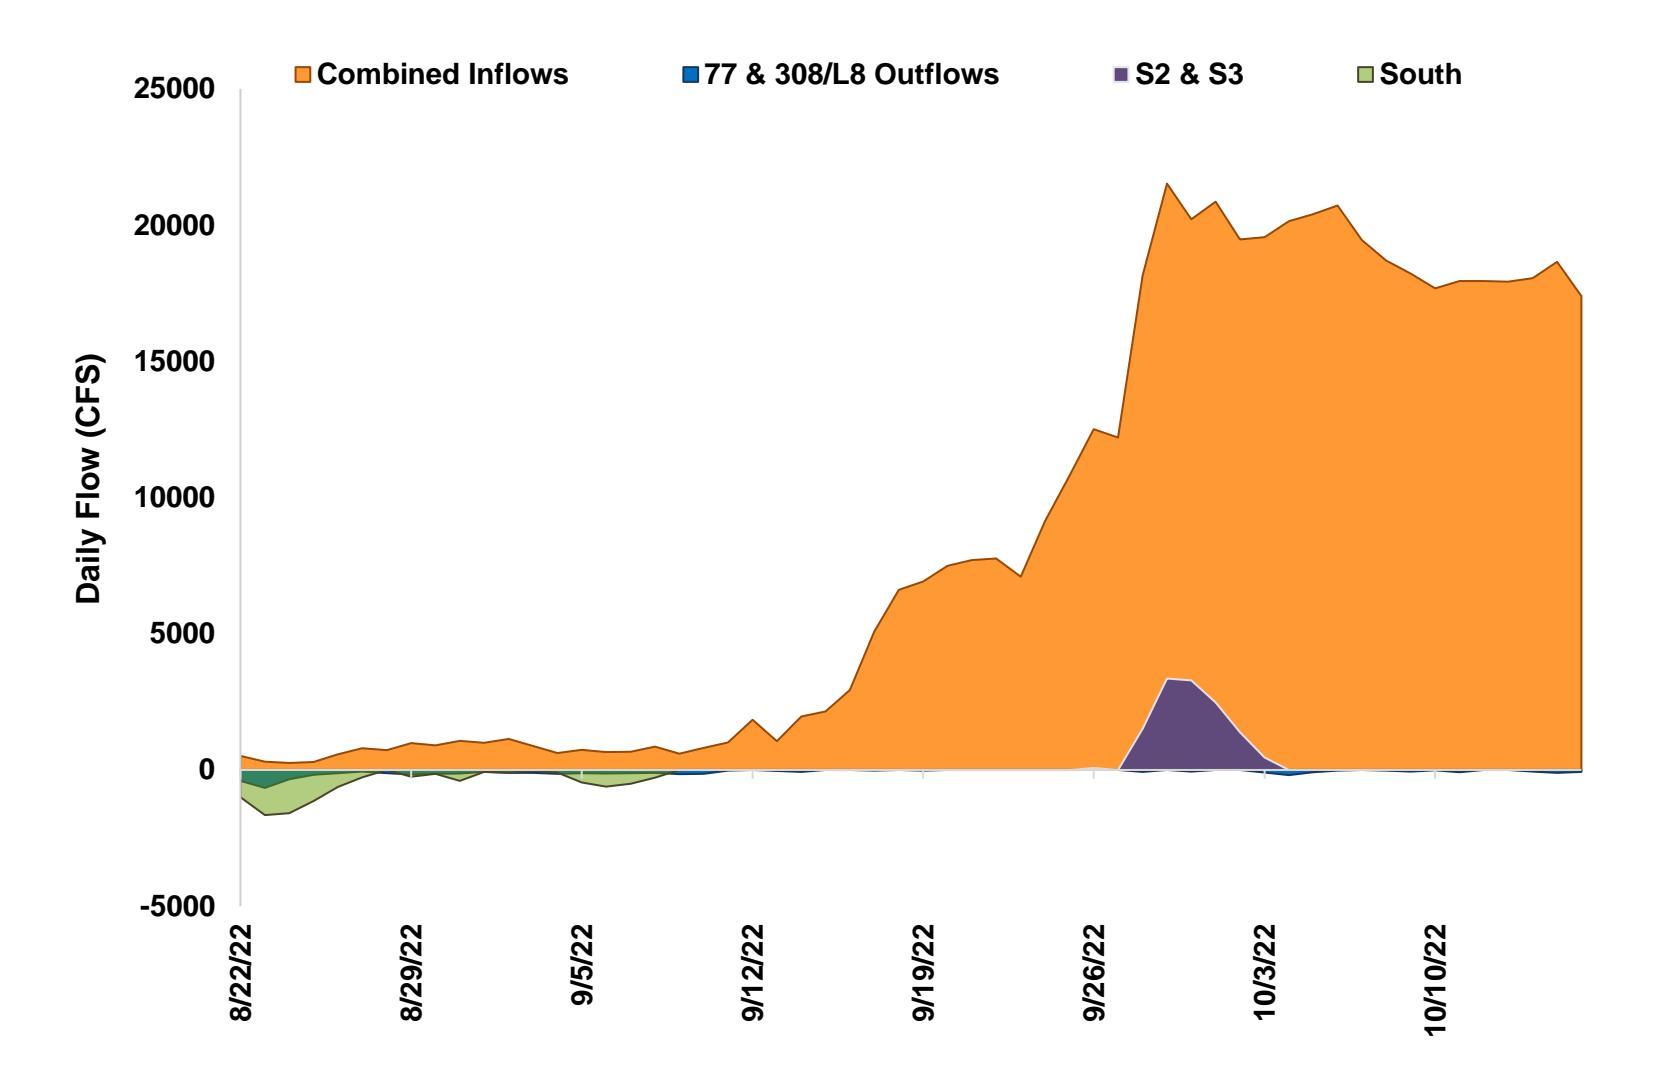
**Figure LO-4.** Major inflows (orange) to and outflows east and west (blue) from Lake Okeechobee. Outflows south are shown in green. Flows into Lake Okeechobee from the L-8 canal through S-271 (formerly Culvert 10A) or from the C-44 canal through the S-308 are included as inflows. Conversely, flows from Lake Okeechobee into the L-8 or C-44 canals are included with outflows. Inflows are shown as positive values; outflows are negative. Outflows through the S-77 (Caloosahatchee) and S-308 (C-44 Canal) structures are based on downstream gauges to include flows to lock openings for navigation.

Average daily inflows (excluding rainfall) decreased from the previous week, going from 19,609 cfs to 17,930 cfs. There were no outflows (excluding evapotranspiration) for the fifth consecutive week. The highest inflow came from the Kissimmee River (C-38 Canal; 13,942 cfs), followed by the S-84 & S-84X structures from the C-41A Canal (1,794 cfs), and Fisheating Creek (1,477 cfs). Back flow was recorded from the L-8 Canal via the S-271 structure at an average daily rate of 194 cfs. **Figures LO-4 and LO-5** show the combined average daily inflows and outflows for the Lake over the past eight weeks, and average inflows and outflows last week, respectively. These data are provisional and are subject to change.

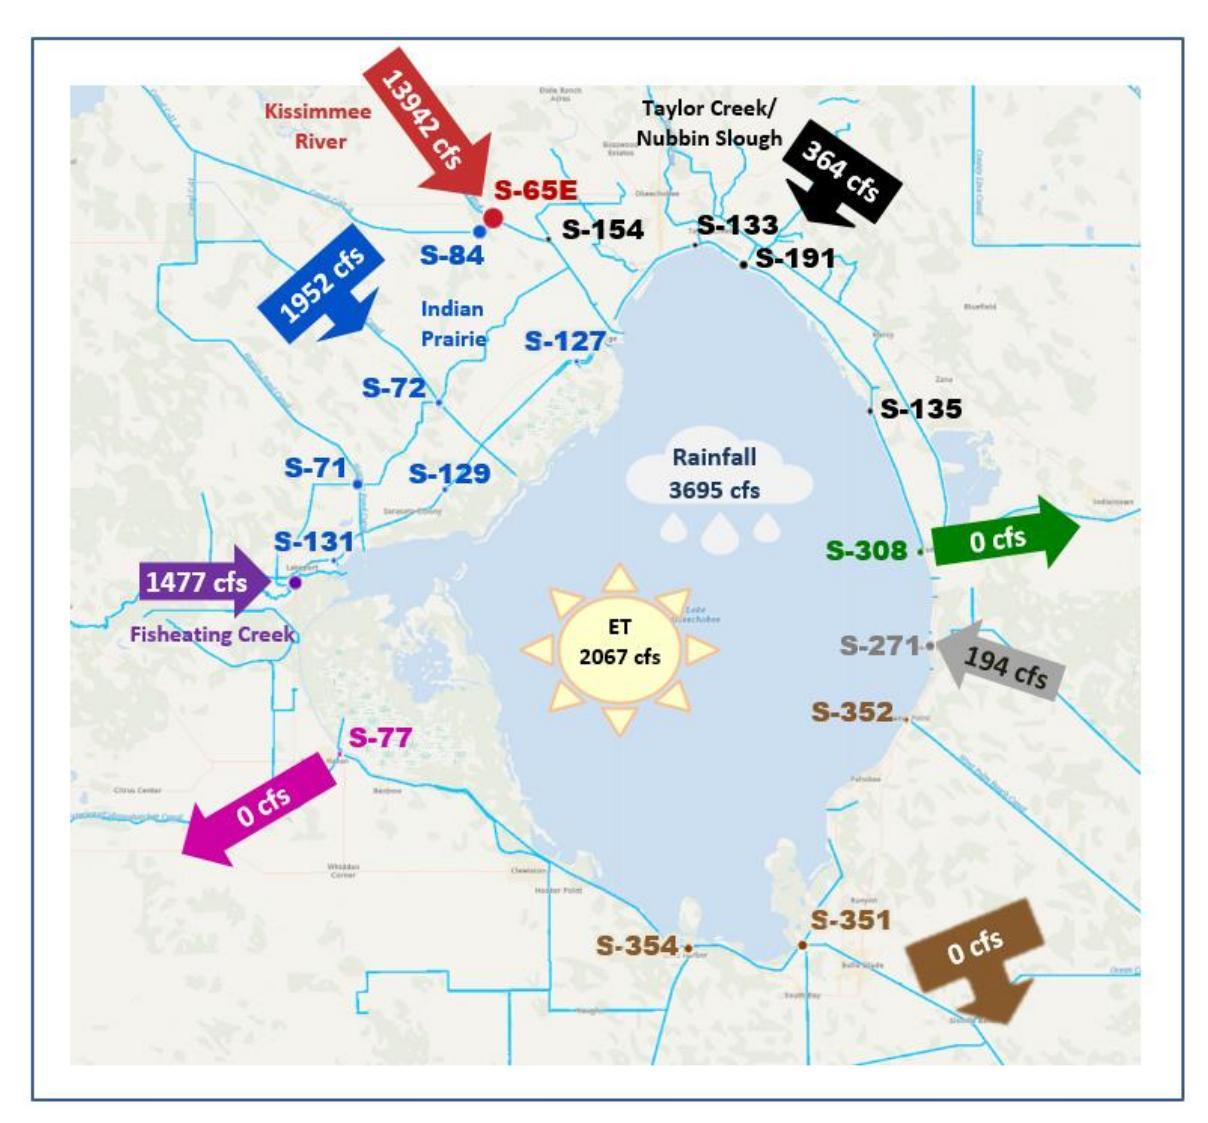
**Figure LO-5.** Inflows into Lake Okeechobee from Indian Prairie basins, Taylor Creek/Nubbin Slough, Kissimmee River and Fisheating Creek, and outflows to the west via S-77, to the east via S-308, to the south via S-351, S-352, S-354, and to southeast via S-271 (formerly Culvert 10A) for the week of October 10 - 16, 2022.

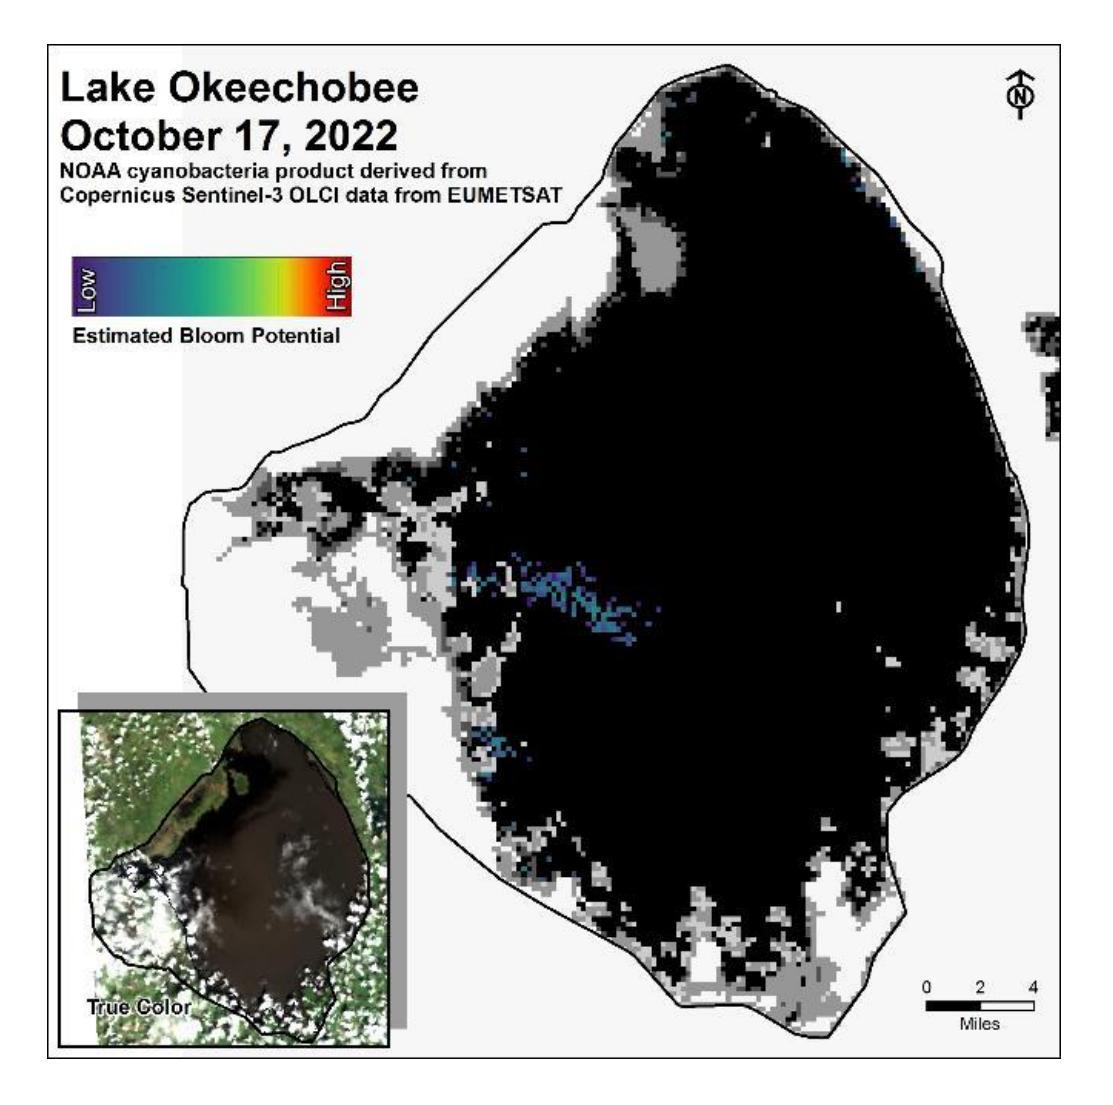
Figure LO-6. Cyanobacteria bloom potential on October 17, 2022 based on NOAA's harmful algal bloom monitoring system. Gray color indicates cloud cover.

The most recent satellite image (October 17, 2022) from NOAA's Harmful Algal Bloom Monitoring System showed there was little to no bloom potential in the lake, decreasing slightly since last week (**Figure LO-6**).
