# MEMORANDUM

**FROM:** SFWMD Staff Environmental Advisory Team

**DATE:** October 19, 2022

**SUBJECT:** Weekly Environmental Conditions for Systems Operations

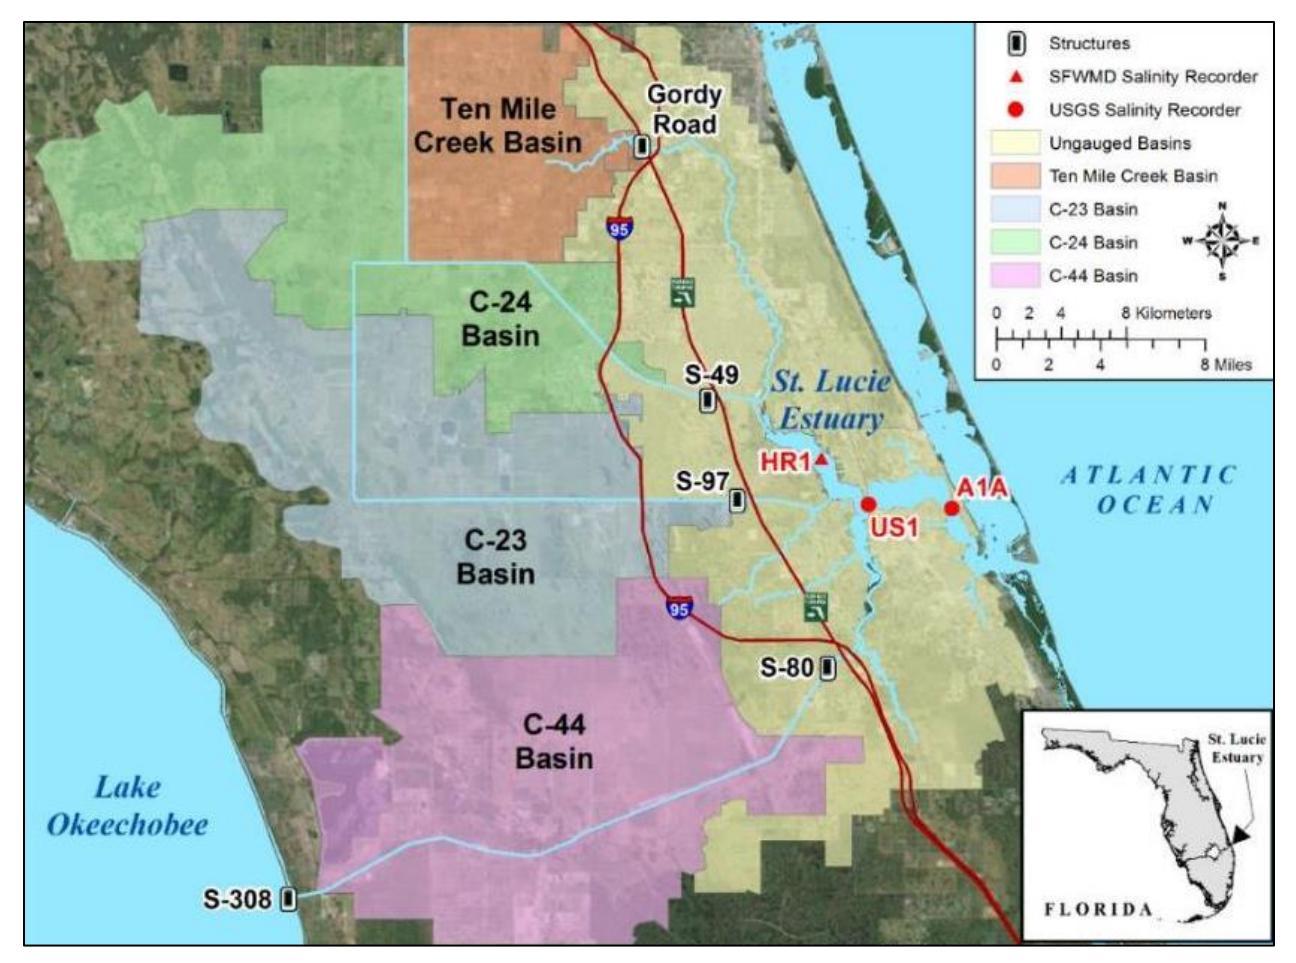
Figure ES-1. Basins, water control structures and salinity monitoring sites in the St. Lucie Estuary.

Over the past week, mean total inflow to the St. Lucie Estuary was 2,607 cfs (**Figures ES-1** and **ES-2**) and the previous 30-day mean inflow was 3,895 cfs. For comparison, the historical provisional mean inflows from the contributing areas are shown in **Figure ES-2**.

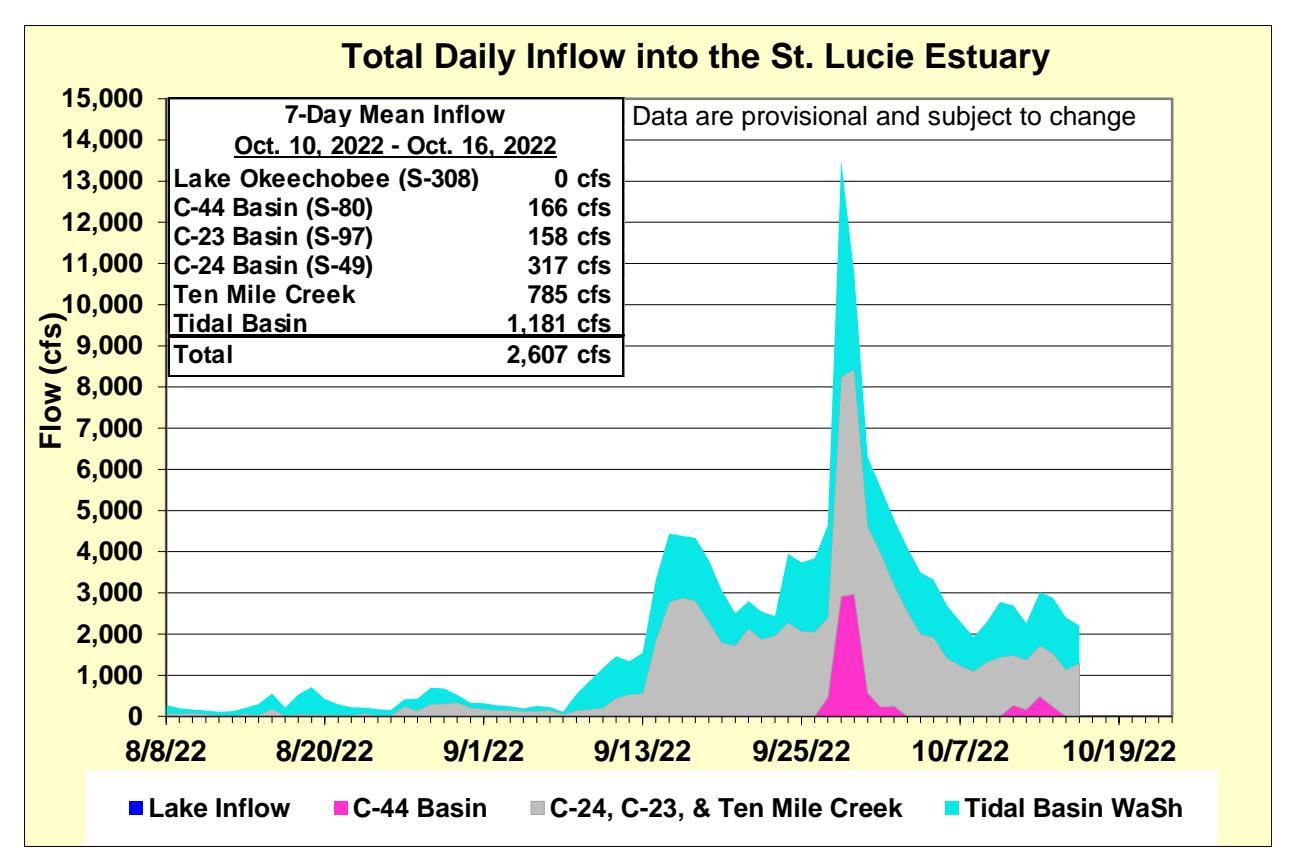
**Figure ES-2.** Total daily inflows from Lake Okeechobee and runoff from the C-44, C-23, C-24, Ten Mile Creek, and Tidal Basins into the St. Lucie Estuary.

The St. Lucie estuary was impacted by Hurricane Ian on September 27 and 28, 2022 with most of the freshwater inflow coming from the basins (**Figure ES-2**). This inflow resulted in a rapid decrease in salinity throughout the estuary, but salinity began recovering quickly (**Figure ES-3**). Long-term impacts to oyster populations are unlikely but will be monitored.

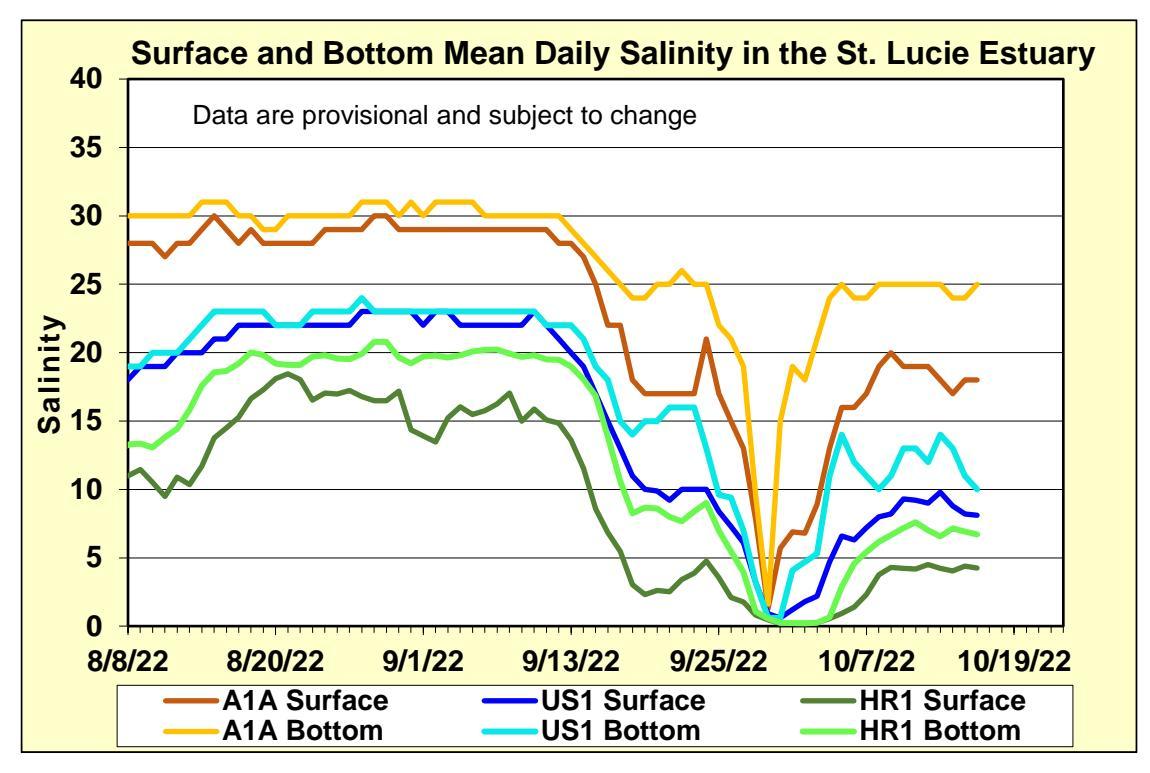
Figure ES-3. Mean daily salinity at the A1A, US1 and HR1 sites in the St. Lucie Estuary.

Over the past week, salinities increased at all sites in the estuary (**Table ES-1** and **Figure ES-3**). The seven-day moving average of the surface and bottom salinities at the US1 Bridge was 10.6. Salinity conditions in the middle estuary were estimated to be within the optimal range for adult eastern oysters (**Figure ES-4**). The mean larval oyster recruitment rate reported by the Fish and Wildlife Research Institute in September was 2.5 spat/shell (**Figure ES-5**).

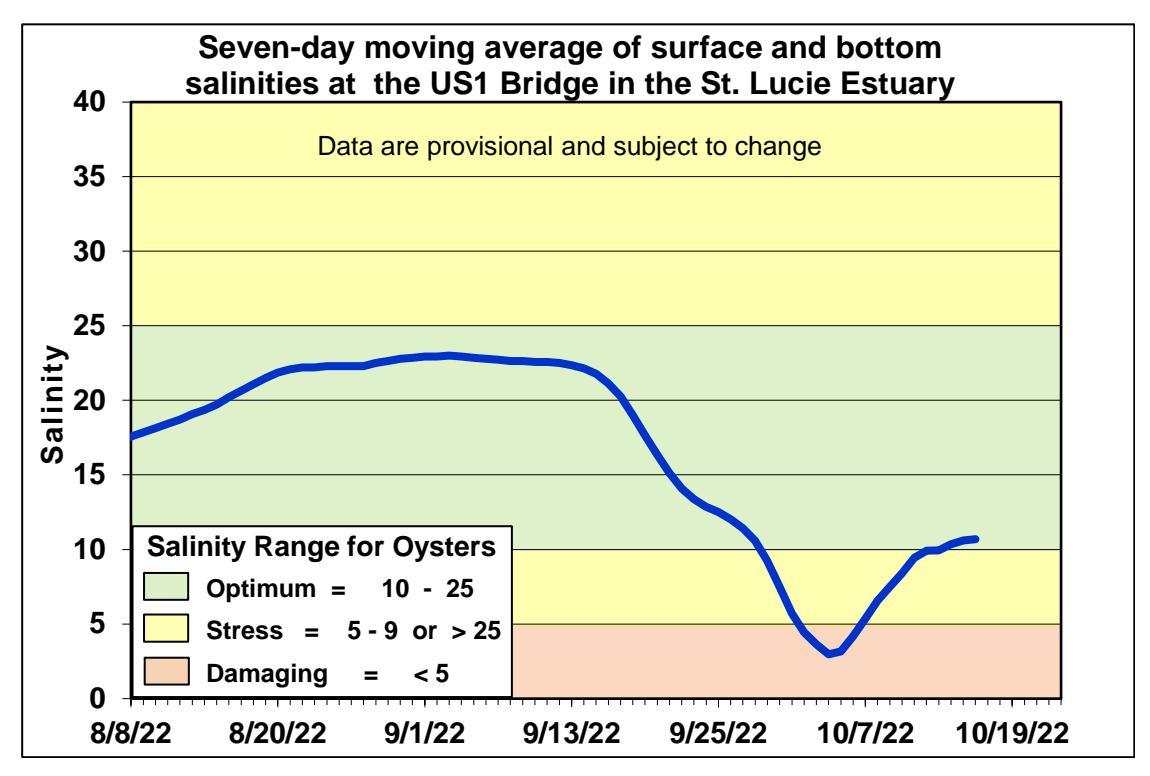
Figure ES-4. Seven-day moving average of the surface and bottom salinities at the US1 Bridge in the St. Lucie Estuary.

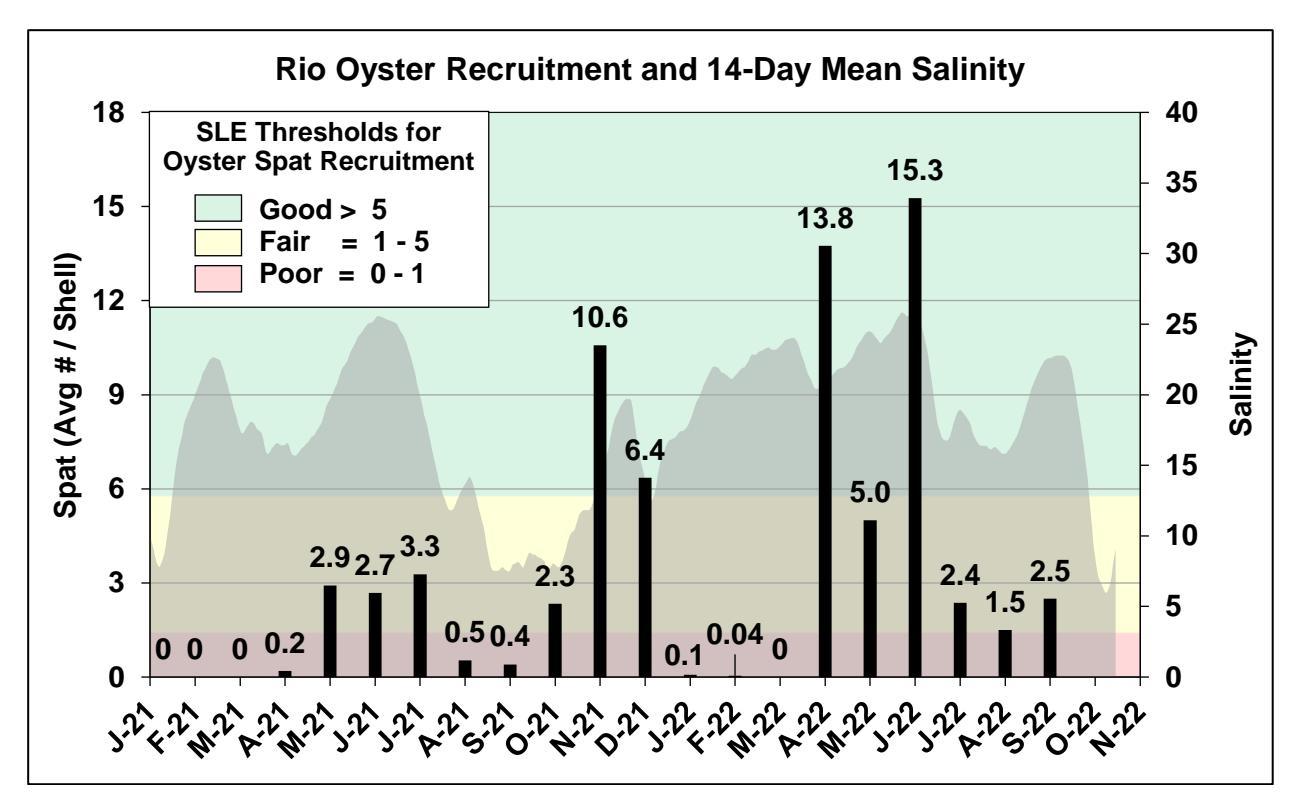
Figure ES-5. Mean oyster recruitment at the Rio oyster monitoring station and 14-day mean salinity at US1 Bridge.

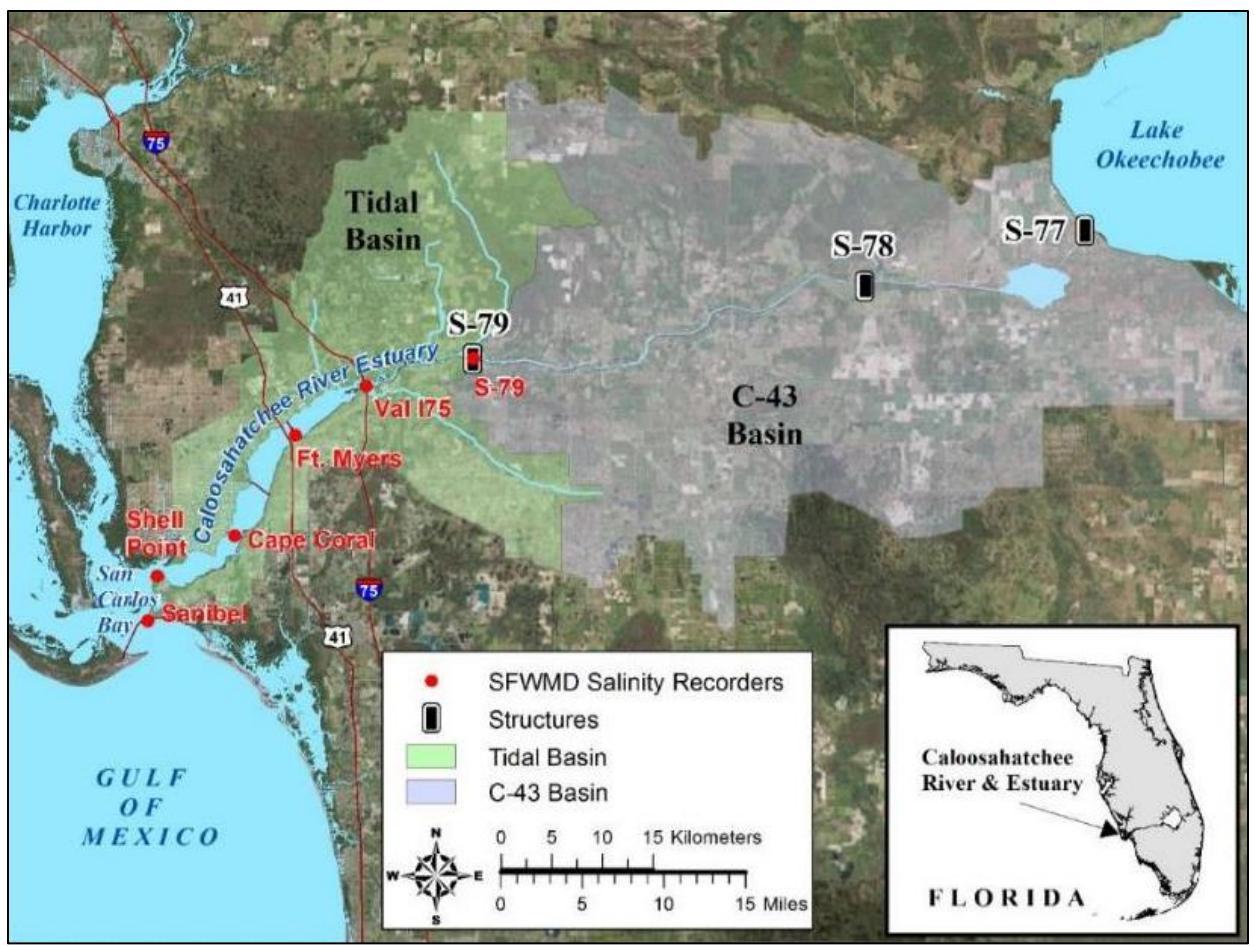
Figure ES-6. Basins, water control structures and salinity monitoring sites in the Caloosahatchee River Estuary.

Over the past week, mean total inflow to the Caloosahatchee River Estuary was 3,920 cfs (**Figures ES-6** and **ES-7**) and the previous 30-day mean inflow was 7,997 cfs. For comparison, the historical provisional mean inflows from the contributing areas are shown in **Figure ES-7**.

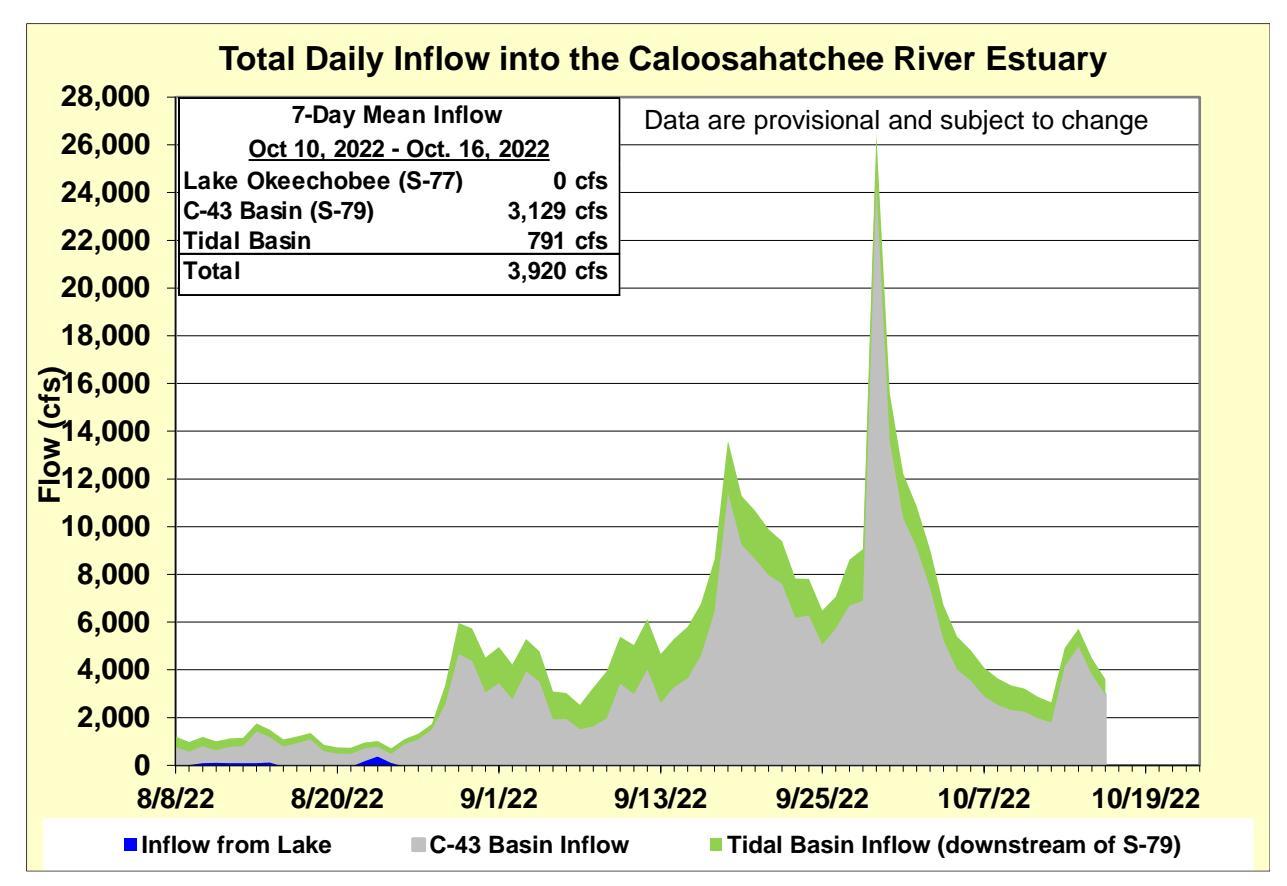
**Figure ES-7.** Total daily inflows from Lake Okeechobee, and runoff from the C-43 and Tidal basins into the Caloosahatchee River Estuary.

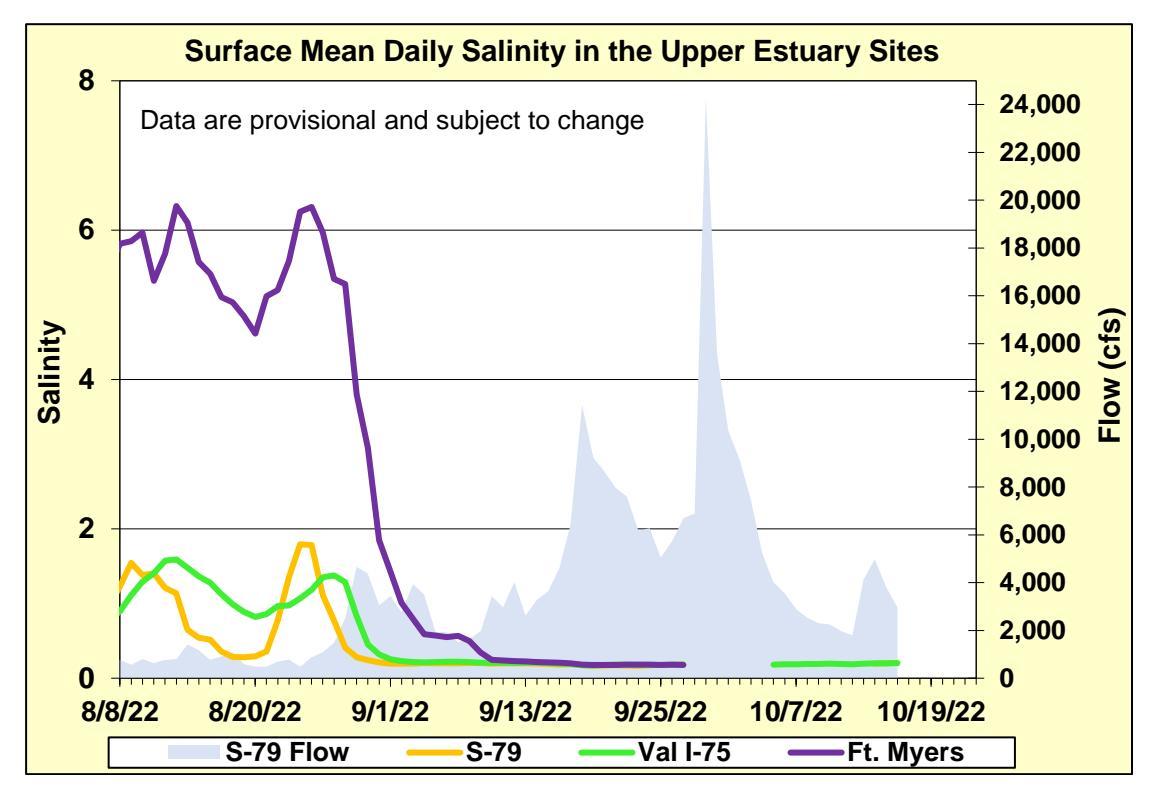
Figure ES-8. Mean daily salinity at upper Caloosahatchee River Estuary monitoring sites and mean daily flow at S-79.

Salinities were reported for Val I-75 from October 5-16, 2022 and for S-79 from October 14-16, 2022 (**Table ES-2** and **Figures ES-8** and **ES-9**). Salinities were not reported for Fort Myers, Cape Coral, Shell Point, or Sanibel (**Table ES-2** and **ES-10**). The mean larval oyster recruitment rate reported by the Fish and Wildlife Research Institute in September was 2.6 spat/shell at Iona Cove and 6.4 spat/shell at Bird Island (**Figures ES-11 and ES-12**). Surface salinity at Val I-75 was forecasted for the next two weeks using an autoregression model (Qiu and Wan, 2013<sup>1</sup>) coupled with a linear reservoir model for the tidal basin. Model scenarios included pulse releases at S-79 ranging from 0 to 1,500 cfs,

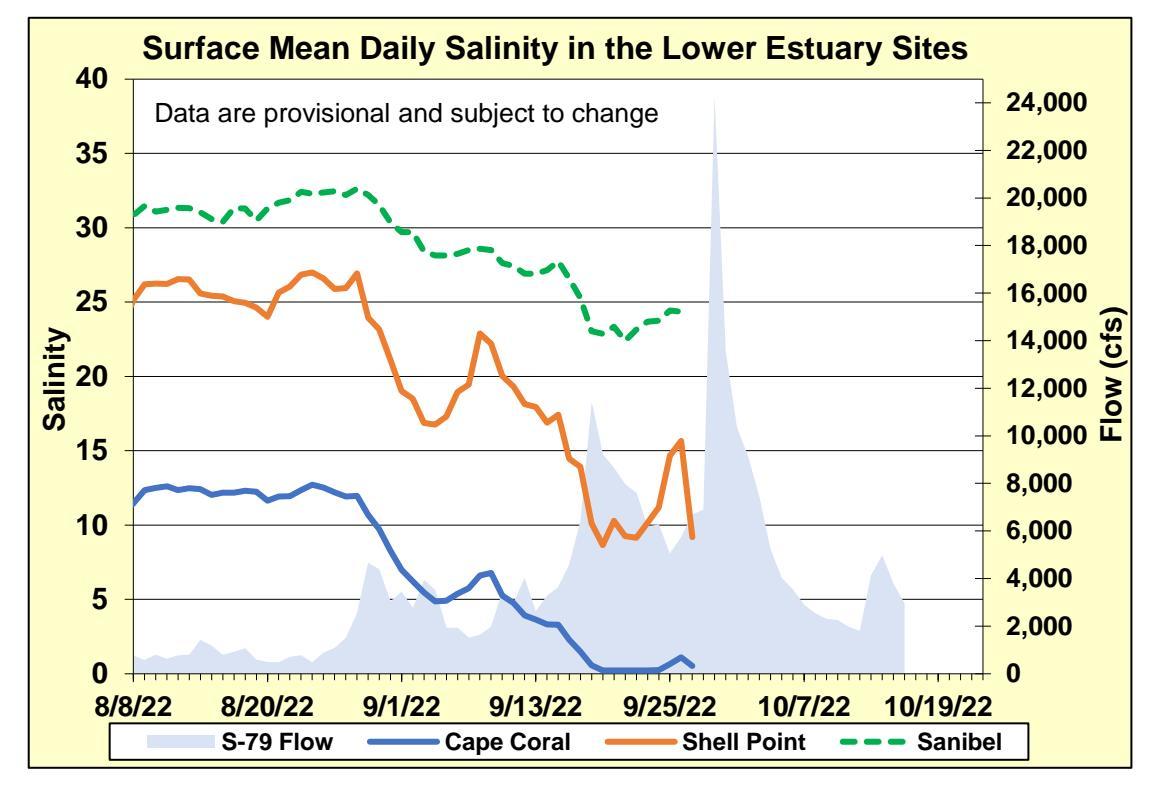
Figure ES-9. Mean daily surface salinity at lower Caloosahatchee River Estuary monitoring sites and mean daily flow at S-79.

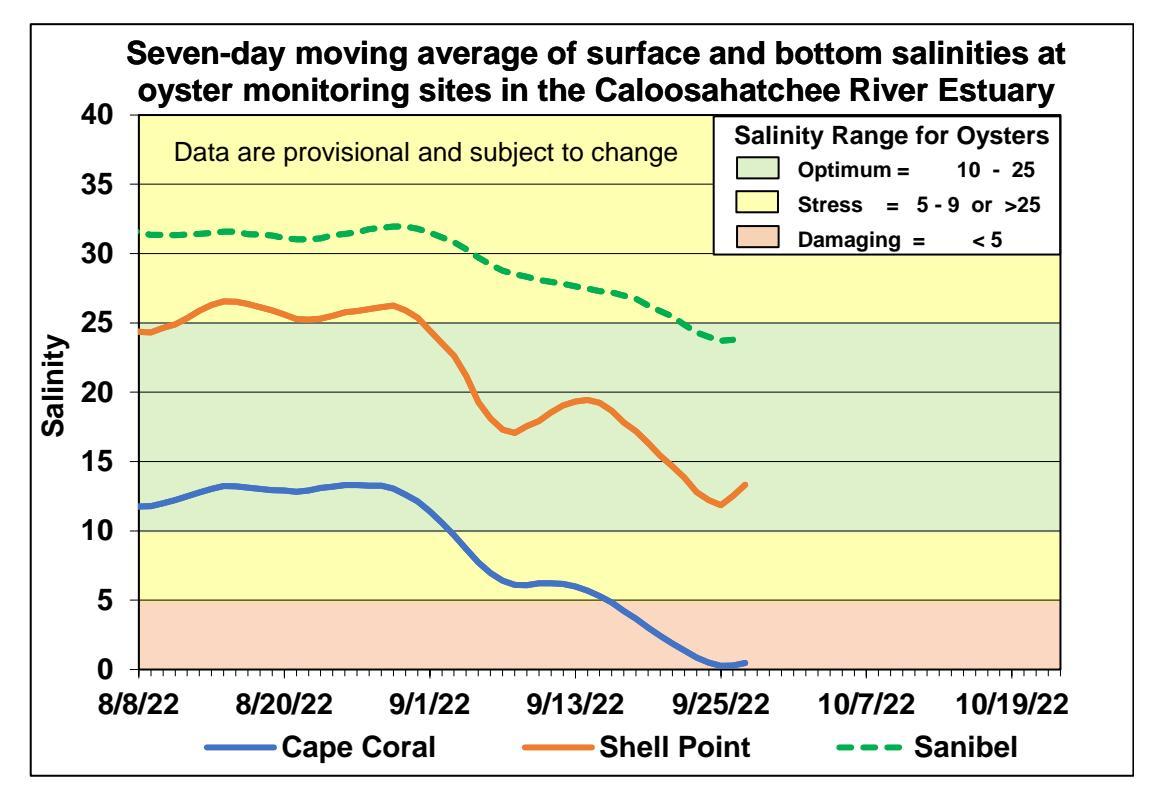
**Figure ES-10.** Seven-day moving average of surface and bottom salinities at Cape Coral, Shell Point and Sanibel monitoring sites in the Caloosahatchee River Estuary.

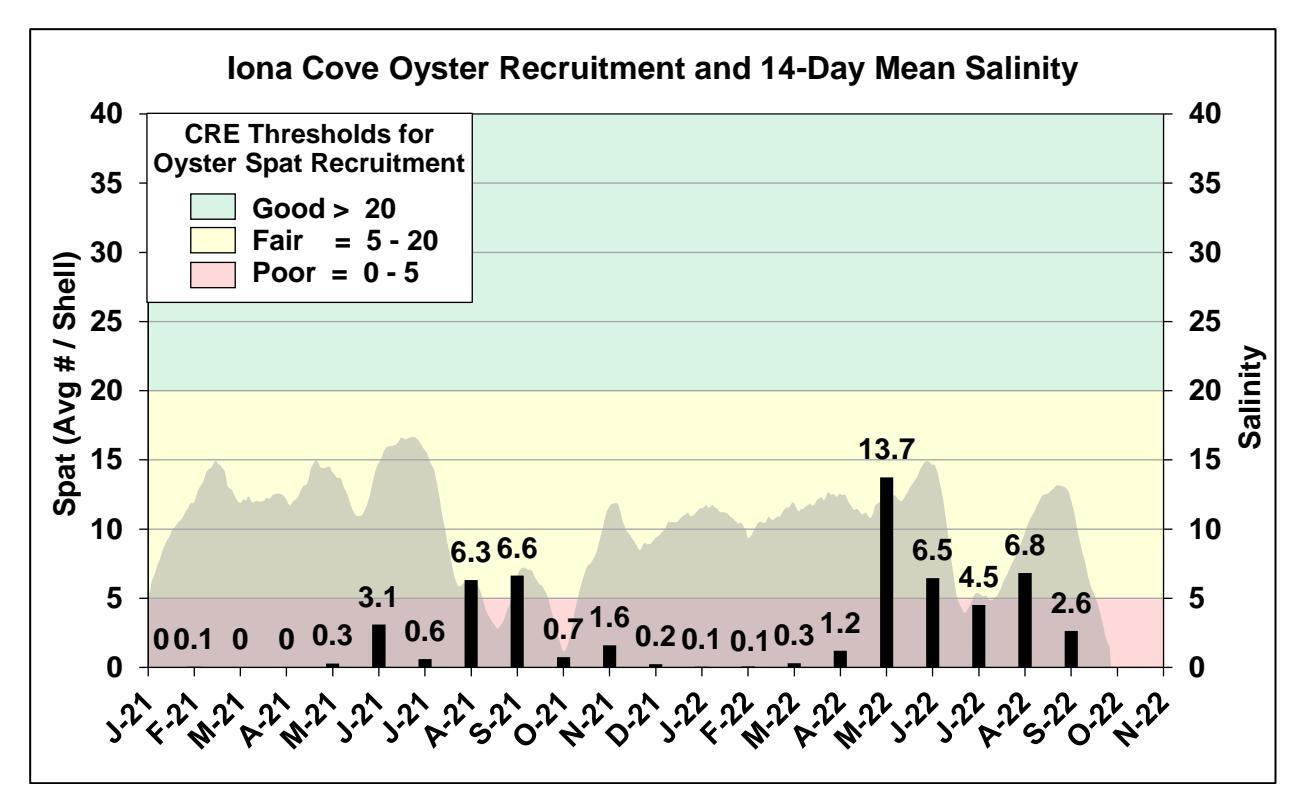
Figure ES-11. Mean oyster recruitment at the Iona Cove oyster monitoring station and 14-day mean salinity at Cape Coral.

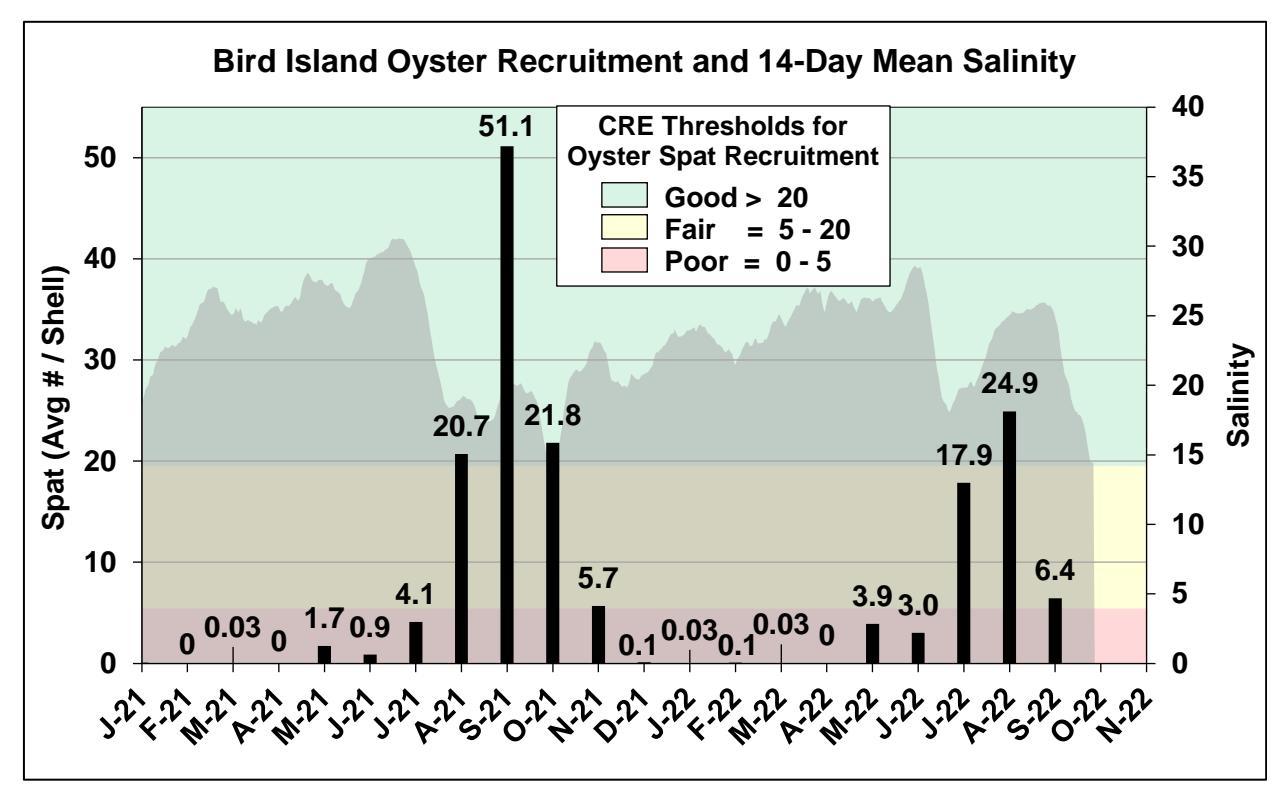
Figure ES-12. Mean oyster recruitment at the Bird Island oyster monitoring station and 14-day mean salinity at Shell Point.

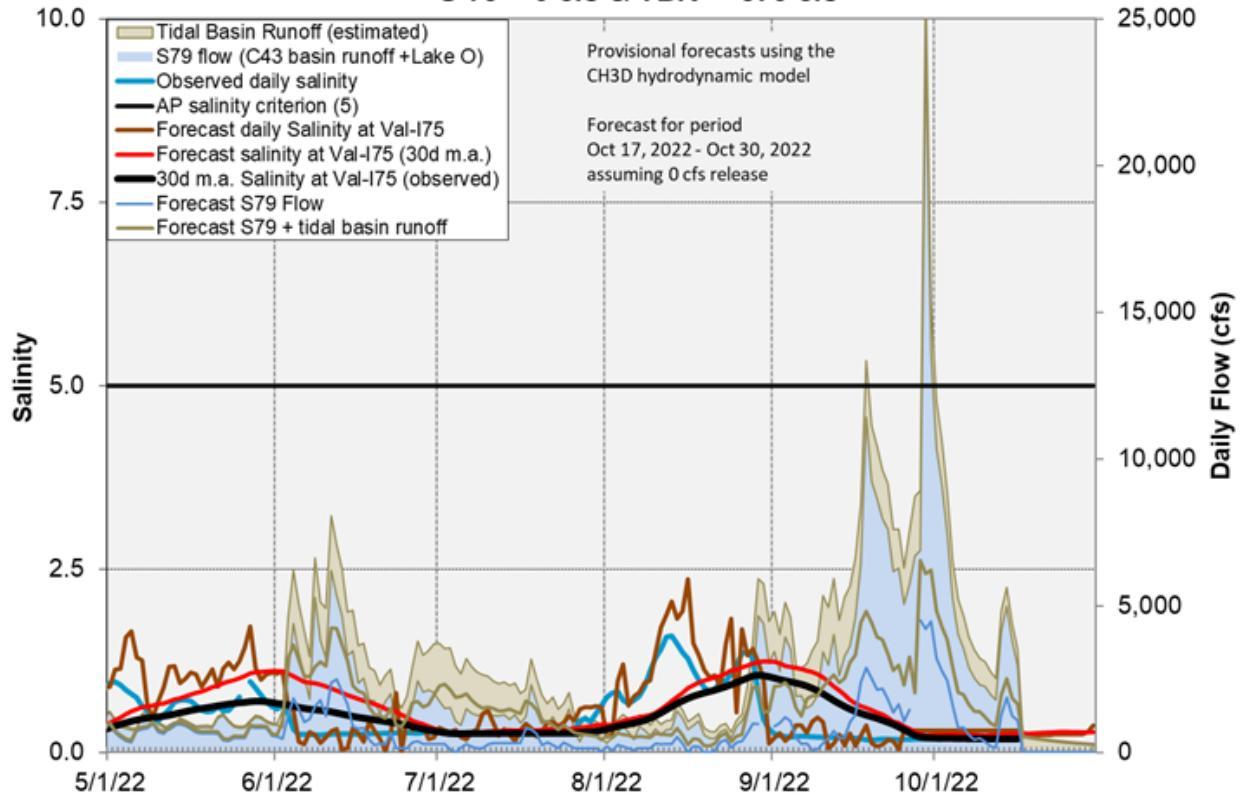
Figure ES-13. Forecasted Val I-75 site surface salinity assuming no pulse release at S-79.

and steady releases at 2,000 cfs with estimated tidal basin inflows of 376 cfs. Model results from all scenarios predict daily salinity to be 0.4 or lower and the 30-day moving average surface salinity to be 0.3 or lower at Val I-75 at the end of the two-week period (**Table ES-3** and **Figure ES-13**). This keeps predicted salinities in the upper estuary within the optimal salinity range (0-10) for tape grass.

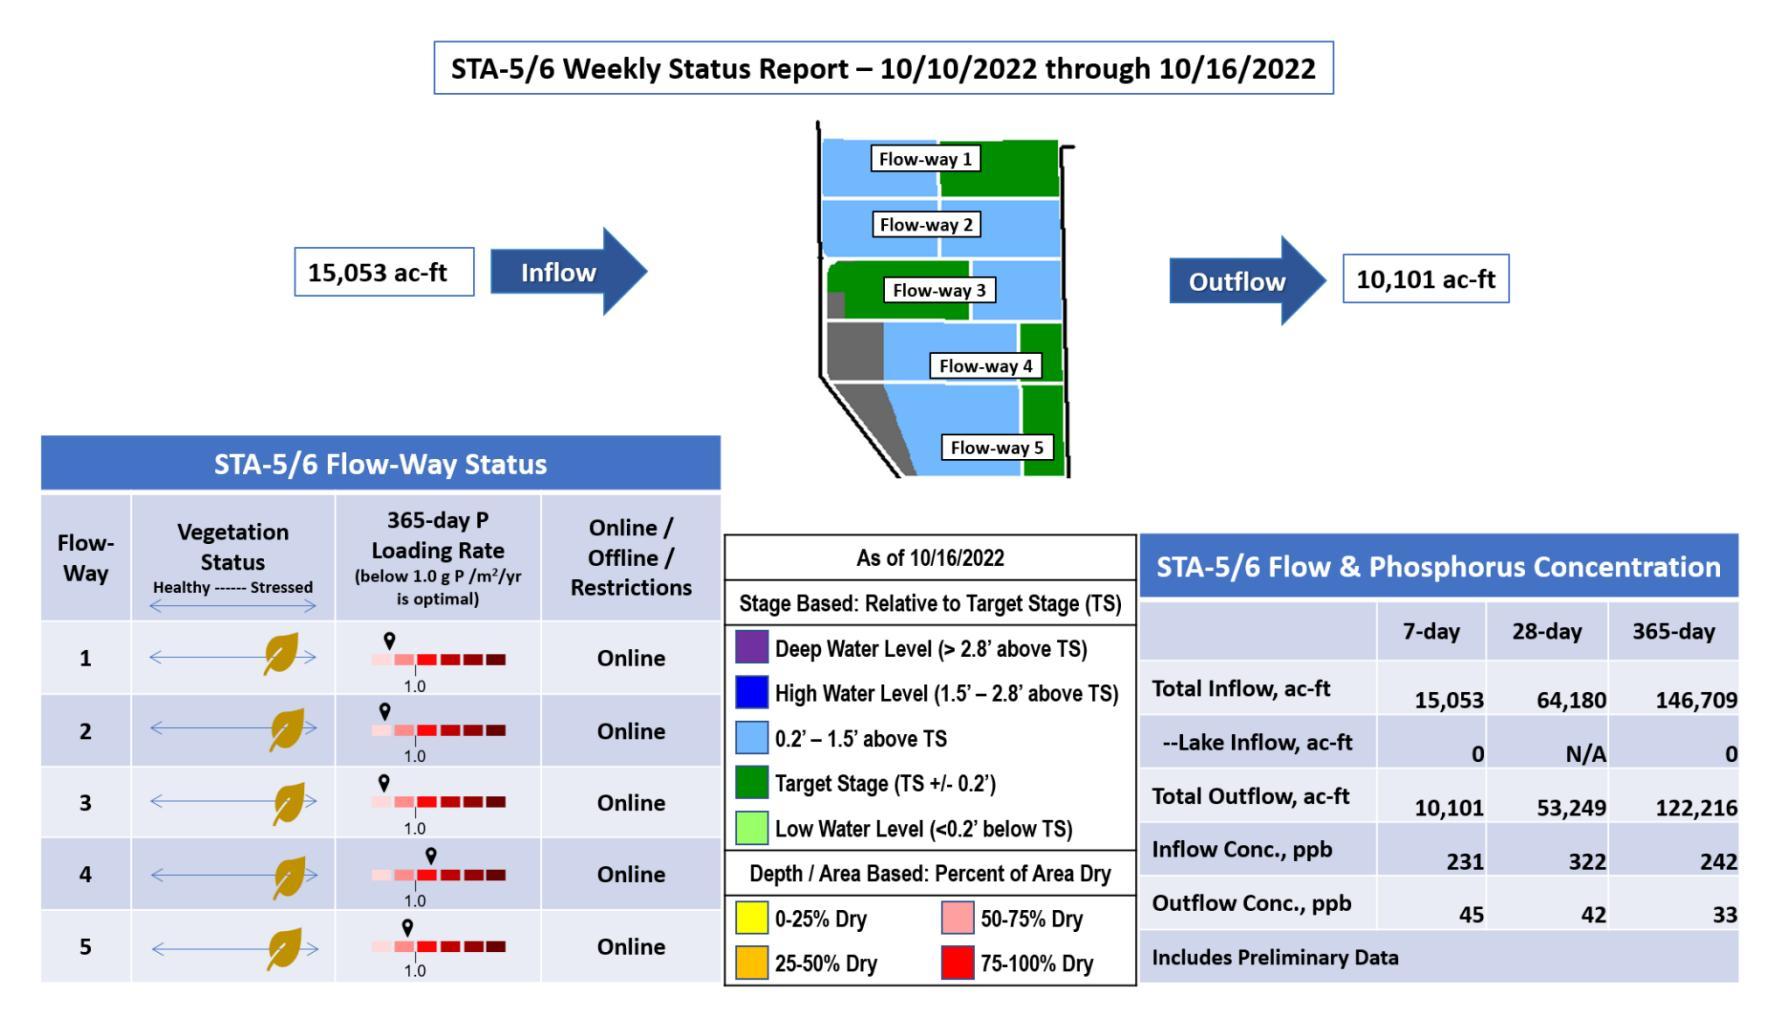
Figure S-5. STA-5/6 Weekly Status Report (Flow-ways 1 - 5)

**STA-5/6:** All flow-ways in STA-5/6 are online. Treatment cells are near or above target stage. All treatment cells have highly stressed vegetation conditions except Flow-ways 7 and 8 which are healthy. The 365-day PLRs for most flow-ways are below 1.0 g/m<sup>2</sup>/year, except Flow-way 4 which is high (**Figure S-5** and **S-6**).

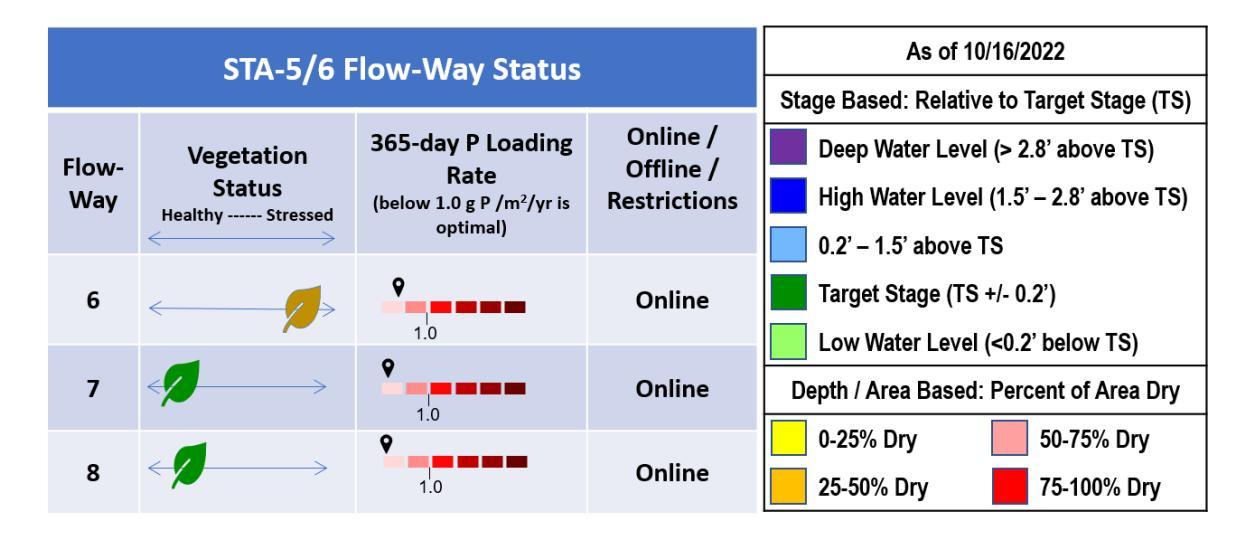
Figure S-6. STA-5/6 Weekly Status Report (Flow-ways 6 - 8)

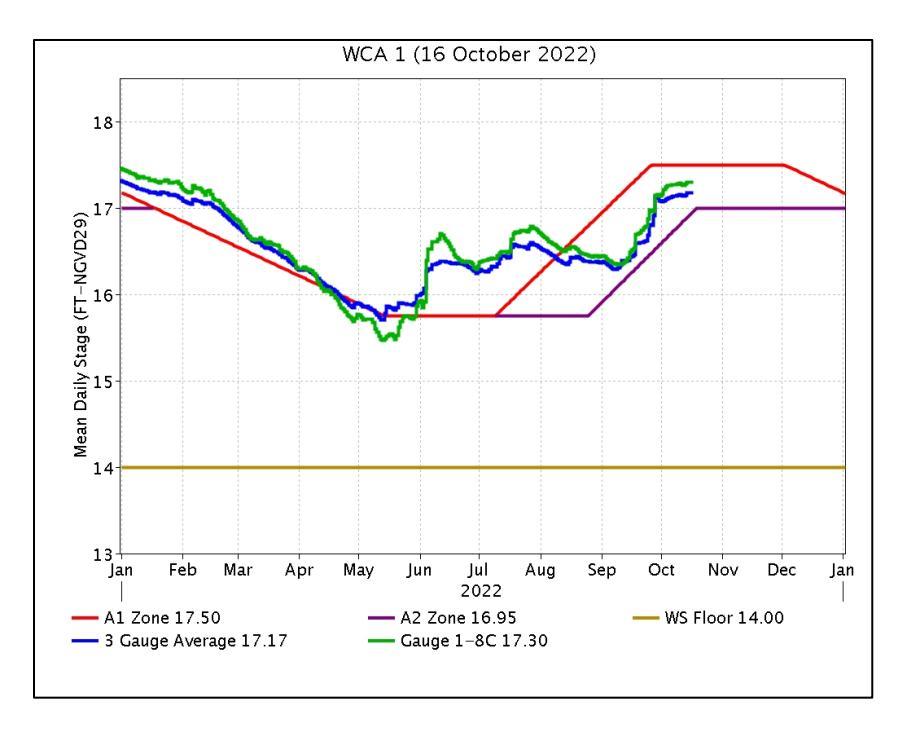
Figure EV-1. WCA-1 stage hydrographs and regulation schedule.

WCA-1: Stage at the 1-8C gauge rose slowly again last week. The average on Sunday was 0.18 feet below the flat Zone A1 regulation line. WCA-2A: Stage at the 2-17 gauge receded at the end of last week. The average on Sunday was 1.12 feet above the falling regulation line. WCA-3A: Last week the Three Gauge Average remained flat for most of the week. The average stage was 0.38 feet above the rising regulation line on Sunday. WCA-3A North: At gauge 62 (Northwest corner) stage continued to fall last week, the average on Sunday matched the flat Lower schedule line (**Figures EV-1** through **EV-4**).

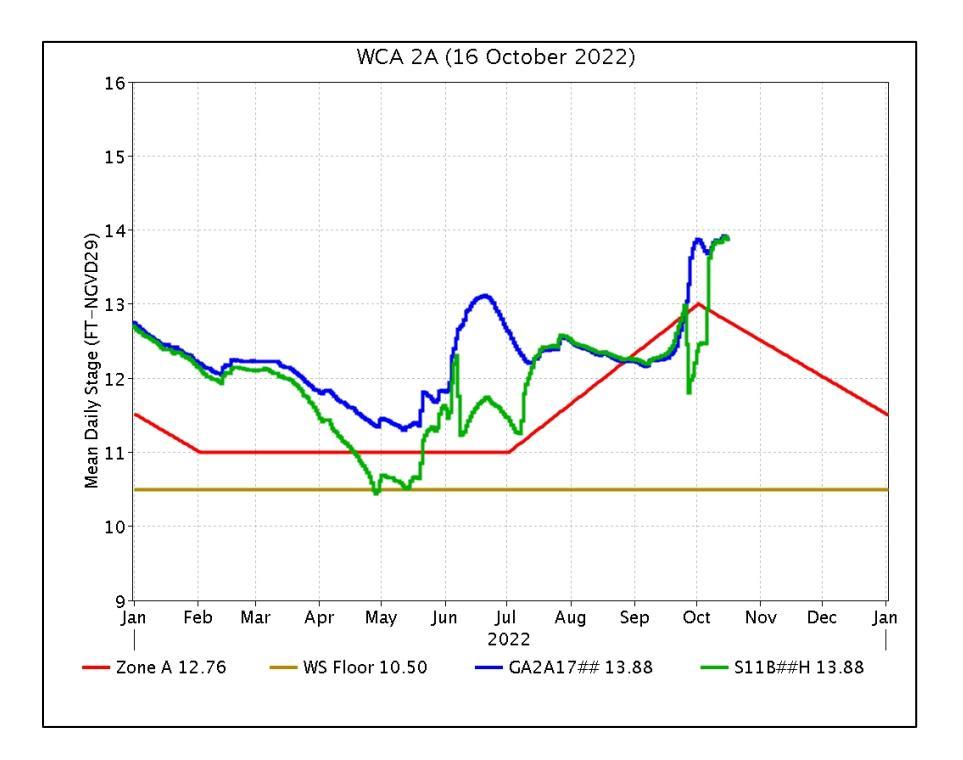
**Figure EV-2.** WCA-2A stage hydrographs and regulation schedule.

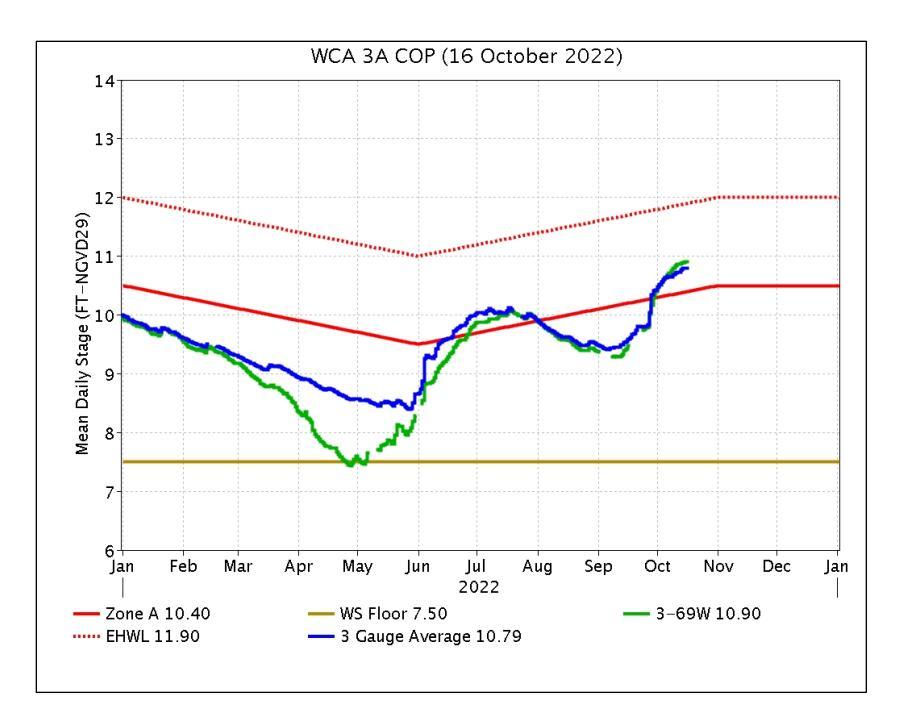
Figure EV-3. WCA-3A stage hydrographs (three-gauge average, S-333 headwater) and regulation schedule.

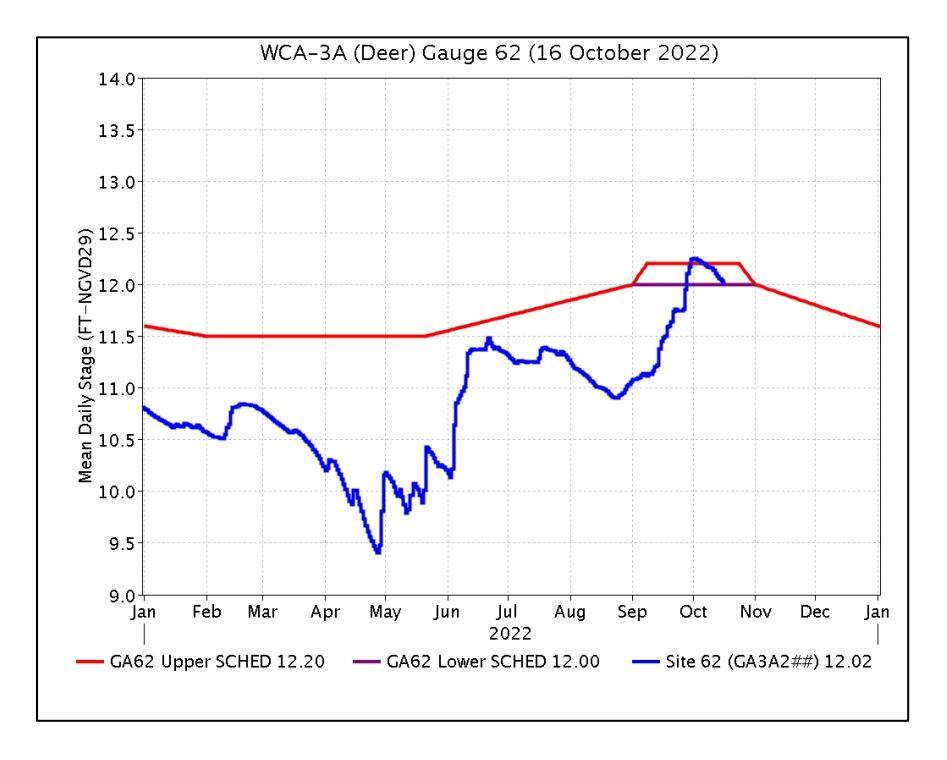
Figure EV-4. WCA-3A stage hydrograph (Deer gauge; Site 62) and CA62 regulation schedule.

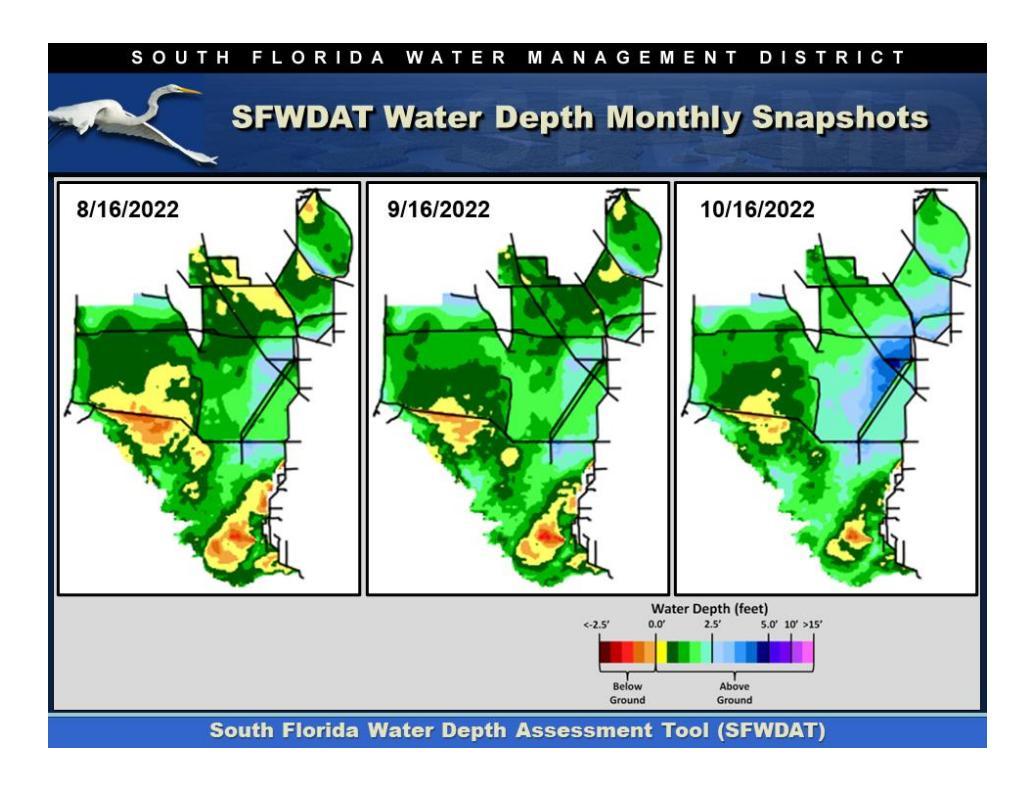
Figure EV-5. Everglades water depths from two months ago (left), one month ago (center) and present (right), based on SFWDAT.

The SFWDAT illustrates the change in water depths from tropical rainfall when comparing depths over the last two months. WCA-2A depths are above 2.5 feet in the southern region. Along the northern reach of the L-67s depths continue to increase and the spatial extent of those deeper conditions has expanded. Connectivity in the western sloughs of ENP continues to strengthen, while remaining strong in the east. Comparing current water depths to one month ago, conditions within the EPA are much wetter (eastern BCNP the exception), with significantly deeper conditions in eastern WCA-3A and southern WCA-2A. Looking back a year ago, WCA-1 and -2A are shallower; conditions are significantly deeper east of the Miami Canal in WCA-3A (**Figure EV-5 and Figure EV-6**). Comparing current conditions to the 20-year median: Above average conditions. ENP continues to experience drier than average conditions to the west and wetter than average in northeast Shark River Slough (**Figure EV-7**).

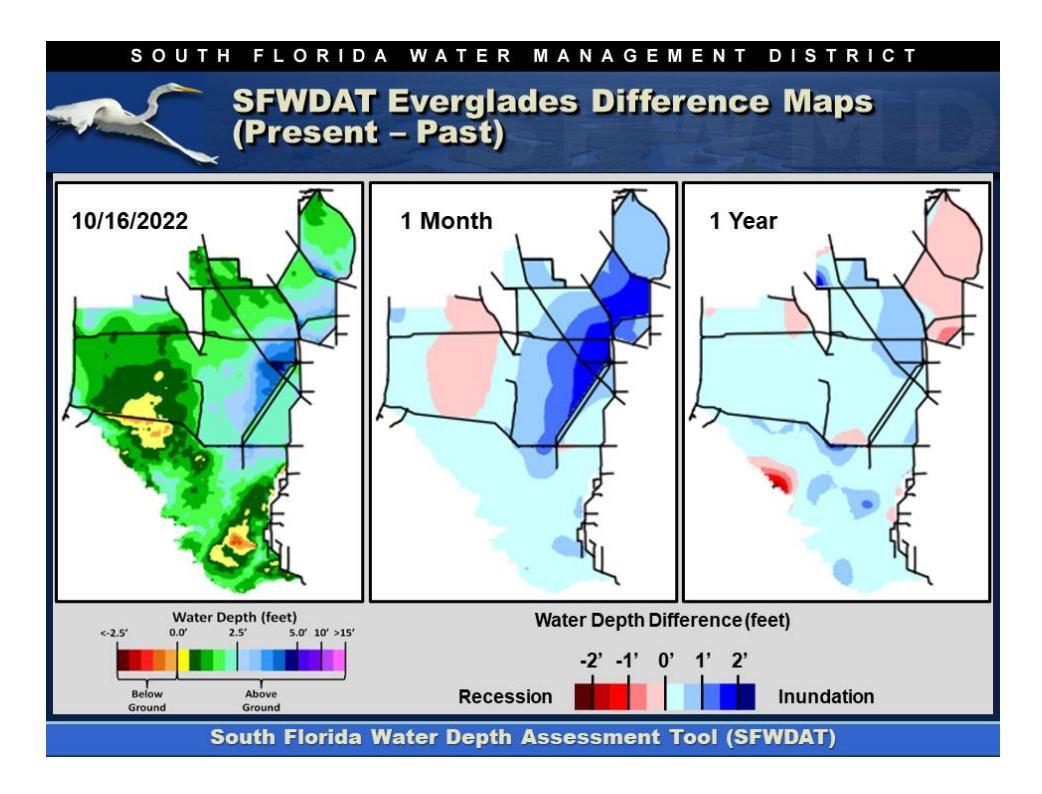
**Figure EV-6.** Present Everglades water depths (left) and water depth changes from one month (center) and one year (right) ago, based on SFWDAT.

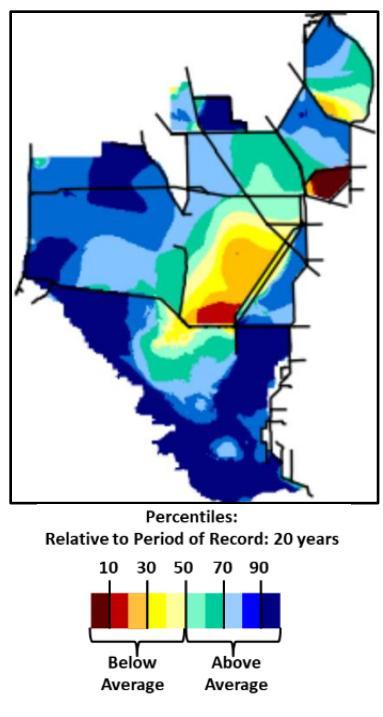
**Figure EV-7.** Present water depths (10/10/2022) compared to the day of year median over the previous 20 years.
