# MEMORANDUM

**FROM:** SFWMD Staff Environmental Advisory Team

**DATE:** October 19, 2022

**SUBJECT:** Weekly Environmental Conditions for Systems Operations

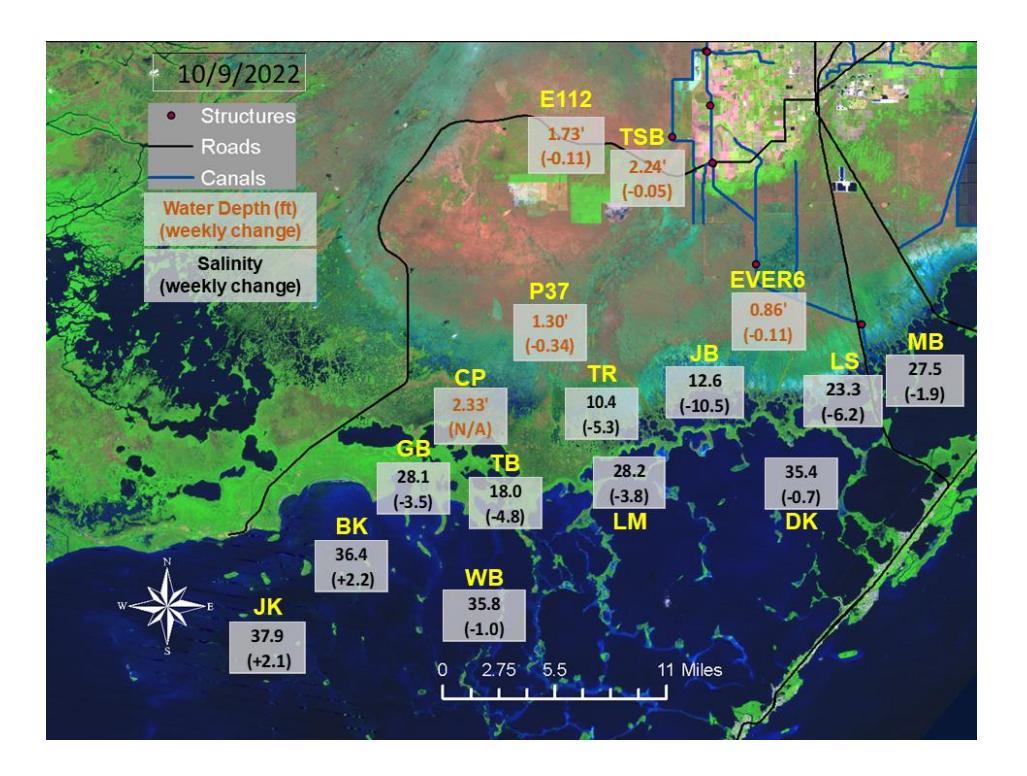
Figure EV-8. Taylor Slough water depths with changes since a week ago and Florida Bay salinities with changes since a week ago.

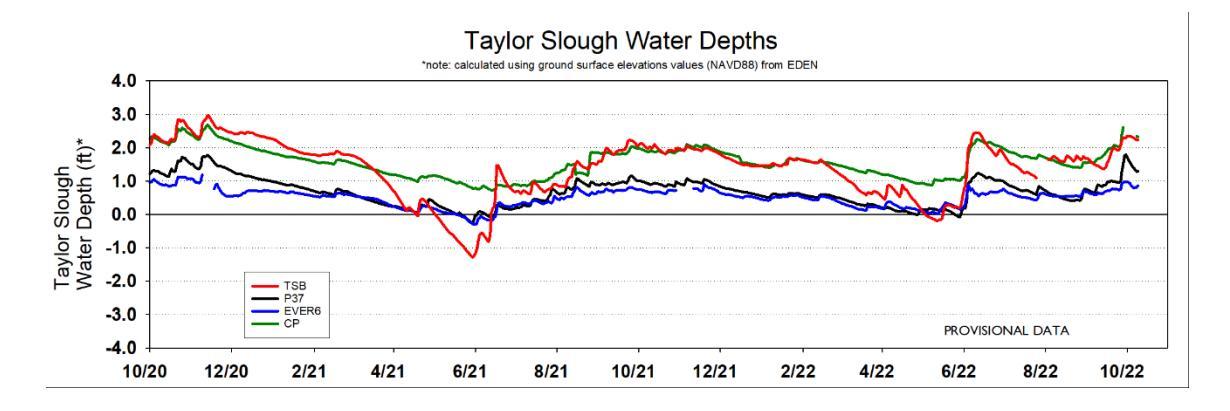
Figure EV-9. Taylor Slough water depth time series.

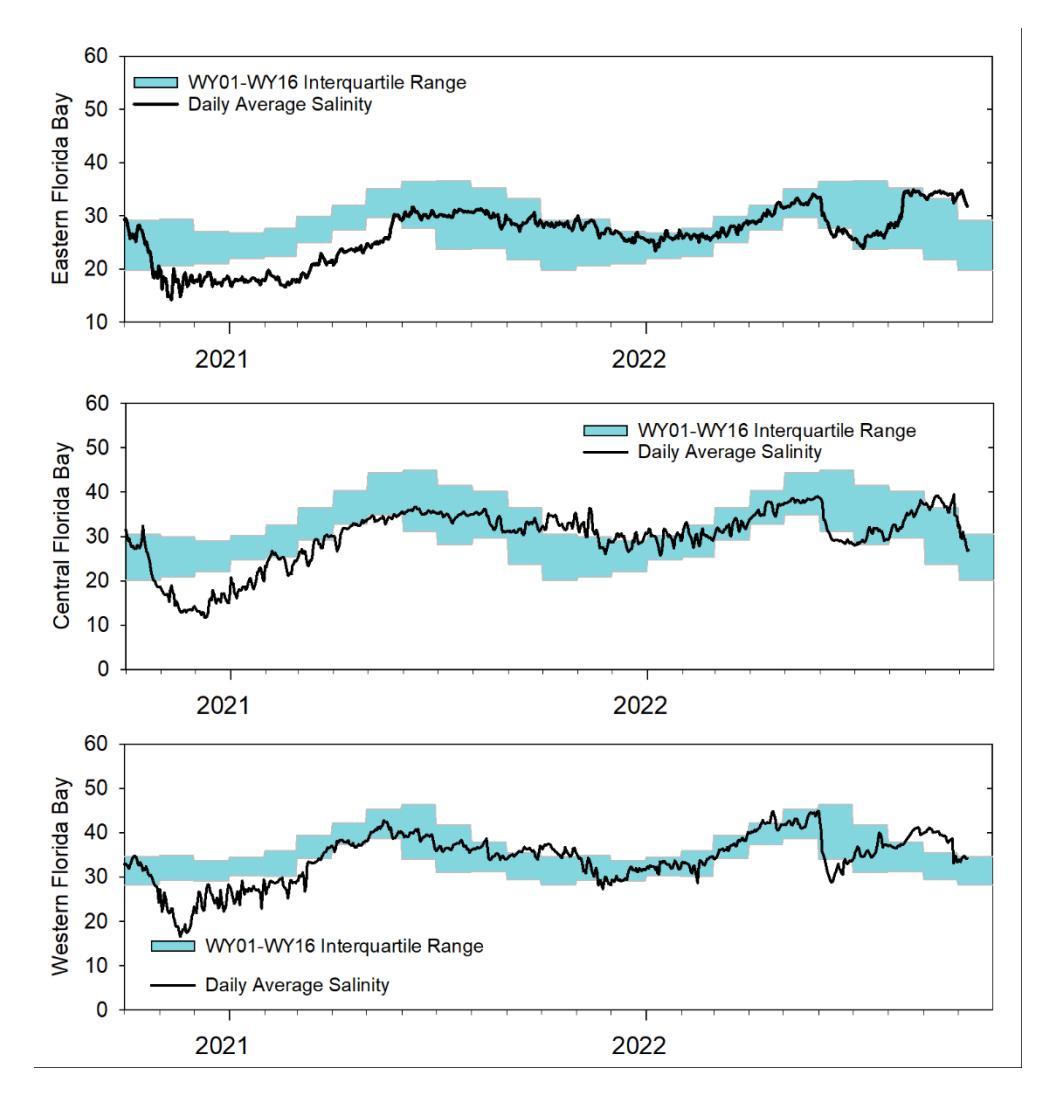
**Figure EV-10.** Eastern (top panel), Central (middle panel) and Western (bottom panel) Florida Bay daily average salinities with interquartile (25-75 percentile) ranges.

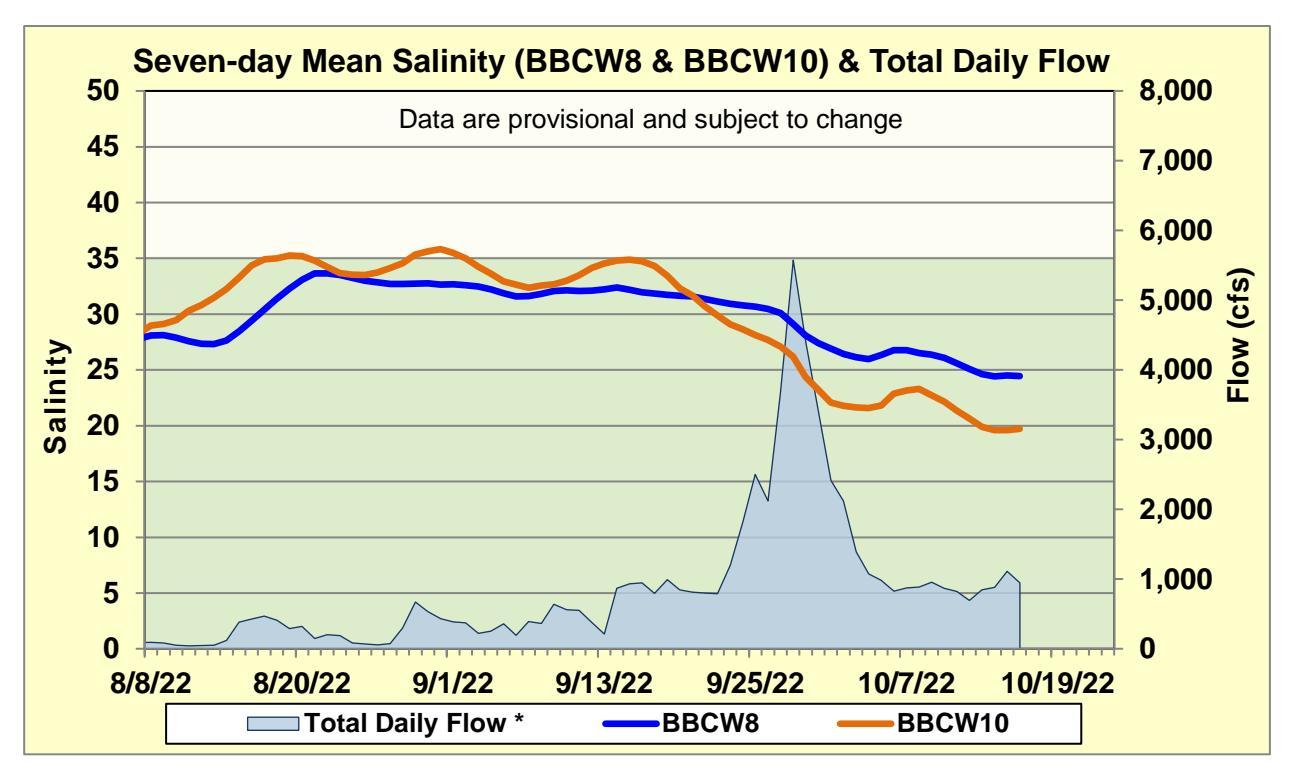
**Figure BB-1.** Seven-day mean salinity at BBCW8 and BBCW10 and total daily flow in Biscayne Bay. Total daily flow was calculated using flow from structures S20G, S20F, S21, S21A, S123, and S700P.

As shown in **Figure BB-1**, mean total inflow to Biscayne Bay was 881 cfs and the previous 30-day mean inflow was 1,582 cfs. The seven-day mean salinity was 24.3 at BBCW8 and 19.5 at BBCW10, both below the preferred maximum salinity of 35 for these sites. Data provided by Biscayne National Park.
